**An Archaeological Evaluation at 7 King Street, Sileby, Leicestershire.**

**ULAS Report No: 2021-096**

**Client:** UCR Construction & Development Ltd

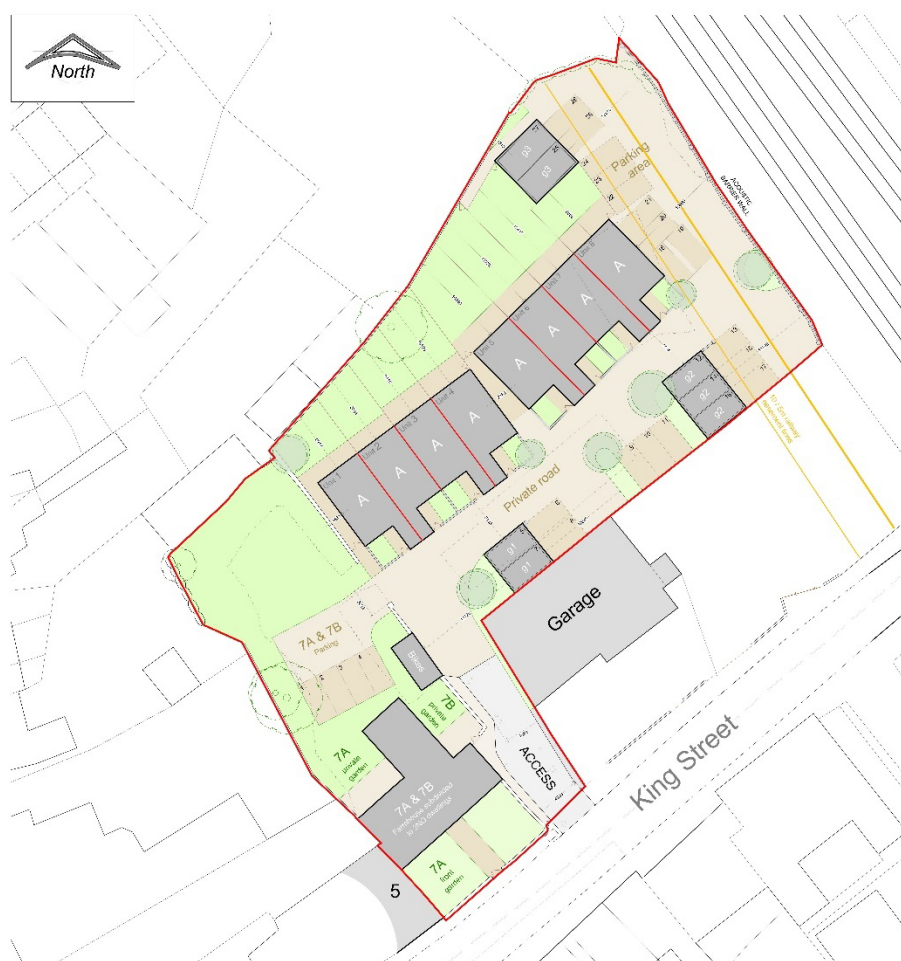
Figure 3: Proposed development plan (provided by client)

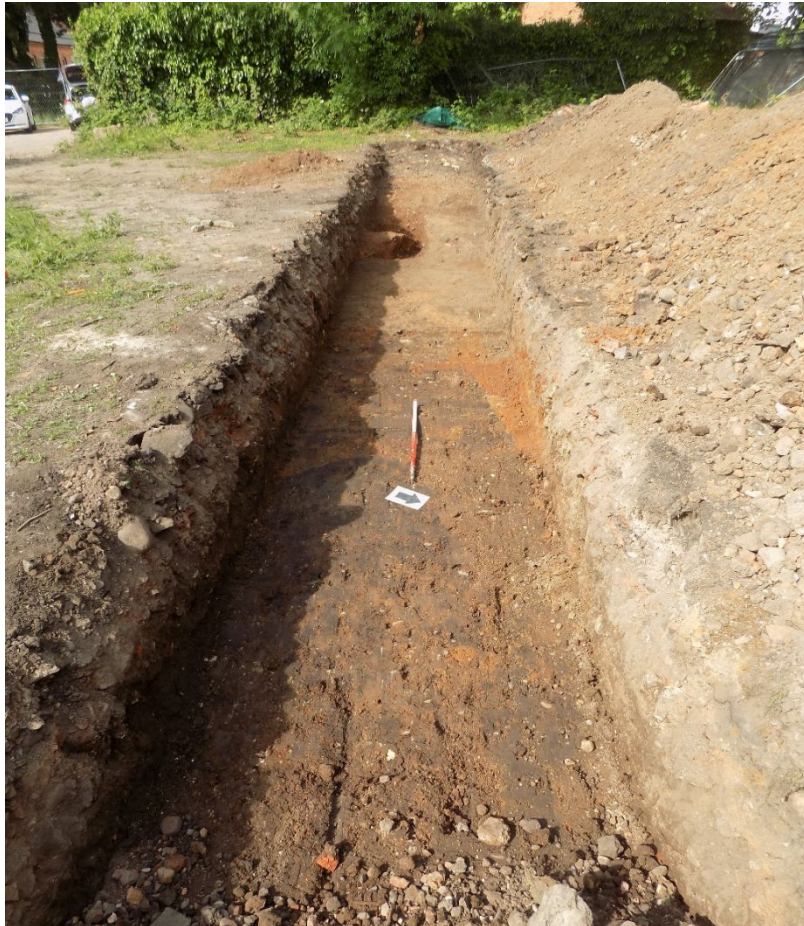
Figure 6: Trench 1: general view west (1m scale)

Trench 1 measured 15m x 1.60m and was aligned northeast to southwest and positioned in the open area west of the ruinous farm building in order to target the footprint of the western of the two proposed terraced residential blocks (Figure 6, Figure 7).

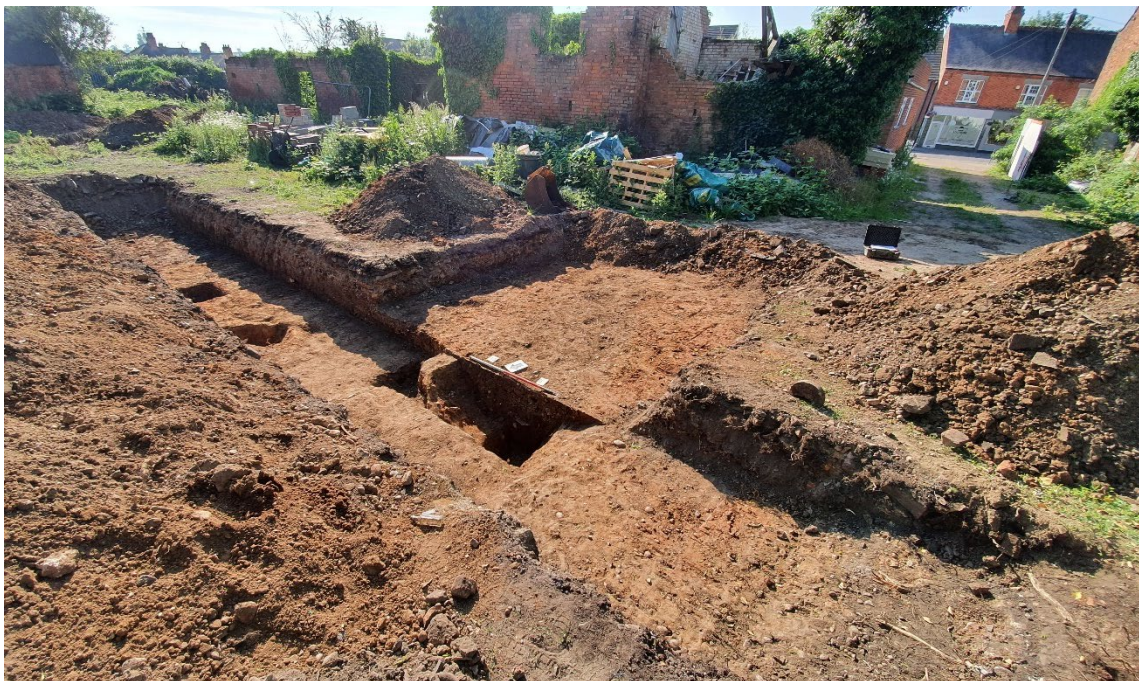
Figure 7: Trench 1: general view southeast (1m scale)

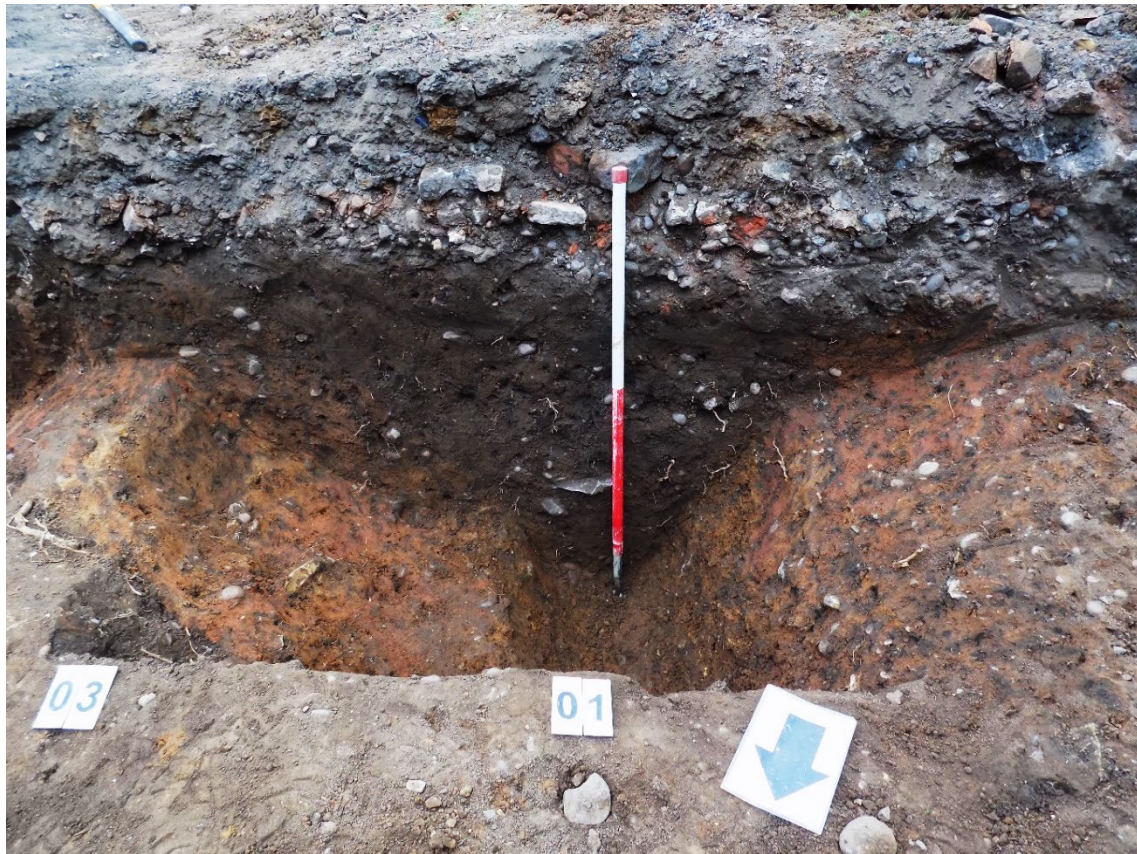
Figure 8: Ditch [01]/[03]; 1m scale

Machine removal of 0.30m-0.40m of mixed pale grey sandy clay loam and brick and masonry rubble overburden revealed, at the western end of the trench, dull reddish brown sandy natural clay. A single substantial ditch **[01]** traversed the trench on a northwest-southeast alignment *c.*2m from the west end of the trench (Figure 8, Figure 9). Its single mixed mid-grey and mid-brown clay silt fill **(02)** produced a single bead and flanged bowl rim pottery sherd dating to the later Roman period (AD 250 to 400) as well as several Roman roof tile fragments. The feature had moderately sloping sides to a narrow concave base. The ditch appeared to have been a recut of an earlier linear **[03]**, the mid orange-grey clay silt fill **(04)** of which produced

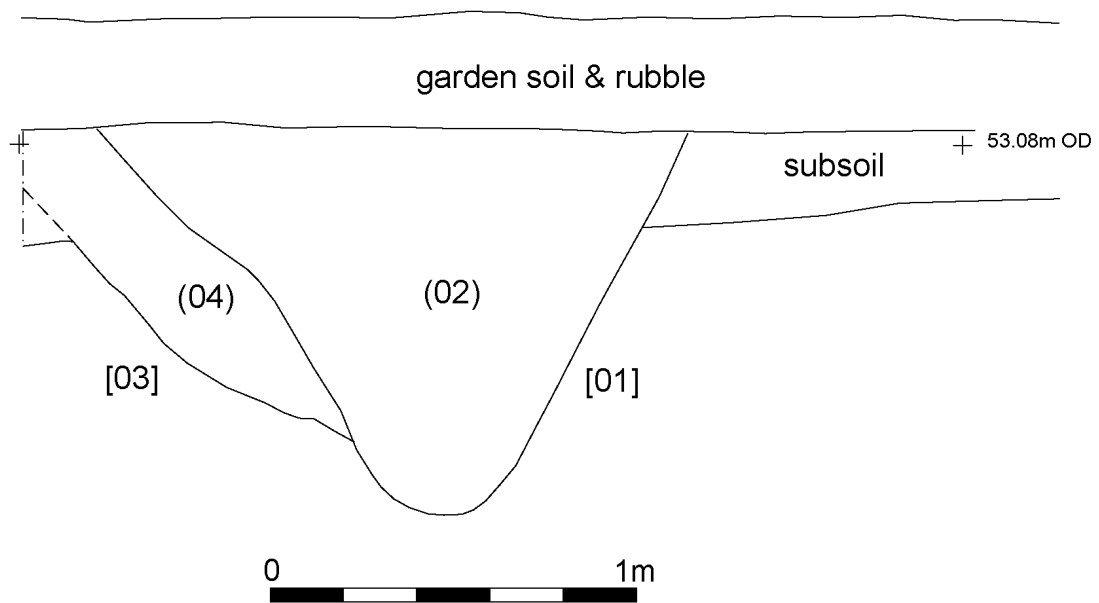
Figure 9: Ditch [01]/[03] section

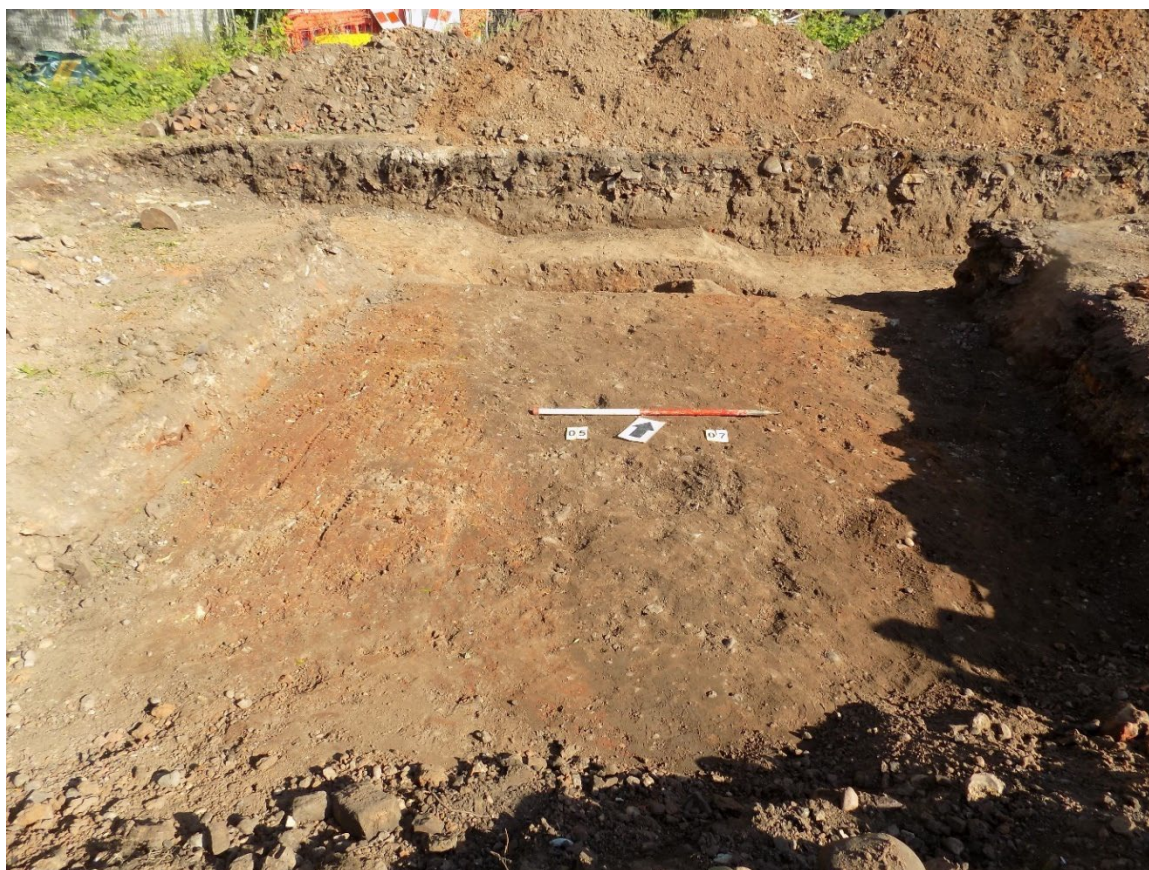
Figure 10: Trench 1 extension, looking south (1m scale)

no dating evidence. The extension of the trench southeast in order to incorporate the full footprint of the proposed building enabled the ditch to be traced for a further 5m (Figure 10).

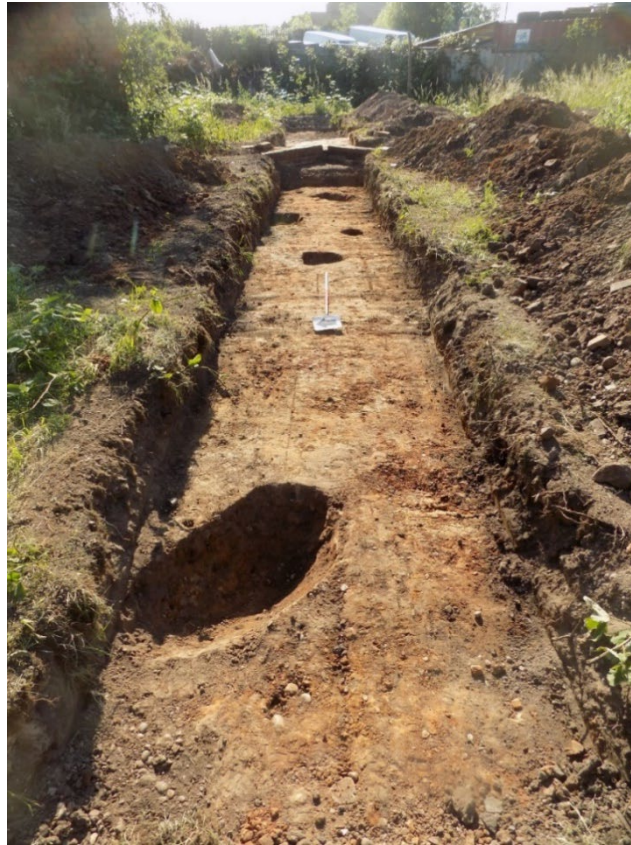
Figure 12: Trench 2: general view east (1m scale)

Trench 2 (15m x 1.60m) was orientated approximately east to west and located in the eastern part of the site, targeting the area between the former farm buildings. The eastern end of the trench was occupied by the brickwork footings and foundations to the demolished building formerly connecting the two extant adjacent 19th century farm structures in a courtyard arrangement. The structure comprised brick-built wall footings (09), (10) and (11) in a corner angle arrangement with an associated unmortared brick floor (12) (Figure 11, Figure 12, Figure 13, Figure 14). Machine removal of the building following recording revealed no archaeology.

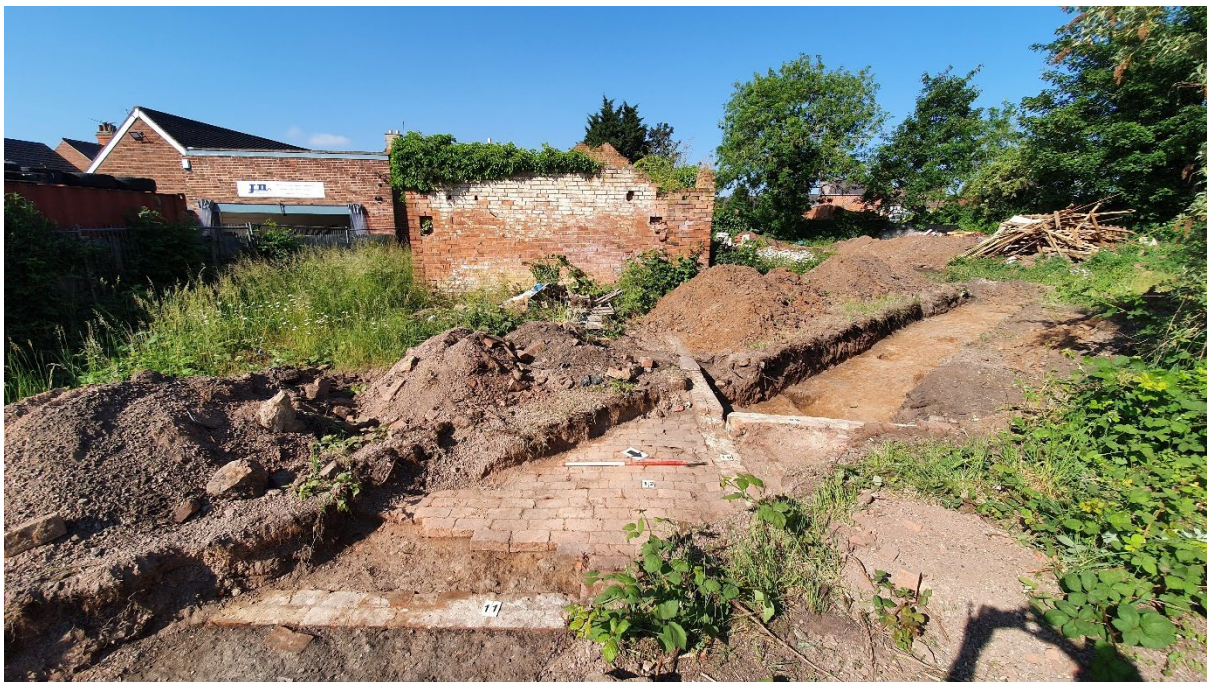
Figure 13: Trench 2: east end of trench; view west (1m scale)

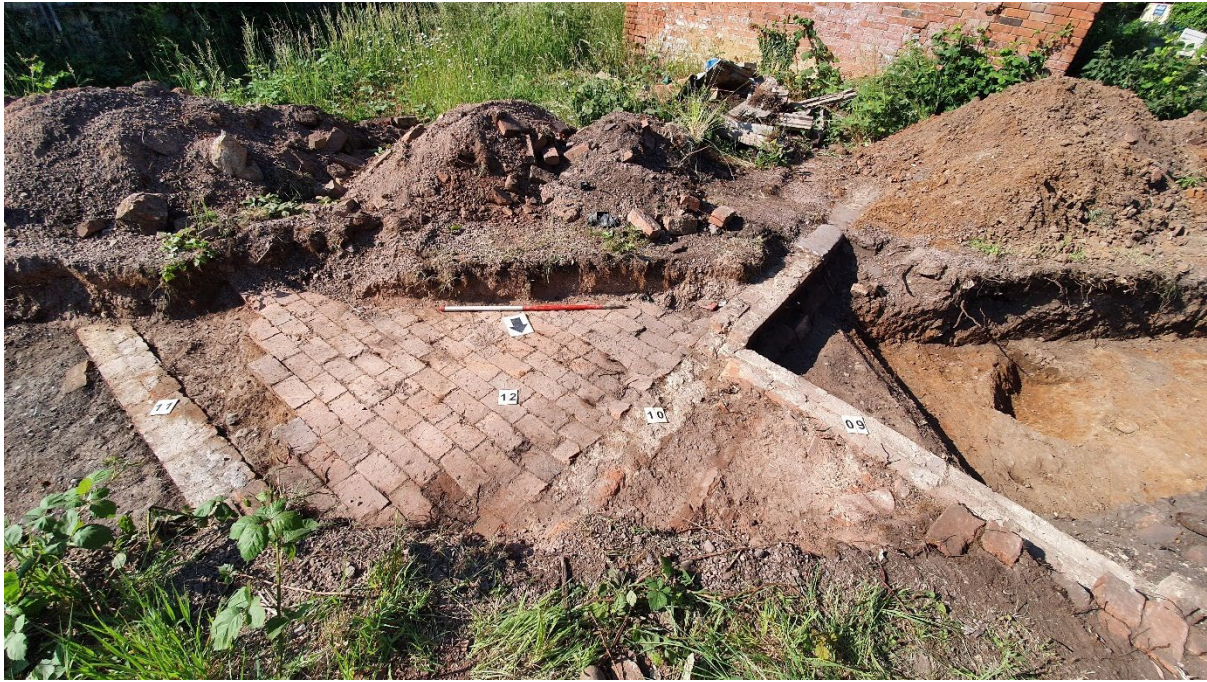
Figure 14: Trench 2: farm building foundations

Analysis of historic maps of the site in the desk-based assessment indicated that the farm buildings had originally been linked in a courtyard arrangement (Pollington 2017). Trench 2 provided physical evidence of this, in the form of the brick foundations of the now-demolished structure formerly linking the two standing 18th/19th century farm buildings (see also Hyam 2021). There were few indications of the existence of archaeology, with the exception of an undated ditch and two truncated pits or scoops.

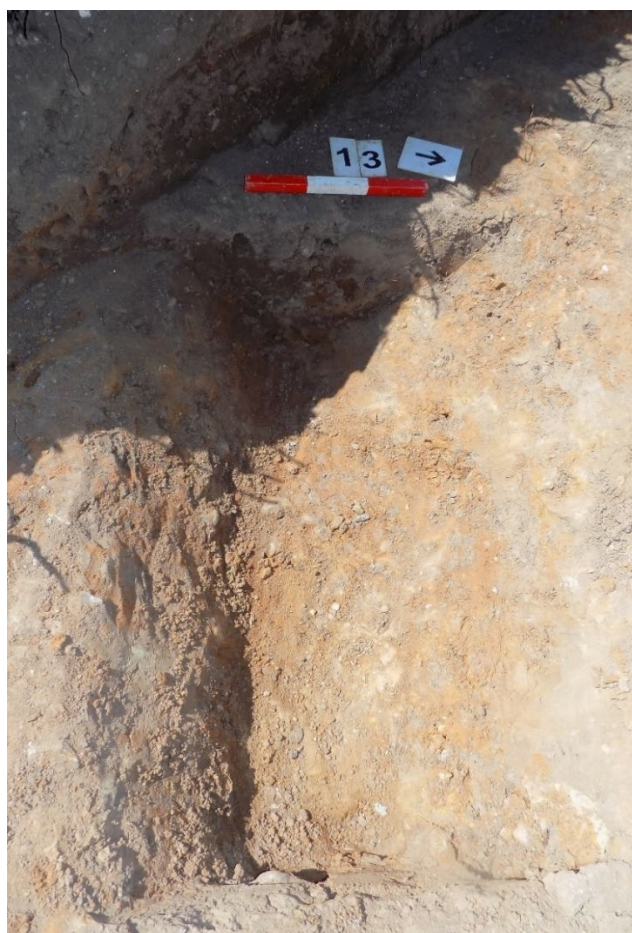
Figure 16: Ditch [13]; view west (15cm scale)

The western half of the trench was occupied by shallow undated features cutting the sandy clay natural, sealed by a 0.08m-0.10m accumulation of grey-brown sandy silt clay subsoil (Figure 15). Ditch [13] measured 0.60m wide, 0.28m deep and with 45° sides to a concave base. The linear ran on a northeast-southwest alignment, parallel to wall (10). Its single mid grey clay silt fill (14) produced no finds (Figure 16). Two additional small scoops or pits [15] and [17]

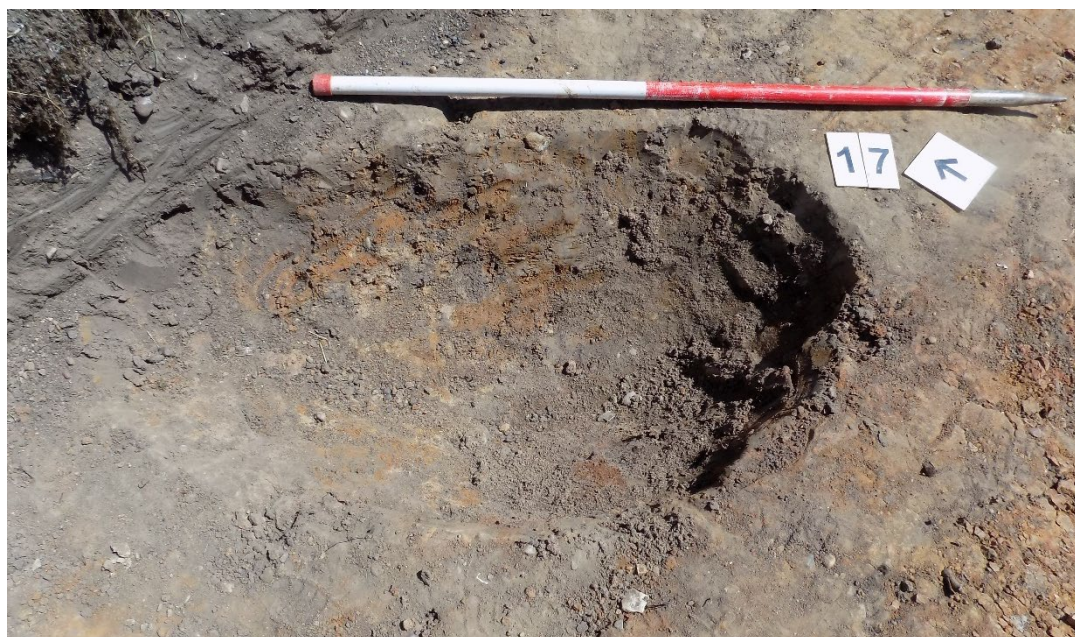
Figure 18: Feature [17]; view northeast (1m scale)

(1m x 0.50m+ x 0.18m and 1.15m x 0.60m x 0.25m respectively) produced no finds (Figure 17 & Figure 18).

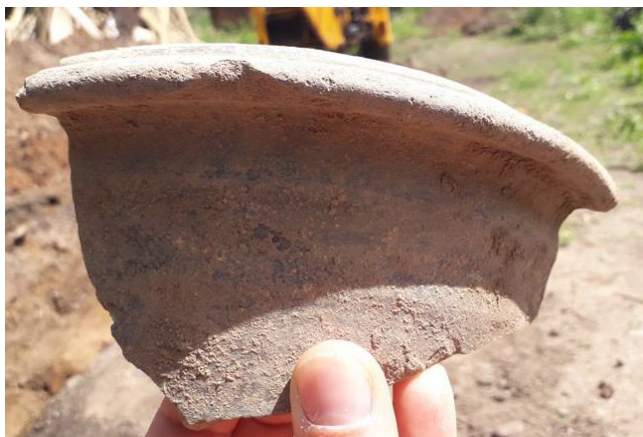
Fig.1 bead and flanged bowl from late Roman ditch (2) [1]

The rim of a bead and flanged bowl (243g) manufactured in a grey ware fabric (Leics. code GW5) dates to the later Roman period (c.AD 250-400) (Fig.1). From the same context came
