**A Level 3 Historic Building Survey at
The Knighton Street Offices,
Leicester Royal Infirmary,
Leicester
NGR: SK 58694 03539**

**ULAS Report No 2021-143
©2022**

Site Name: Knighton Street Offices, Leicester Royal Infirmary.

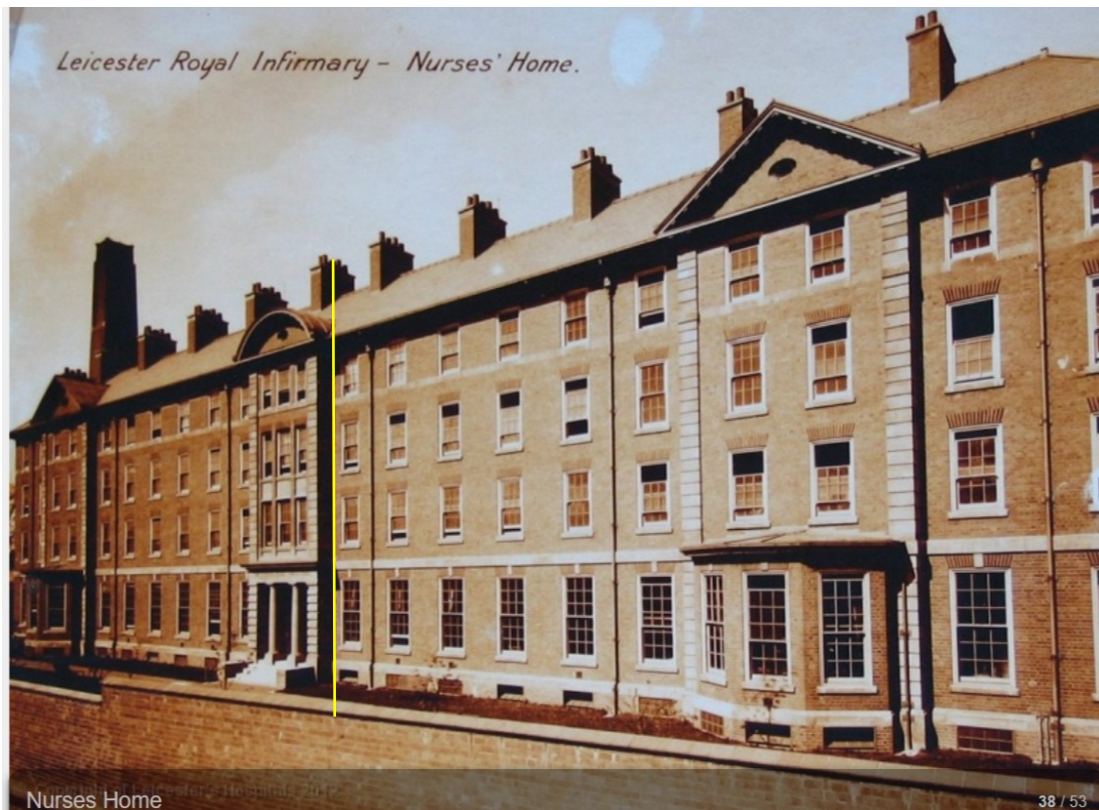
Figure 5 The Edward Wood Nurses' Home as built in 1910

The low brick wall in the foreground marks the line of Knighton Street. Only the building to the right of the yellow line remains – see Figure 18

Initially the nurses' home consisted of an E-shaped structure with the main axis following the line of Knighton Street (Fig. 5). Subsequent years saw additional wings and rear elements being added until a maximum size was reached in the 1950s. The growth of the hospital complex meant that in later years the nurses' home has been reduced in size leaving only around 40% of the original. The growth of the building is discussed in more detail in the cartographic section below.

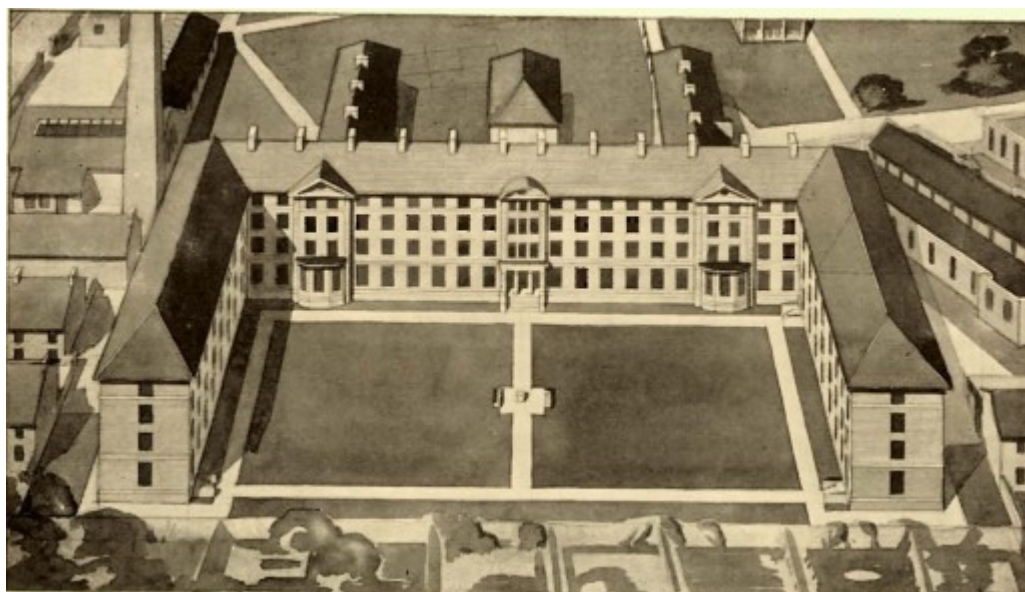
Figure 11 Architect's drawing on the full building
The final building differed in detail but not in size or extent. Source J. Currington, LRI

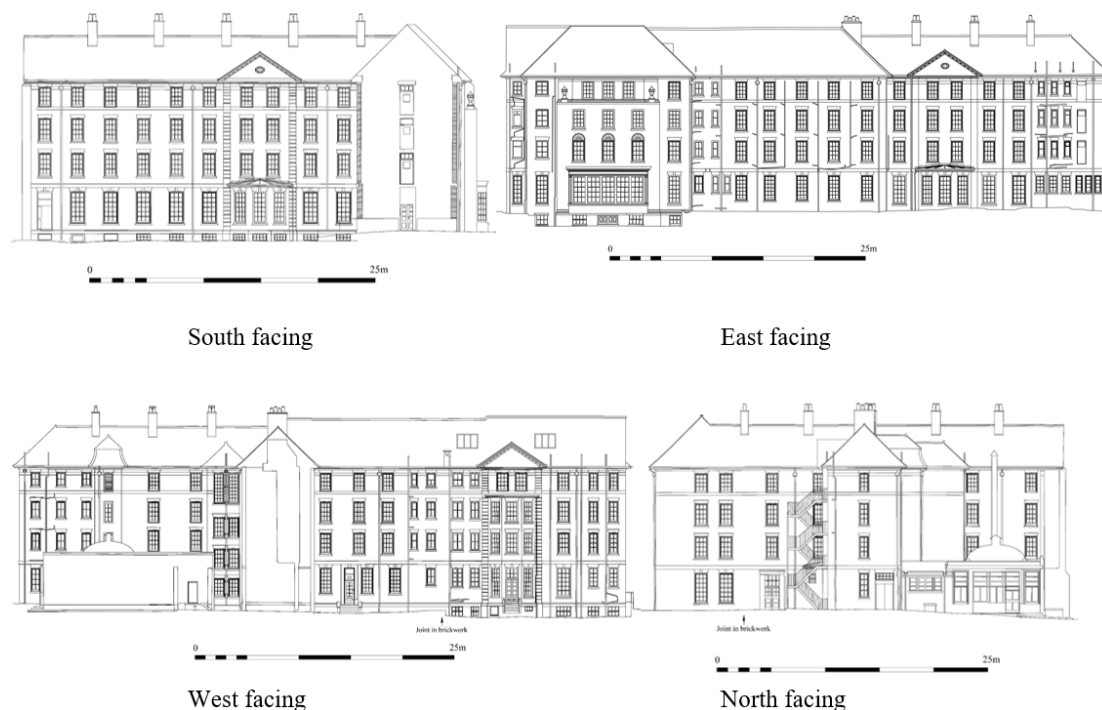
Figure 13 Principal elevations

Modified from drawings supplied by Client. See Appendix 1 for larger scale drawings

Architectural drawings of each elevation were created for the client and modified for the requirements of this report. All of the elevations are shown in Appendix 3 of this report. Plans of each floor are shown in the results section below.

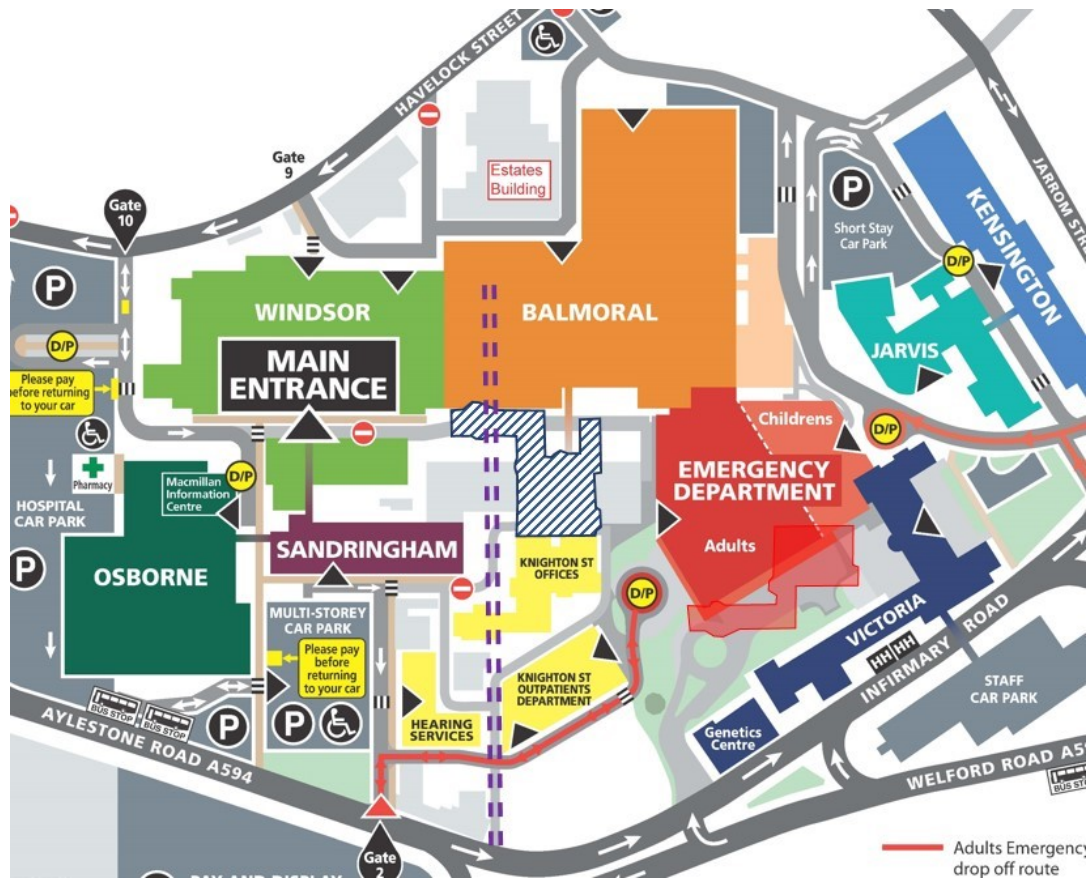
Figure 14 Location of the entire nurses’ home within the hospital North to right of picture. Knighton Street Offices shown in centre of site in yellow. Demolished portion and full extent of entire building shown in blue hashed outline. Line of Knighton Street shown as purple dots. Source: Modified from Leicester Royal Infirmary map

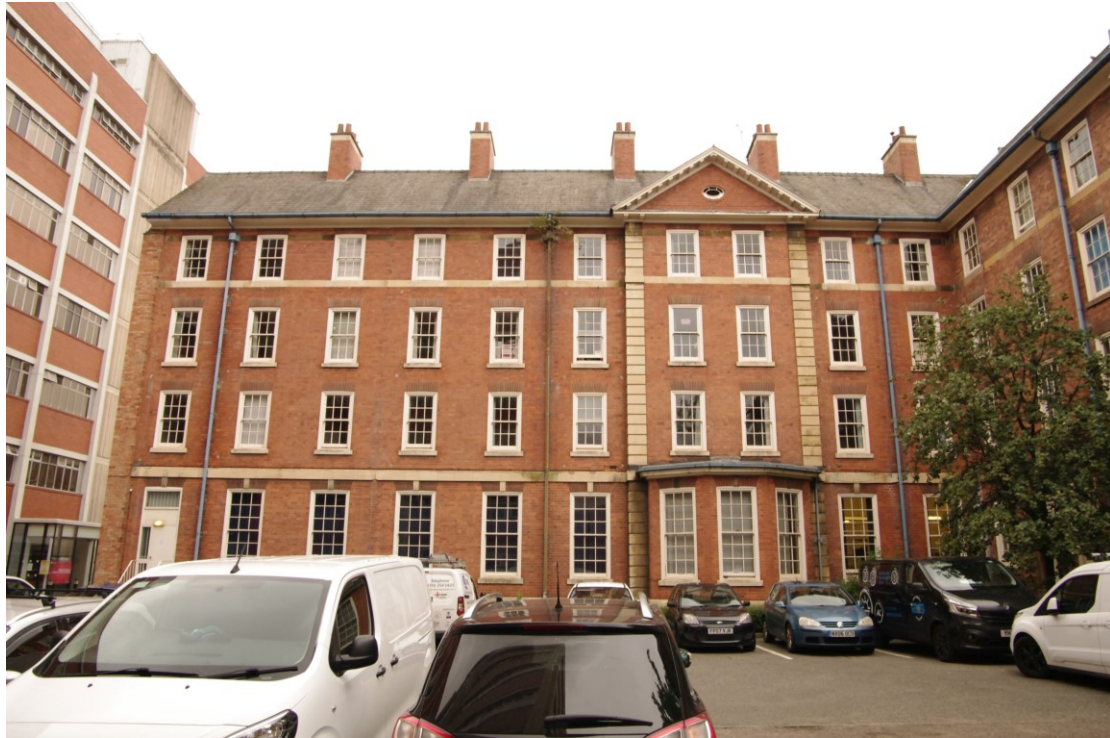
Figure 19 South facing elevation of the 1910 range
Looking north. The original main entrance was to the left of the current edge of
building. Compare with Fig. 5. See also Appendix 1

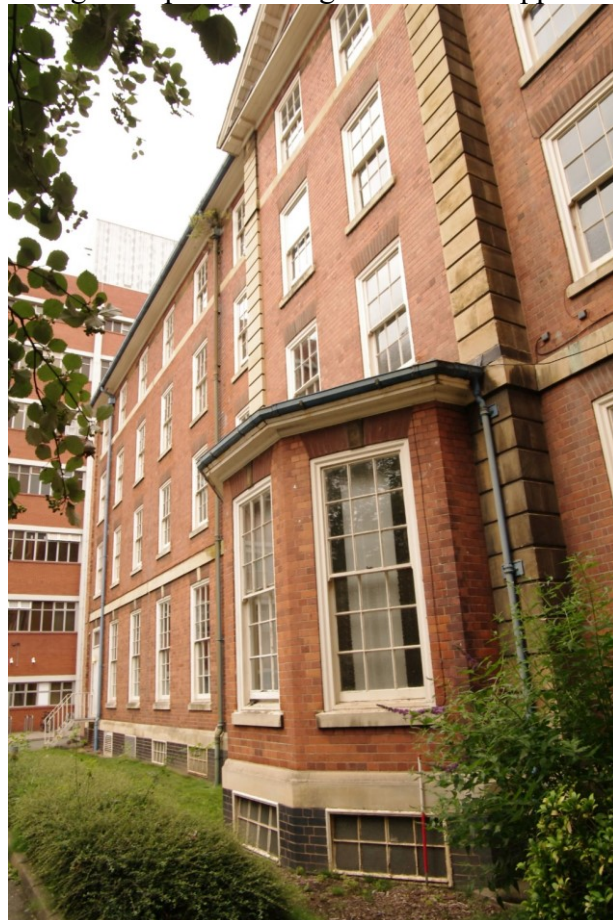
Figure 20 Bay on south facing elevation of 1910 range
Looking north-west. 1m scale

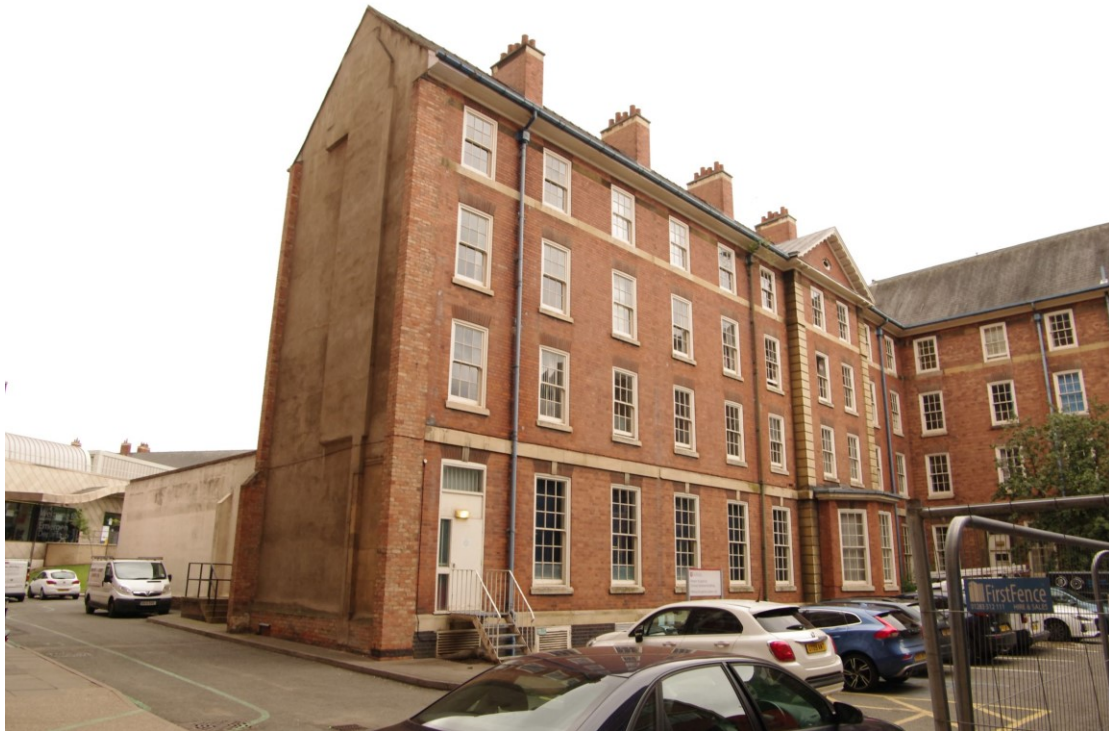
Figure 21 South facing elevation of the 1910 range
Looking north-east. Later east wing extension on right

The removal of the western part of the building has resulted in a crude west facing elevation covered with grey cement render and modern non-matching Fletton type bricks (Figs 21 and 22). On the north side of the 1910 range this scarring left by the partial demolition shows where one of the central rear wings extended to the south. The map shows that this missing wing was slightly wider than the flanking wings and may have had an important entrance facing towards the hospital site. One of the former light wells remains with windows on each floor facing westwards into it (Fig. 23). Because of the demolition only part of the light well remains. A single storey connecting corridor runs to the north of this light well and, presumably, ran the entire length of the building.

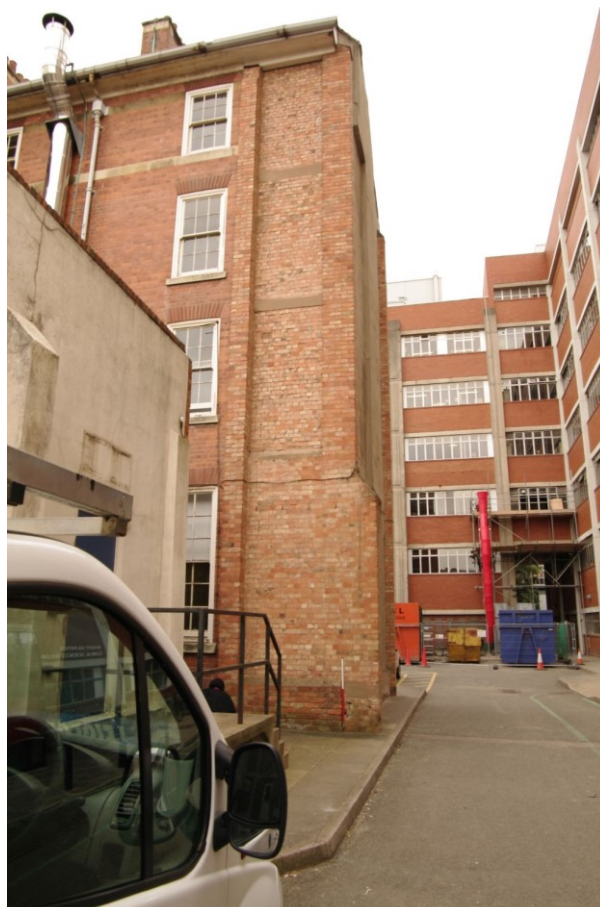
Figure 22 Scarring left on north side of 1910 range
Note the new bricks on the right mark where one of the rear ranges extended towards the white van in the foreground. Looking south. 1m scale

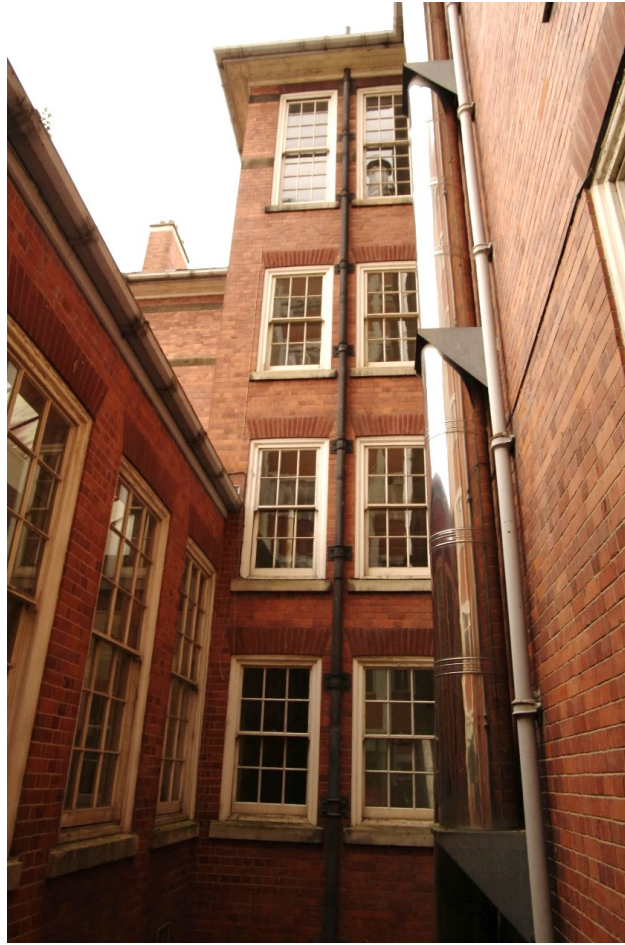
Figure 23 North side of the 1910 range. Former light well
Looking east

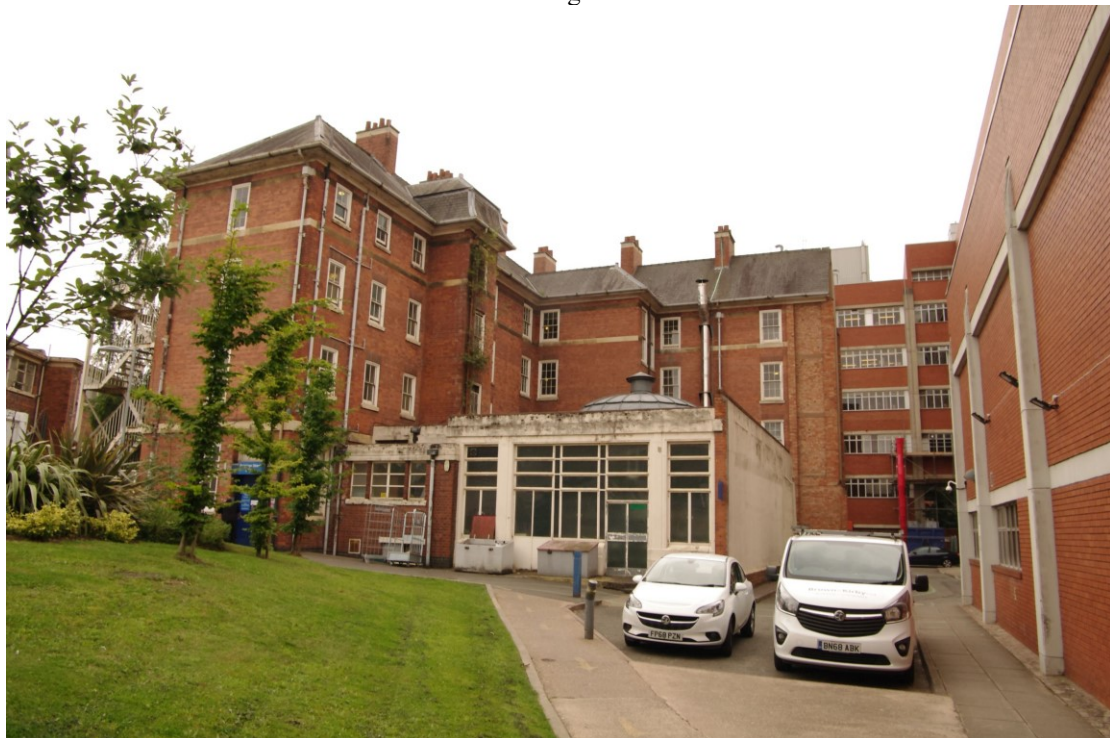
Figure 24 Rear of the 1910 range and 1930s theatre
Looking south-east. Clinical Sciences building on right.

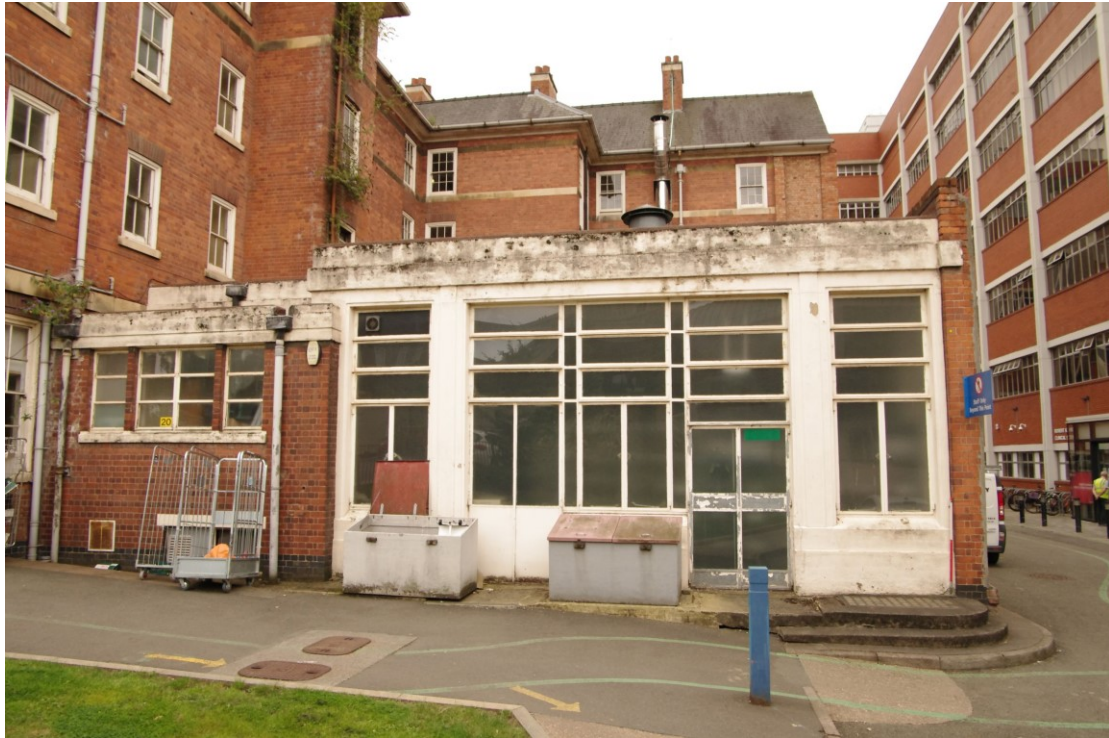
Figure 25 Close-up of the north facing elevation of the theatre
Looking south

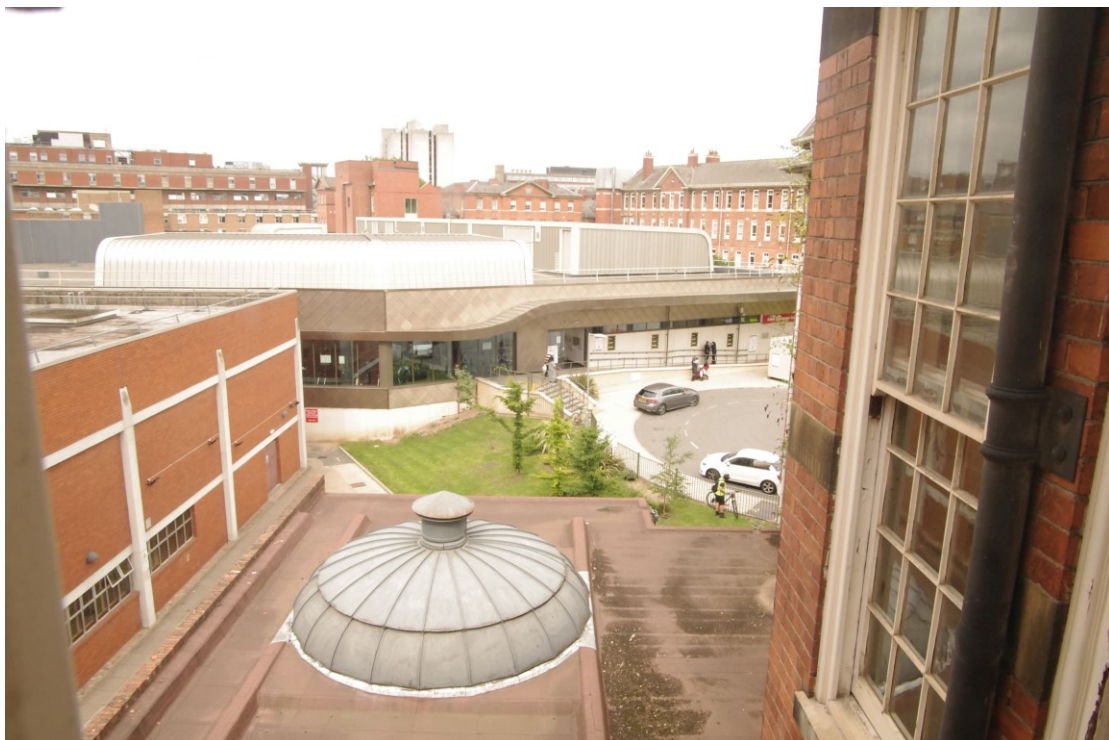
Figure 26 Round dome rooflight of the recreation room
Looking north from second floor. Original hospital buildings on far right

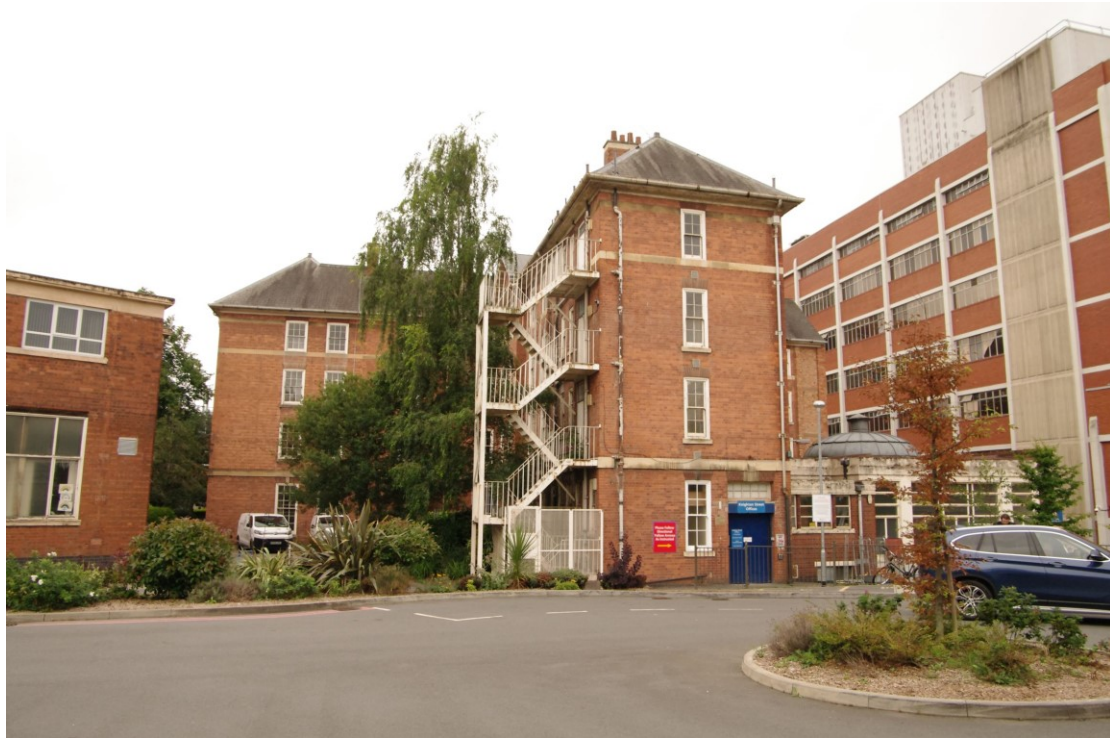
Figure 27 Rear, eastern, wing of the 1910 range
Looking south-west. Corner of Knighton Street Outpatients Building on left

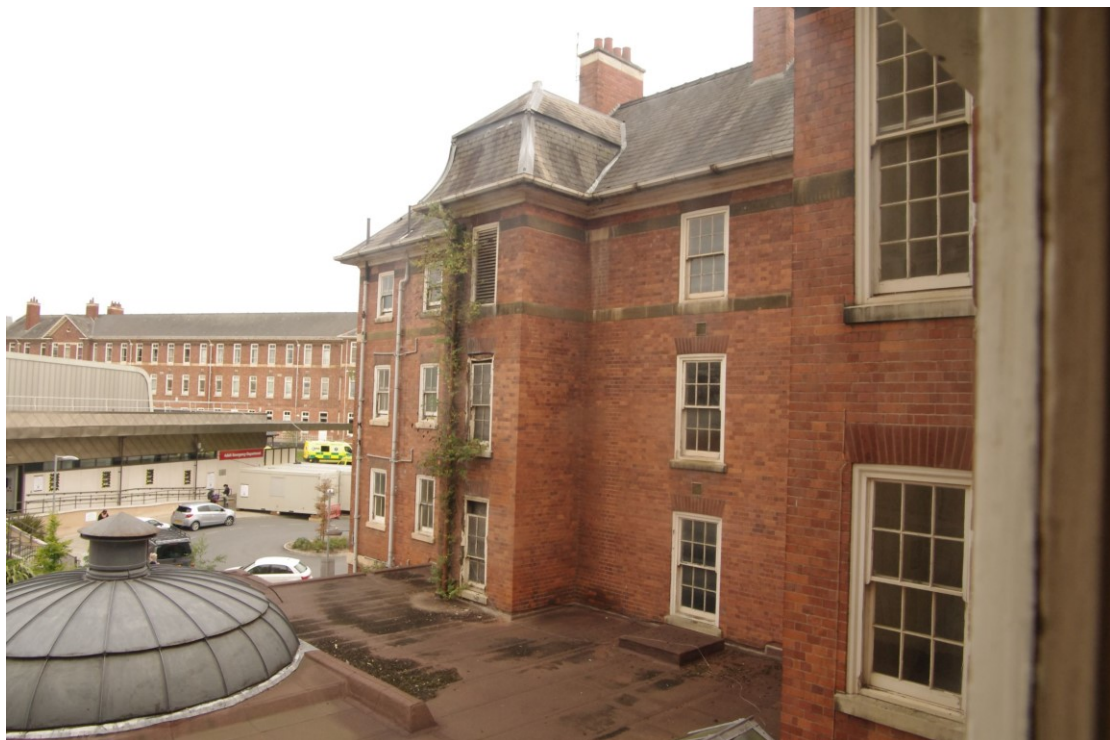
Figure 28 Rear, eastern, wing of the 1910 range
Looking north-east. The projection holds a modern lift shaft. Recreation room roof on left

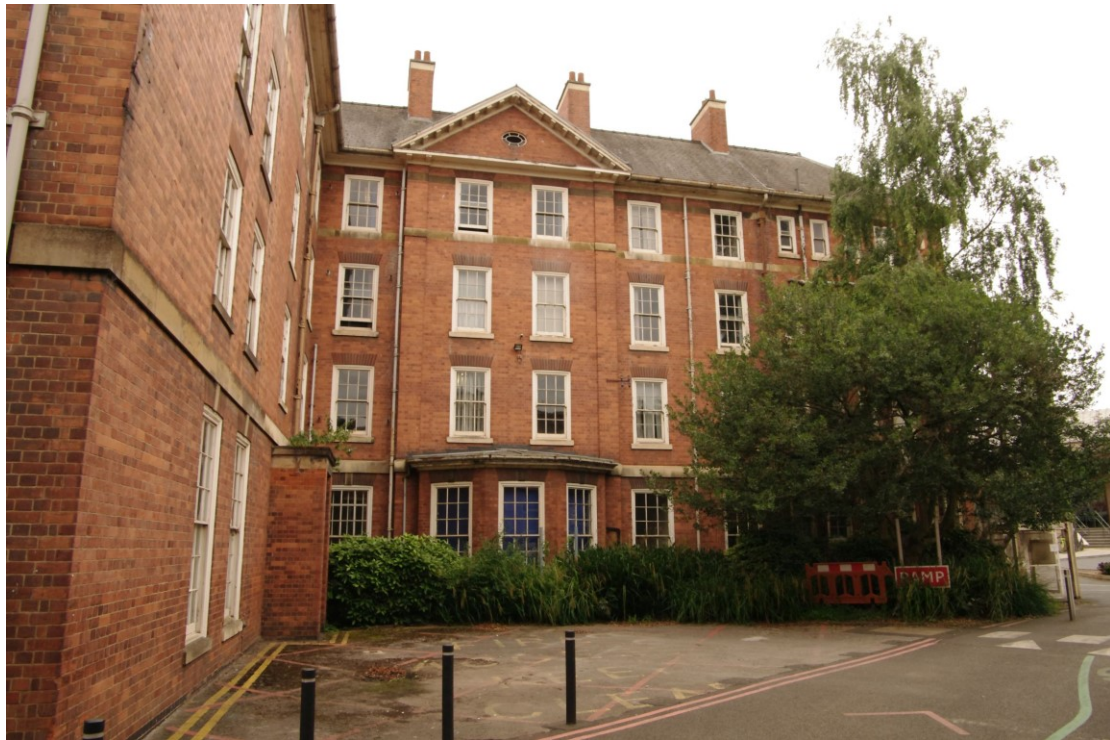
Figure 29 East facing elevation of rear wing, 1910 range
Looking west

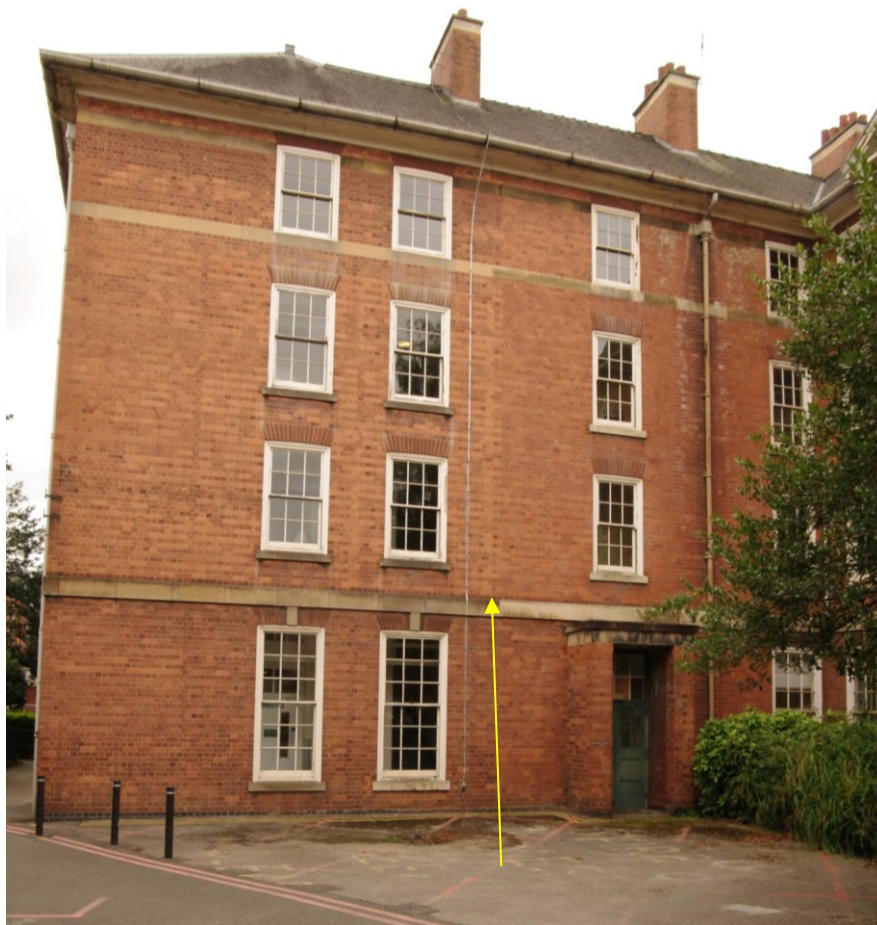
Figure 30 North facing elevation of 1910 range and later extension
Looking south. The joint between the 1910 range (on right) and the 1930s extension (on left) is shown
by the arrow

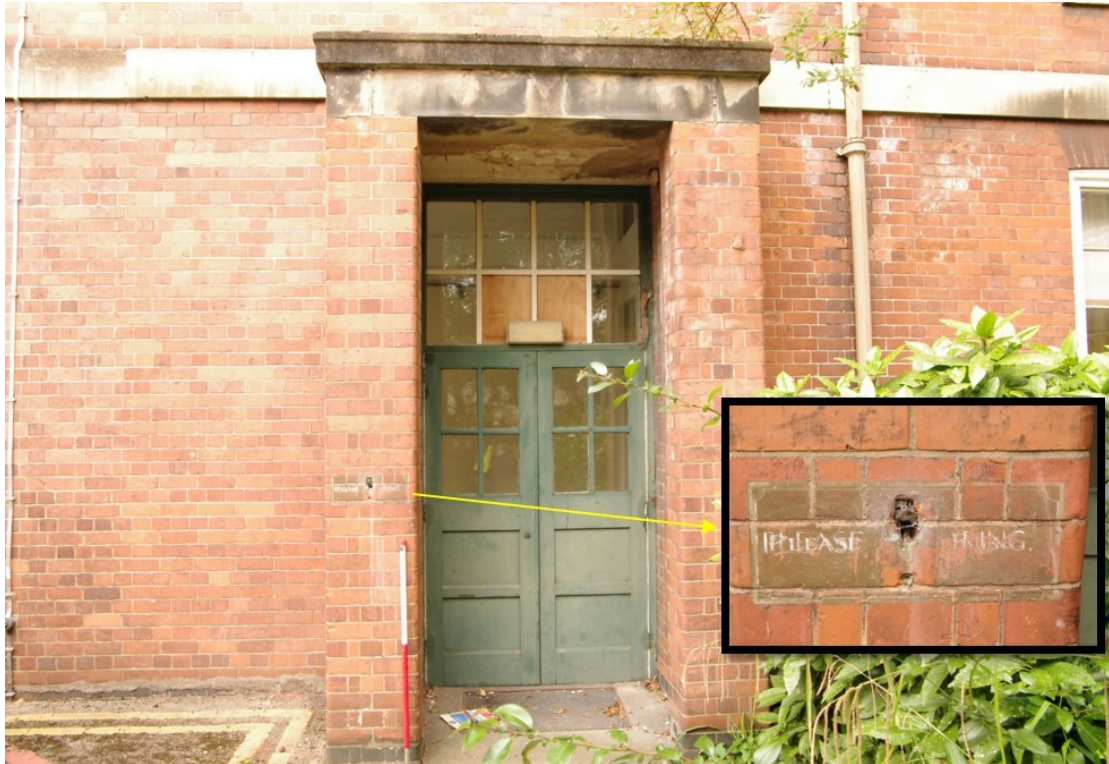
Figure 31 Porch on north face of 1910 range
Looking south. Inset: detail of doorbell and sign

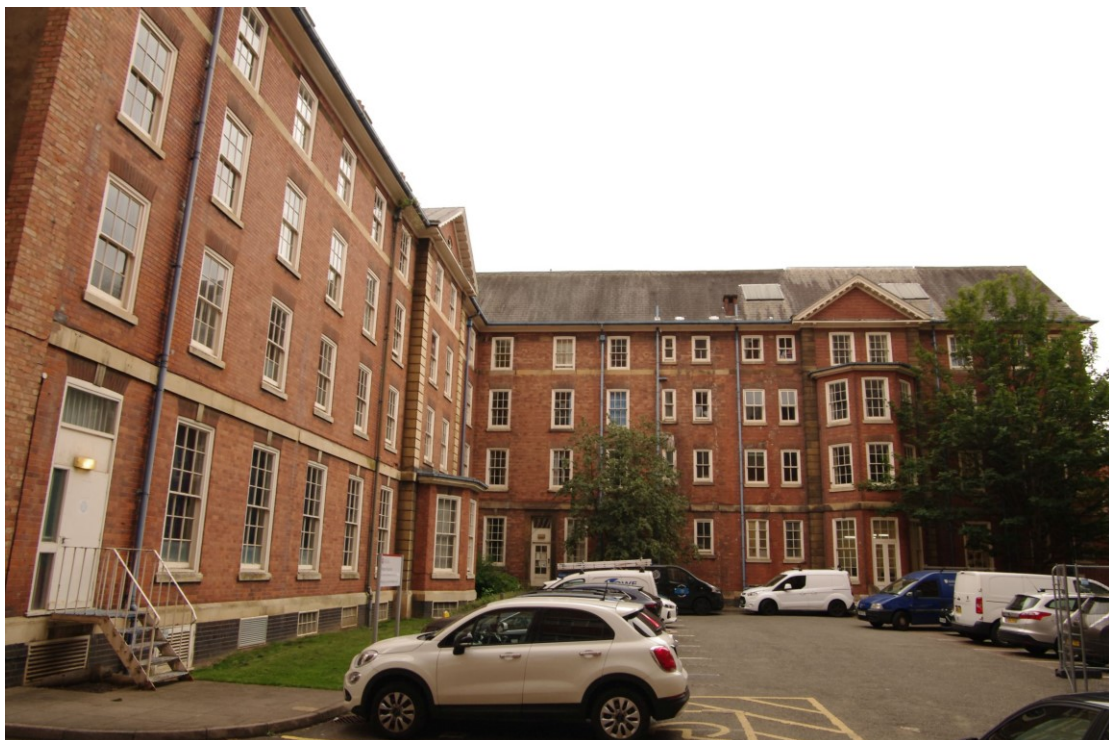
Figure 32 West facing elevation of 1930s extensions
Looking east. 1910 range on left. Compare with Figure 33

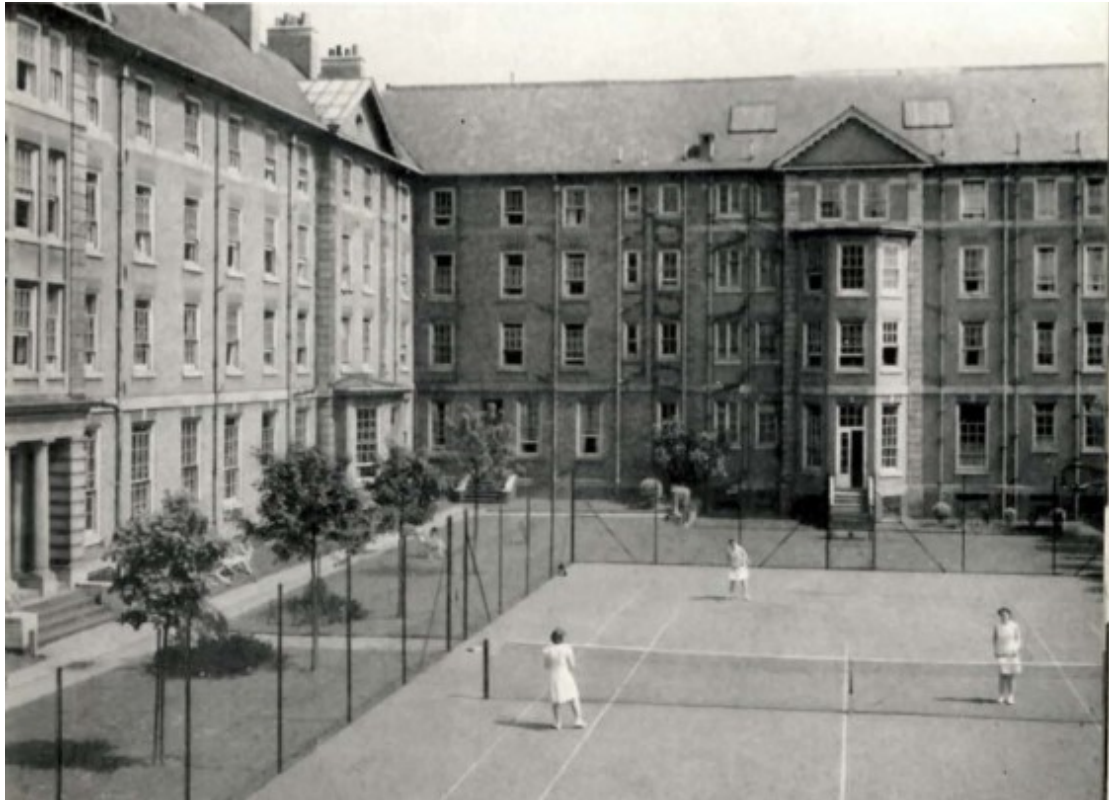
Figure 33 East wing of the 1930s range soon after completion
Probably taken from the first floor of the now-demolished west wing. Source J. Currington, LRI

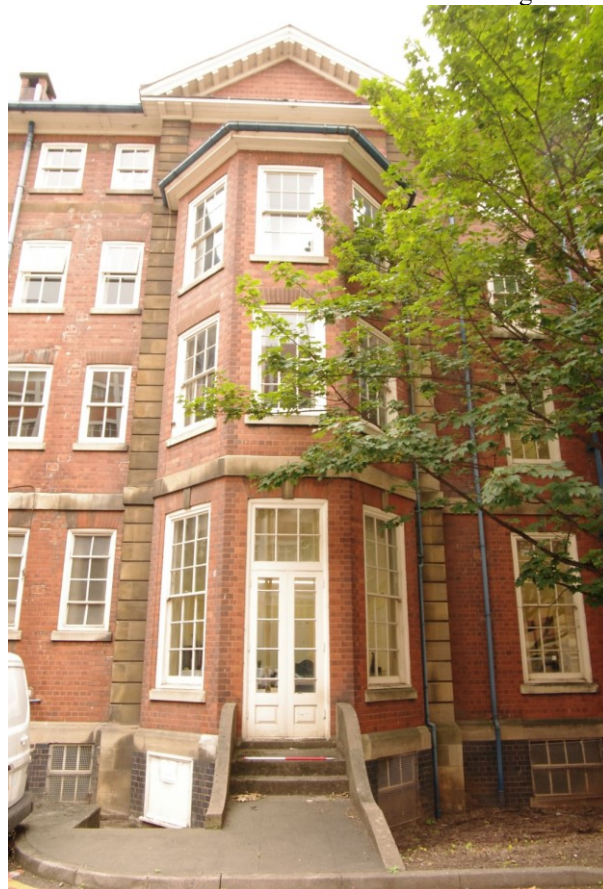
Figure 34 Detail of the 1930s extension west facing bay
Looking east. Note the small bridge from the French windows. 1m scale

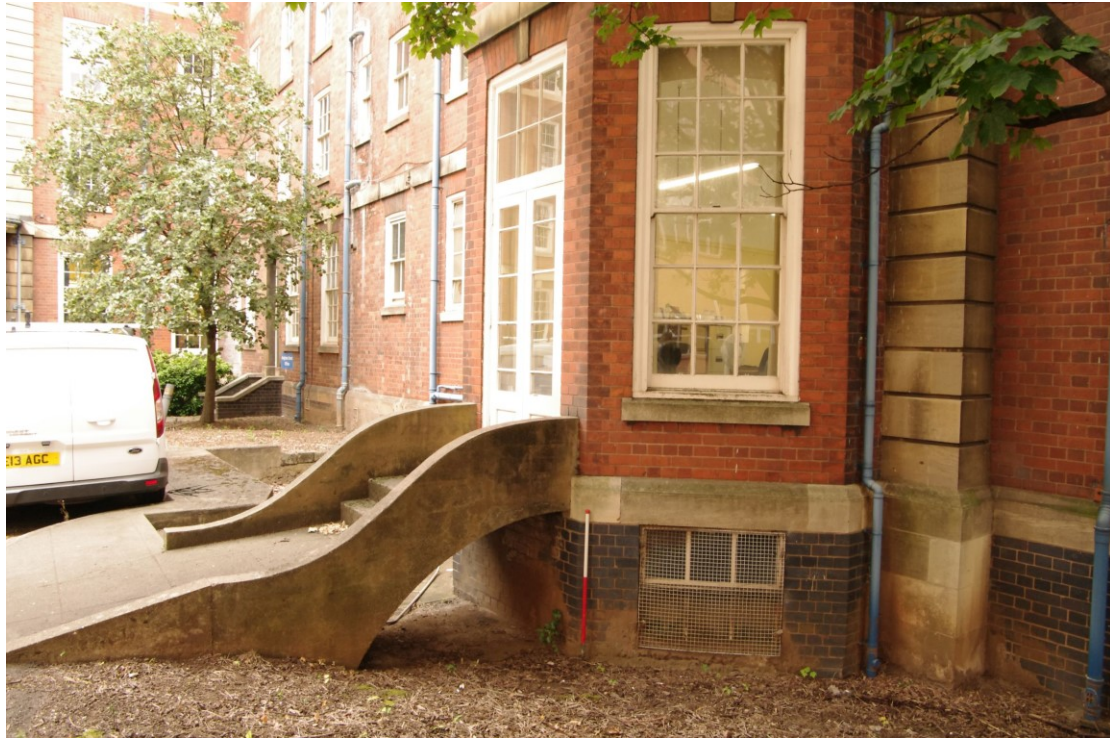
Figure 35 Bridge leading to the 1930s bay
Looking north. 1m scale

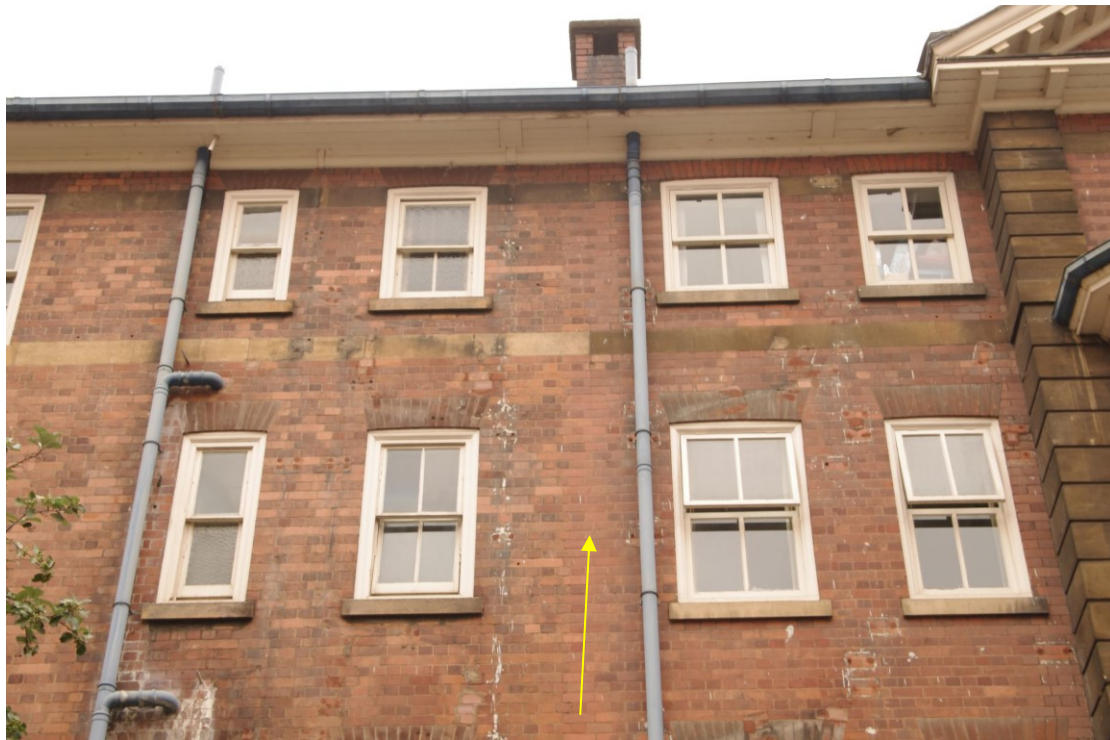
Figure 36 1930s west facing wing, joint between the two phases
Looking east. Arrow points to the joint, earliest extension on left

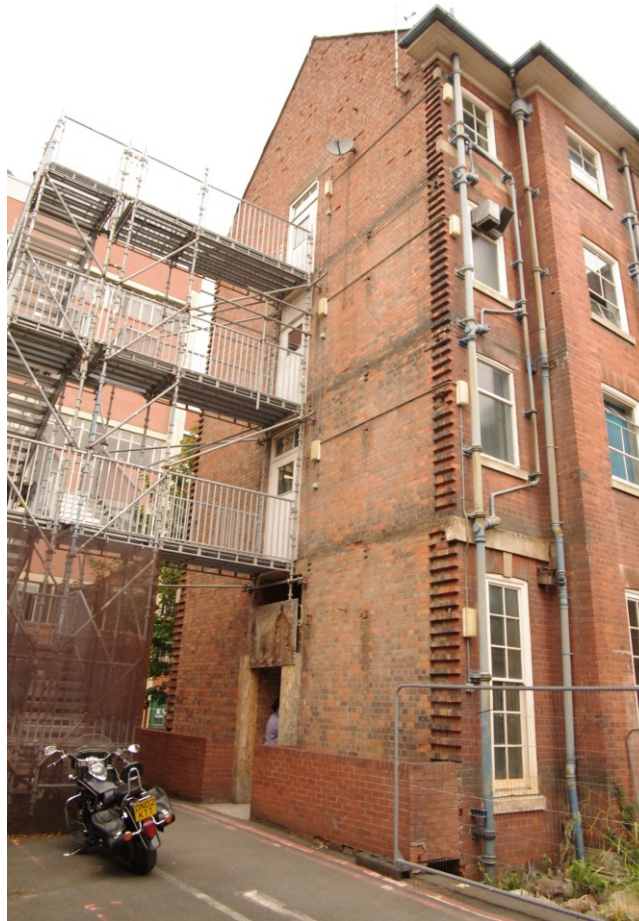
Figure 37 South facing gable end of 1930s wing
Looking north-west. Note the alternating projecting brick courses for future keying of new brickwork

At the southernmost end of the east wing there is evidence that there was provision for extending the building even further southwards. The south facing gable end has alternating brick courses at each corner which would allow for easy keying in of new brickwork (Fig. 37). The stone string courses also project slightly too. The bricks used in the plain gable end wall are of lower quality and have been affected by frost and weather which suggests that they were not intended to be exposed for long before another extension was added. These suggest that each phase was carefully thought out with the intention of adding to each phase.

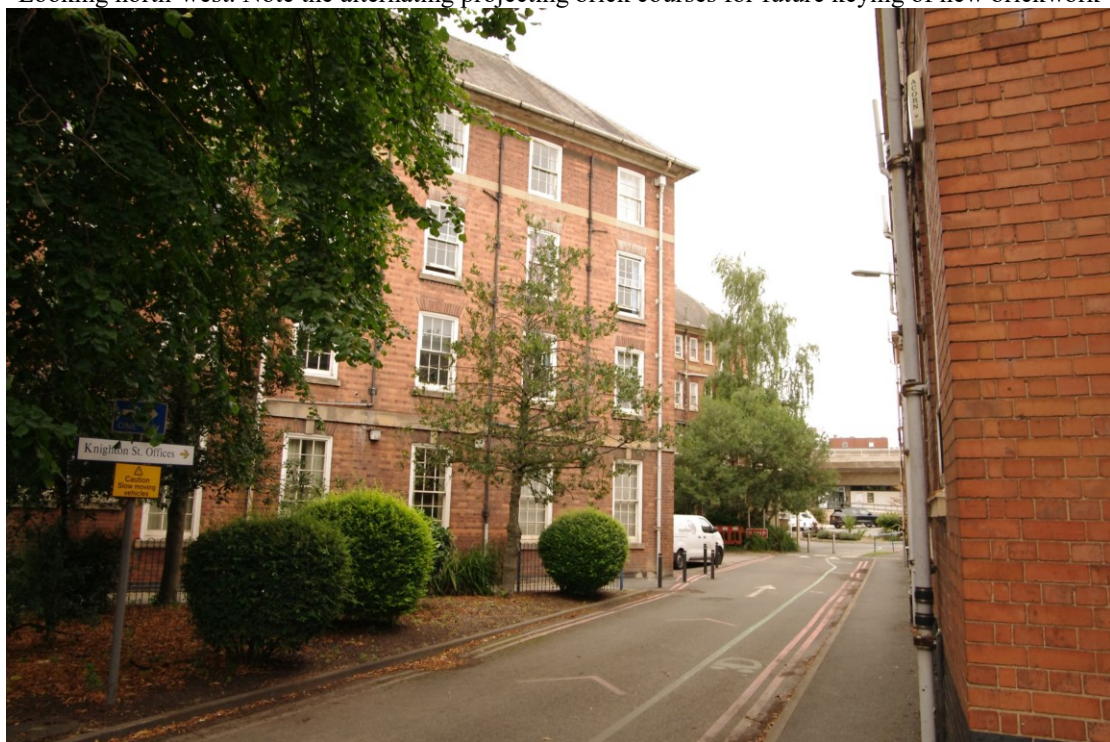
Figure 38 East facing elevation of earliest 1930s extension phase
Looking north-west. Rear of 1910 range visible above the white van. Outpatients Building on right

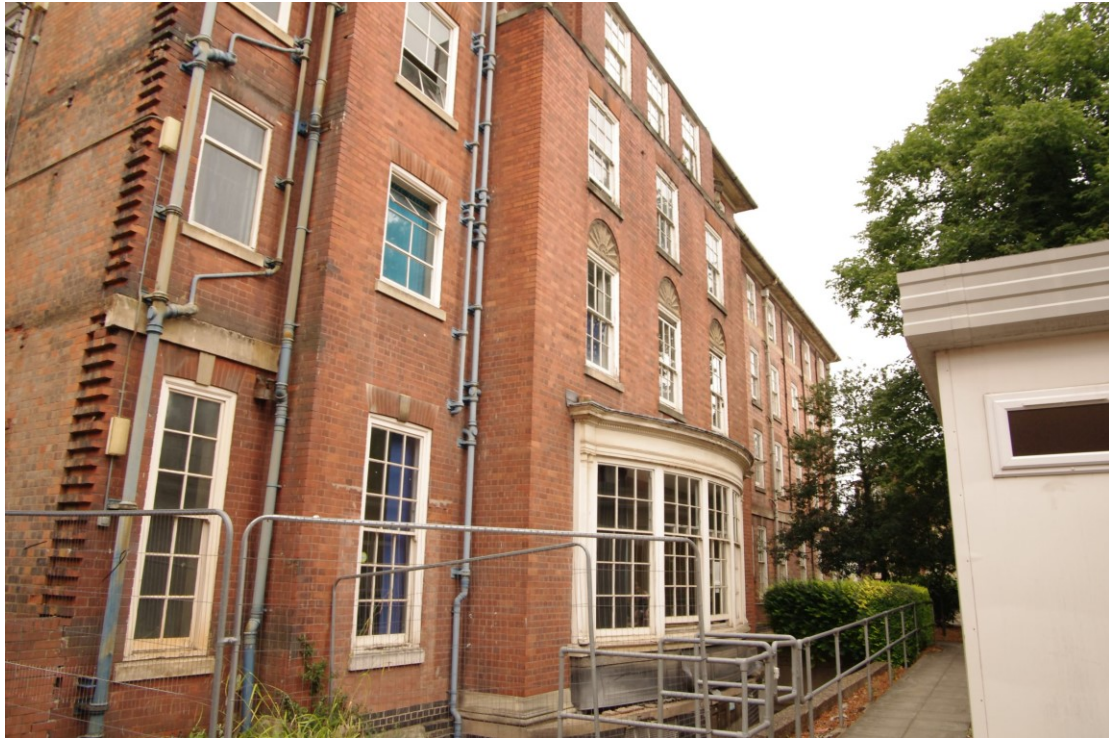
Figure 39 East facing elevation of later 1930s extension
Looking north-west

The east facing elevations of the 1930s extensions follow the general style of the rest of the building with one significant difference of a decorative ground floor bow-fronted window. The earliest 1930s phase is fairly plain with seven bays including the toilet block windows at its southern junction with the later phase (Fig. 38). The stone detailing is present but no bay. The later phase of the extension is dominated by a projecting bay with an attractive bow window at ground floor level (Figs 39 and 40). The bow window and bay has received a much lighter, almost Adam style, decorative touch than the rest of the building (Fig. 41). At present it is almost hidden behind a modern building but when first built, according to the 1938 map, it faced eastwards towards a large open space (see Figure 10). Beneath the wooden-framed window are panels of decorated lead above mahogany doors to the basement. At first floor level scalloped fan decorative panels can be seen (Fig. 42). The third floor of the bay is slightly recessed with curved alcoves holding a pair of stone urns (Fig. 43).

As noted, the corridor widens south of the joint between the two 1930s phases. On the east side of the corridor is the large room with the bow window seen in Figs 39 to 41 above. This room is presently used as a lecture room but early photographs suggest it may have been used as a writing room (Figs 90 and 91). Presently the floor is carpeted but the earlier photograph shows wooden block flooring. Beneath the window is a low cast-iron radiator which, in early photographs, can be seen as one of a number fitted beneath a curved window seat that has since been removed (Fig. 92). The room is sparsely decorated but has retained its original picture rail. Along the western side of this room is a partially glazed wood and glass partition to the corridor (Fig. 93). It is not clear if this is original or has been modified.

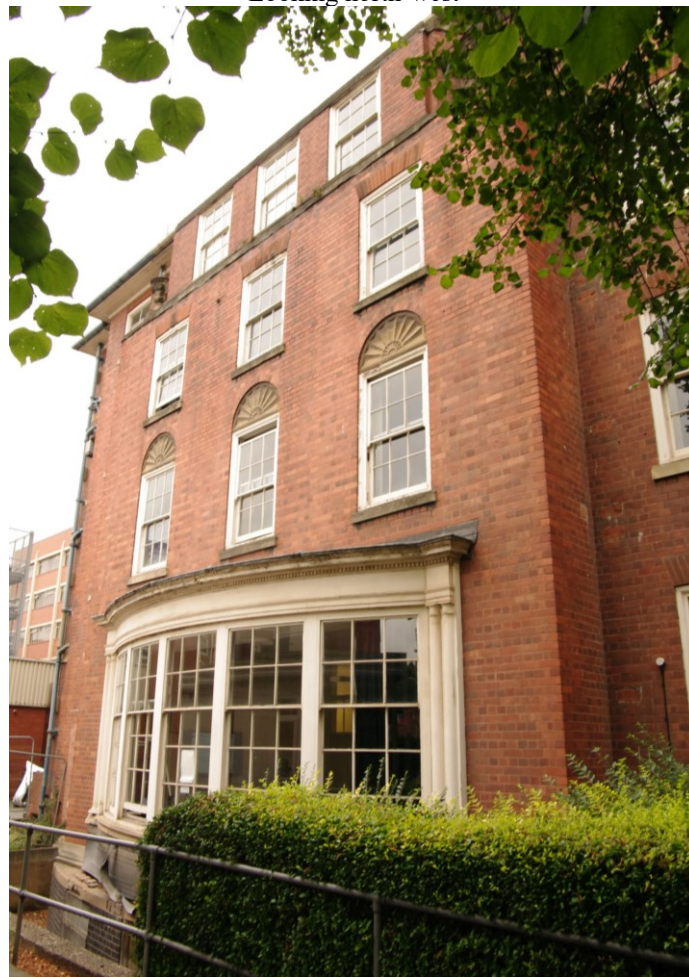
Figure 40 East facing elevation of later 1930s extension
Looking south-west

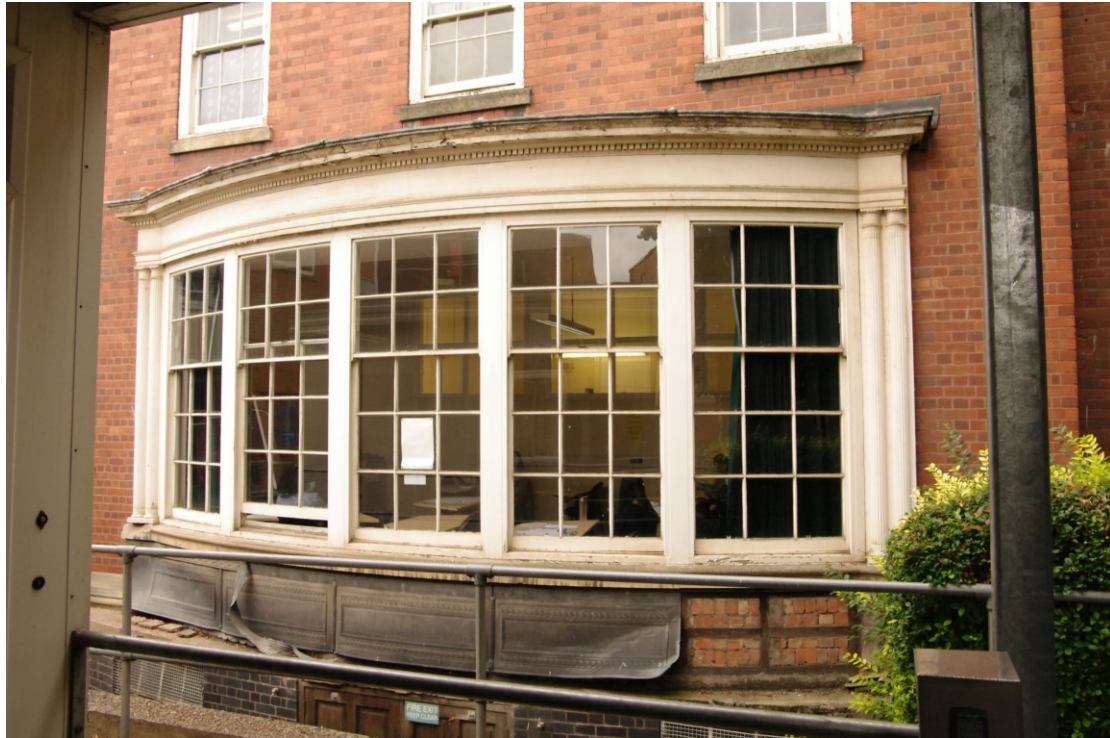
Figure 41 Detail of bay window
Looking west
