**A Level 3 Historic Building Survey at
The Knighton Street Offices,
Leicester Royal Infirmary,
Leicester
NGR: SK 58694 03539**

**ULAS Report No 2021-143
©2022**

Site Name: Knighton Street Offices, Leicester Royal Infirmary.

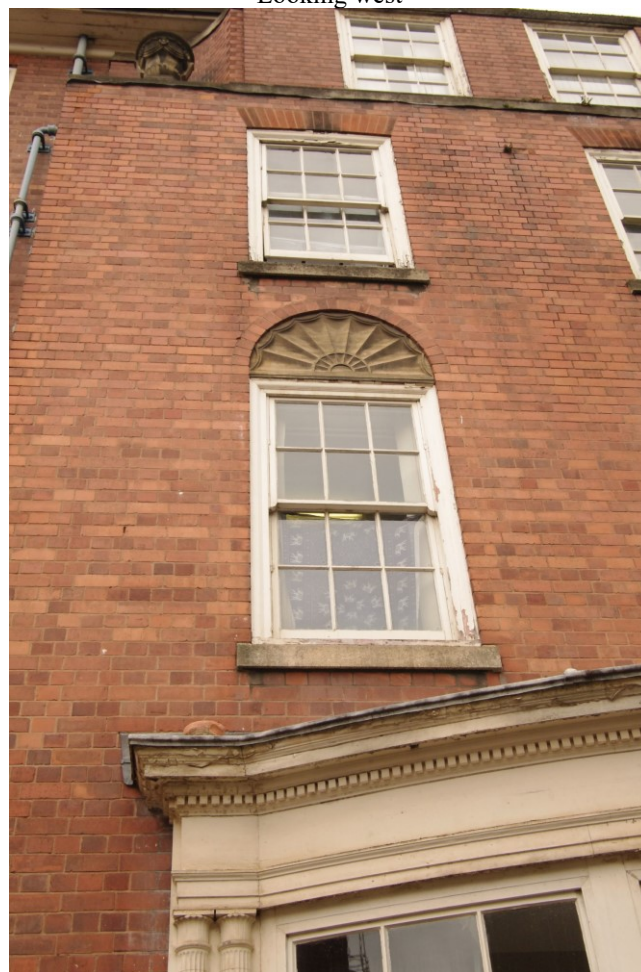
Figure 42 Decorative detail of east facing bay
Looking west

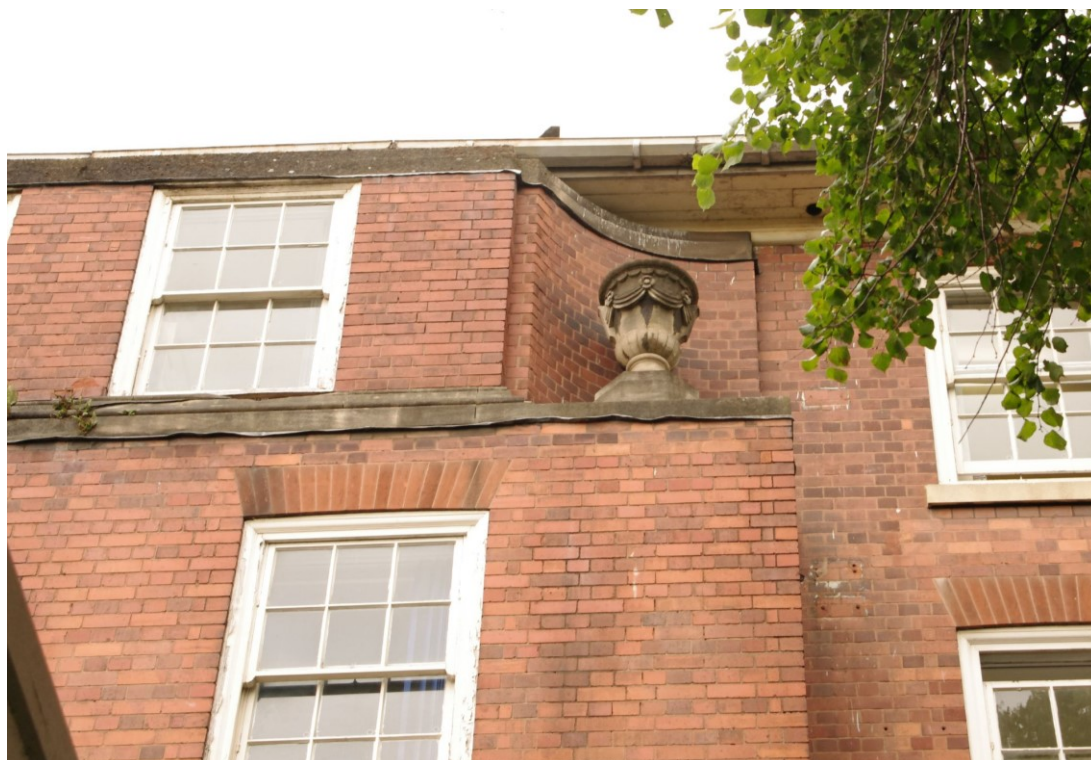
Figure 43 Decorative urn at third floor level
Looking west

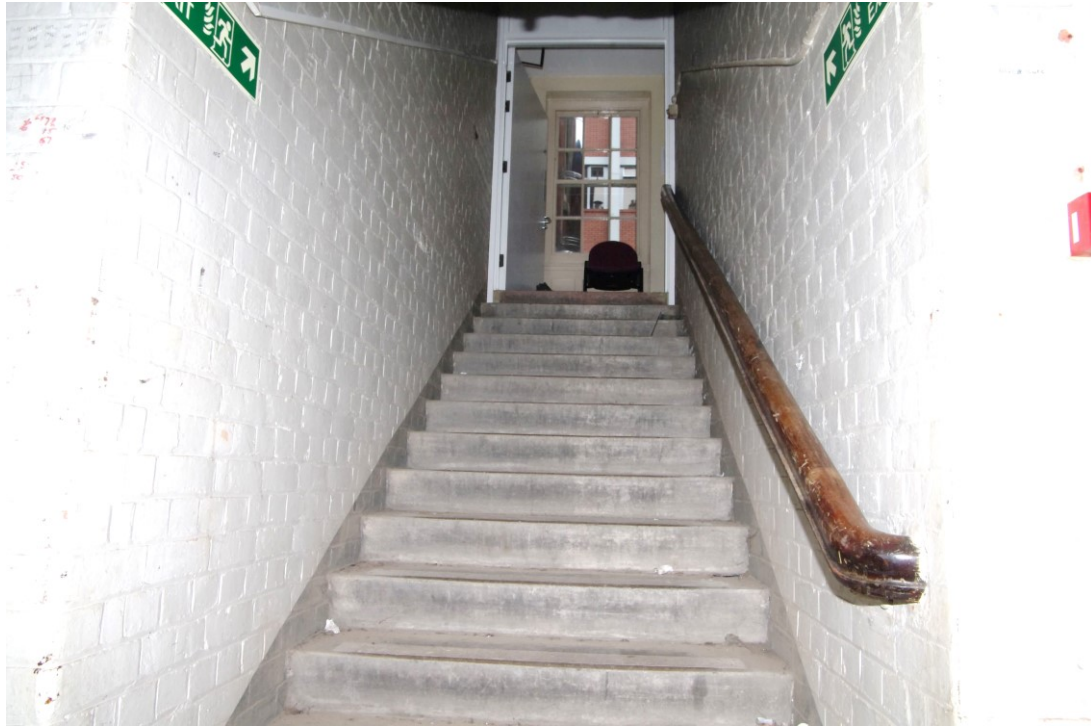
Figure 45 Basement stairs looking up towards ground floor
Facing west. Note Wooden hand rail

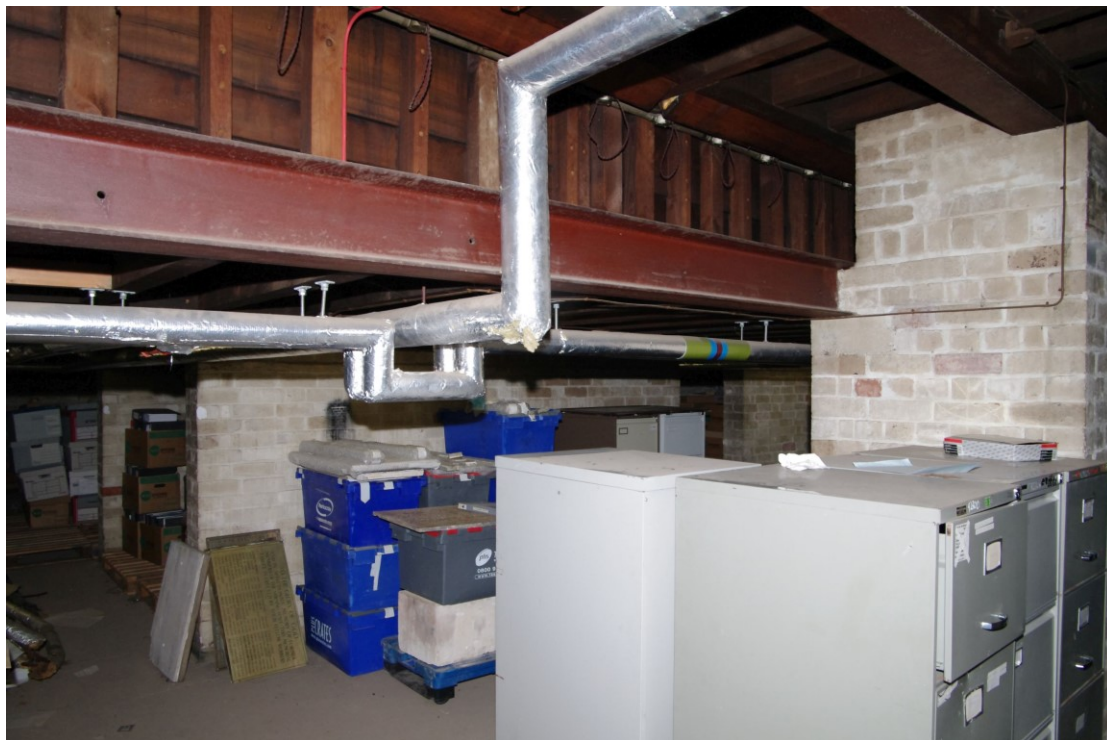
Figure 46 Basement room beneath the theatre
Looking north-east. Note the step in the ceiling

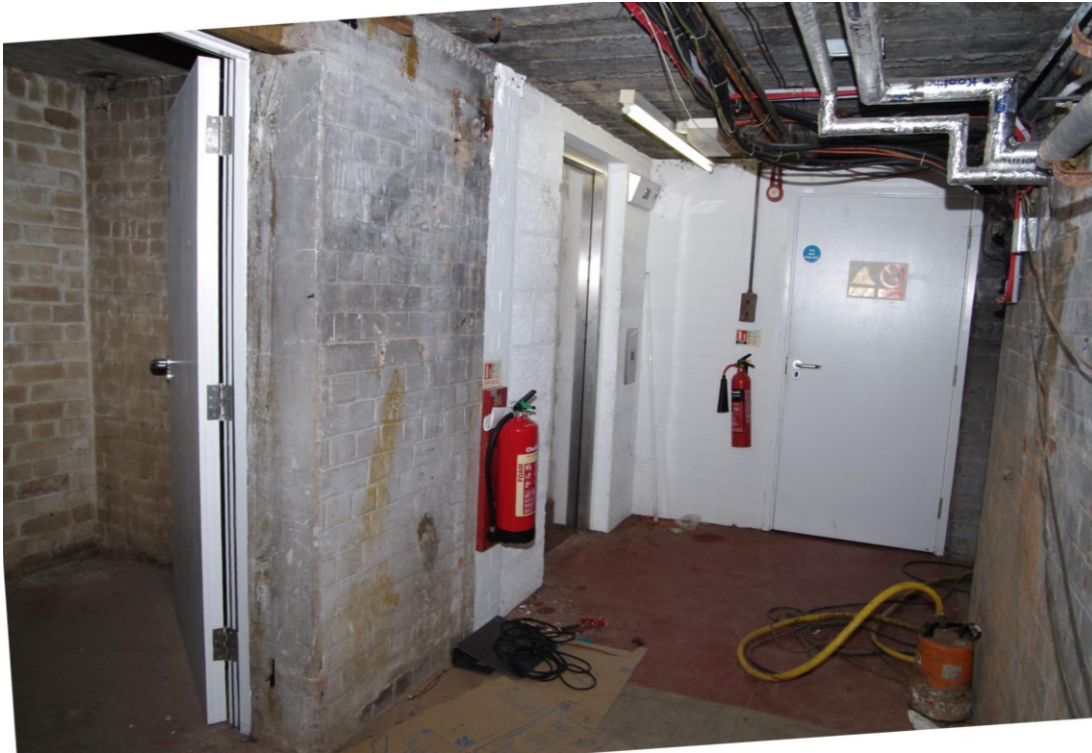
Figure 47 Basement corridor with lift shaft on left
Looking north-west

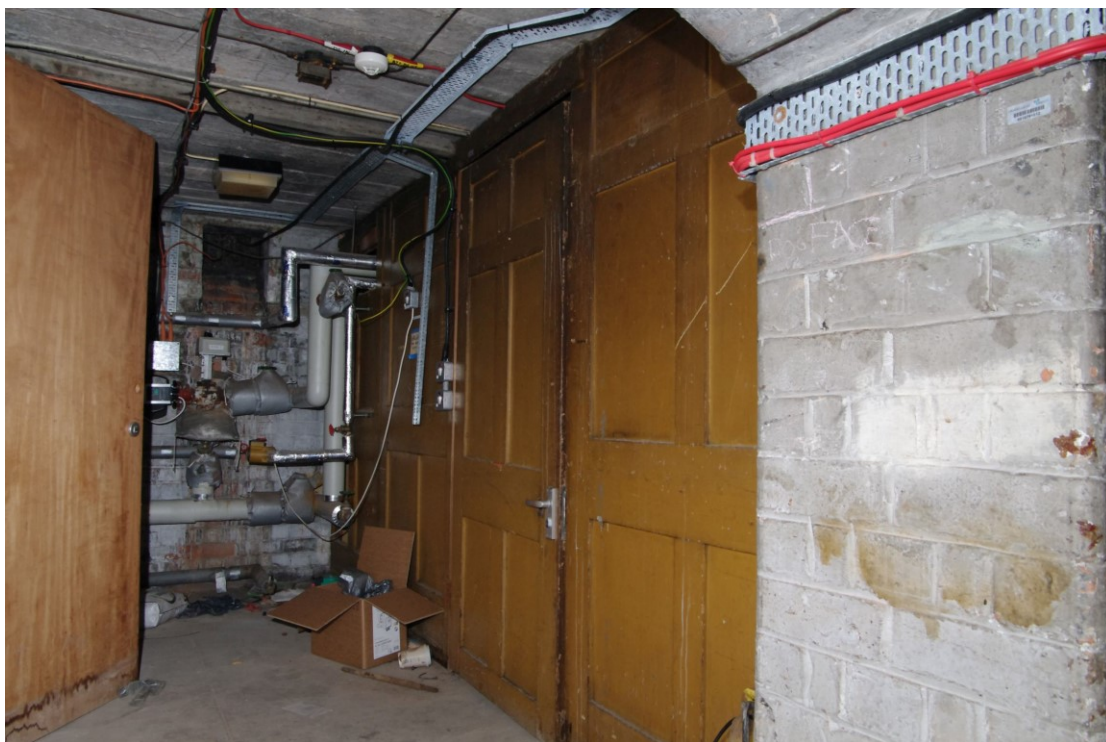
Figure 48 Basement: panelled cupboard in Room 1012
Looking north-east

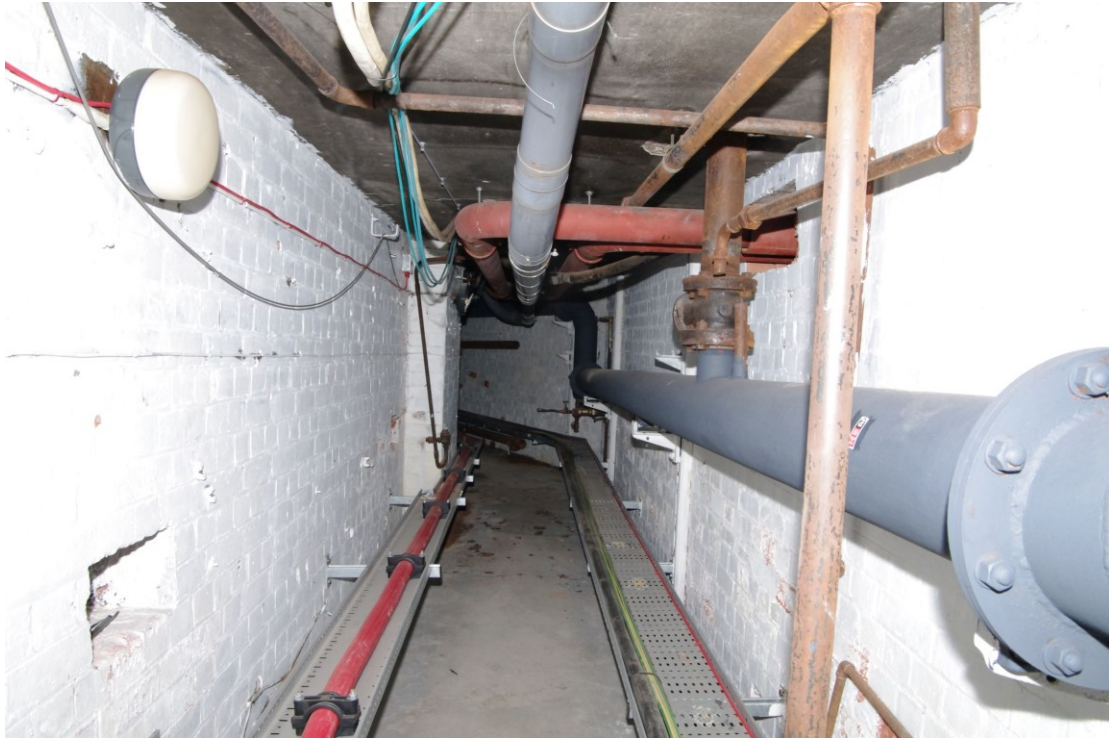
Figure 49 Basement: service tunnel
Looking east. Corridor leads towards the Outpatients Building

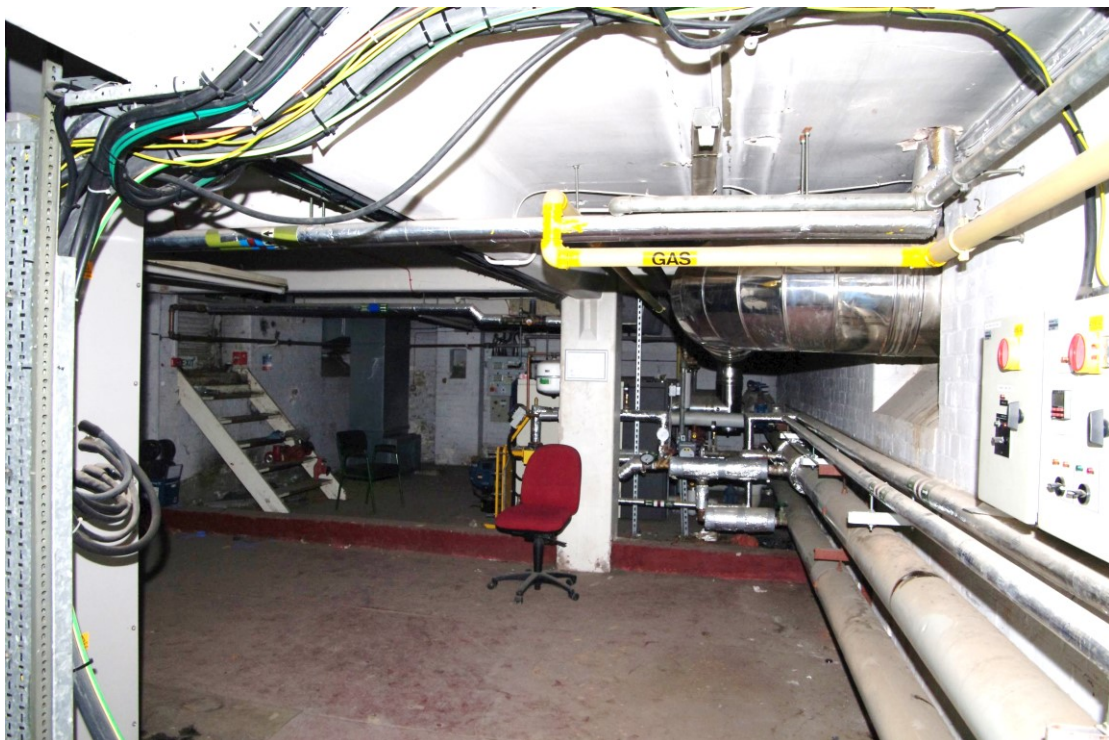
Figure 50 Basement: Room 1021 beneath 1910 range
Looking south-west

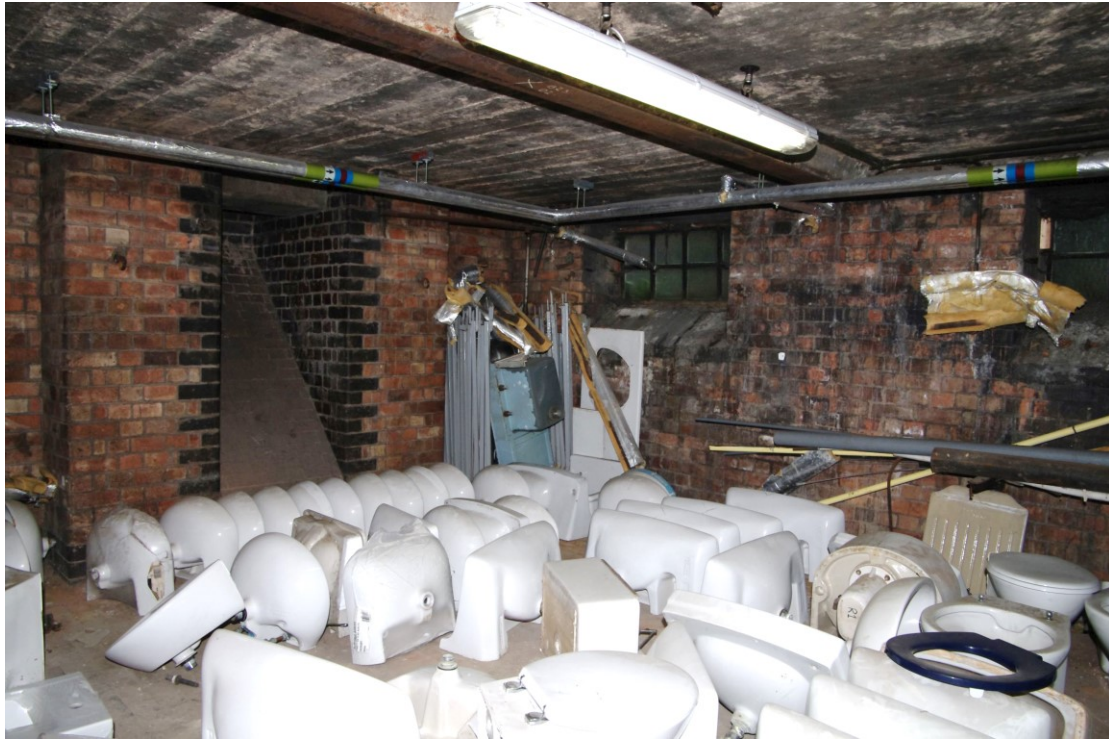
Figure 51 Basement: coal store and former chute
Looking south-east. Blocked chute on left hand wall

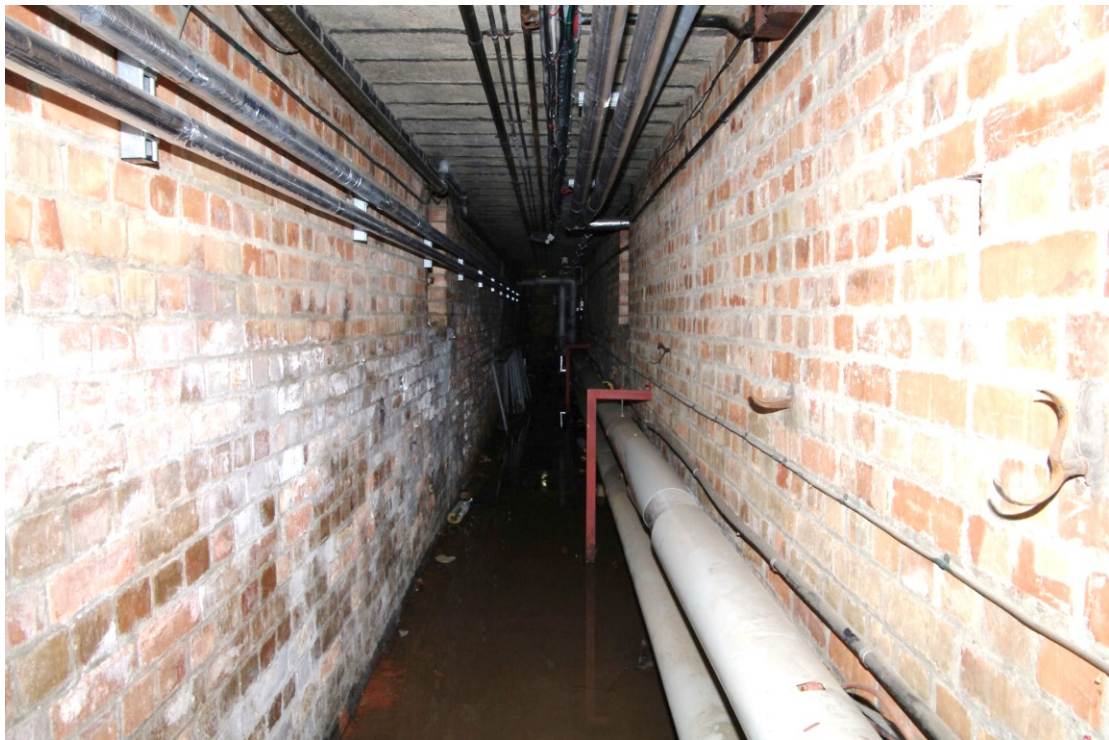
Figure 52 Basement: corridor beneath 1930s extension
Looking south

A corridor leads past the coal store room and turns to the south to enter the space beneath the first phase of 1930s extension (Fig. 52). The basement here consists of a narrow corridor with shoulder-high shafts on either side leading to small openings. The rest of the area beneath this phase appears to be solid and has no access. The end of this corridor stops at a brick where the later 1930s phase begins. No access could be gained into the adjacent space and the two basement areas are not interconnected.

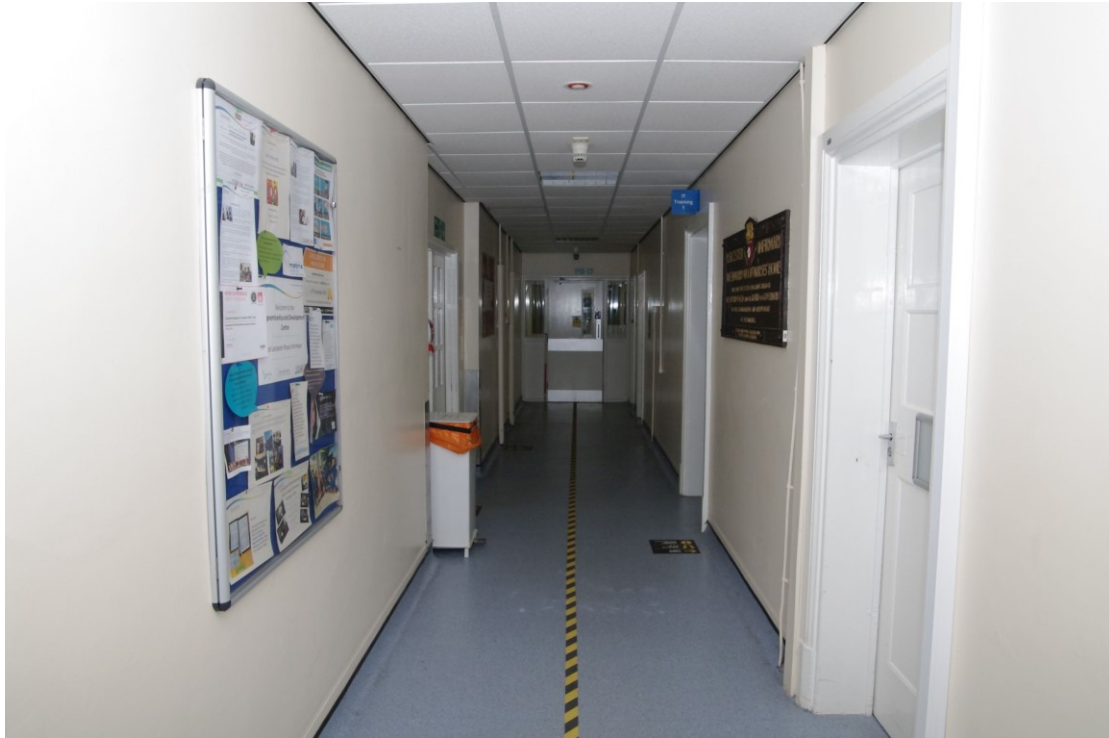
Figure 54 Ground floor: main entrance

Looking north toward external door. Note the plaque on the right wall – see Figure 4 the doorway just behind the orange bin leads to the rear east to west corridor

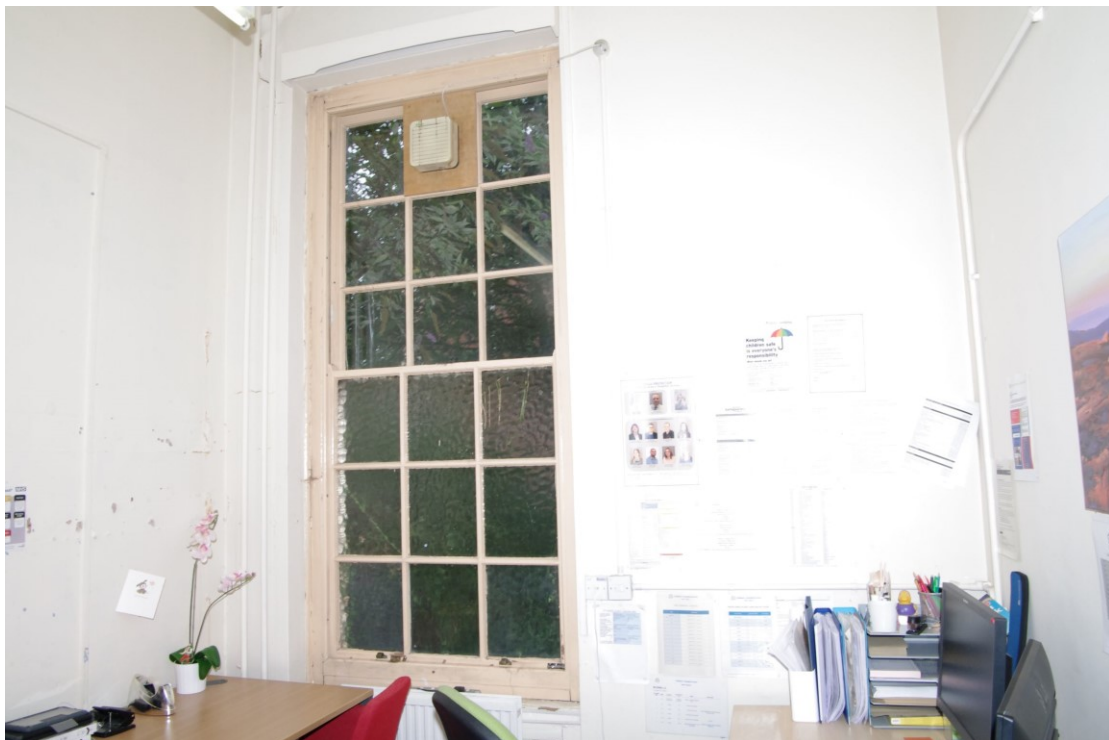
Figure 55 Ground floor window detail

Looking north-east. Room 015

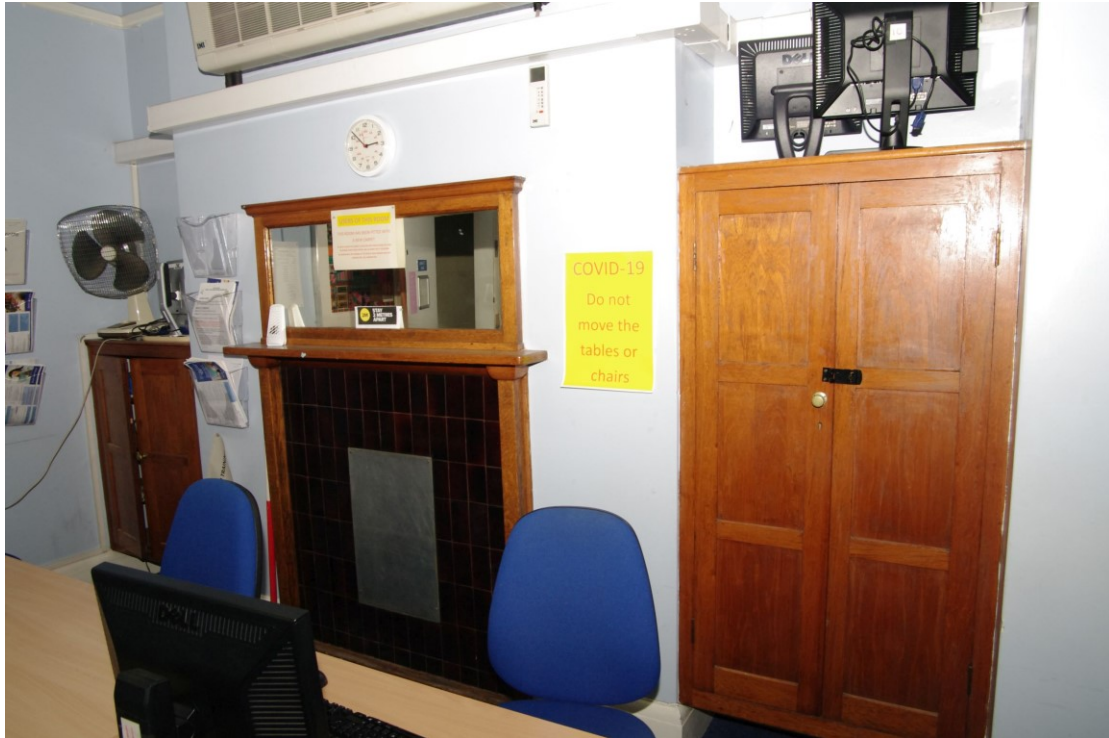
Figure 56 Ground floor: fireplace in Room 018
Looking north-west

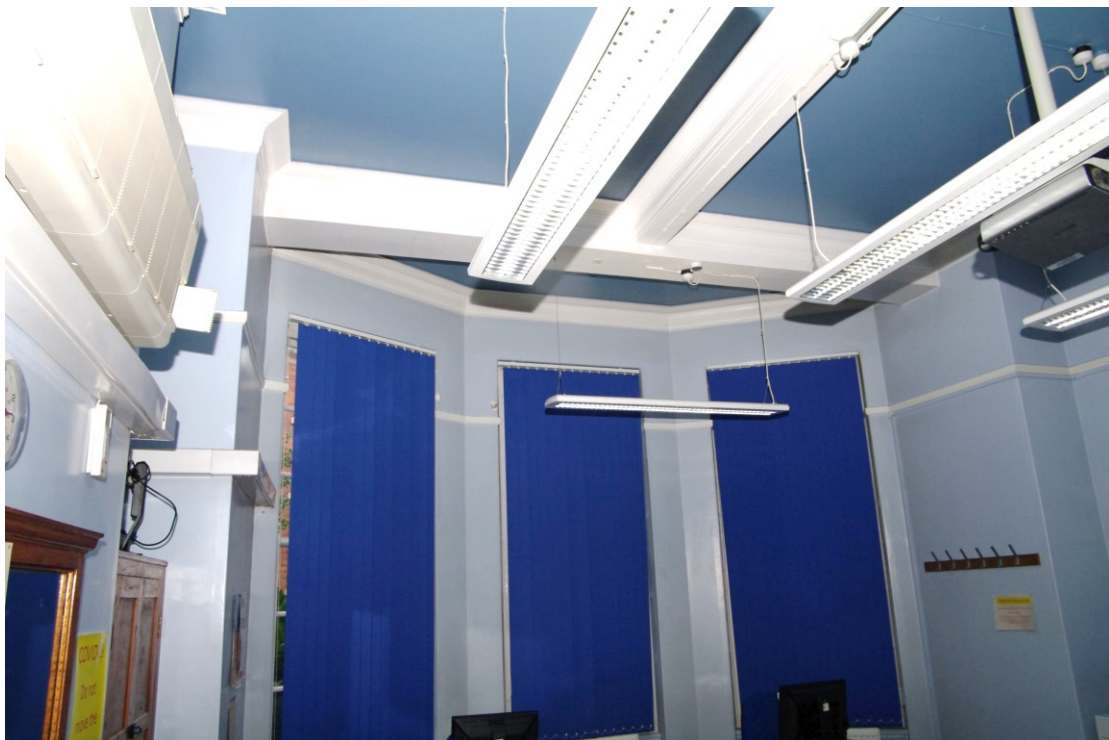
Figure 57 Ground floor: window and ceiling detail
Looking east

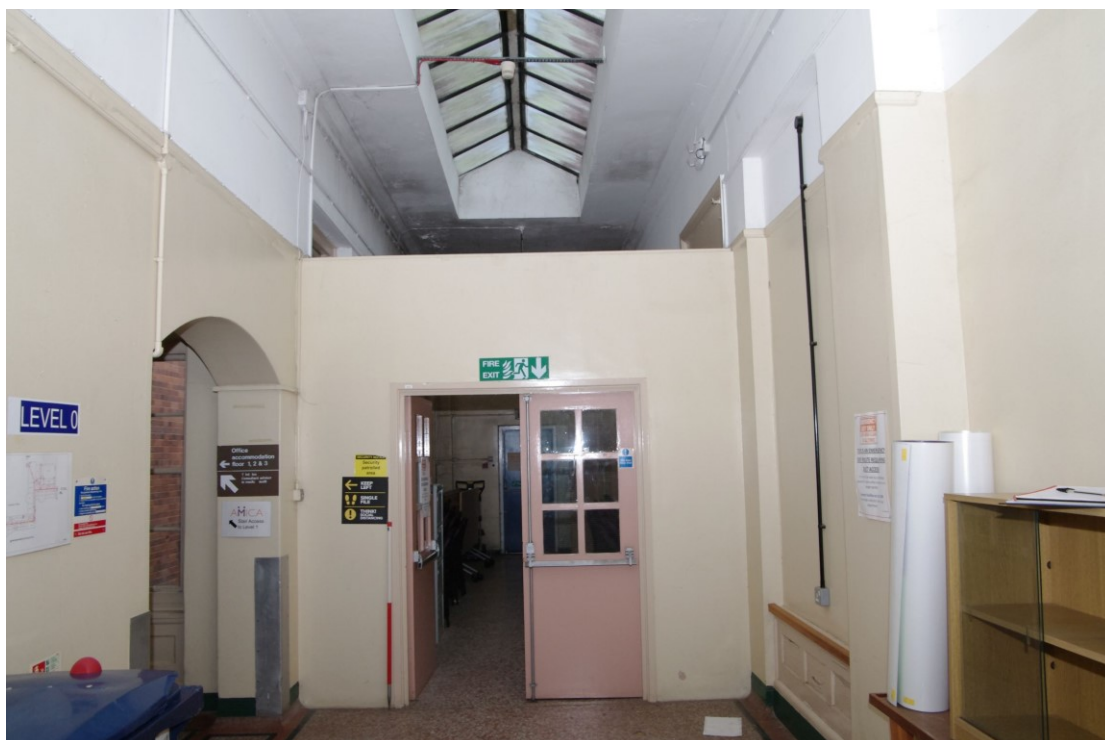
Figure 58 Ground floor: rear east to west corridor
Looking west. The archway on the left leads to the stairs to the basement and upper floors. See also Figure 59

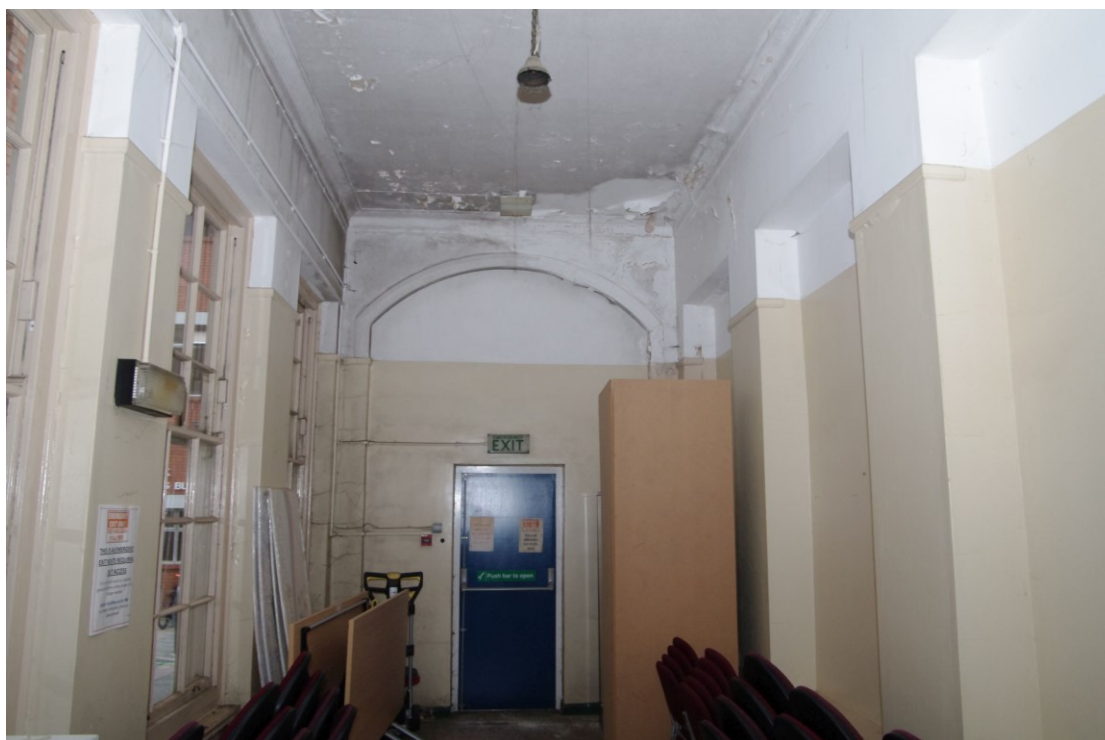
Figure 59 Ground floor: east to west corridor
Looking west towards the blocked arch which continued across the entire 1910 range. The blind arcades on the right may have held windows which were blocked following the construction of the theatre

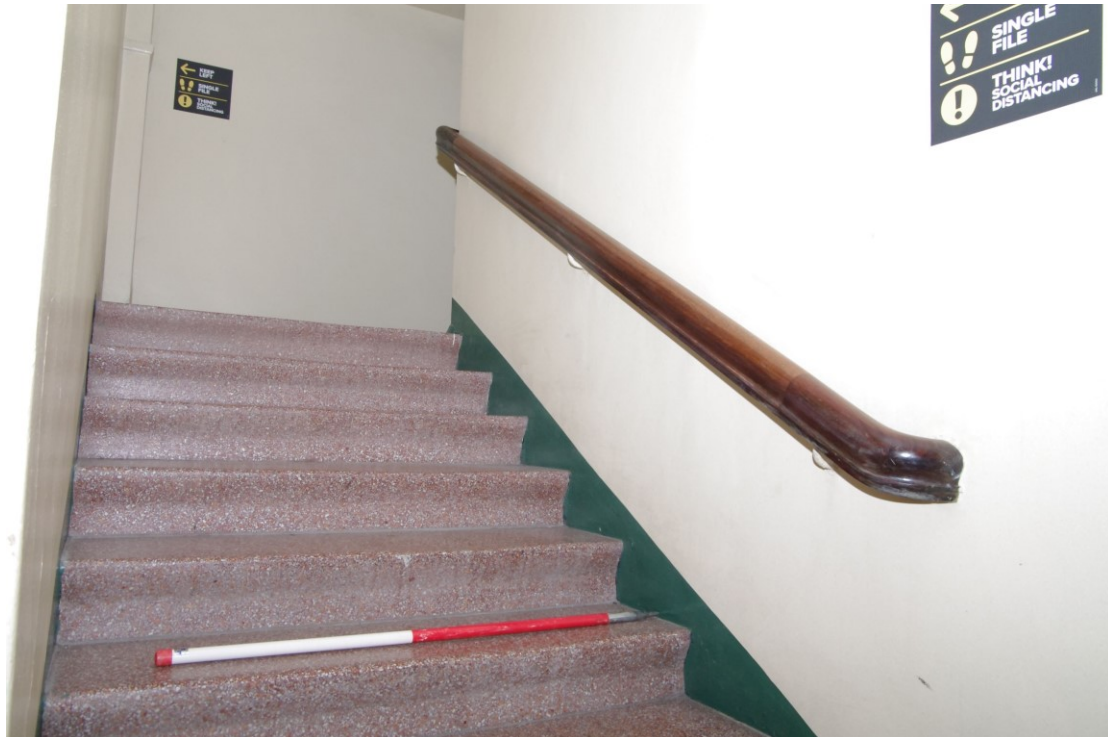
Figure 60 Ground floor: stairs to first floor from the rear east to west corridor
Looking south-west. 1m scale

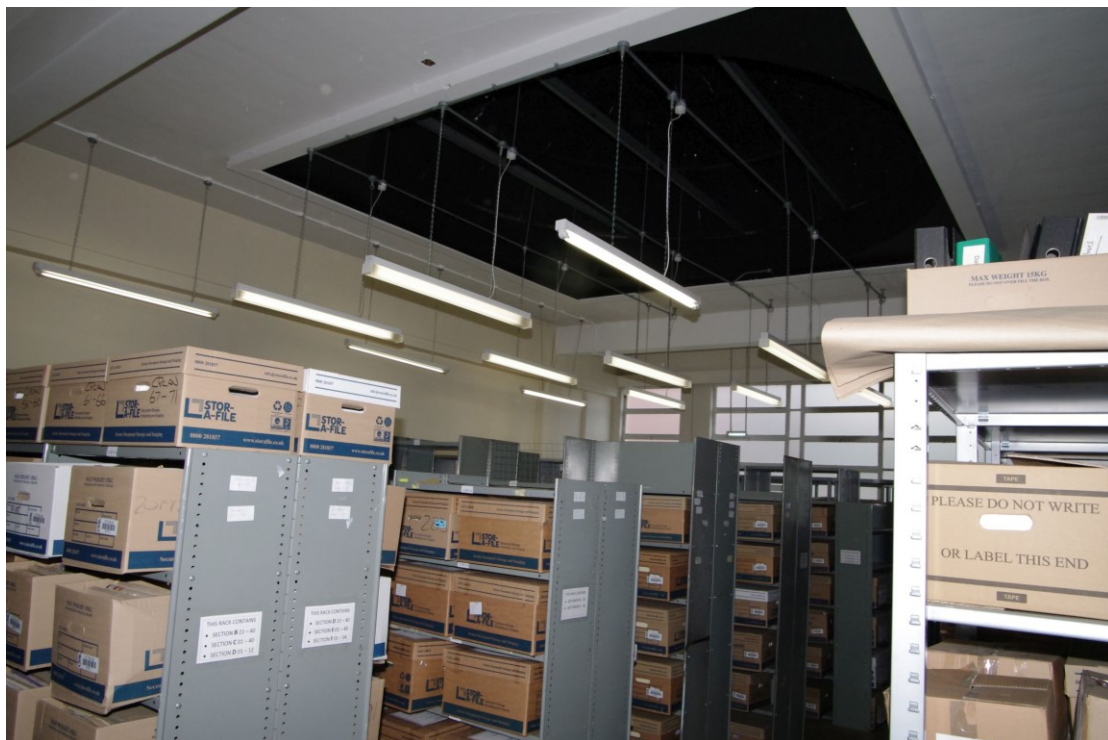
Figure 61 Recreation room/theatre general view from corridor
Looking north-west. The black shape in the ceiling is the glass dome – see Fig. 26

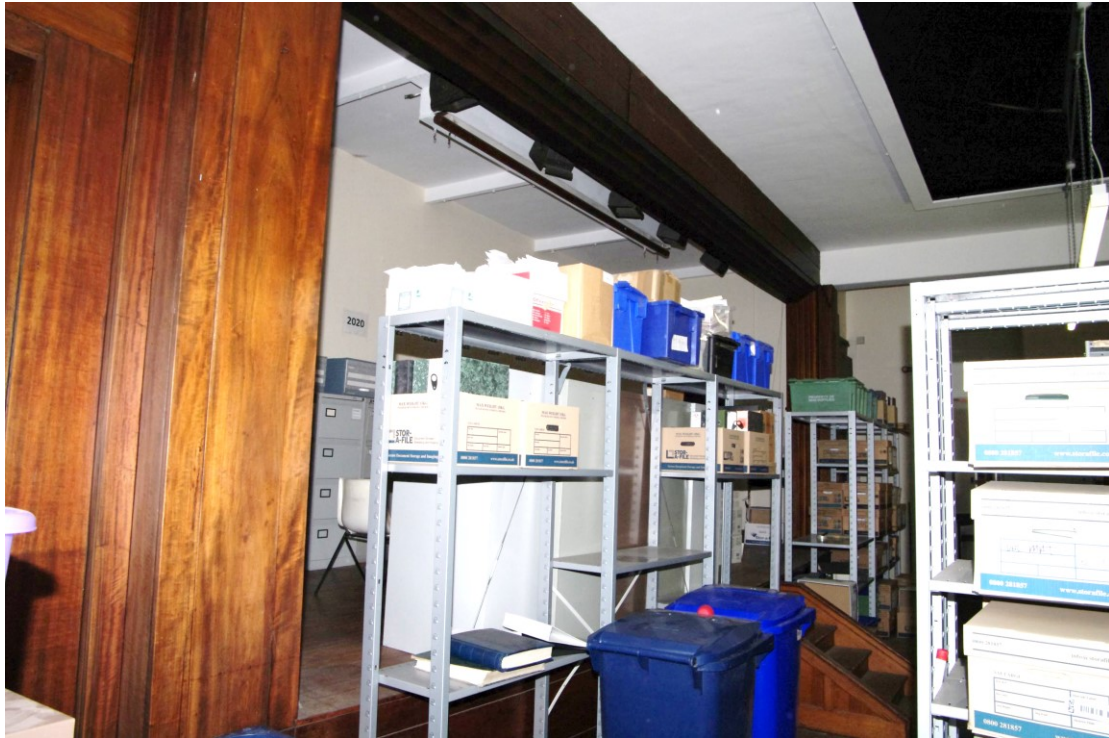
Figure 62 Recreation room/theatre – stage
Looking south-east. Note wooden steps up to the stage

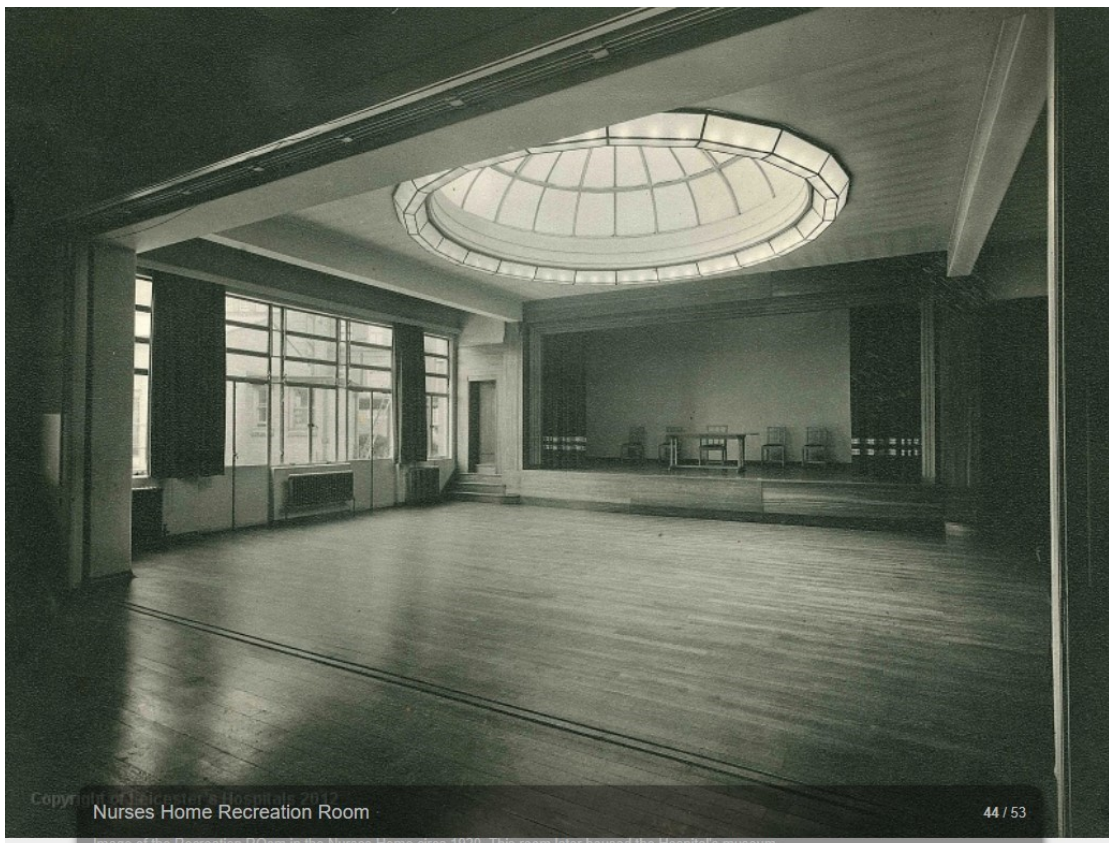
Figure 63 Recreation room/theatre: soon after being built
Photo taken looking north-east. Note that the present room stops at the room division in the foreground
Source: Leicestershire Hospital virtual website

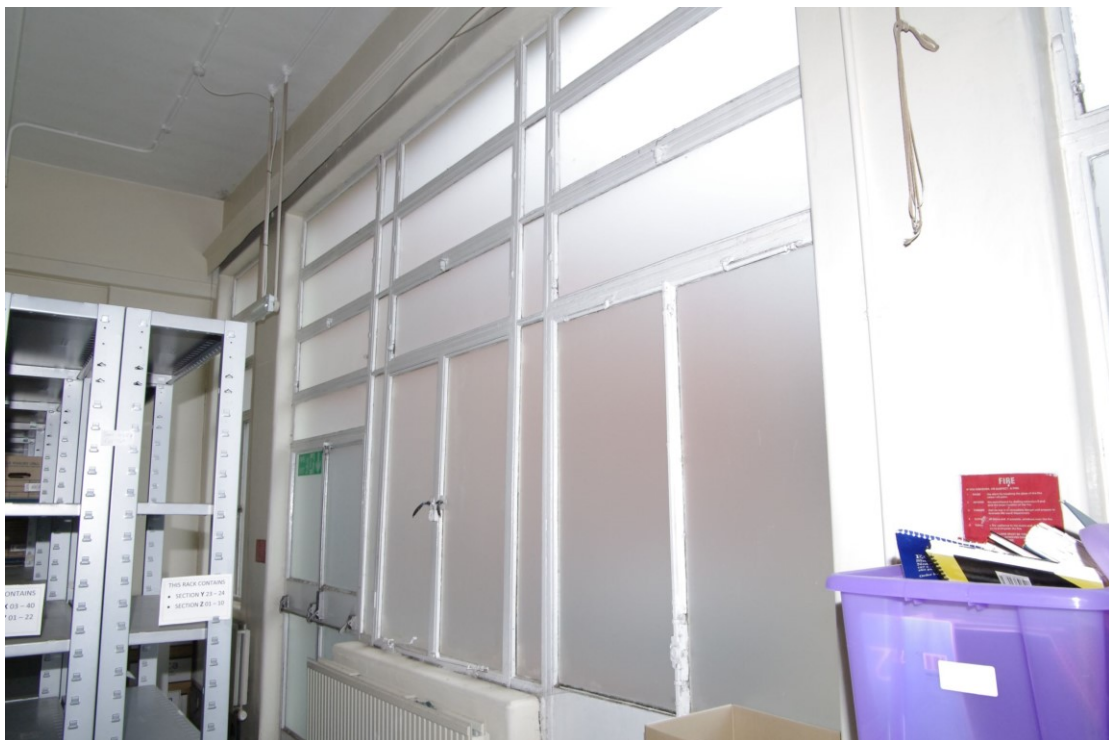
Figure 65 Recreation room/theatre: north wall window detail
Looking north-west. Note the pelmet for the missing curtains. The fire doors are modern.

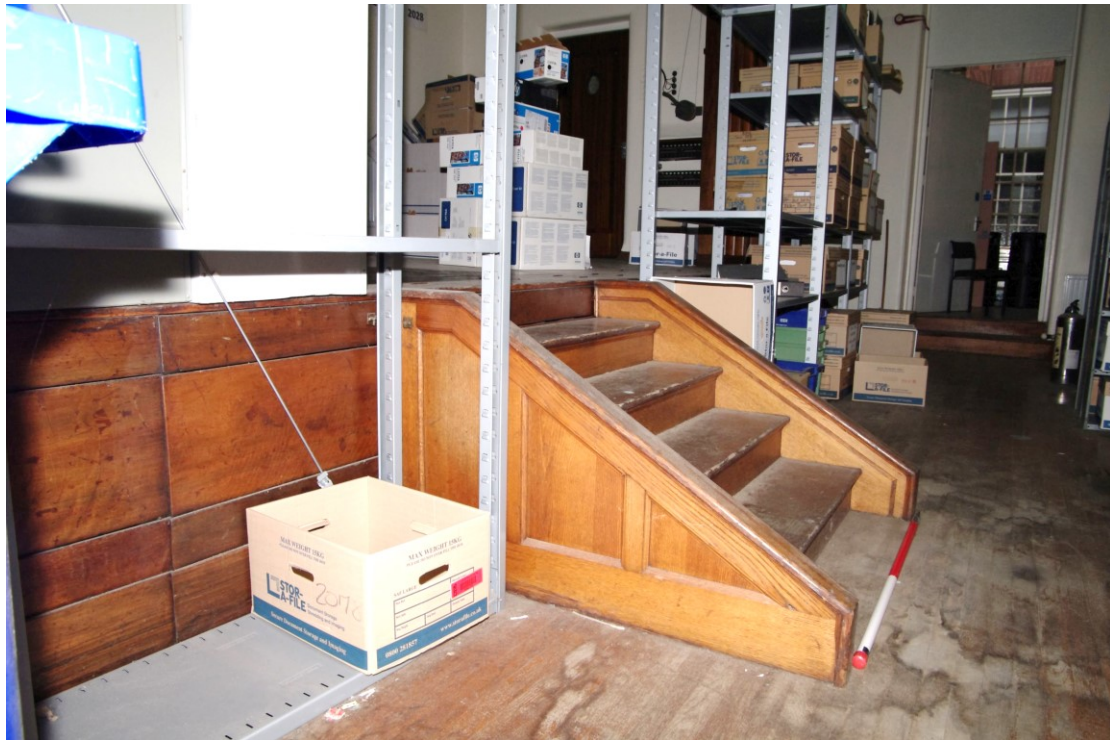
Figure 66 Recreation room/theatre: stage steps
Looking south-east. Note the step up to the outside corridor to the right. 1m scale

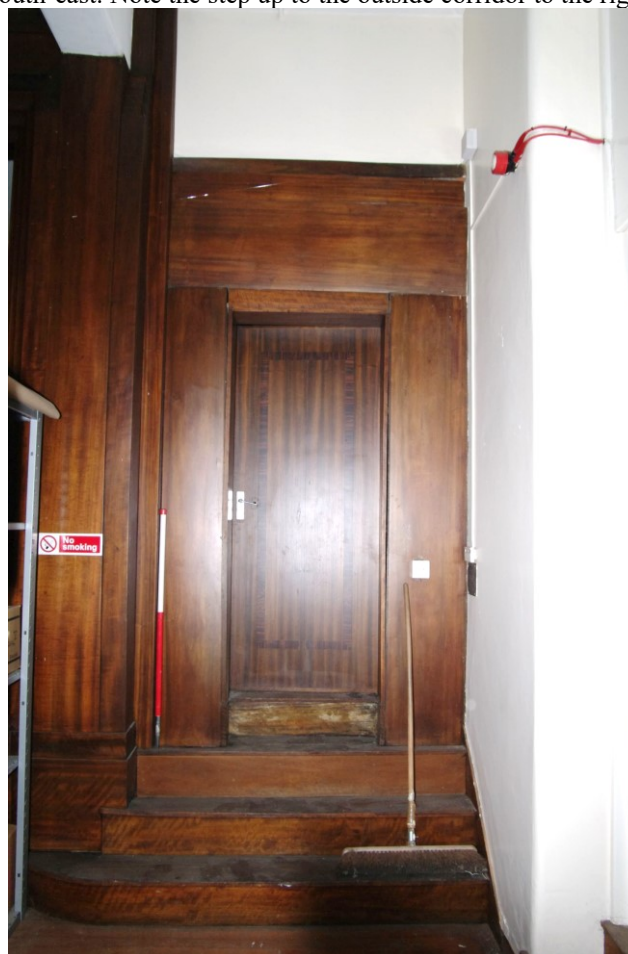
is framed by a moulded wooden Art Deco frame with similar design and marquetry repeated on the doors either side (Fig. 67). The stage appears to have a very slight rake on it along with many features which would allow the nurses to put on amateur dramatics shows. Recessed into the front of the stage are three narrow hinged boards which can be lifted to reveal the coloured footlights (Fig. 68). Burn marks on the underside of the boards show where the lights have been accidentally turned on without lifting the boards. On the south side of the stage is the curtain winding apparatus and light switches (Figs 69 and 70). The stage doors to the wings have inlaid wood borders and oval porthole style windows to allow an inconspicuous view of the stage. Above the stage are sets of coloured lights, spotlights and the curtain rail (Fig. 71). For films and lectures there is also a drop down projector screen. A number of other hooks indicate where backcloths could have been hung. At the time of the survey the two side rooms were full of dismantled furniture and no access could be obtained to the two other small rooms which lead out to the north-south corridor.

Figure 67 Recreation room/theatre: door to the changing rooms in the wings
Looking east at the southern door. 1m scale

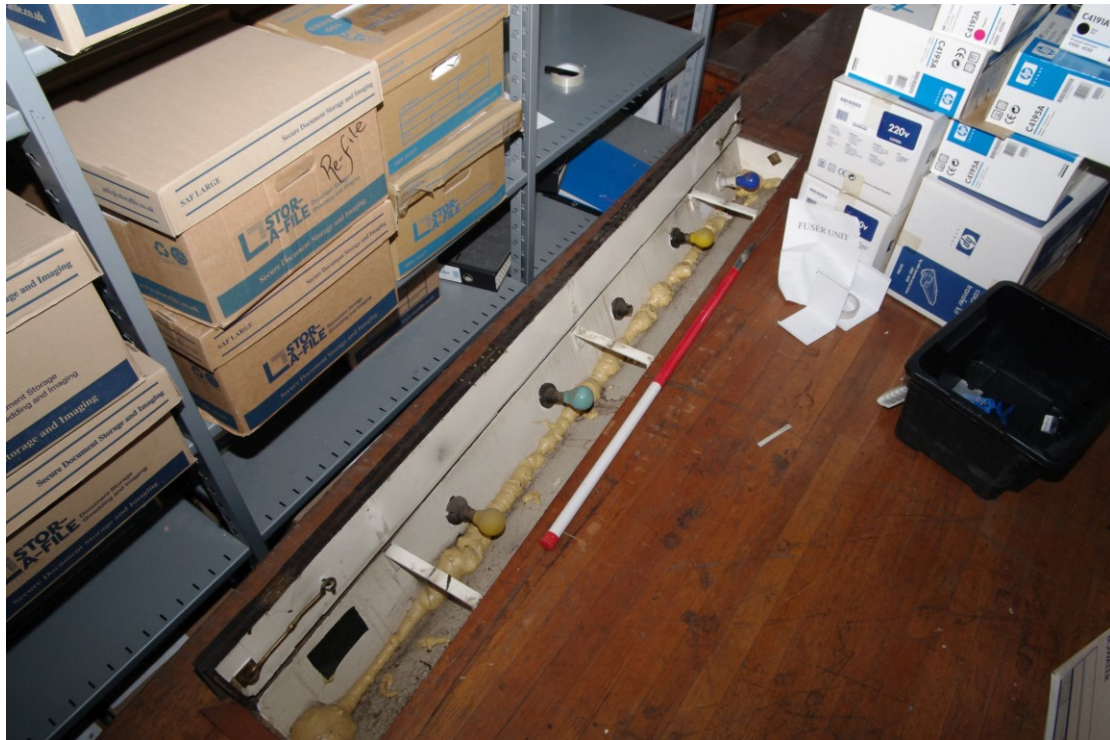
Figure 68 Recreation room/theatre: footlights set into the stage
The board is hinged and drops down to create a flat surface. 1m scale

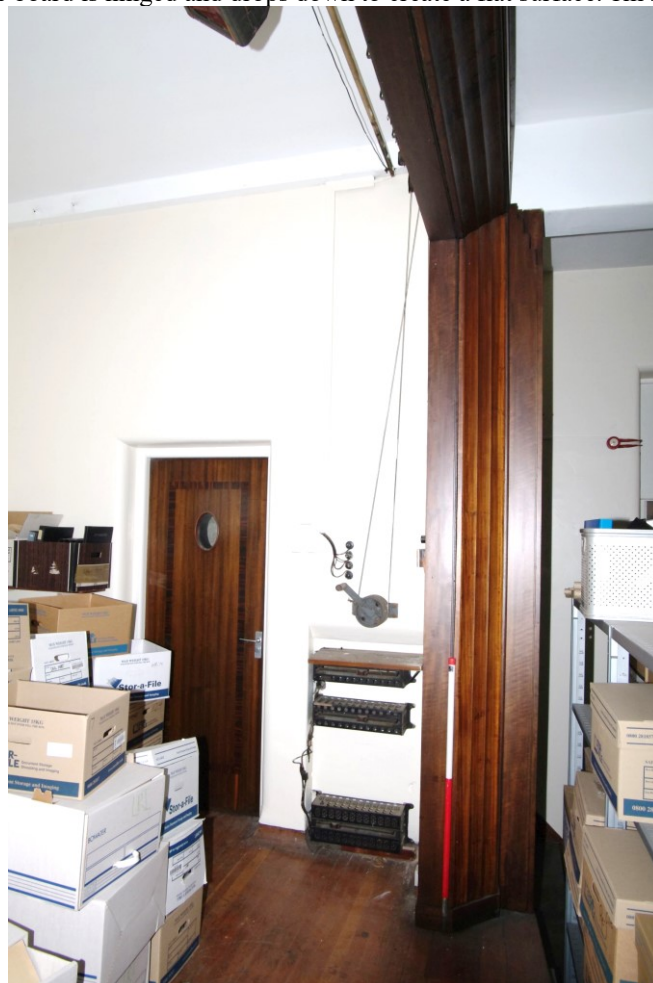
Figure 69 Recreation room/theatre: stage curtain winding gear
Looking south. Note the door to the left which leads into the wings and changing rooms. 1m scale

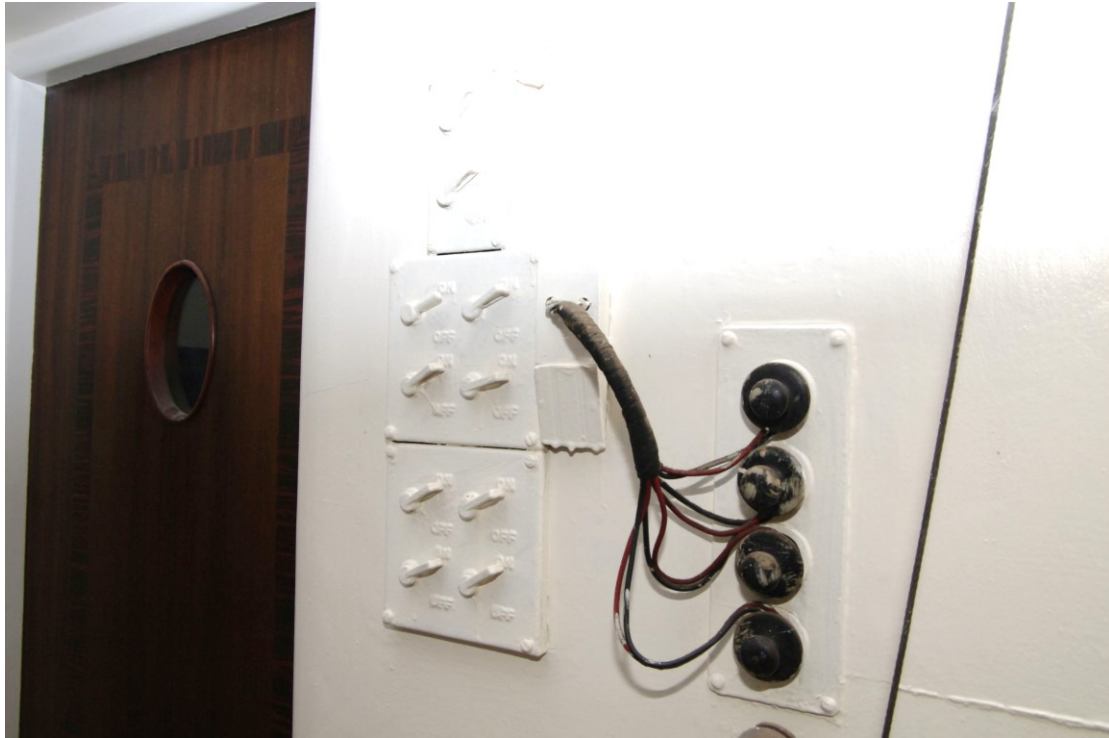
Figure 70 Recreation room/theatre: Stage light switches

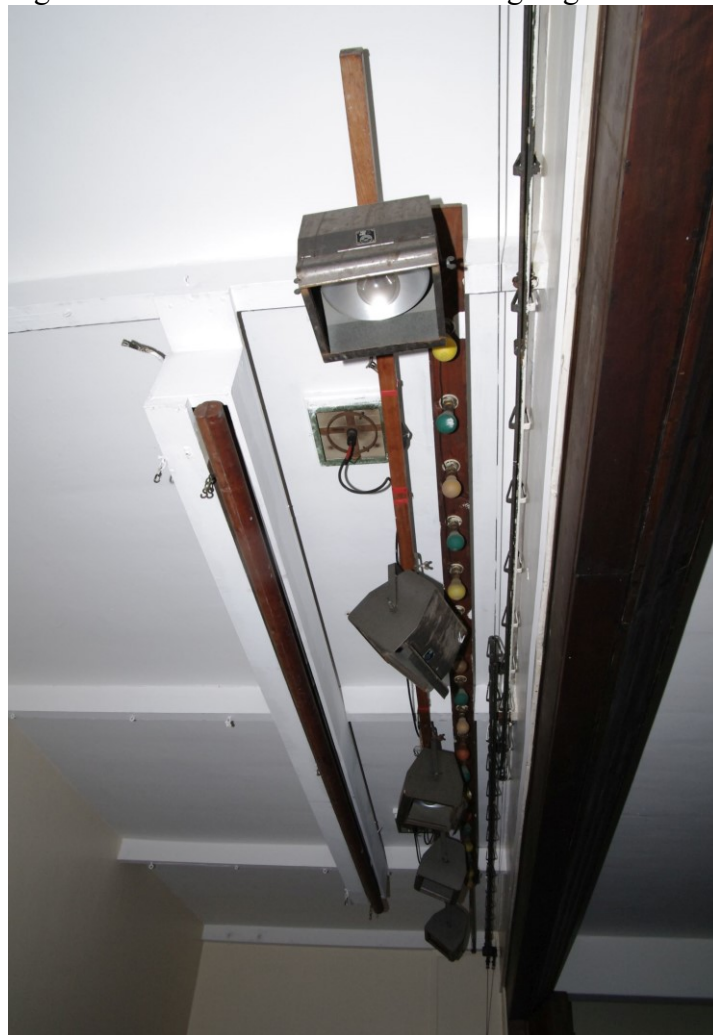
Figure 71 Recreation room/theatre: stage lights, curtain rails and drop down screen
