**A Level 3 Historic Building Survey at
The Knighton Street Offices,
Leicester Royal Infirmary,
Leicester
NGR: SK 58694 03539**

**ULAS Report No 2021-143
©2022**

Site Name: Knighton Street Offices, Leicester Royal Infirmary.

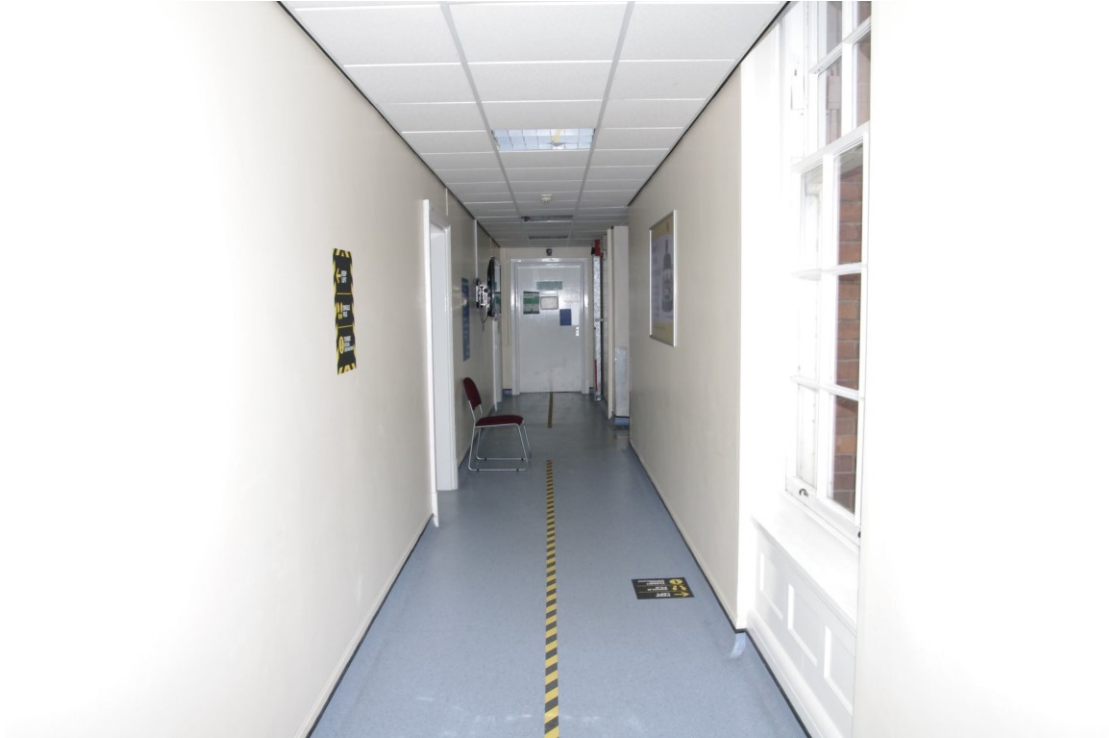
Figure 72 Ground floor: 1910 east to west corridor
Looking west. The doorway to the right leads to the 1910 north to south corridor. The closed door at the far end of the corridor leads to Room 049 currently known as the Beech Room

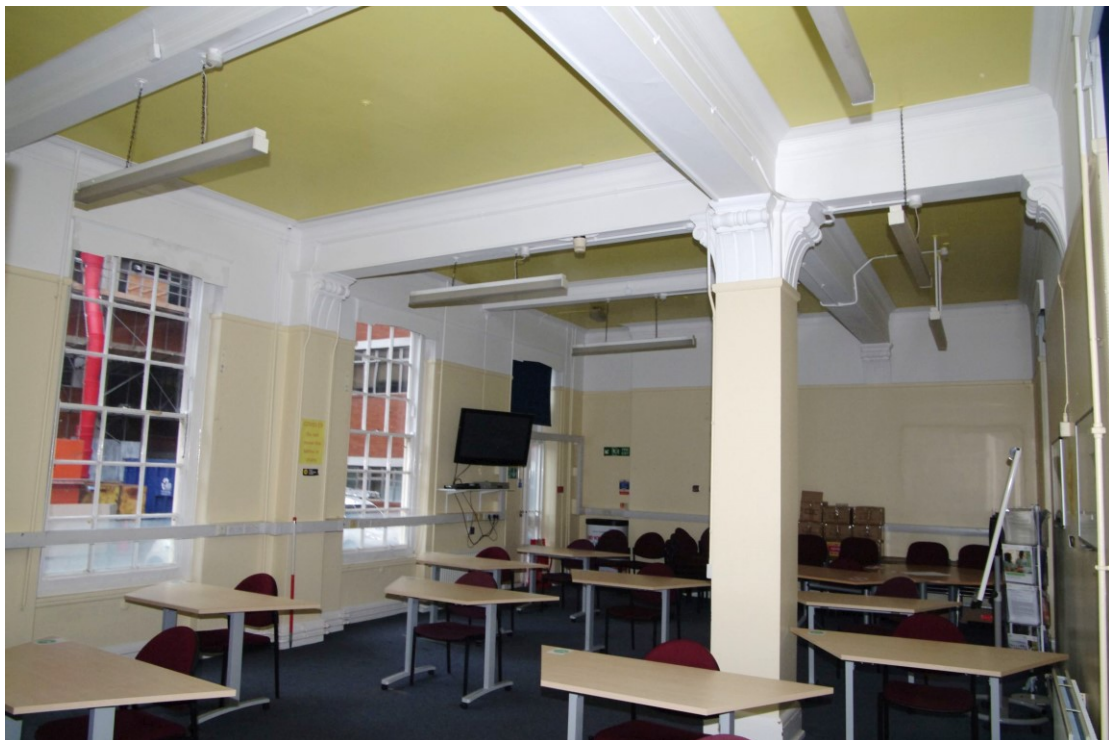
Figure 73 Ground floor: Room 049 the Beech Room
Looking south-west. 1m scale. See also Figure 74

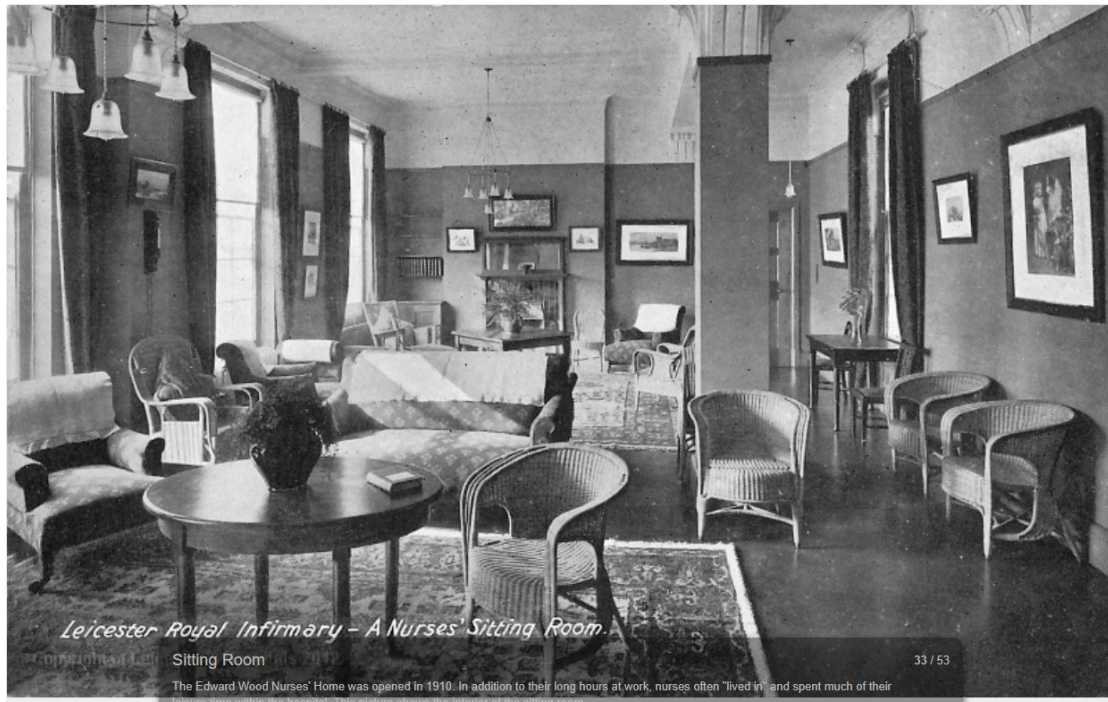
Figure 74 Ground floor: typical large sitting room which may be the Beech Room
See Figure 73. Source: Leicestershire Hospital virtual website

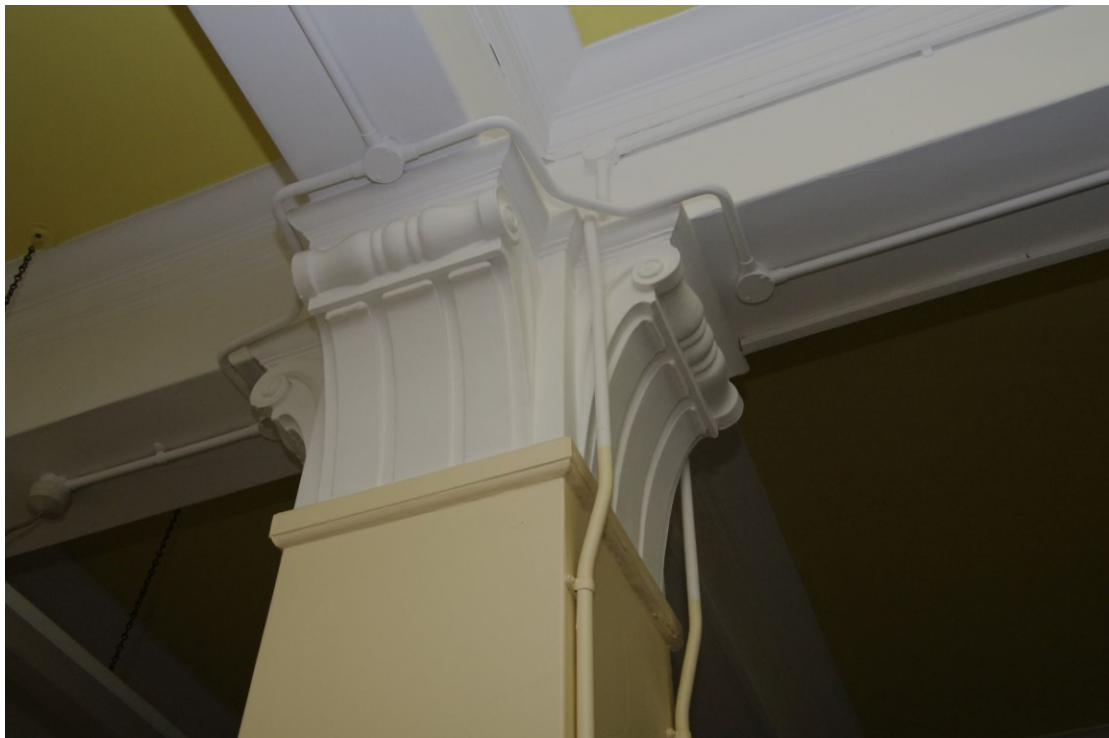
Figure 75 Ground floor: Room 049 decorative capital

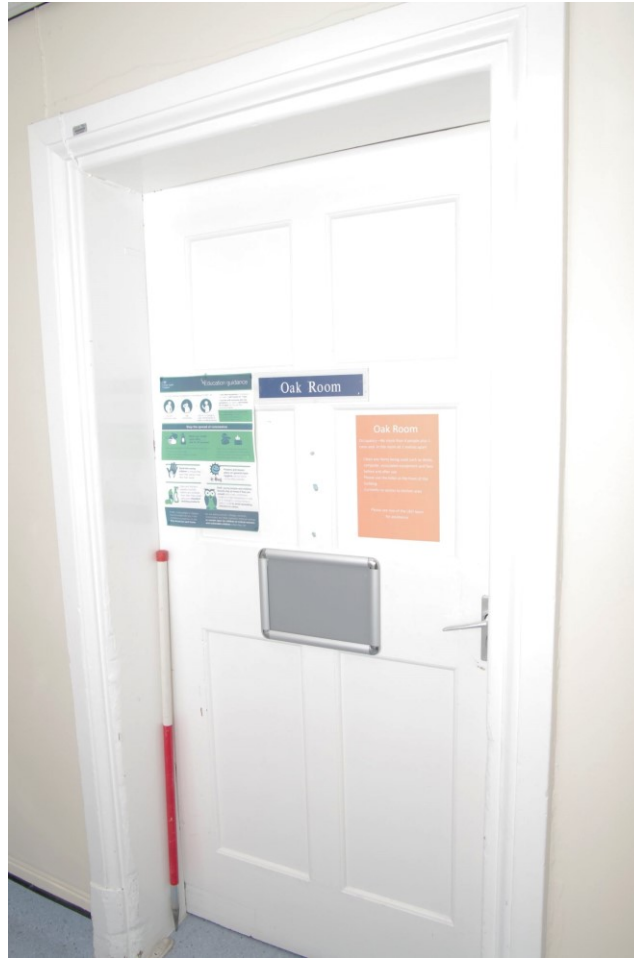
Figure 76 Ground floor, 1910 east to west corridor: door detail
Note also the moulded plater skirting detail. 1m scale

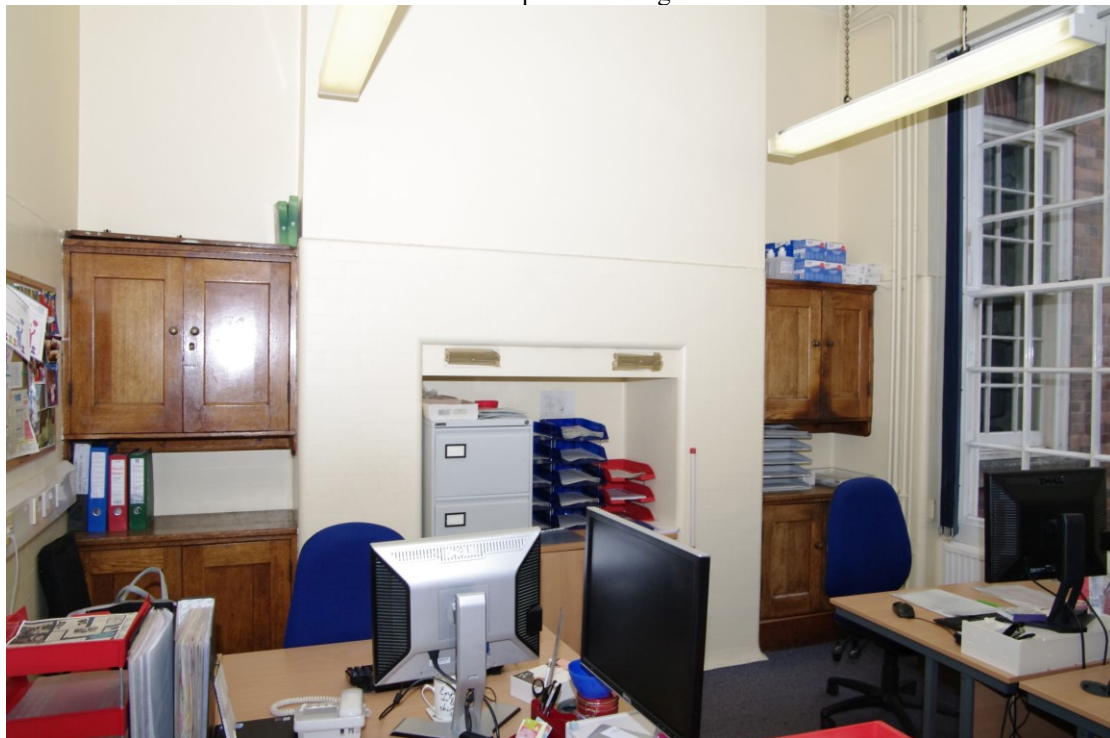
Figure 77 Ground floor, 1910 east to west corridor: Room 048
Looking south-east. Bay window of adjacent room visible through window

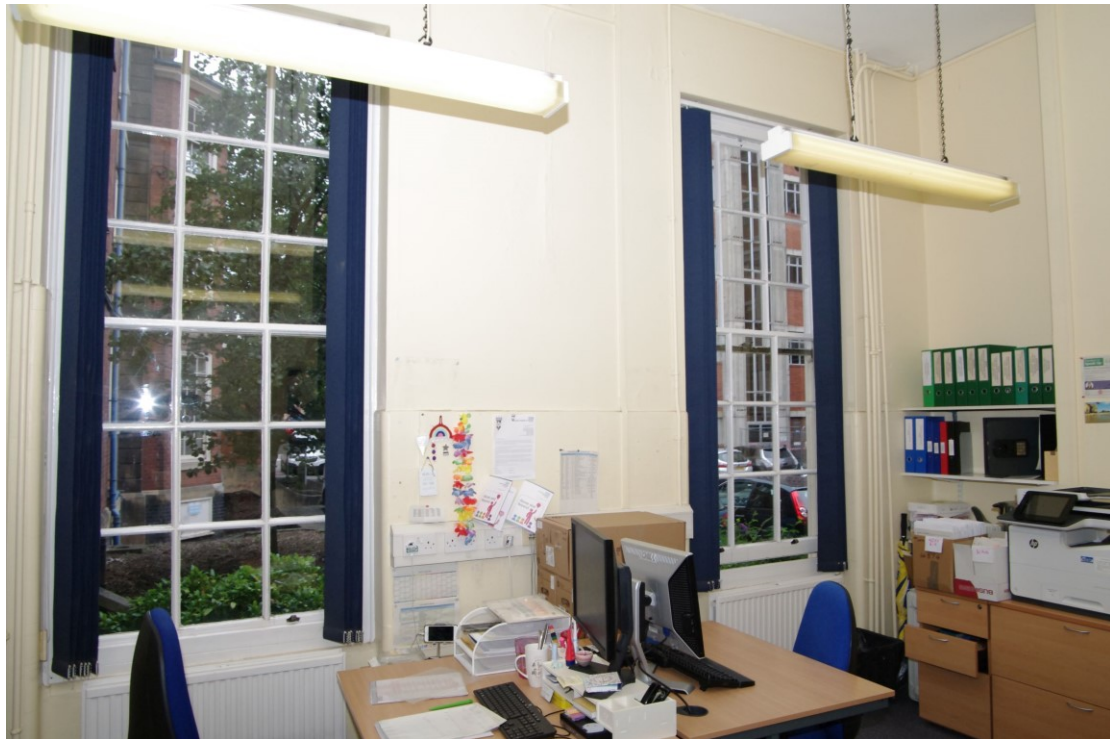
Figure 78 Ground floor, 1910 east to west corridor: Room 048 window detail
Looking south-west

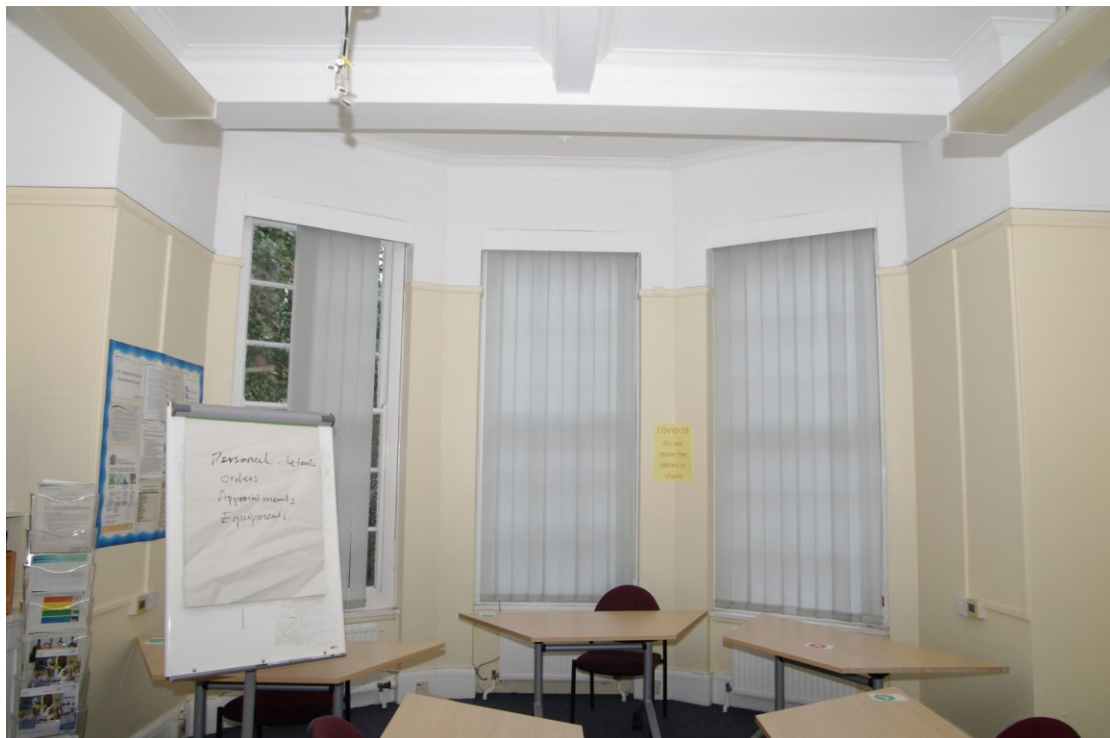
The central office with the bay window lacks any original fittings with the exception of a moulded beading at picture rail height (Fig. 79). The later 1930s or 1940s brochure suggests that these bay windowed rooms may have served as smaller, more private, sitting rooms (Fig. 80).

Figure 79 Ground floor, 1910 east to west corridor: Room 047
Bay window detail. Compare with Figure 80

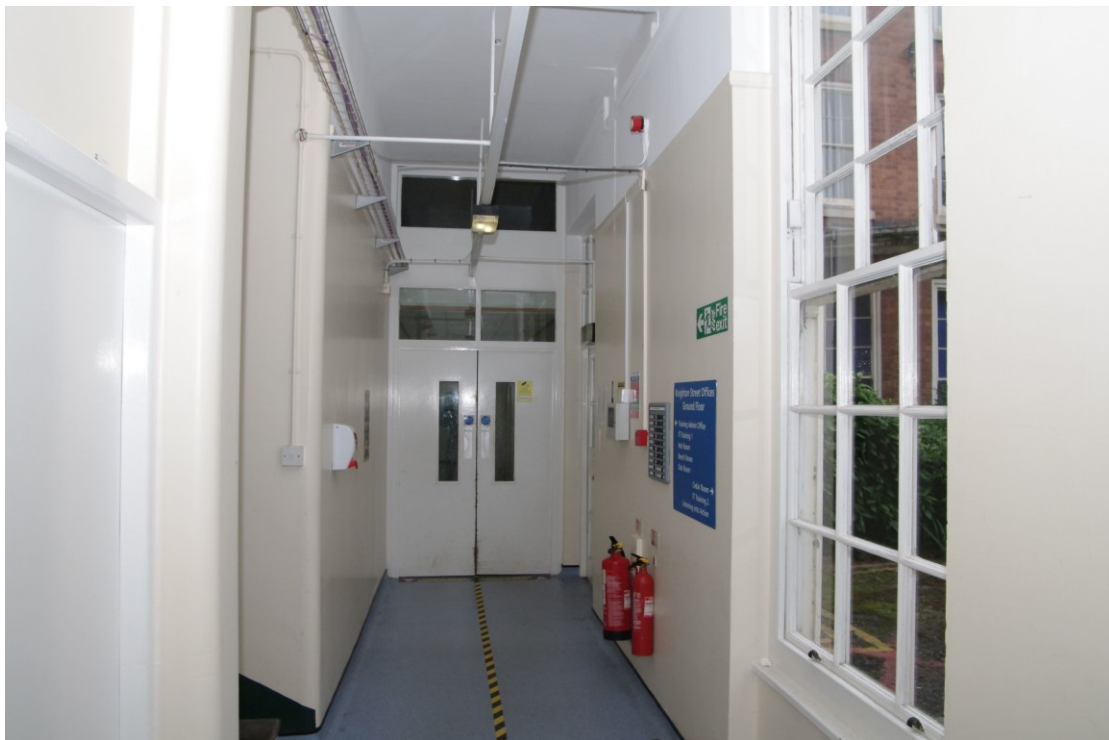
Figure 81 Ground floor east to west corridor

On the north side of the east to west corridor are sash windows and the small doorway with a porch shown in Figures 30 and 31 (Fig. 81). The junction between the 1910 phase and the 1930s phase cuts across the corridor at this point but the joint is seamless. Immediately to the east of the 1910 joint are a set of stairs up to the floors above. These are part of the 1930s extension and, although they have the same moulded handrail as the earlier stairs, the steps are of polished concrete rather than terrazzo (Fig. 82).

Looking west. The external doors are to the right. Stairs to upper floors on left. The joint between the 1910 and 1930s range is approximately where the fire extinguishers are

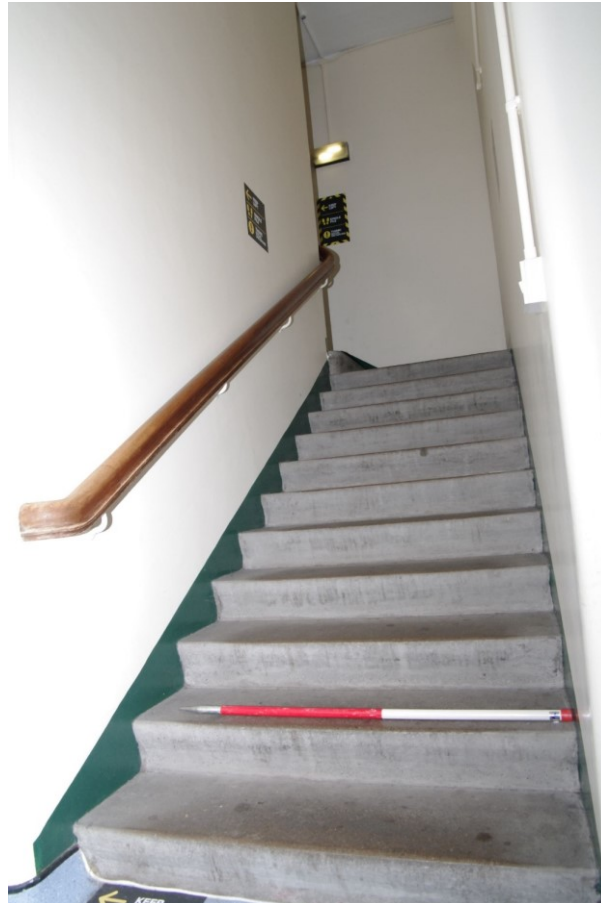
Figure 82 Ground floor: 1930s extension stairs
Looking south. 1m scale

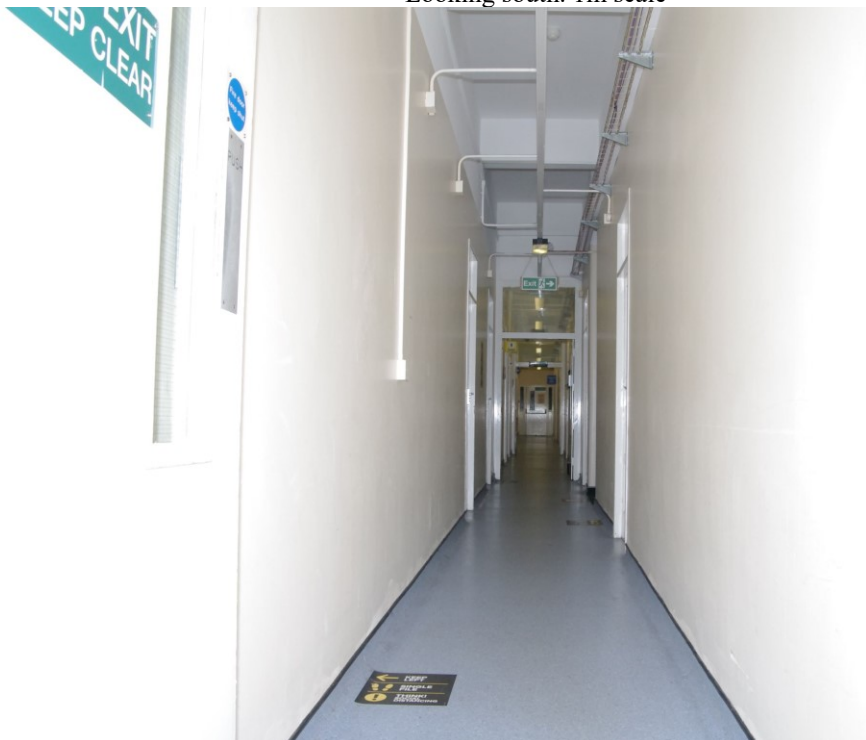
Beyond the stairs the corridor turns by ninety degrees to form a long north to south corridor running the entire length of the two 1930s phases (Fig. 83). Plain doors with small rectangular fanlights lead off from both sides of the corridor. It is not clear if the doors were once panelled and now have modern smooth coverings attached. Most of the fanlights have solid infilled panels but it is easy to imagine that these would have

Figure 83 Ground floor: 1930s extension north to south corridor
Looking south. The far double doors mark the joint between the two 1930s phases

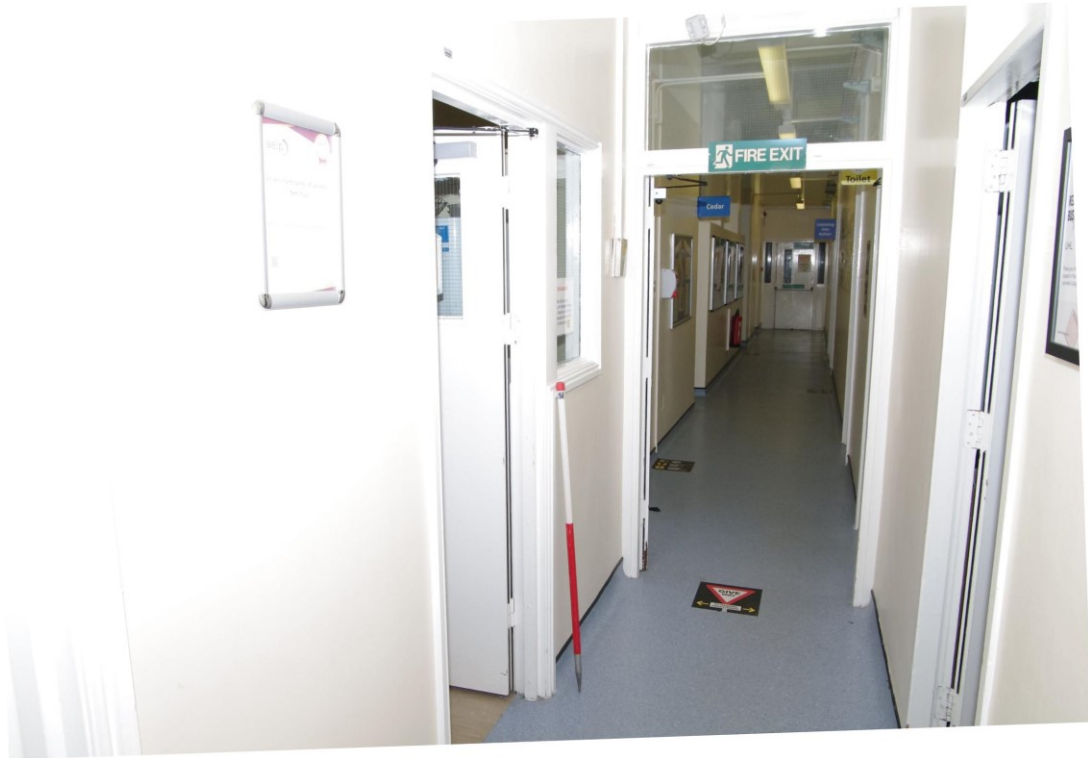
Figure 84 Ground floor: junction between the two 1930s phases
Looking south. Toilets either side in foreground. Note how the corridor widens beyond the doorway

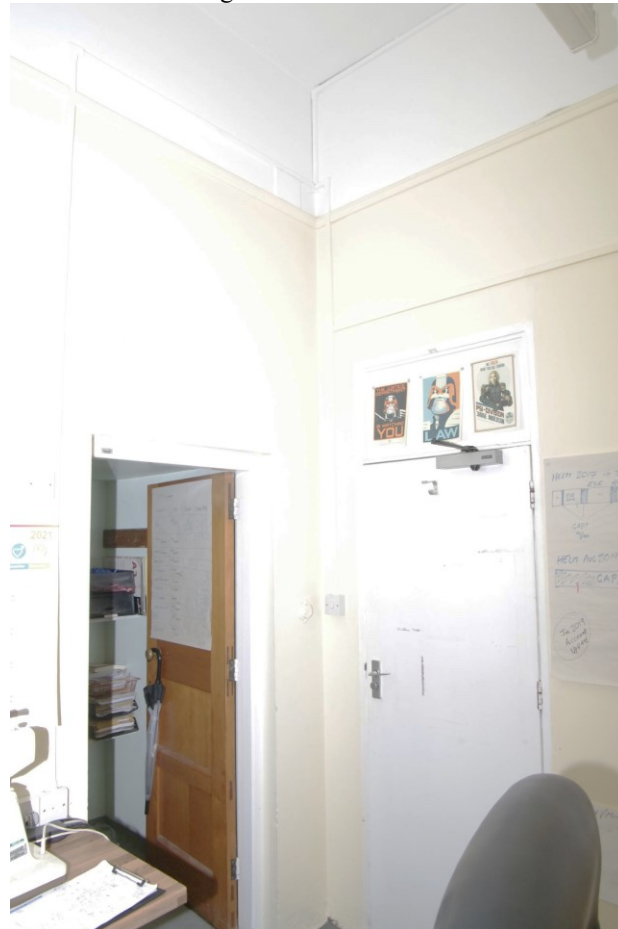
Figure 85 Ground floor: earliest 1930s phase room
Looking north-east in Room 044. Note panelled door to cupboard beneath the stairs

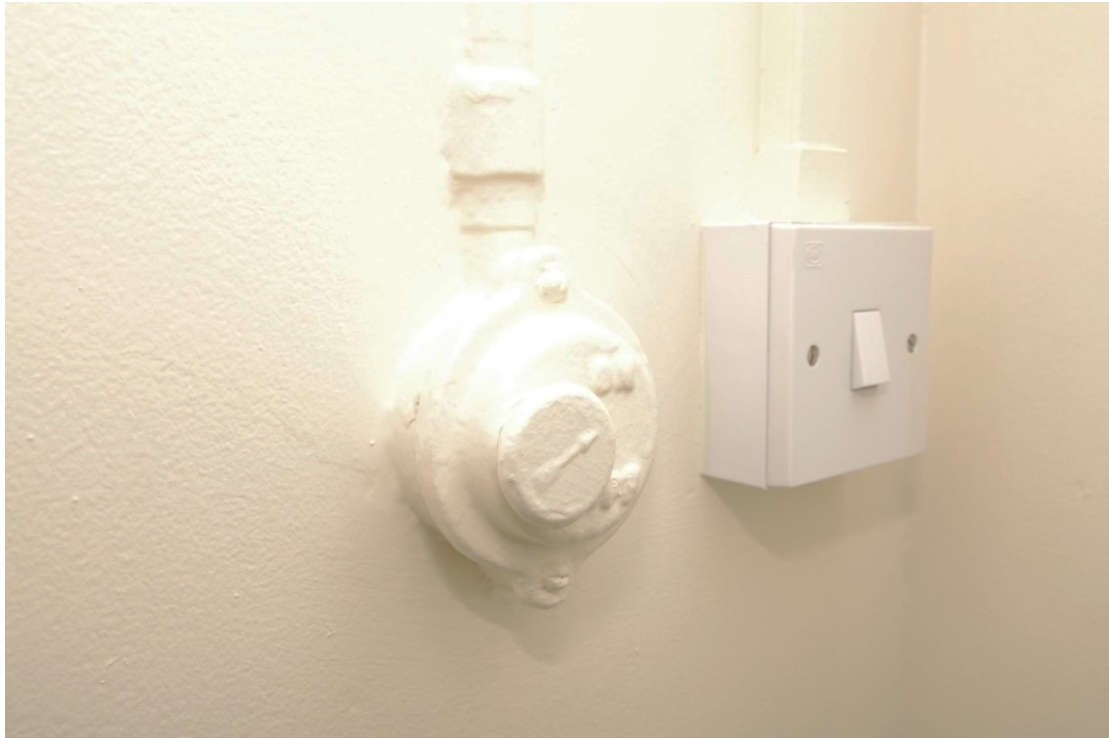
Figure 86 Ground floor: 1930s phase light switch

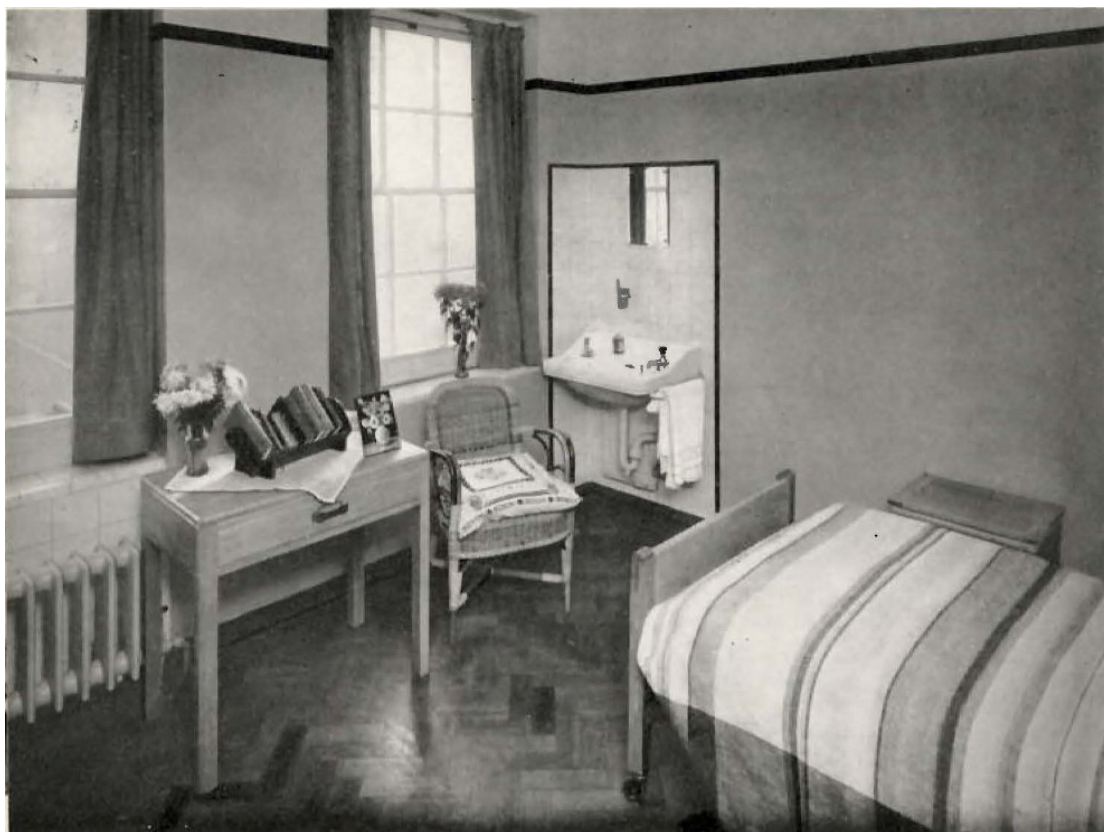
Figure 88 One of the nurses' larger bedrooms with tile splashback
This room has two windows and tiles behind the radiators. Most rooms had one window. Source: J Currington, LRI

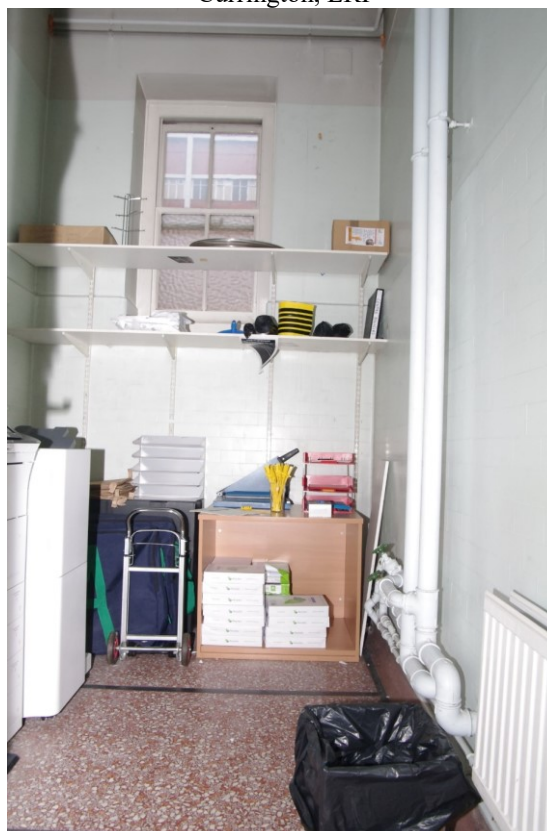
Either side of the northern end of the corridor are seven small rooms of varying sizes. It is possible that their prime position and variable sizes meant that they were intended for use as bedrooms by senior staff. Most lack any surviving fittings although Room 044, which is adjacent to the stairs, has a small cupboard below the stairs with a bare wood panelled door of 1930s style (Fig. 85). The style of the door panelling may indicate what the corridor doors may have been like. Many rooms within the 1930s extension have retained their, now non-functioning, light switches of semi-industrial style (Fig. 86). Although lacking many fittings almost all rooms, on this floor and the floors above still have a tiled splashback surround set to the side of the window (Fig. 87). No fittings remain and all have been painted over but old photographs indicate that a small sink was fitted here (Fig. 88). The rooms also have high ceilings and a wooden picture rail. At the end of the first 1930s phase extension are the toilet blocks. Currently these have a range of uses but appear to have been built as toilets, wash rooms and stores. The floors still have pink and black terrazzo which is the same as in the 1910 range (Fig. 89).

Figure 89 Ground floor: south end of first 1930s phase
Looking east. Note terrazzo floor

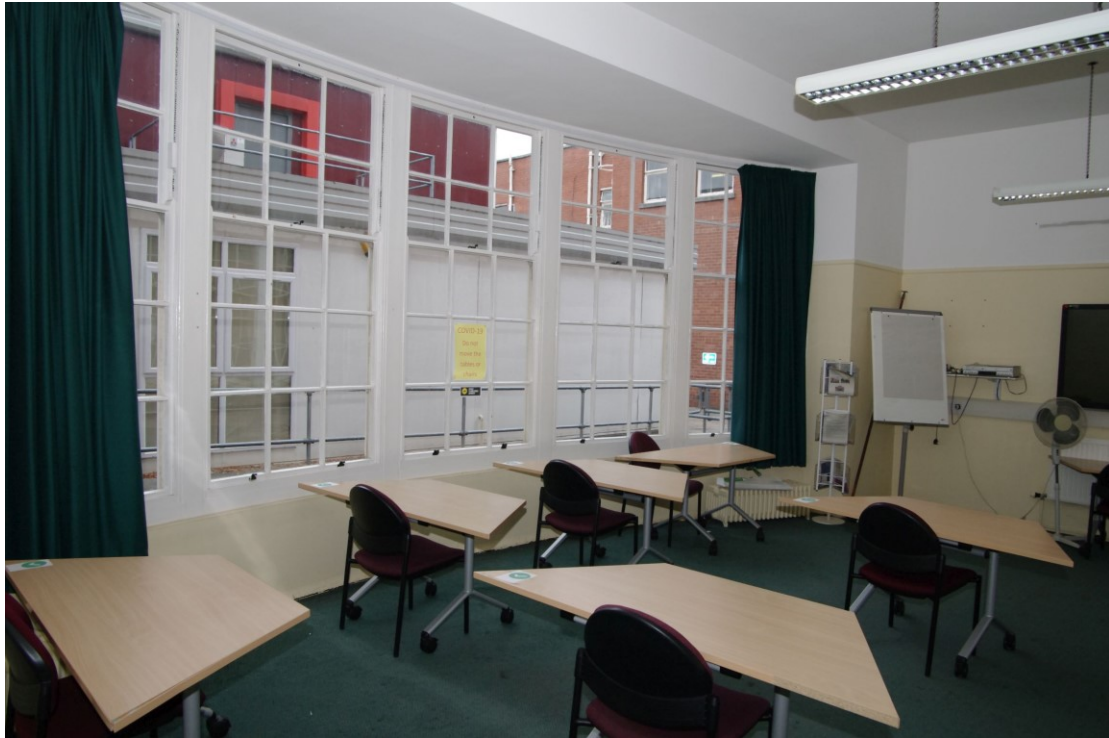
As noted, the corridor widens south of the joint between the two 1930s phases. On the east side of the corridor is the large room with the bow window seen in Figs 39 to 41 above. This room is presently used as a lecture room but early photographs suggest it may have been used as a writing room (Figs 90 and 91). Presently the floor is carpeted but the earlier photograph shows wooden block flooring. Beneath the window is a low cast-iron radiator which, in early photographs, can be seen as one of a number fitted beneath a curved window seat that has since been removed (Fig. 92). The room is sparsely decorated but has retained its original picture rail. Along the western side of this room is a partially glazed wood and glass partition to the corridor (Fig. 93). It is not clear if this is original or has been modified.

Figure 90 Ground floor: bow-windowed room
Looking south-east. Compare with Fig. 91

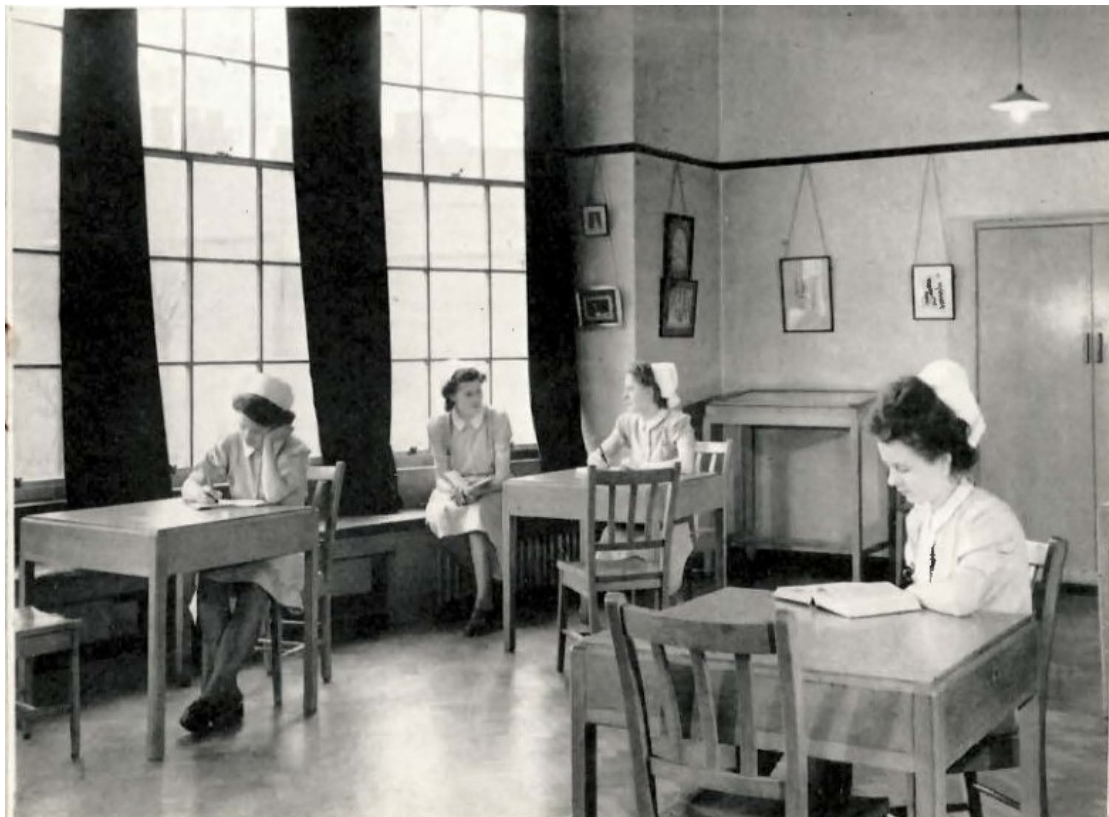
Figure 91 Bow-windowed room in its original layout
Source: J Currington, LRI

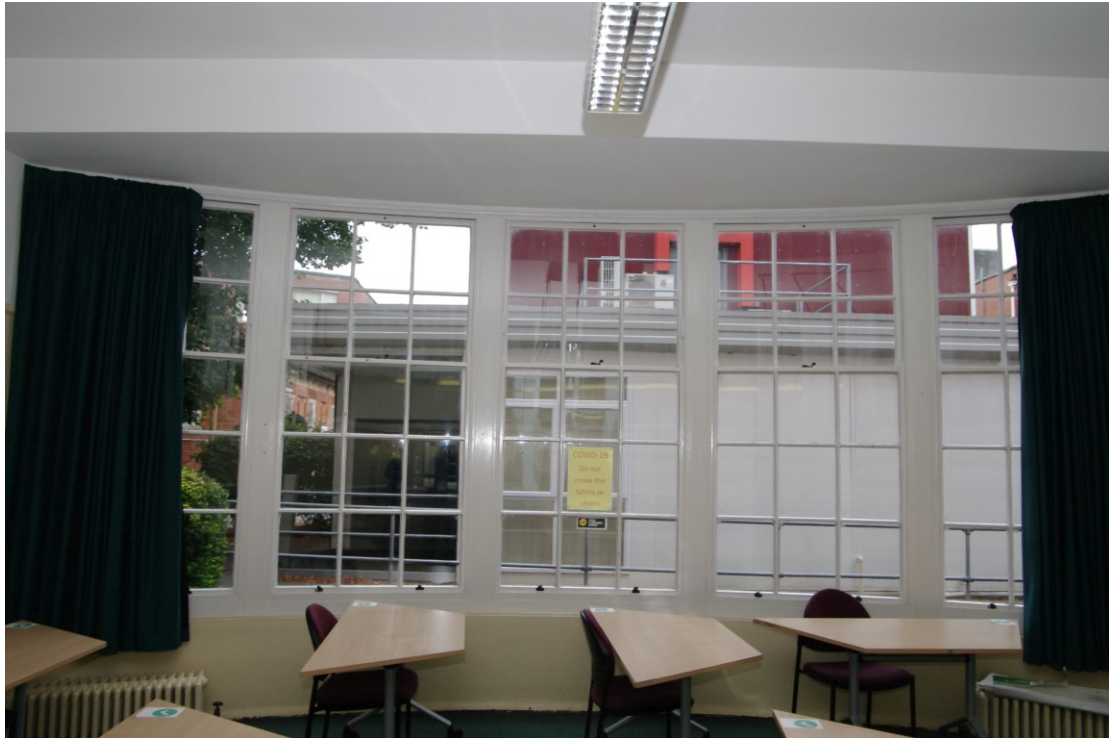
Figure 92 Ground floor: bow window detail
Looking east. Note the low radiators. See also Figure 91

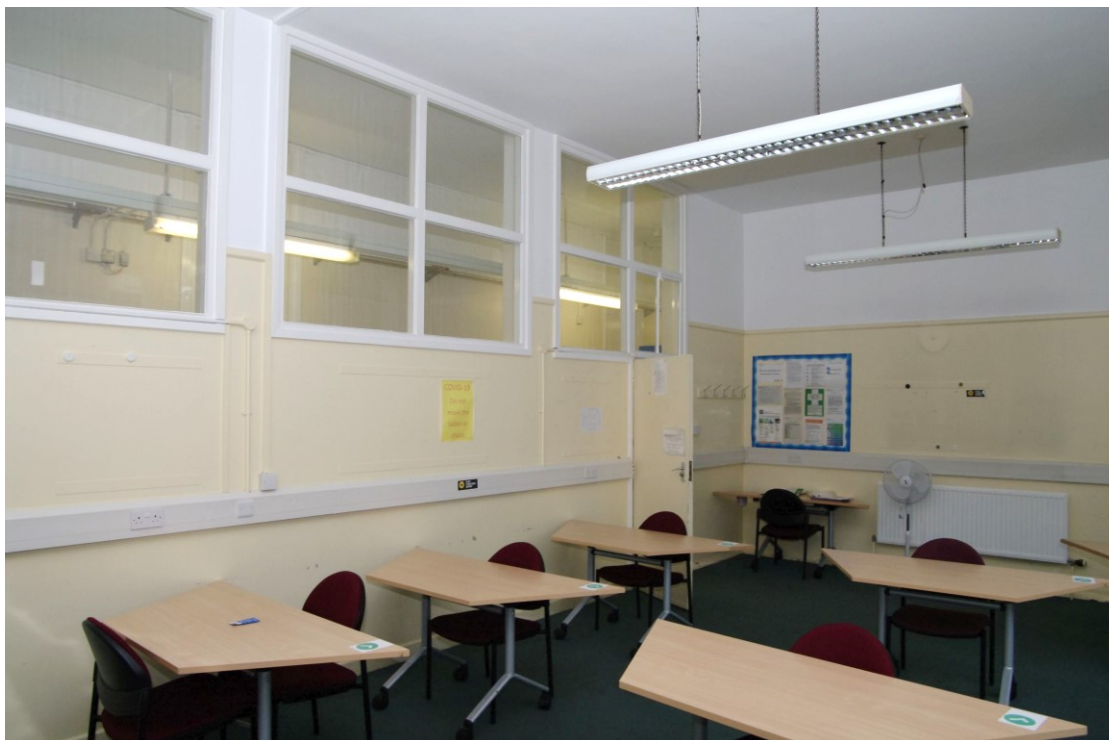
Figure 93 Ground floor: bow window room partition with corridor
Looking north-west

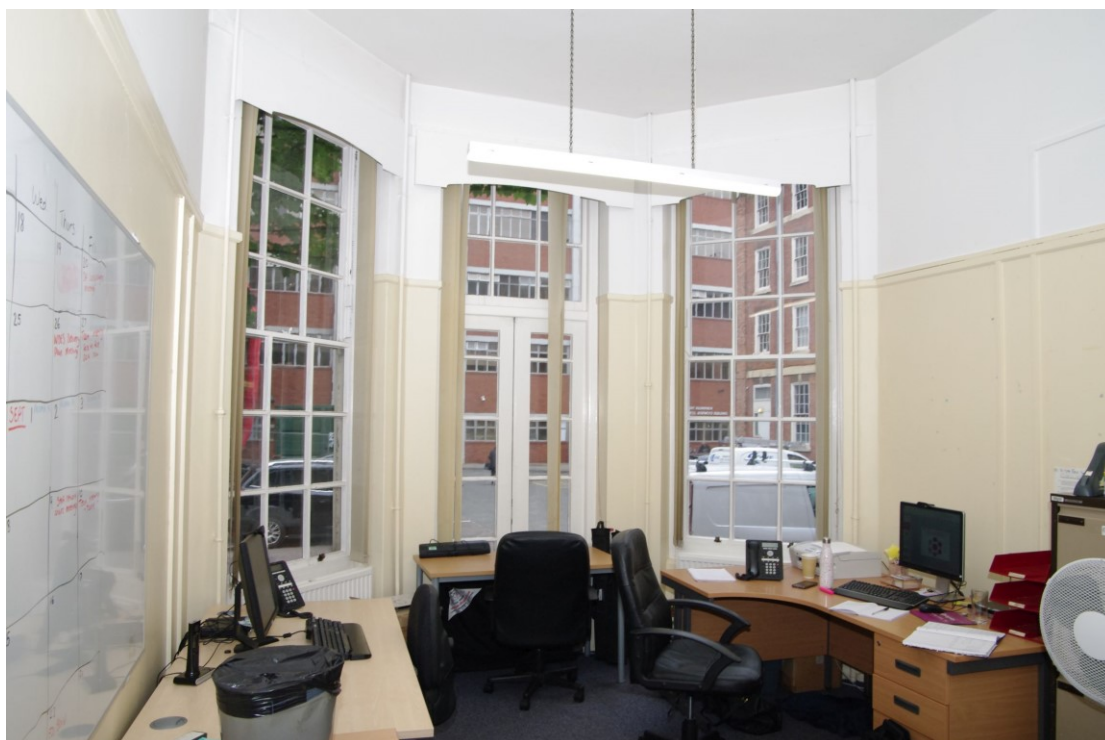
On the west side of the corridor is the ground floor room with the three-sided bay windowed room with the French windows (Fig. 94). The presence of the access to the outside suggests that this was likely to be another communal sitting room. The room has retained its picture rail but has no other original fittings. South of this room are more toilets and access to the modern fire escape.

Figure 94 Ground floor: bay window in later 1930s extension
Looking north-west. Note the central French doors

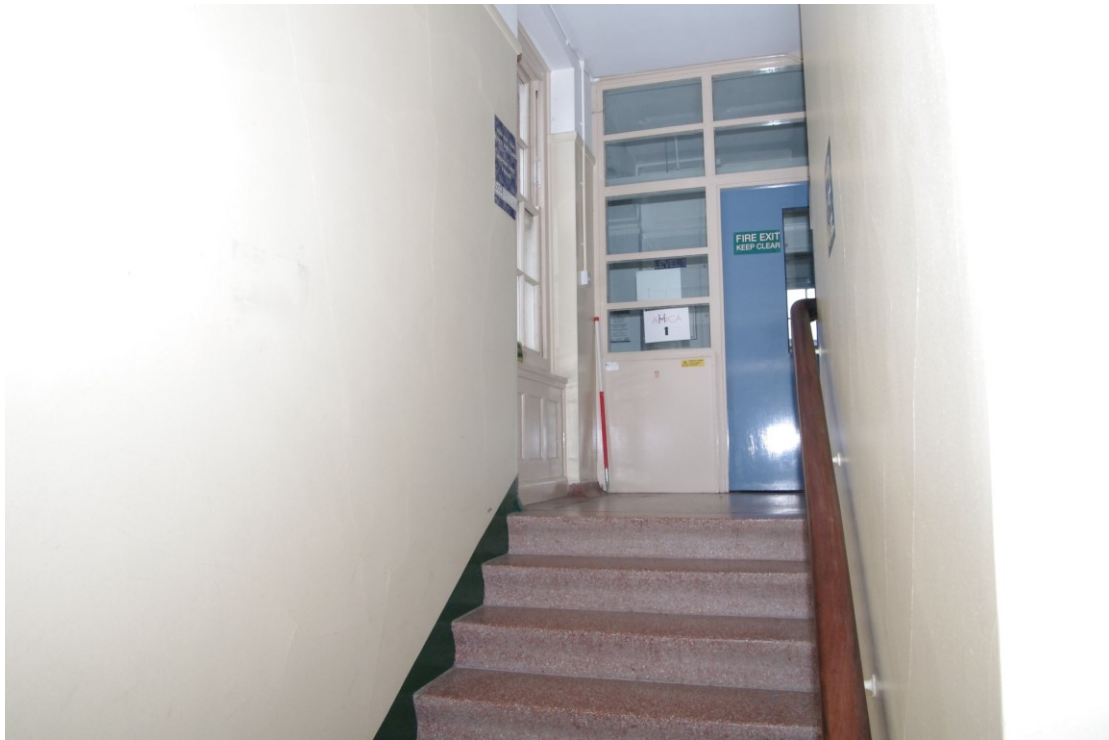
Figure 96 1910 stairs to first floor
Looking south-east. 1m scale

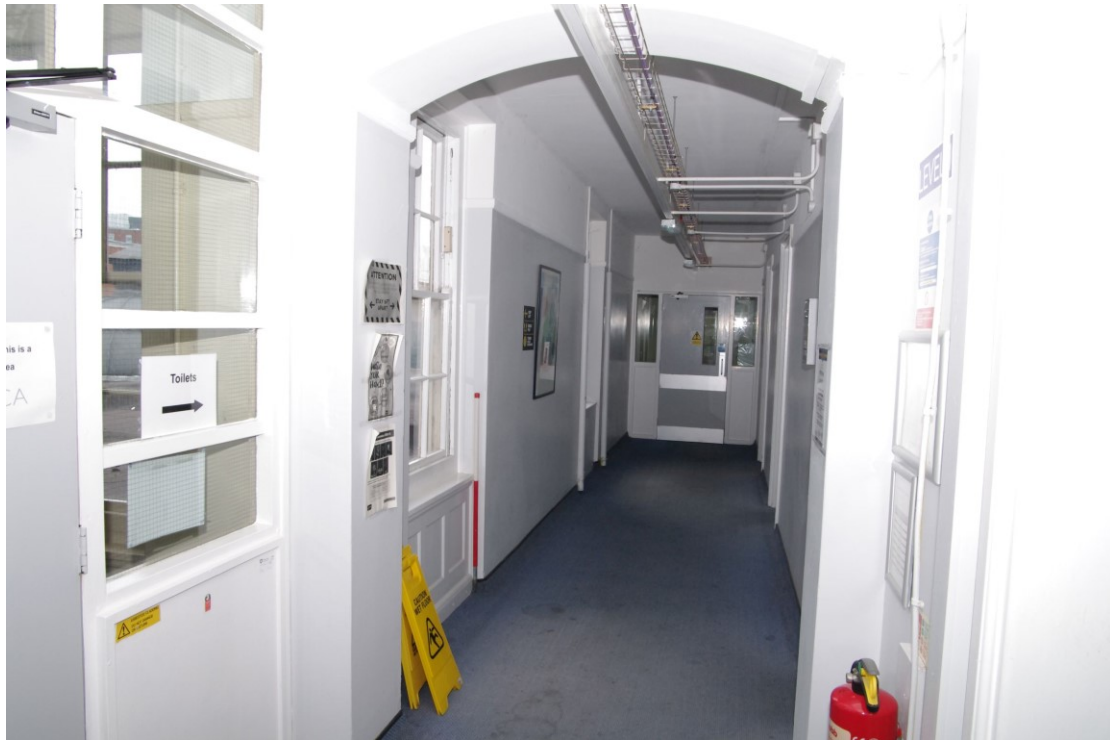
The 1910 rear, north, to south corridor is relatively plain with less-pronounced moulding around the doors and no moulded plaster detail at skirting level (Fig. 97). Beneath each sash window is a wooden panelled detail to break the otherwise plain corridor. A transverse arch supports the main wall of the 1910 range. Along the east side to the corridor are the larger bedrooms many of which still retain their fitted wardrobe and cupboards (Fig. 98). The wardrobes are bare wood of similar style to those seen on the ground floor. The rooms in this corridor do not have the tiled splashbacks seen elsewhere but do have chimney breasts although these are all blocked. Early photographs indicate that the 1910 range rooms did not have plumbed sinks in each room but had a dressing table and ewer (Fig. 99).

Figure 97 1910 rear north to south corridor
Looking north. Stairs on left. Toilet block and lift beyond modern door. 1m scale

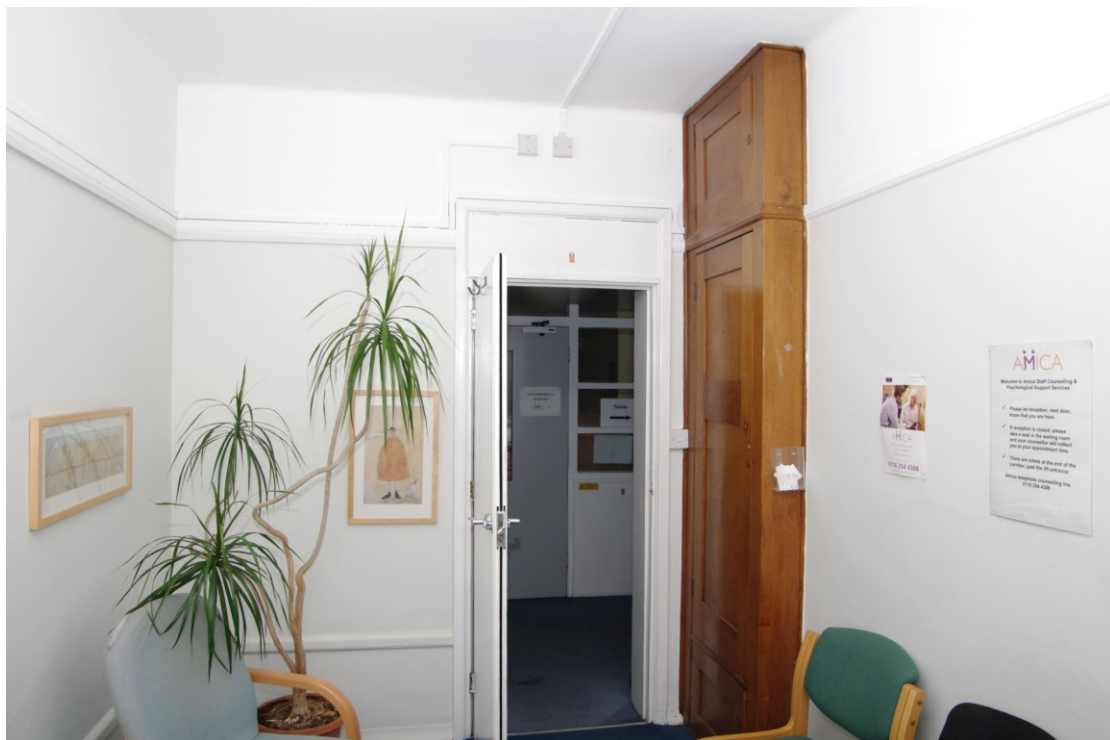
Figure 98 First floor: 1910 rear north to south corridor room detail
Looking west. Note fitted cupboard. Room 118

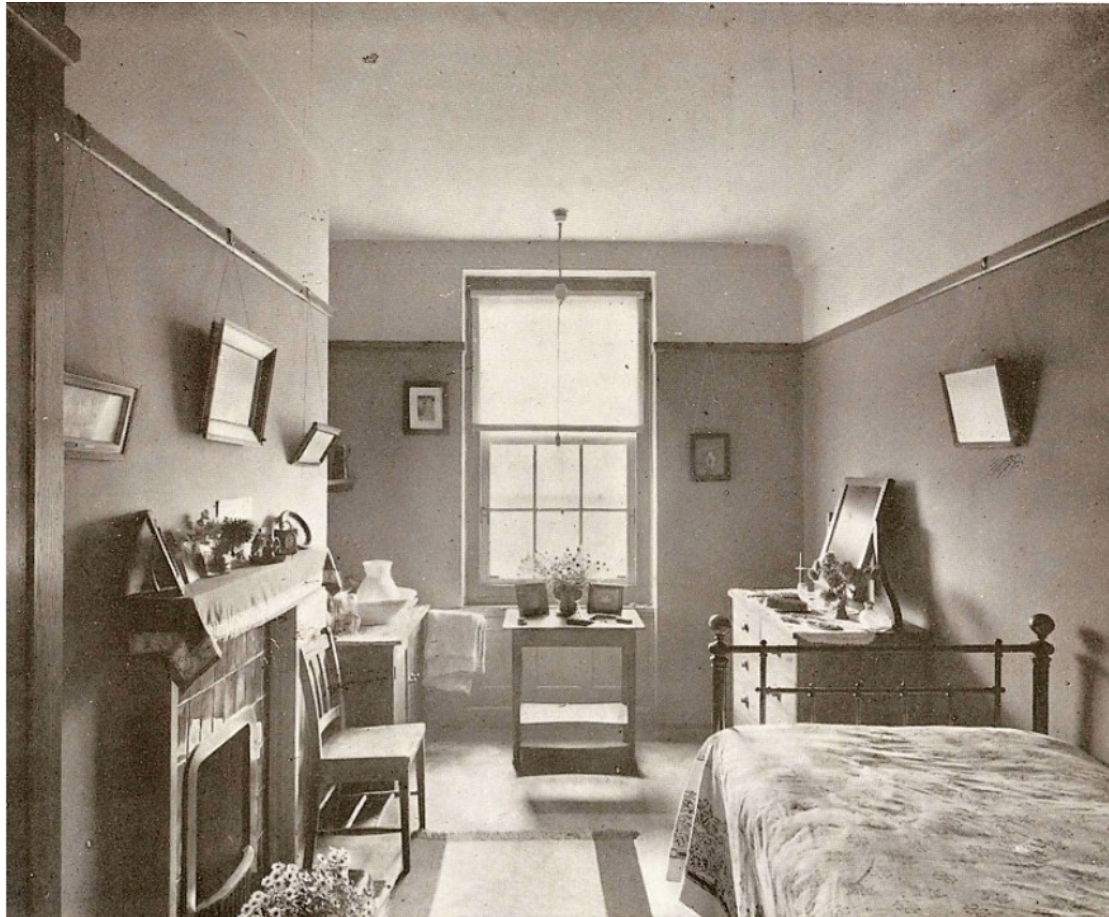
Figure 99 Bedroom in the 1910 range
Note the fitted cupboard front left and the ewer instead of a sink
Source: J Currington, LRI

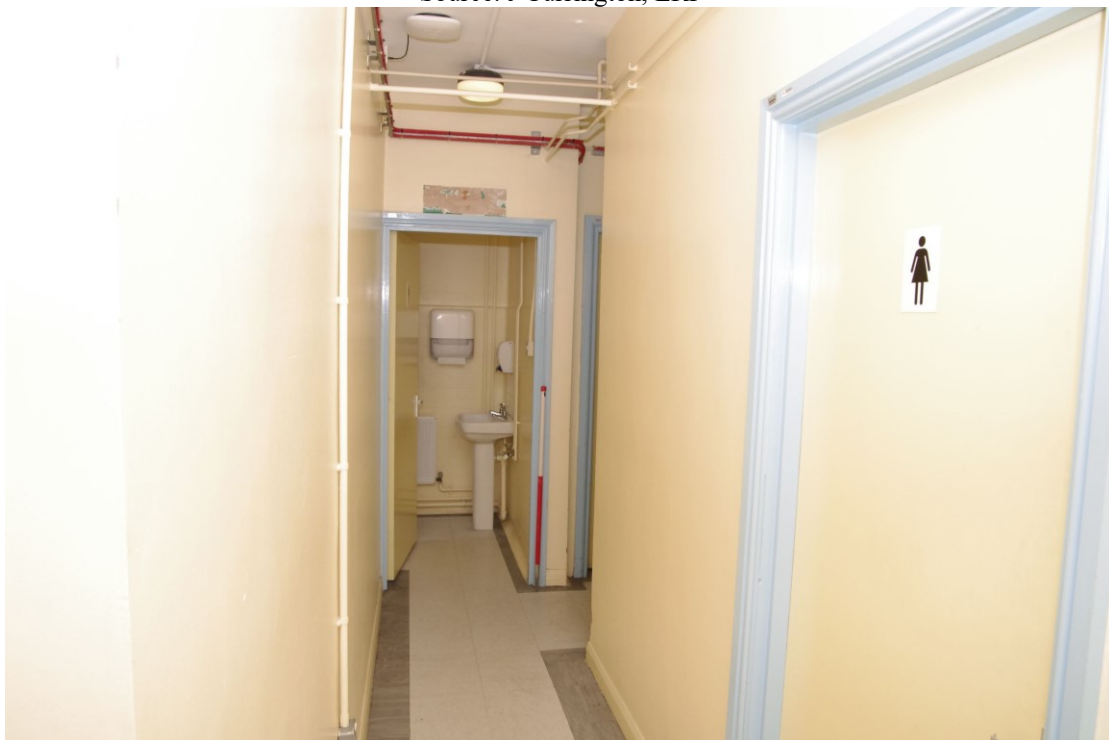
At the northern end of the 1910 north to south corridor is the toilet block with the modern lift shaft. Although the toilet fittings are modern, the layout and cubicles appear to be original (Fig. 100). A passageway leads through the toilet block to the external fire escape which also appears to be an original feature.

Figure 100 First floor: 1910 rear corridor, toilet block
Looking north. 1m scale
