**A Level 3 Historic Building Survey at
The Knighton Street Offices,
Leicester Royal Infirmary,
Leicester
NGR: SK 58694 03539**

**ULAS Report No 2021-143
©2022**

Site Name: Knighton Street Offices, Leicester Royal Infirmary.

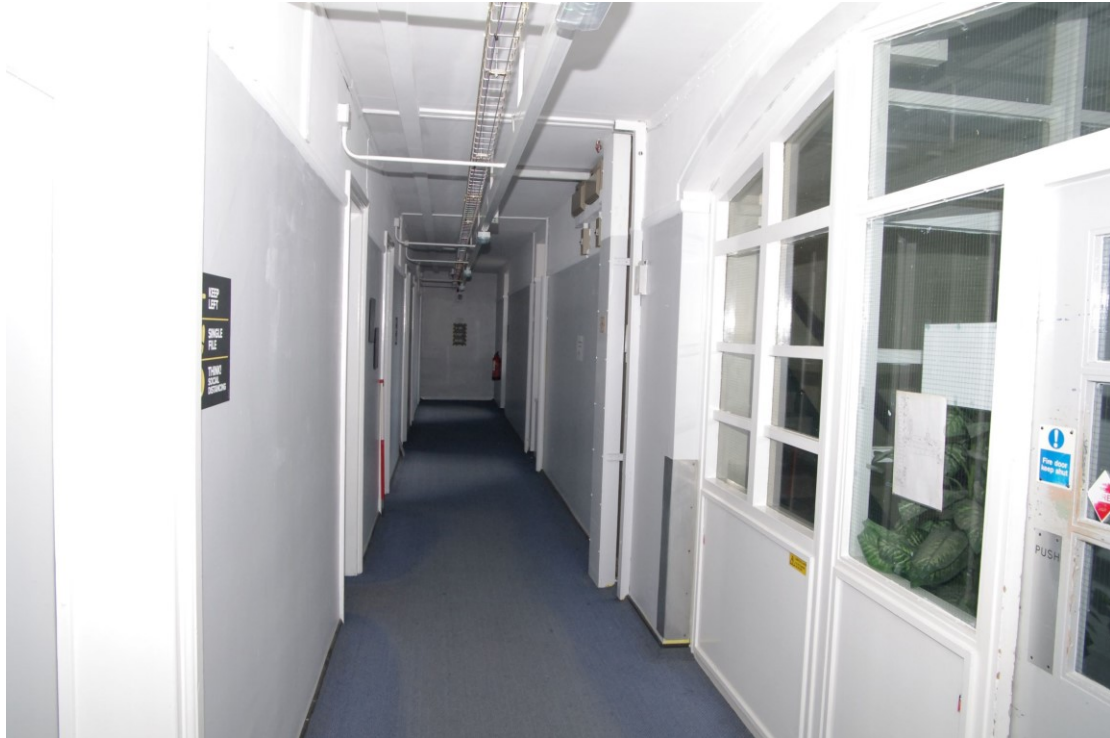
The 1910 range east to west corridor is very similar to the rear corridor with large rooms opening to the south of the corridor (Fig. 101). These rooms do have tiled splashbacks and most also retain their fitted cupboards beside the blocked fireplaces (Fig. 102). Although a fireplace is shown in early photographs only a perforated air-brick is now present (Fig. 103). Before being used as offices some of these offices may have been used as medical consulting rooms as there are rails for curtains behind the doors in some rooms (Fig. 104).

Figure 101 First floor: 1910 east to west corridor
Looking west. Stairs on right. 1m scale

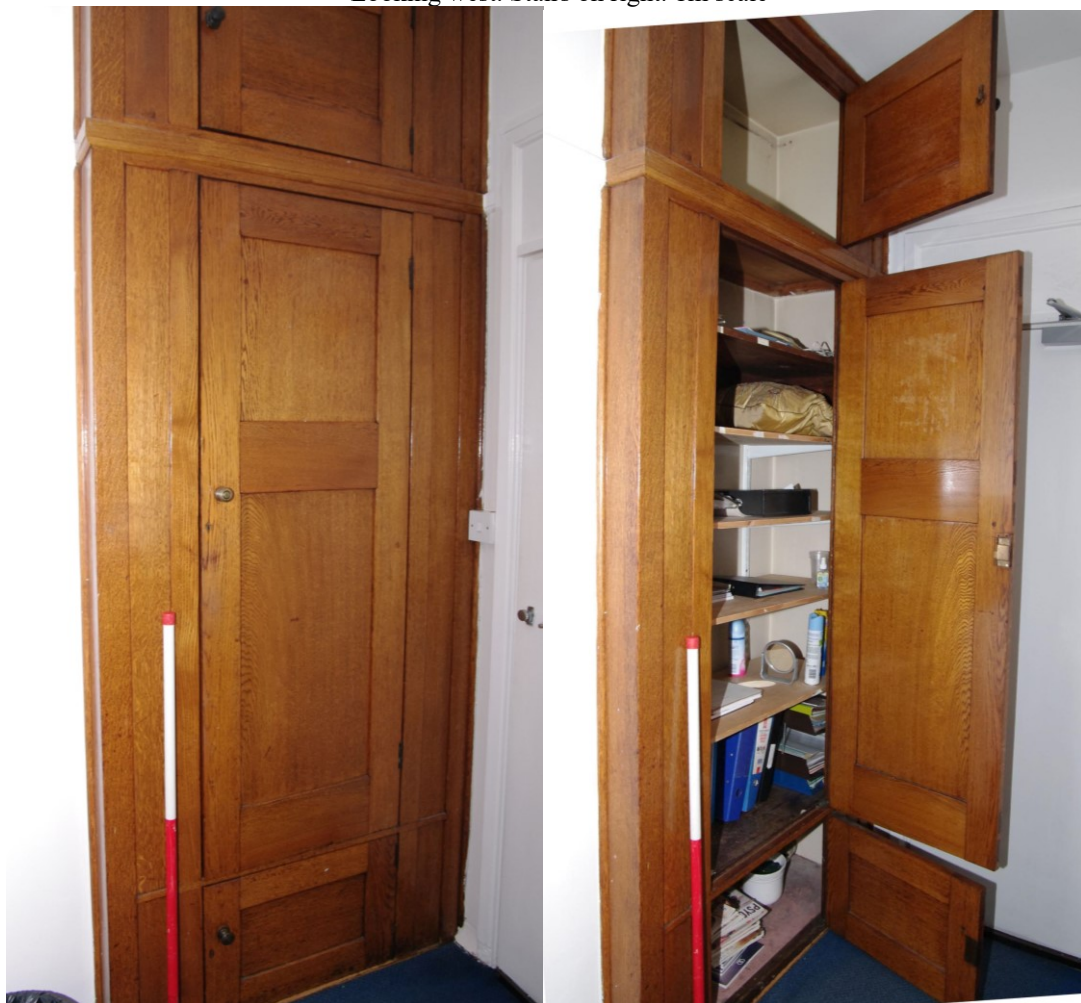
Figure 102 First floor: 1910 range fitted cupboard detail

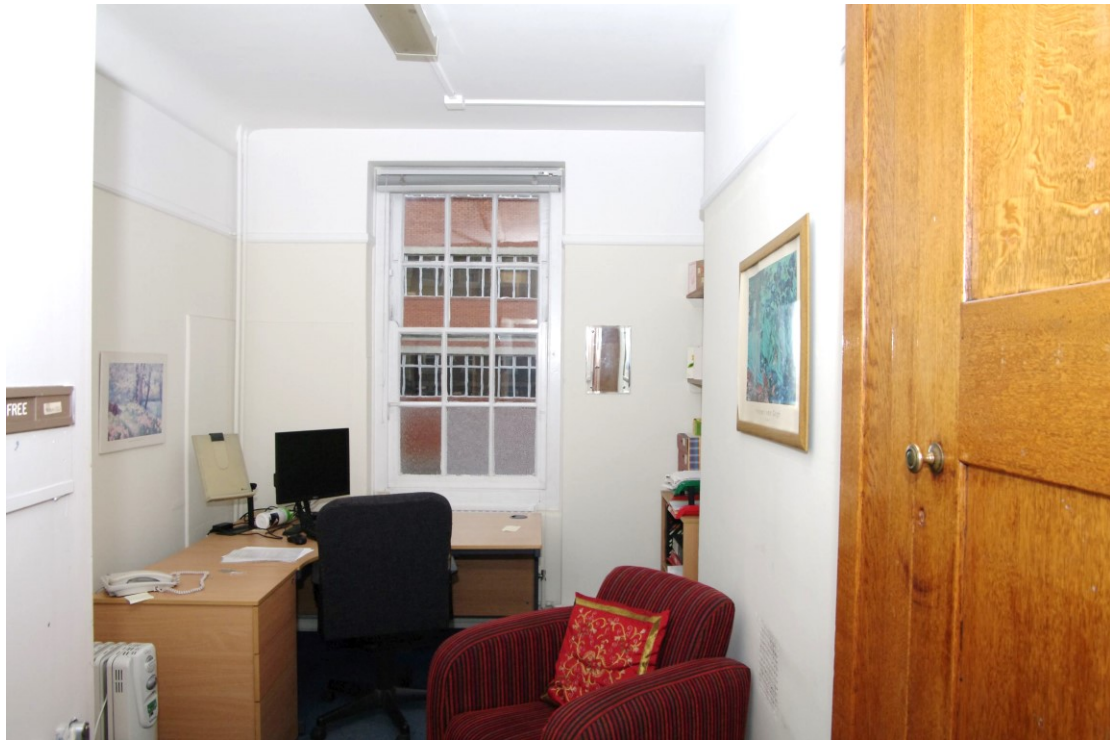
Figure 103 First floor: east to west corridor 1910 range room
Looking south. Note vent in fireplace

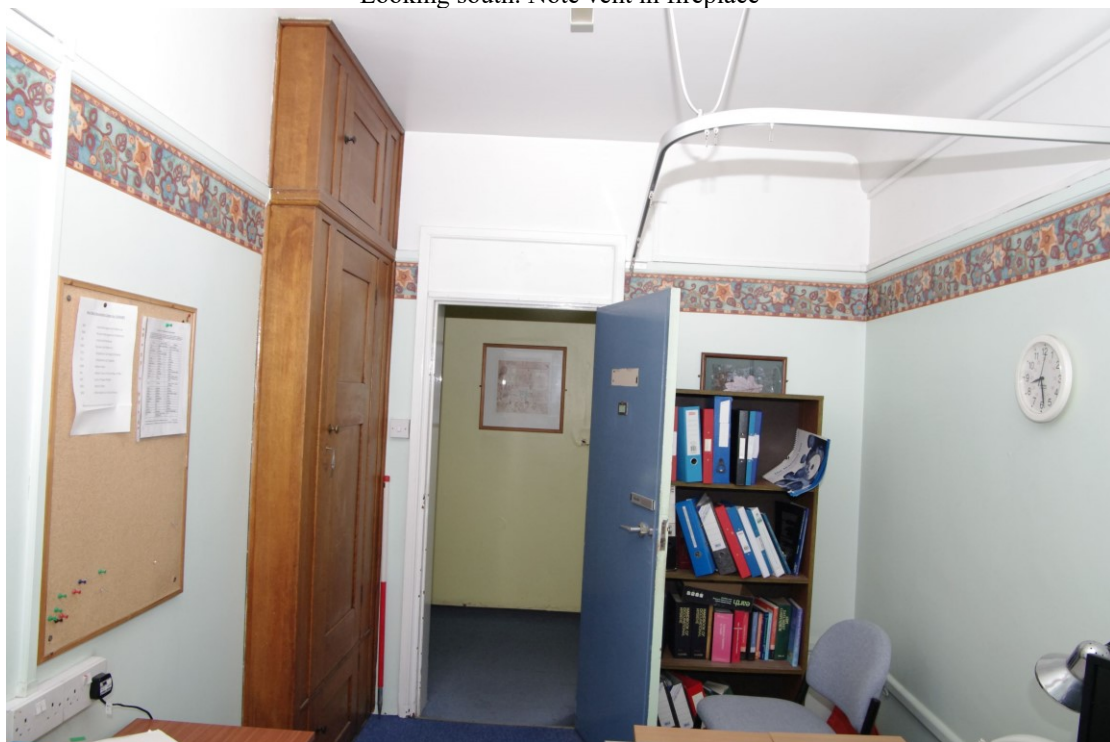
Figure 104 First floor: office on 1910 east to west room
Looking north in Room 151. Note curtain rail on right. 1m scale

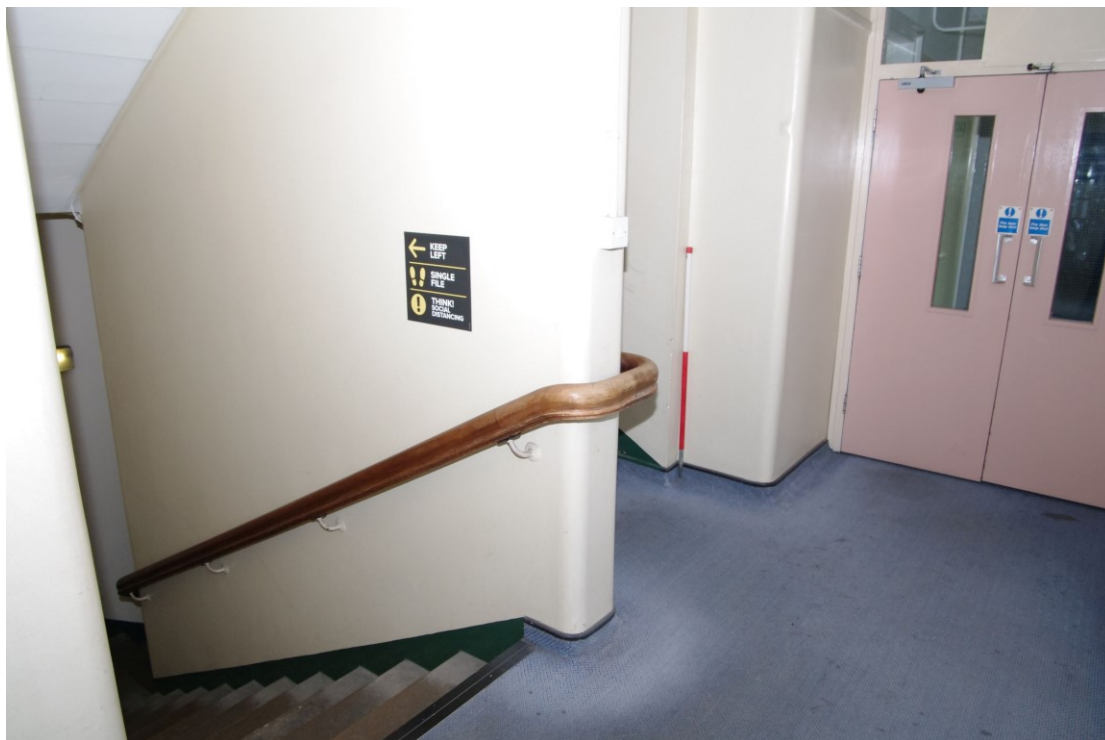
Figure 105 First floor: 1930s stairs
Looking south-west. 1m scale

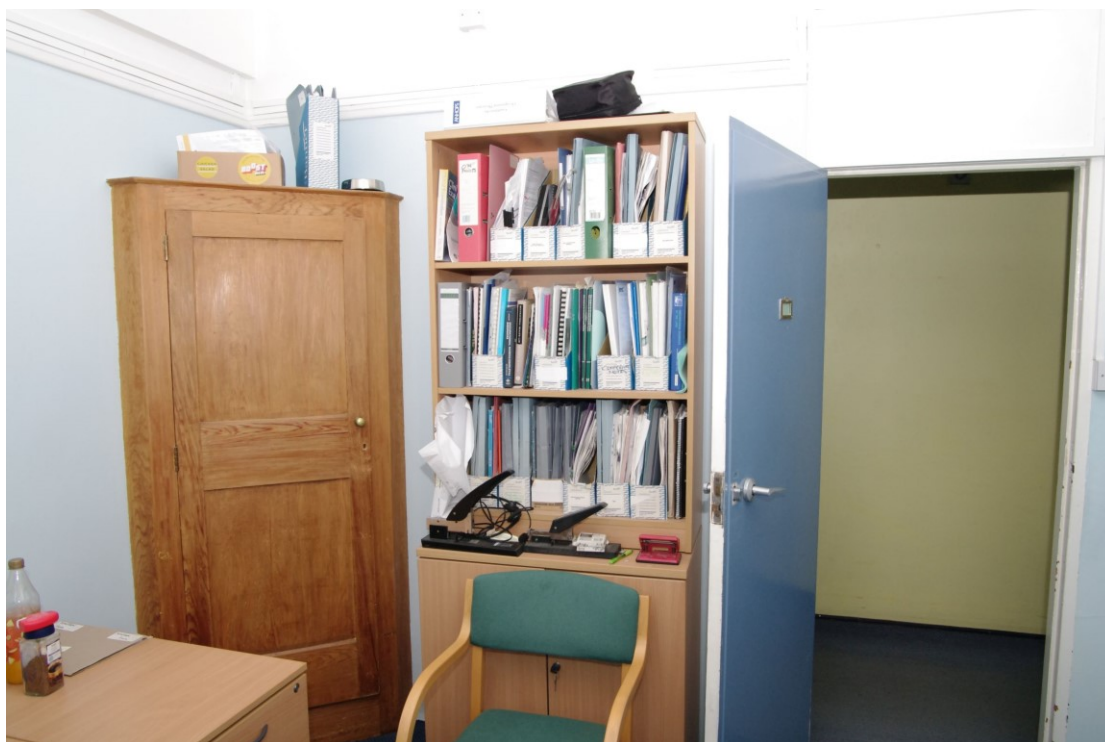
Figure 106 First floor: first phase 1930s north to south corridor. Corner cupboard
Looking west. Note the presence of a smooth covering over the possible panelled door with its number and nameplate (see below)

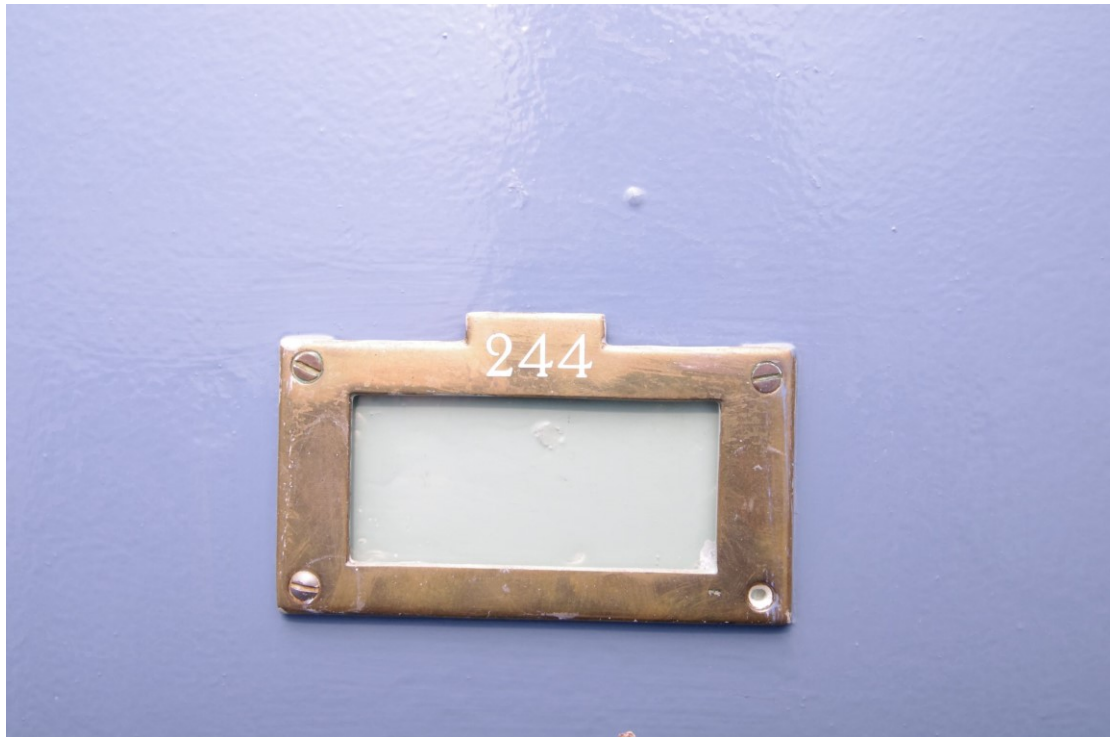
Figure 107 Typical number and nameplate on each 1930s First floor room
Ground floor: first phase 1930s north to south corridor

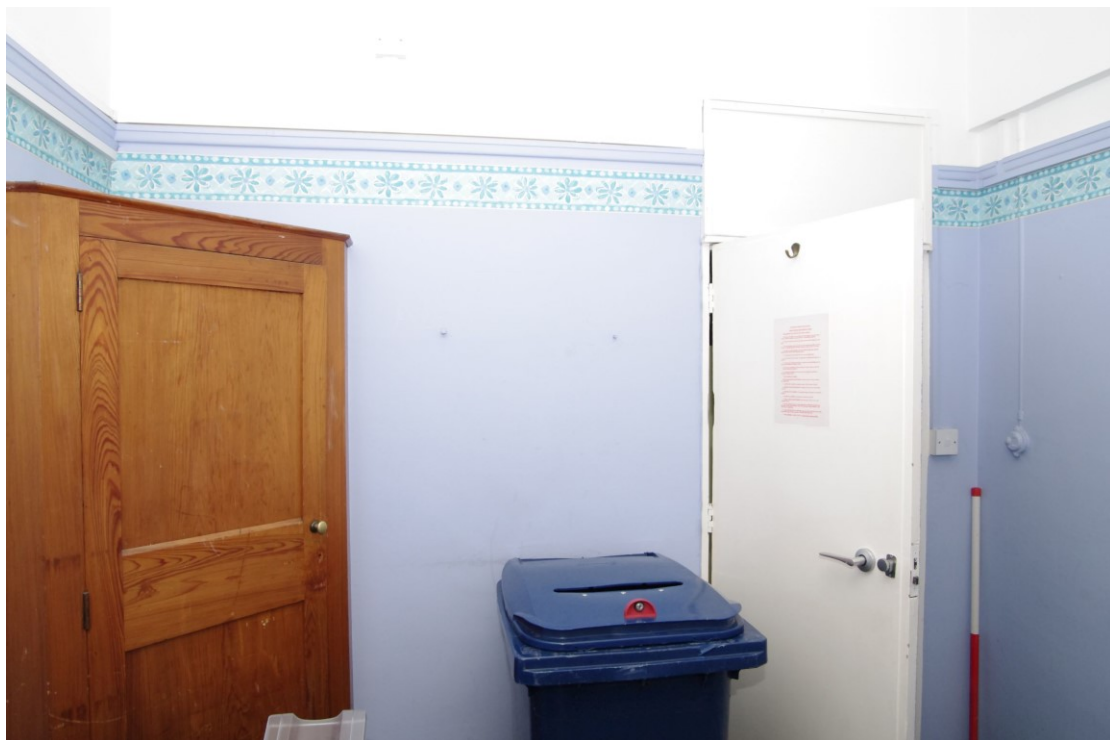
Figure 108 First floor: first phase 1930s north to south corridor. West side
Looking east. Note light switch and original coat hook on door. 1m scale

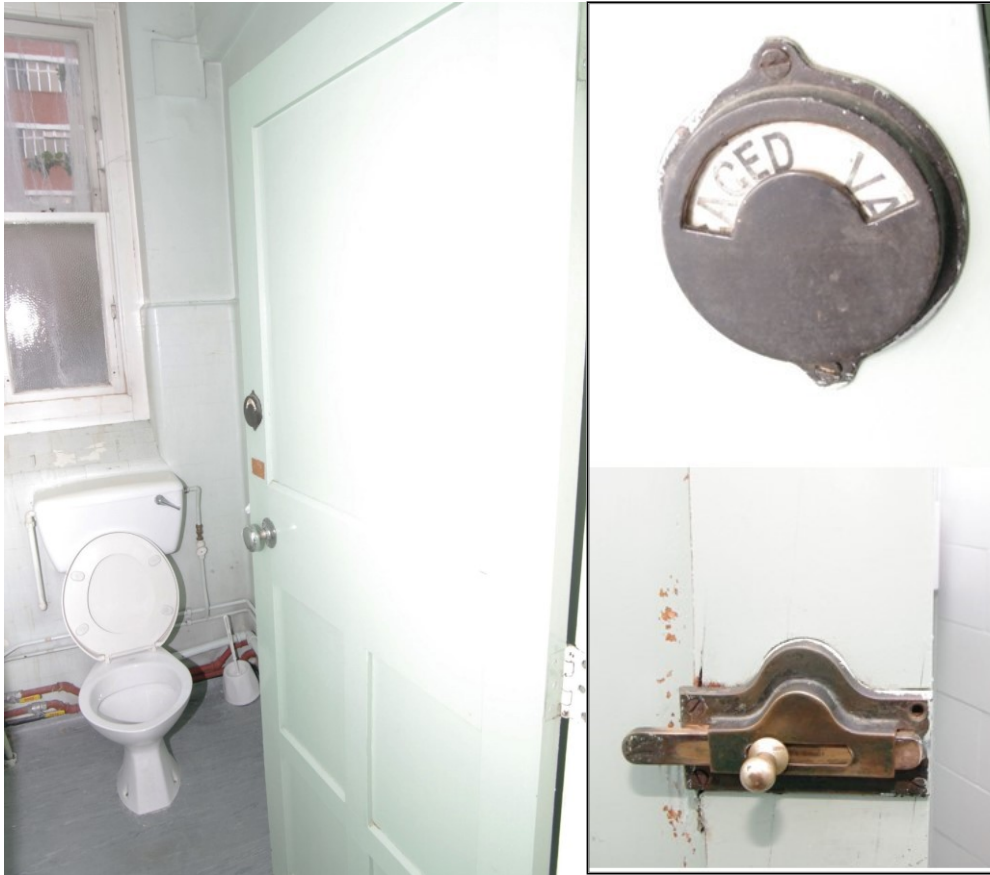
Figure 109 First floor: first phase 1930s north to south corridor toilets
Note paneled door. Fittings shown on right

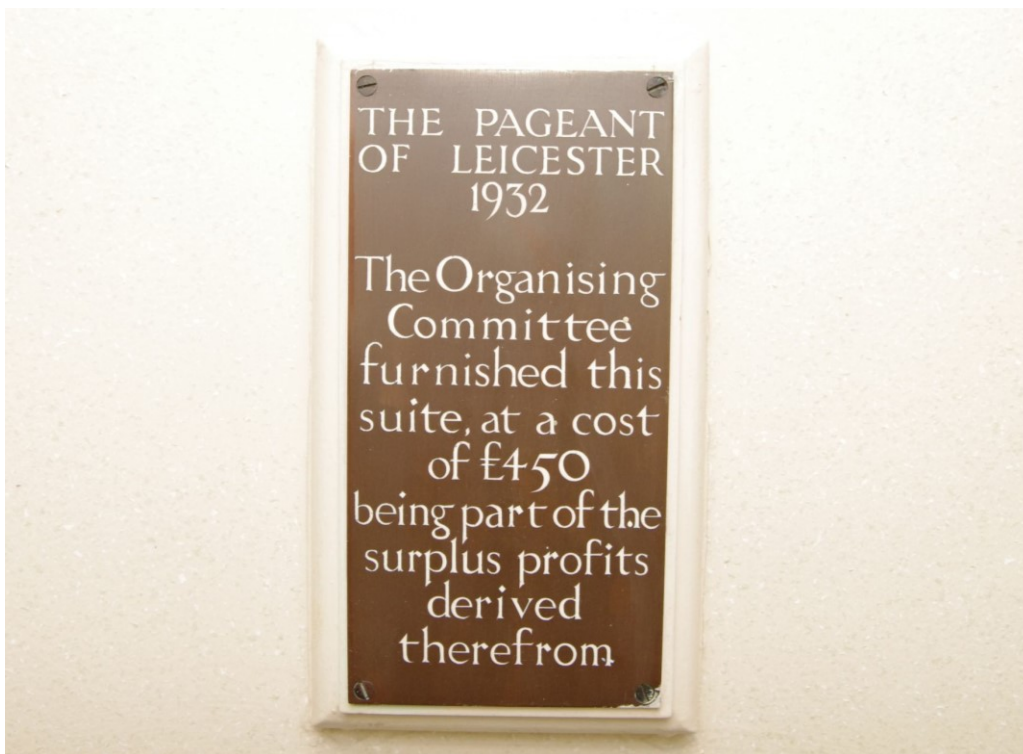
Figure 110 First floor: later 1930s phase north to south corridor plaque
Plaque attached to eastern side of corridor wall

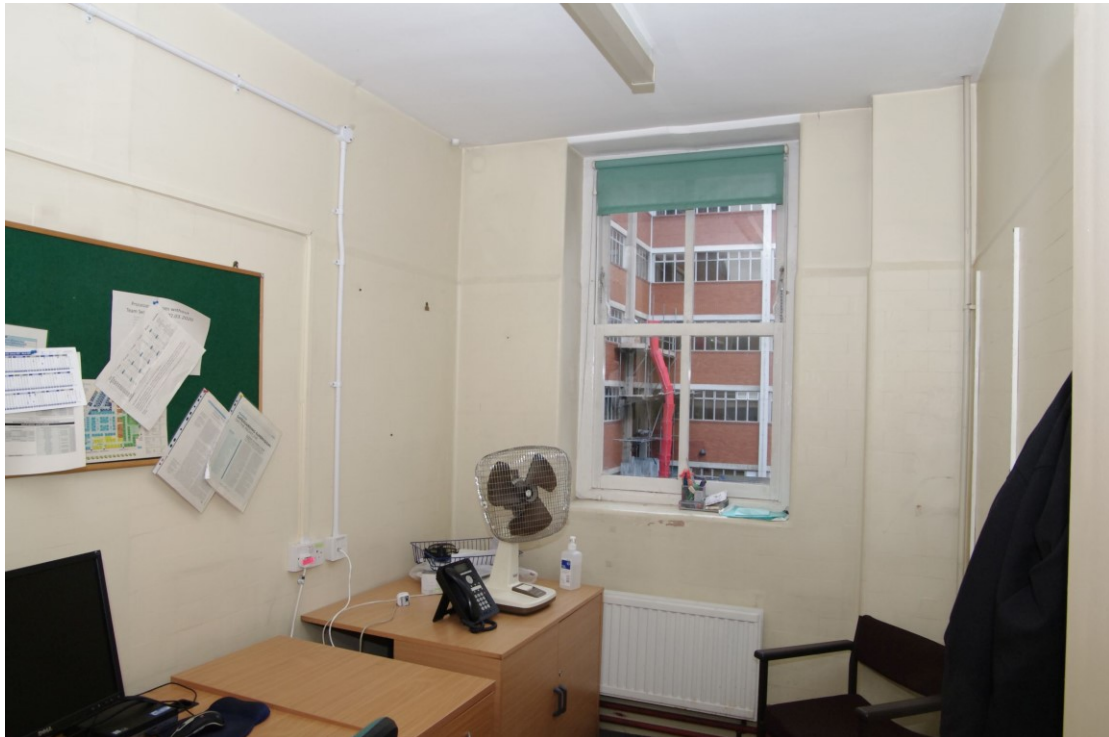
Figure 111 First floor: later 1930s phase, glazed brick lined room
Looking west in Room 143. The bricks have been painted over

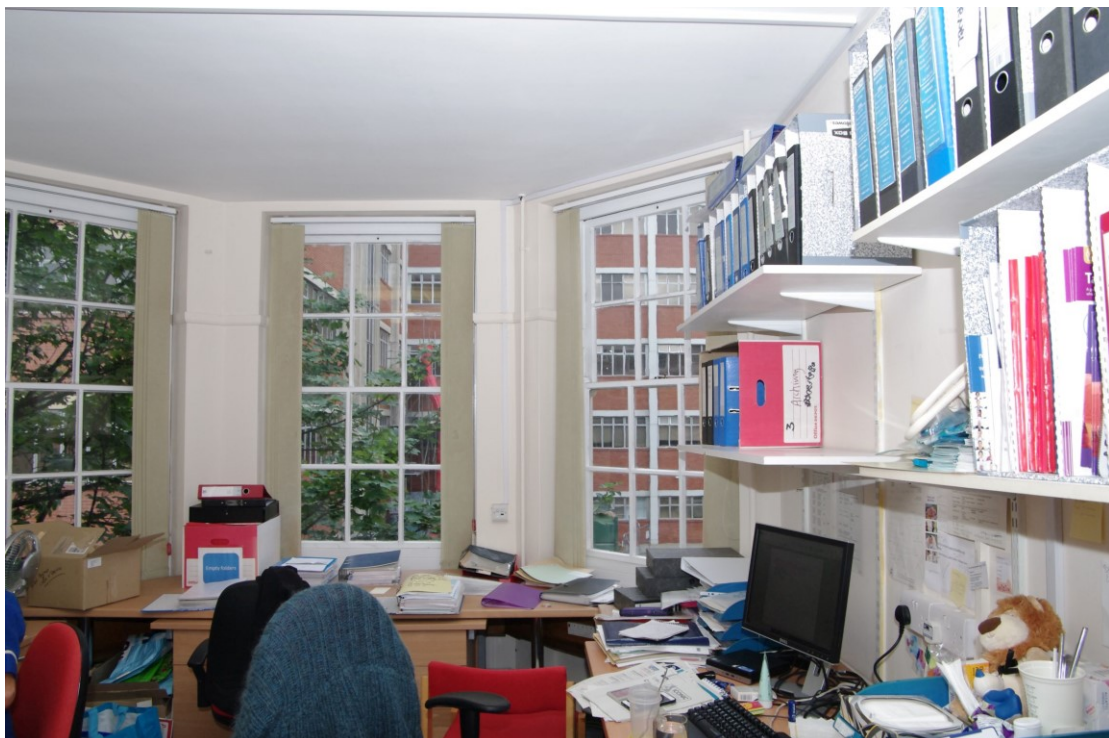
Figure 112 First floor: later 1930s phase former lounge
Looking west in Room 141

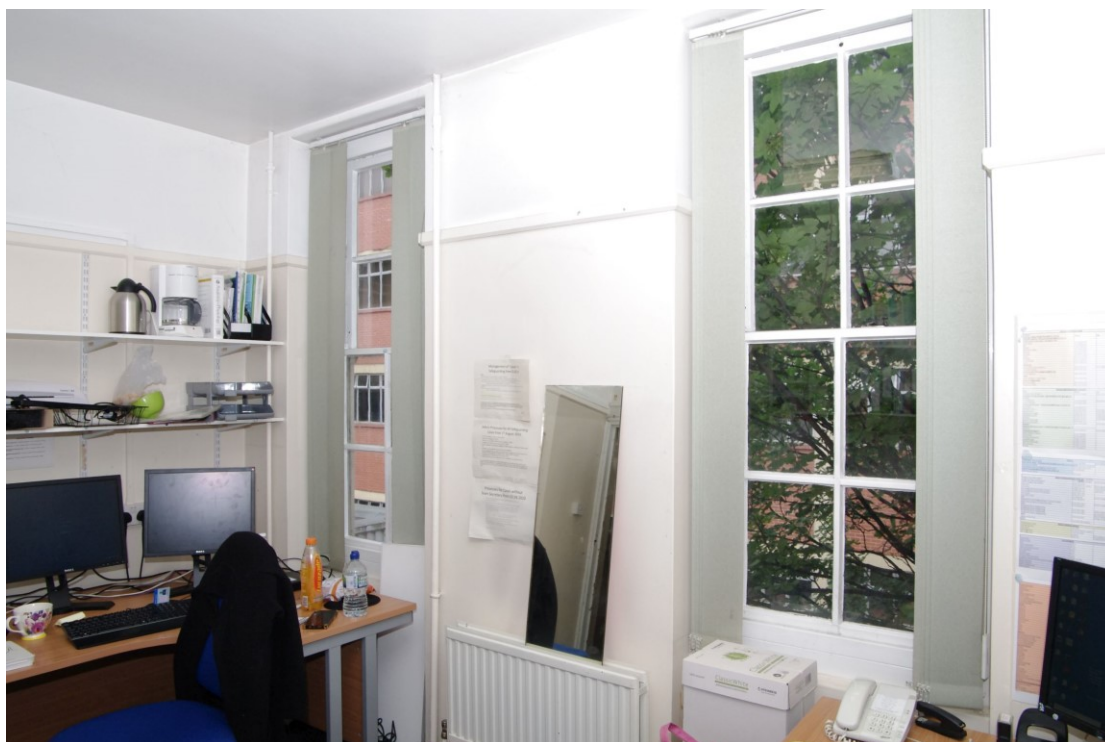
Figure 113 First floor: later 1930s phase south-eastern room
Looking south-west in Room 139

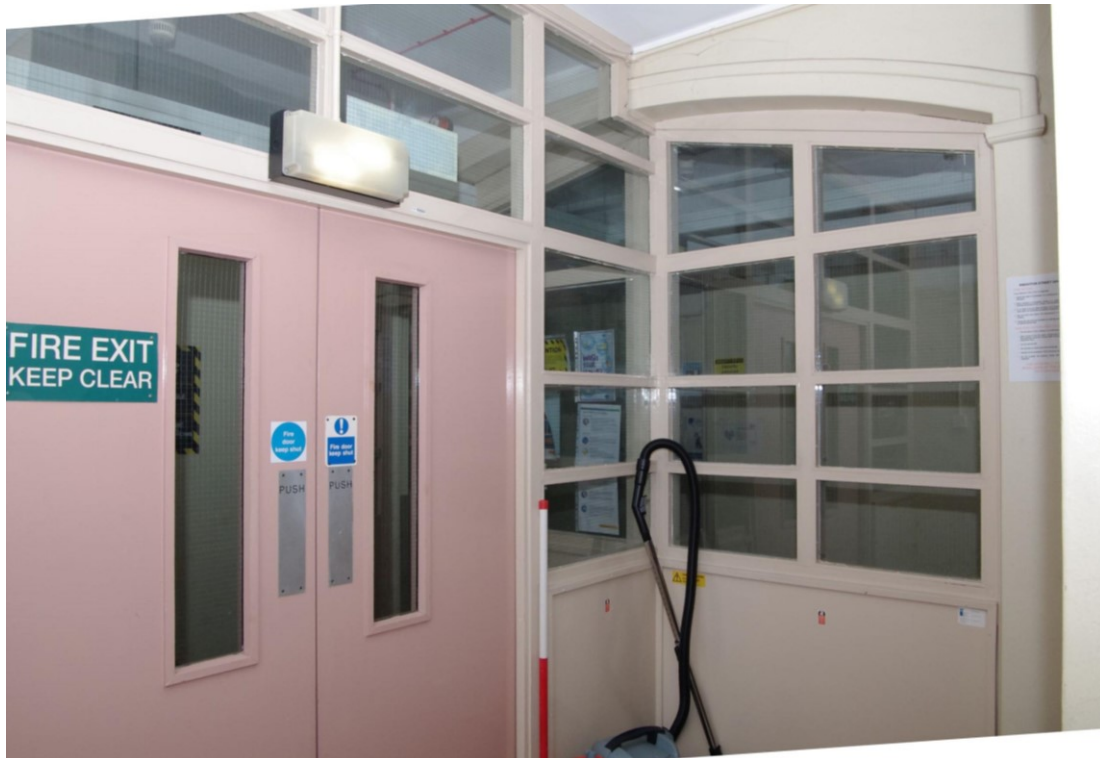
Figure 115 Second floor: top of 1910 stairs
Looking south-east. 1m scale

The 1910 stairs lead up to a small enclosed partially glazed landing (Fig. 115). This is a relatively plain and functional structure but, given that a similarly style structure is not seen on the 1930s stairs it seems likely to be an original feature.

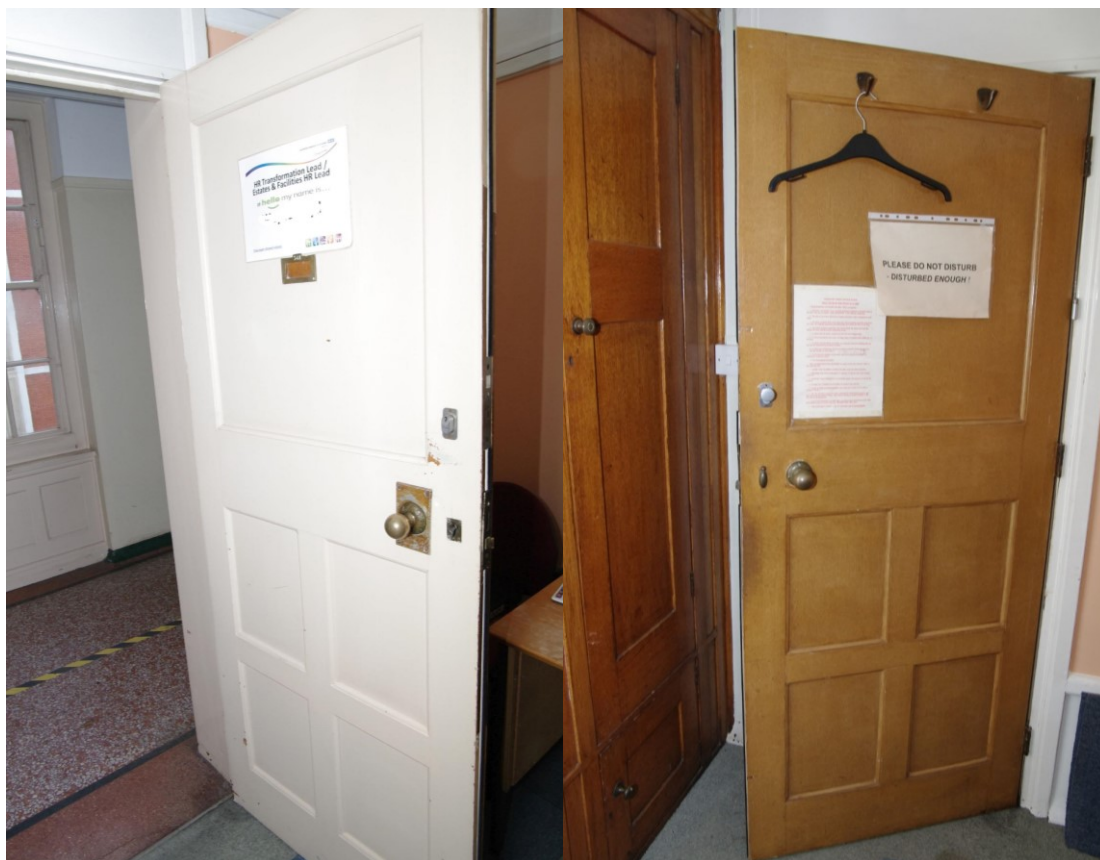
Figure 116 Second floor, 1910 north to south corridor: door detail
Note brass door fittings and fitted cupboard. Room 217

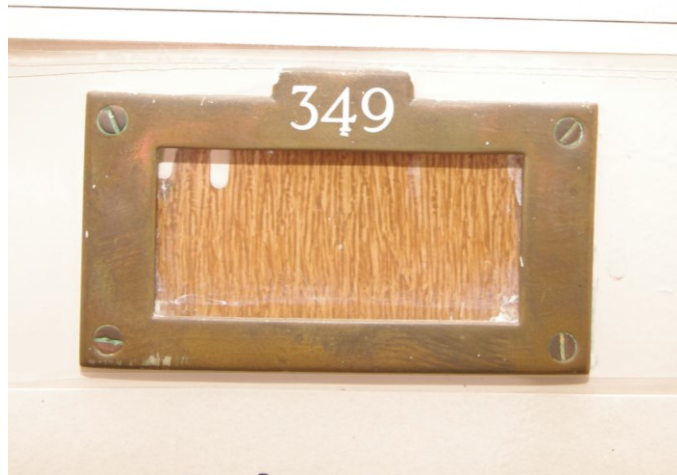
Figure 117 Second floor, 1910 north to south corridor: name and number plate holder
Note that this is Room 217 on the estates plan in Fig. 114)

The 1910 rear, north to south corridor, has the same room layout as the first floor but on this corridor some of the original panelled doors remain exposed within their moulded doorframes (Fig. 116). Many of the doors also have the brass name and number plates which call this floor Floor 3 (Fig. 117). The corridor is not carpeted and has pink terrazzo floors as seen on the ground floor and the 1910 stairs (Fig. 118).

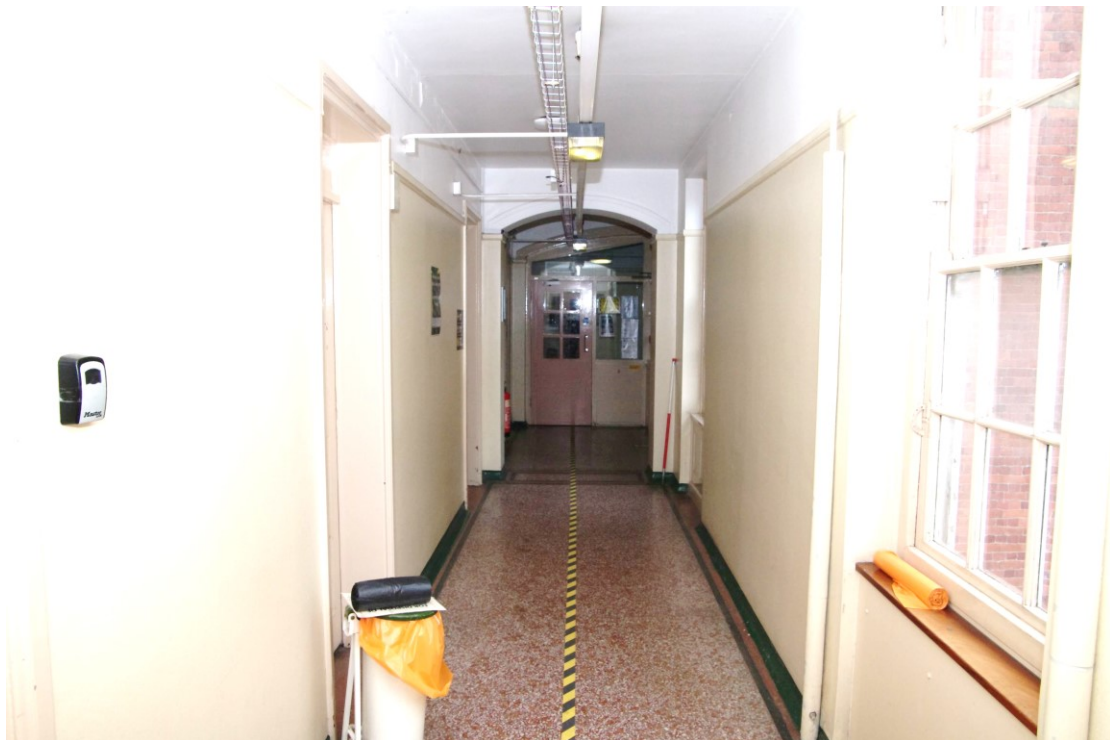
Figure 118 Second floor: terrazzo floor

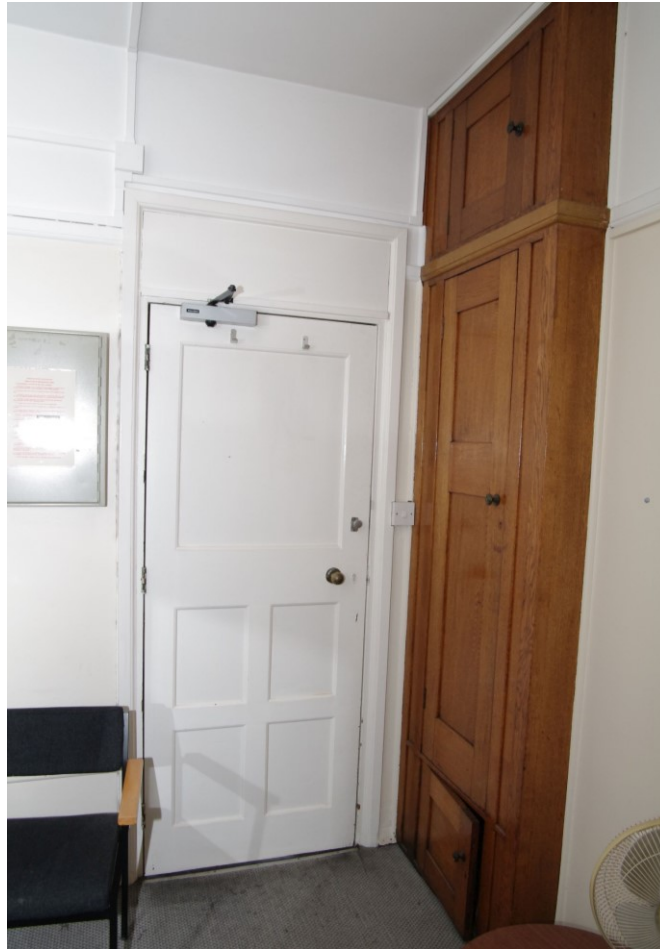
Figure 119 Second floor, 1910 north to south corridor: fitted cupboard
Looking west in Room 217

Within the rooms the stripped wooden fitted cupboards are still present at the side of the chimney breasts (Fig. 119). The second floor rooms also continue the curved coving detail seen on the floor below (Fig. 120). This consists of a slightly curved junction between the wall and ceiling on both side walls but not on the corridor or window walls.

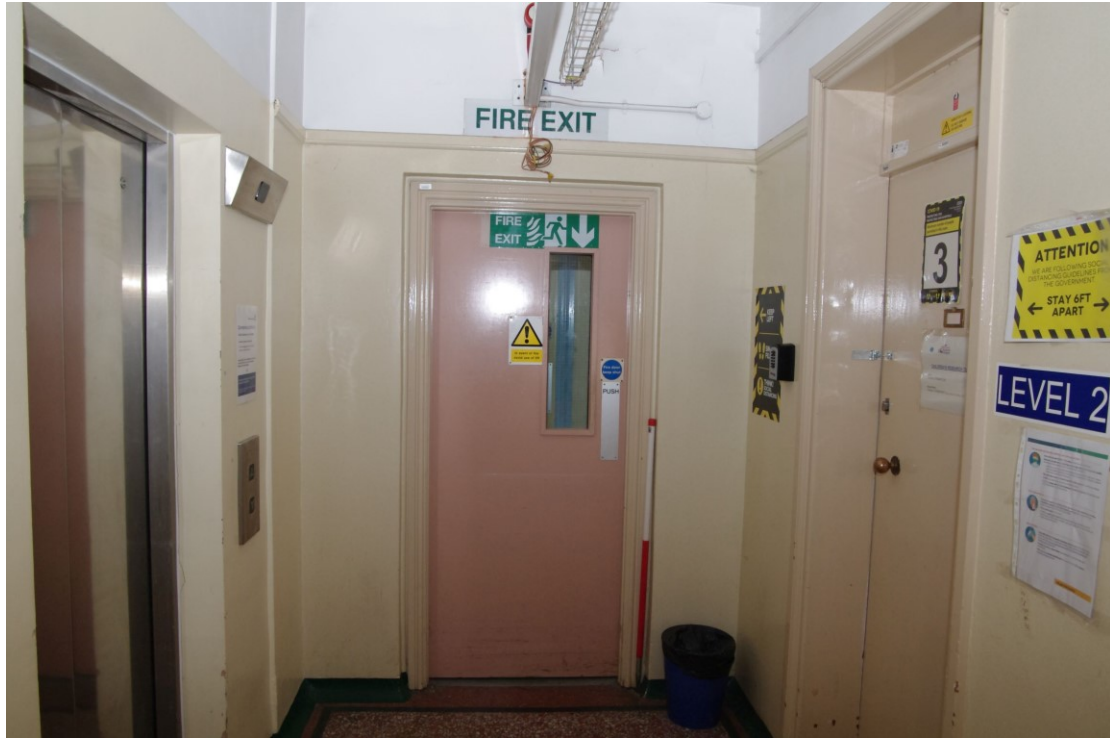
Figure 121 Second floor, 1910 north to south corridor: toilet block
Looking north. Modern lift on left. 1m scale

At the north end of the 1910 north to south corridor is another toilet block with a corridor leading out to the external fire escape on the north-east corner (Fig. 121). The modern lift shaft also opens out onto this corridor.

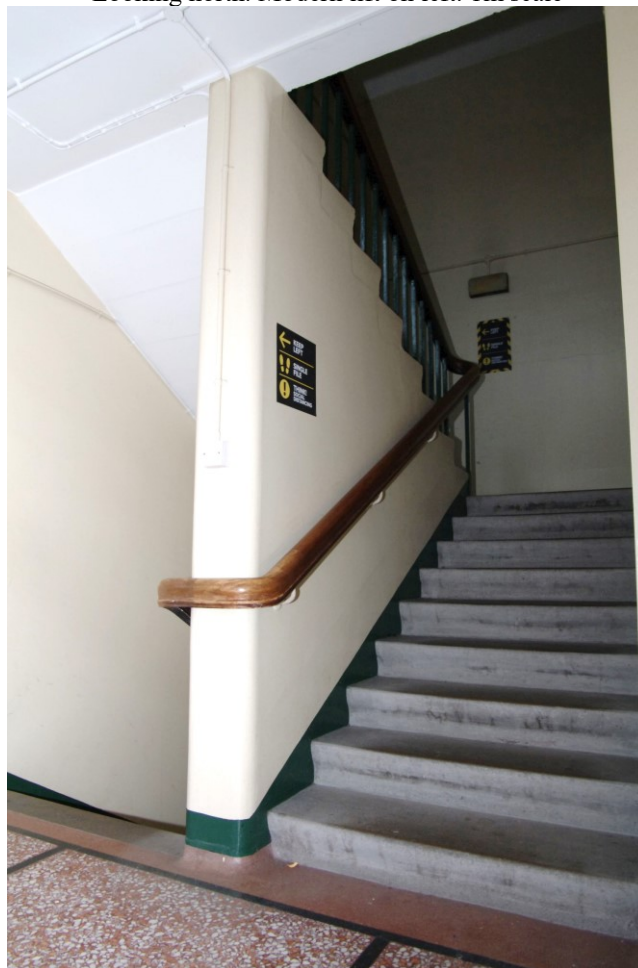
Figure 122 Second floor: 1930s stairs
Looking south-east

The 1910 east to west corridor continues eastwards as part of the 1930s extension with the stairs still being bare concrete (Fig. 122). The pink terrazzo floor continues into this phase from the 1910 phase. Beyond the stairs the corridor turns to the south with small rectangular offices/bedrooms either side as far as the central toilet block before widening at the later 1930s phase (Figs 123 and 124).

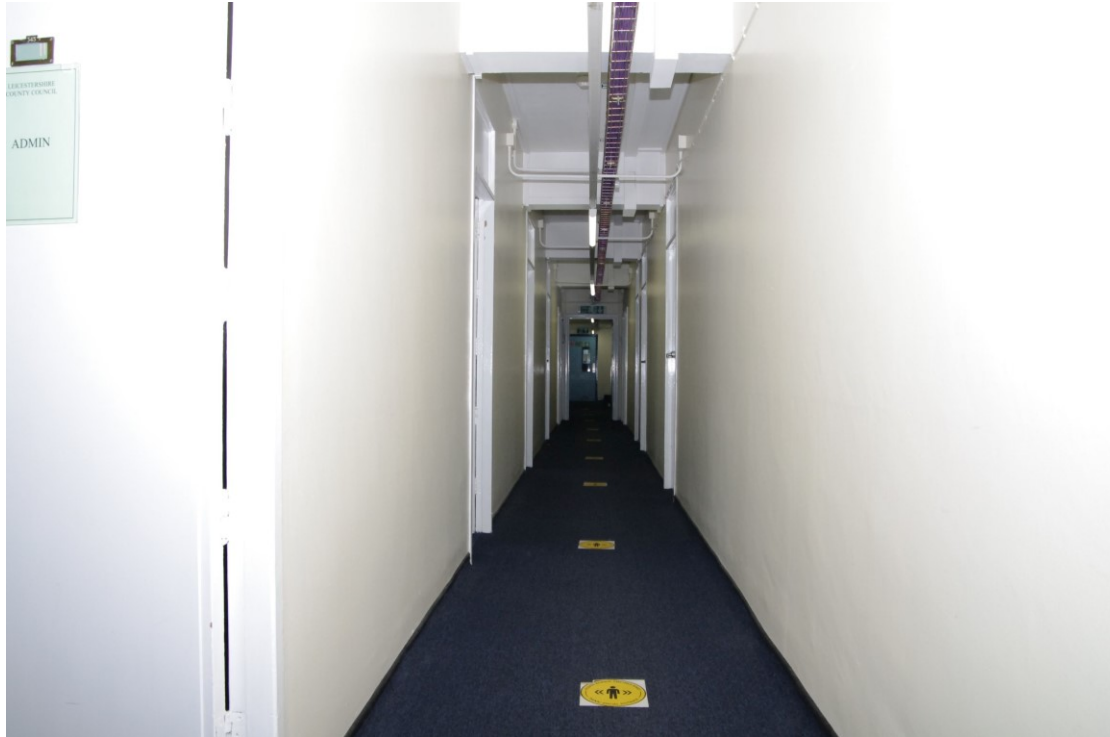
Figure 123 Second floor, first 1930s extension north to south corridor
Looking south

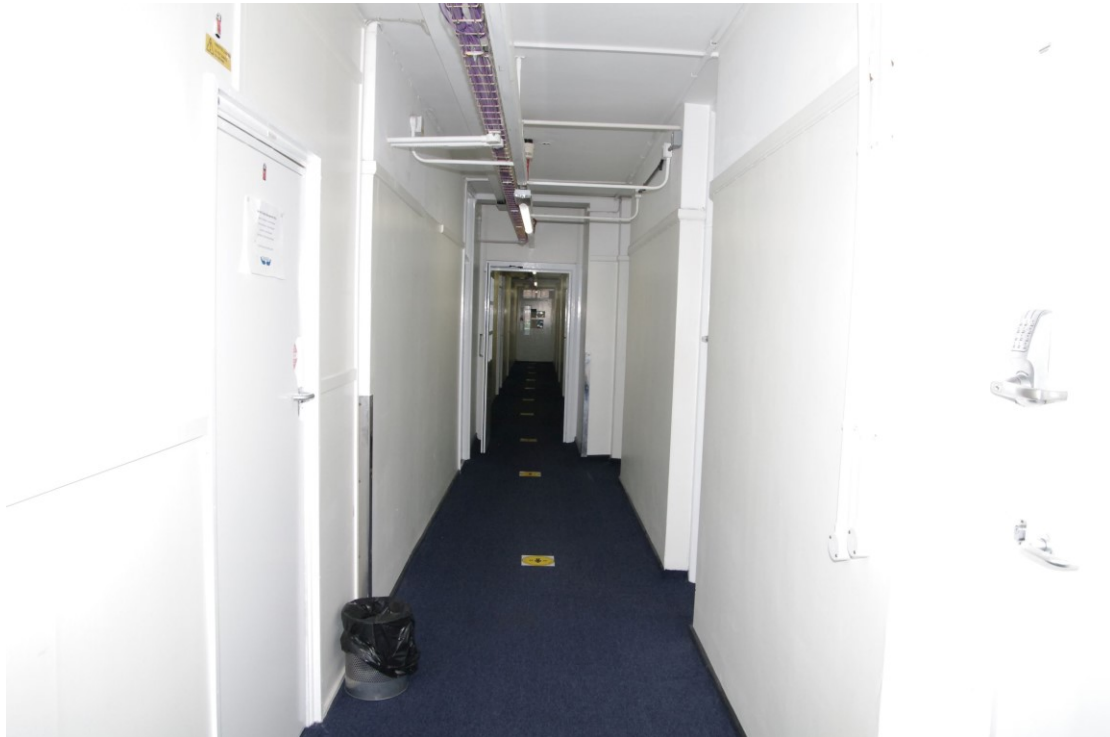
Figure 124 Second floor, later 1930s extension north to south corridor
Looking north. Note how this part of the corridor is wider than the earlier corridor beyond the doorway

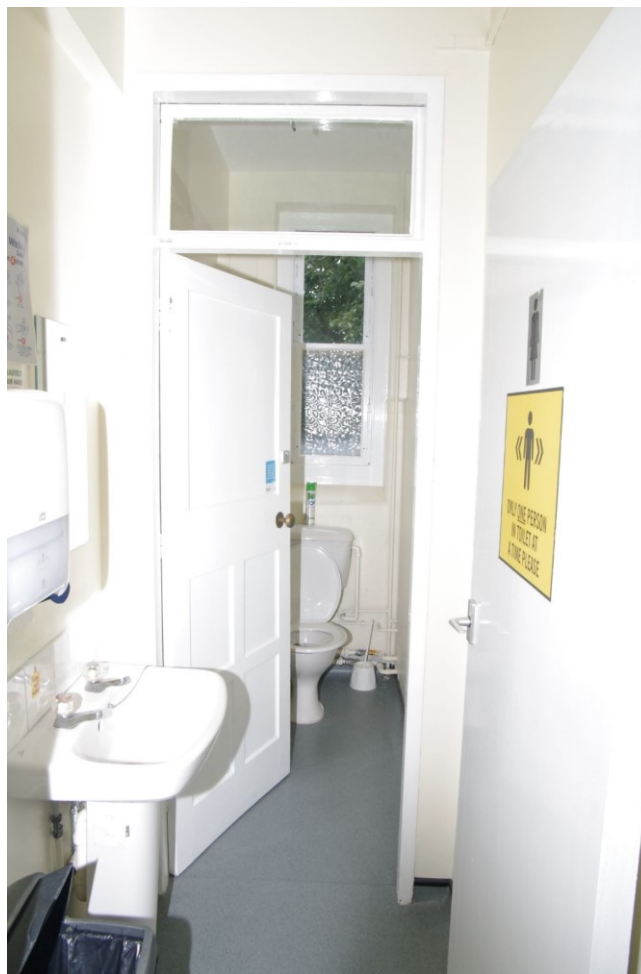
Figure 125 Second floor, first 1930s extension: toilet block
Looking east. Note fanlight above panelled door

The toilets have been fitted with new sinks and toilets but still have their original panelled doors. They also have clear glass fanlights above the doors which may show how all room doors were once built (Fig. 125). Former washrooms now perform the function of small kitchens and stores etc.

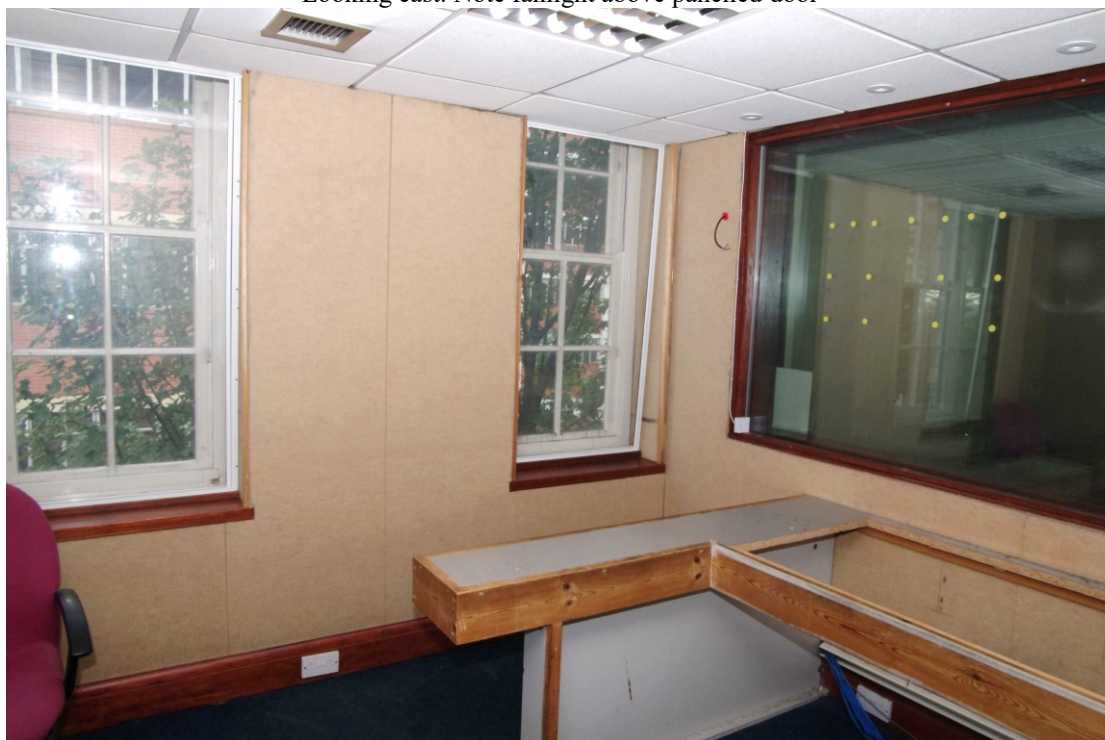
Figure 126 Second floor, later 1930s extension: Radio Fox studio
Looking north-west. Note false ceiling and sound insulation on walls

The most recent occupants of the offices at the southern end of the later 1930s phase corridor were Radio Fox, the hospital radio service. The rooms have been fitted out as a studio and control room along with Green Room and service rooms. No radio equipment was left behind when the organisation left the building to a new base at the Leicester General but some fittings remain. The studio and control room have a fitted desk and glass soundproof window (Fig. 126). The room has a low false ceiling and sound deadening covering to the walls and windows. Beneath the carpet is the original herringbone block flooring (Fig. 127). Although all of the other offices now have carpet, old photographs indicate that this type of flooring should be present in most former bedrooms. A number of original switches and sockets are still present in the two south-eastern end rooms (Fig. 128). These closely match those seen in the ground floor recreation room/theatre which may suggest that these are from the same phase of building. A former service room, which may have been a toilet or store has bare terrazzo floors with a cream and green decoration rather than the pink seen in the east to west corridor (Fig. 129).

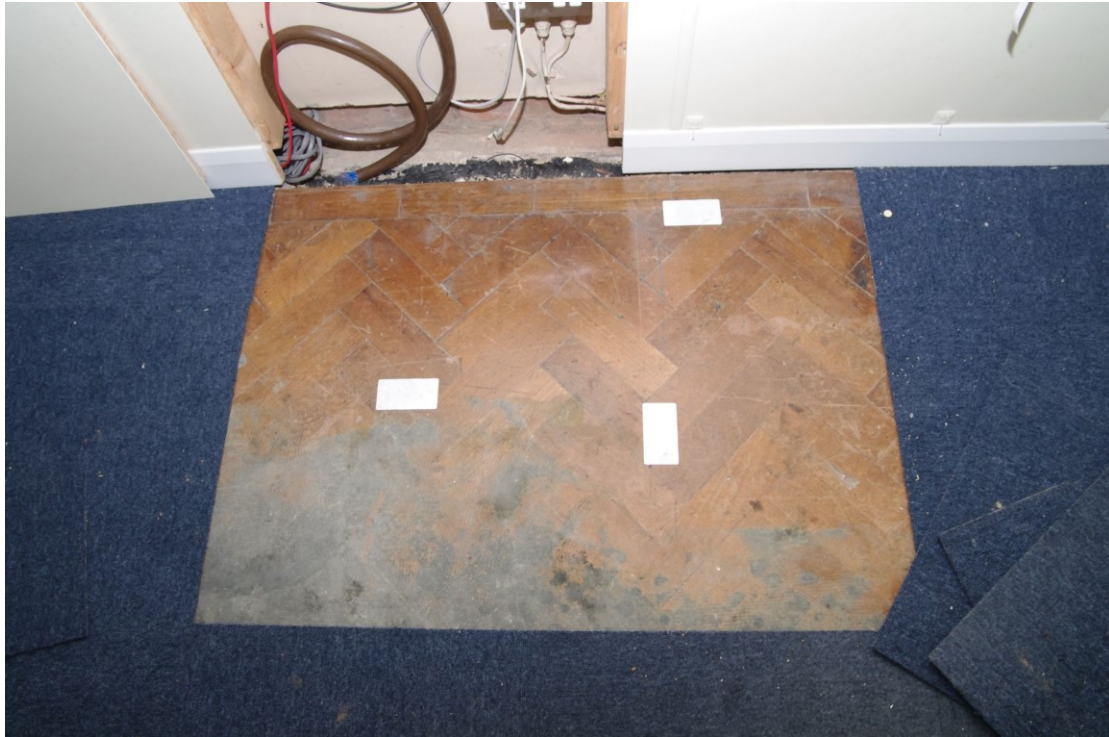
Figure 127 Second floor, later 1930s extension: wooden flooring beneath carpet

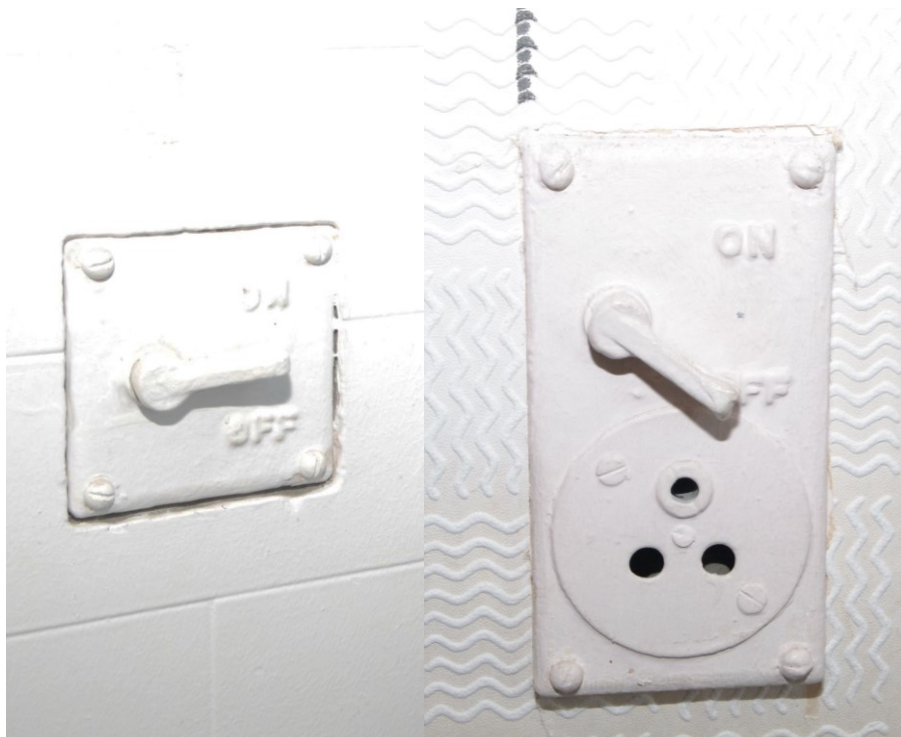
Figure 128 Second floor, later 1930s extension: swith and socket detail
