**A Level 3 Historic Building Survey at
The Knighton Street Offices,
Leicester Royal Infirmary,
Leicester
NGR: SK 58694 03539**

**ULAS Report No 2021-143
©2022**

Site Name: Knighton Street Offices, Leicester Royal Infirmary.

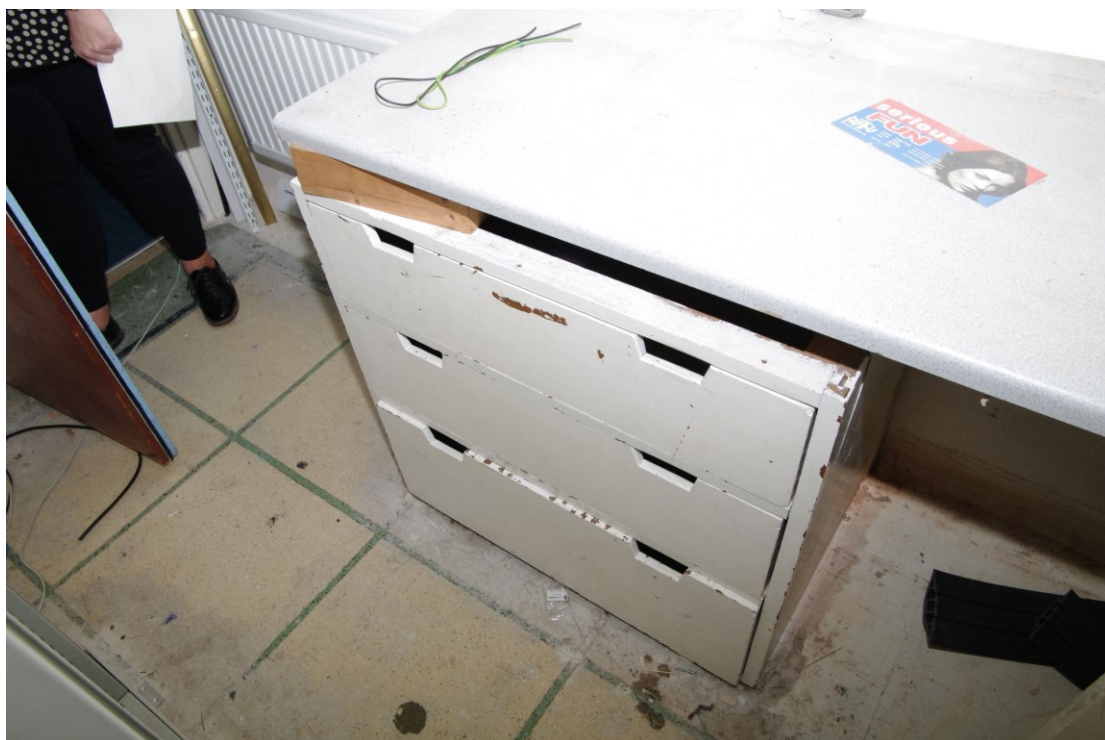
Figure 129 Second floor, later 1930s extension: floor in service room
Looking north-west in Room 237

The most recent occupants of the offices at the southern end of the later 1930s phase corridor were Radio Fox, the hospital radio service. The rooms have been fitted out as a studio and control room along with Green Room and service rooms. No radio equipment was left behind when the organisation left the building to a new base at the Leicester General but some fittings remain. The studio and control room have a fitted desk and glass soundproof window (Fig. 126). The room has a low false ceiling and sound deadening covering to the walls and windows. Beneath the carpet is the original herringbone block flooring (Fig. 127). Although all of the other offices now have carpet, old photographs indicate that this type of flooring should be present in most former bedrooms. A number of original switches and sockets are still present in the two south-eastern end rooms (Fig. 128). These closely match those seen in the ground floor recreation room/theatre which may suggest that these are from the same phase of building. A former service room, which may have been a toilet or store has bare terrazzo floors with a cream and green decoration rather than the pink seen in the east to west corridor (Fig. 129).

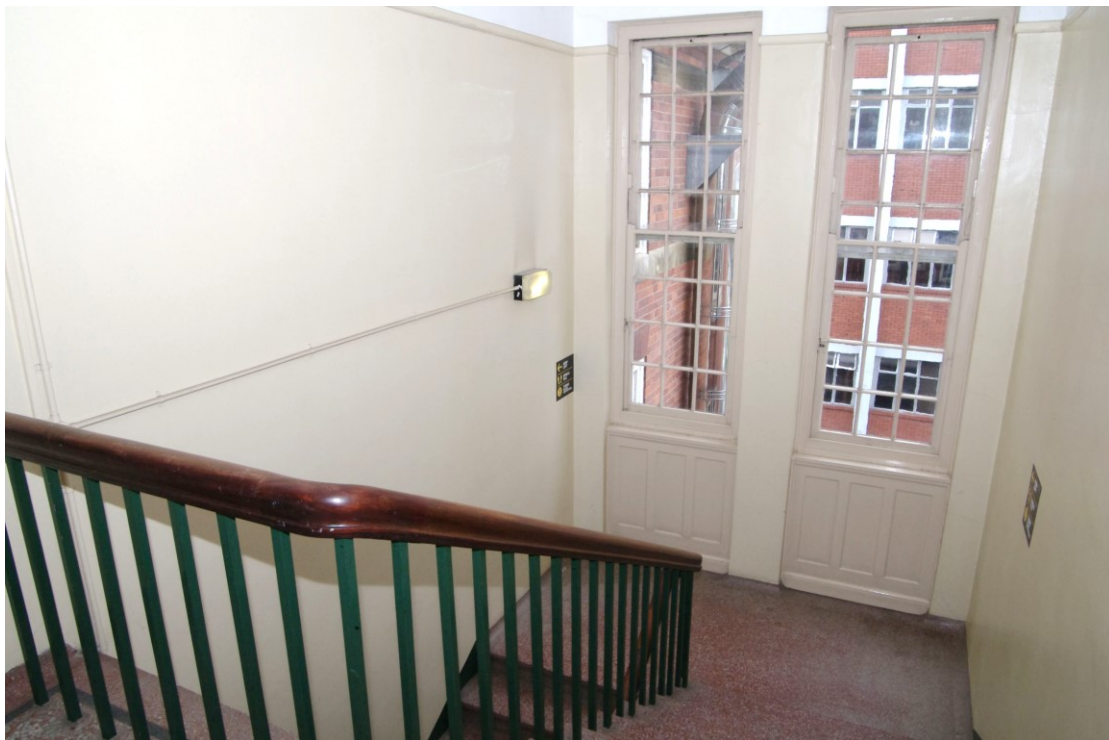
Figure 131 Third floor: top of 1910 stairs
Looking south-west

Starting once more at the top of the 1910 stairs the head of the stairs at this point, because it no longer has to support the floor above, is open with square-section plain metal balusters supporting the handrail (Fig. 131). The stairs are still enclosed by the wood and glass partition but there is evidence of an earlier doorway on the floor of the 1910 north to south corridor (Fig. 132). A small archway in the ceiling lies above two infilled holes which appear to have held the bottom supports of a pair of doors. It is not clear if these doors matched those still present at the junction with the east to west corridor but it seems likely.

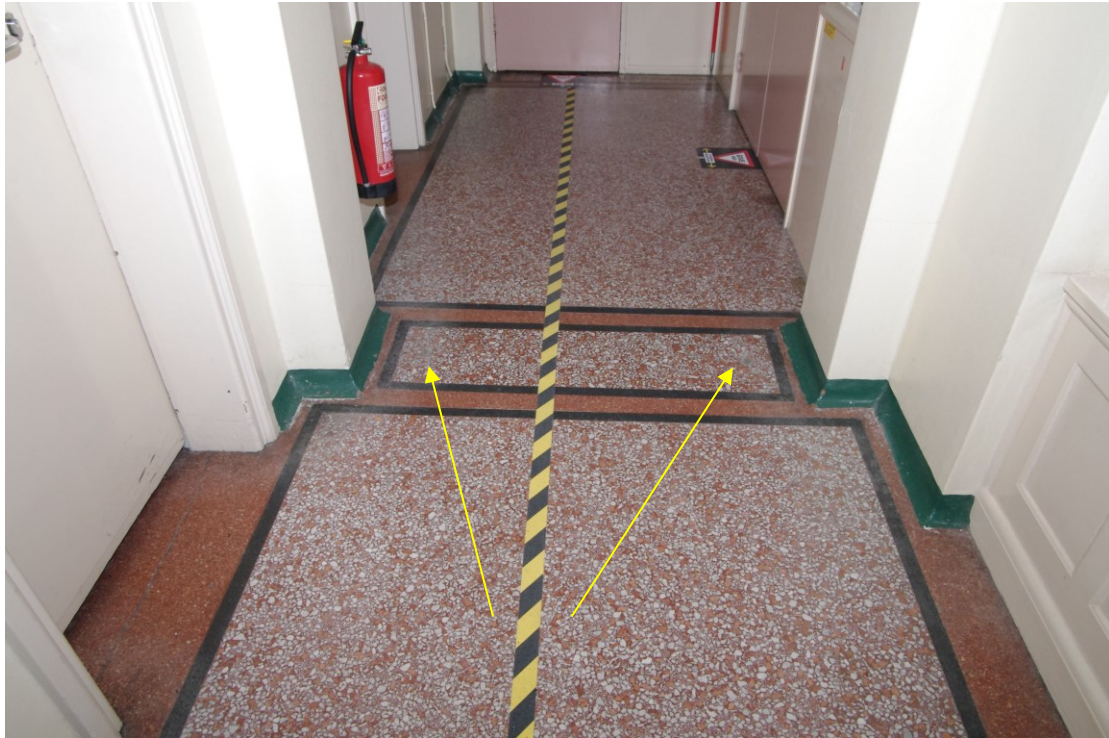
Figure 132 Third floor, 1910 north to south corridor: floor detail by stairs
Looking south. The two arrows point to door sockets. Stair doors on right. 1m scale

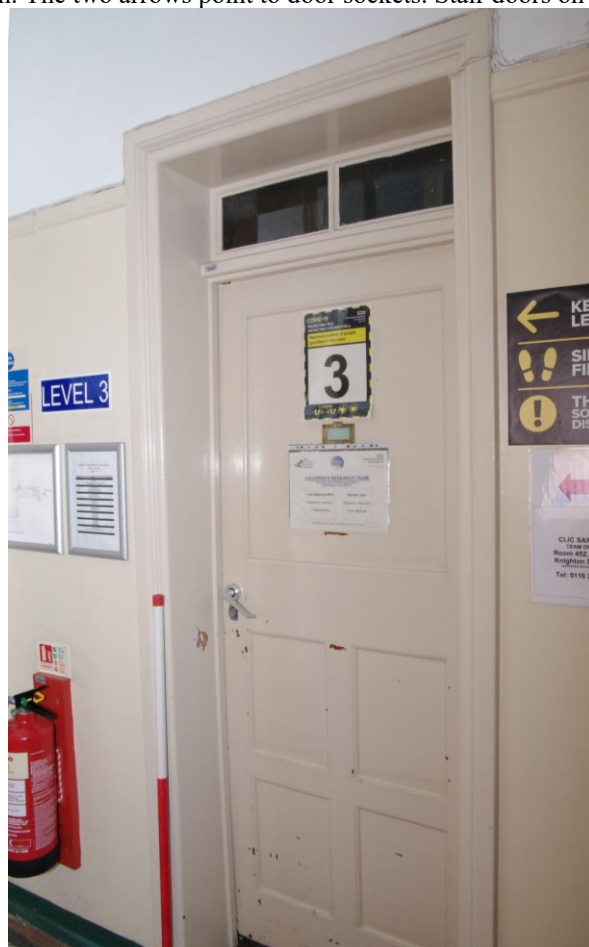
Figure 133 Third floor, 1910 north to south corridor: door detail
Looking east at Room 318 (450 on the door plate). 1m scale

The 1910 north to south corridor has some panelled doors which also have their original fanlights above them (Fig. 133). The fanlights in this part of the building consist of two rectangular fixed panes and are smaller than elsewhere. Inside the rooms can be seen the bare wood cupboards fitted in the space at the side of the chimney breast (Fig. 134). No curved coving at ceiling height can be seen in the rooms on this floor. The toilet block, modern lift and corridor to the external fire escape at the north end of the corridor are all identical to the floor below.

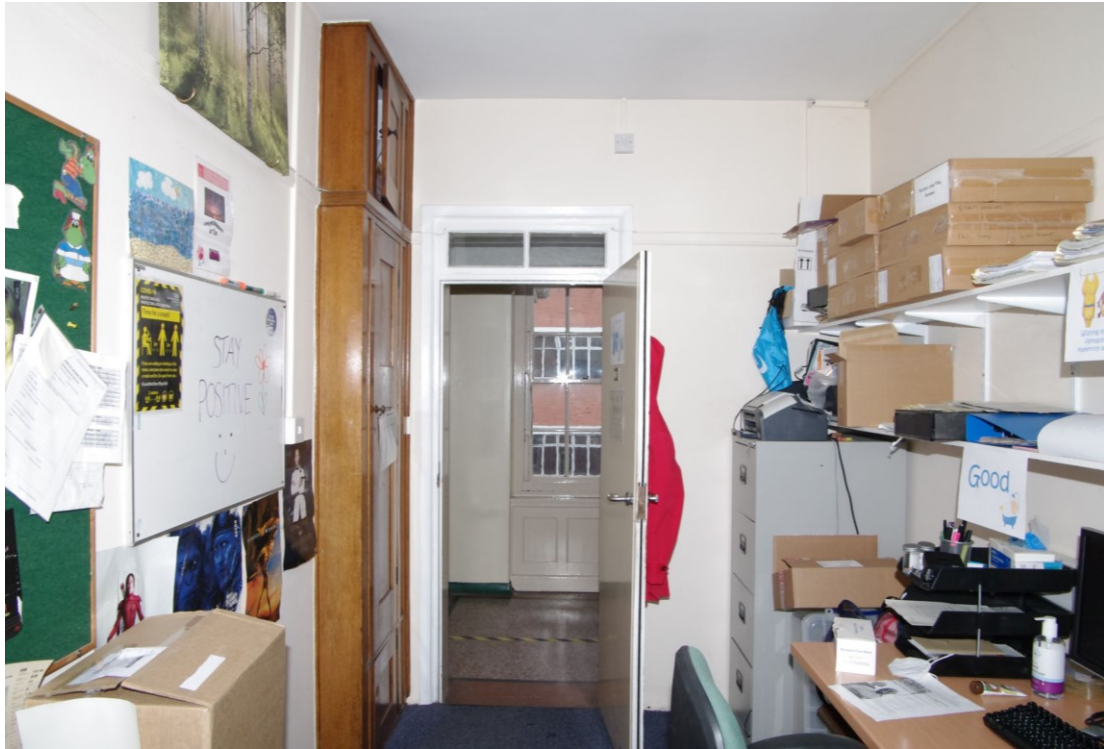
Figure 134 Third floor, 1910 north to south corridor: office detail
Looking west. Note cupboard and lack of curved coving. The door also has a modern covering

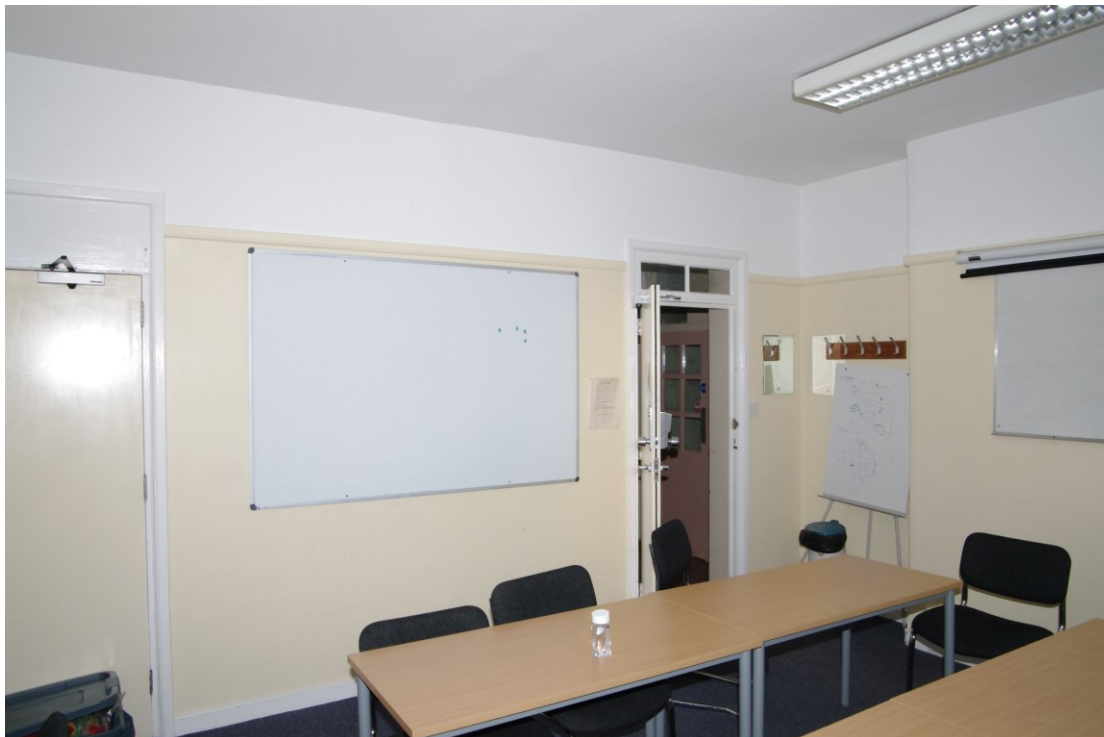
Figure 135 Third floor, 1910 east to west corridor: enlarged room
Looking north-east in Room 350. Note one of the fanlights has been blocked

The 1910 east to west corridor appears to be the same within the corridor area. However, instead of ten rooms to the south side of the corridor eight have had their partitions removed to create four double-sized rooms along with two smaller rooms. The resulting enlarged rooms have (blocked) fireplaces at either end, two windows and two doors (Fig. 135). Care has been taken during this conversion work as the picture rails and skirting boards show little evidence of modification. Similarly the plasterwork on the walls and ceiling show only the slightest imperfections which may suggest that the work was undertaken some time ago. In some cases one of the doorways into the room has had its fanlight blocked whilst the other doorway into the same room retains its glass fanlight.

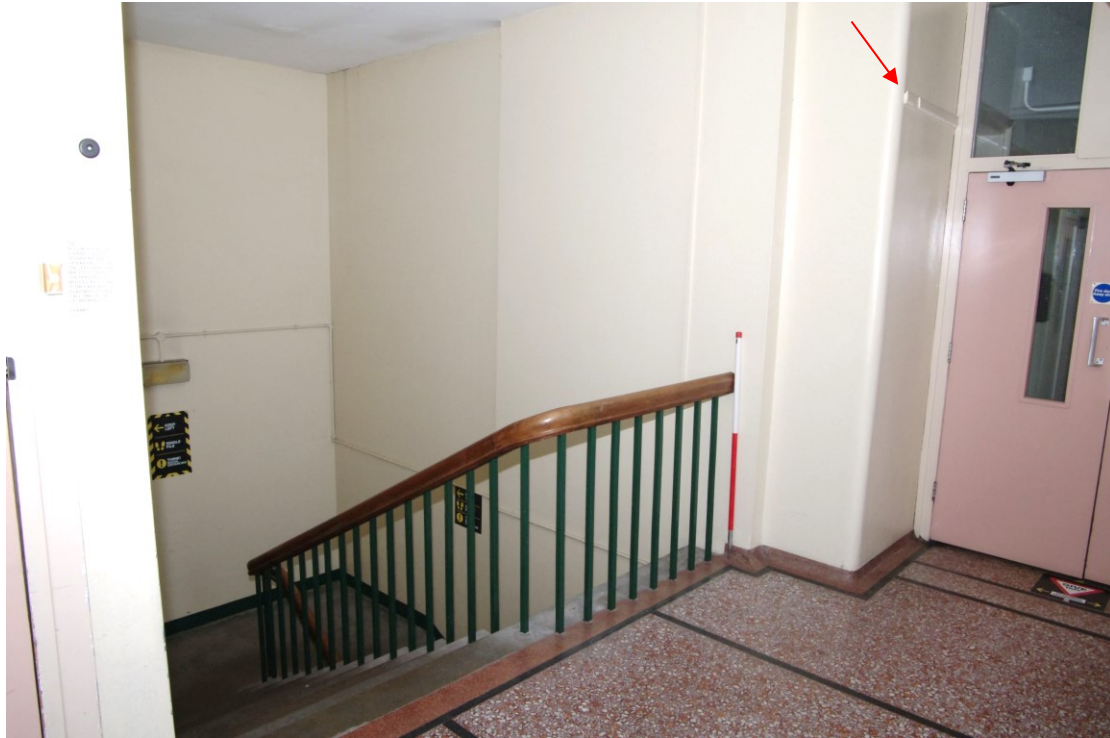
Figure 136 Third floor, top of 1930s stairs
Looking south-west. 1m scale. Arrow points to location of earlier door

At the top of the 1930s concrete stairs, at the eastern end of the 1910 east to west corridor, is a set of fire doors. Marks on the wall and floor along with lines in the terrazzo floor show where an earlier door was located in a slightly different position (Fig. 136). The stairs on this floor are open and have the same wooden handrail and iron balusters as the 1910 stairs.

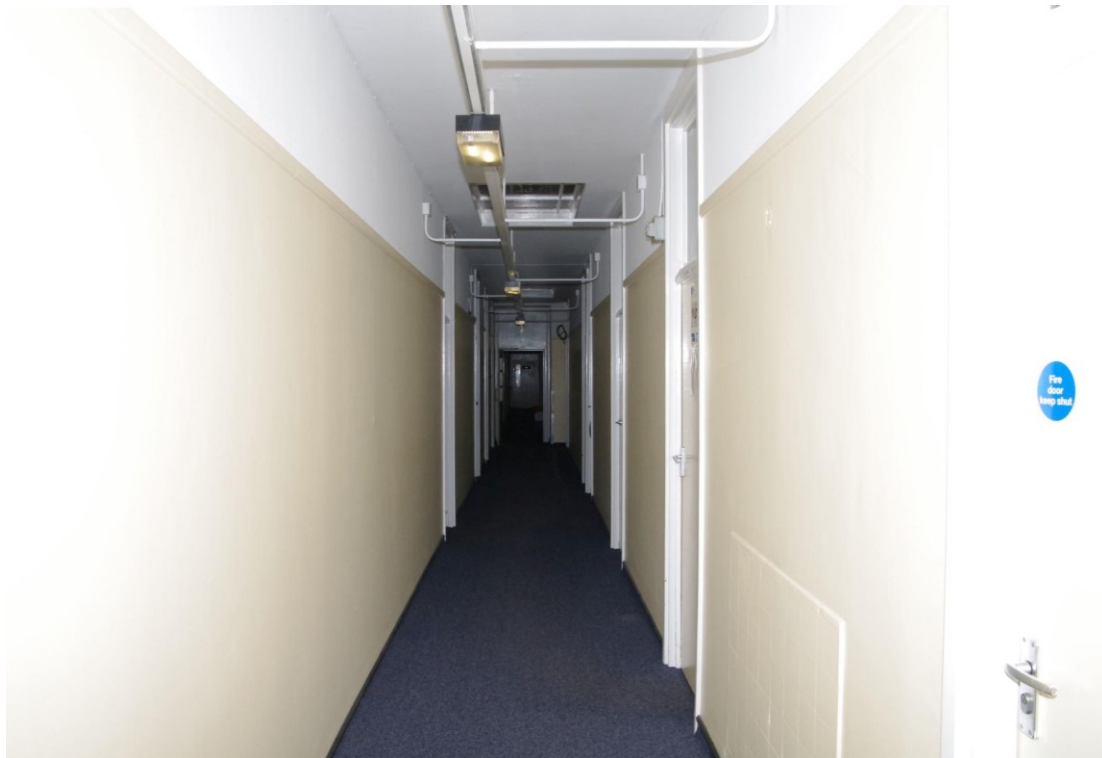
Figure 137 Third floor, later 1930s north to south corridor
Looking north. Noted painted over glazed brick panel in foreground on right

The 1930s north to south corridor widens at the junction between the two 1930s phases as already noted on the floors below. In the later 1930s corridor a small glazed panel on the east side of the corridor wall may indicate where a radiator was located (Fig. 137). It is possible that this floor was significantly colder than the floors below and required additional heating. The comfort of the corridor would not have been helped by the presence of glazed skylights in the corridor ceiling to allow in extra light given by glass panels set in the outer roof (Fig. 138).

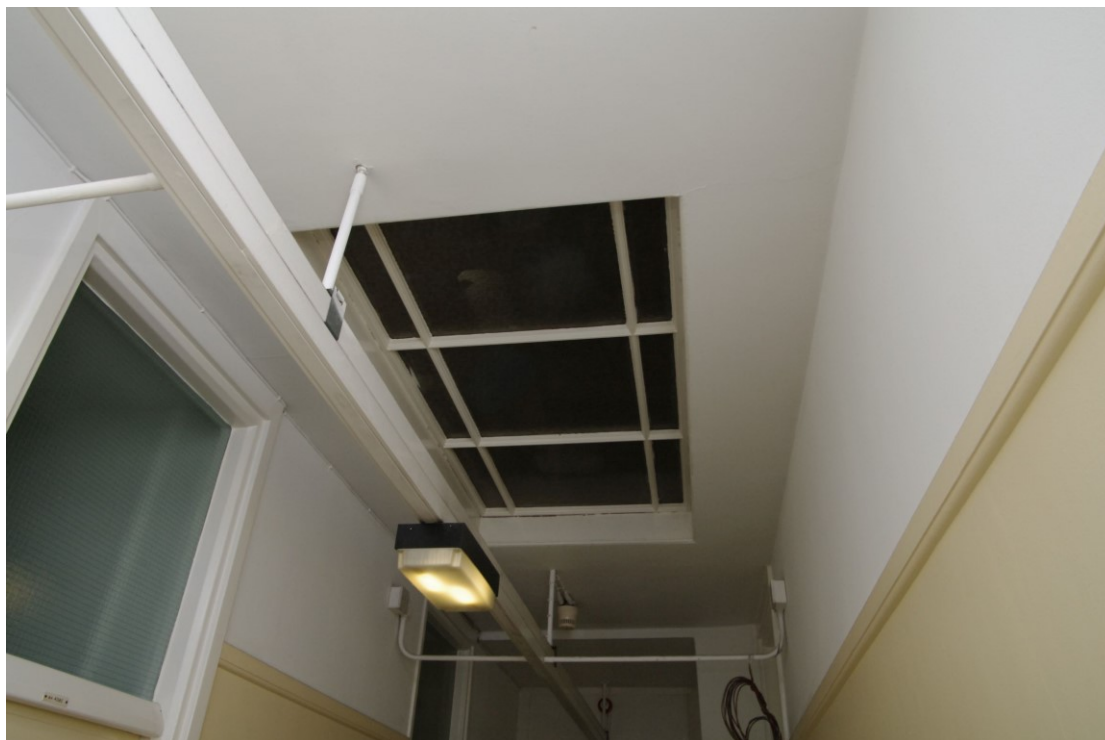
Figure 138 Third floor, later 1930s north to south corridor: skylight
Looking north. Also note the narrowing of the corridor to the earlier 1930s phase

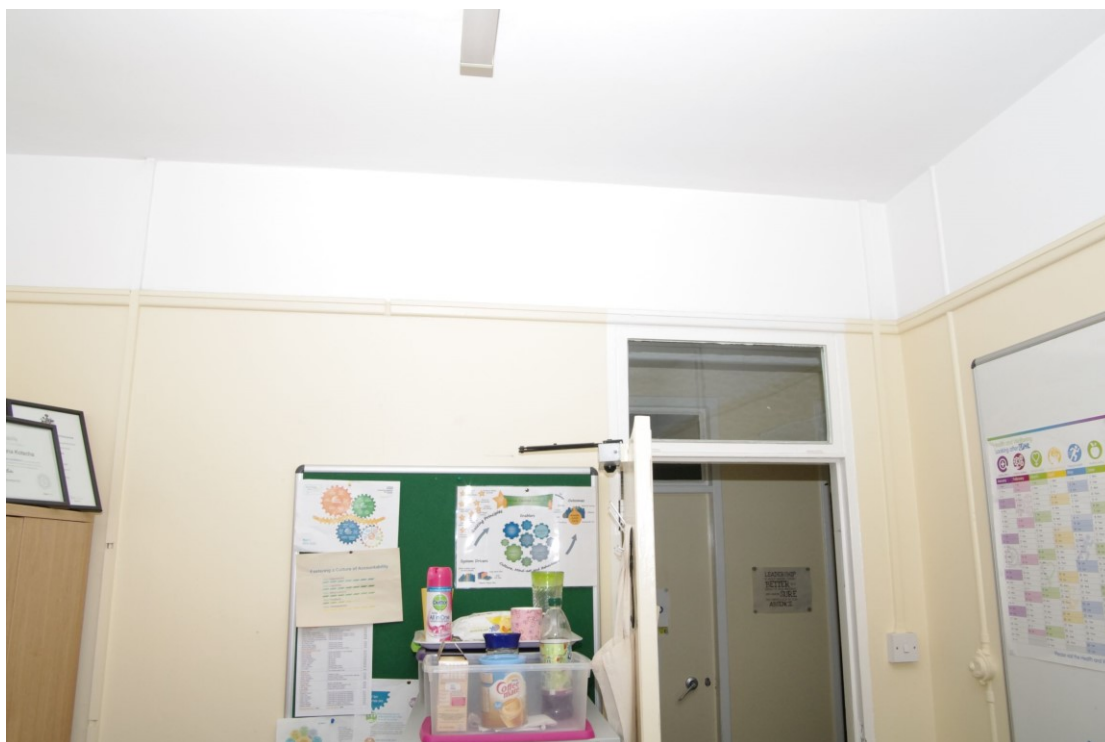
Figure 139 Third floor, earlier 1930s north to south corridor: office detail
Looking west in Room 324. Note fanlight still in place and original light switch

Inside the rooms the original light switches remain in most cases although no fitted cupboards were noted (Fig. 139). The toilet block half way along the corridor, at the junction of the two 1930s phases has received the same modernisation treatment as on

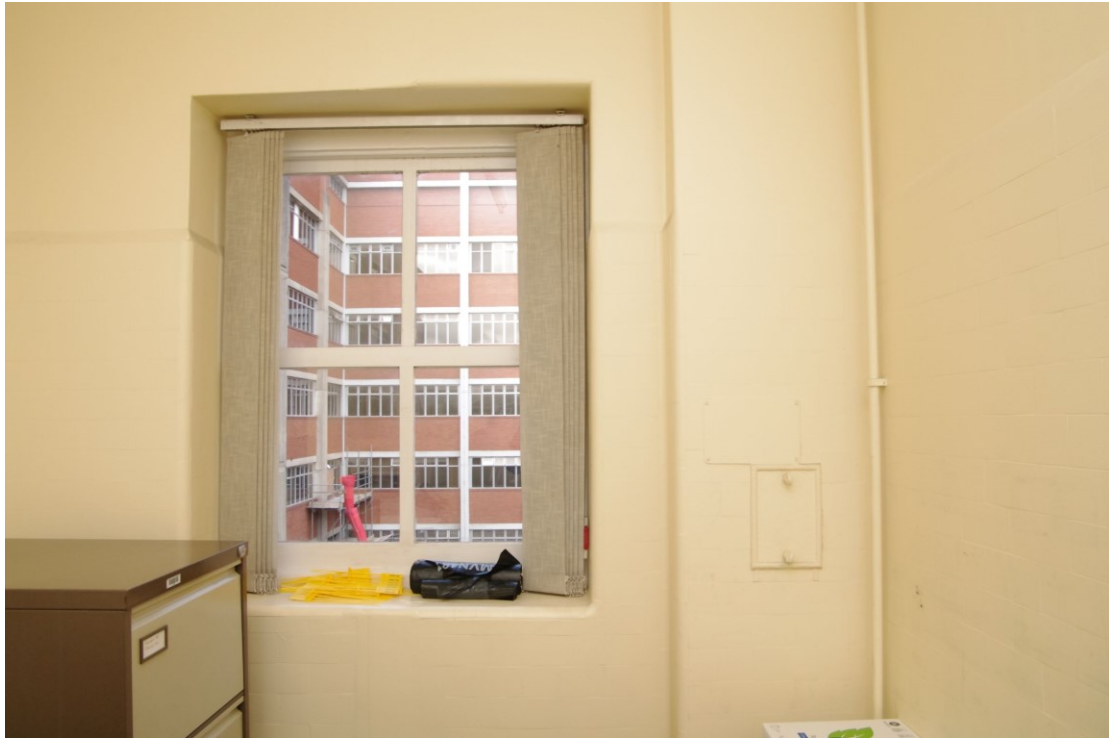
Figure 140 Third floor, earlier 1930s north to south corridor: washroom detail
Looking west. Note painted-over bricks

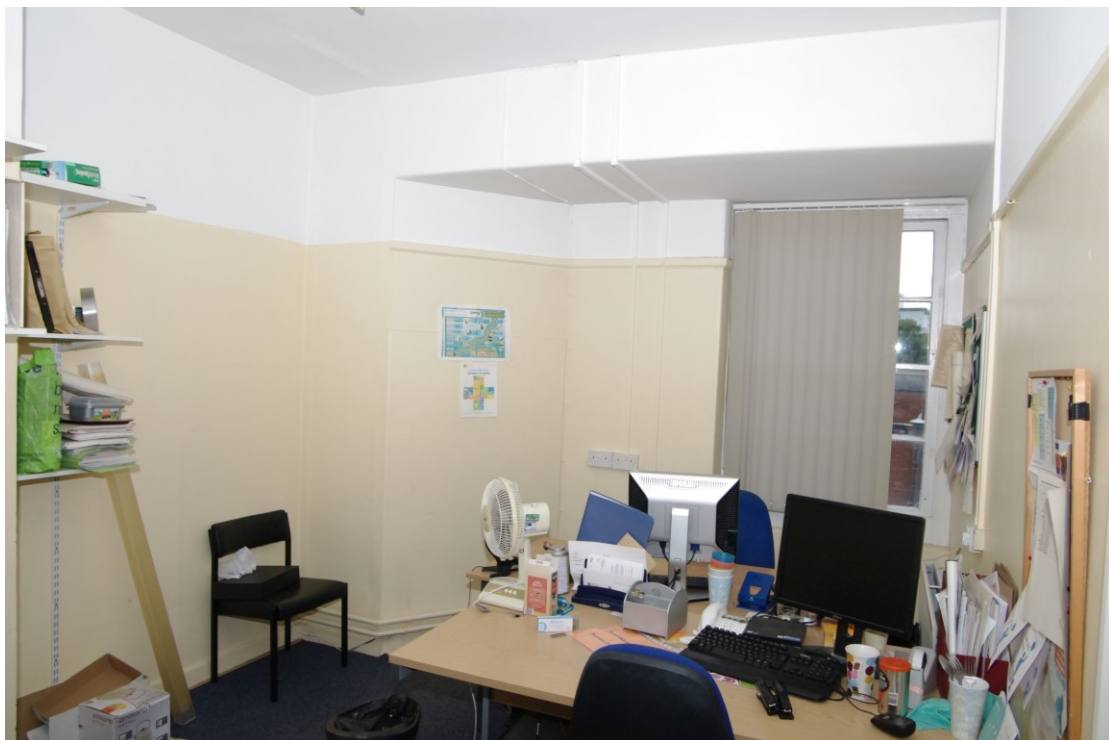
Figure 141 Third floor, later 1930s north to south corridor: room above bow-window
Looking east in Room 332

The offices above the bow-fronted window in the later 1930s have had doors knocked through to create separate but connected offices which appears to be a later modification. Two of these offices have angled north-east and south-east corners in order to accommodate the large urns sitting outside (Fig. 141). A substantial masonry beam runs across the eastern side of all three rooms which supports the wall plate and roof structure.

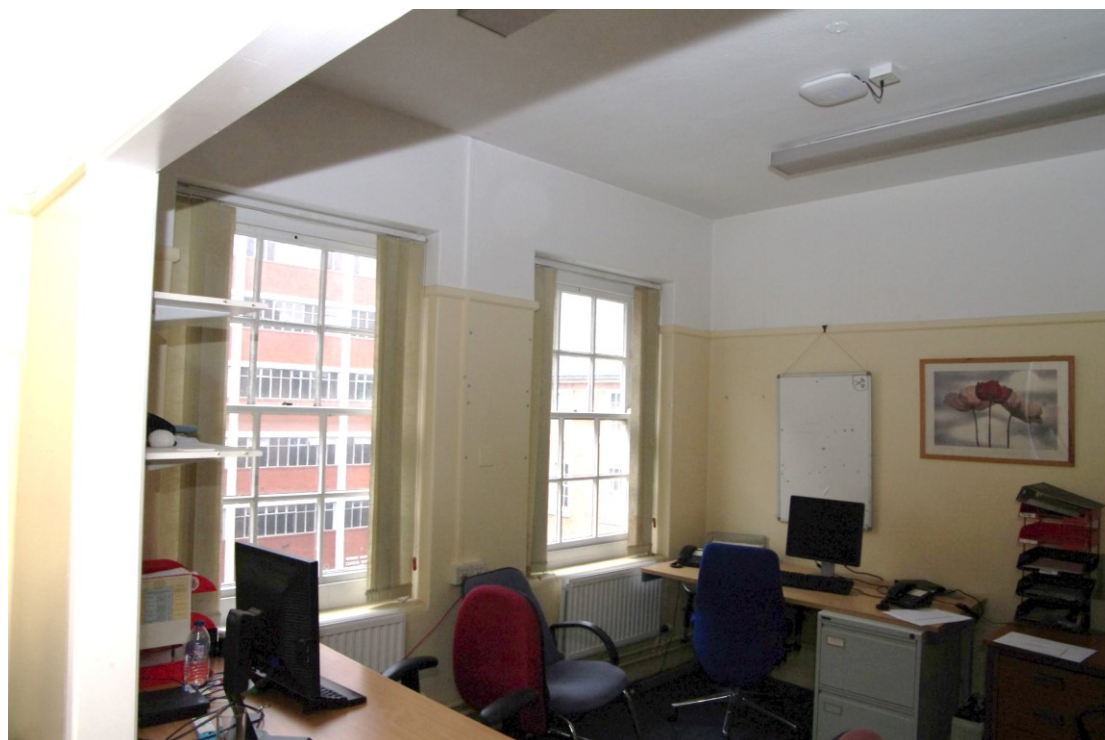
Figure 142 Third floor, later 1930s north to south corridor: room above bay window
Looking north-west in Room 337

On the west side of the corridor the west facing bay window stops at second floor level meaning that this floor has straight walls (Fig. 142). This room has been enlarged by removing part of the southern wall to combine it with the adjacent room.
