**A Historic Building Heritage Impact Assessment at
The Knighton Street Outpatients Building,
Leicester Royal Infirmary,
Leicester
NGR: SK58735 03545**

ULAS Report Number: 2021-151

A Heritage Impact Assessment at the Knighton Street Outpatients Building, Leicester Royal Infirmary (SK 58735 03545)

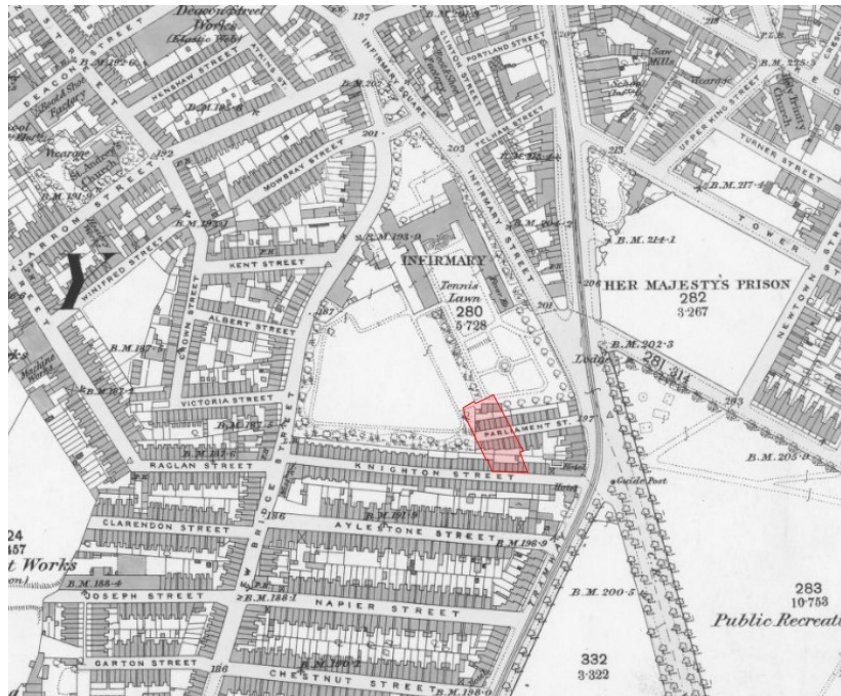
Figure 4 Detail from the First Edition Ordnance Survey map of 1888
 Approximate location of current building highlighted
 Sheet: XXXI.14. Original scale 25 inches to 1 mile

The first available map showing any clear details of the hospital site is the First edition Ordnance Survey 25 inch scale map published in 1888 (Fig. 4). This map shows the LRI site significantly smaller than it is at present. The original 1771 block is shown to the north of the site with a fever house added to one wing (now known as the Victoria building). A large open space is shown covering most of the rest of the site with what appear to be laid out gardens and a tennis lawn. Two narrow streets with terraced housing either side are shown as Parliament Street and Knighton Street and extend

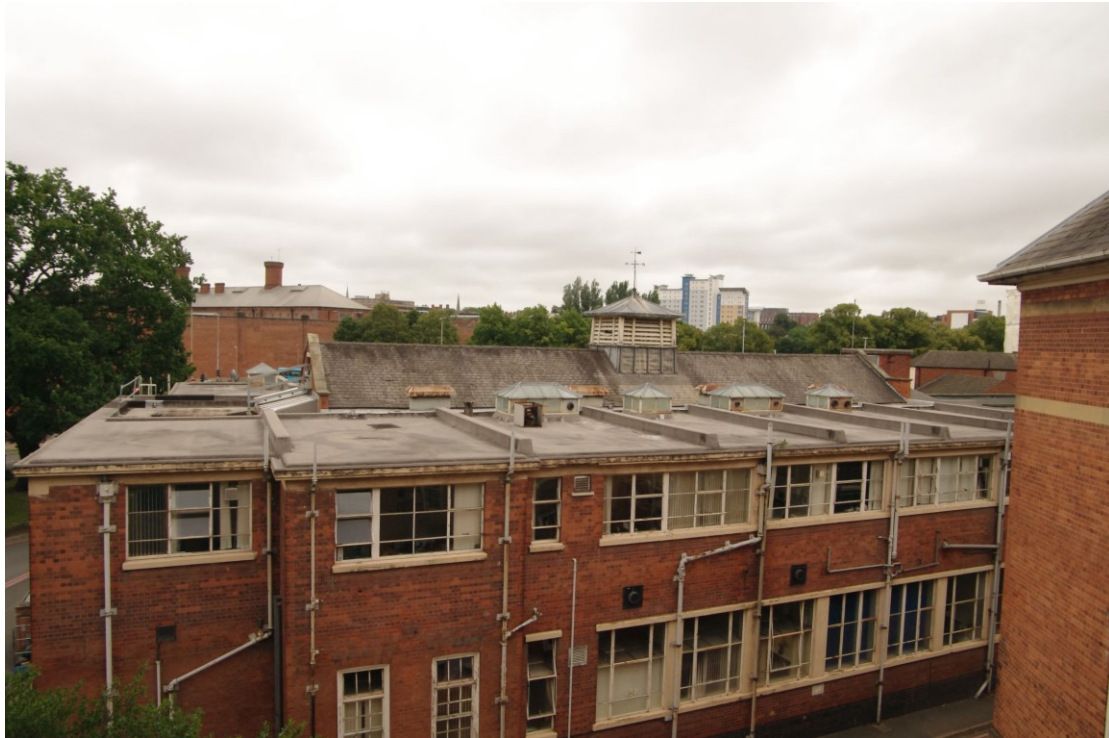
Figure 10 Knighton Street Building roofscape
Looking east. Note central hall roof and tall vent

At its heart the building consists of a central hall with a large ventilation tower built across the ridgeline of the roof (Fig. 10 and 11). The vent has decorative leadwork and a delicate weathervane on top. When first built the hall appears to have had single storey rooms built around it so that the vent could easily be seen (Fig. 12). Later extensions have increased the side rooms to two storeys so that the original roofline is very hard to see. All external elevations have been heavily modified from their original state with little attempt to achieve a continuous style across the building.

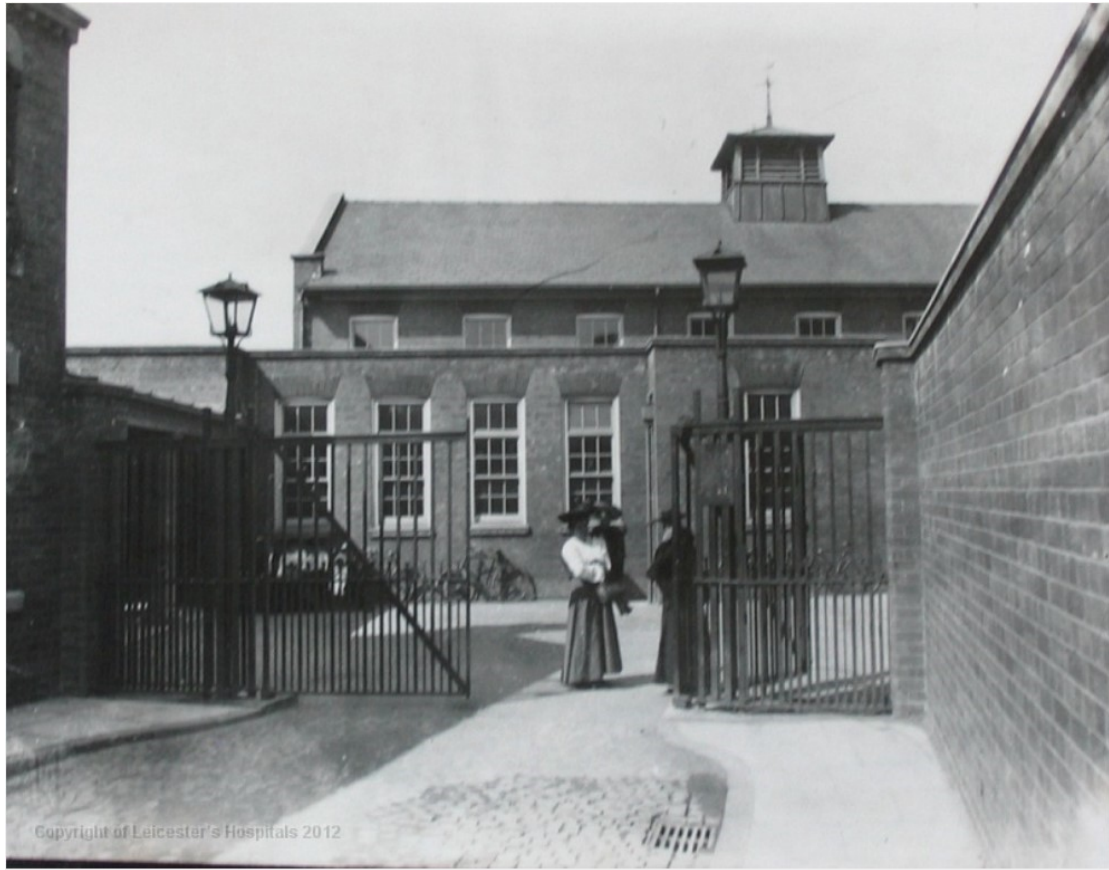
Figure 12 Knighton Street Buildings in 1905

Looking west along Parliament Street. Note that the flanking rooms are single storey in this picture.
Source: Leicestershire Hospital virtual museum website

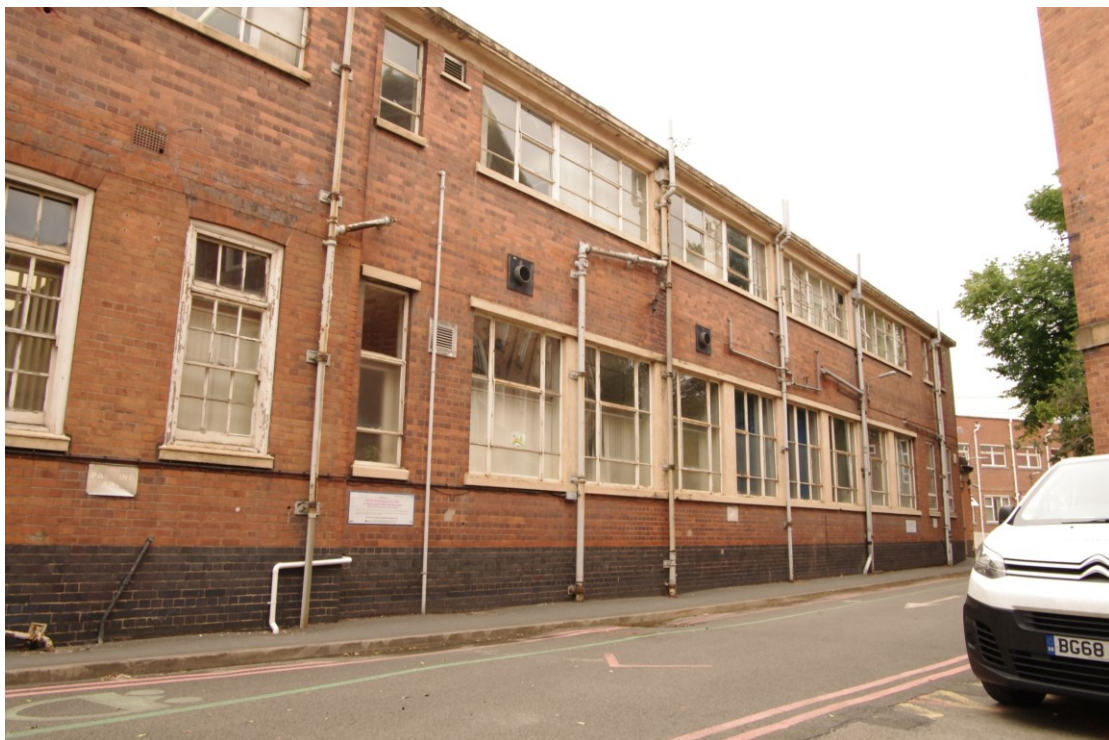
Figure 13 East facing elevation

The west facing elevation is a typical example of this piecemeal growth with some sash windows surviving near the northern end of the elevation but with metal 1930s style Crittal windows along the rest of the elevation which has also been increased from a single storey to two storeys (Fig. 13). Even more phases can be seen on the angled, south-facing, elevation which was extended to face across Knighton Street between 1915 and 1920 (Figs 14, 15 and 16). This elevation contains some dressed stonework but appears to have been added to grace the open space to the south and a decorative bay on the south-east corner of the nurses' home. As a wall it does little to benefit the use of the Knighton Street Building.

Looking south-east. Note original sash windows on left with added second floor above them. 1930s windows to right

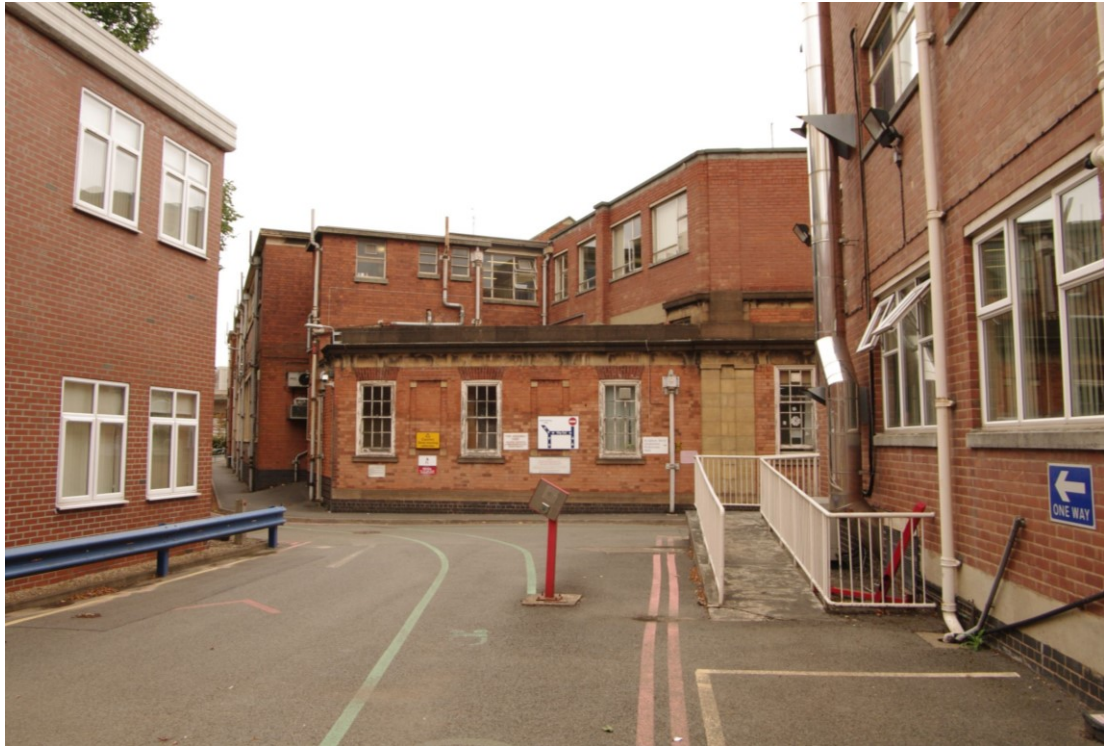
Figure 14 Western end of south facing elevation
Looking north. The line of Knighton Street ran from left to right in front of the building

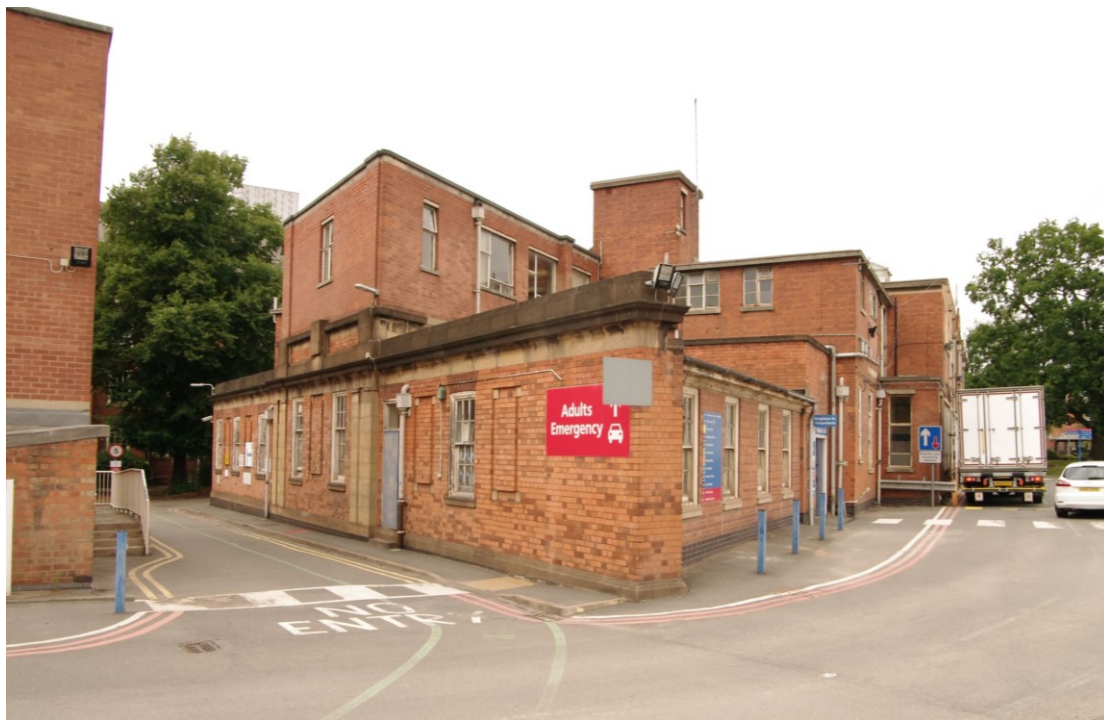
Figure 15 South facing elevation
Looking north-east

To the south of the entrance area are a set of rooms with the angled southern wall (see Fig. 15) forming one side (Fig. 24). The rooms have no decorative features although the east side has sash windows which appear to have been outside windows at one stage. The splayed blocked doorway indicated by the painted over sign seen in Figure 18 can be seen in the easternmost of these rooms (Fig. 25). At the western end of these angled rooms are three small rooms, one of which has a wooden picture rail whilst another has painted glazed brick walls. Otherwise there is little of architectural interest in this area.

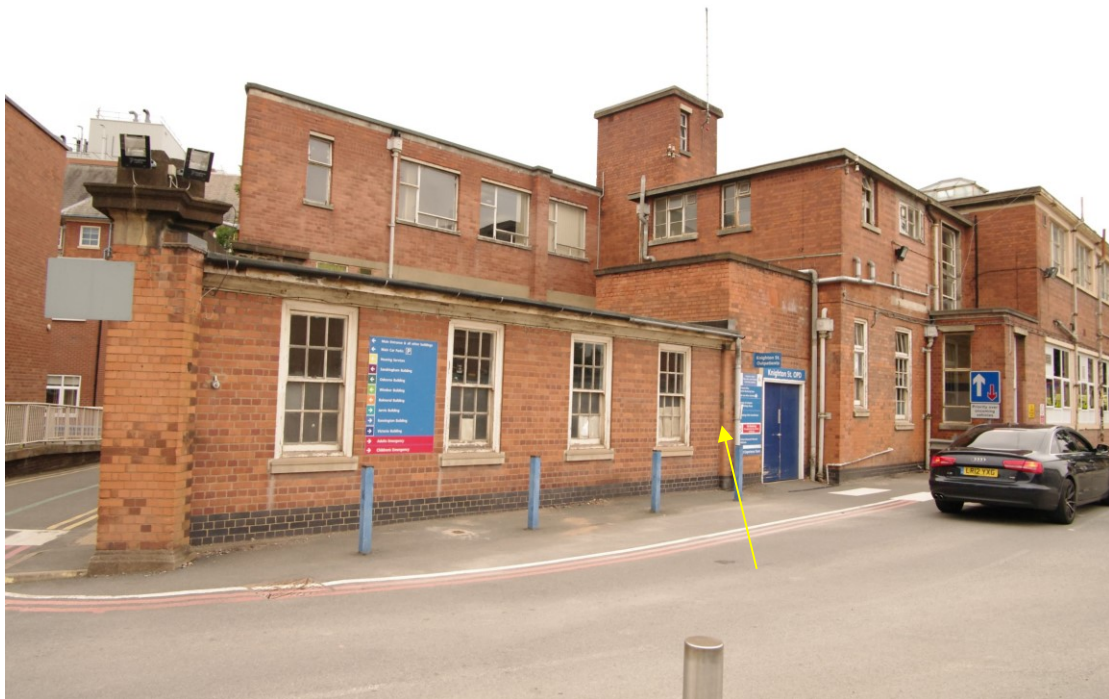
Figure 17 South-east corner of east facing elevation
Looking north-east. Yellow arrow points to obscured sign – see Figure 18

At the southern end of the east facing elevation the junction of the earlier phase and angled later phase can be seen along with later first floor additions (Fig. 17). An earlier entrance appears to have faced south as the edge of a painted sign has been partially obscured by the later extension (Fig. 18). At first floor height modern blocking brickwork can be seen where a pedestrian overbridge connected to the now-demolished building to the east. Elsewhere along this elevation Crittal windows show where the façade was extended to create a smooth wall line and where the upper floor was added (Fig. 19). Some sash windows survive on the earlier parts of this elevation. The same pattern is seen on the north-facing elevation although here the added first floor steps out beyond the original building footprint (Fig. 20). A low brick building gives access to the basement which was not accessed during this assessment.

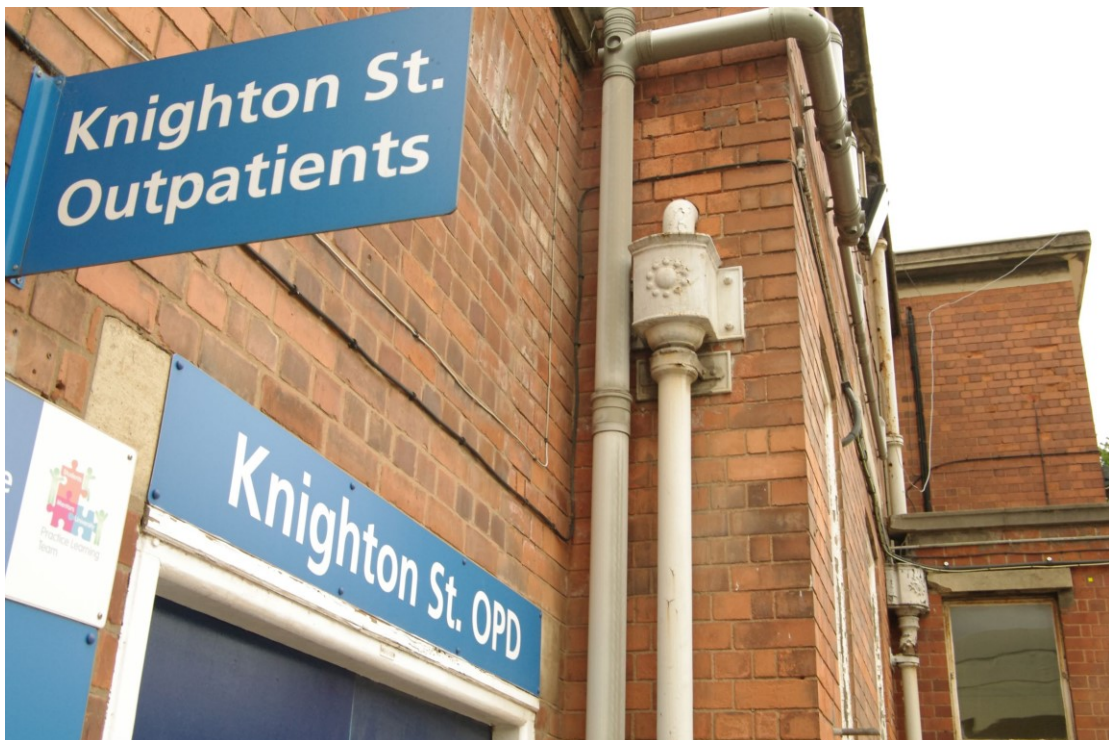
Figure 21 Decorative rainwater hopper
This pattern is seen around this building and on the adjacent Knighton Street Offices

A decorative feature seen across all elevations are the cast iron rainwater hoppers (Fig. 21). These are a simple design of a circle surrounded by a ring of dots. The same design is seen on the rainwater goods on the neighbouring Knighton Street Offices.

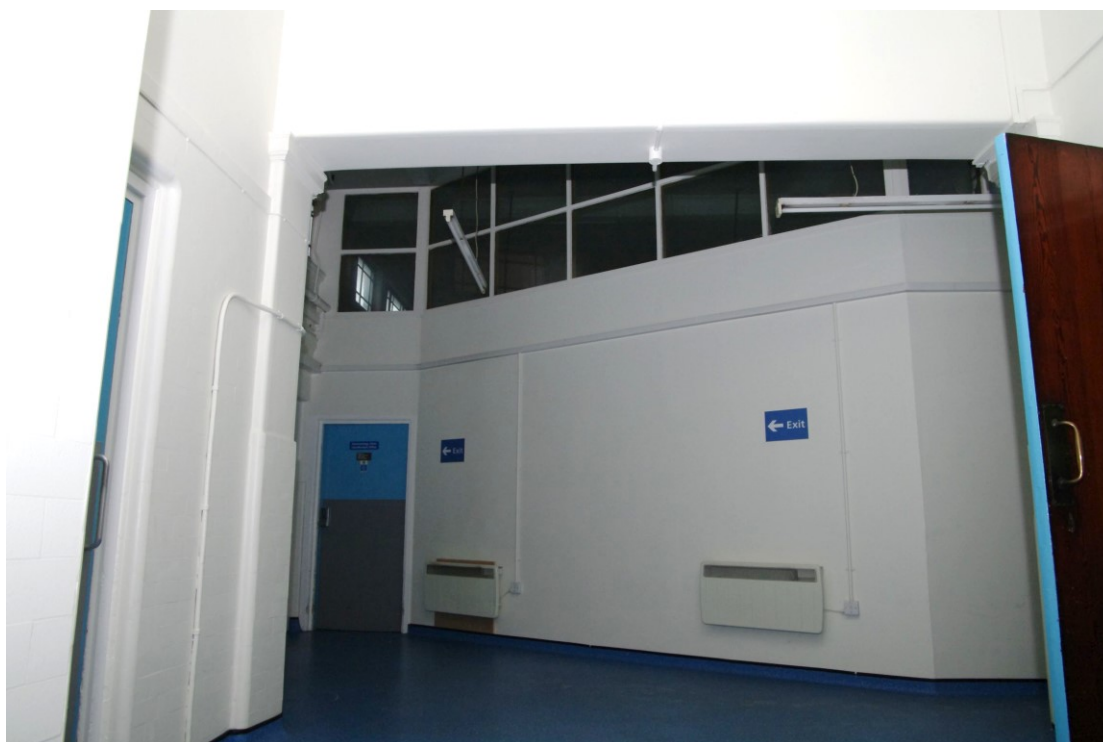
Figure 22 Entrance hallway
Note decorative plasterwork on pilaster on left

Entering the building from the southern end of the east facing elevation leads into a slightly strangely shaped hallway with an angled partition south wall (Fig. 22). The space and the open area beyond are very plain although there are two pilasters supporting a flat arch which have some plaster decoration close to the top. There are a number of low lintels in this area which support walls from earlier phases. Within the larger entrance area are the female toilets which have retained their brass handles, hinges and fittings (Fig. 23). The doors are painted on the outside but are still stained bare wood inside.

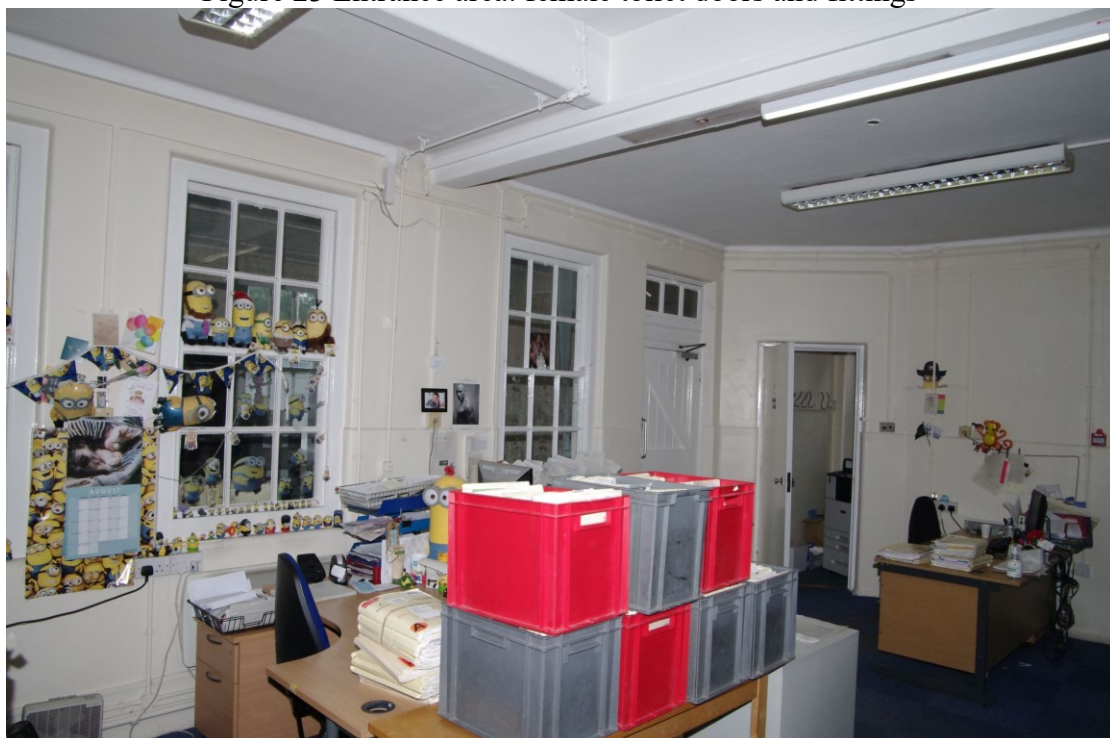
Figure 24 Southern offices

Looking south-east. Note the sash windows which appear to have been outside windows at one stage

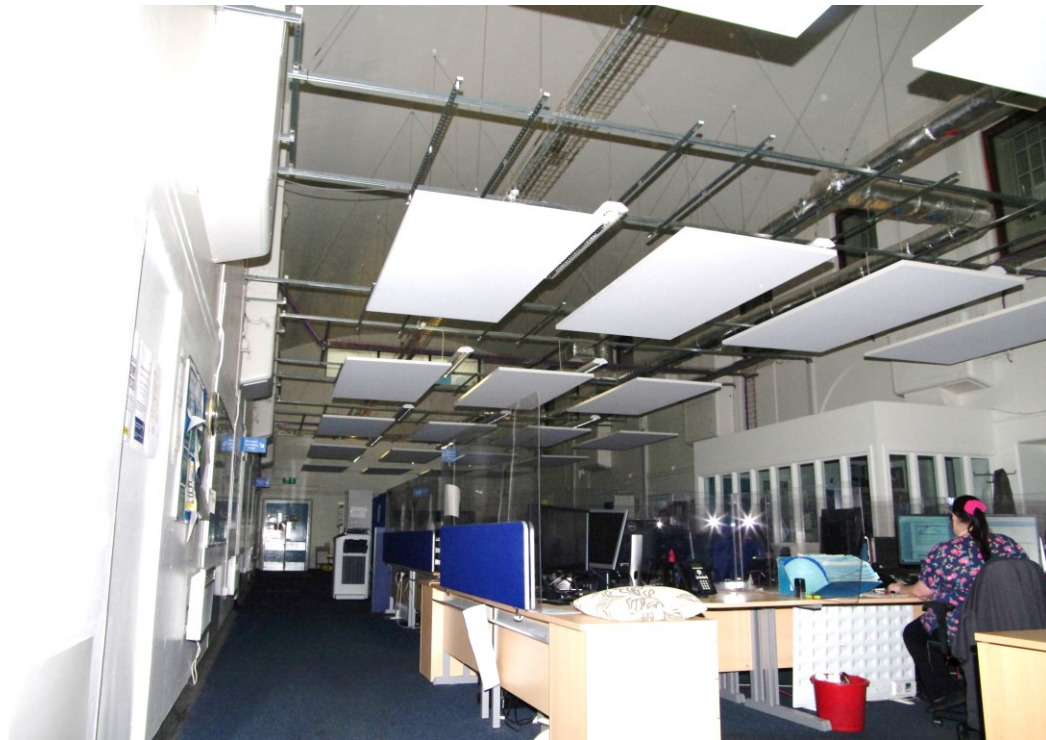
Figure 26 Central hall
Looking north-east. See also Figure 27

The full-height central hall is the main feature of the building and, at the time of this assessment, was in use as an open plan office with partial false ceilings which obscured much of the area (Fig. 26). When first built this hall had glazed brick or tile walls to picture rail height and a frieze of patterned tiles (Fig. 27). At the time of the survey these tiles were still present but were painted over (Fig. 28). Black and white images suggest that the tiles are multi-coloured. Despite the paint they were still in an apparently good state and may be recoverable. Just above the frieze old photographs indicate that the title and function of each side room was marked to the side of the doorway. Careful cleaning may reveal these although, at present, nothing could be seen. At ground level are a series of open vents which, presumably lead up to the central vent seen on the roof acting as a passive ventilation system for the large number of people who would be in the room. At the time of the assessment these vents had been boarded over.

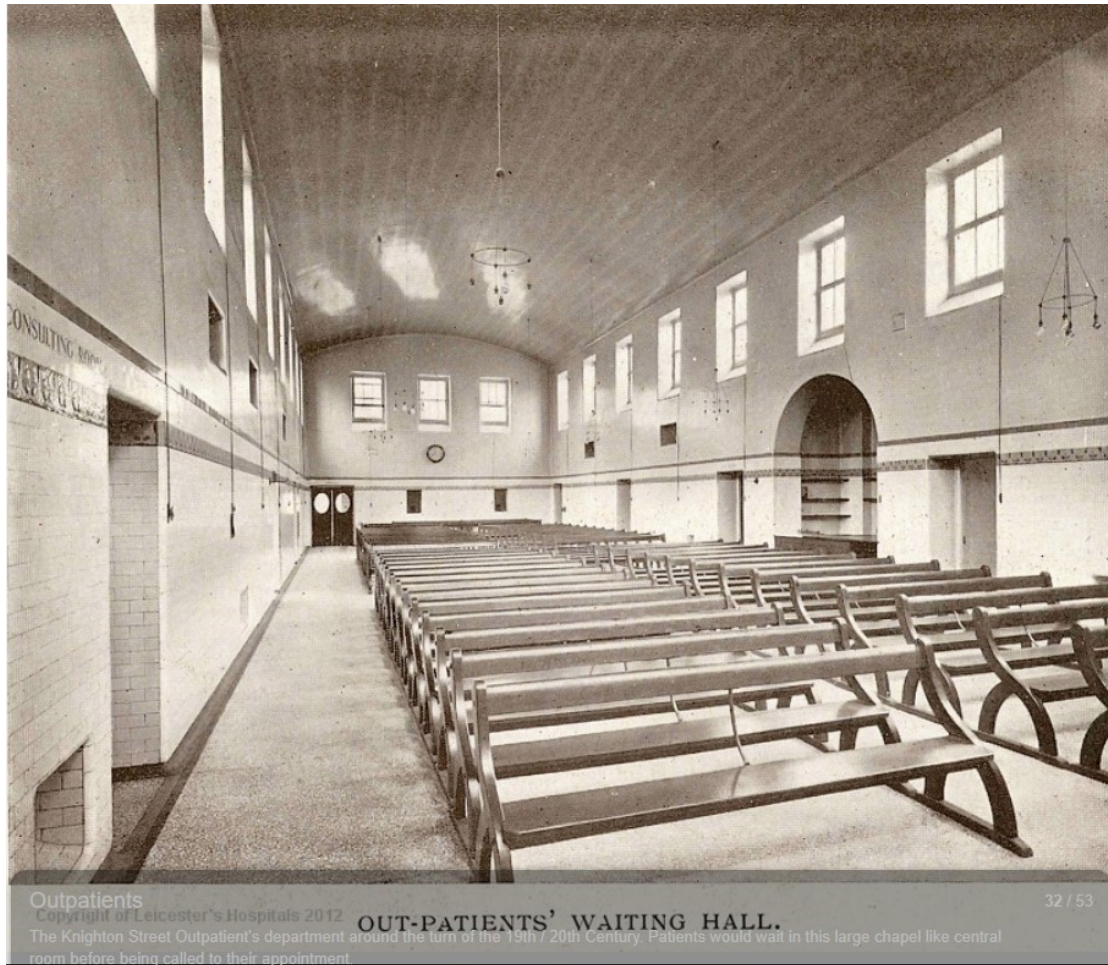
Figure 27 Central hall as first built

Taken from same location as Figure 26. Note that the far doors match that shown in Figure 23.

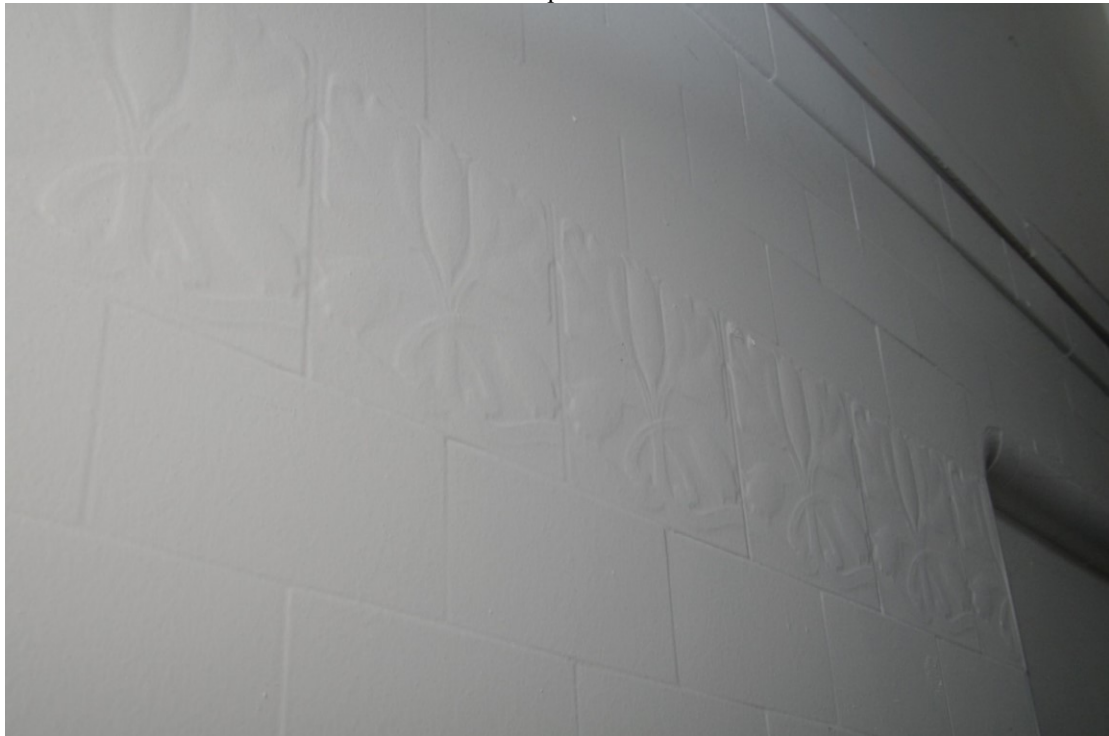
Figure 28 Painted over frieze running around the hall

Another feature which, if not recovered, could be studied further is a decorative tile frieze within the main hall. The frieze is complete but is currently hidden behind layers of paint.

Ideally the glazed tiles and frieze within the central hall should receive further attention. At the very least an area of paint could be removed in order to observe and record the colour and pattern of the frieze and surrounding tiles. Such cleaning may also reveal the original name and room titles seen in earlier photographs. It may be possible to lift and retain at least some of the tiles for future use.

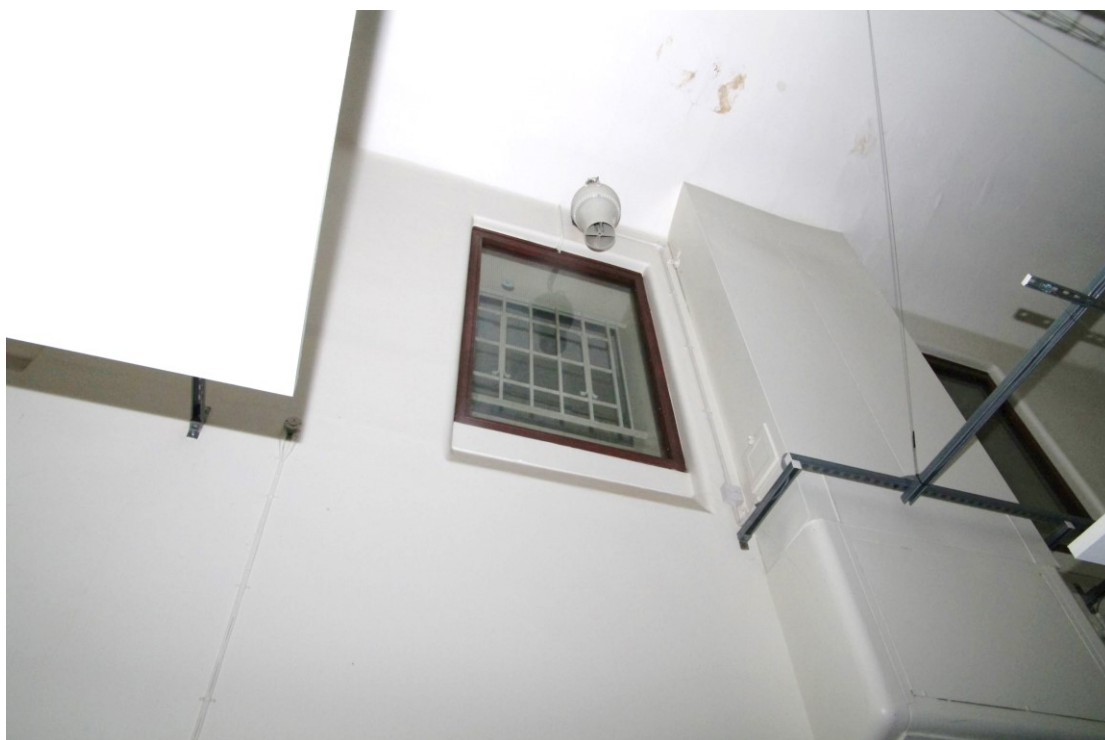
Figure 29 Former external window in central hall
Modern glazing unit is in front of the earlier iron grille

The hall has a series of windows at first floor level running around the perimeter. When first built these were external windows but the addition of a first floor meant that these were replaced by wrought iron grilles which subsequently have been covered by glazed panels (Figs 29 and 30). The grilles are simple but attractive and could be easily removed for re-use elsewhere.

Internally the building has been thoroughly modernised leaving few fittings present although it would seem that all of the phases were built without too much decoration and embellishment anyway. The obvious features worthy of retention are the three commemorative plaques on the first floor which should not be too difficult to remove. Also relatively easy to remove would be the wrought iron grilles around the upper windows of the hall. The same applies to any surviving door fittings.

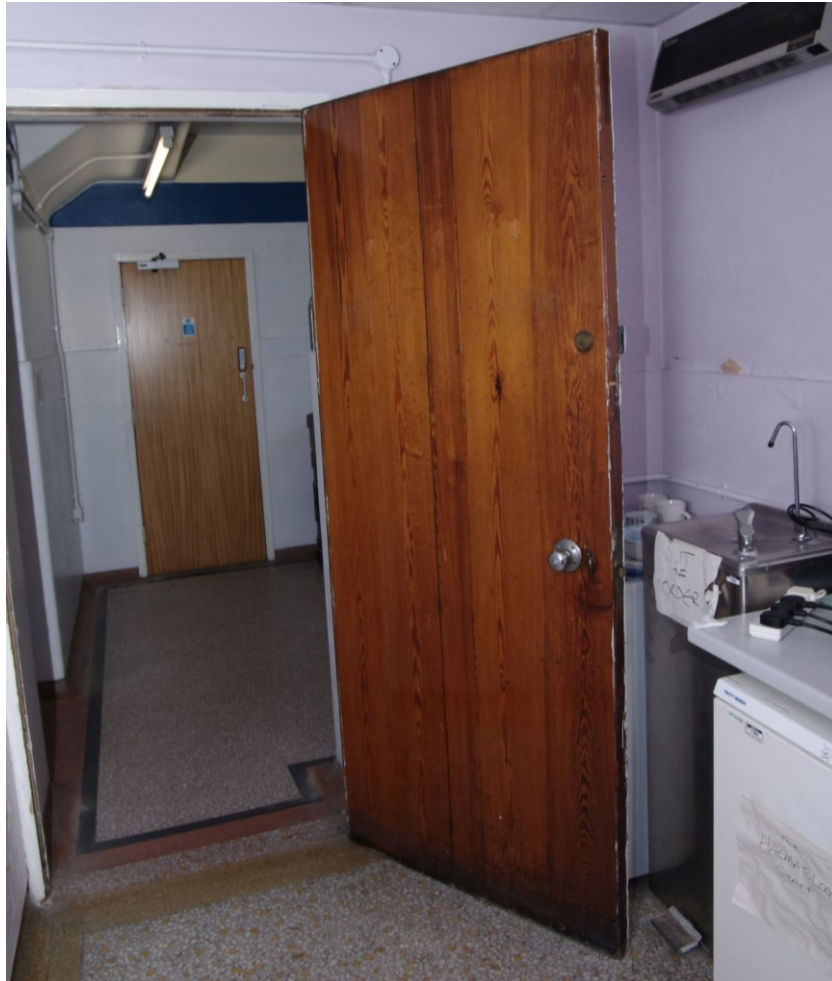
Figure 31 One of the few remaining original doors
Room to south of the east fire escape. Note original terrazzo floor

All of the ground floor side rooms have had their earlier fixtures and fittings removed and modernised. Some rooms have glass brick sky lights which form part of the floor of the rooms above. A small kitchen area to the south of the eastern fire escape door still has its heavy wooden door although the fittings have been removed (Fig. 31). This area still has its original terrazzo floor.

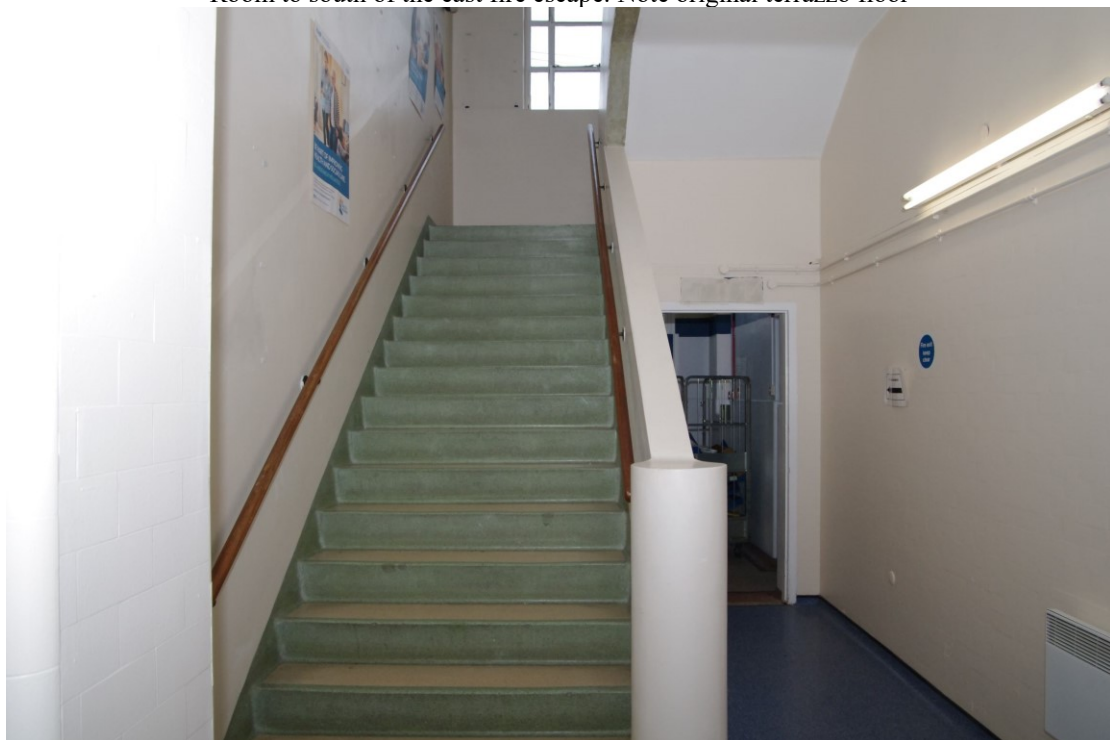
Figure 32 Stairs up to first floor
Looking east

A wide set of stairs in the south-eastern part of the building leads up to the first floor (Fig. 32). The stairs are functional with a hint of art deco styling especially around the newel post at ground floor level. The walls have painted-over glazed bricks or tiles on them. At the bottom of the stairs is a large but undecorated archway and the original brass light switch panel (Fig. 33).

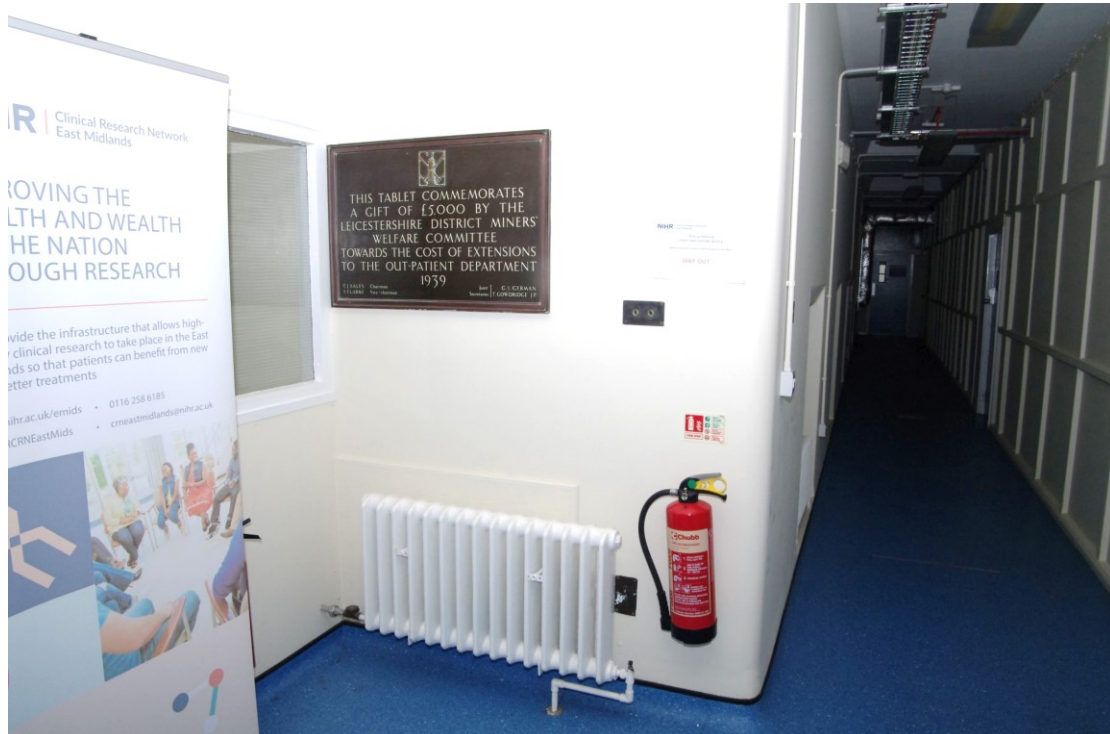
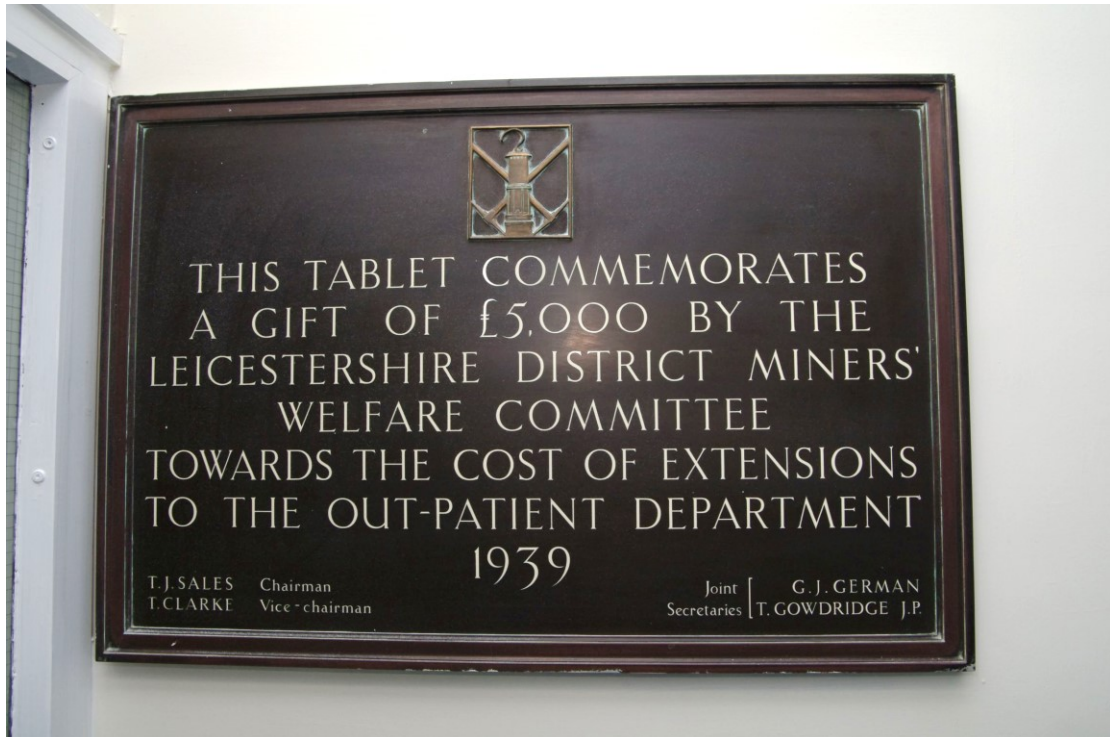
Figure 35 Plaque on first floor close to eastern corridor

bronze plaque marking the donation of £5,000 in 1939 by the Leicestershire Miners' Welfare Committee towards the costs of the Outpatients building (Figs 34 and 35). This gives an idea of the date of at least one phase of the extensions but is also a plaque worthy of retention not only for the sake of the Hospital but also as a reminder of a now-dead local industry.

Despite being thoroughly modernised there are some features worthy of retention such as bronze plaques commemorating donations towards extensions. Another plaque marks the opening of an education centre. Also noteworthy is a delicate weather vane set on the top of the original building. Elsewhere in the building some original doors and door fittings have survived as have a number of wrought iron grilles.

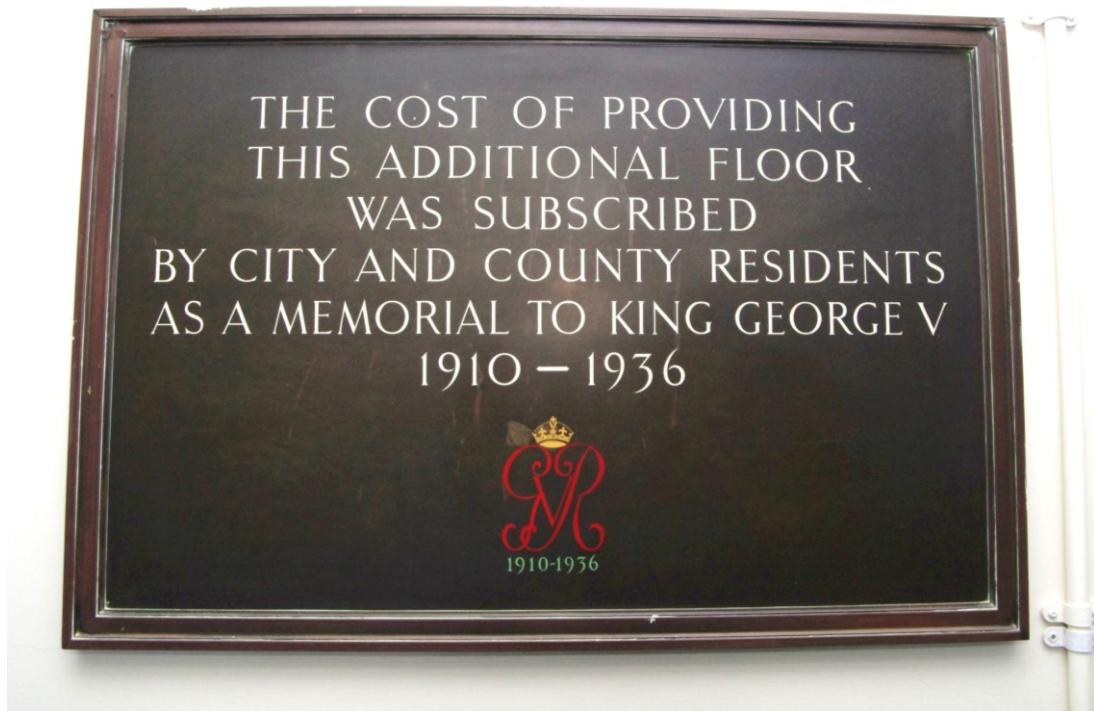
Figure 36 Plaque close to the first floor western corridor

Another similarly-sized and styled plaque is located close to the corner of the western corridor (Fig. 36). This commemorates the raising of funds for the addition of an extra floor as a memorial to King George V. The King died in 1936 so the plaque is likely to be of a similar date to the miners' plaque. Also in this area is a smaller and more modern plaque dedicated to the opening of the Knighton Street Education and Practice Learning Academy in 2015 (Fig. 37). Although not as grand as the other two bronze plaques this one still represents a significant part of the history of the building. It also reflects the age when it was put up when all funds go towards the project rather than diverting some towards what would be quite expensive memorial plaques.

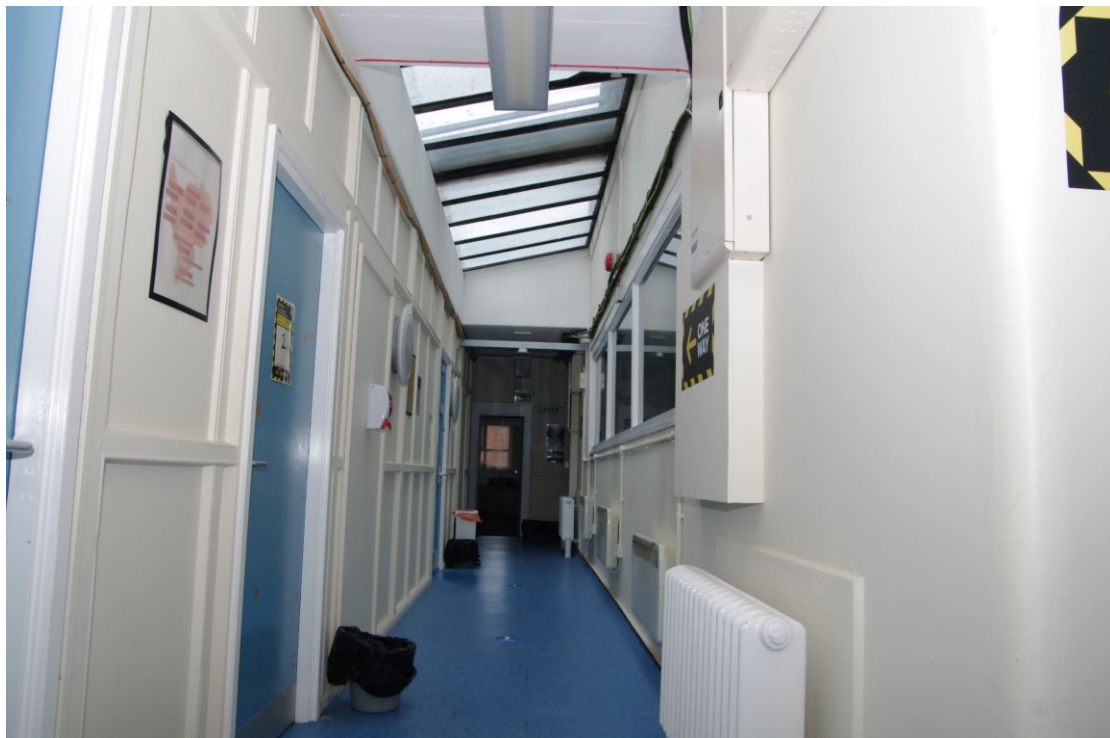
Figure 38 First floor northern corridor
Note original radiator with glazed panel behind

The first floor corridors have outer walls made of fairly thin section timber frames and boards. Along the inner walls are the original cast iron radiators set into the former window recesses. Along the northern corridor the radiators have glazed tile panels behind them (Fig. 38). Within the rooms there are no fittings which relate to any earlier uses and most spaces have been modernised. In some cases 1930s style panelled doors have survived but these have modern fittings attached (Fig. 39). The doors, as with the partition walls, appear to have been built with a tight budget.
