**Archaeological Observation, Investigation, Recording,
Analysis and Publication and Historic Building Recording at
Fermyn Woods Hall,
Causin Way, Brigstock,
Northamptonshire
NGR: SP 95816 87120**

**ULAS Report No. 2022-029
©2022**

Site Name: Fermyn Woods Hall, Causin Way, Brigstock,
Northamptonshire.

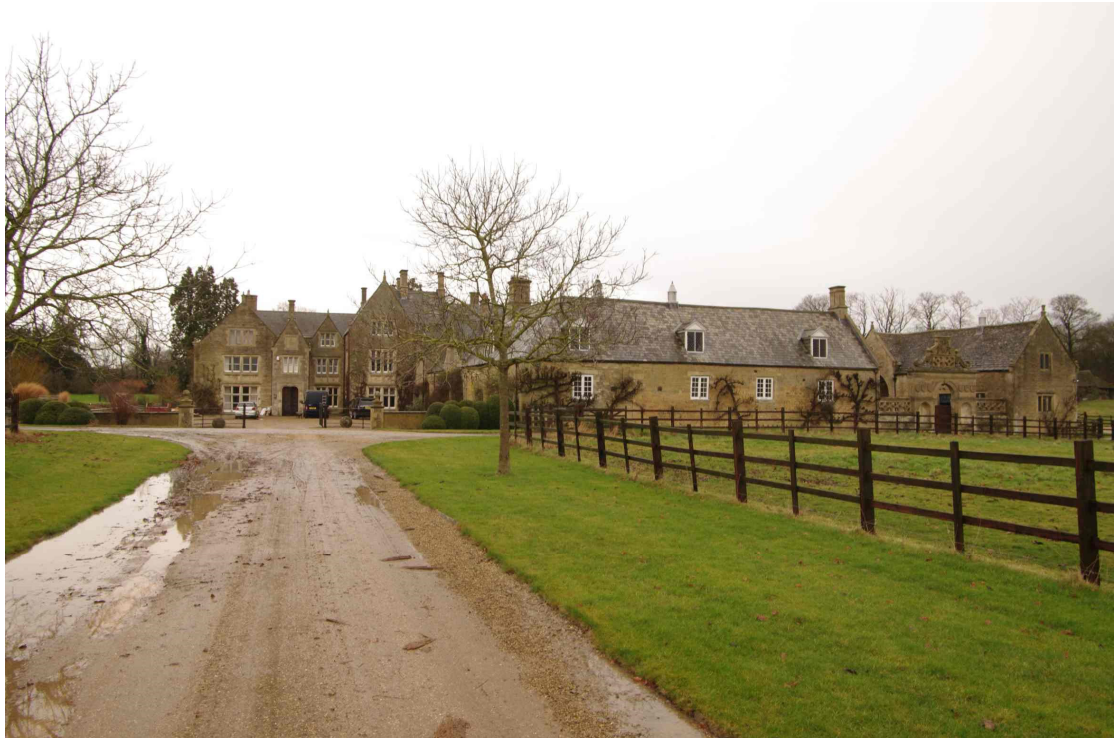
Figure 8 Driveway approach to Fermyn Woods hall
Looking north. Hall on left, former stables on right

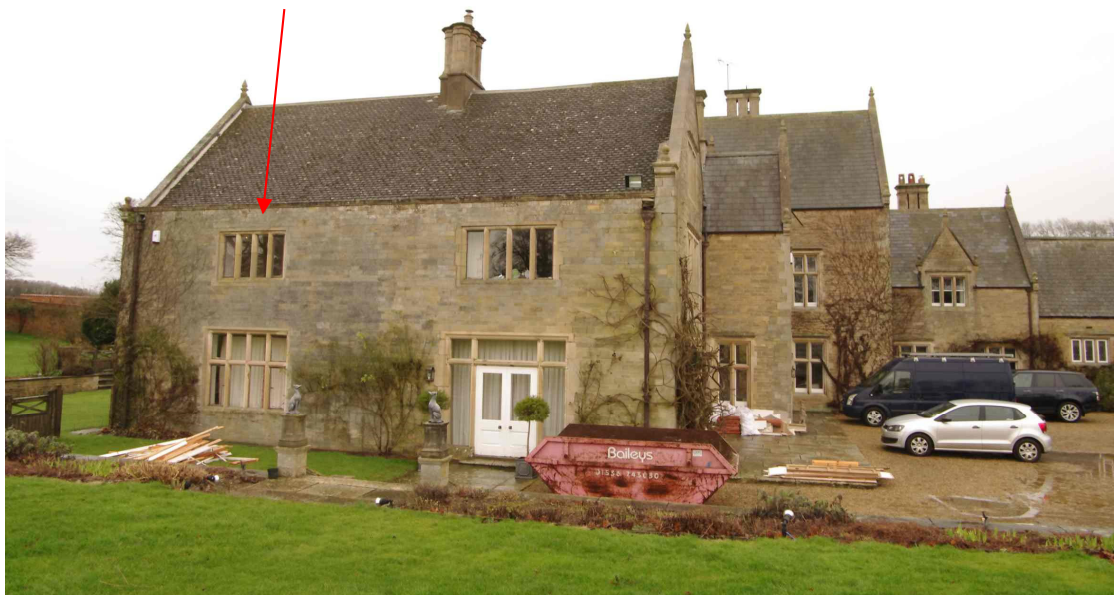
Figure 9 West facing elevation
Looking north-east. Bathroom window is arrowed

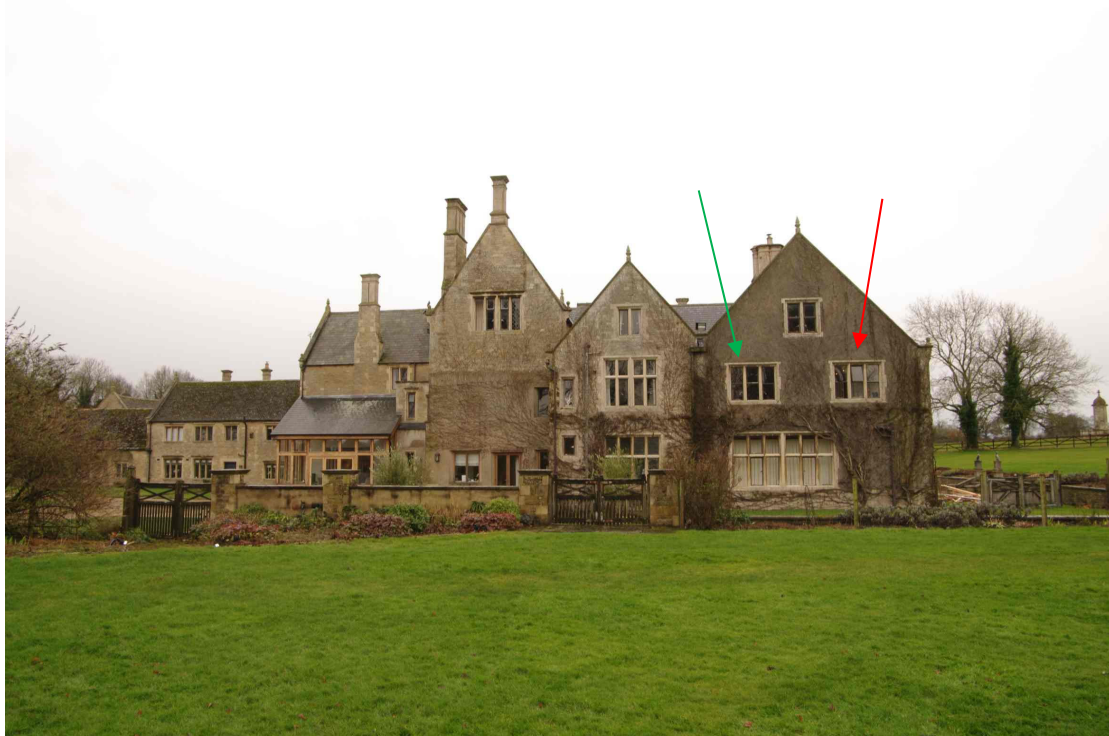
Figure 10 North facing elevation
Looking south. Dressing room shown by green arrow, the bathroom is the red arrow

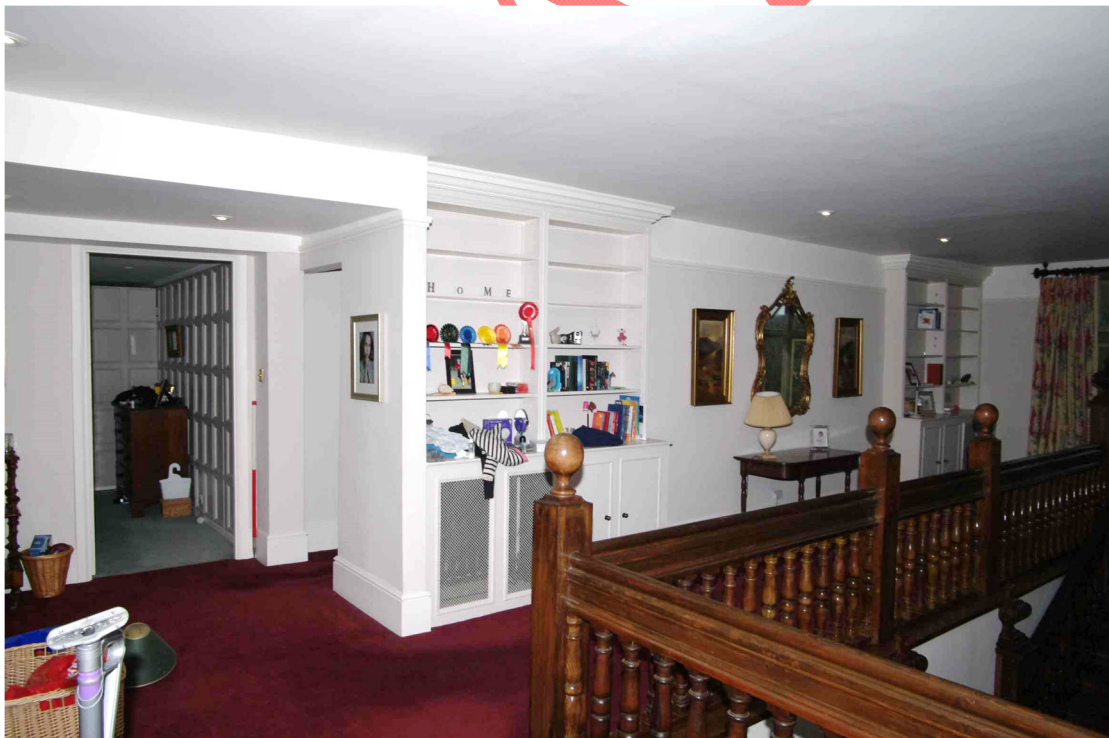
Figure 11 First floor landing
Looking north. Doorway to dressing room is to the right of the 1m scale. The door to the bathroom is through the bedroom on the left

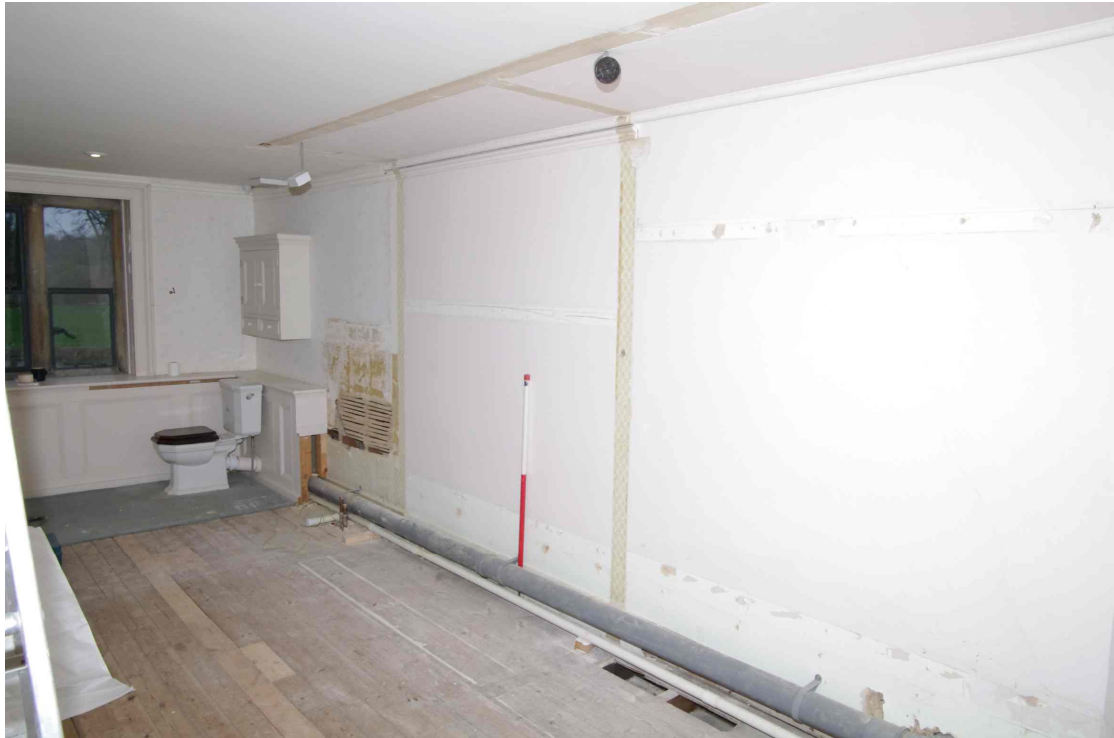
Figure 12 General view of bathroom and affected wall
Looking north-east. The new doorway will be where the 1m scale is located. The mark on the ceiling shows where modern fitted cupboards were located

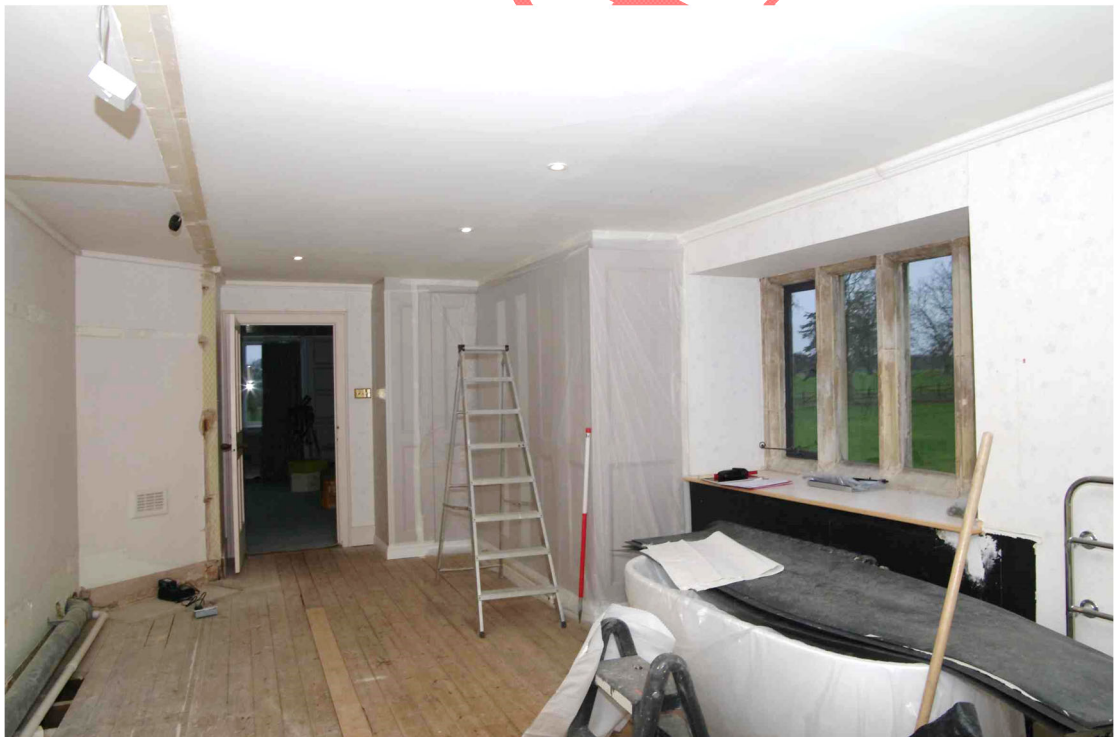
Figure 13 General view of bathroom
Looking south-west. 1m scale. Note corner fireplace on left

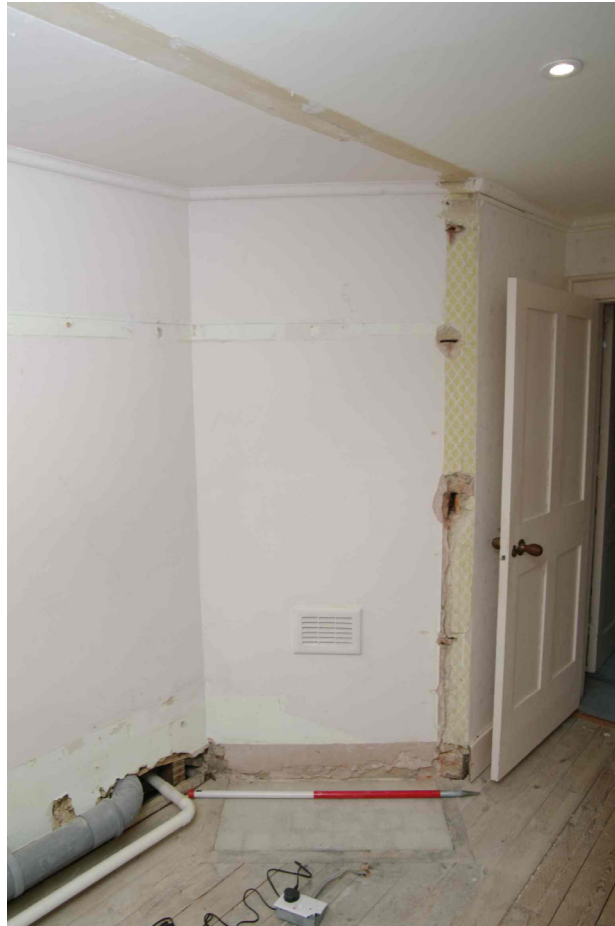
Figure 14 Blocked fireplace in the bathroom
Looking south-east. 1m scale

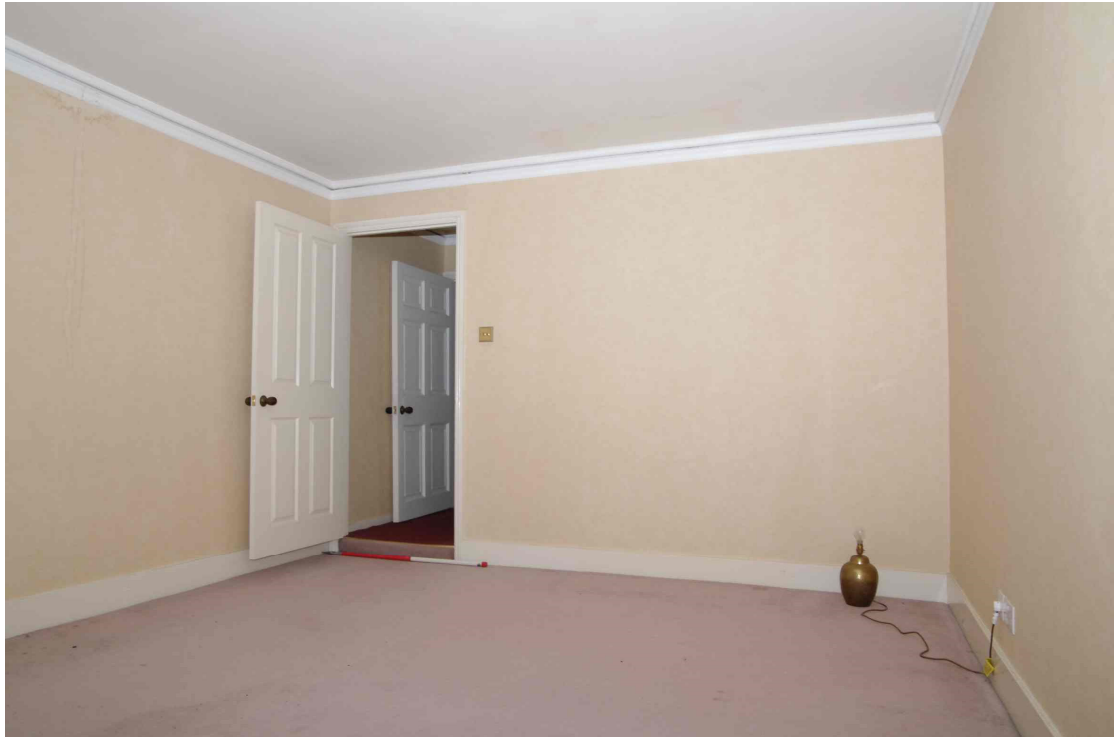
Figure 16 General view of dressing room

Looking south. Note step in floor above the 1m scale. The wall in the centre of the picture has the shower room behind it and is 20th century in date. The doorway will be blocked and a new door inserted to the right of it

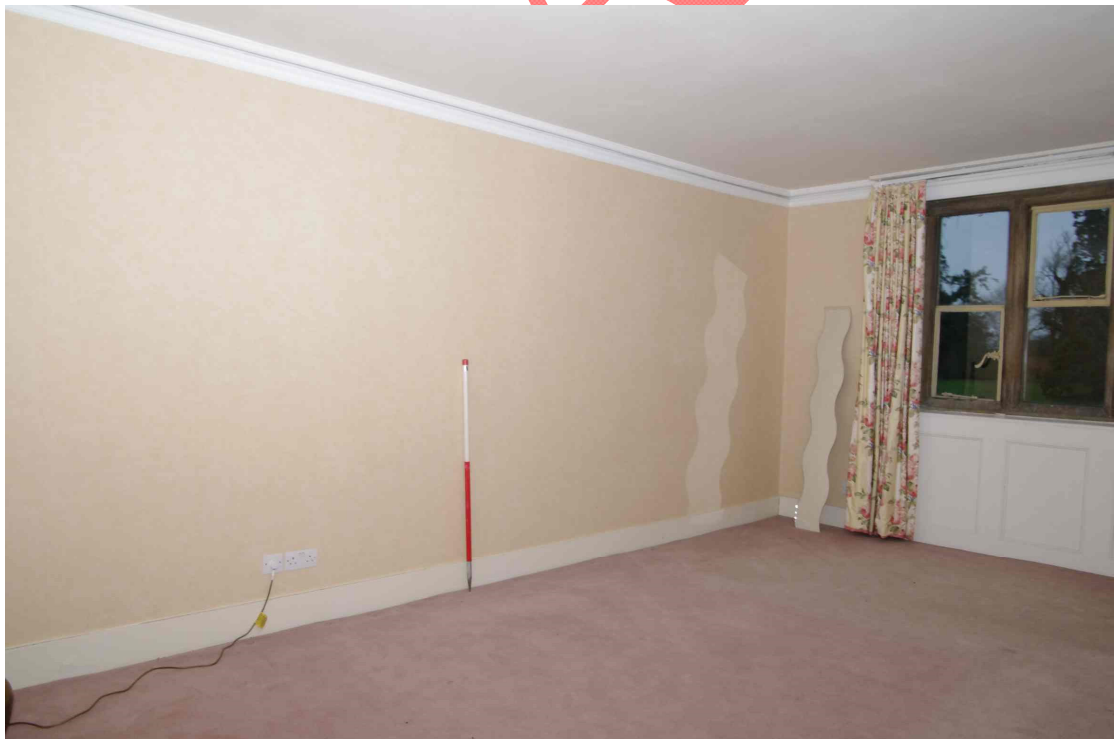
Figure 17 Dressing room and adjoining wall to the bathroom

Looking north. The new doorway to the bathroom will be to the left of the 1m scale

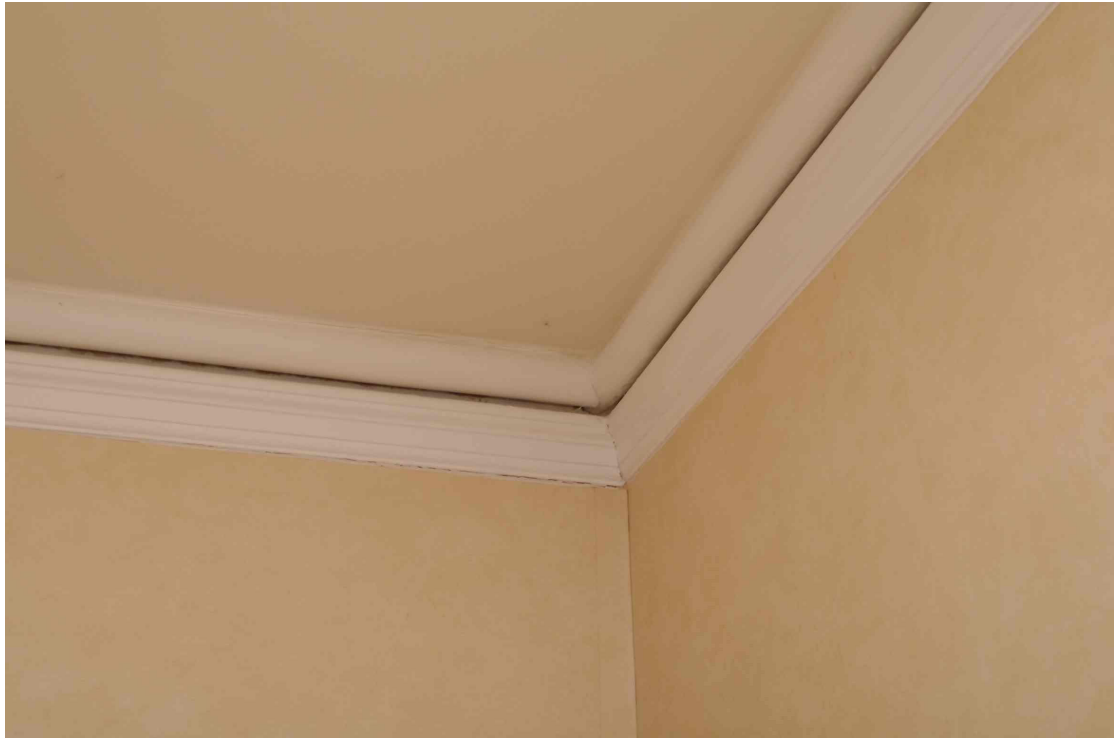
Figure 18 Beading detail in the dressing room ceiling
Looking north-east. The beading on the left is a modern copy fitted to the modern stud wall

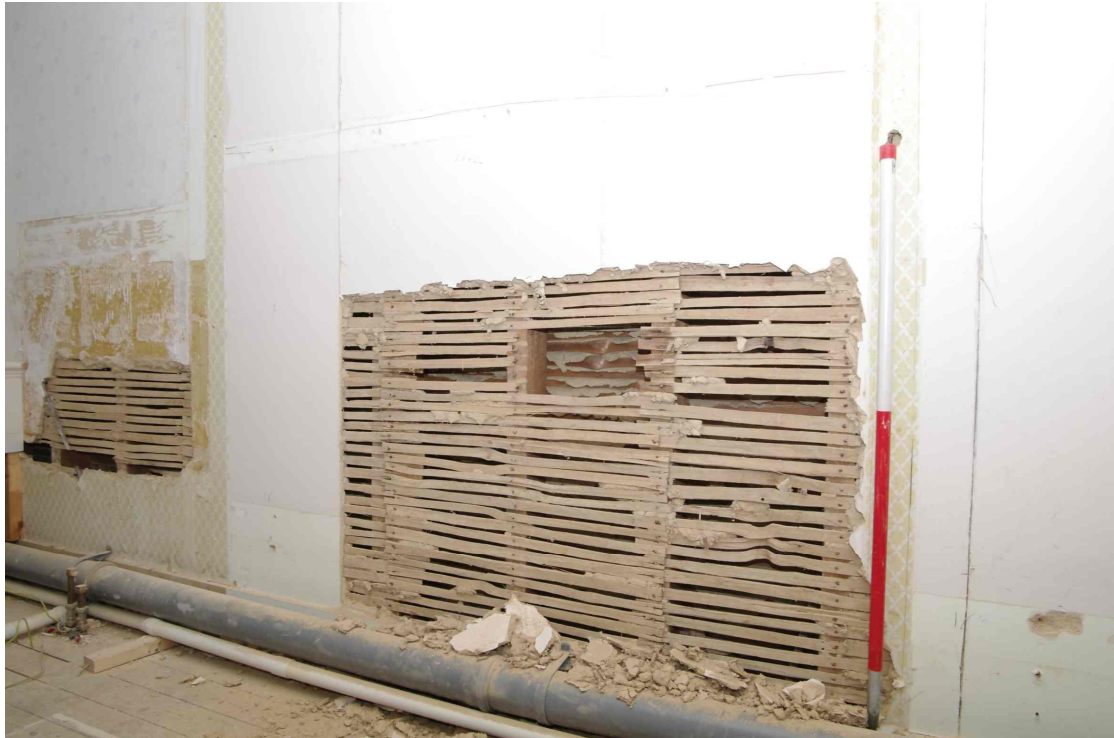
Initial removal of plaster on the wall between the bathroom and dressing room showed it to be a plaster and lath stud wall and not the masonry wall expected in the RTK Heritage Assessment (Figure 20). Because some of the wooden studs were structural and supporting the ceiling it was decided that a sliding door set within the wall thickness would not be practical and that any door would need to be set between supporting studs instead. The new doorway will still be around 2m high but only will only be approximately 1.1m wide and with conventionally opening doors.

Figure 20 Initial removal of plaster in the bathroom
Looking north-east. 1m scale

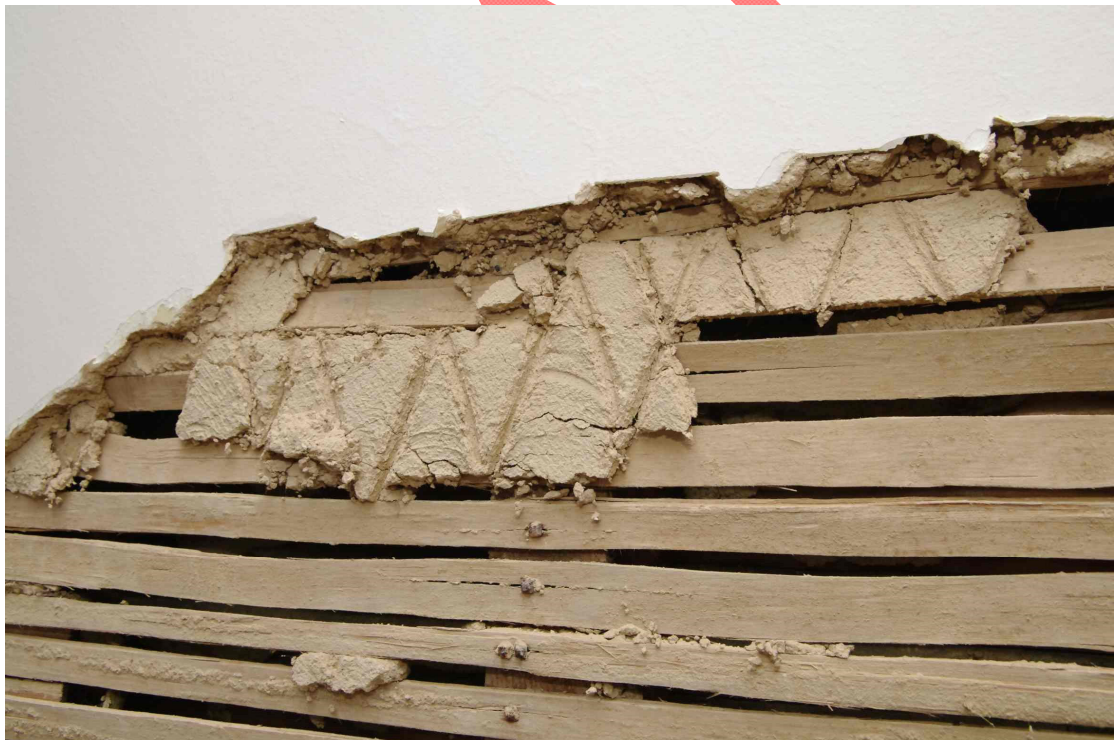
More removal of plaster showed that the plaster was a lime mix full of animal hair with a primary layer pressed into the laths and scored with a trowel to provide a key for the skimming layer (Figure 21). Square section nails with square heads were used to attach the laths to the studs (Figure 22). This type of nail and the plaster type would suggest a probable mid-19th century date for the wall.

Figure 21 The two layers of plaster on the bathroom wall

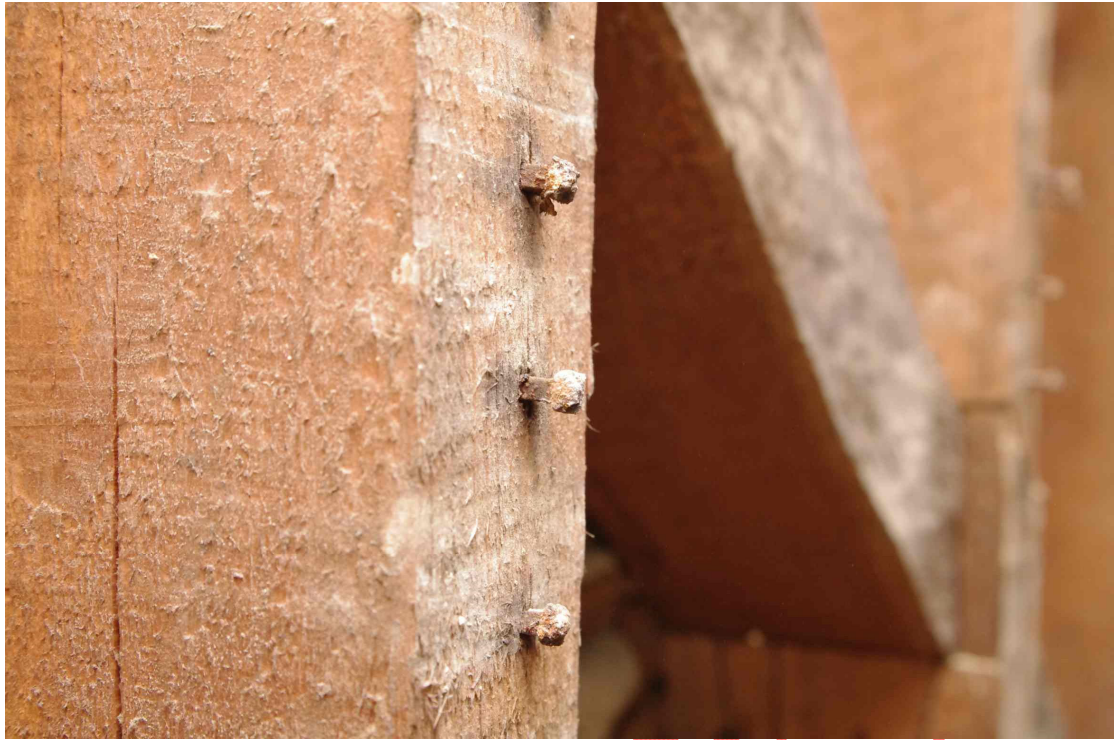
Figure 22 Nail detail used to hold laths

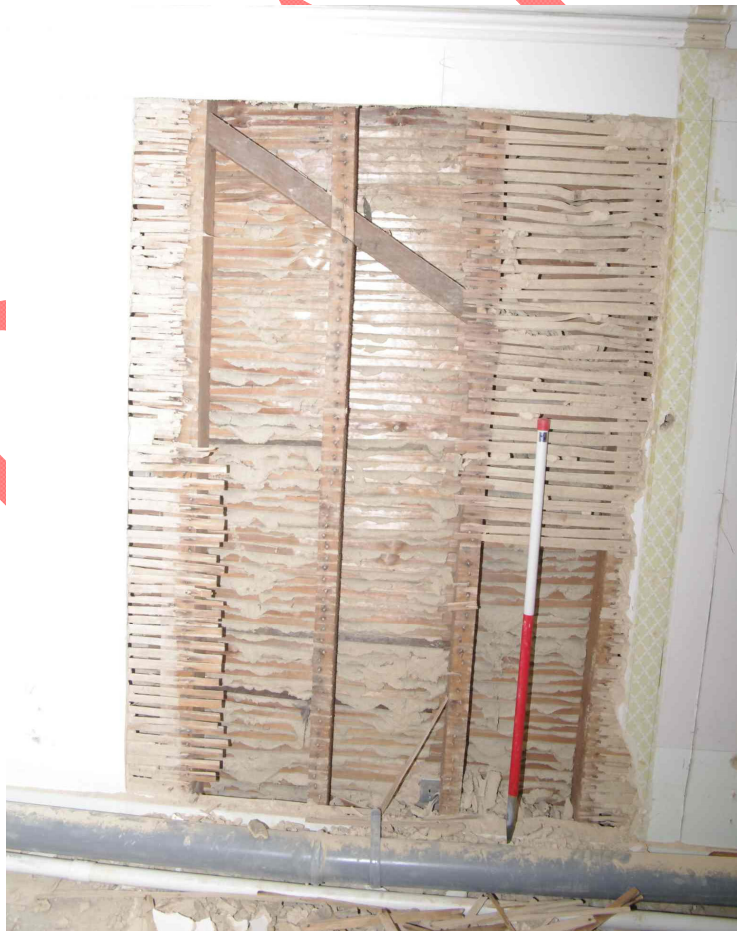
Figure 23 Plaster and laths removed on the bathroom side of the wall
Looking west. 1m scale. This will be the full width of the new door

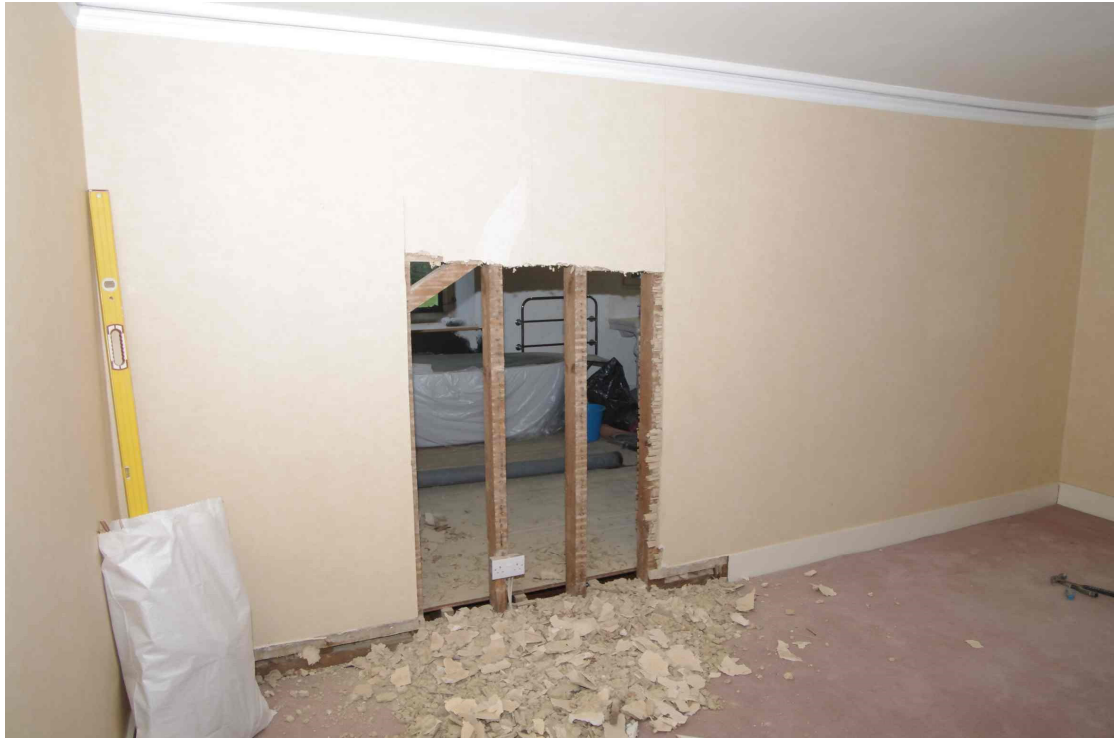
Removal of the laths to the full width of the new doorway continued on both sides of the wall leaving just the studs in place (Figure 24). This work proved that the entire wall was of a single phase with no masonry being present. Once the new doorway had been opened it was possible to see that the bathroom floor had been raised by laying new (i.e. 19th century) joists on top of the existing floor (Figure 25 and Figure 26). This raised floor then matched the floor height of the bedroom to the south. It is not clear why the dressing room floor did not receive the same treatment to create a level floor throughout. All new services for the bathroom and the dressing room will be placed within the void beneath the raised floors so that no historic fabric will be affected by this stage of the alterations. Also exposed during the work was a small wooden box which appeared to be a box to hold an electrical socket from a very early phase of electrification. A brief inspection of the rear of the plain skirting boards in both rooms indicated that they had been cut with a circular saw.

Figure 24 Plaster and laths removed from dressing room side
Looking north-west. The opening is not yet up to its full 2m height in this picture

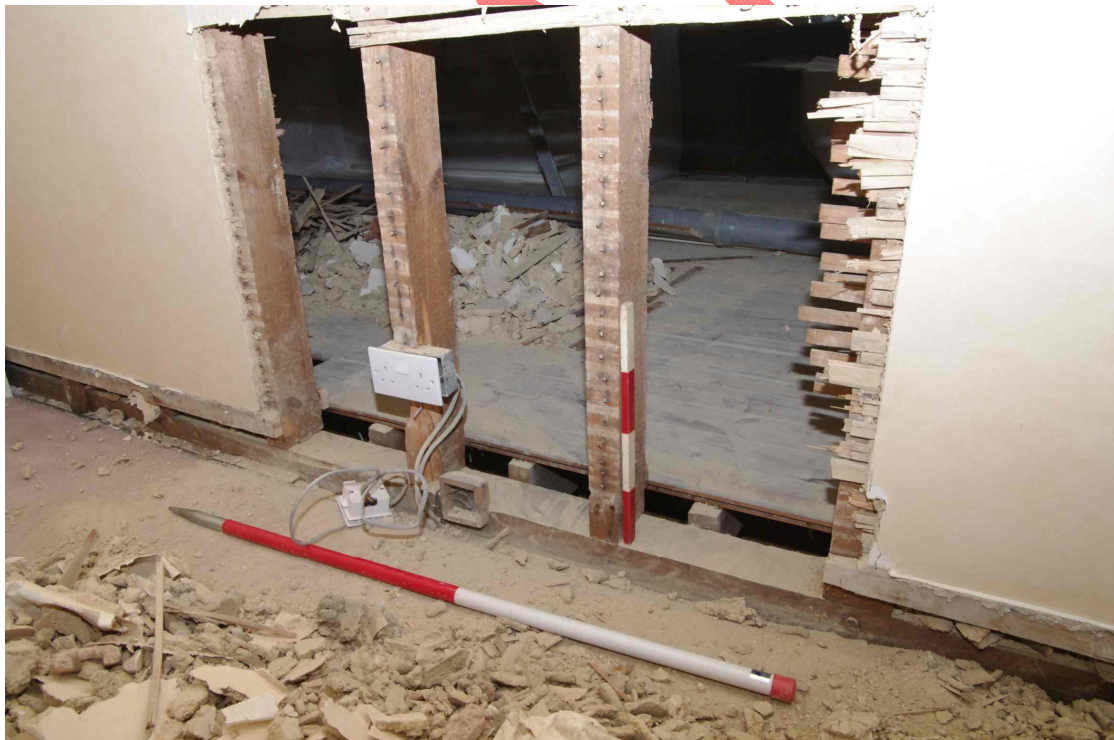
Figure 25 Difference in bathroom floor height seen from dressing room
Looking south-east. 1m scale. Note the small wooden box for early electrical socket

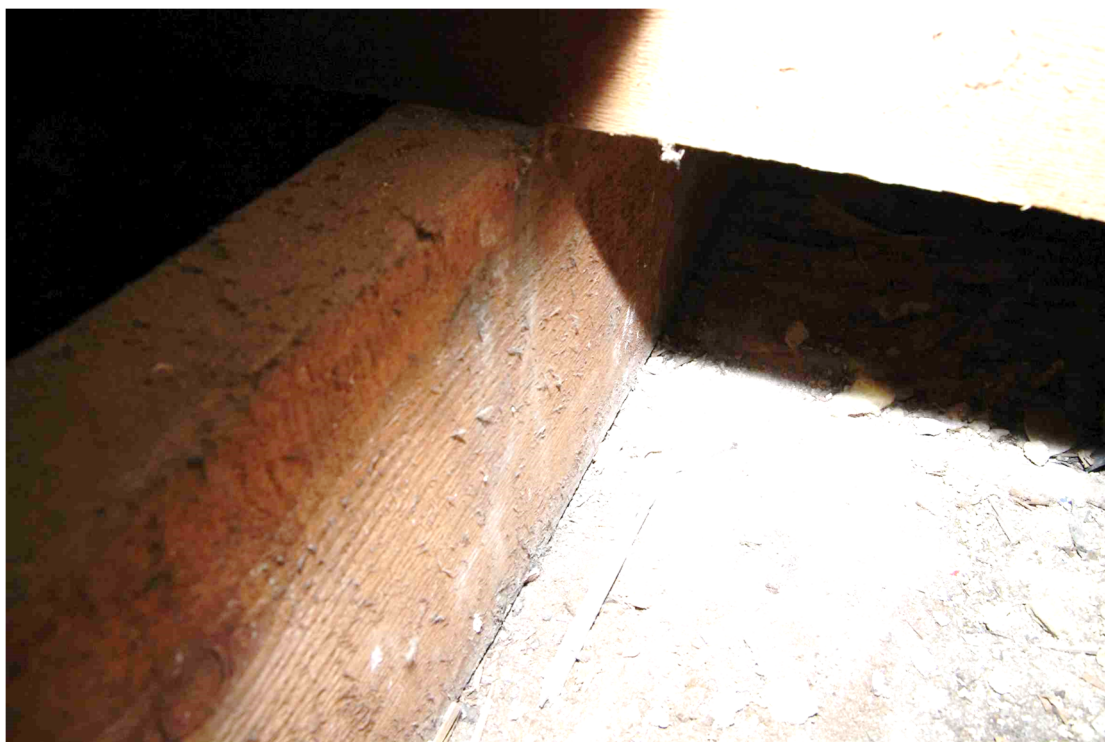
Figure 26 Transverse joist sitting on earlier floorboards in bathroom
Looking through the existing bathroom floor

The floor of the bathroom appears to have been raised by placing joists on top of an existing floor in order to avoid a step up into the adjacent bedroom to the south. It is not clear why the same floor treatment was not given to the new dressing room although it is possible that this room was intended for a maid or nanny who, given her status in the household, would not qualify for such comforts. The raising of the floor indicates that the room as a whole is earlier than mid-19th century and that the lath and plaster wall, angled fireplaces and new floor level represent an inserted phase of building or modernisation. That the bathroom floor was originally lower than the bedroom to the south means that it, and the new dressing room, are probably of a different phase to the adjacent rooms.
