**A Photographic Survey and
Archaeological Watching Brief at
St Cuthbert's Church, Great Glen
Leicestershire
(SP 652 977)**

St Cuthbert's Parochial Church Council

ULAS Report No 2008-199 ©2008

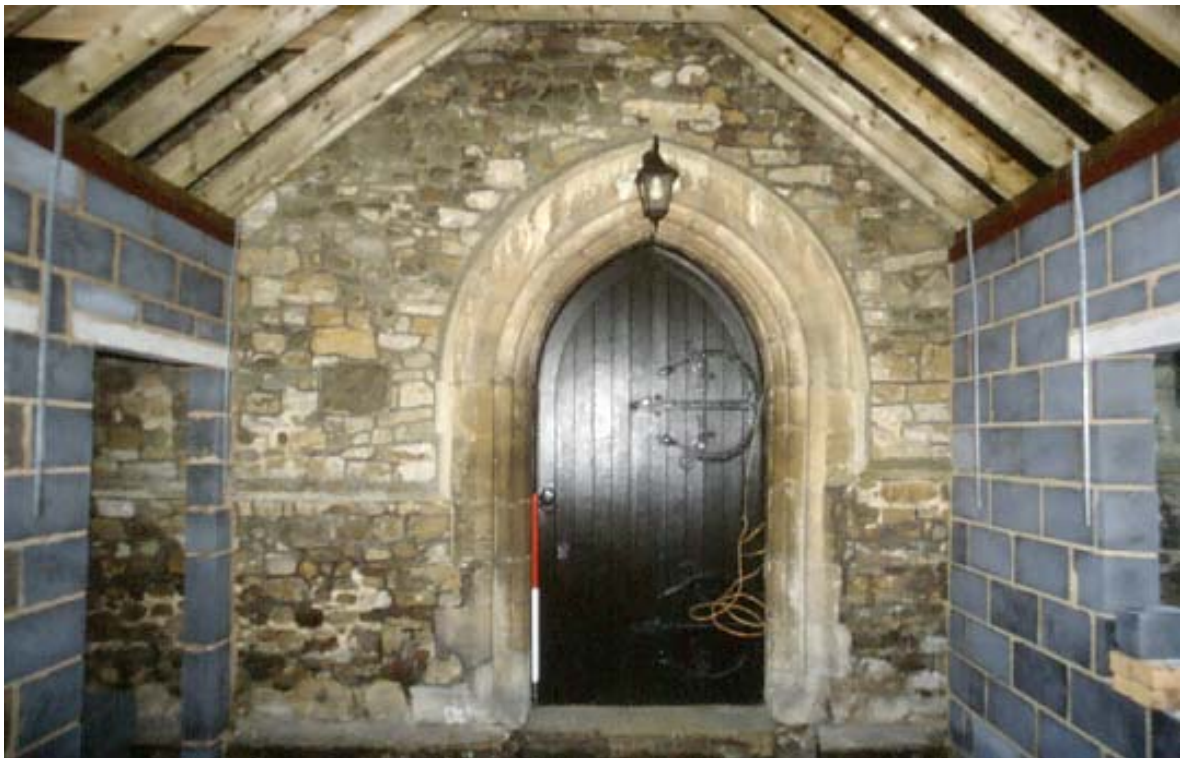
Figure 2 Northern wall and door.

The photographic survey provides a permanent visual record of that part of the north wall affected by the construction of the new porch and of the north door prior to its relocation. Construction work on the new porch had already commenced when notification was provided and the first site visit was made (*Figures 2 & 3*). The re-used Anglo-Saxon stone in the north wall above the new porch was not affected by the development work (*Figure 4*). A visual inspection of the north wall indicated that no other early stonework was impacted upon by the new porch.

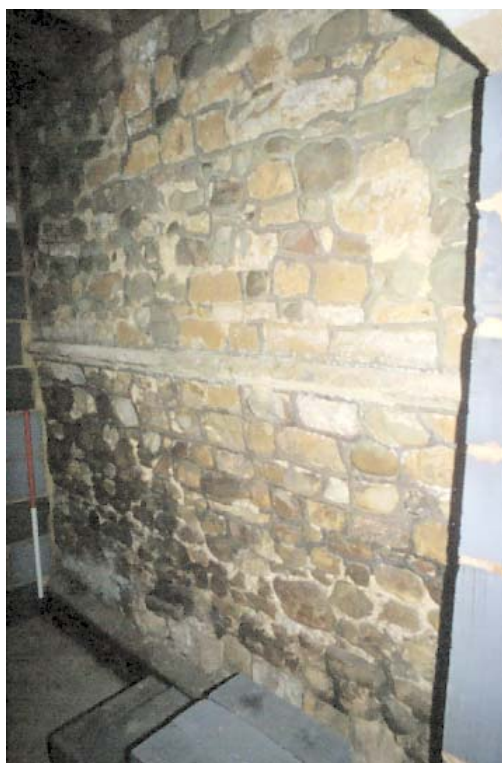
Figure 3 Northern wall.

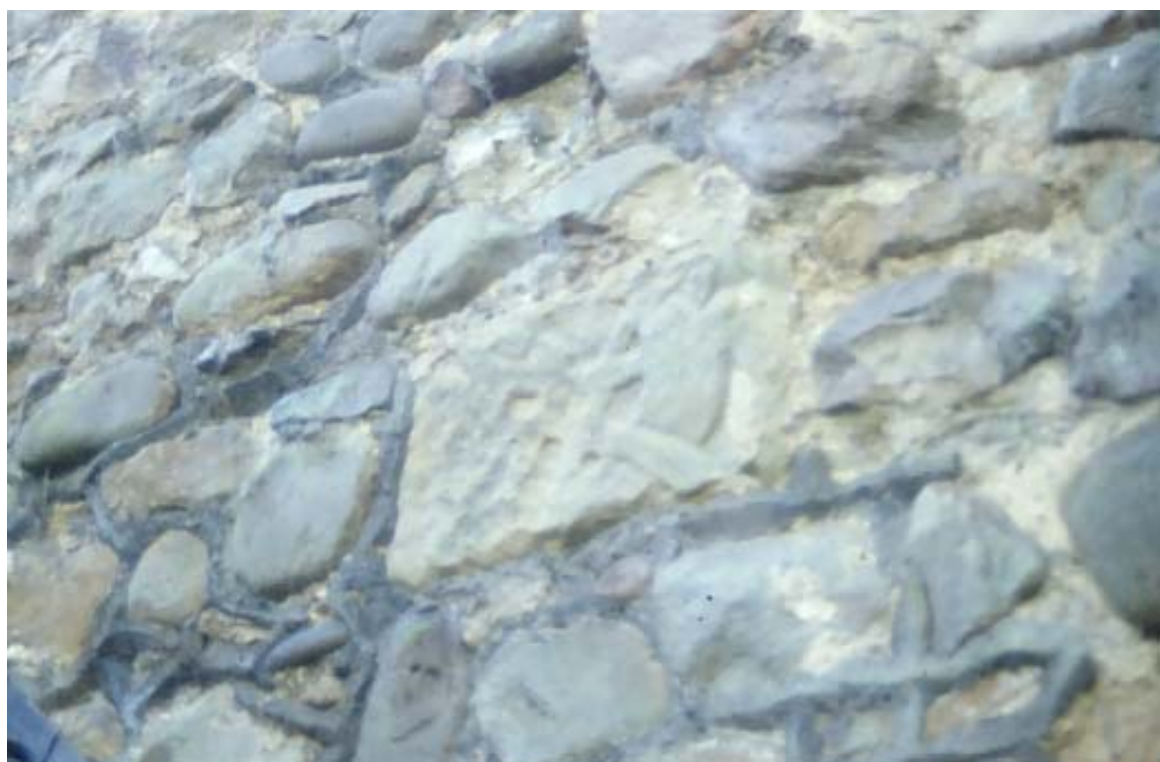
Figure 4 Detail of Re-used Saxon Stone in North wall.

The photographic survey produced a permanent visual record of the external elevation of the north aisle prior to it being partially concealed by the new porch. Construction of the porch did not affect the reused Anglo-Saxon stone incorporated into the north wall of the north aisle and no other early decorated stonework was identified in this wall.

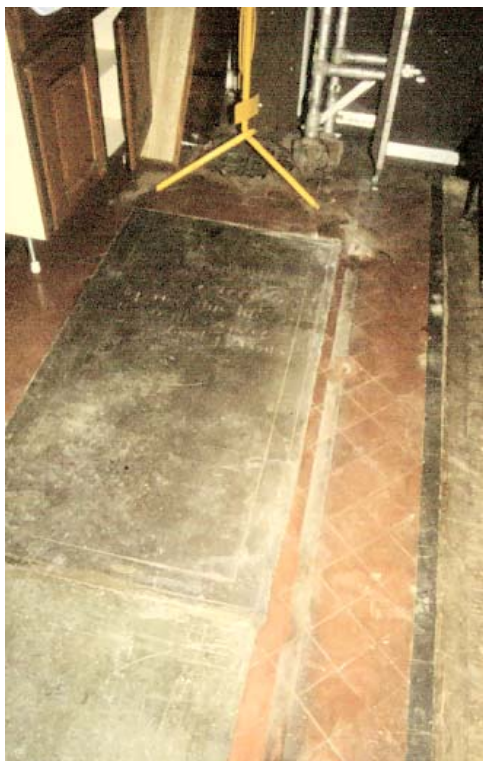
Slab 1 Western Slab

*_nn the wife of
_____odgkin
departed this life
the 6 of October
1727 aged 45 years
_____*

Figure 5 Westernmost Grave Slab (Slab 1).

Internally, there were two grave slabs within the north aisle which it was proposed to conceal beneath the new suspended floor of the proposed kitchenette area. A photographic record and location plan was made of these slabs (*Figures 5, 6 & 10*). The inscriptions on both slabs were badly worn, with only a few legible fragments remaining:-

Although worn there are two identifiable names ending in "odgkin" and it can be assumed that this is the name Hodgkin. The Victoria County History records a Green Hodgkin as an important landowner at the time of the 1758 Enclosure Act and notes that there were formerly numerous inscribed floor slabs within the church dating from the 18th century, many of which were taken up and used to pave the tower in 1876 (VCH 1964, 102-112).

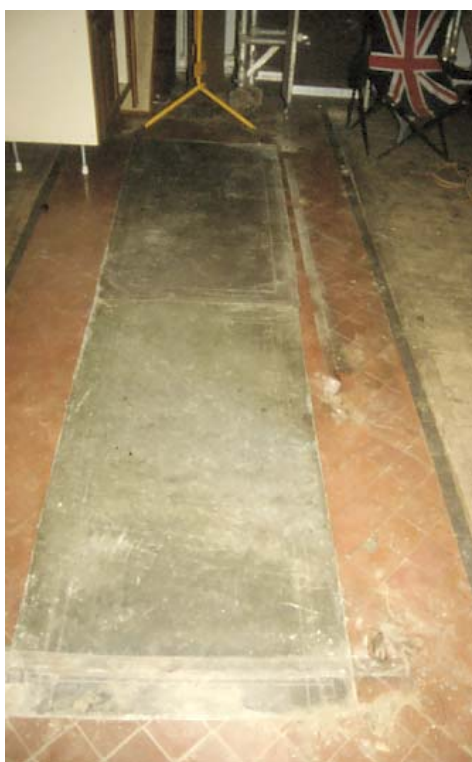
Slab 2 Eastern Slab

*Illegible
_____of
Illegible
____dgkin
who departed this life
the ___day of February
(Numbers) in the
_____of life*

Figure 6 Easternmost Grave Slab (Slab 2).

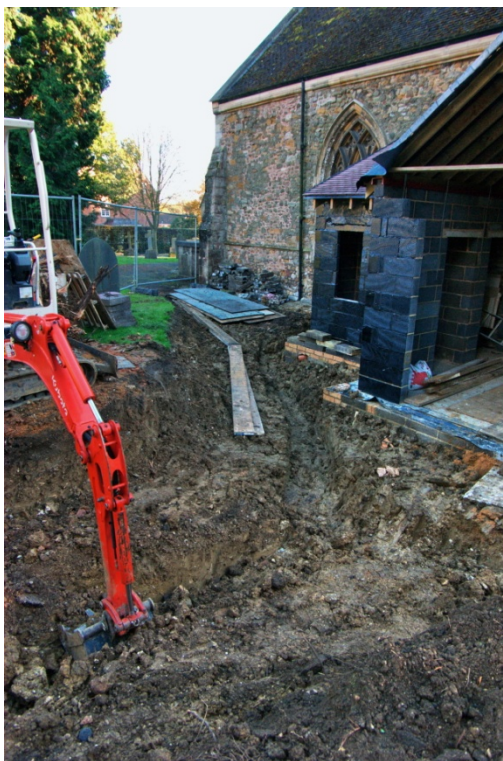
Ground level around the porch was reduced by between 300mm and 500mm. Approximately 300mm of topsoil overlay the weathered bedrock substratum of yellow brown boulder clay. Nothing of archaeological significance or any burials were observed during this phase of work. Further service trenches were excavated below this level; these trenches were approximately 300mm deep (approximately 700mm below former ground level) and cut into the boulder clay. Once again no burials or other features of archaeological significance were observed.

Figure 7 External Groundworks (looking east-south east).
