An archaeological watching brief at The Manor, Donington Le Heath Coalville, Leicestershire SK 422 127

ULAS Report Number 2008-009 ©2007 X.A.233.2007

An archaeological watching brief at The Manor, Donington Le Heath Coalville, Leicestershire (SK 422 127)

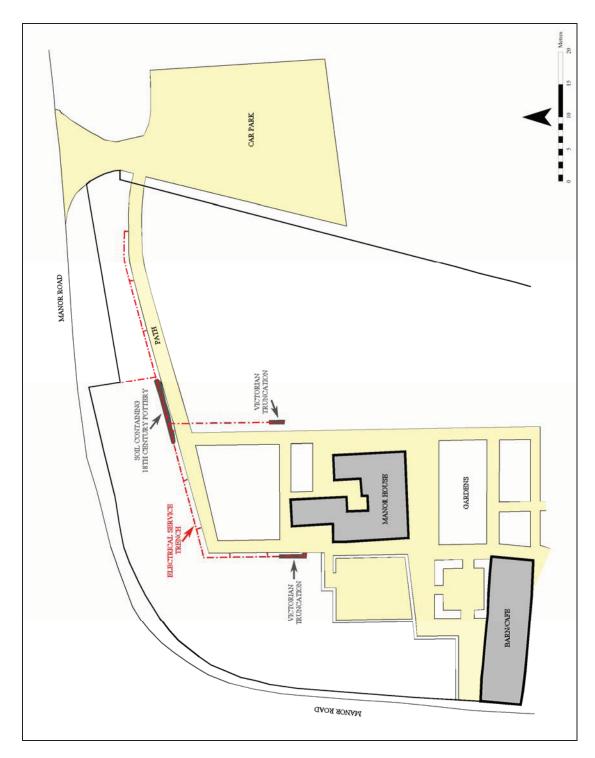
Figure 2: Plan of the Manor grounds showing the location of the service trench and exposed features

Only three areas of the work produced results differing from this sequence of natural beneath topsoil/turf. At the southern end of the eastern and western north-south trenches, shallow cuts, c0.45-0.5m deep, were observed cut into the subsoil (figure 2). The northern edge of these was present in both trenches but the other three sides extended to the south, east and west beyond the edge of excavation. The cuts were both filled with a very dark brownish-grey sandy silt containing stone, pebbles, grit, charcoal, broken brick, glass, clay pipe and Victorian china. The backfill within the western truncation capped further thin fills of charcoal and ash. The third area of difference was a spread of soft dark greyish-brown silty soil, 0.2m thick, capping the subsoil beneath the topsoil/turf (figure 2). The western edge of this began c.25m north of the Manor House's north-east corner and spread 11m to the east. It contained six sherds of late 18th century earthenware and modern stoneware weighing 164g (pers. comm. D. Sawday and which was discarded after identification) and appeared to be present only over the rising terraced ground.

The work involved the inspection and recording of hand-excavated trenches extending north from the north-west and north-east corners of the manor house to connect with a trench running approximately east-west extending towards the car-park in the property's north-east corner (*figure 2*). These trenches were no greater than 0.3m wide, 0.4-0.5m deep and were, in total, c.97.5m in length. They were excavated parallel with the existing paths, offset 0.5m to the north and west. Along the western length, three short branches, 6m apart, extended east to connect with the path. These were dug to similar dimensions to the main trench. A further seven branches, spaced 8m apart, extended south from the east-west length.

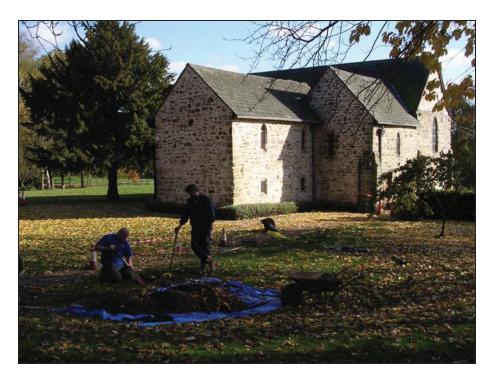
Figure 3: General view of the site, looking south-east, showing the excavation of the western north-south trench.

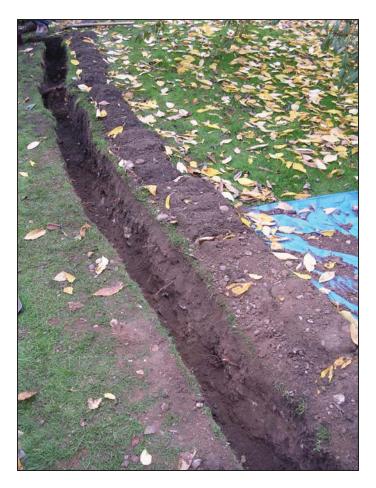
Figure 4: View of western north-south trench, looking south. the subsoil can be seen in the foreground whilst the darker soil to the back represents the Victorian truncation.
