**A further Archaeological Evaluation and
Watching Brief at
Newtown Linford Lane,
Groby, Leicestershire**

SK 524 075

ULAS Report No 2008-055

A further archaeological evaluation and watching brief at Newtown Linford Lane, Groby, Leicestershire

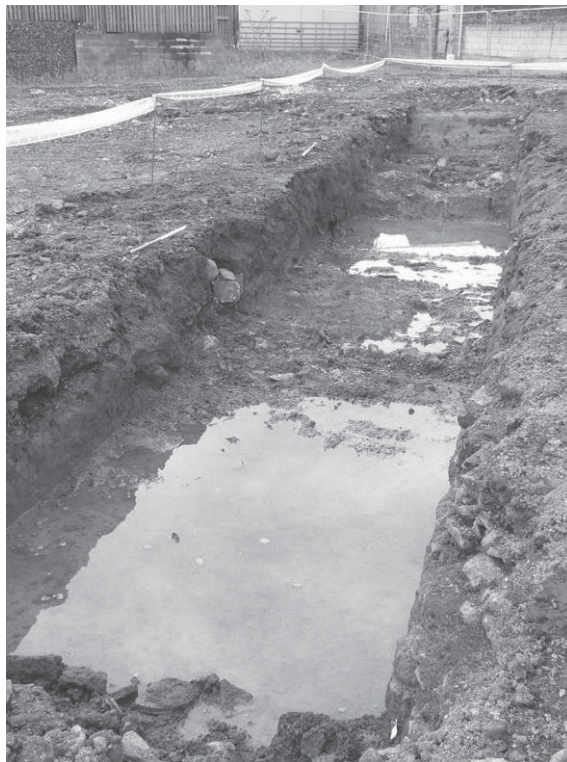
Figure 6 Evaluation: Trench 6, looking SW

Measuring 17m by 2.1m, trench 6 covered an area of 38.8 m², and was orientated south-west/north-east across the footprint of the southernmost demolished industrial unit (Figs 2 and 6). A thin skim of modern stone chippings and hardcore covered most of the trench area. Beneath this, to the south-west end of the trench, there was an expanse of disturbed demolition debris, consisting mainly of slate rubble and sandstone, with some brick fragments (Figs 3 and 4). To the centre and east end of the trench was a more homogeneous red-brown clay soil; this however was not undisturbed natural as was seen from the presence of occasional fragments of masonry, ceramic building material (CBM), and common charcoal flecks. This deposit had been cut into (or possibly not, see below) by three land drains aligned roughly north-west/south-east running across the trench. Two of these land drains were of an unusual construction not previously encountered by the author, consisting mostly of slate rubble and sandstone masonry within a clay matrix, together with some granite rubble and occasional CBM (Fig. 7). One large piece of what appeared to be Dane Hills sandstone (a Leicester building stone) indicate that at least some of this material may have been brought onto the site from elsewhere. There was no structure or bonding; these materials appeared to have been dumped randomly into position, and there were several outliers off-line from the main run. No cut was visible

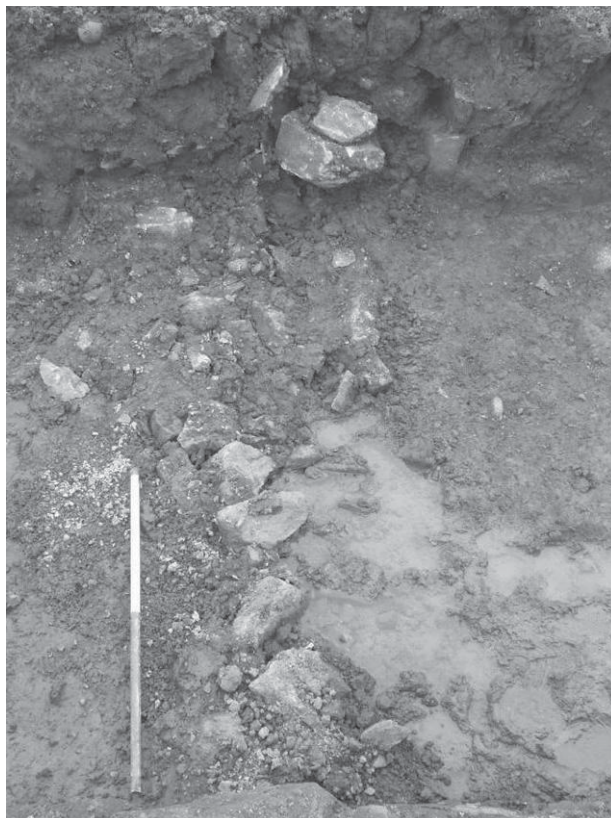
Figure 7 Evaluation: Trench 6 stone filled drain, looking SE

in the baulk sections. Both of these drains had 'sink-holes' above them which consisted of a dump of modern small stone chippings which reached up to the surface, implying that they were visible during the construction of the overlying buildings and were utilised. Taking into account the fact that the surrounding clay soil was not undisturbed natural, even at 1 metre depth, there was no visible cut, and the construction appear to be haphazard, another possibility is that the whole area was built up artificially and the drains roughly created by earthmoving equipment in advance of the construction of the recently-demolished building. This may have been to counter groundwater problems, as the central and eastern parts of trench 6 flooded during machining as these drains were disturbed. Only the top of the (lower) third drain was visible, it was disturbed during the machining but appeared to have consisted of angled slate slabs set on end. The clay fill was in parts a slightly different colour to the surrounding clay deposits, this may have percolated into the drain throughout its use. Presumably slate slabs would have covered it originally. This feature may represent an earlier drainage attempt.

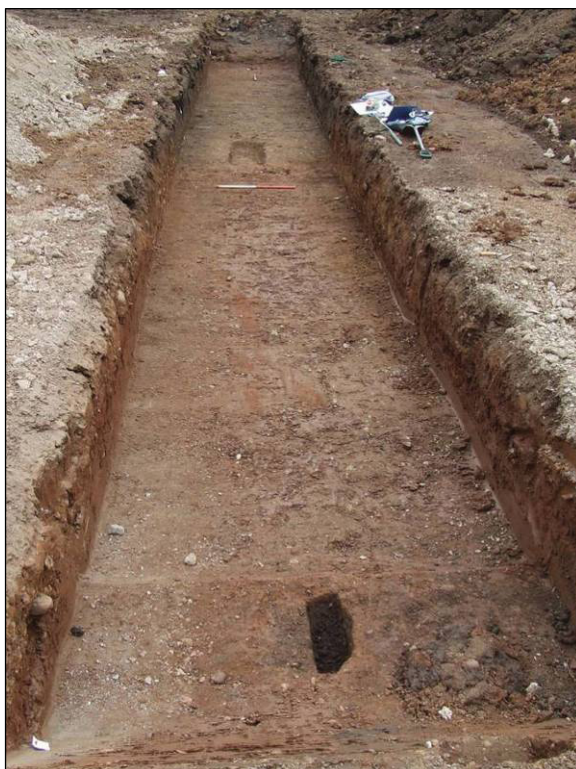
Figure 8 Evaluation: Trench 7, looking SE. Half sectioned post hole in foreground.

4.2.1 Trench 7 was 2.1m in width and originally machined to a length of 21m. It was orientated north-west/south-east across the footprint of a demolished industrial unit (Figs 2 and 8). A layer of modern stone chippings and make-up extended the length of the trench. At the north-west end, a dark sub-square feature was encountered; as the fill appeared very dark, and the appropriate level for machining had not had an opportunity to be established, the upper part (c 15-20 cm) of this feature was machined off; but when it persisted the machining was stopped and the trench base left high. On excavation this was revealed as a vertical-sided post hole, with a charcoally clayish fill (Fig. 8). Pieces of Swithland or Groby slate at the base had been wedged into the south-eastern side of the cut, and the feature appeared undercut at this side; it is suggested that the slate originally lay at the base of a post and was displaced on its removal (Fig. 9). No dating evidence for this feature was recovered.

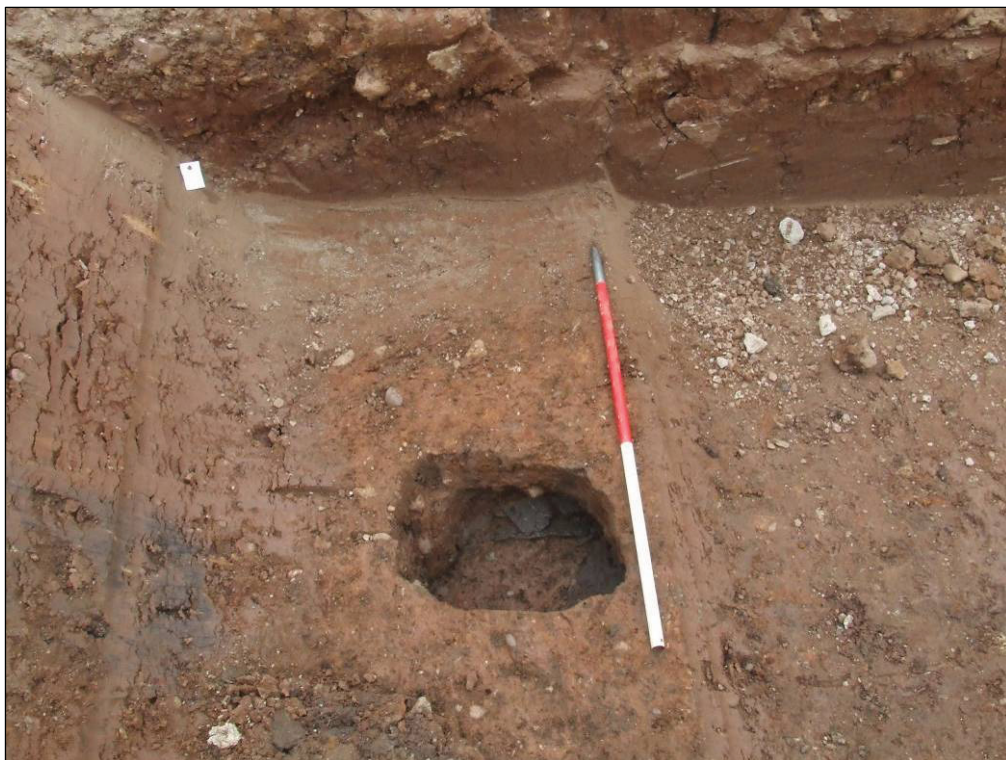
Figure 9 Evaluation: Trench 7, excavated post hole showing slate to base, looking NE

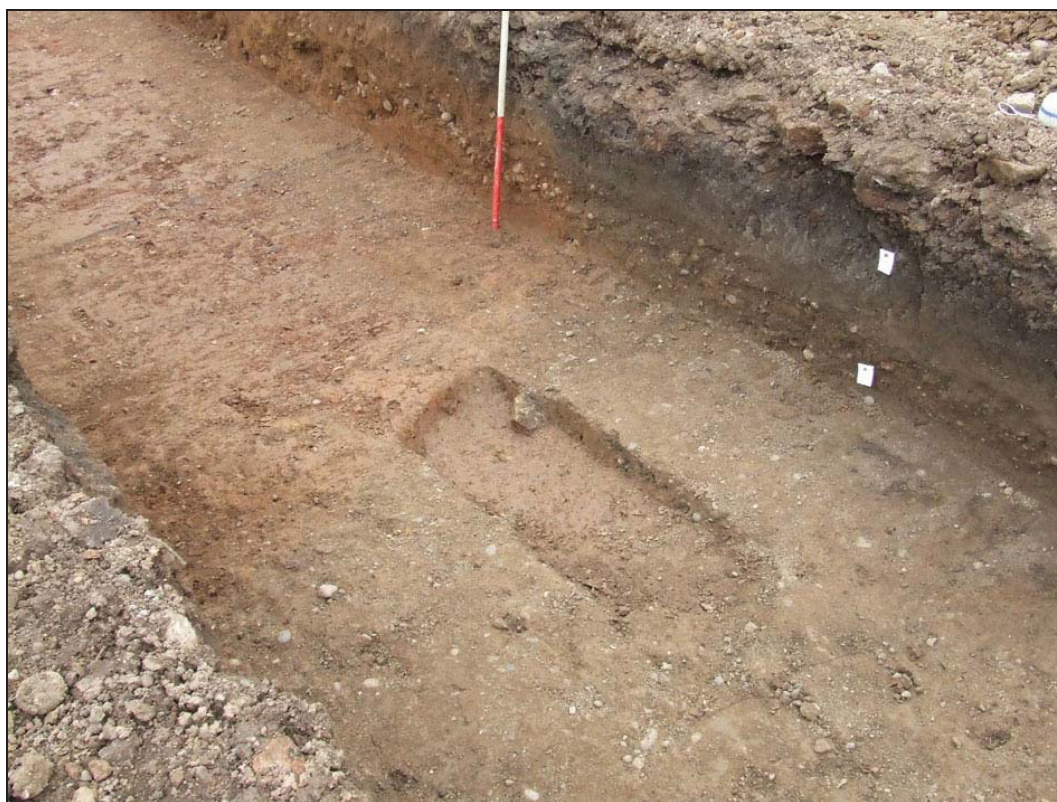
Figure 10 Evaluation: Trench 7 NW edge of silty feature and small sondage, looking N

4.2.2 The trench was then stepped down to the full 1 metre depth immediately past the feature (Figs 3 and 4). One edge of a large grey silty clay feature [32] was encountered approximately half way along the trench (Figs 10-12). This was assumed to be a continuation of the feature seen in trench 2 to the north. In an effort to establish depth and profile, this was machined through until the full 1 metre depth allowed for by the risk assessment had been reached. This feature carried on along the entire length of the trench, abruptly finishing at the south-east end of the trench with a curious vertical junction to a dark reddish-brown clay soil. Examination of this dark clay soil revealed that this was not likely to be undisturbed natural: some sandstone fragments and common charcoal flecks pointed to redeposition. No sign of a base was evident by this depth, although there appeared to be a possible differentiation in fill as the north-west side of the feature appeared lighter, more silty and with more pebbles than at the centre and south-east end. Two small hand-dug sondages into the fill showed that although the fill at the north-west end was shallow

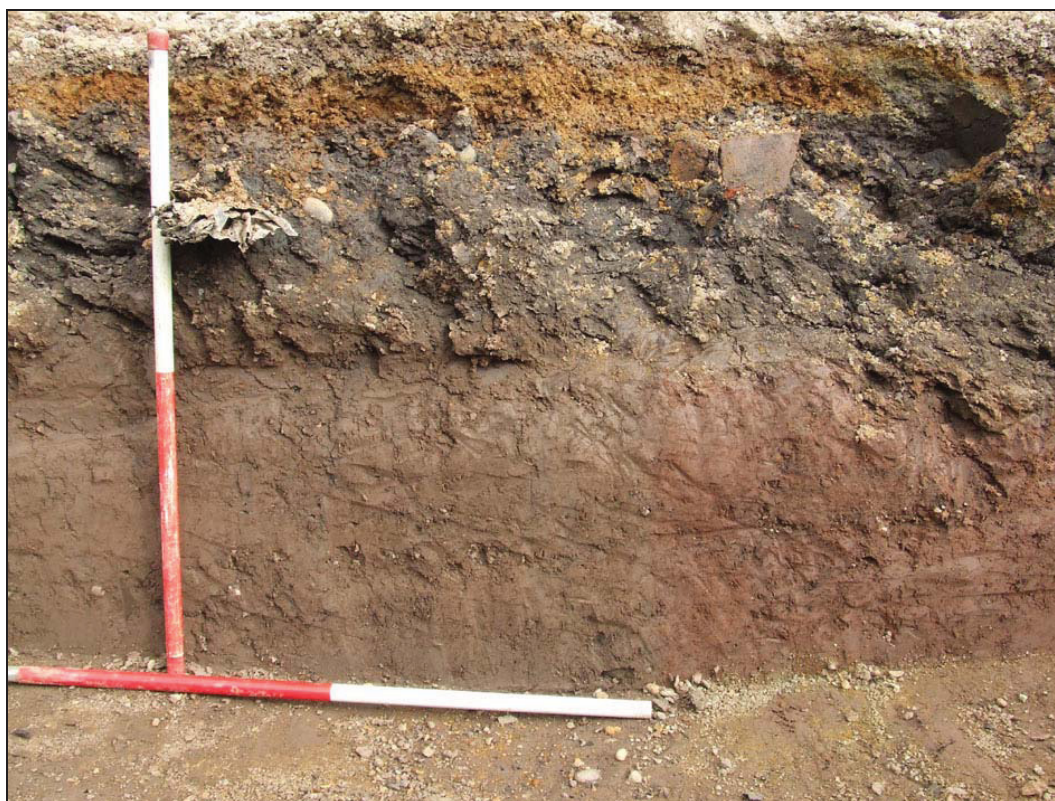
Figure 11 Evaluation: Trench 7, SE edge of silty feature, showing apparent vertical junction. Looking N

and pebbly, a more clayish, greyer fill [34] existed further to the SE which was not bottomed. Sherds of Potters Marston were recovered from this second fill [34] showed it to have been deposited some time around the 12th to mid 13th century.

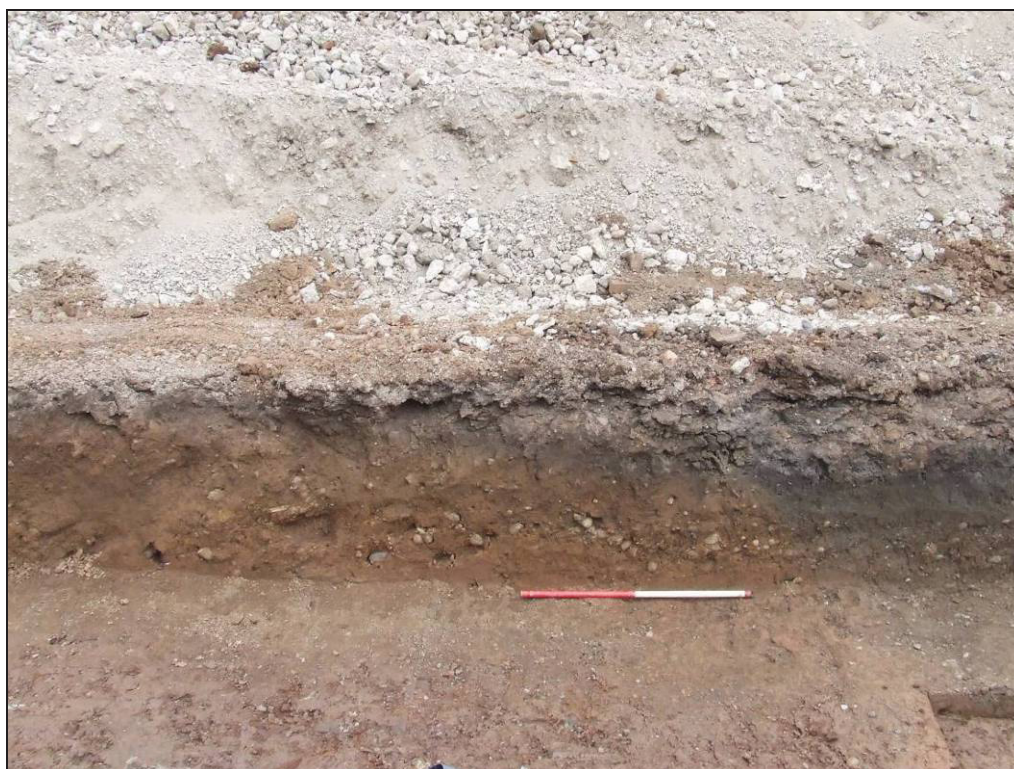
Figure 12 Evaluation: Trench 7, layer of pebbles etc NW of feature cut. Looking NE

4.2.3 No other features were noted in the trench with the interesting exceptions of a layer of pebbles/small cobbles noticeable in the lower baulk section immediately to the north-west of the feature cut, and an *in situ* horseshoe ceramic land-drain sitting high up in the baulk on the junction of a stony clayish soil and more homogeneous reddish clay layer. As these drains were always dug in well under any cultivation layers so as to avoid plough damage, this drain probably gives an indication that a considerable amount of original land surface has been truncated off this part of the site. The abrupt drop of *c* 2m between the land surface to the west and east of the nearby property boundary also supports this hypothesis.

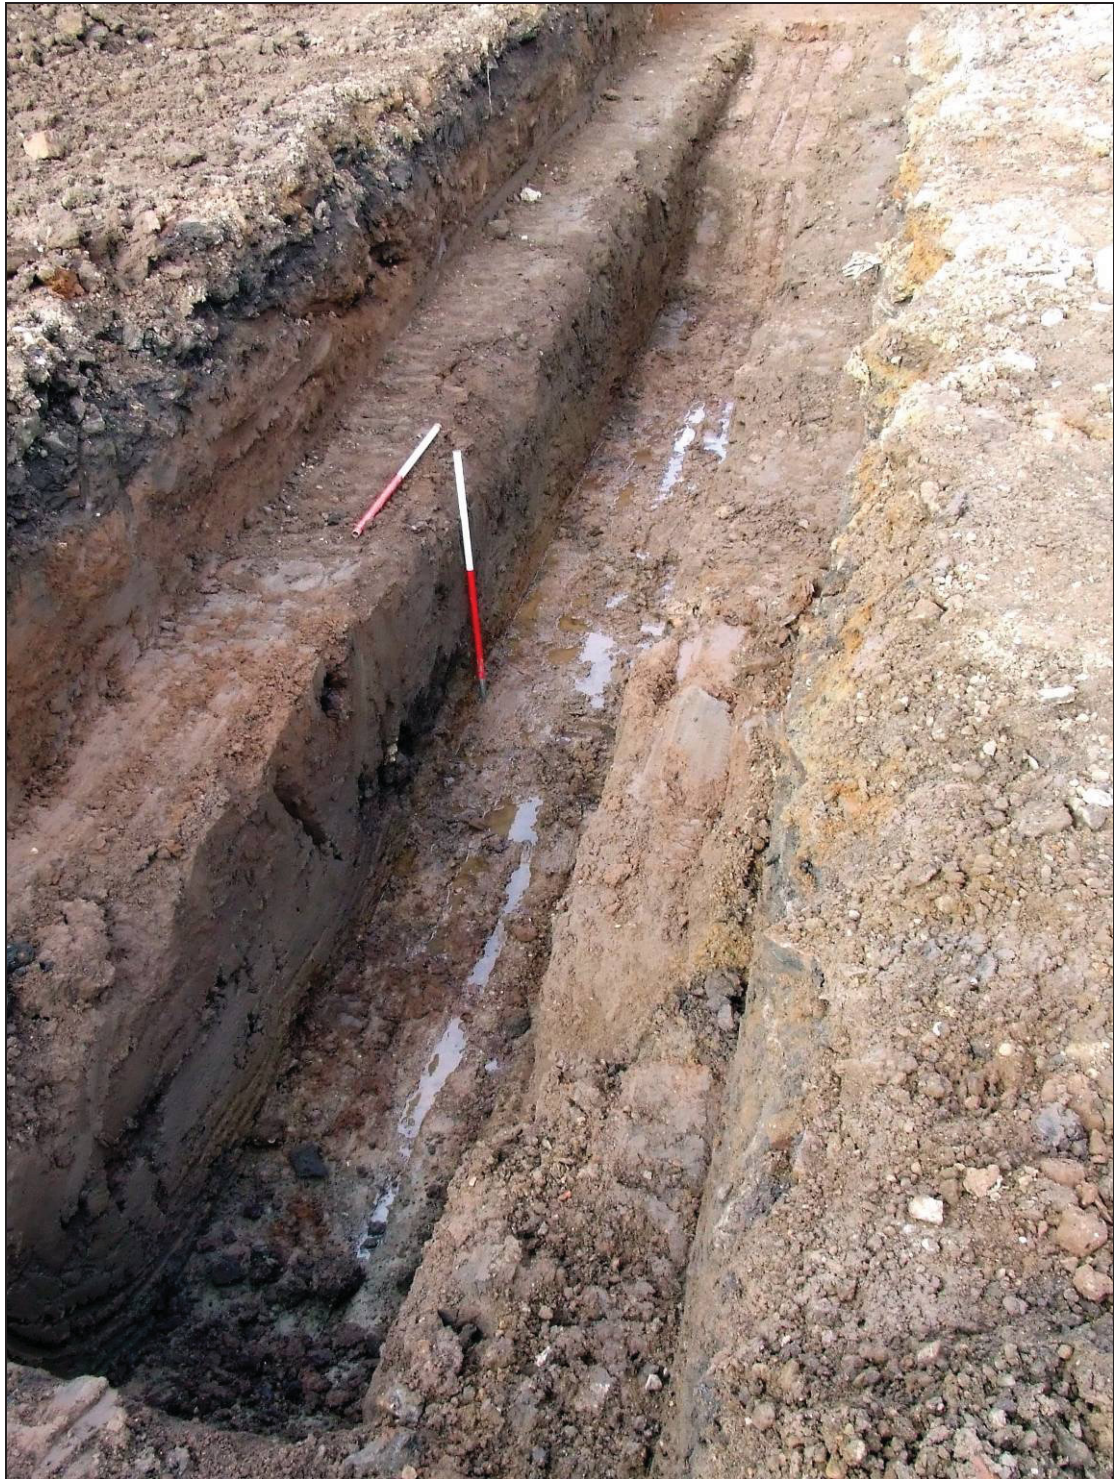
Figure 13 Trench 7, Evaluation: extent of re-machined feature. Looking W

4.2.4 After a visit from the archaeological adviser to the Planning Authority, it was decided that, if possible, the full extent and profile of the large silty clay feature be defined by means of a slit trench within the base of the trench as excavated. Although the risk assessment noted potentially unstable ground and the risk of flooding, the baulk sections of the trench appeared stable and no flooding was occurring, even though the base of the trench was below that of the flooded trench ten metres to the south. A mini excavator was used to excavate a 0.80m wide slit trench through the silty feature (Fig. 13). This succeeded in establishing the depth of the feature, revealed several fills, but unfortunately did not establish its full extent: the vertical junction with the dark reddish brown clay soil at the south-east end was shown to be misleading, in that it represented a large dump of redeposited material with a circular ceramic land drain in its base. This had cut the feature fill, which continued to the south-east. Although the author would normally consider circular ceramic land drains to be unlikely to date later than the early 20th century, the vertical cut and large volume of redeposited soil point to the use of mechanical excavators, indicating a later date. The remainder of the feature fill was chased for another 1.5m before the main north-south sewer running across the site was encountered, ending further machining. The very base of the feature started flooding after machining. In all, the total depth of the feature was *c* 2m from present ground surface.

4.2.5 The lowest fill of the feature was a largely sterile grey to beige-coloured clay or sandy clay, which appeared to have little organic matter. However, above this was a more organic sandy clay fill [33] which contained common charcoal, and bone fragments, which appear to have been waterlogged for some time after deposition, although the deposit was not waterlogged at the time of excavation. This fill was sampled, and a single sherd of pottery (SF50) was recovered, of a similar date range to the Potters Marston in the context above. Due to concerns about stability the baulk section of the slit trench was planned from above using an EDM rather than by hand.

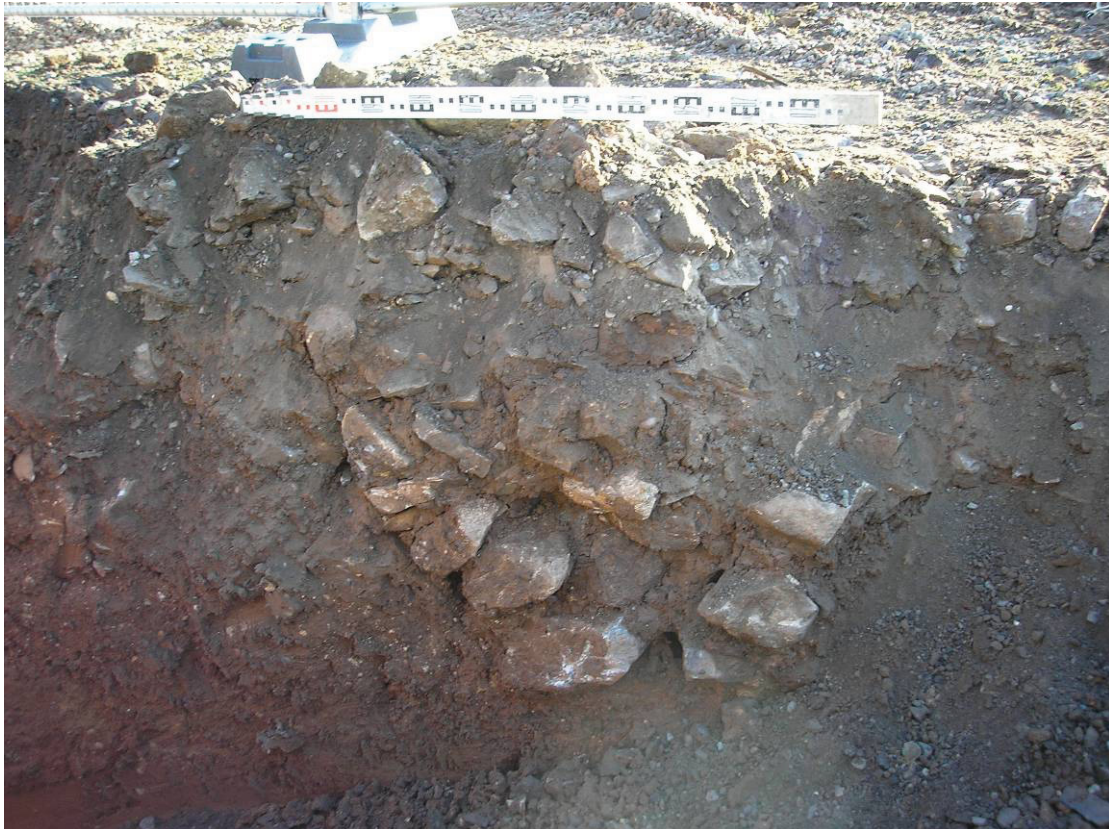
Figure 16 Watching brief: Section 2 showing wall 1

5.4 At 4.50m south of M4, at the western area of the trench, **Wall 1** was located at a depth of 0.20m and cut a red brown clay make up layer. It had a width of 1.10m and ran east-west across the trench, then turning to the north at the western face of the trench. The wall appeared to have collapsed in places, as seen in section 2 (Figs 15 and 16), and was constructed of granite with a red clay bonding, and had a depth of 0.60m. Further south at manhole M3, **Wall 2** was seen in the western section of the manhole running north-east – south-west at a depth of 0.40m from present ground level and cutting silts of fish pond 2, this was 0.80m wide and 0.40m in depth, and was constructed of granite with a mortar bonding (Fig. 17).

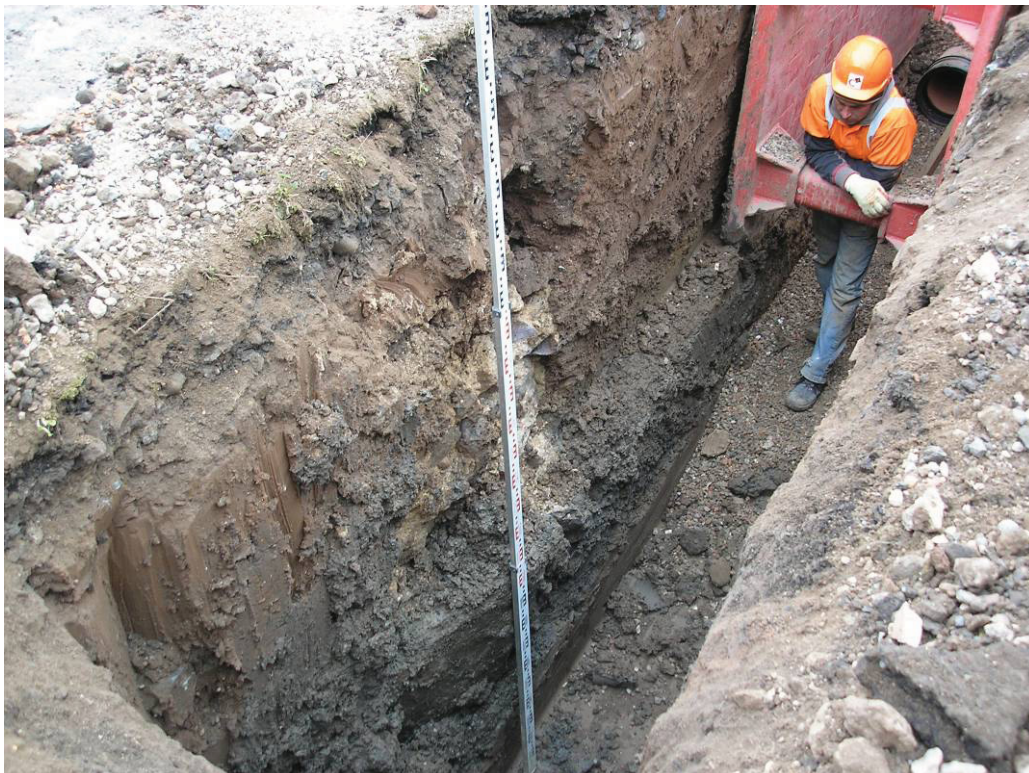
Figure 17 Watching brief: Showing wall 2 above pond silts

6.3 The watching brief on the sewer line confirmed the presence of the probable fishponds, but failed to provide any firm dating evidence for them. Also located were two east-west linear ditches which also lacked any dating evidence – containing only animal bone fragments in the fills – but were presumed to be of the medieval period. They may have may have been boundary ditches, but it was unclear if the ditches were associated with the motte and bailey castle to the west. Two walls were also encountered. Wall 1 may have been part of a medieval boundary wall extending east, and lining up with a similar wall seen in evaluation trench 4, but this is purely speculative. Wall 2 could have been part of a dwelling or smaller structure but not enough was seen to be sure of this, although it appeared to be of a later date than wall 1, probably post medieval in date.

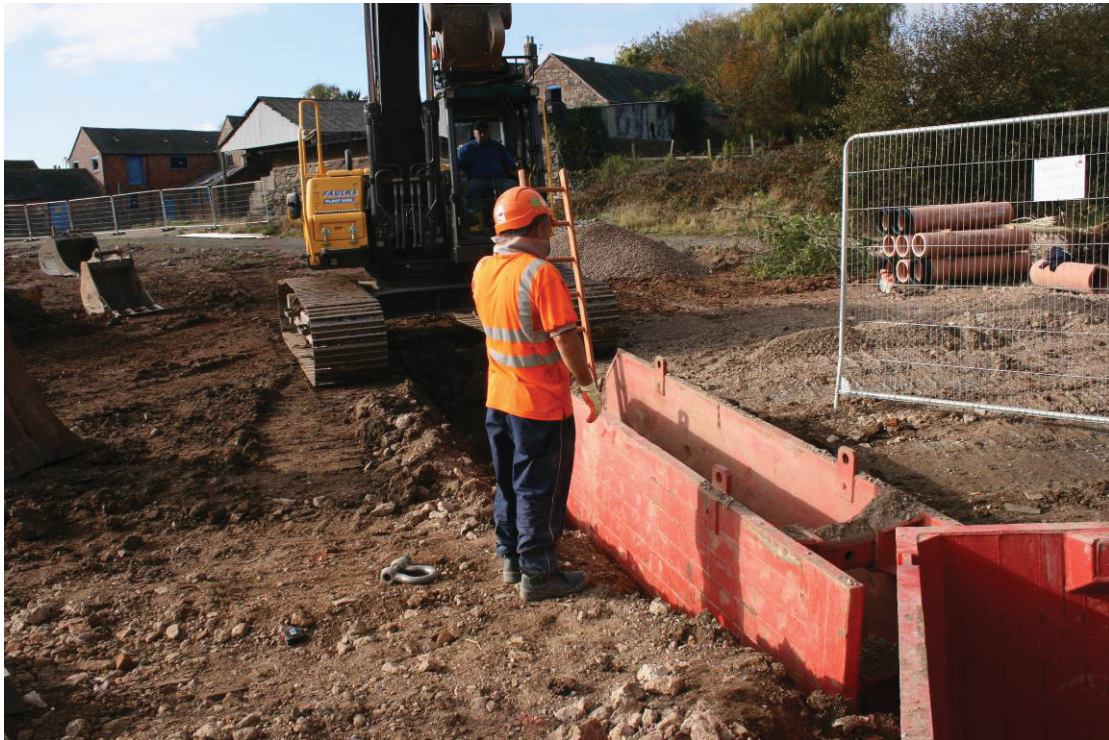
Figure 18 Watching Brief: View looking S/W from manhole 5

5.1 The main impact on the site from the development proposals was the re-routing of the main sewer, located at the western area of the development (Figs 14 and 18). This had a length of nearly 100m, a width of 1.00m, and a depth of 2-2.50m. Also seven holes for manholes were excavated, each measuring 2.50m x 2.50m square. Due to the depth of these ground works, for safety reasons it was not possible to gain access to the excavations, except on rare occasions.

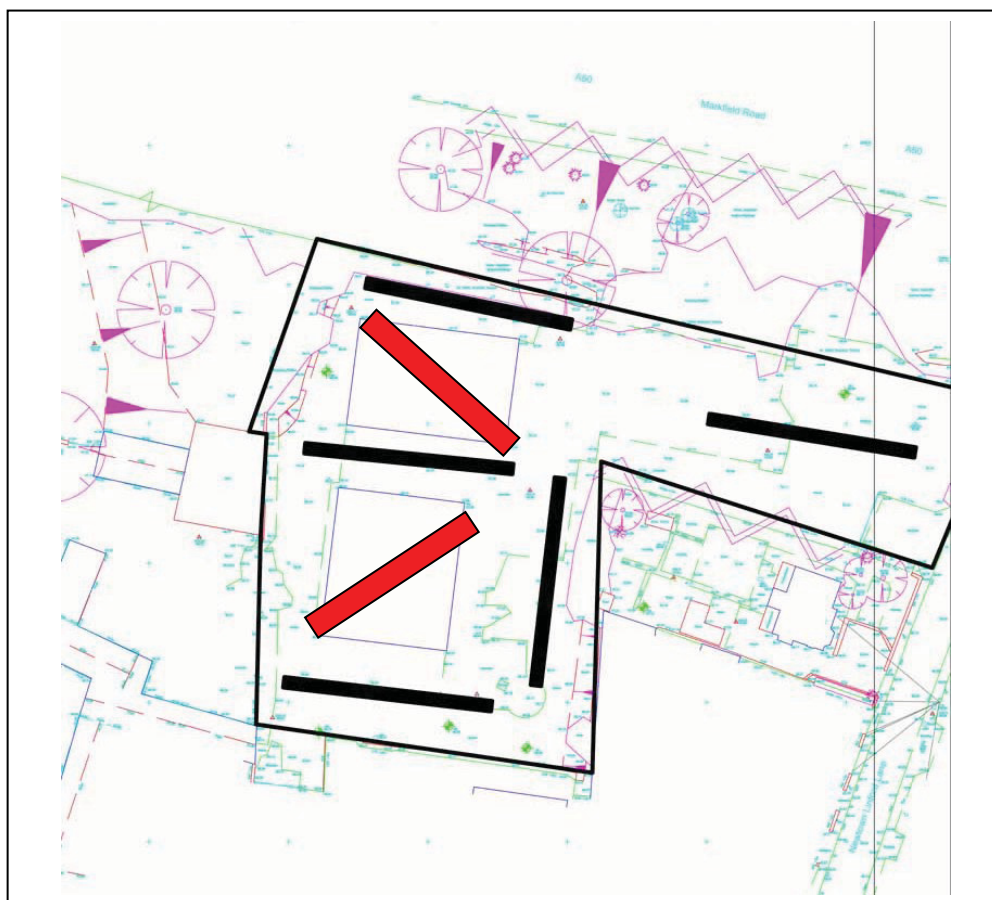
Fig 3. Proposed additional trench locations in red.
