**An Archaeological Watching Brief of groundworks
at Bath Lane, Welles Street, Holy Bones
and Vaughan Way, Leicester (SK 580 045)**

For: Leicester City Council

**ULAS Report Number 2008-120 ©2008
Accession Number XA98.2008**

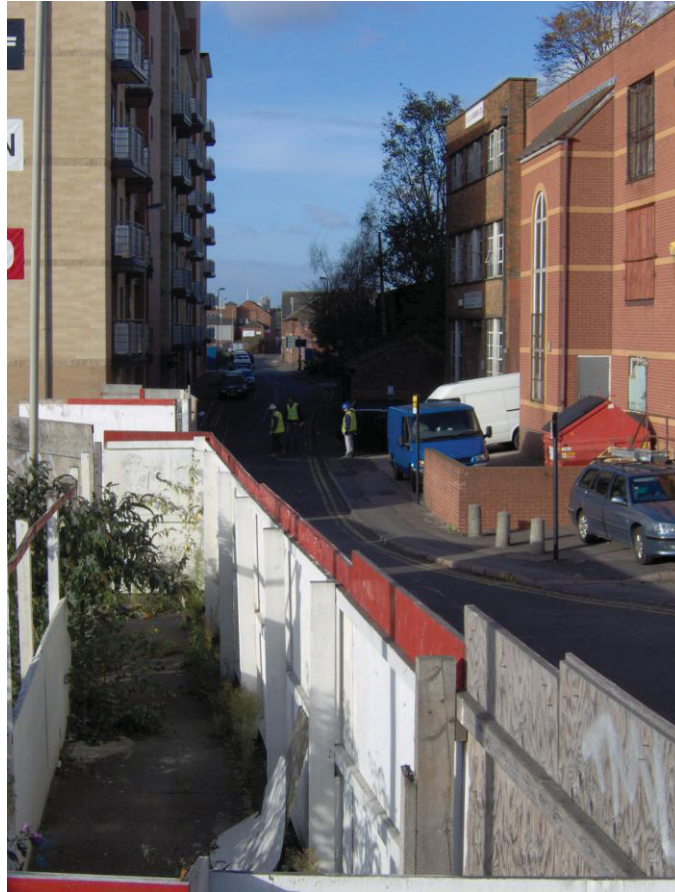
Figure 3: view north along Bath Lane prior to groundwork.

Groundworks for pavement upgrading and laying of CCTV cables involved the removal of the present made ground and surfaces and their replacement with new granite paving slabs set on thicker foundations (figures 3-4). The new formation levels rested at levels deeper than the current or normal pavement foundation levels. This greater depth accommodated deeper and thicker foundations, composed of successive new concrete pads, mortar gravel bedding mix and adhesive resins for the overlying new Chinese granite paving slabs. Initially this involved ground breaking of existing tarmac paving and associated concrete pads with a tracked mini digger using a 0.6m toothed and ditching buckets. Adjacent property frontages where these constituted road access ramps, extended pavement verges and edges of the street road surface were also affected by groundworks along the length of Bath Lane while parking bays at the south end were also affected.

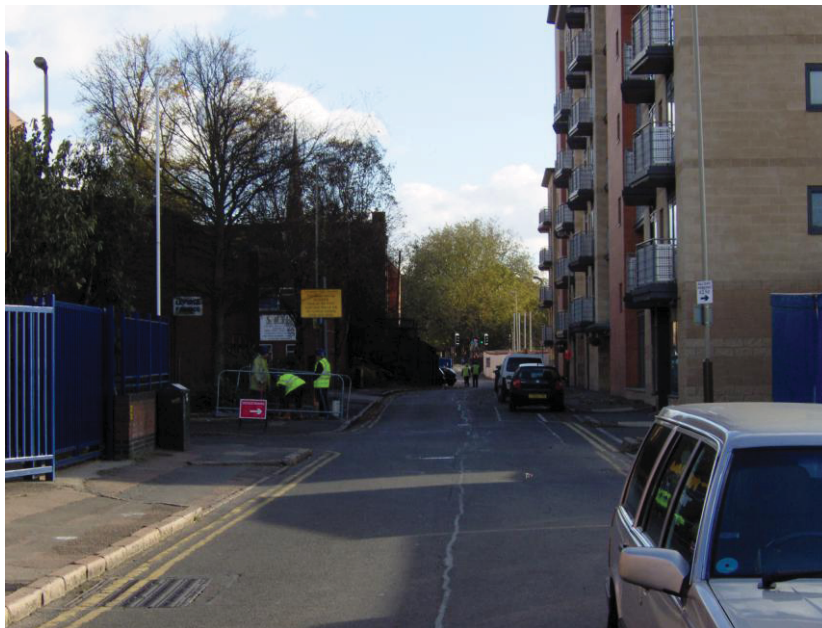
Deposits observed in sections of the CCTV ducting trenches suggested subsurface layers were modern made up ground for the depth observed.

Figure 4: View looking south along west pavement Bath Lane prior to groundwork.

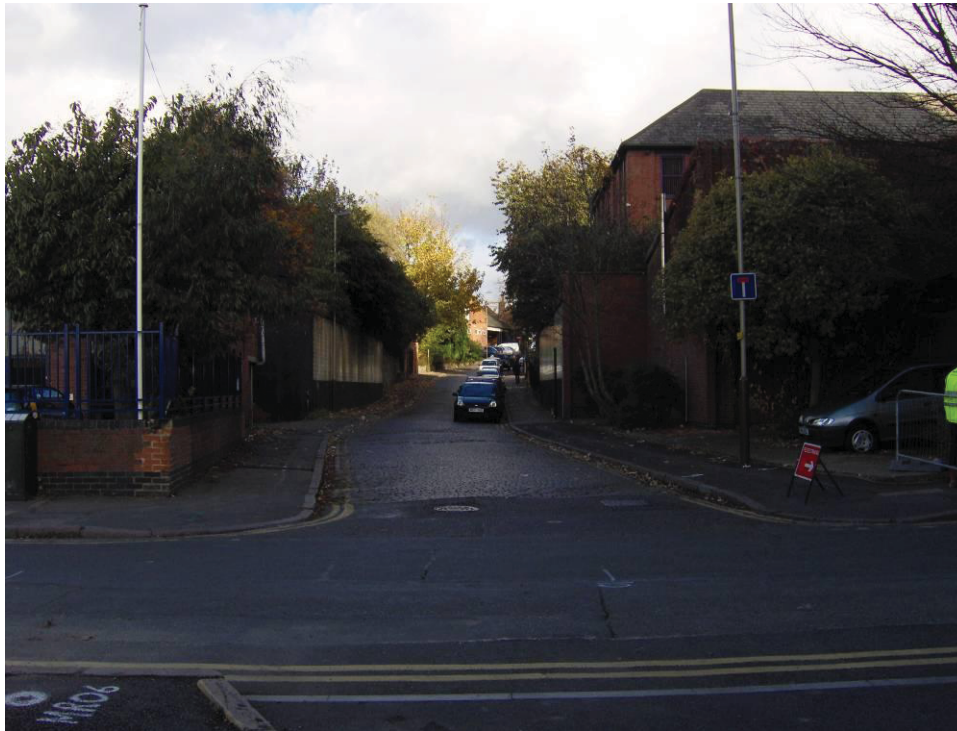
The CCTV ducting groundwork required a single continuous trench along the course of the pavements in the area from Bath Lane to St Nicholas Place, passing along Welles Street) ((Fig 2 B-C; Fig.5), along the north and east external edge of the graveyard boundary wall of St Nicholas church at Holy Bones (figure 6). A linear extended trench measuring 0.4m wide and min of 0.4m depth was excavated following prior test pitting along the length of the proposed circuit of ducting prior to archaeological attendance. This was excavated piecemeal on successive occasions along the length of the route of the groundworks.

Figure 5: view East along Welles Street prior to groundwork.

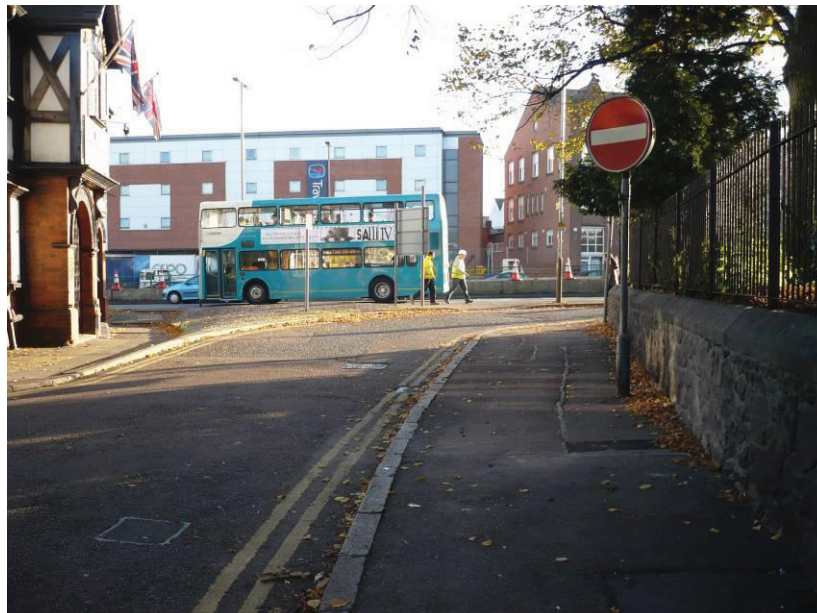
Figure 6: view east along Welles Street / Holy Bones towards Vaughan Way prior to groundwork

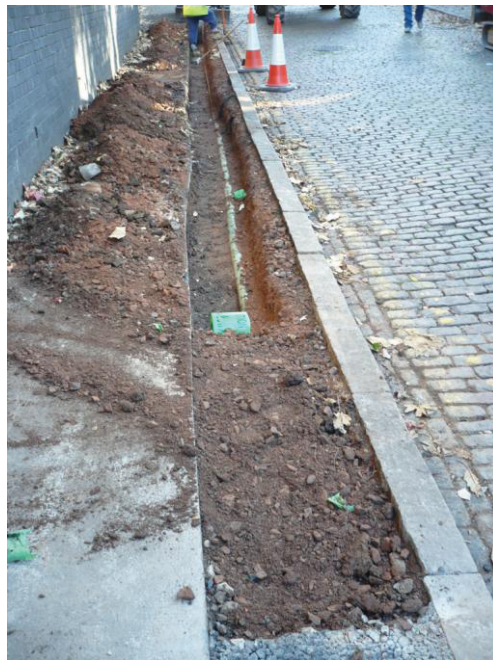
Deposits observed within the ducting trench were modern made ground layers of gravel and sands for contemporary pavement construction.(Fig 7). An anomalous deposit was observed 1m south of the north face of the railway viaduct within the trench base on the west side. This appeared solid and firm, directly beneath the make up of the pavement. The material constituted yellow mortar bonded to angular small granite blocks, approx 0.3, length x 0.15m width, reminiscent of Roman mortared walling and resembled the mortar excavated further north at the Vine Street excavation (Figure 8; Higgins 2007). The deposit measured approx 0.7m x 0.7m square and was cut down its centre by modern cables and to the north by ceramic pipe work. The confines of the trench prevented further examination and a CCTV access hatch was laid over the deposit, which remained in situ. This may represent the line of a wall, or mortar concrete dump, of uncertain date, orientation, function or origin.

Figure 7; Welles Street view east along west pavement at Bath Lane junction end following groundwork

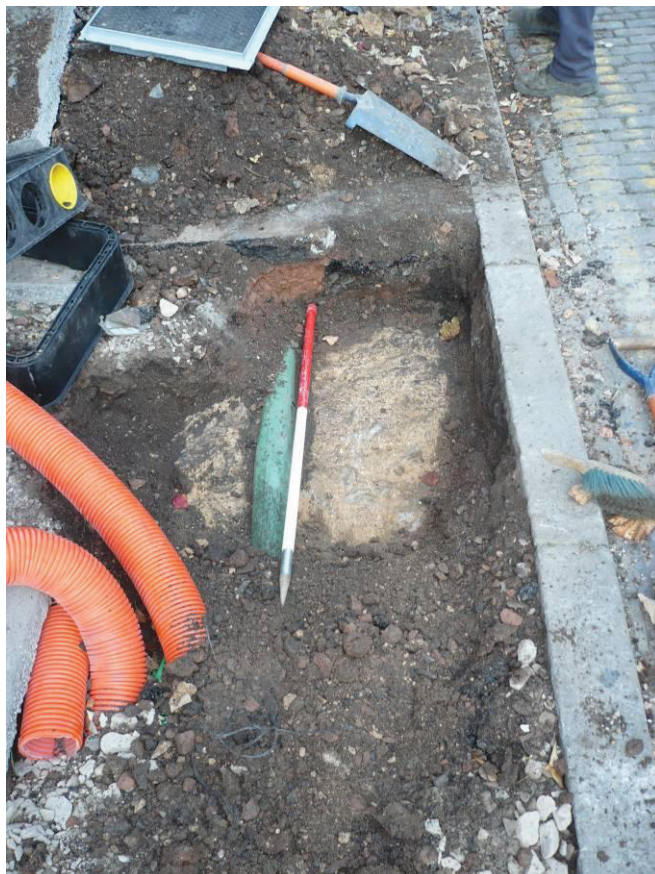
Figure 8: view east of deposit under CCTV access hatch

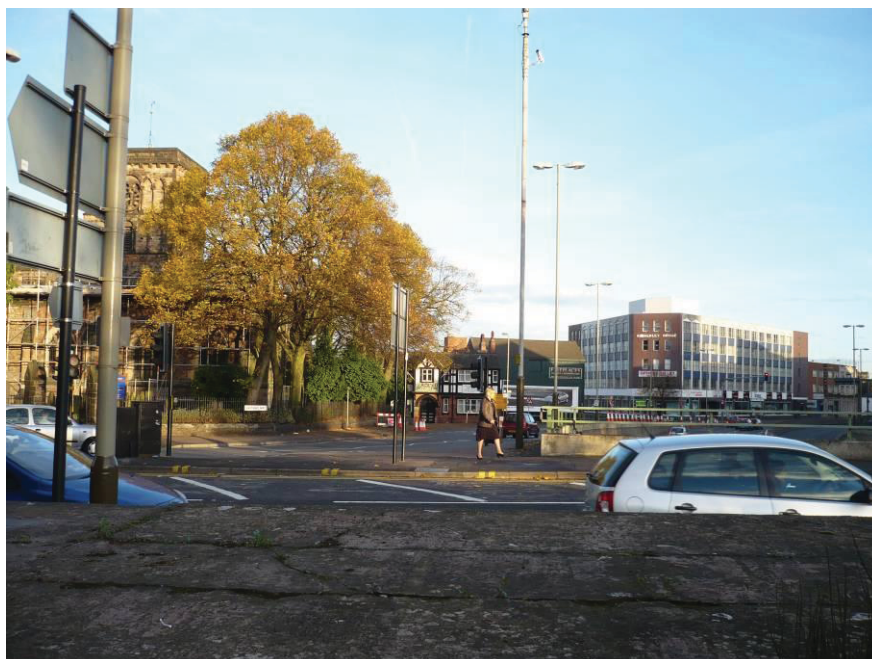
At the junction with Vaughan Way (figure 9) the CCTV trench turned south along the pavement parallel to the eastern perimeter of St Nicholas churchyard. At the junction with St Nicholas Circle it crossed Vaughan Way and continued in an easterly direction passing along the northern east / west pavement of St Nicholas place (Figs 2 and 10) .

Figure 9: View east along Vaughan Way / Holy Bones prior to groundwork

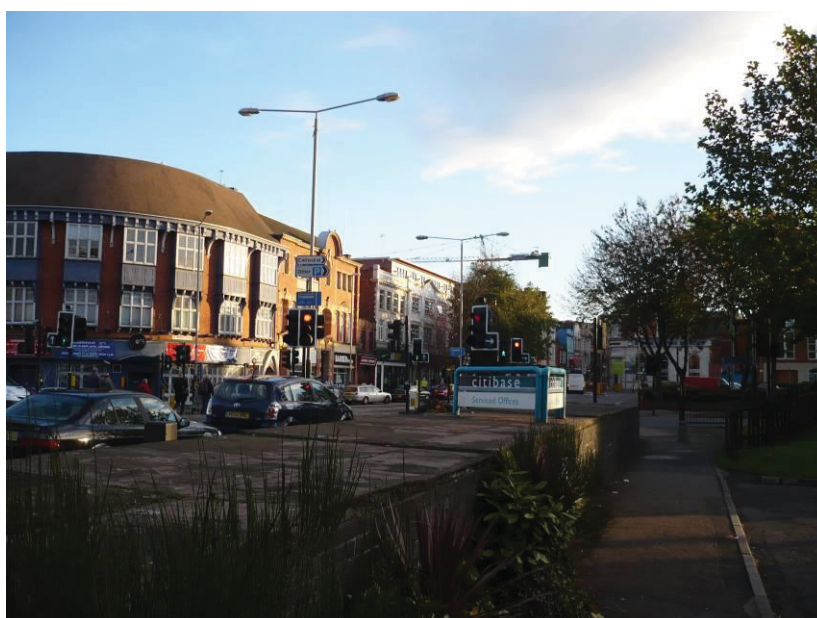
Figure 10 : View east along St Nicholas Place prior to groundwork.

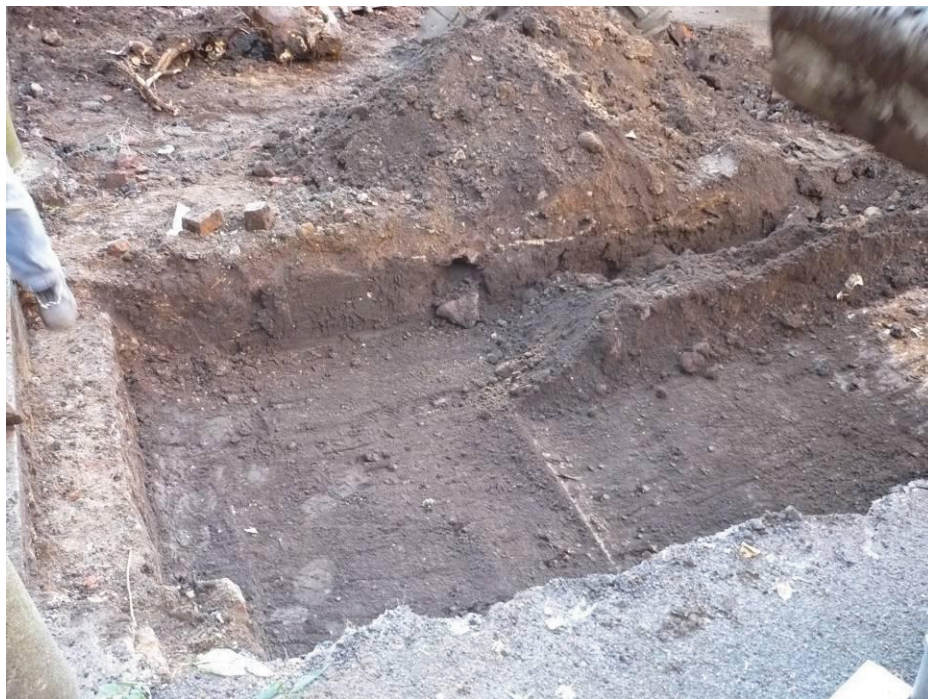
Below the modern made ground lay a mixed layer of brown silty make up 100mm in depth. Beneath these was a homogenous layer of black silty loam containing occasional animal bone, medieval pottery (appendix 1), occasional oyster shell with very small occasional mortar flecks. These appeared to constitute potentially well preserved late medieval deposits of garden soil from 150mm to a depth of 500mm from the modern ground surface. No other archaeological deposits were observed (Figure 11).

Figure 11: Deposits under east pavement and parking bay Bath Lane

The attendance at street refurbishment and pavement groundwork at Bath Lane has confirmed the presence of undisturbed medieval dark earth deposits at the south end of Bath Lane beneath and west of the eastern pavement and the presence of a homogenous silty subsoil disturbed by modern utilities along the length of the eastern pavement from the south side of the junction with Welles Street.
