**A Historic Building Significance Assessment  
of the Laban Tansey Building,  
Ashcroft House, 127 Upper Bond Street,  
Hinckley, Leicestershire.  
SP 428 945**

**For: HSS Architects**

**ULAS Report Number 2008-062  
©2008  
Accession Number X.A.63.2008**

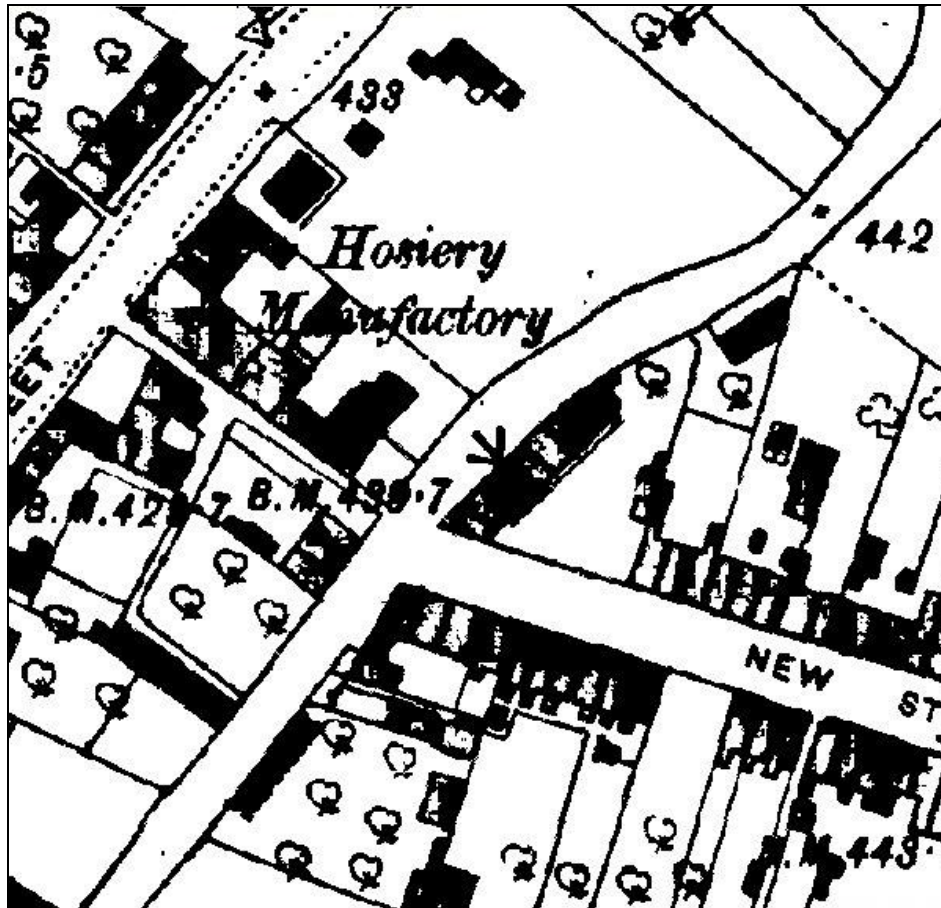
Figure 5. 1st edition Ordnance Survey map 1:2500

In plan the buildings are far from square which may indicate that they had to fit around an earlier set of buildings or property boundaries when originally built. The 1st edition Ordnance Survey map shows the property boundary between the old and new phases of the building and a boundary to the north which would be half way across the garage next door.

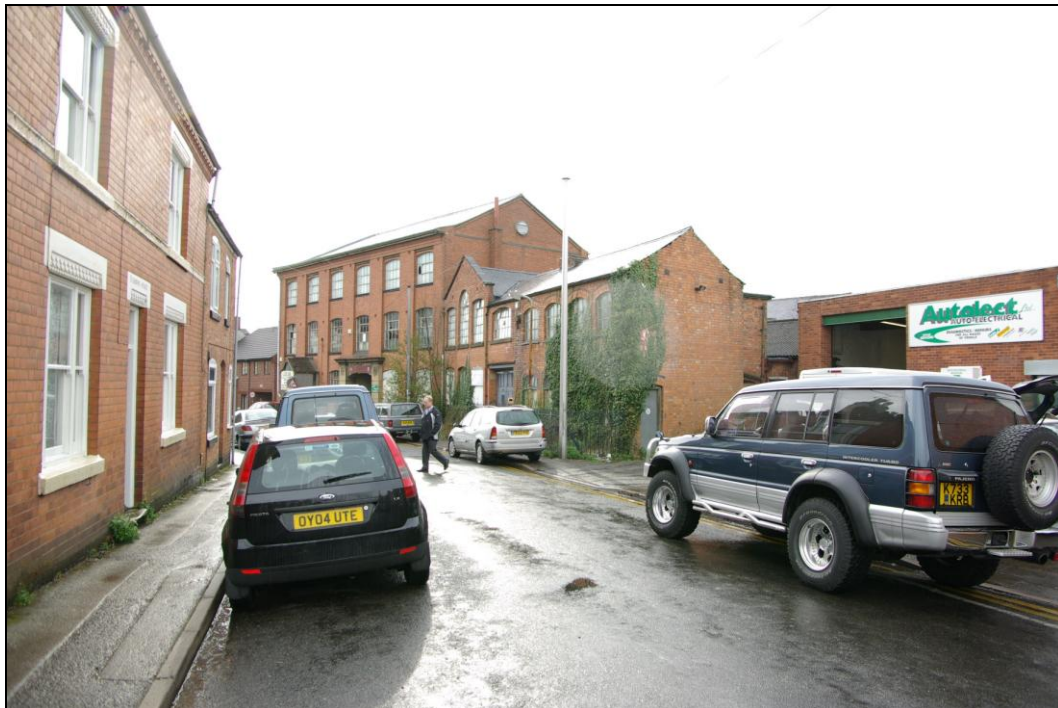
Figure 6. Laban Tansey building and adjacent buildings.  
Looking south-west down Druid Street.

The Laban Tansey Building is located within the northern part of the Druid Quarter Conservation Area which Hinckley and Bosworth Borough Council describe as an area with special architectural or historic character, which is desirable to preserve and enhance. The whole of Druid Street has been associated with the hosiery and knitting industry since at least the second half of the 19th century with a number of factories and industrial buildings being constructed from the 1880s to just before the First World War. Many buildings have since changed ownership and use, with few having any association with their original purpose. Piecemeal demolition and redevelopment has also taken place along Druid Street. A number of late Victorian houses line both sides of the street to the north of the Laban Tansey Building but modern houses have been built directly opposite. A modern garage unit has also been built adjacent to its northern wall (fig. 6). Butting up against the south side of the building is a large three-

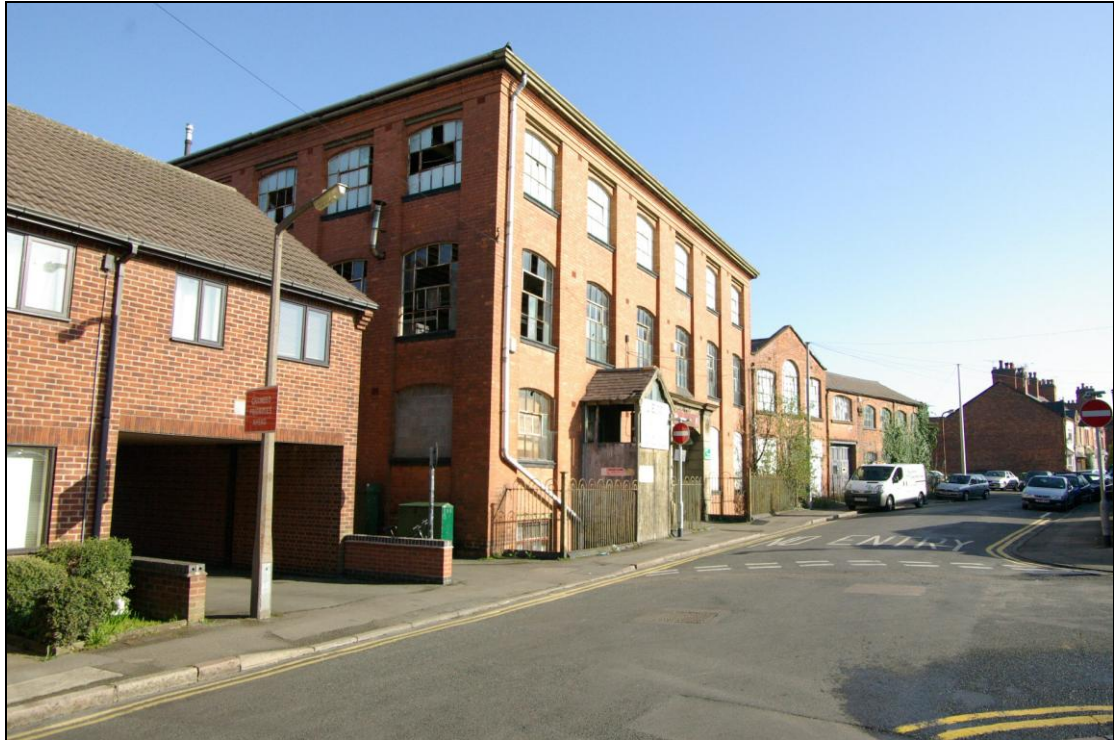
Figure 7. Laban Tansey building with hosiery mill to the south.  
Looking north-west up Druid Street.

storied hosiery mill with a date of 1911 carved around the entranceway (fig. 7). The main part of the mill is presently empty and scheduled for conversion and redevelopment into flats but will keep much of the façade intact. An annex to the large mill, containing a glazing business, and some domestic housing fronting onto Upper Bond Street are located to the rear of the Laban Tansey Building. Much of Druid Street to the south of this site has also been demolished and redeveloped in the recent past following the demise of the hosiery industry in the 1980s and '90s. The Laban Tansey Building is currently empty but as part of the redevelopment plan for this site it has been proposed that the building be demolished to make way for a small number of offices and apartments.

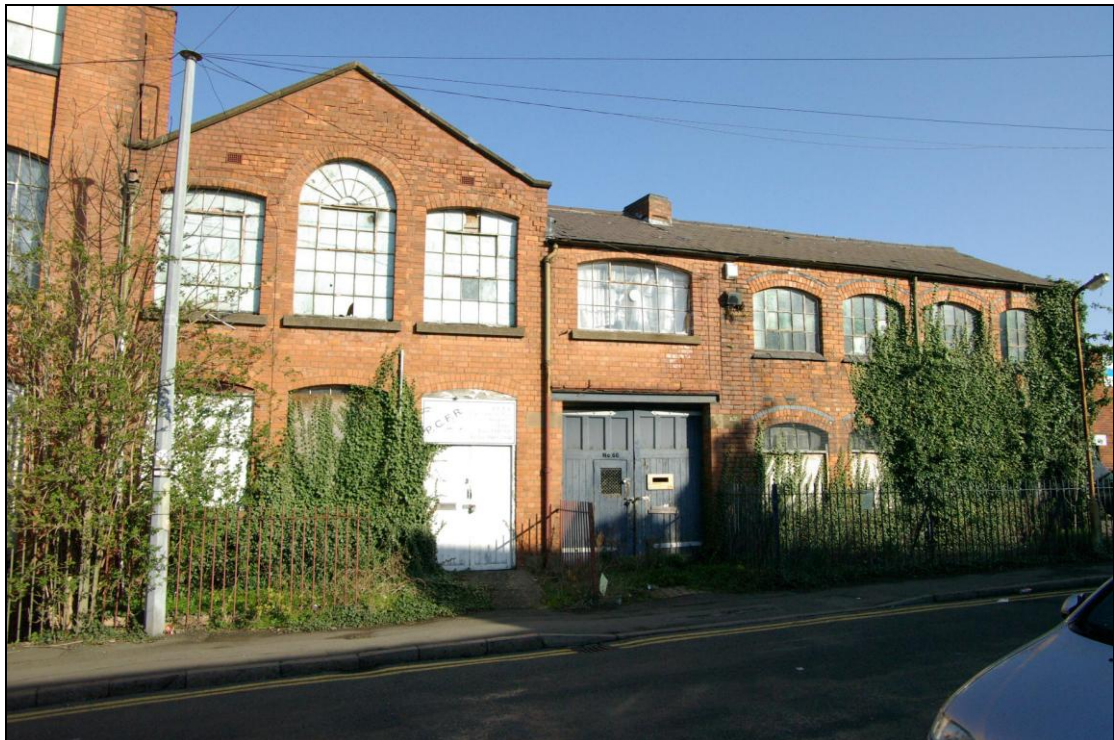
Figure 8. Laban Tansey building. Frontage.  
Looking west.

The whole frontage is built on the same alignment running parallel to the street and is set slightly back from the pavement behind a set of plain iron railings (fig. 8). On the northern hand is a two-storey four-bay building built of red brick with a Welsh slate roof. A small brick chimney, which appears to have been capped, rises from the centre of the roof at the southern end of the four bays. The ridge tiles to the north of the chimney have a small rolled-top decoration which is not seen on the plain ridge tiles on the other side of the chimney. An apparent colour change in the slates can also be seen at this point along with a slight undulation in the roof height indicating a different building phase. This line can be followed down to a joint in the brickwork running vertically between the main building and the goods entrance (fig. 9). The bricks for the main building, laid in a Flemish Garden Wall bond, measure 220mm long x 80mm high x 115mm wide and those above the goods entrance and the gable-ended building, laid in an English Bond, measure 230mm long x 80mm high x 115mm wide, again indicating two phases.

The four-bayed building has cast iron guttering and downpipes which are likely to be original. The tops of the windows have shallow arches using two rows of red brick headers and an upper course of blues whilst the sills are of shaped blue brick. The upper floor windows have cast iron frames, three panes high by five wide. The ground floor windows are identical in design but are four panes high which have been partially boarded over but otherwise appear to be original and unmodified.

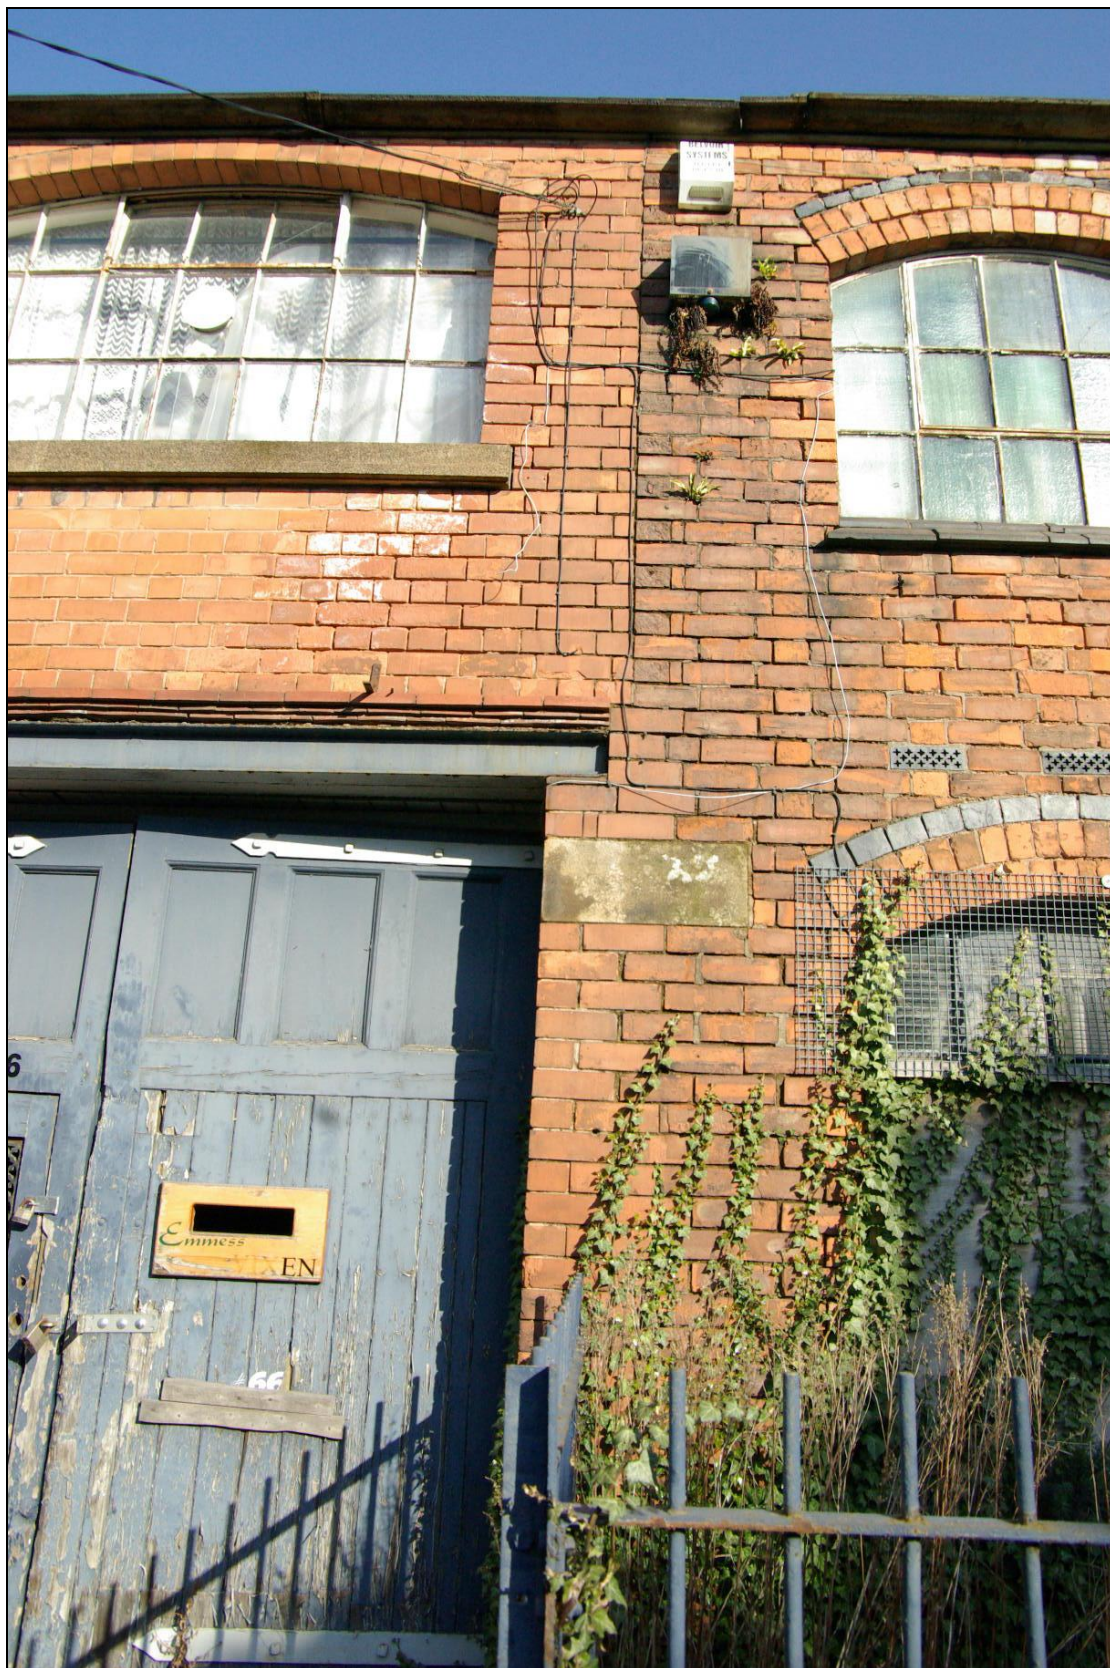
Figure 9. Laban Tansey Building. Joint between phases on frontage.  
Looking west.

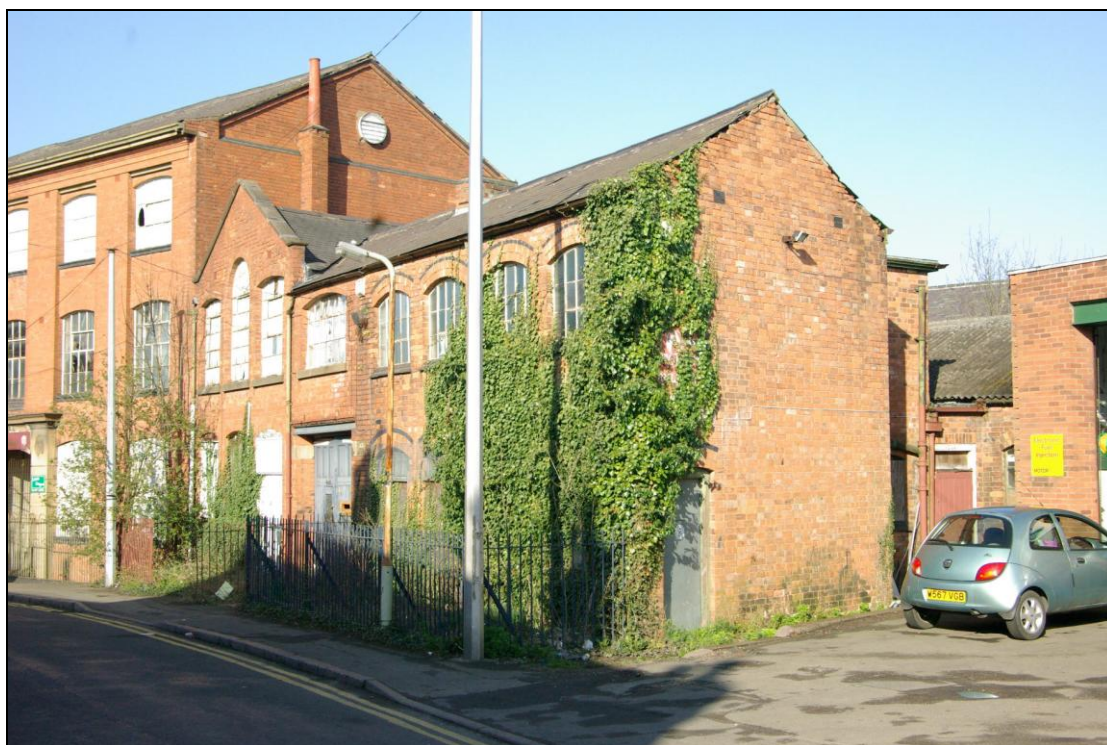
Figure 10. North wall of main building.  
Looking south-west.

The northern end of the main building which forms part of the adjacent garage forecourt is a plain gable end with a single ground floor doorway with the same three courses of red and blue brick header detail seen above the windows to the front. There is no evidence of any blocked or inserted openings (fig. 10). Two windows survive intact on the north-west corner and are identical to those on the street frontage apart from the upper window missing the blue brick upper course (fig. 11).

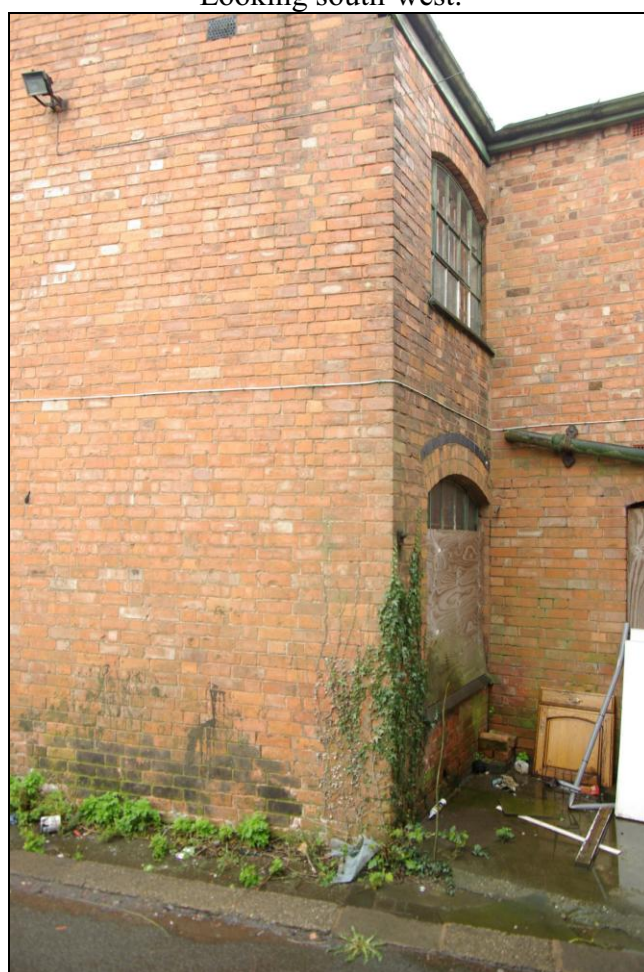
Figure 11. Rear wall of main building with later outhouse addition.  
Looking south.

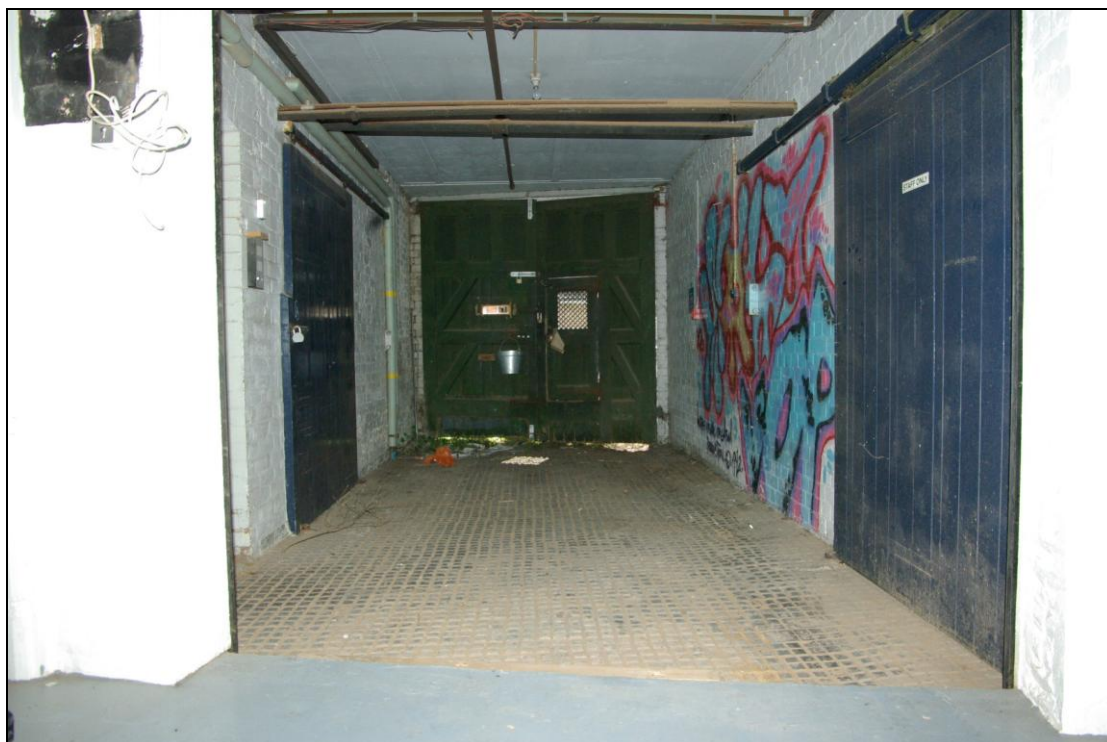
Figure 12. Inside of goods entrance.  
Looking east.

Access to the building is via a sliding door in the south-west corner from the goods entrance although it is not clear whether this is a later inserted doorway or not (fig. 12). A second single-width doorway has been inserted through the rear wall from the stairwell where a window used to be. Inside, the room is currently empty with a concrete floor and boarded ceiling which do not give any indication of past uses or locations of machinery (figs. 13 and 14). A small blocked fireplace is located on the southern wall. This had a 0.92m wide (3 feet) opening but only extends into the room by 0.36m which seems small for any industrial process. On the eastern wall can be seen the four windows fronting onto Druid Street. The central six panes are tilted about their axis and can be secured by a crudely shaped iron bar (fig. 15). Two identical windows survive at each end of the eastern wall but the central windows have been blocked and replaced by a single door as seen in figure 13. No evidence of an internal staircase can be seen.

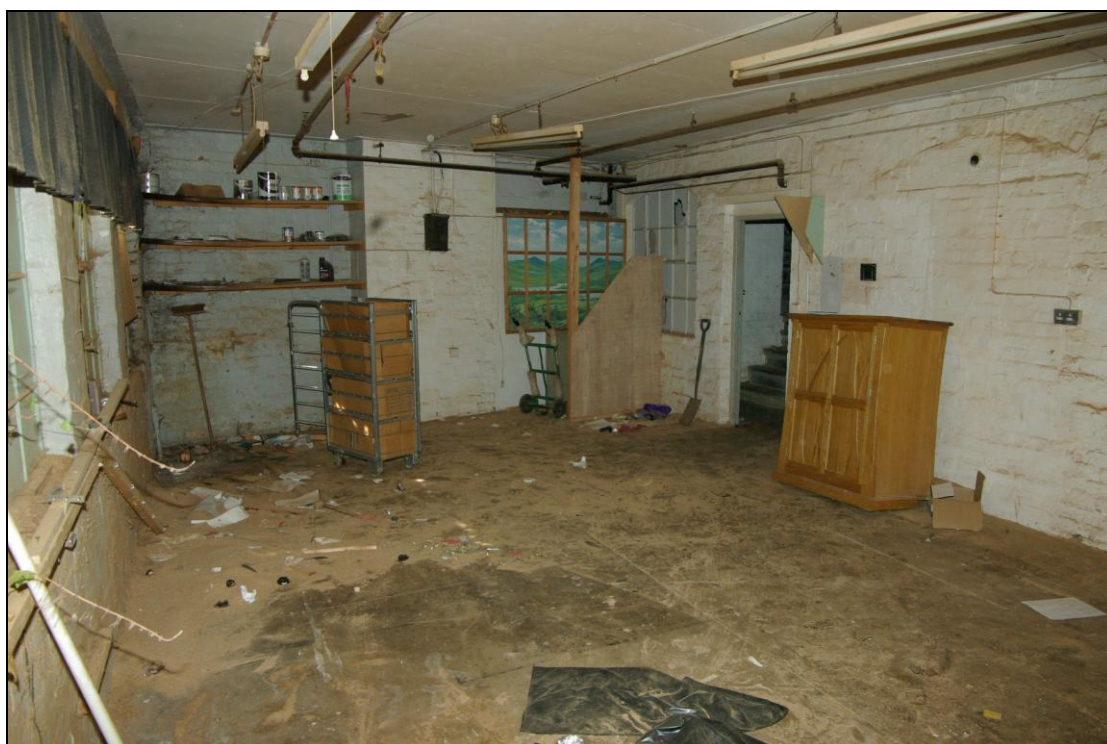
Figure 13. Main building, ground floor.  
Blocked windows on rear wall and inserted doorway. Looking south-west.

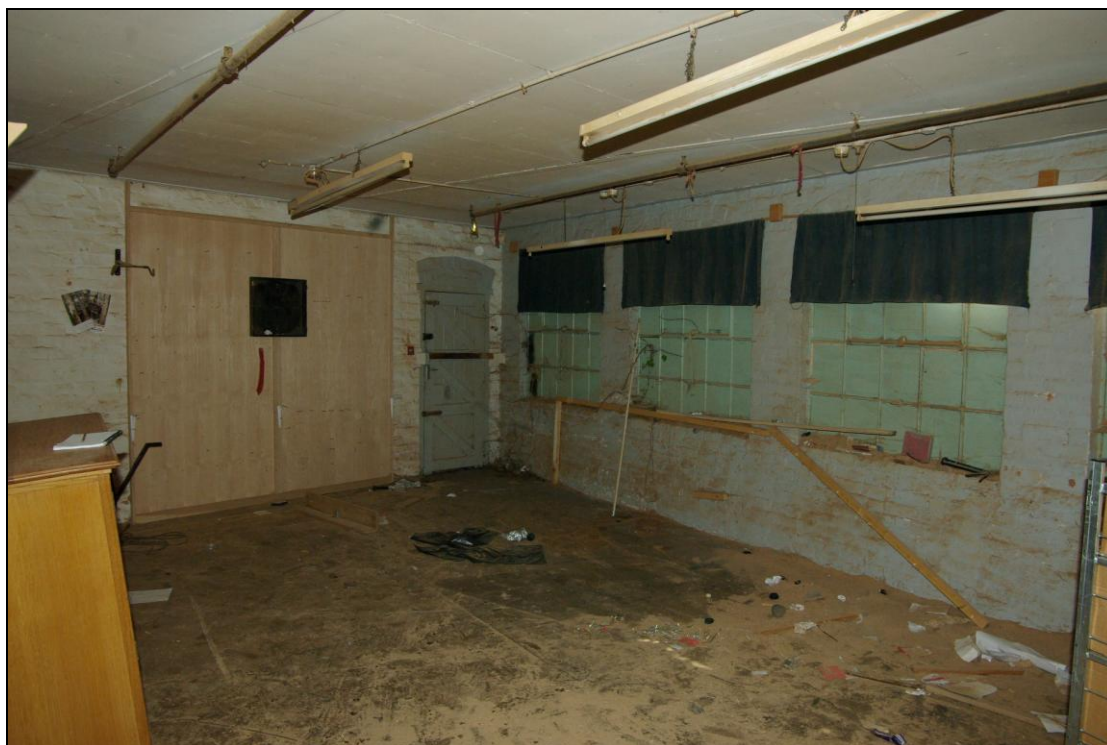
Figure 14. Main building, ground floor.  
Front windows and north wall. Looking north-east.

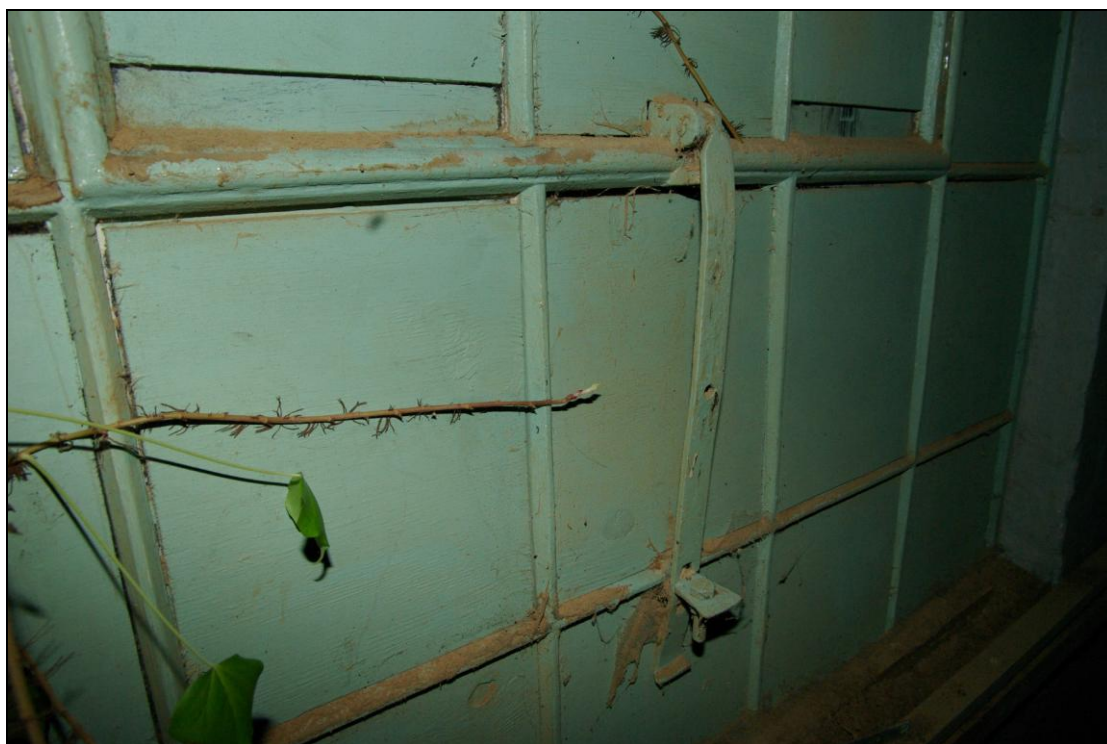
Figure 15. Main building. Window latch detail.

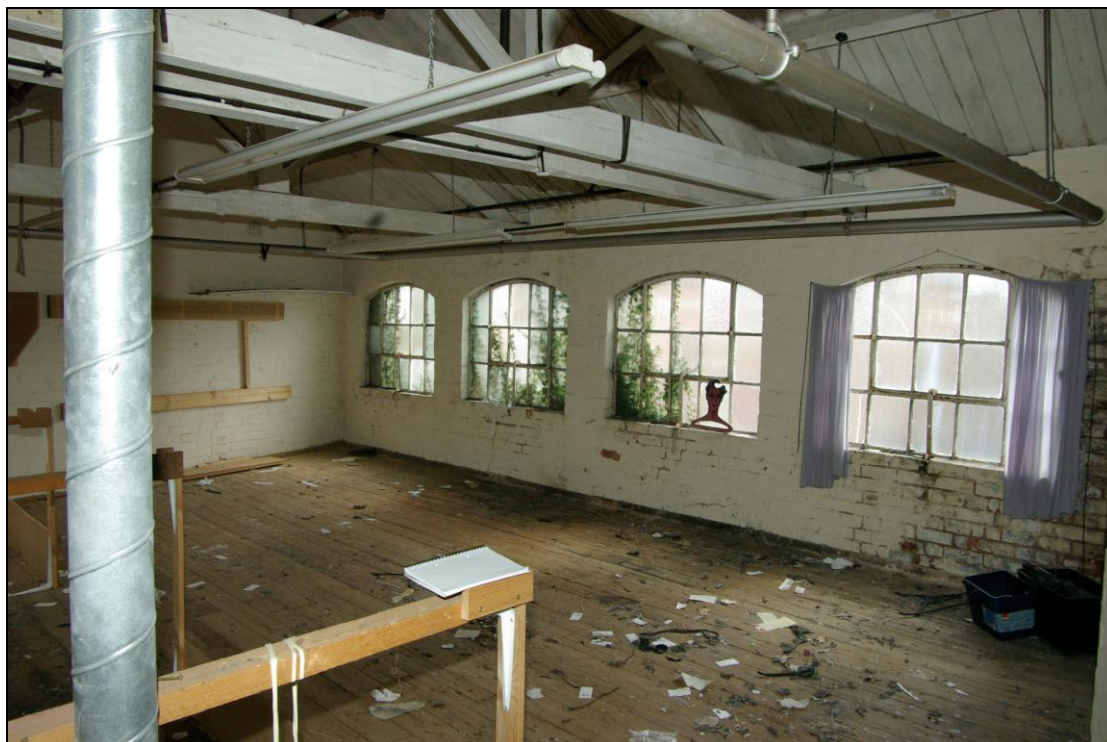
Figure 16. Main building, first floor.  
Front windows. Looking north-east.

The first floor of the main building is via a staircase built as part of a range of small outbuildings attached to the rear. This addition is made from the same sized bricks as the gable-ended building with which it is probably contemporary. The stairs are also lit by what appear to be the re-used original windows taken from the main building after they were blocked. The first floor, like the ground floor is a single open room (figs. 16 and 17) The small size (0.6m wide) of the blocked fireplace again suggests

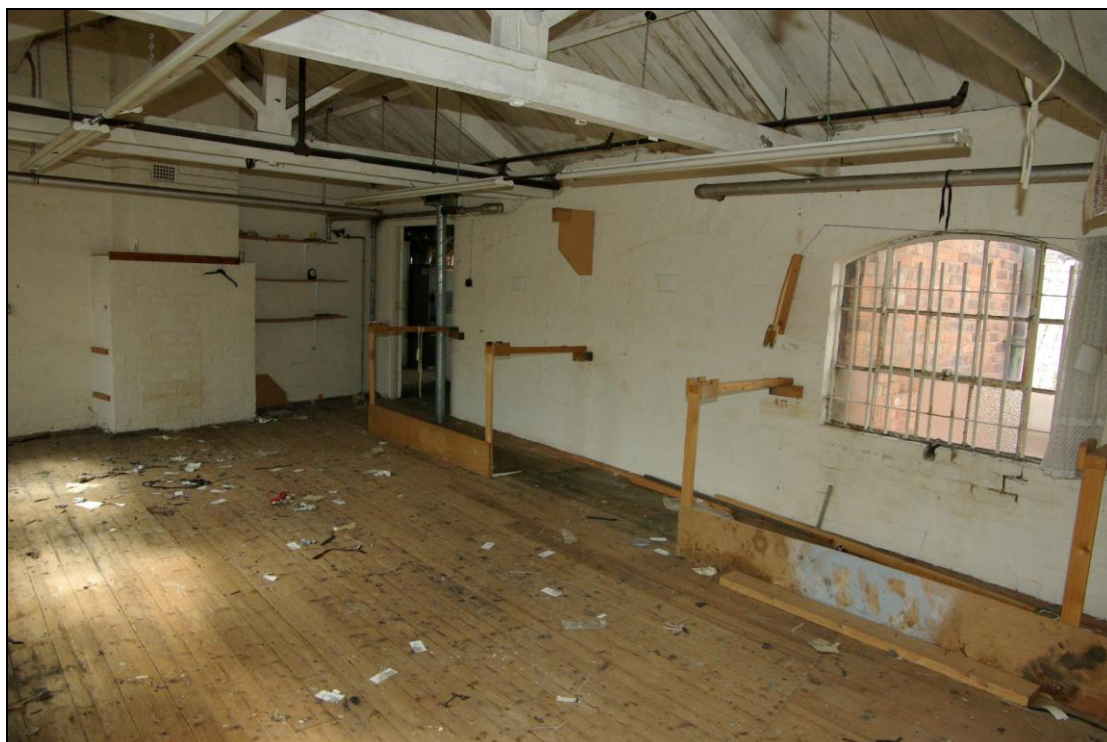
Figure 17. Main building, first floor.  
Blocked windows on rear wall and inserted doorway. Looking south-west.

The upstairs windows all have the same opening mechanism as on the ground floor. Only one window survives on the rear wall, the rest have been blocked or knocked through to make the double entrance from the stairs (fig. 17).

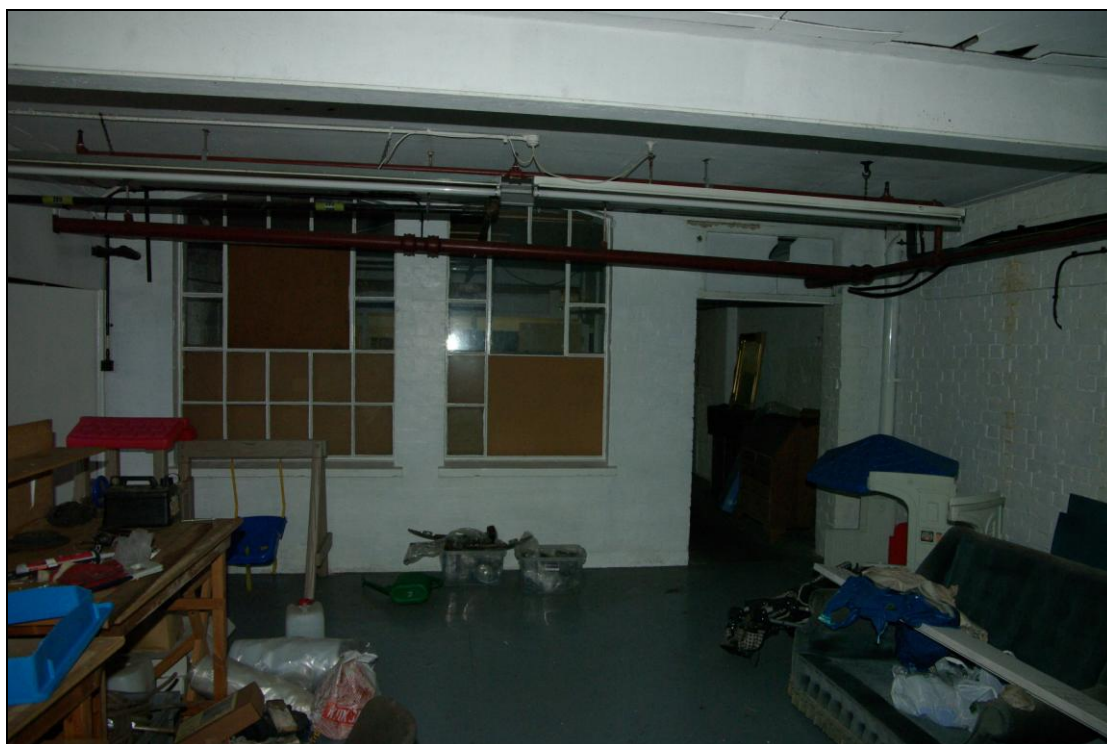
Figure 19. Gable-ended building, ground floor. Original back wall and windows.  
Looking east.

The ground floor of the gable-ended building is entered by the narrow double doors from Druid Street. The two cast-iron framed windows to the south being the same width as the doorway. A number of wooden-partitioned offices cover much of the ground floor as far as a brick wall which appears to have formed the original back wall of the building (fig. 19). The wall is pierced by two cast-iron framed windows and an unframed doorway. There is no indication that the doorway was once a window. On the other side of this wall the windows have sloping sills built to deflect the rain showing that this was once an outside wall. A matching window in the northern wall also indicates that this was originally outside. A later phase of building work has extended the gable-ended building to the west which had the result of doubling its length. This brick built extension contains no windows but has three openings on the northern side into a roof-lighted single storey workshop built behind the main building (fig. 20).

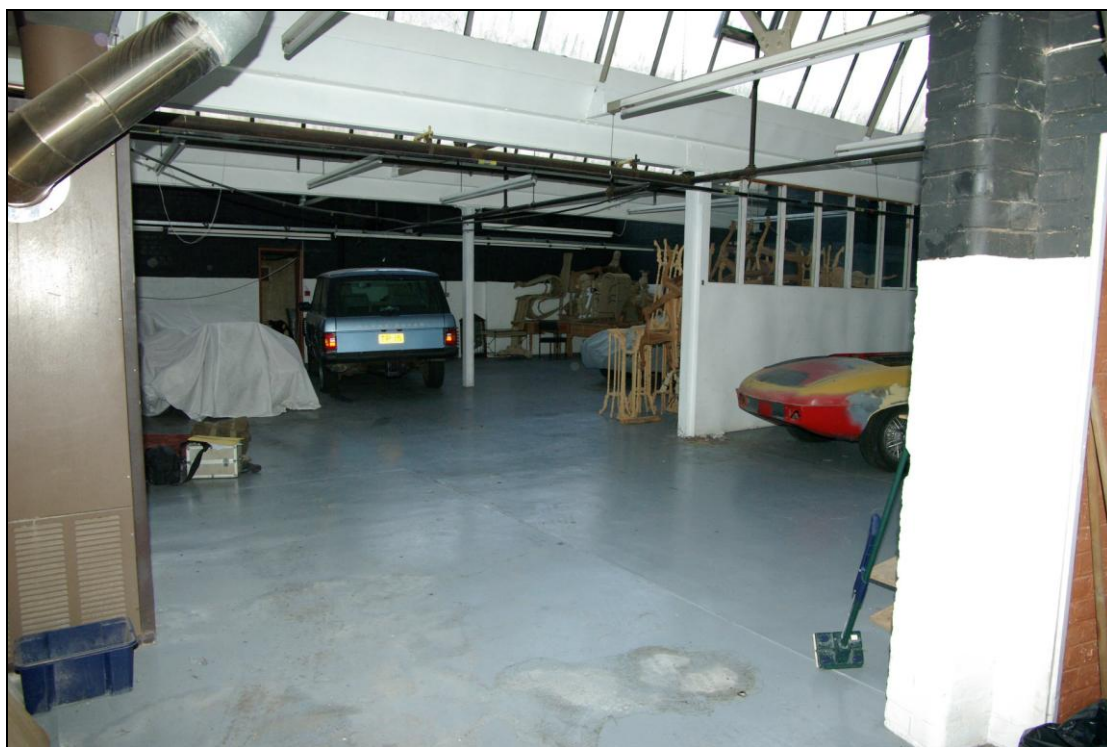
Figure 20. Rear workshop. Viewed from goods entrance.  
Looking north-east.

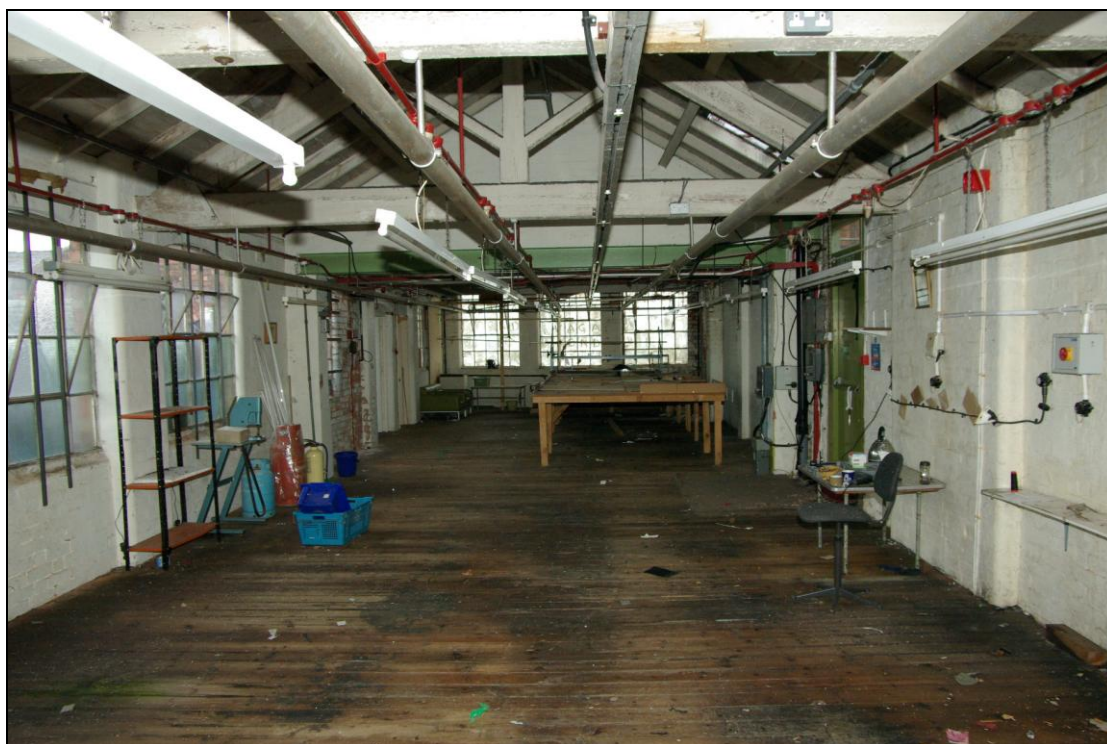
Figure 21. Gable-ended building, first floor. Front windows.  
Looking east.

The open upper floor is entered through a double width opening at the side of the small office. Apart from overhead lighting and heating pipes, a modern bench and some shelves there is no remaining evidence concerning the use or purpose of the room (figs. 21 and 22). The three Venetian style windows form the southern end of the room and the tops of a similar set of windows can be seen in a bricked up gable half way down the room which is supported by an I-section steel girder (fig. 22). This blocked gable corresponds with the wall and windows seen on the ground floor and shows that the building was only half its present length when originally constructed. Along the northern wall, a three-pane high by four wide cast-iron window forms the only side window from the original room, but with the extension, three more windows were added which are a combination of five by four and four by four paned windows all with the same style of cast-iron frames (fig. 21). The open roof structure is of similar king-post design for both parts of the room but the later extension has the addition of iron strapwork at the key joints.

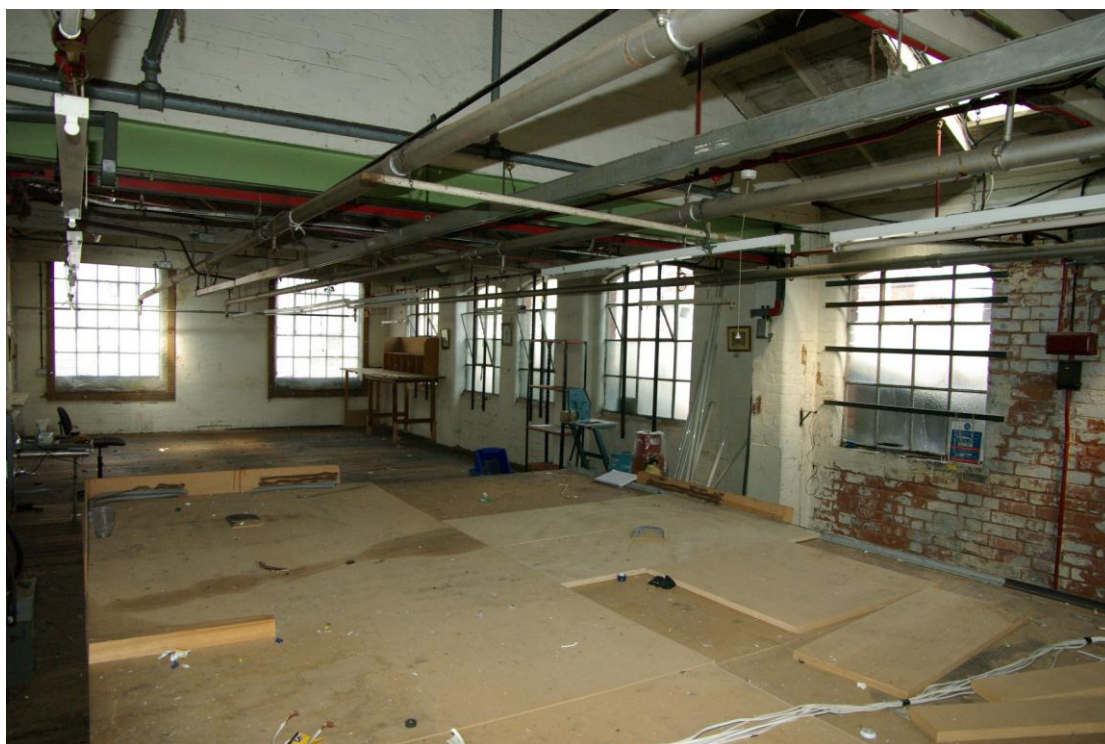
Figure 22. Gable-ended building, first floor. Blocked remnant of rear Venetian windows in gable. Looking north-east.
