**An Archaeological Watching Brief  
at the Concordia Theatre  
Stockwell Head, Hinckley, Leicestershire  
NGR: SP 426 940**

**ULAS Report Number 2008-154**  
©2008  
**X.A142.2008**

*An Archaeological watching brief was undertaken by ULAS on behalf of the Concordia Theatre during groundwork for the extension and alterations to form a new staircase and lifts at the Concordia Theatre, Stockwell Head, Hinckley (NGR: SP 426 940). The construction involved the reduction and levelling of the site area together with construction of new shafts. Attendance at the site occurred on the 15th and 16th of October 2008. No significant archaeological finds or deposits were observed during groundworks. The archive is to be deposited with Leicestershire County Council under accession number X.A.142.2008.*

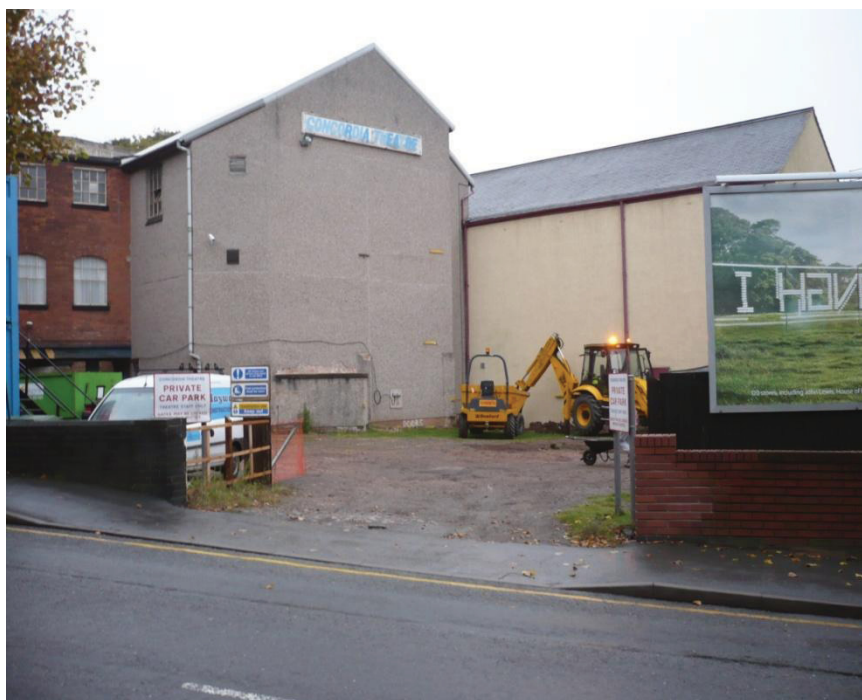
Figure 3: rear of Concordia theatre showing site location.

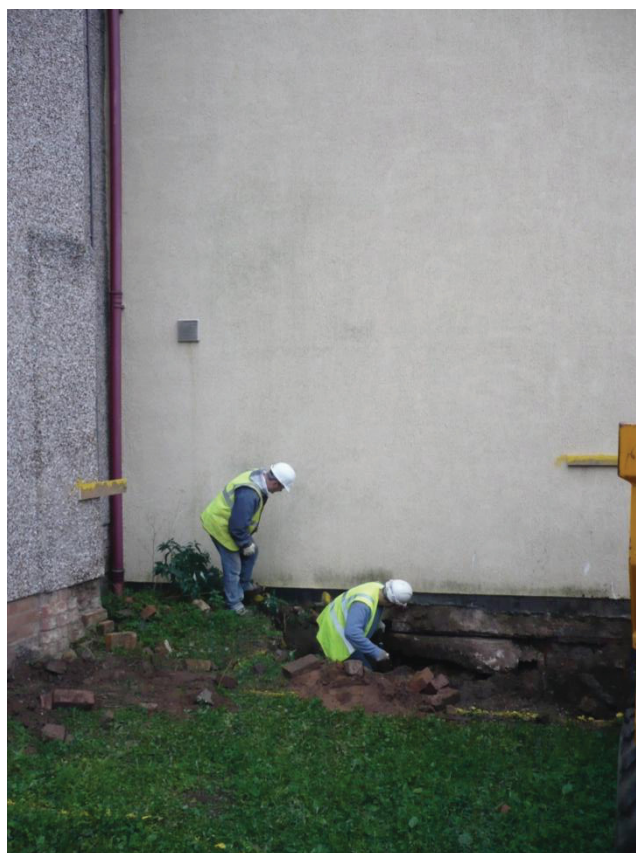
The material within the lift cavity comprised modern brick, slate and building debris presumed to derive from the demolition of a superstructure associated with the subsurface room. Along the section of the current upstanding northern wall of the theatre two 1.5m wide breaks in the wall were observed. These were each bricked up and possibly represented approximately 1.5m high access points into the current cellar of the adjacent theatre. Personal communications with site staff suggested this may have been the demolished remains of possible boiler rooms and coal bunkers associated with the buildings which currently house the Concordia theatre, prior to their conversion to the theatre.

Figure 4 : exposure of first of two potential coal bunker openings.

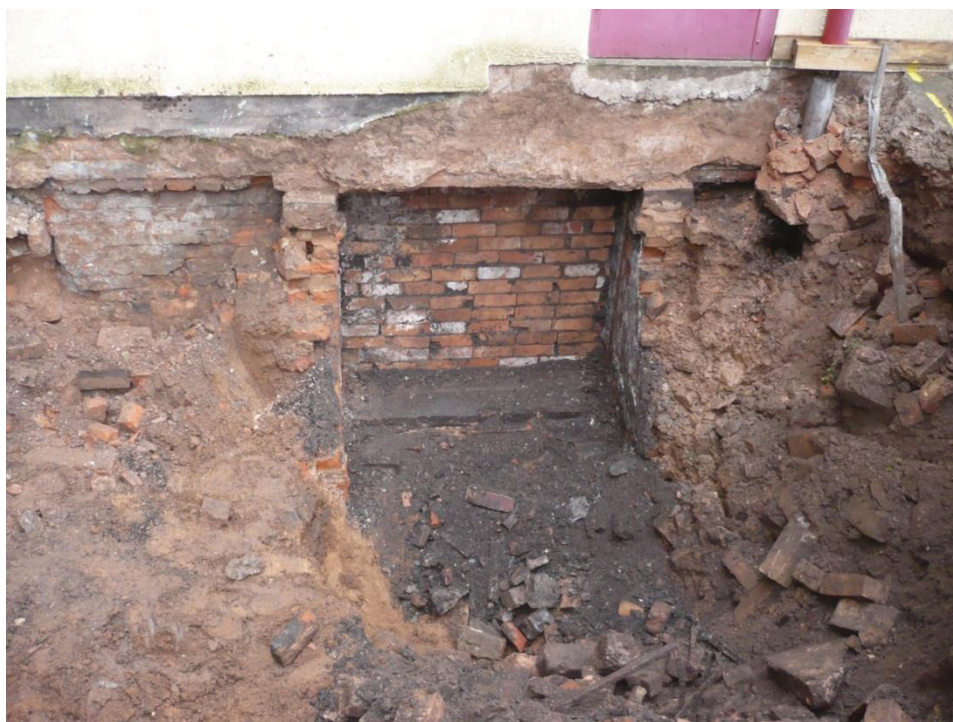
Figure 5 : bricked up coal bunker passing through external wall.

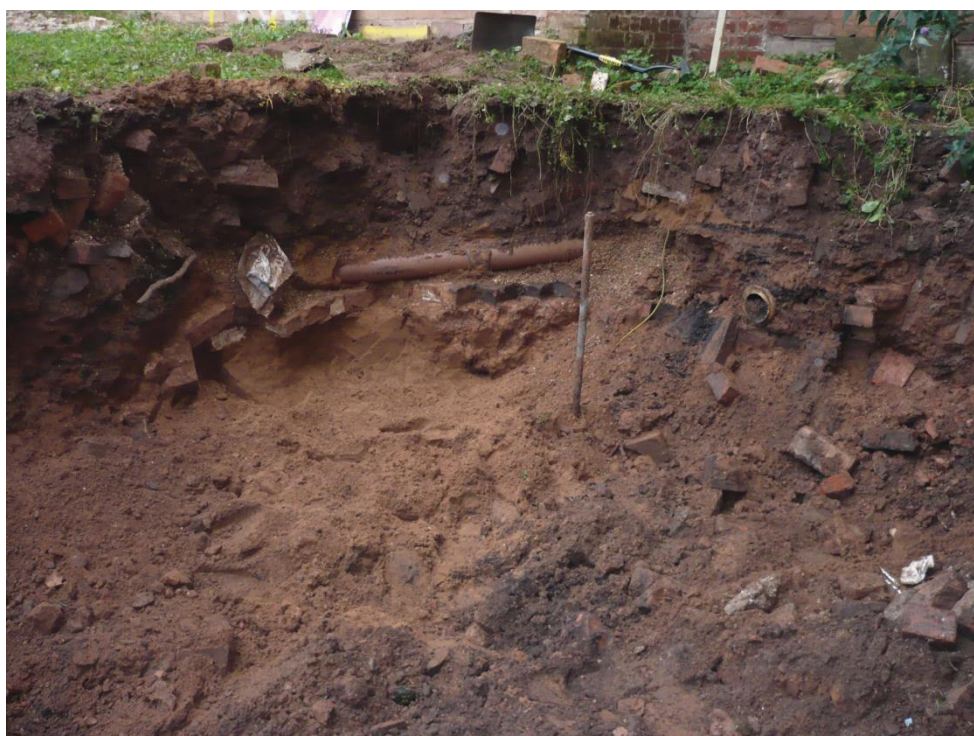
Observation of the sections of the lift shaft cavity, (Figure 2 box marked B-E), suggested the exposed backfilled subsurface room extended west and north- west beyond the limit of the new shaft. In a corner of the north - east section of the cavity fine dark orange sand was observed. This was at a depth of 0.9m from the current surface in section. In the north - west corner of the cavity this same sand was observed at a higher level approximately 0.4m below the current ground surface. This material was interpreted as the underlying natural.

Figure 6: south east facing section of lift shaft void, showing natural beneath made up ground.

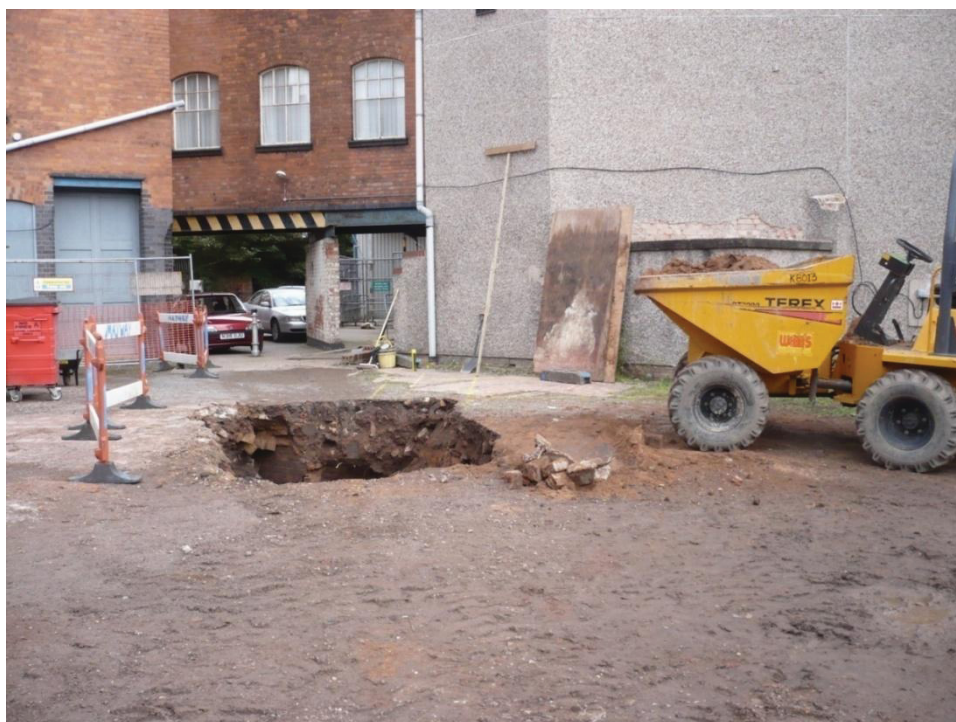
A further deep excavation was carried out at the North West corner of the new extension (Figure 2 box marked F- I) to underpin the new walls where they passed over a storm drain which traversed the rear car park. The sections of this void revealed extensive modern disturbance similar in nature to that observed within the lift shaft cavities. In the north - east corners and west side of the cavity subsurface, walls were seen and a brick floor observed in section. The southern section of the void comprised modern brick, slate and building debris presumed to derive from the demolition of a superstructure associated with a subsurface room, probably the continuation north of that seen in the lift shaft cavity. A storm drain was observed

cutting this debris along the southern side of the cavity. Within the west half of the northern face of the cavity, fine orange sand was observed approximately 0.4m below ground surface and horizons of modern deposits. This was identical to deposits seen further south and interpreted as the underlying natural.

Figure 7: view north east of second excavation.

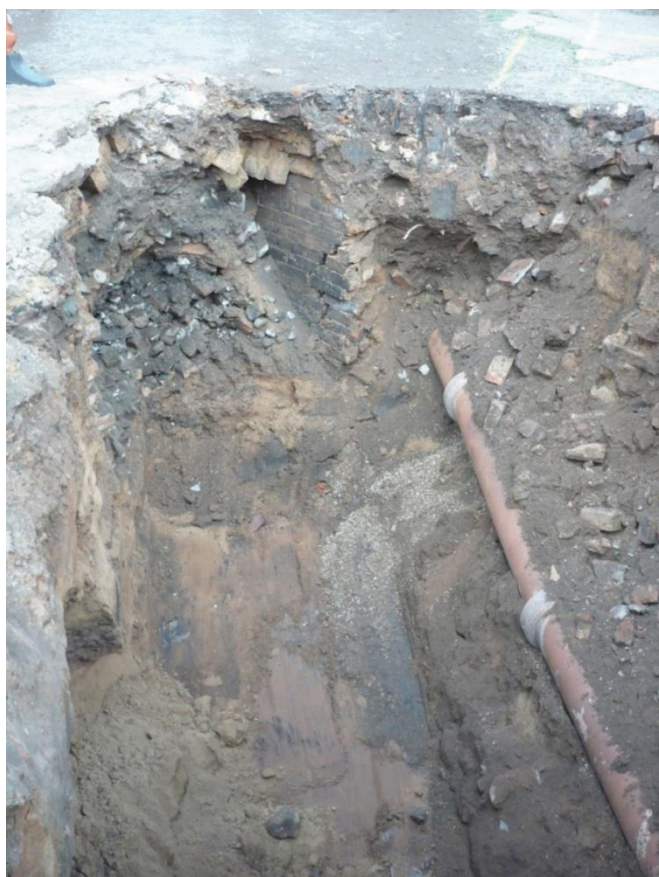
Figure 8: view of north east section showing subsurface walling.
