**An Archaeological Building Survey and
Recording Exercise at The Pine Studio,
Talbot Yard, Market Harborough,
Leicestershire.**

**ULAS Report Number 2008-047
©2008
Accession Number X.A 23.2008**

An archaeological survey and recording exercise of the floor surfaces within the former Pine Studio, Talbot Yard, Market Harborough was undertaken for BJC Properties by the University of Leicester Archaeological Services (ULAS) on the 18th of January 2008. The former stable and Pine Studio is of probable 18th century origin and is currently undergoing redevelopment and conversion to offices and flats. As part of the programme of work the present floor surface was to be altered and needed to be recorded prior to this work taking place. Much of the floor was of red and blue brick blocks from the late 19th century with possible earlier areas of river-washed cobbles surviving in places.

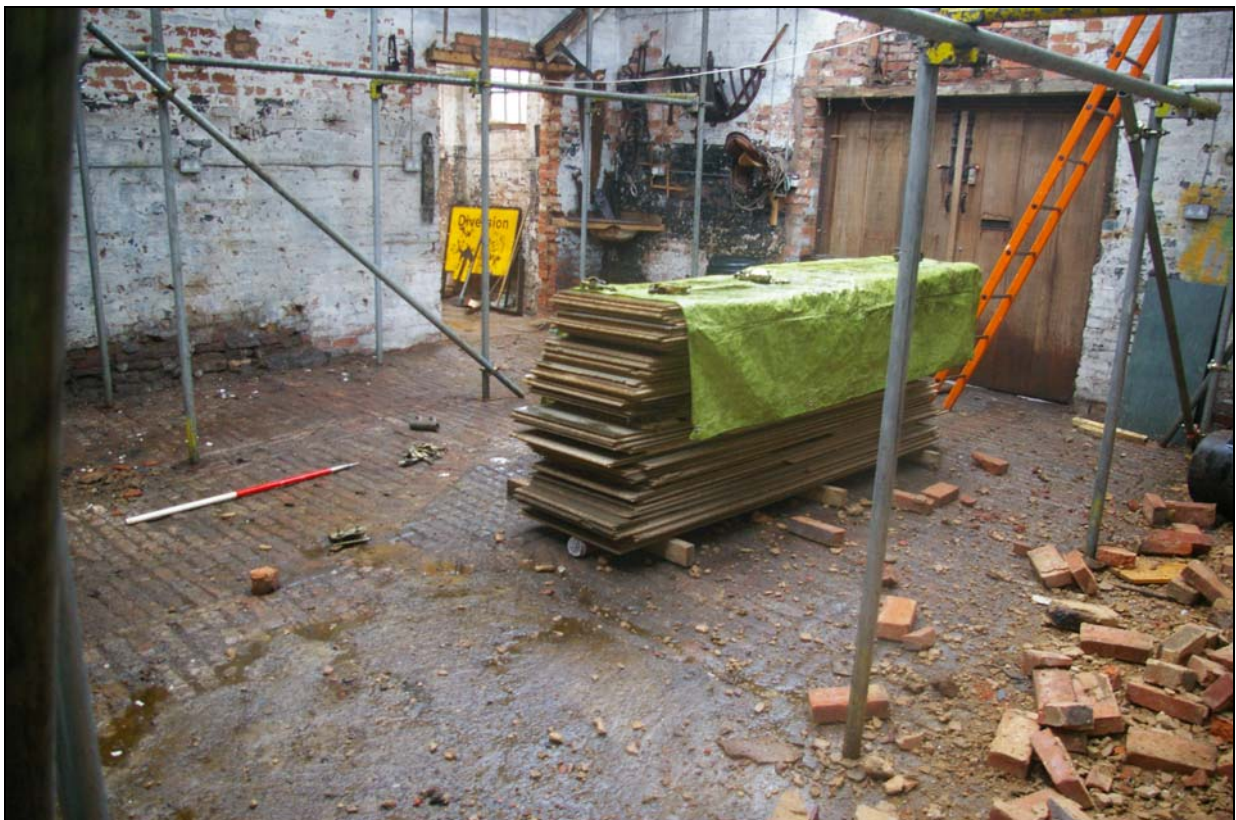
Figure 9. South-western room, looking east.

6.65m x 6.9m (fig. 9)

The rest of the room is covered with the red brick blocks seen in the north-eastern room which are laid in the same pattern and orientation. The surface is relatively level unlike the adjacent room although there are areas of distortion and heavy wear. Similarly two gullies run from north-west to south-east across the room. However, in this case they are four bricks wide and are offset half way across the room. A flat iron plate 220mm square covers the drainage point of each gully.

The floor surface in the south-western room shows much less damage although is still quite worn. Because the red bricks have been fitted so carefully around the blues it again seems more likely that they are contemporary with each other. It may also be expected that the bricks used for the floor would be of the same dimensions as the wall if they were of the same age. This is not the case as the wall bricks are thinner.

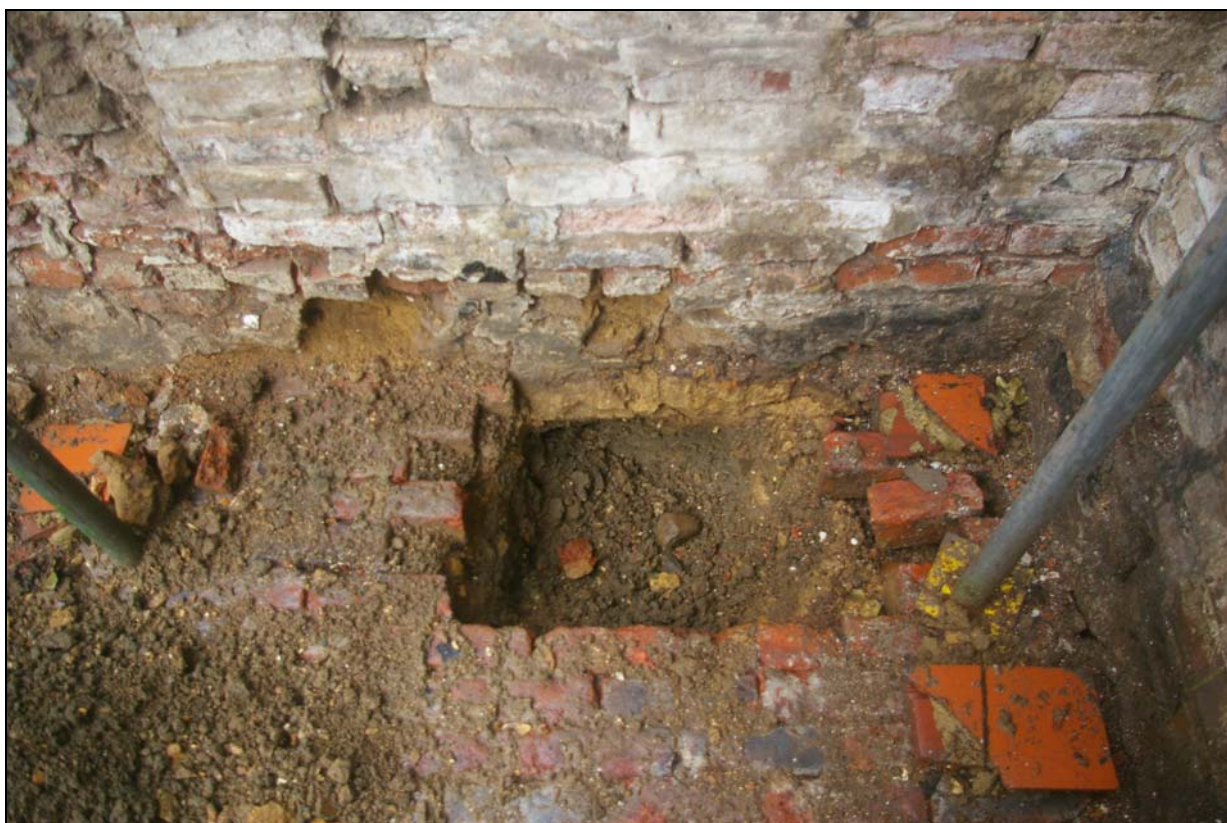
Figure 11. Hole through floor in south-western room.

A number of small holes dug through the floor during construction work show that the bricks are laid on a layer of sandy clay. However, as in the case of the north-eastern room the thickness of this layer is not known but is at least 0.25m thick (fig. 11).
