An Historic Building Photographic Survey
Monckton House Barns, Main Street,
Thorpe by Water, Rutland

NGR: SP 8919 9633

ULAS Report Number 2009-065

An Historic Building Photographic Survey at Monckton House Barns, Main Street, Thorpe by Water, Rutland. NGR: SP 89199633

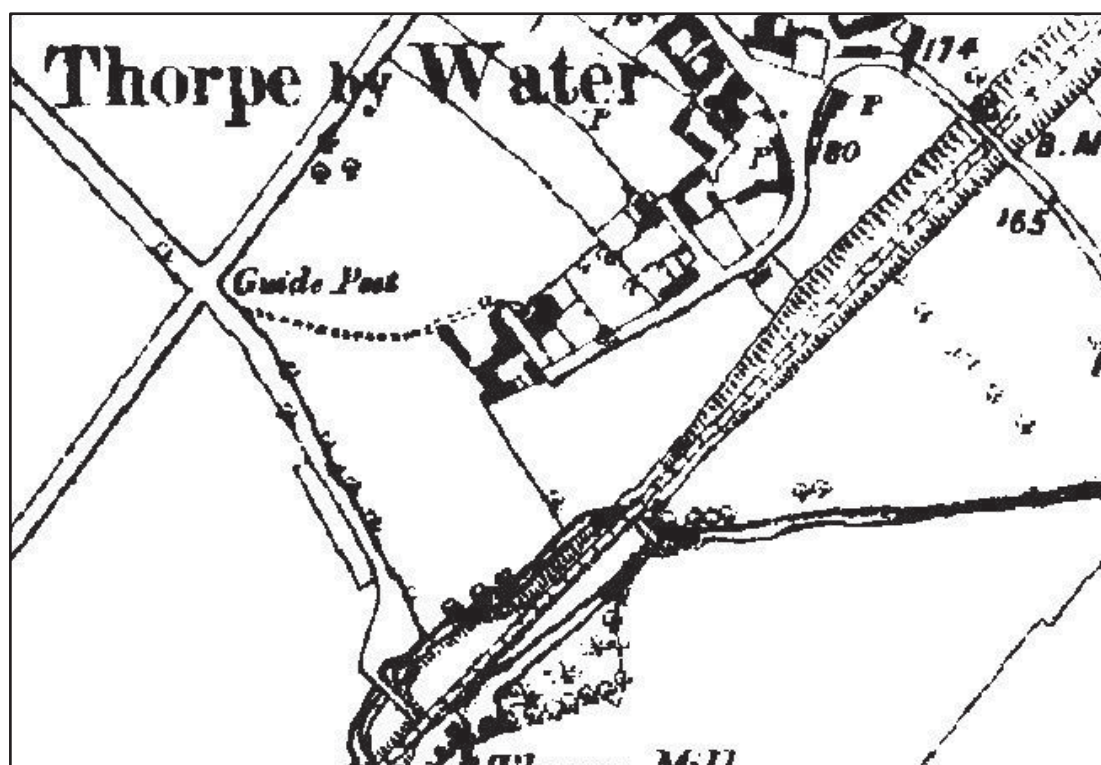
Figure 4: 1889 1st edition Ordnance Survey map

The earliest available map of the barns with enough detail is the First Edition Ordnance Survey map of 1889 which shows the existing barns plus an east to west range and another small building which both effectively enclose the south side of the yard (fig. 4). A large building can also be seen to the north west of the barns. The 1958 OS map shows a similar layout and number of buildings, but by 1976 these additional buildings have disappeared leaving the ones existing today (figs. 5 and 6). From the architectural style it would seem that the adjacent house pre-dates the barns by some years and despite being of fairly grand proportions it is still quite clearly a farm house which would have had similar barns associated with it when first built.

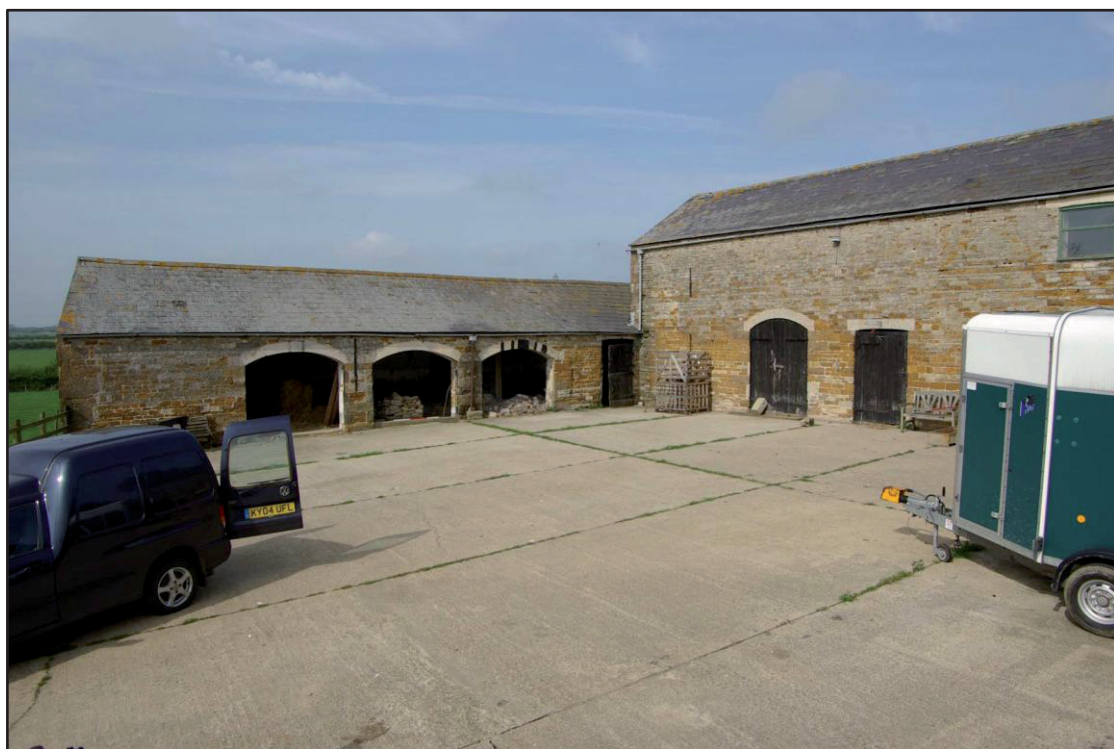
Figure 10: Cattle/cart shed and main barn
Looking west

The barns and adjacent house form the south western end of Main Street of the small hamlet (figs. 7, 8 and 9). The stockyard would have been enclosed by the buildings shown on the 1889 OS map but their demolition has left it open to the fields and road on the southern and eastern sides (fig. 10). The barns are constructed of coursed limestone and ironstone rubble with some attempt at polychrome banding along the lower courses on the yard elevations. Finer grain limestone, similar to that used in the house, is also used for the quoins, heads of arches and window lintels on the yard elevations indicating that a little more care and expense was taken in their construction. Welsh slate is used for the roofing material instead of the cheaper pan tiles which are often seen in East Leicestershire and Rutland.

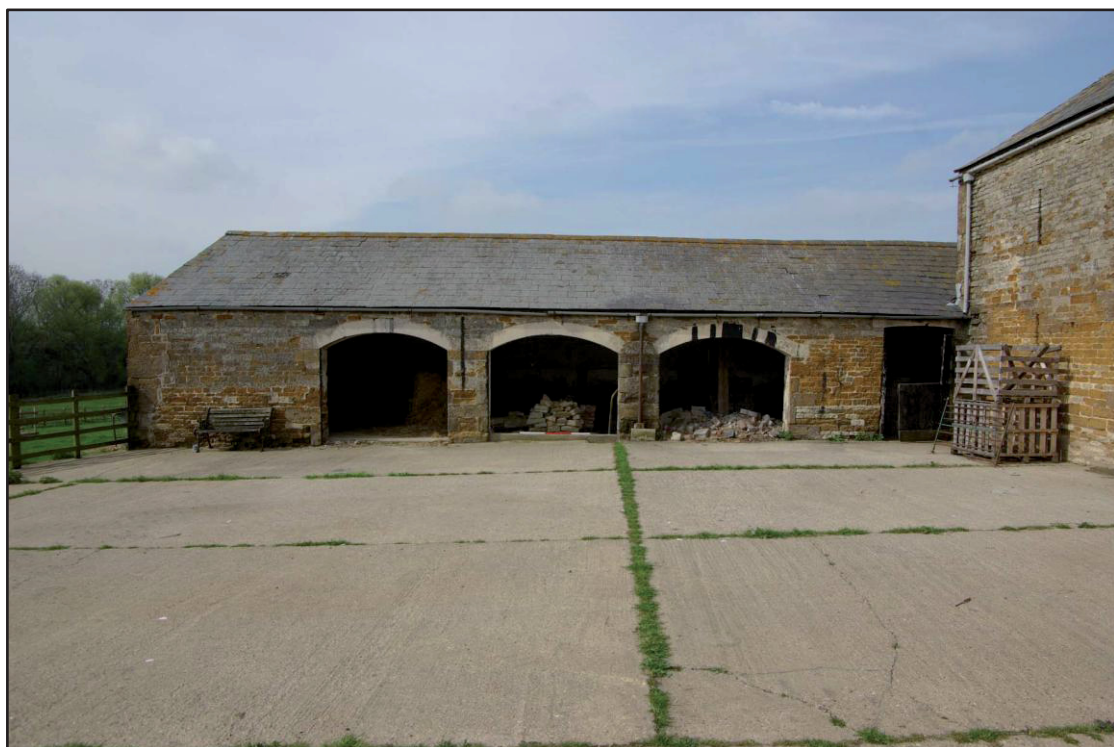
Figure 11: Cattle/cart shed east elevation
Looking south west. 1.5m scale

The cattle shed is a single storey building which was probably built as a cart shed as it has three wide arched openings on its eastern elevation (fig. 11). The northern gable end wall has been rebuilt using breeze blocks and an outer skin of stone whilst the southern gable is beginning to crack and slip down the hillside, possibly due to the demolition of the building to the south. Inside are traces of concrete and steel cattle pens and troughs which have recently been removed to leave an open space (fig. 12). A number of small alcoves are built into the south end of the east, west and south walls; the purpose of these is unknown (fig. 13). At the north end the ridgeline of the roof turns 90° to join the main barn which is on a south west to north east alignment (fig. 14). There is a wide stable door located in the north eastern corner of the building (fig. 15).

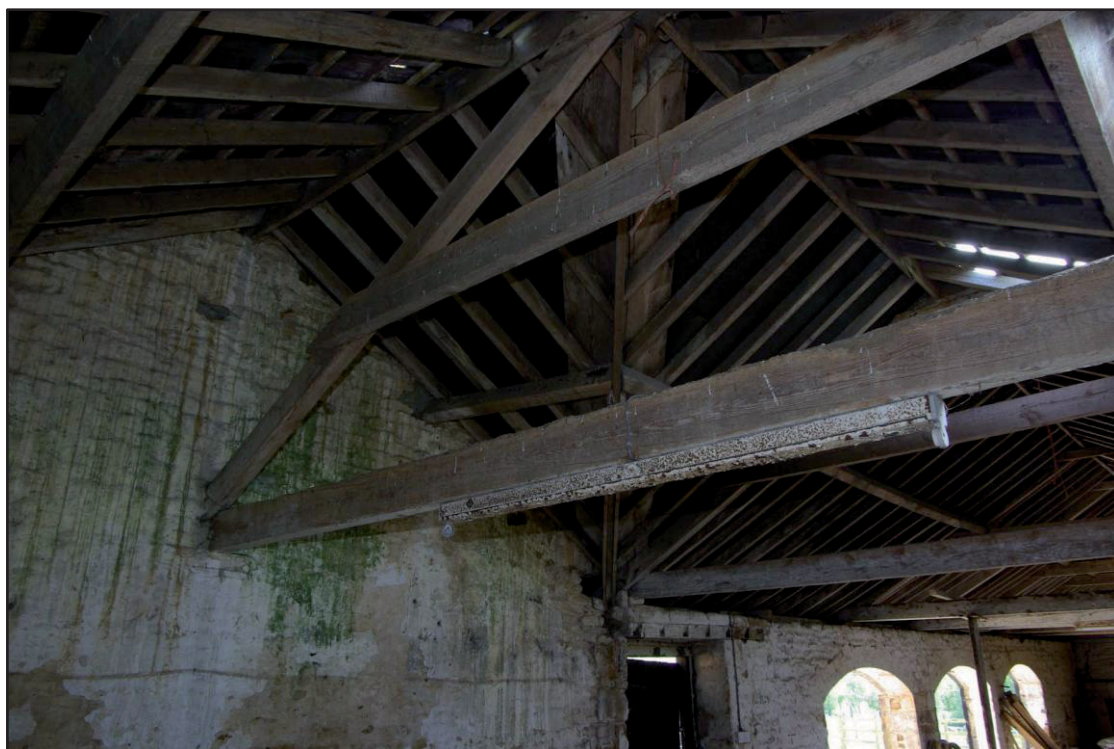
Figure 14: Cattle/cart shed roof detail
Looking east

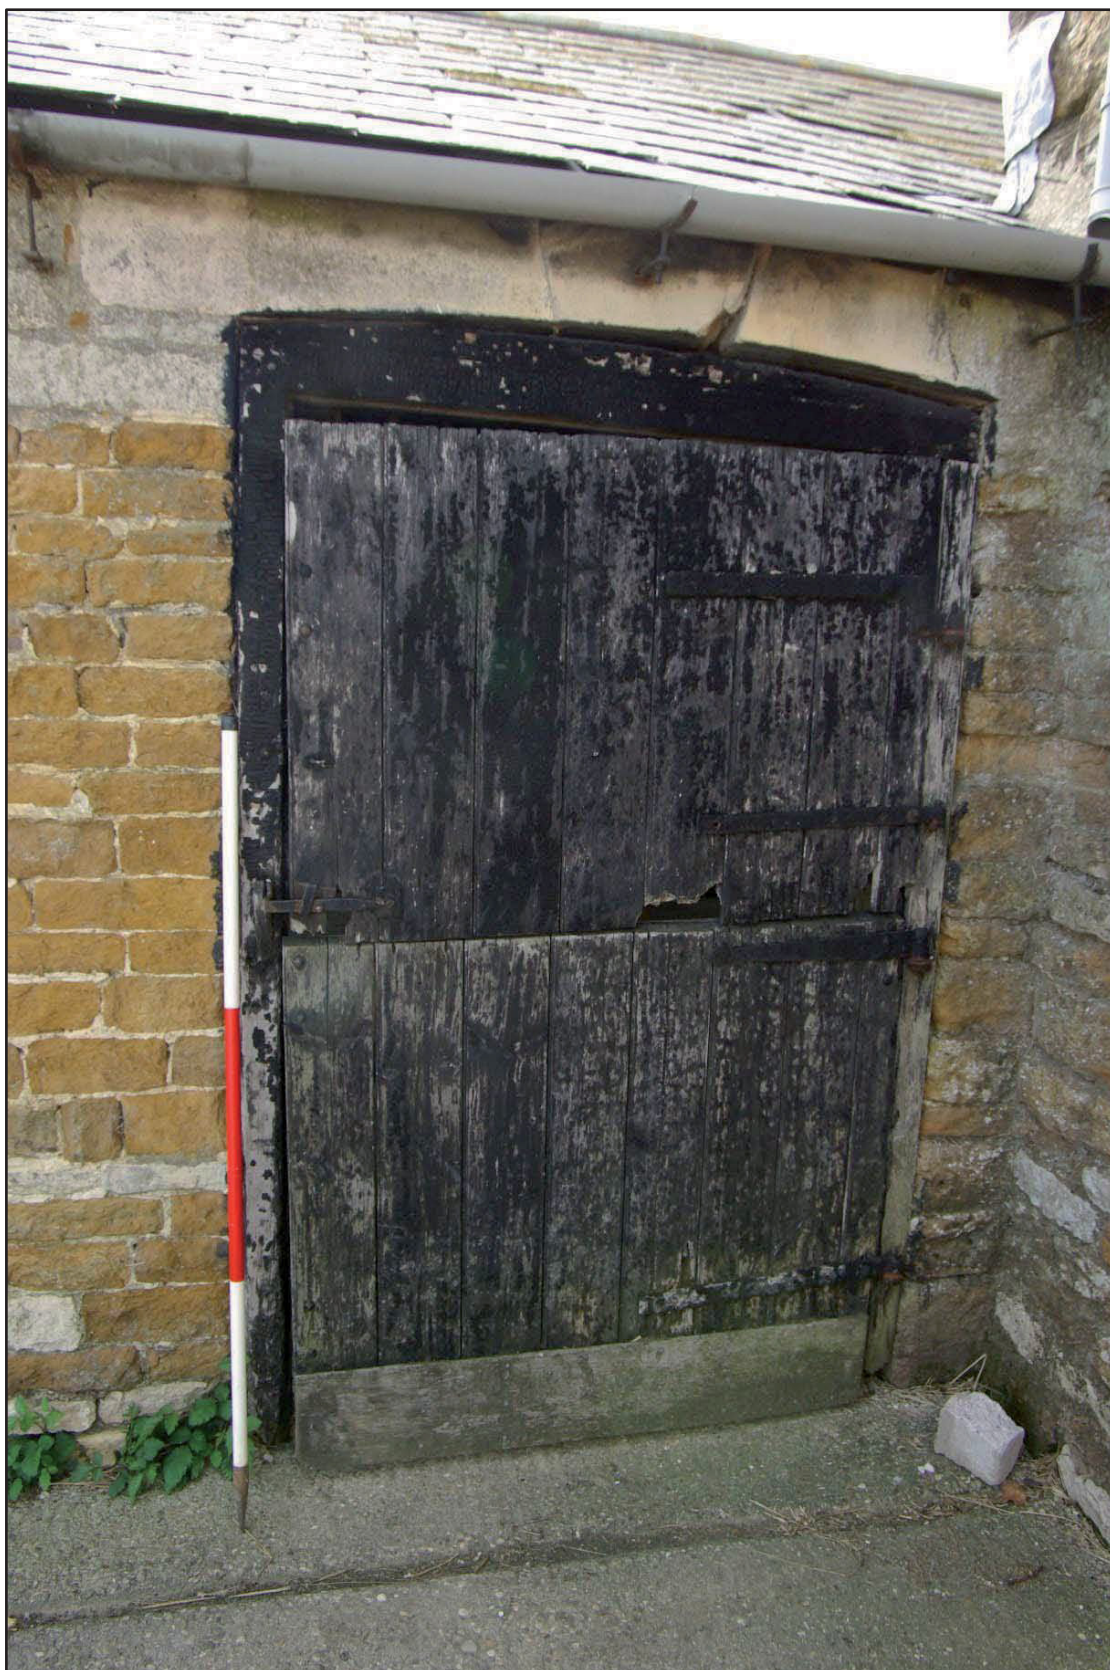
Figure 15: Cattle/cart shed yard door detail
Looking west. 1.5m scale

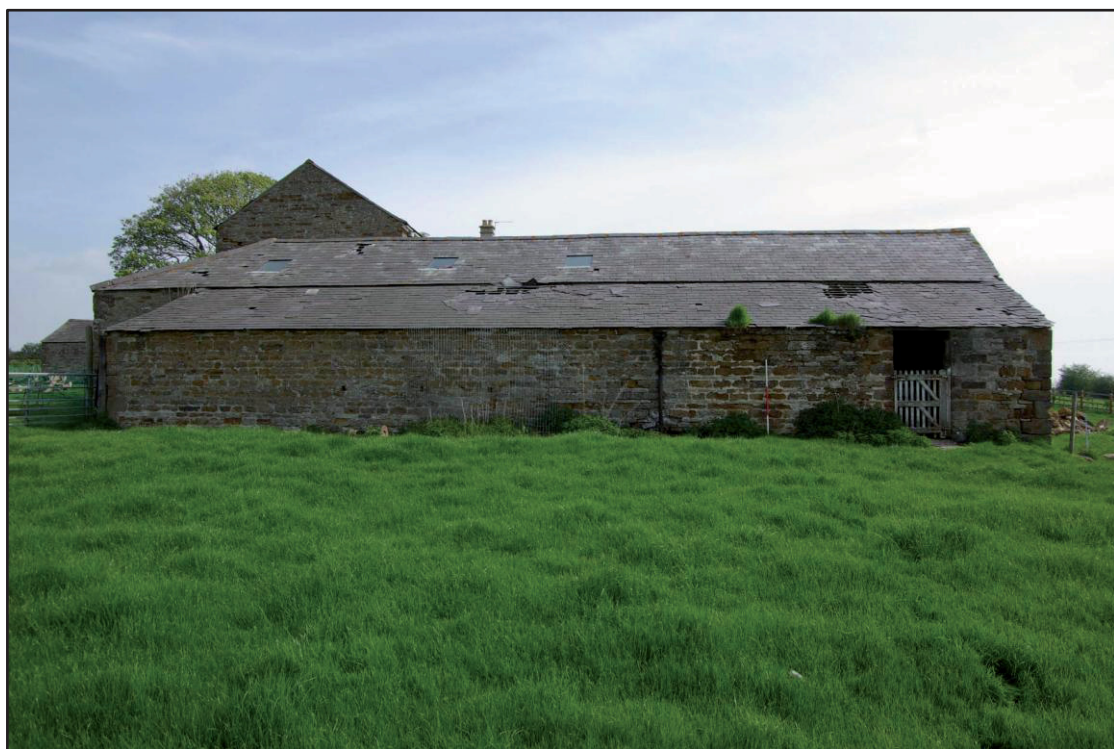
Running along the western side of the cattle shed is a narrow lean-to structure described in the architect's plans as a machinery shed (fig. 16). This is clearly a later addition to the cattle shed as the stonework between the two is not continuous and there is a break in the roofline (fig. 17). The northern gable end is open and there is a small doorway at the south western corner. Inside there is an earth floor and a very simple rafter and truss roof (fig. 18).

Figure 16: Machinery shed, west elevation
Looking east

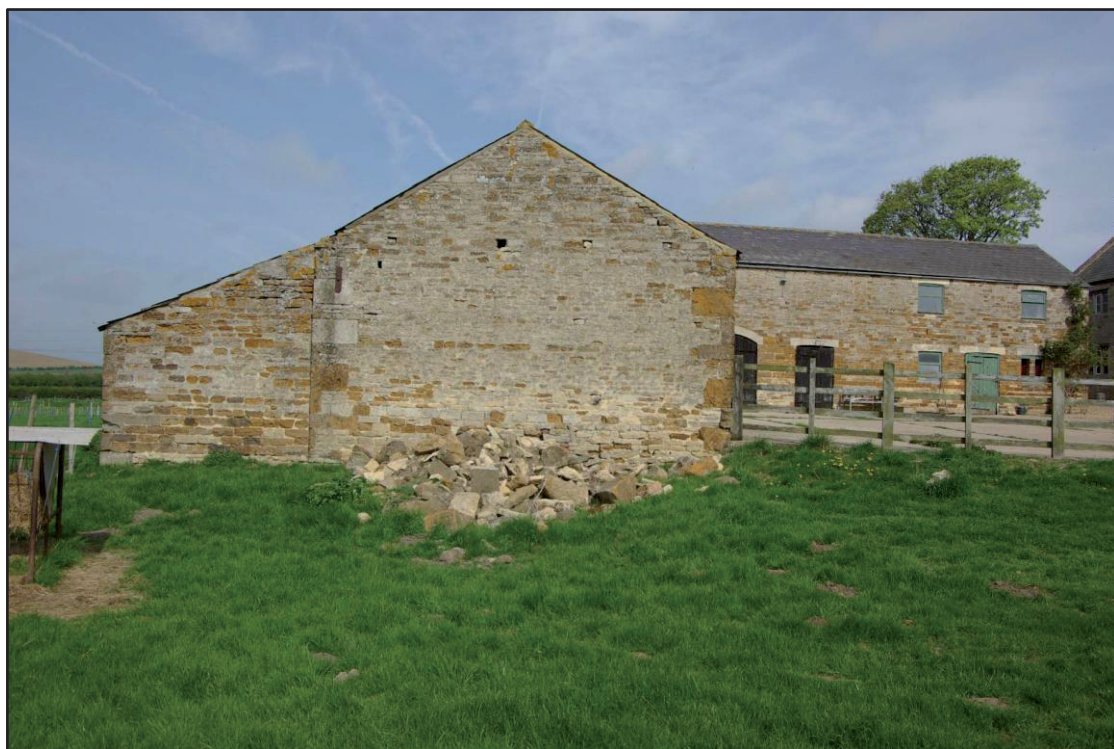
Figure 17: South end of cattle/cart shed and machinery shed
Looking north west

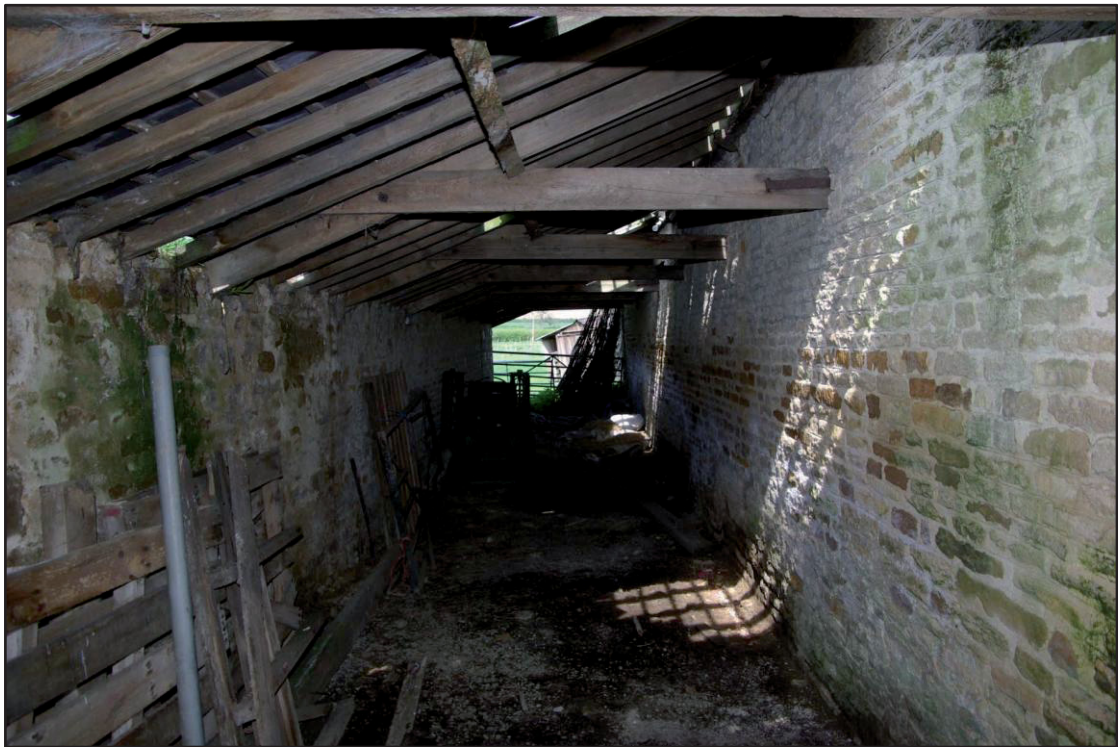
Figure 18: Machinery shed interior
Looking north west

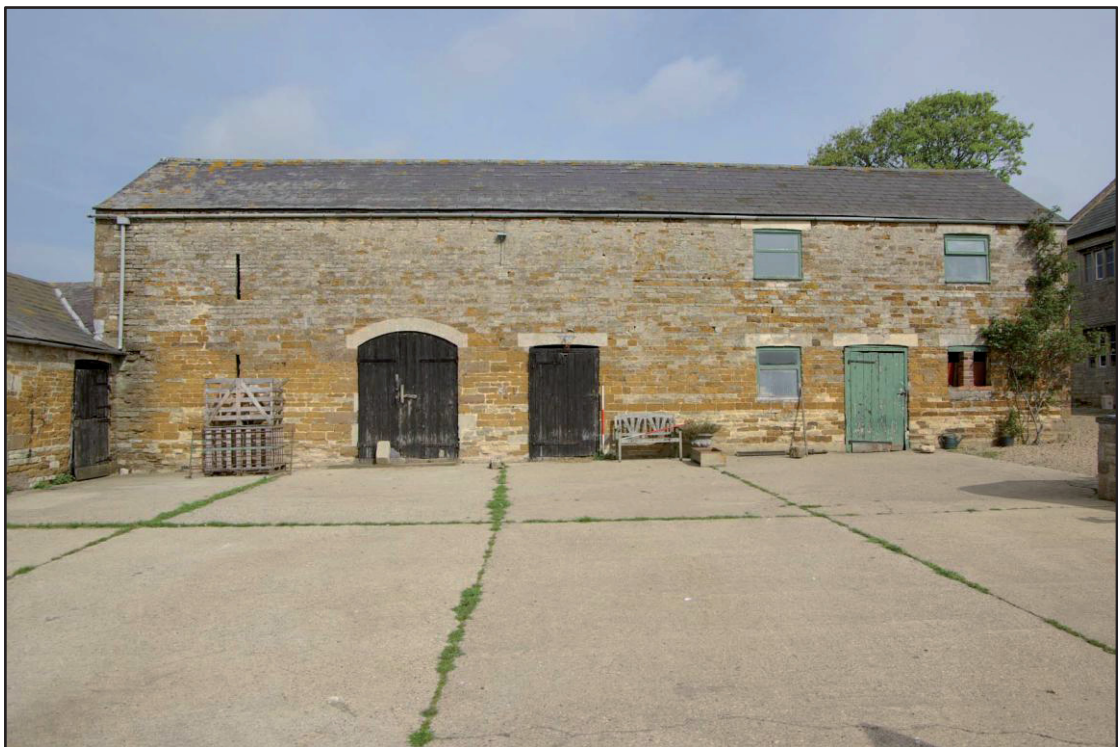
The main barn butts up against the north eastern corner of the cattle shed and appears to be contemporary with it. The main elevation with limestone detailing faces south-east onto the yard (fig. 19). All of the window and door openings appear to be original and no evidence can be seen for any blocked features. The double and single doors leading onto the yard appear to have their original fittings (figs. 20 and 21). Two narrow slit ventilators can be seen one on top of the other at the western end. The barn is divided into three ground floor rooms with a first floor, which appears to be original and may be a hayloft or possibly worker's accommodation, over the easternmost room. An external set of stone steps on the eastern gable end lead up to a doorway to the first floor room (fig. 22). The rear elevation, to the north, has a double and single door matching those on the south with the addition of a hayloft door in the western corner suggesting that a floor has been removed from this half of the building (fig. 23). A slit ventilator similar in style to those on the main elevation is located below the hayloft door. All openings on the northern elevation have limestone lintels. Inside, the westernmost room is open to the roof which has a simple rafter and truss structure (fig. 24). The eastern end of this room has a single height stone wall to create a smaller room within this main room which is accessed via the single doors on each elevation (fig. 25). At the eastern end of the barn is an open stable or cattle pen with brick built troughs and a single wooden partition (figs. 26 and 27).

Figure 19: Main barn, south elevation
Looking north west. 1.5m scale

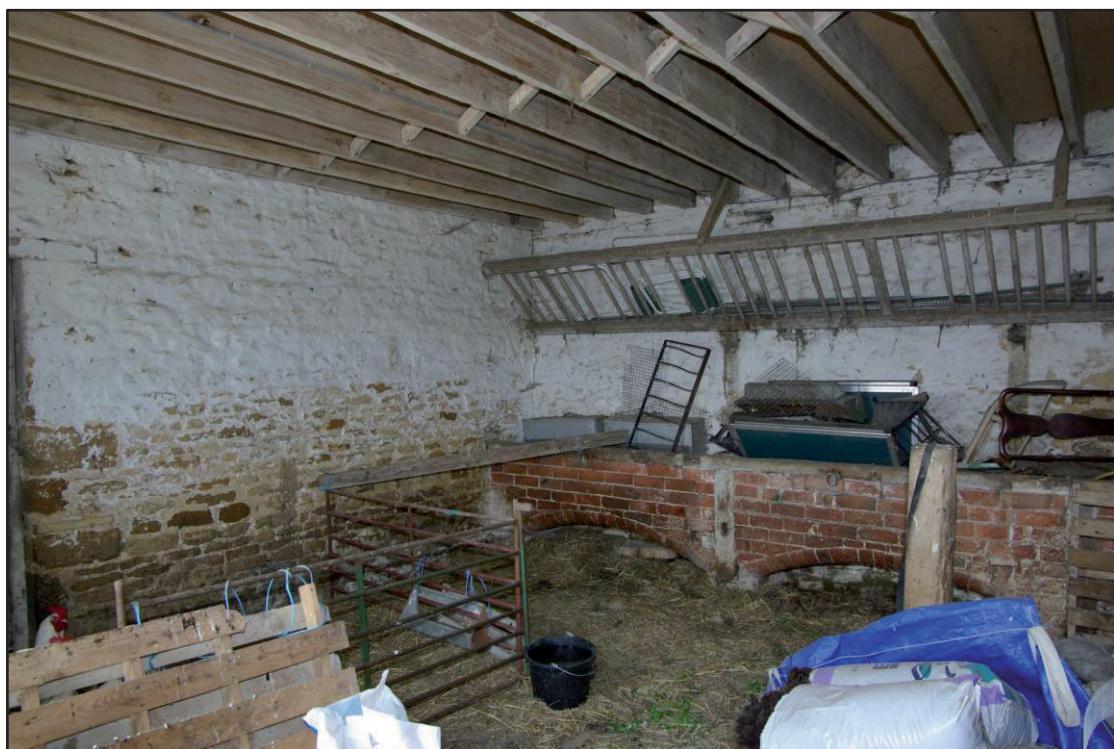
Figure 26: Main barn interior, eastern room
Looking west

Figure 27: Main barn interior, eastern room
Looking east

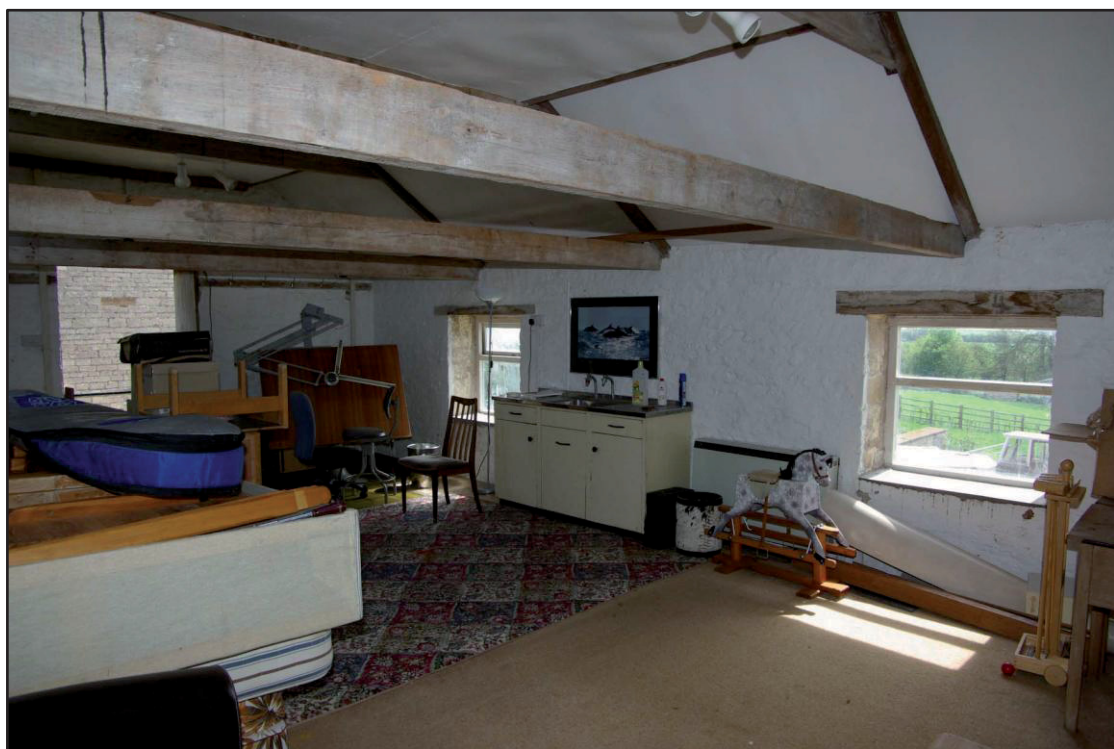
The single upstairs room appears to have been recently refurbished to create a small studio (fig. 28). The roof structure is the same as in the rest of the barn but the eastern truss has evidence of being used elsewhere as there are a number of redundant mortice holes in it (fig. 29).

Figure 28: Main barn, first floor
Looking east

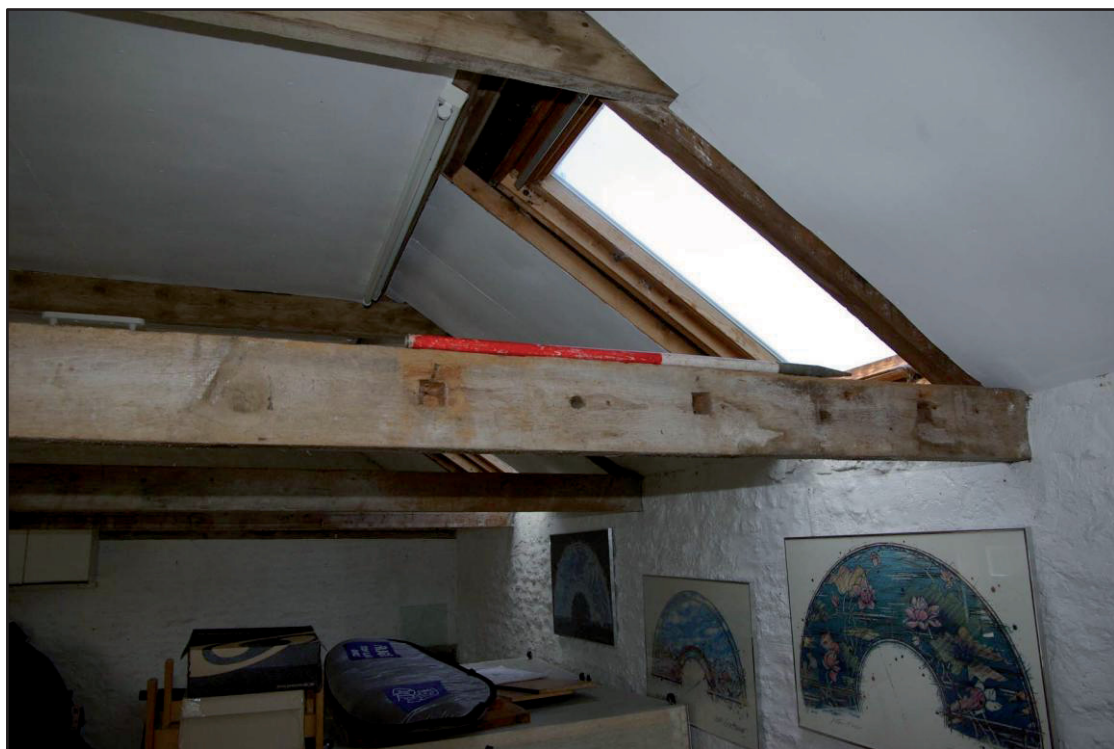
Figure 29: Main barn first floor truss
Looking west. 1m scale

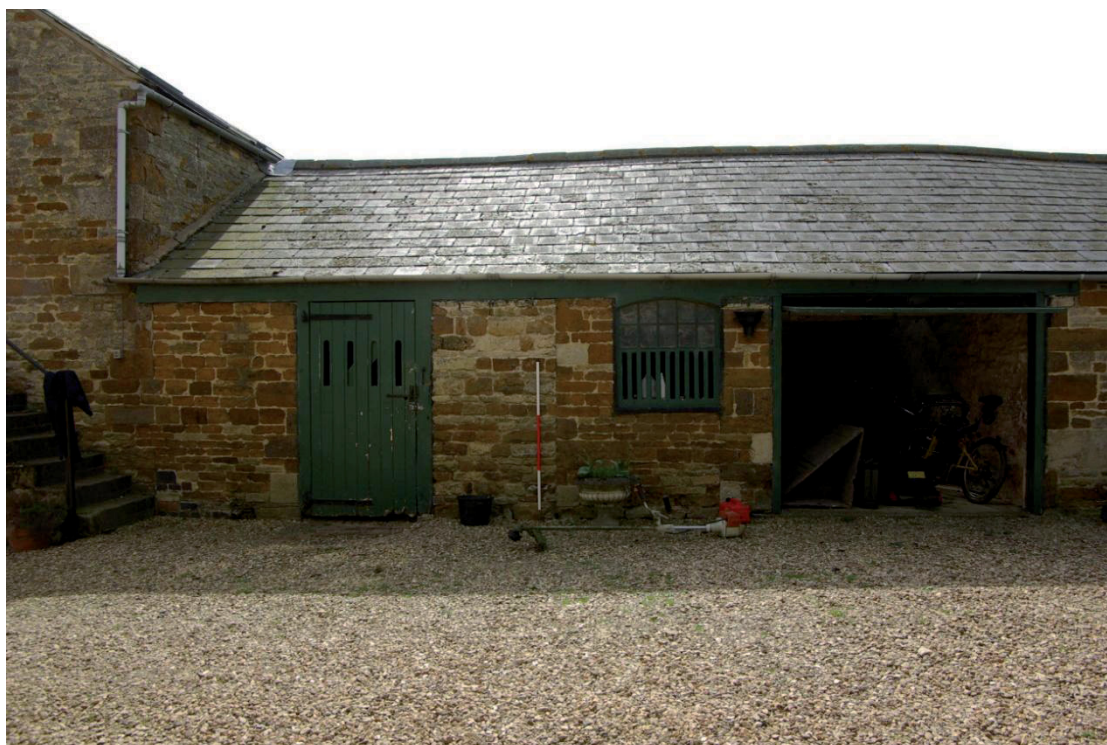
The southern gable end of the stables butts against the north-eastern corner of the main barn (fig. 30). The stonework between the two buildings does not quite match and there is an suggestion of a straight-line joint indicating that the stables are later in date. The western elevation of the stables is fairly plain although the southern half shows some evidence of repointing (fig. 31). The stables are divided into three main rooms with only the southern room retaining its wooden troughs and dividing partition (figs. 32 and 33). The remaining two rooms are currently used as a garage and store room (figs. 34 and 35).

Figure 30: Stables, east elevation
Looking south west. 1.5m scale

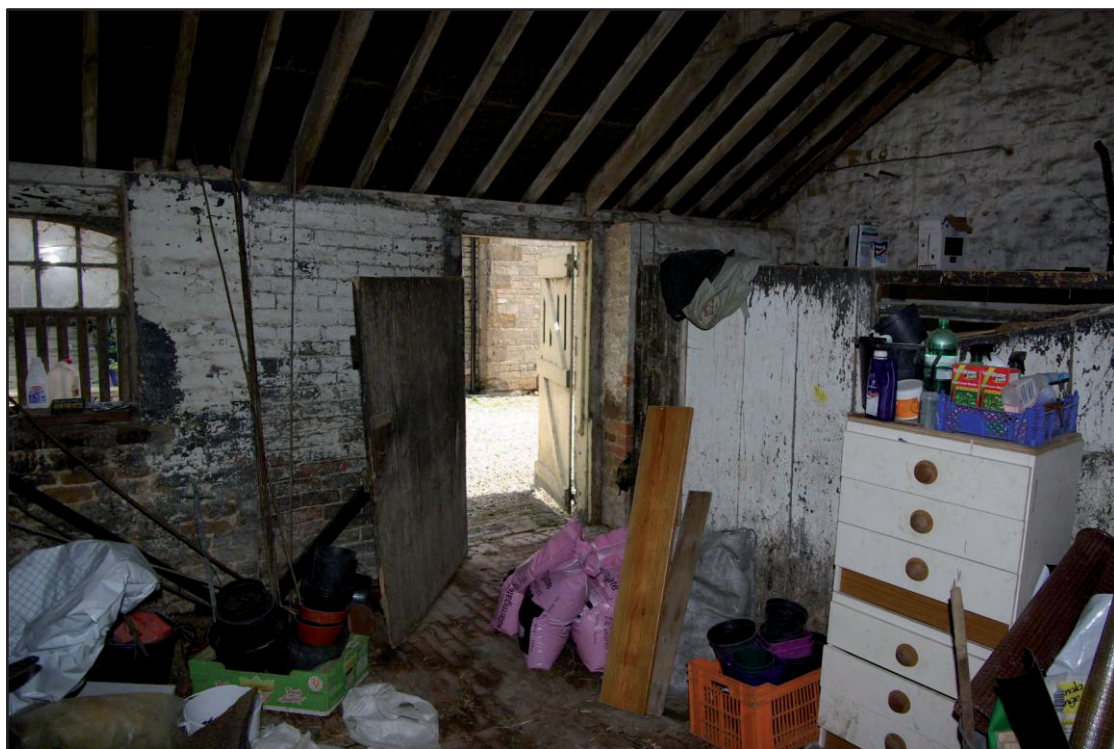
Figure 32: Stable interior
Looking south west. 1m scale

Figure 33: Stable interior
Looking north east

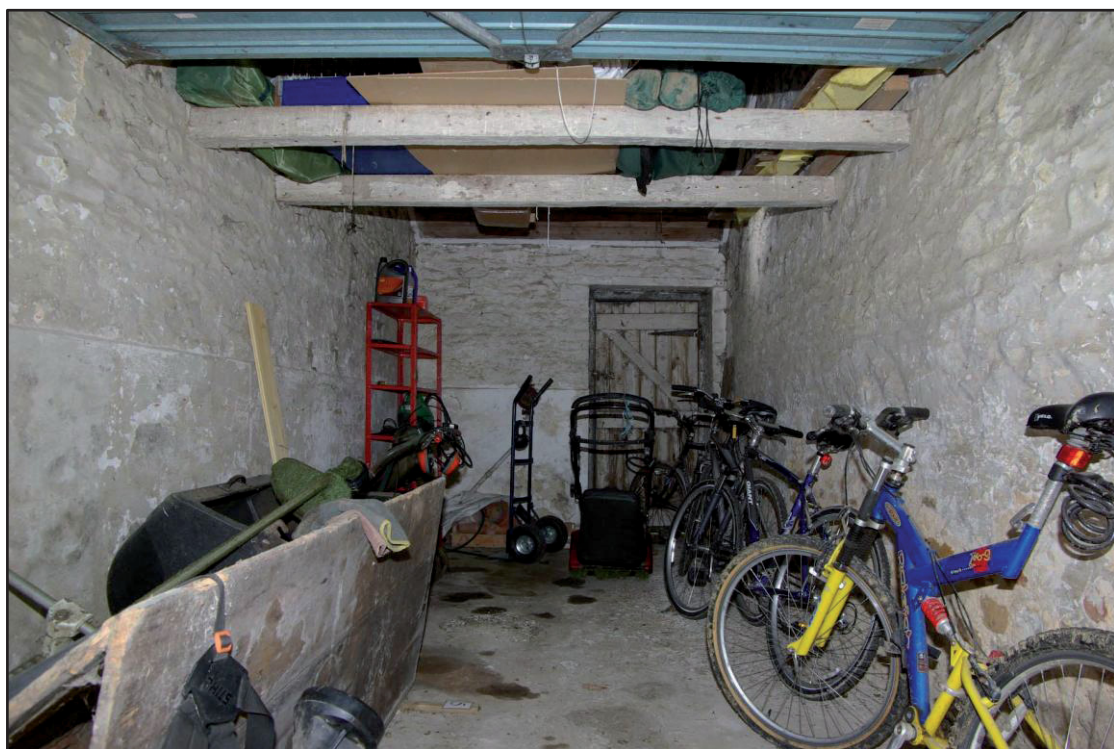
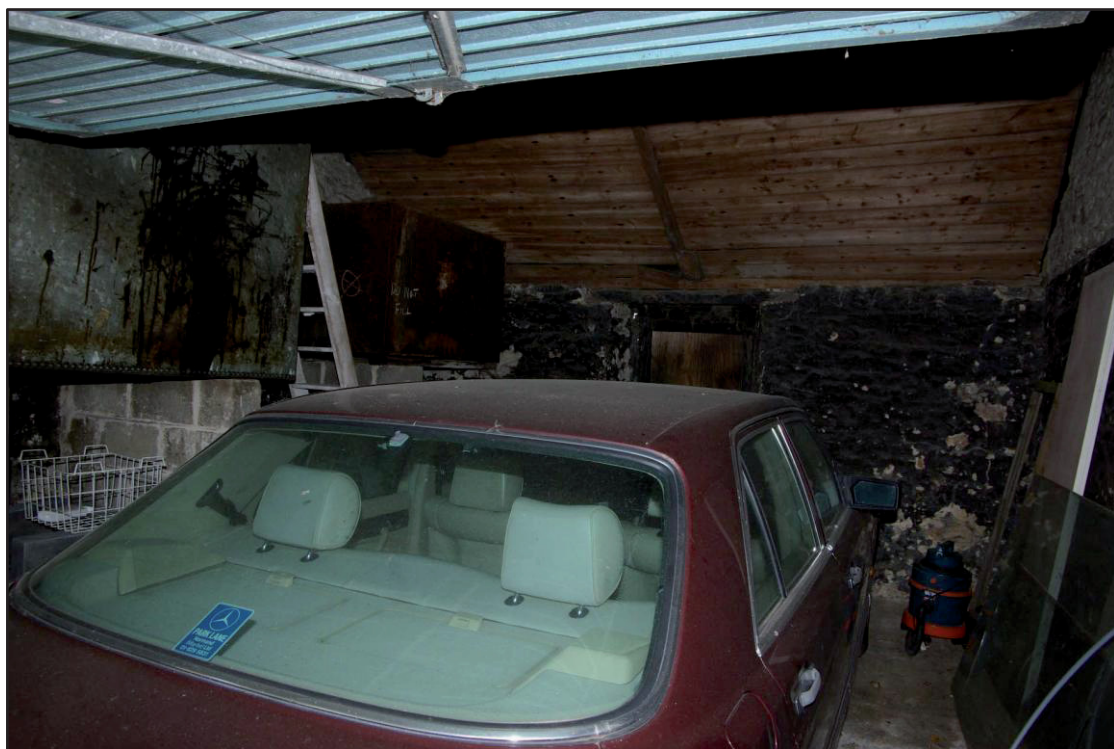
Figure 34: Stable interior, middle room
Looking south west

Figure 35: Stable interior, north room
Looking south west

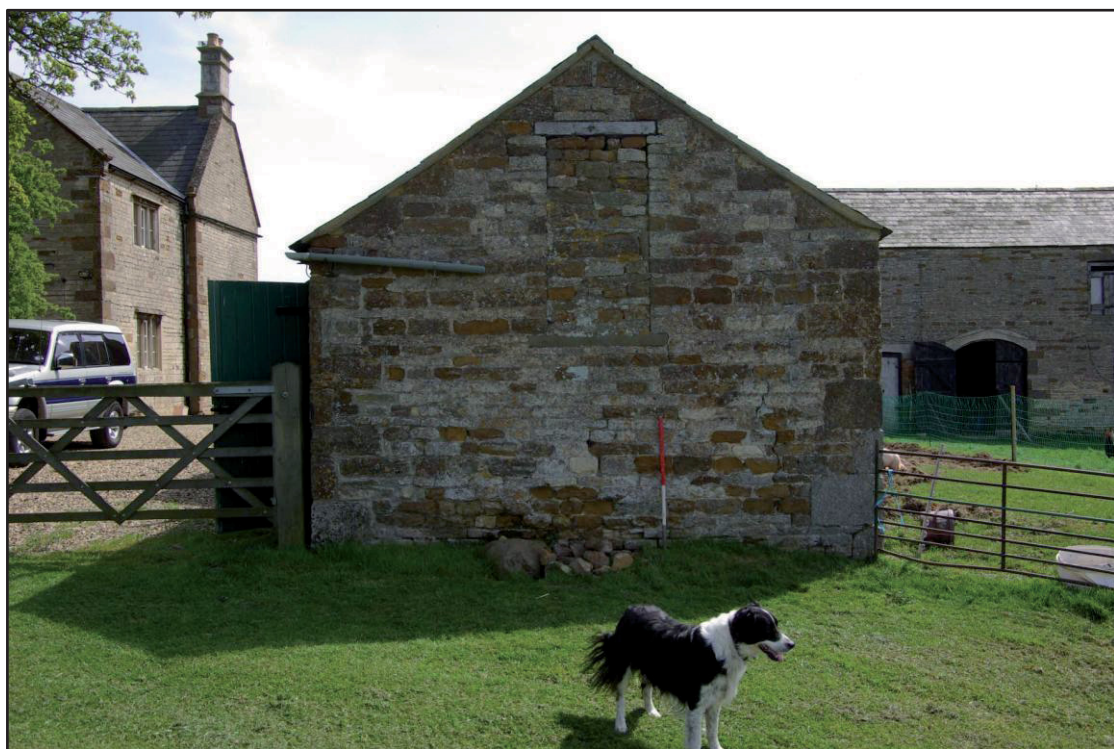
Built onto the northern end of the stables is a smaller outbuilding which is also used as a garage (fig. 36). The gable end has had a rectangular window blocked with stone which can be seen both externally and internally (fig. 37).

Figure 36: North gable of stable range
Looking south east. 1m scale

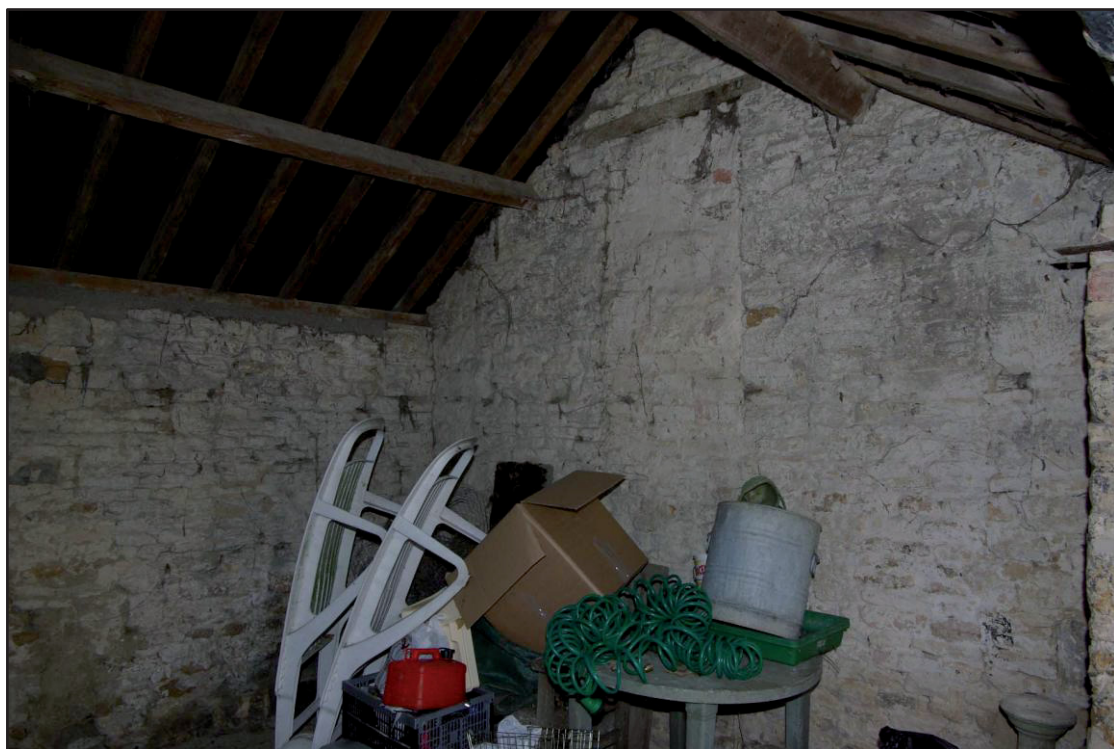
Figure 37: Stable range, end outbuilding
Looking north west
