**Historic Building Survey on
Blaby Road and Canal Street ,
South Wigston,
Leicestershire (SP 590 983)**

For South Leicestershire College

Planning Application No. 07/00511/CON

Report No. 2008-078

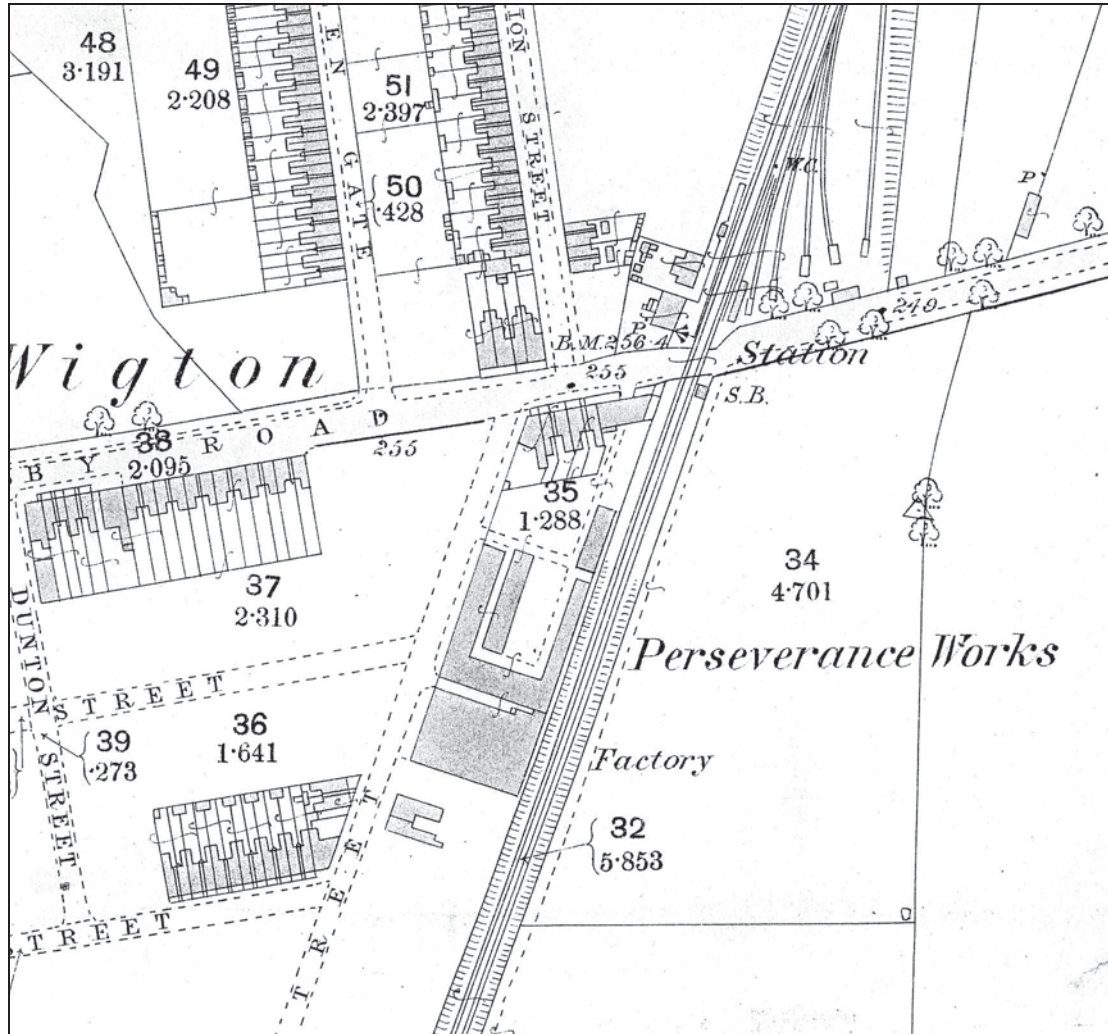
5.2.2 The first edition Ordnance Survey map sheet XXXVII.10 of 1886 (fig.4) shows the layout of the street system surrounding Blaby Road and Canal Street to be in place, with signs of some residential and commercial development. Development of the northern part of Canal Street and the present application area, is largely complete at this time, including terraced shops/houses at 119-127 Blaby Road, and the industrial complex located just to the south, which is marked as Perseverance Works. Further to the south of the works is another industrial building, noted simply as 'Factory'; the remaining development within the present application area at this time are two adjoining properties, presently nos. 28 and 30 Canal Street. The railway line running parallel to Canal Street, to the east of the Perseverance Works, but within the boundaries of the present application area, is the LMSR Leicester-Rugby Branch Line.

Figure 4. First edition Ordnance Survey Map XXXVII.10 of 1886. Scale 1:2500.

The First Edition Ordnance Survey map of 1886 (fig. 4) shows the row of terraces comprising number 4 Canal Street and nos. 119-127 Blaby Road to appear in pretty much their present surviving form, confirming a date of 1884 for their construction. The terraces at 4a -8 Canal Street can be confirmed as being of a later construction date, but were certainly in place by 1914 (fig. 5). Outhouses constructed to the rear of the Blaby Road terraces by 1914 were not standing at the time of the survey and appear to have been demolished after 1992 (fig. 9).

The First Edition Ordnance Survey map sheet XXXVII.10 of 1886 (fig. 4) shows three of the presently extant buildings (Blocks G, I and J) identified as part of the Perseverance Works. Within the central courtyard is a fourth range, parallel to the frontage block G, but not evident within the present structure. To the south of the Works, in the position of the present Block K, is a large rectangular building, noted simply as 'Factory'.

The First Edition Ordnance Survey map sheet XXXVII.10 of 1886 (fig 4.) confirms no.'s 28-30 as the earliest elements of the range and they appear here as two apparently separate buildings of unspecified function. By 1914 (fig. 5), the terrace is complete and there are a variety of structures located to the rear of the frontage range, including the two storey range to the rear of no.28. No change can be seen on the OS map of 1930. By 1955 (fig. 7), Block N and the northlight factory element located to the rear of no. 30 have been constructed as part of the adjacent Vaseledge Works. No.'s 28-30 appear to have been combined to form a single warehouse unit and a structure noted to the rear of no.32 on the OS map of 1930, is marked as a ruin by 1955. By 1971 (fig. 8), all of the buildings, including no.'s 26 and 30, in addition to Block N and the northlight range that were previously part of the Vaseledge Works, have been incorporated into a single industrial complex, noted as a 'Hosiery Works'. The most recent OS survey of 1992 shows no further change (fig. 9).

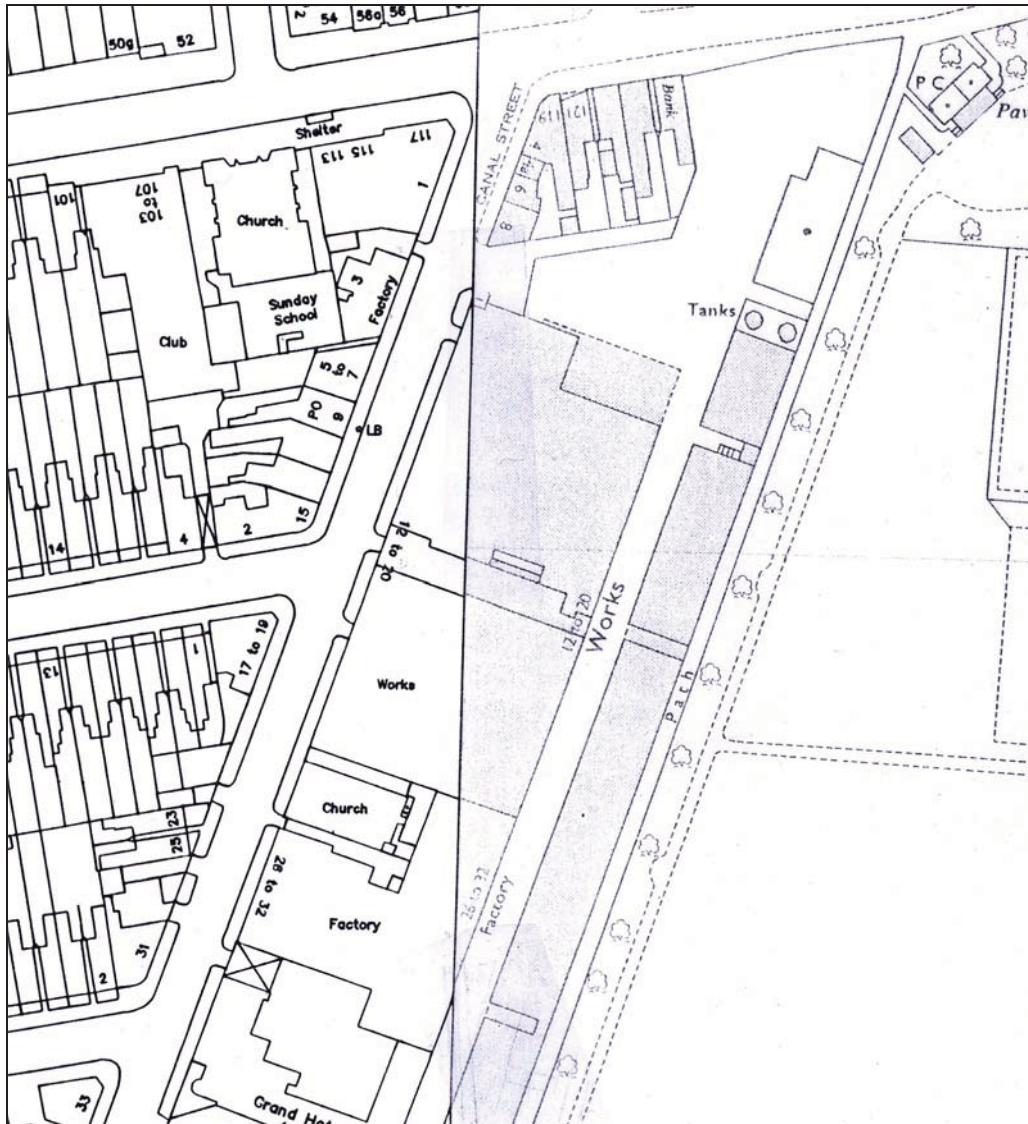
Figure 9. 1992 Ordnance Survey map SP5898-5998. Scale 1:1250.

5.2.7 The most recent Ordnance Survey of 1992 shows the expansion of the Dye Works along the eastern boundary of the site, in to the area left vacant by the dismantling of the former railway line. This expansion appears to comprise a range of long, rectangular warehouse type buildings running parallel to Canal Street along the full length of the development area, necessitating the loss of an earlier warehouse building, constructed between 1914-1930 (see figs. 5 & 6) and the early garage buildings previously located in the north-eastern part of the site.

By 1971 (fig. 8), the buildings are noted simply as 'Works', with Block N (see below) now forming part of a Hosiery Works located at 28-30 Canal Street. The Block E office range now appears at the northern end of the Works, at no. 12-16. The most recent OS map of 1992 (fig. 9) shows no further change to the layout of the buildings, although internal divisions are no longer shown. The Works are given a single address, spanning 12-20 Canal Street.

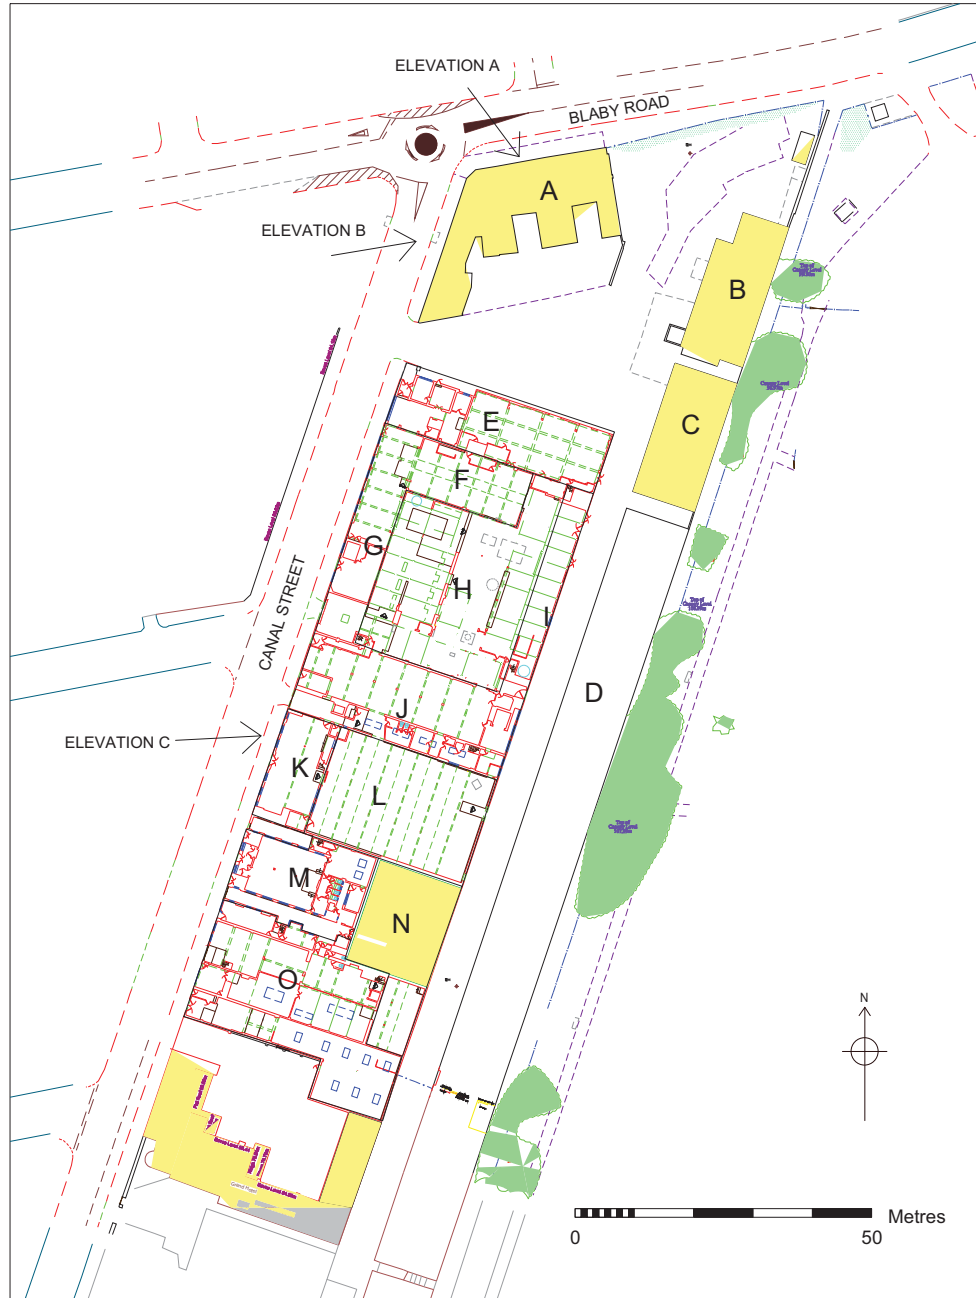
In order to facilitate the planning process, an interim report was issued to the Client and to Leicestershire County Council on the 17th March 2008. As part of the report, a block plan of the development area was created, in order to identify buildings of particular significance. This plan is reproduced below (Fig 10) in order to locate the various built elements subject to survey.

Figure 10. Block Plan of the Development Area (derived from Greenhatch survey).
Scale 1:1250

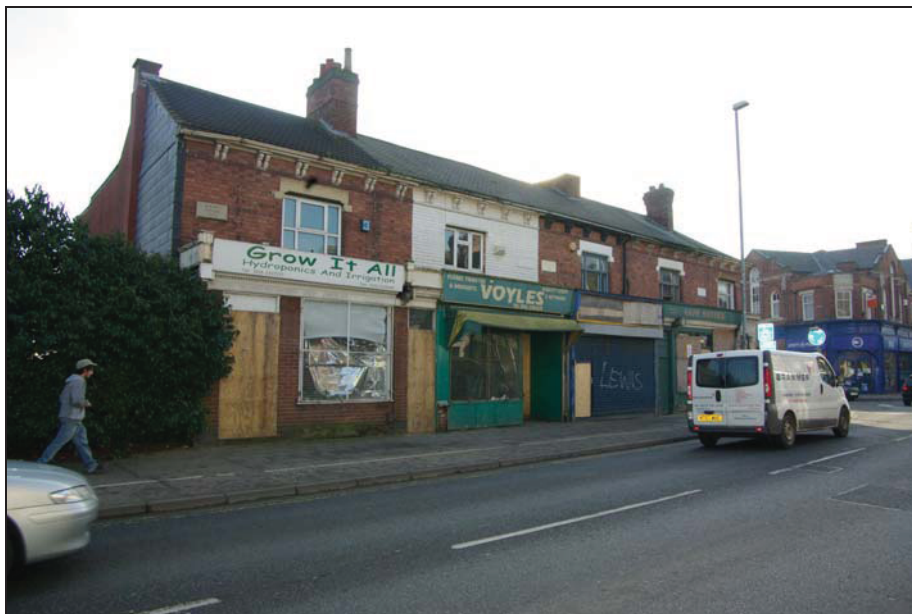
Figure 13. 127-121 Blaby Road, looking south.

Shop frontages to nos. 121-127 Blaby Road are modern, although evidence of early identical timber fascias with moulded and dentilated decoration, located behind the modern shop signs, suggests that the entire row was speculatively conceived for commercial purposes. Early glazed and timber shop windows were also noted at nos. 121 (most recently Café Mendez) and 125 (most recently Voyles Florists). Early timber and glazed sash windows to first floor level have been replaced by modern UPVC double glazed windows to nos. 125 and 127 (most recently Grow It All Hydroponics and Irrigation). Internally, the buildings are in a structurally poor condition and have been subject to vandalism; access was therefore limited and only a basic survey of each was made.

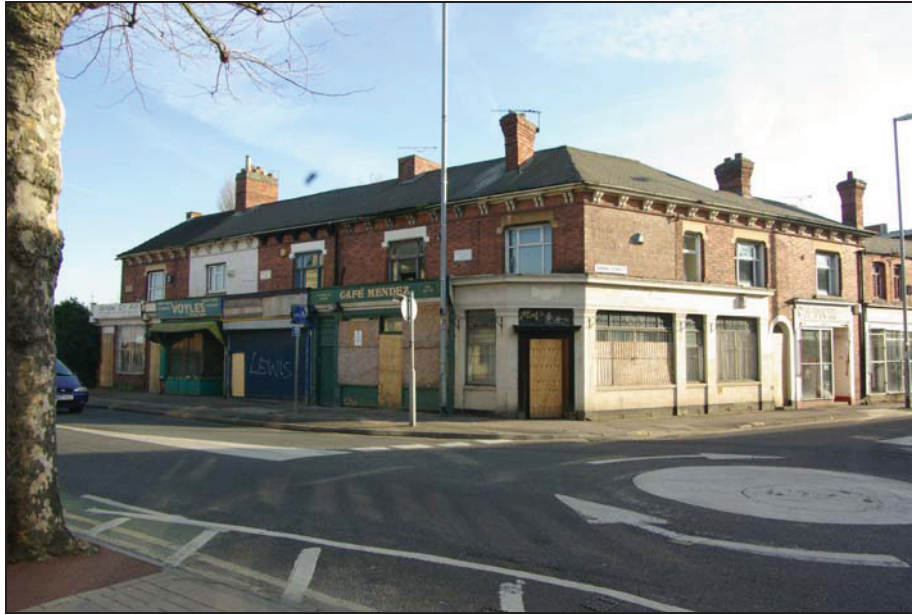
Figure 14. 119-127 Blaby Road and 4a-6 Canal Street, looking southeast.

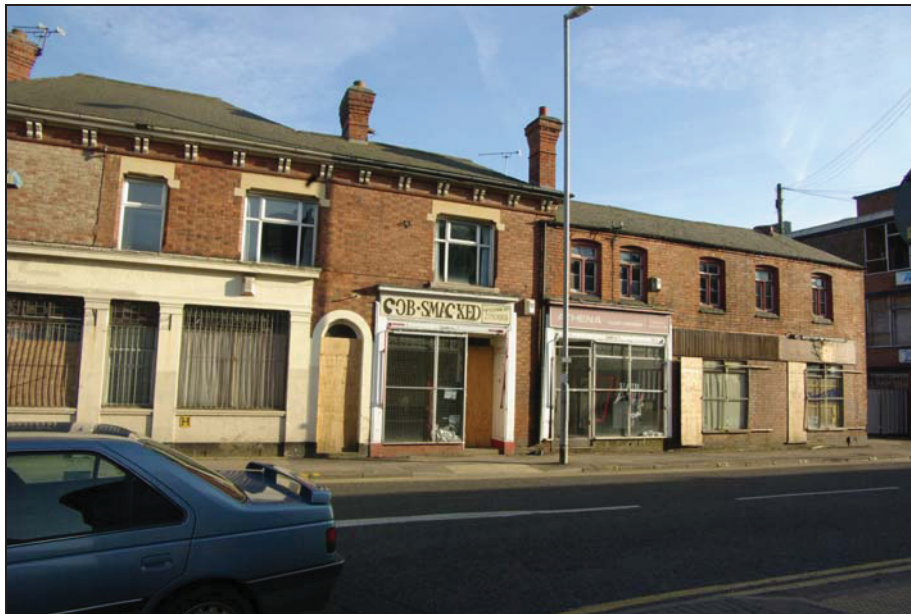
Figure 15. 4, 4a-8 Canal Street, looking east.

The adjacent block at 4a-8 Canal Street is also of two storeys and constructed of red brick, with a slate roof, but is smaller in scale and plainer in style. Ground floor shop frontages (Athena Hair Design at no. 4a and Temptations Massage Parlour at 6-8 Canal Street) are modern; timber and glazed casement windows to first floor level appear early. Internally, no early fixtures or fittings were observed to survive and the rooms had been subdivided with modern partition walling.

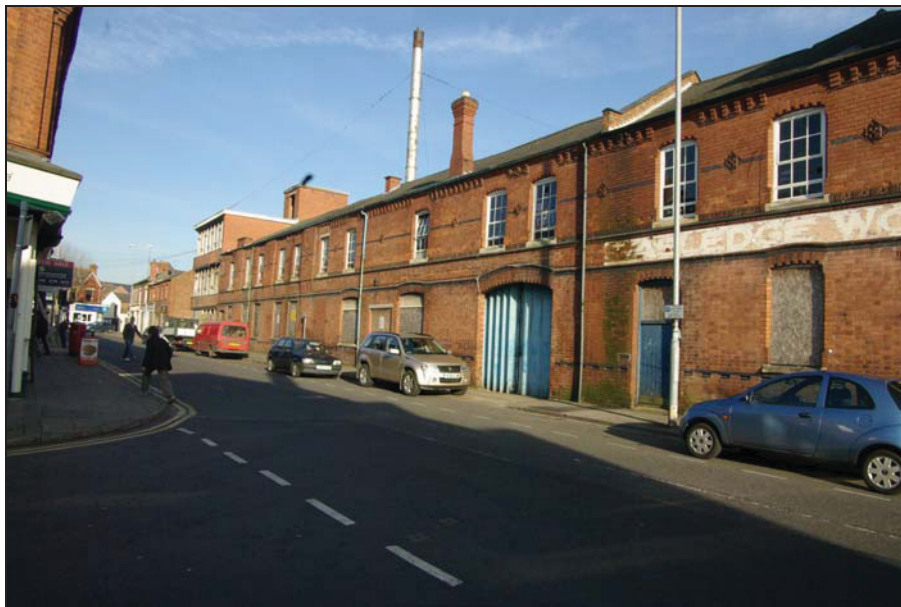
The buildings located at 12-16 Canal Street comprise a range of industrial structures of varying architectural quality and date, most recently occupied by a dyeworks, 'Wigston Dyers Ltd.', but originating as the 'Perseverance Works', which appears on the First Edition Ordnance Survey map of 1886 and represents one of the earliest industrial complexes within the township.

Figure 16. Block G Canal Street frontage, Orson Wright's 'Perseverance Works'.
Looking north.

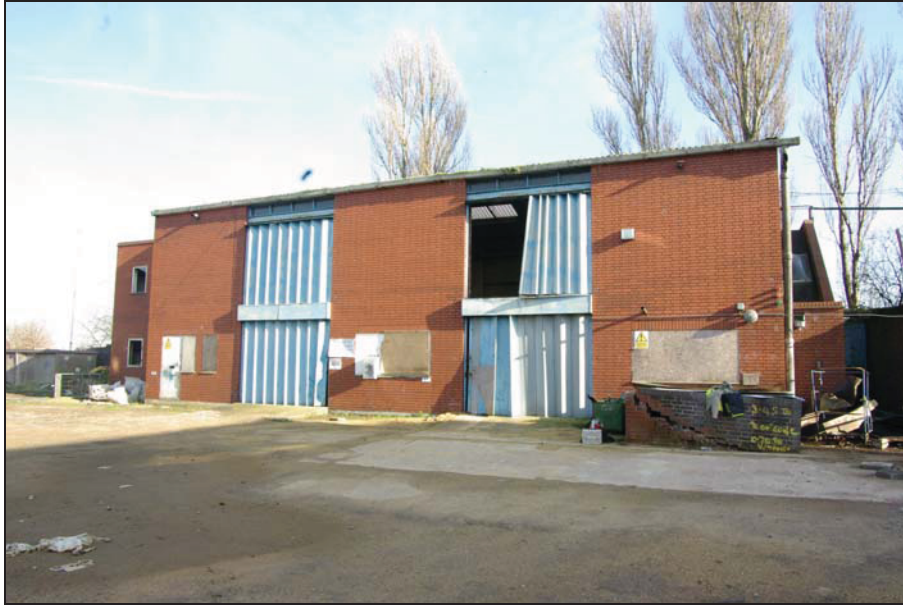
At the time of the building survey, all of the buildings were empty and in a state of dereliction, having been subject to significant attacks of vandalism and arson. Blocks B-D (figs. 10 & 17) consist of recent industrial units of little architectural or historic value, apparently constructed between 1971 and 1992 and are discussed no further as part of this report. Due to concerns over their structural integrity, photographic survey was limited to external shots only. Likewise only a basic photographic survey was undertaken of Block E, which consists of a modern brick and steel structure, built in two phases over three stories as offices and warehouse space for the dyeworks, between 1955 and 1992 (figs. 7 & 9).

Figure 17. Block B, looking east.

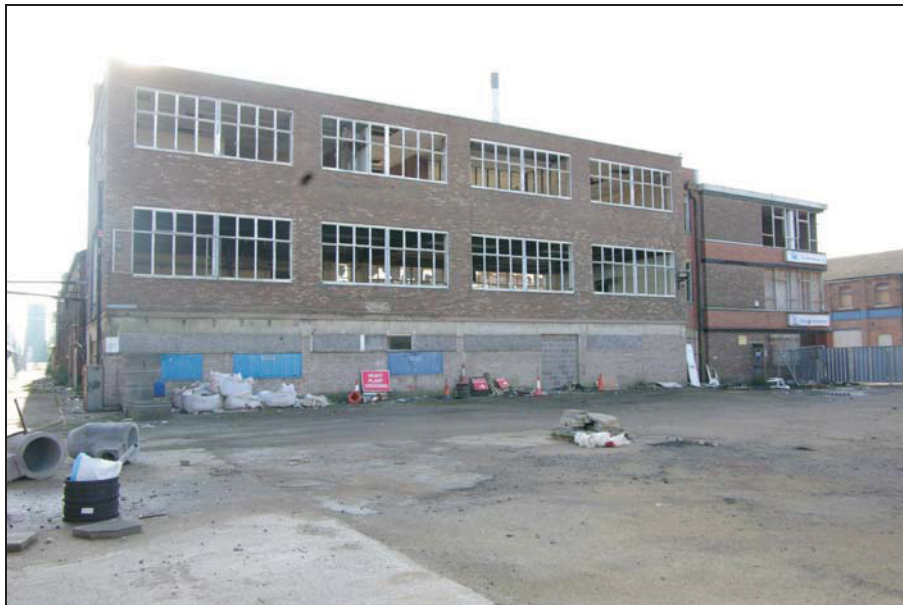
Figure 18. Block E, looking south.

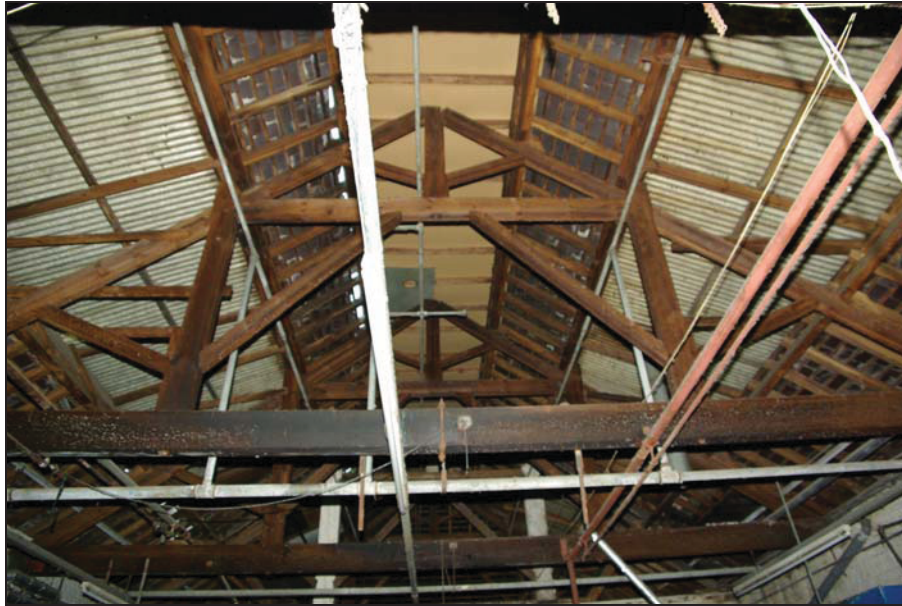
Figure 20. Block F Roof Structure, looking northwest.

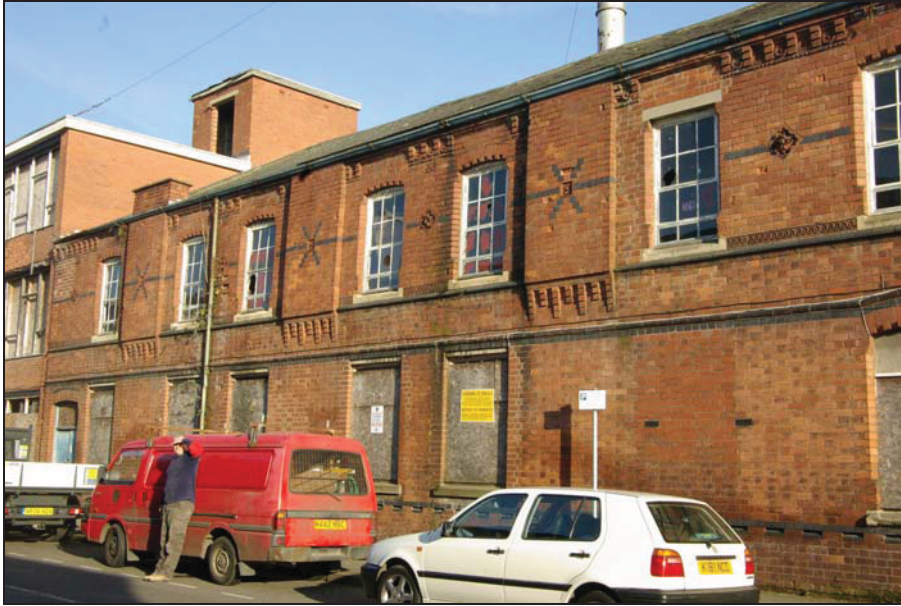
Figure 21. Block G. Decorative treatment to external chimney stacks. Looking northeast.

In addition to the above detailing, the façade also presents such a wide variety of decorative terracotta bricks and tilework, in the form of scrolled banding, egg and dart, fleur de lys and floral motifs, to suggest itself almost as a showpiece for Wright's Wigston Brick and Tile Works, from where the building materials were almost certainly sourced. A painted band running across this building and also across the adjacent three storey factory (Block K below) reads 'Vasledge Works' (with different spelling to the 'Vaseledge' Works referred to in the documentary sources). Roofing material consists of Welsh slate; the hip located at the southern end of the building relates to Block J, which runs at right angles to the frontage block and may be contemporary: there is no vertical join in the façade and no interruption to the decorative banding.

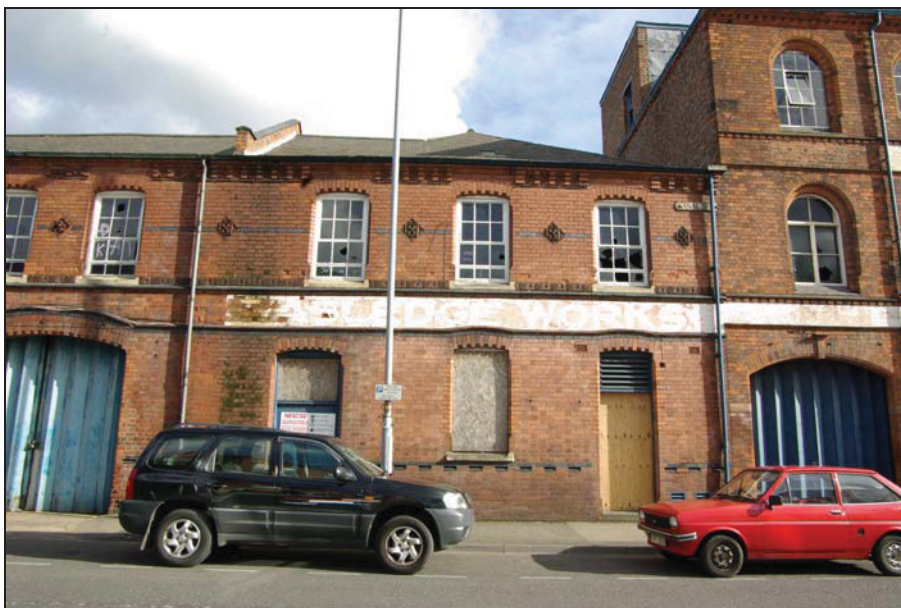
Figure 22. External junction between Blocks G, J and K. Looking east.

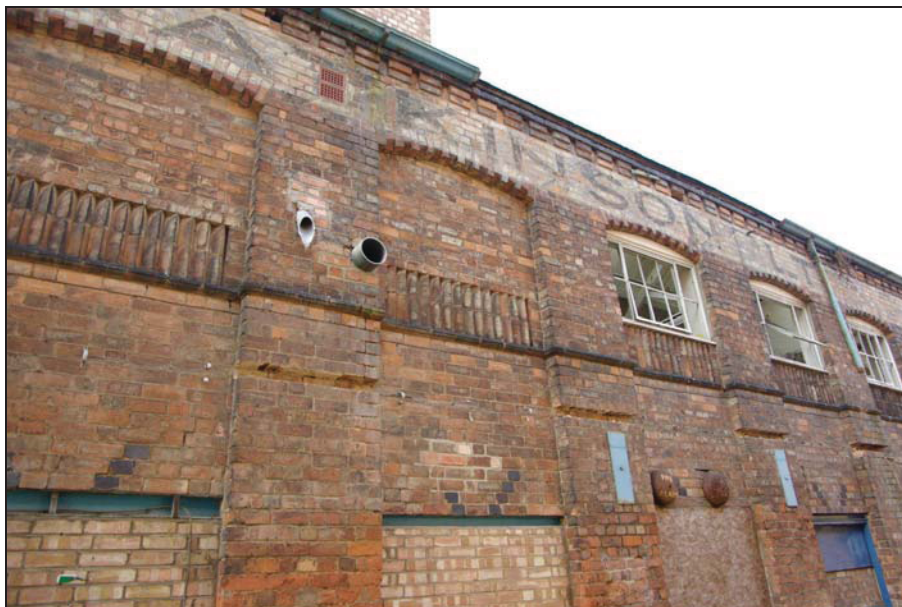
Block I, forming the eastern boundary of the original Perseverance Works, is also two stories in height, with a slate roof supported by 6 timber king post roof trusses. Original fenestration is restricted to the east facing wall and consists of cast iron multi-pane window frames. The east-facing external elevation has some decorative features, including recessed blind windows to the ground floor, with decorative segmental arch heads to first floor windows, blue brick banding with star motif and inset terracotta tiles to match the decorative detailing to the Canal Street elevation of Block G. A painted band, located below the dentilated eaves course, reads 'W. A. Atkinson Ltd', the 'W' no longer visible due to the position of an inserted window.

Figure 23. East facing façade of Block I, showing remnants of decorative brickwork.

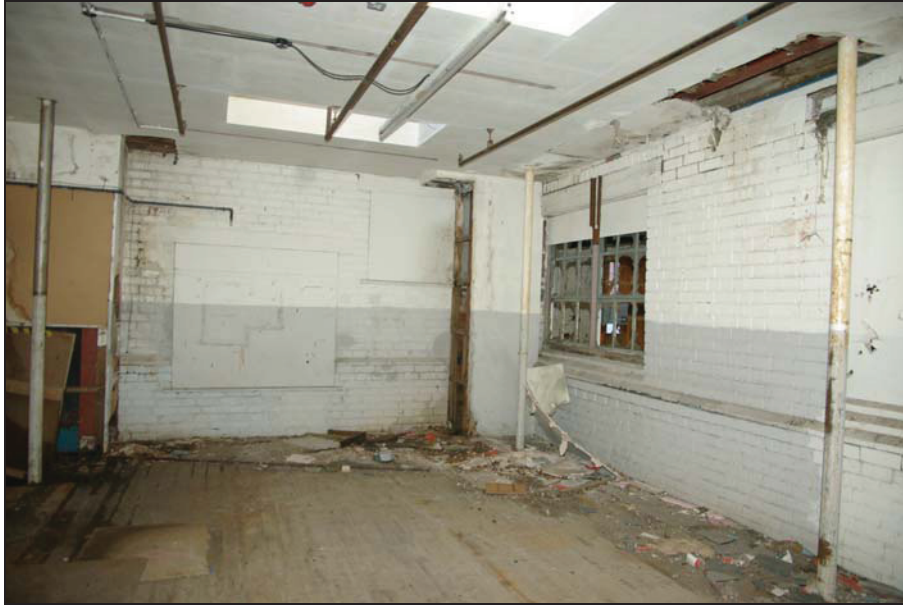
Of the western side of the building, only a short section of wall survives, locating the corner of this and the north-eastern corner of Block J. A projecting chamfered string course that runs around this corner, provides evidence that these were originally external walls (fig. 24), as indicated by the first edition Ordnance Survey of 1886 (fig. 4).

Figure 24. Formerly external walls locating junction between Blocks I and J.
Looking south east.

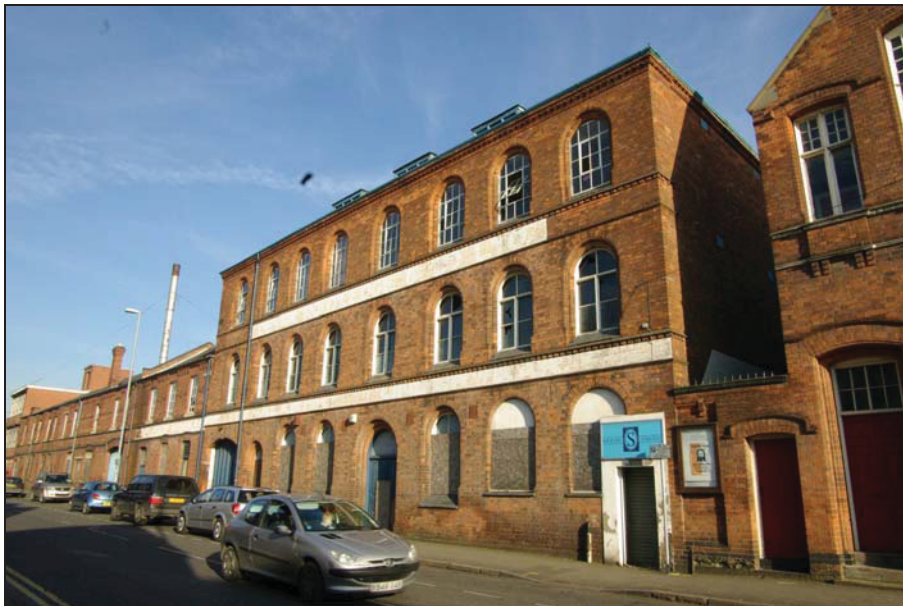
Figure 25. Block K (Benjamin Toone's Factory), Canal Street Elevation. Looking northeast.

The façade is generally simpler in style than the two storey element (Block G) located immediately to the north; there are decorative dentilated brick string courses at the level of the first and second floor window cills and a similar eaves course. Painted bands beneath the upper storey windows have traces of lettering, with 'Devas. Routledge and Co. Ltd' printed beneath the second floor windows and 'Lenalastik Underwear' printed beneath the first.

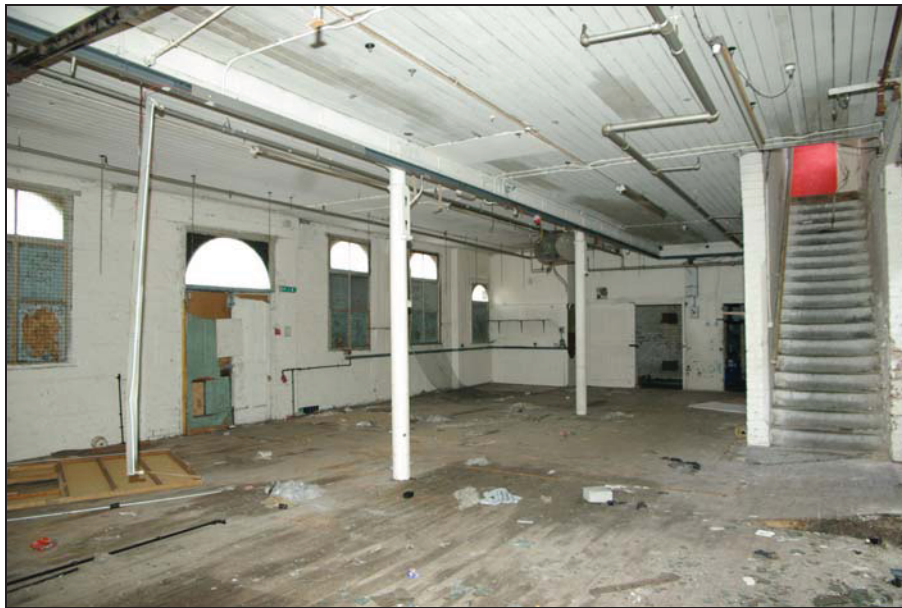
Figure 26. Block K, Ground Floor. Looking north.

Internally, the ground and first floors are open in plan, with timber floors and a row of three cast iron columns, with housings for line shaft bearings, running down the centre of the building. The second floor has been subdivided into a series of smaller units by modern partition walls, but was not accessed due to the suspected presence of broken asbestos sheeting.

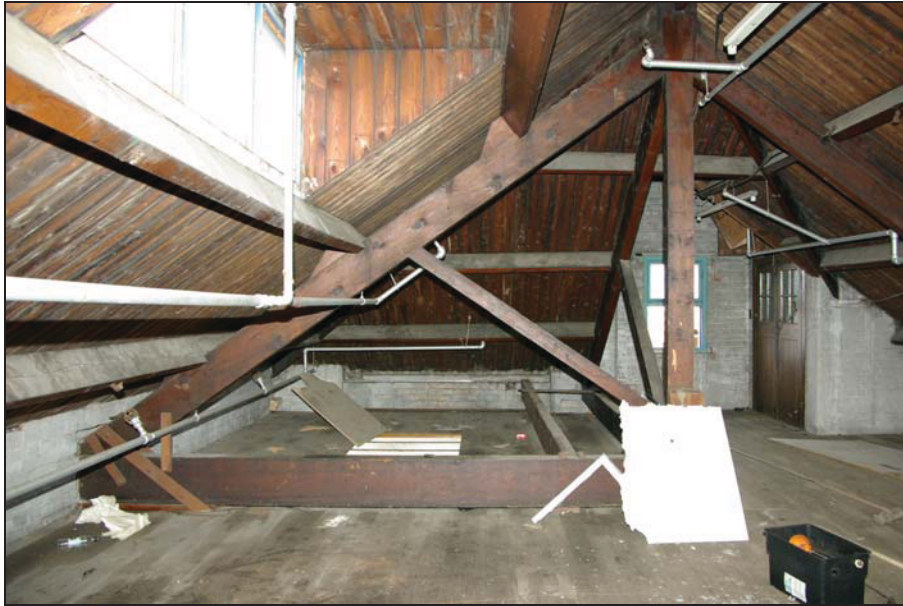
The roof structure is supported by four timber king post roof trusses, visible within the roof space, which is boarded over at the level of the tie-beam. The roof appears originally to have been hipped at ends, the northern end having been subsequently modified to accommodate the lift-winding mechanism.

Figure 27. Block K, modified hipped roof structure. Looking north.

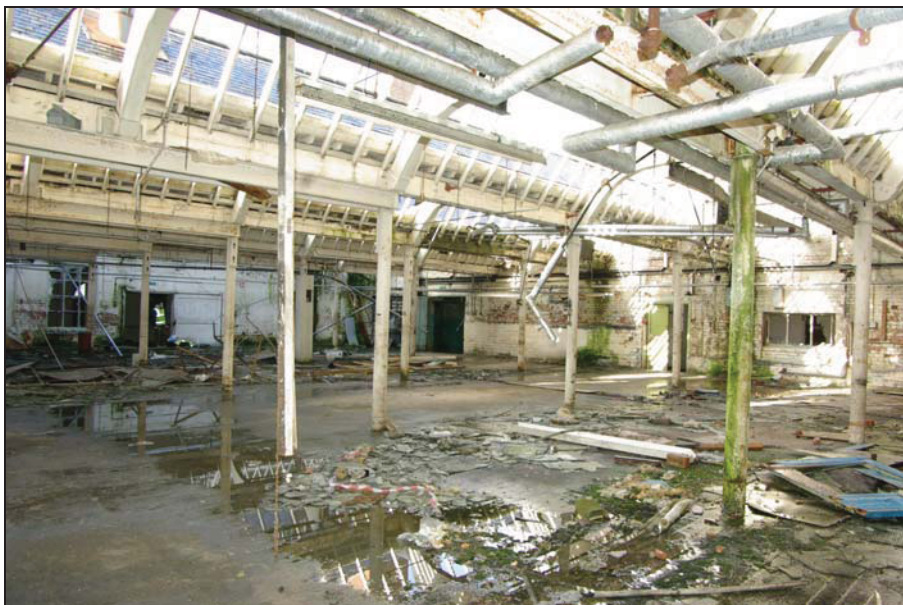
Block L consists of a single storey northlight factory, presently accessed by inserted openings through the rear wall of Block K. Access into the building was limited due to concerns over health and safety and only a basic photographic survey was undertaken.

Figure 28. Block L, northlight factory to rear of Block K. Looking northwest

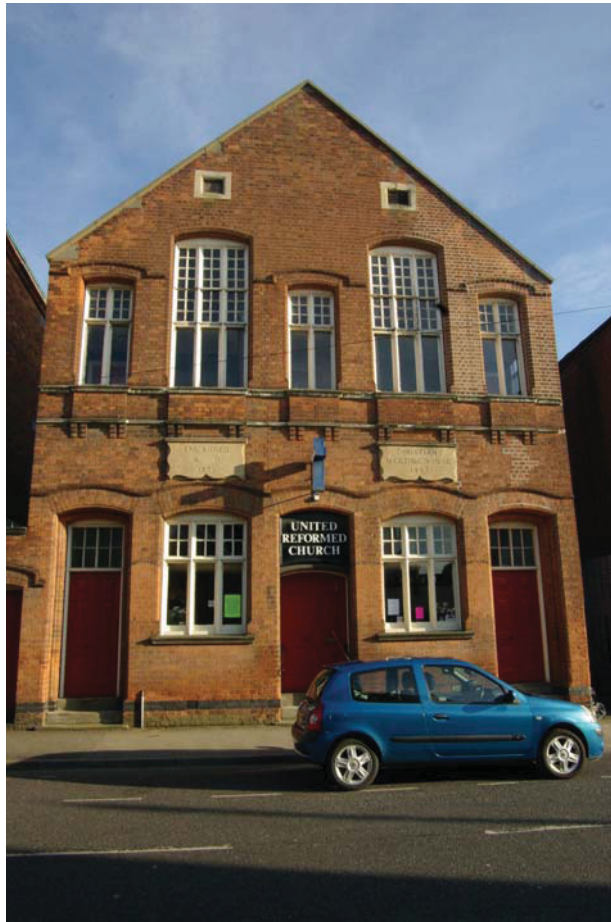
Figure 29. United Reformed Church, looking east.

The United Reformed Church is an imposing building of two storeys plus basement, constructed of red brick, with a slate roof and built with gable end facing onto Canal Street. Plaques inset into the brickwork between ground and first floor windows are inscribed 'Christians Meeting House 1887' and 'Enlarged A.D. 1892'. Gated access on the northern side of the main building leads to a small courtyard, providing further access into a modern extension, comprising a stairwell, reception and a kitchen, located to the rear of the chapel. The main entrance, located in the centre of the façade, housing double timber panel doors, leads into the church, located on the ground floor of the building. Further doorways on either side of the main entrance provide separate access points to the first floor reading room.

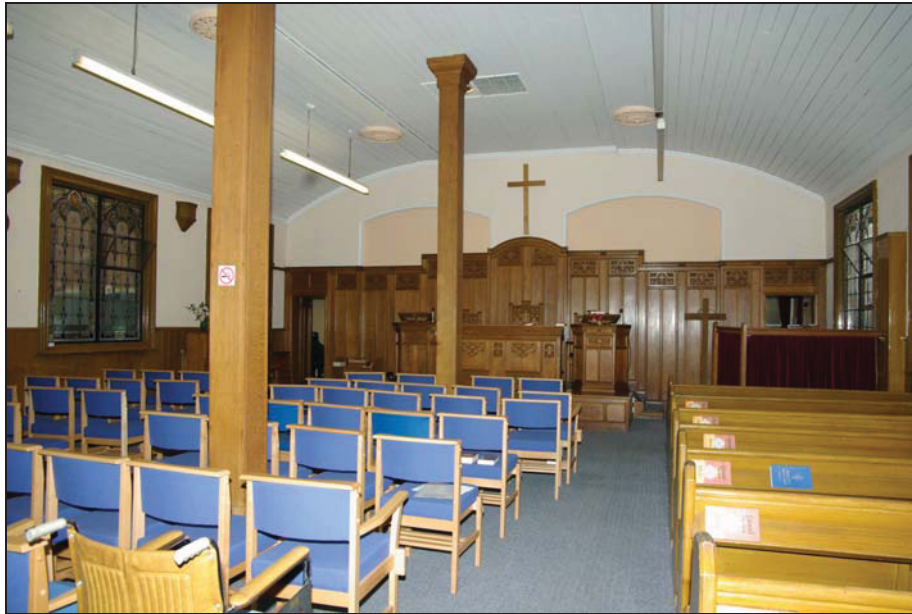
Figure 33. Ground floor, looking east.

The ground floor church room is of open plan, with two large oak-clad pillars located centrally, supporting a timber vaulted ceiling. The internal fixtures and fittings, comprising altar platform, panelling and pews are of oak. Stained glass windows are set within the window openings located within the side walls. Flanking the altar, at the eastern end of the building are a pair of doorways: the door on the southern side leads into the vestry and toilet block, contained within the original build. The doorway to the north of the altar leads into the reception room and kitchen, contained within the modern extension. From the kitchen, a further doorway leads to a rear courtyard, containing early outbuildings and the entrance to the basement boiler house, which runs beneath the vestry.

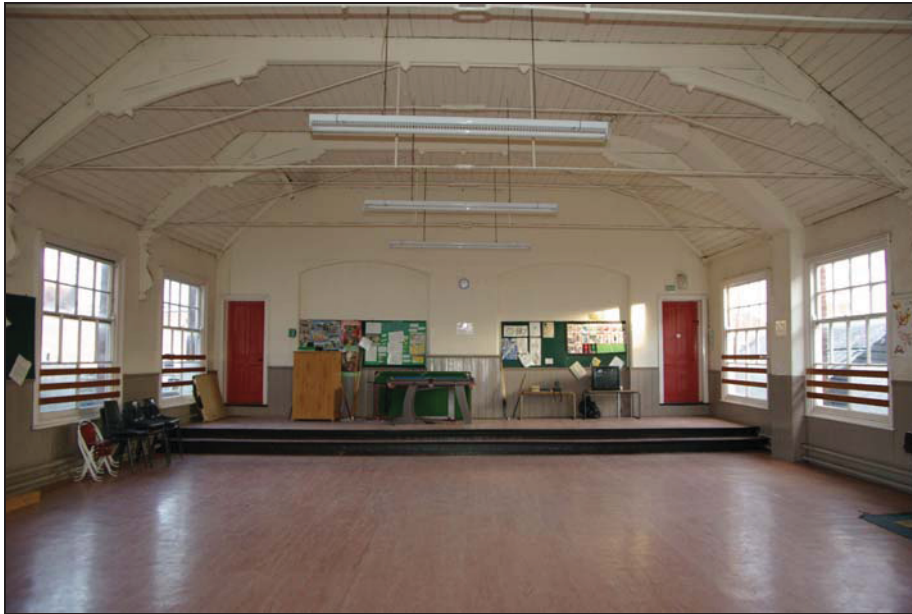
Within the modern entrance vestibule, stairs lead up from the ground floor to a mezzanine level located above the vestry and toilet blocks, contained within the original build. The mezzanine is divided into two rooms, presently used as a library and an office. The rooms are separated by a single flight of (early) stairs, with moulded handrail, leading to a first floor landing area located on the southern side, and a separate room located to the north, presently used for the storage of childrens' toys and Sunday School paraphernalia. Doorways from the storage room and the landing area lead into the main reading room, to mirror the arrangement on the ground floor.

Figure 34. First floor reading room, looking east.

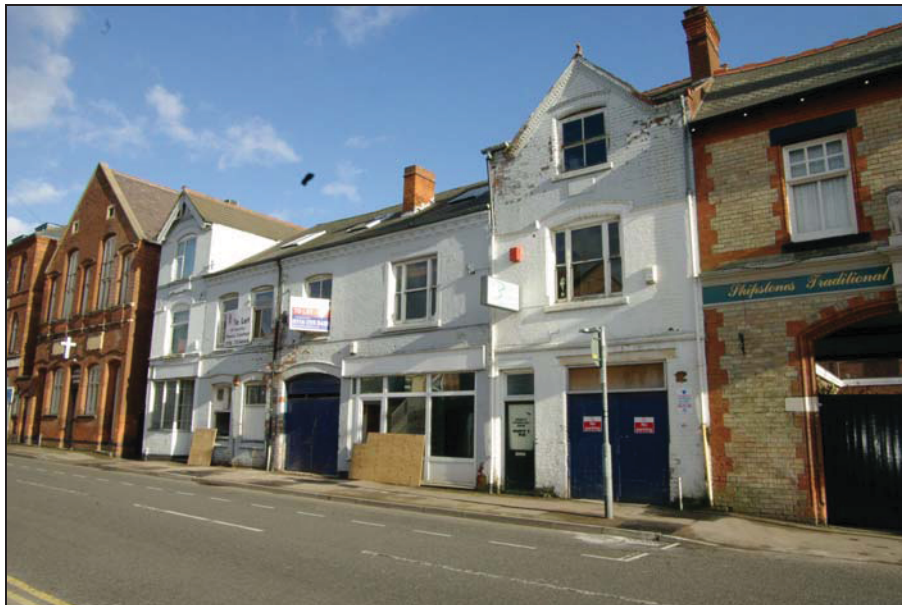
Figure 36. 26-32 Canal Street, looking north-east

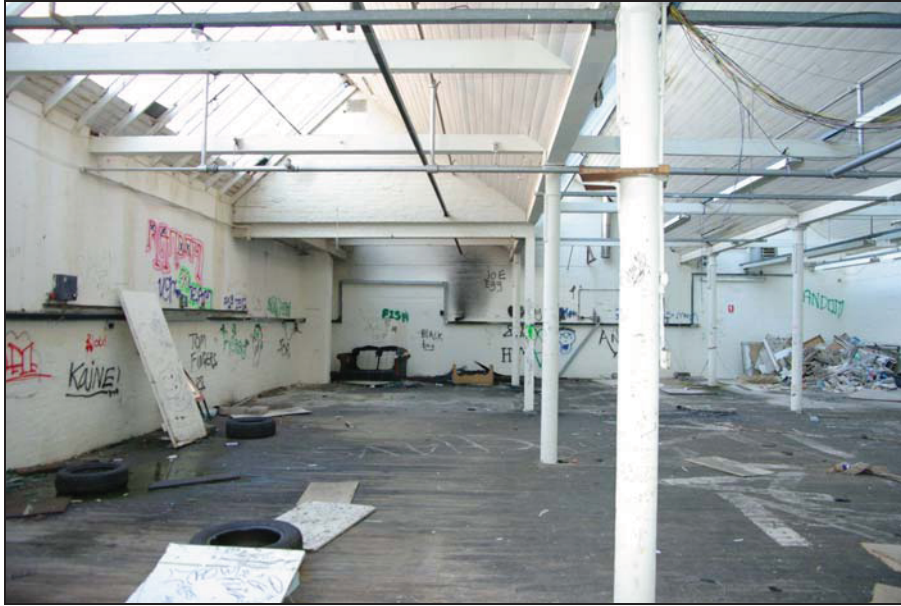
Block N consists of a single-storey northlight factory building, located to the rear of the United Reformed Church and presently accessed via a courtyard entrance between the church and no. 26 Canal Street. Two rows of cast iron columns, each with a bracket for line shaft bearings, are located along the centre of the building, supporting the timber and glazed roof structure. Blocked doorways located on the northern and southern end walls indicate former communication with the northlight factory elements Block L (above) and to the rear of no. 30 Canal Street, Block O (below).

Figure 38. Block N Northlight factory, looking north

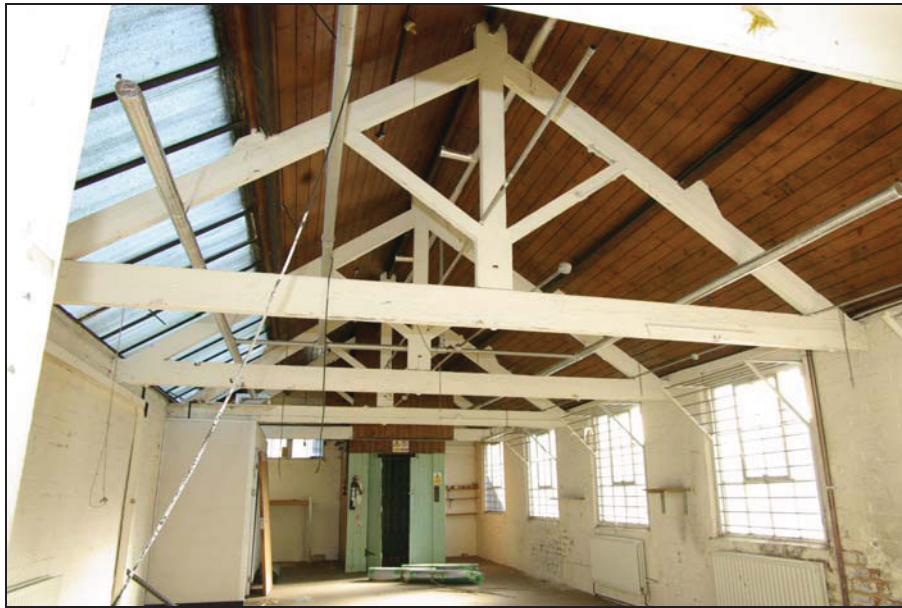
No. 28 appears to have been most recently occupied by a printing firm, and is industrial in character, being of open plan at ground floor level, with a concrete floor and overhead I-beams supported on brick piers to carry the timber first floor structure. A range to the rear of the Victorian building appears to be later. At first floor level, no. 28 is open to the rafters; the roof structure of the frontage range is supported by two wide-span timber queen-post roof trusses, with king-post rising from the strainer beam. The roof structure of the range to the rear, running at right angles to the frontage, is supported by a series of smaller king-post roof trusses.

Figure 39 .King-post roof trusses to rear workshop at 28 Canal St, looking east.

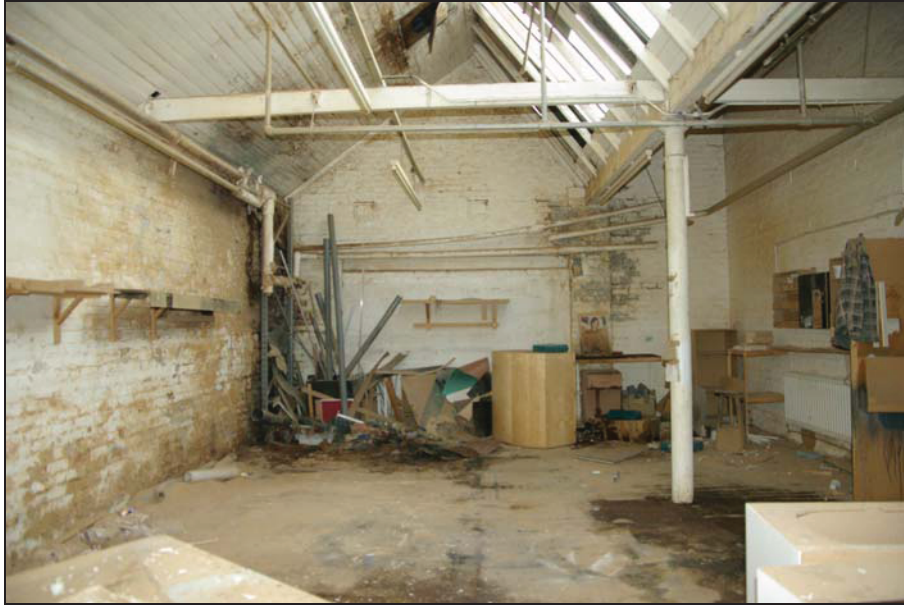
Figure 40. Northlight range to rear of No. 30 Canal Street, looking south.

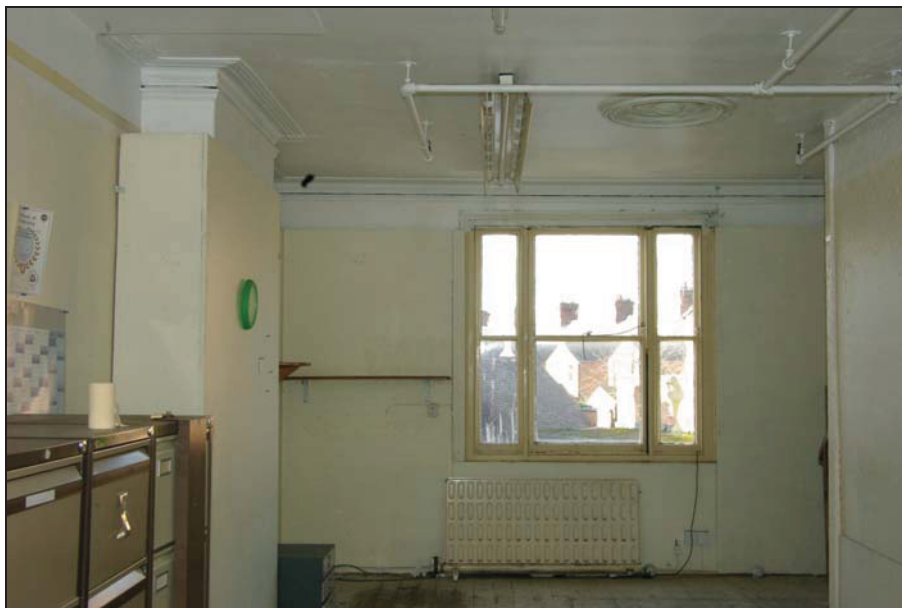
The façade of no. 32, being the latest building within the terrace, appears to have been constructed to create a symmetrical aspect to the range and displays decorative treatment similar in style to no. 26. The building was most recently occupied by 'Time Display' screen printers, involved in the production of shop signs for well-known high street companies. At ground floor level, the building has been stripped of all fixtures and fittings, including all internal walls, to form an open space of industrial character. The ground floor has been extended to the rear and connects with a single storey workshop area of modern concrete block-work construction.

Figure 41. 32 Canal Street, early fixtures to first floor front room, looking west
