**Oxney Grange, Eyebury Road,
Eye, Peterborough (TF 229 023):
Standing Building Survey.**

For Manor Construction Ltd.

**University of Leicester Archaeological Services
Report 2006-003 ©2006**

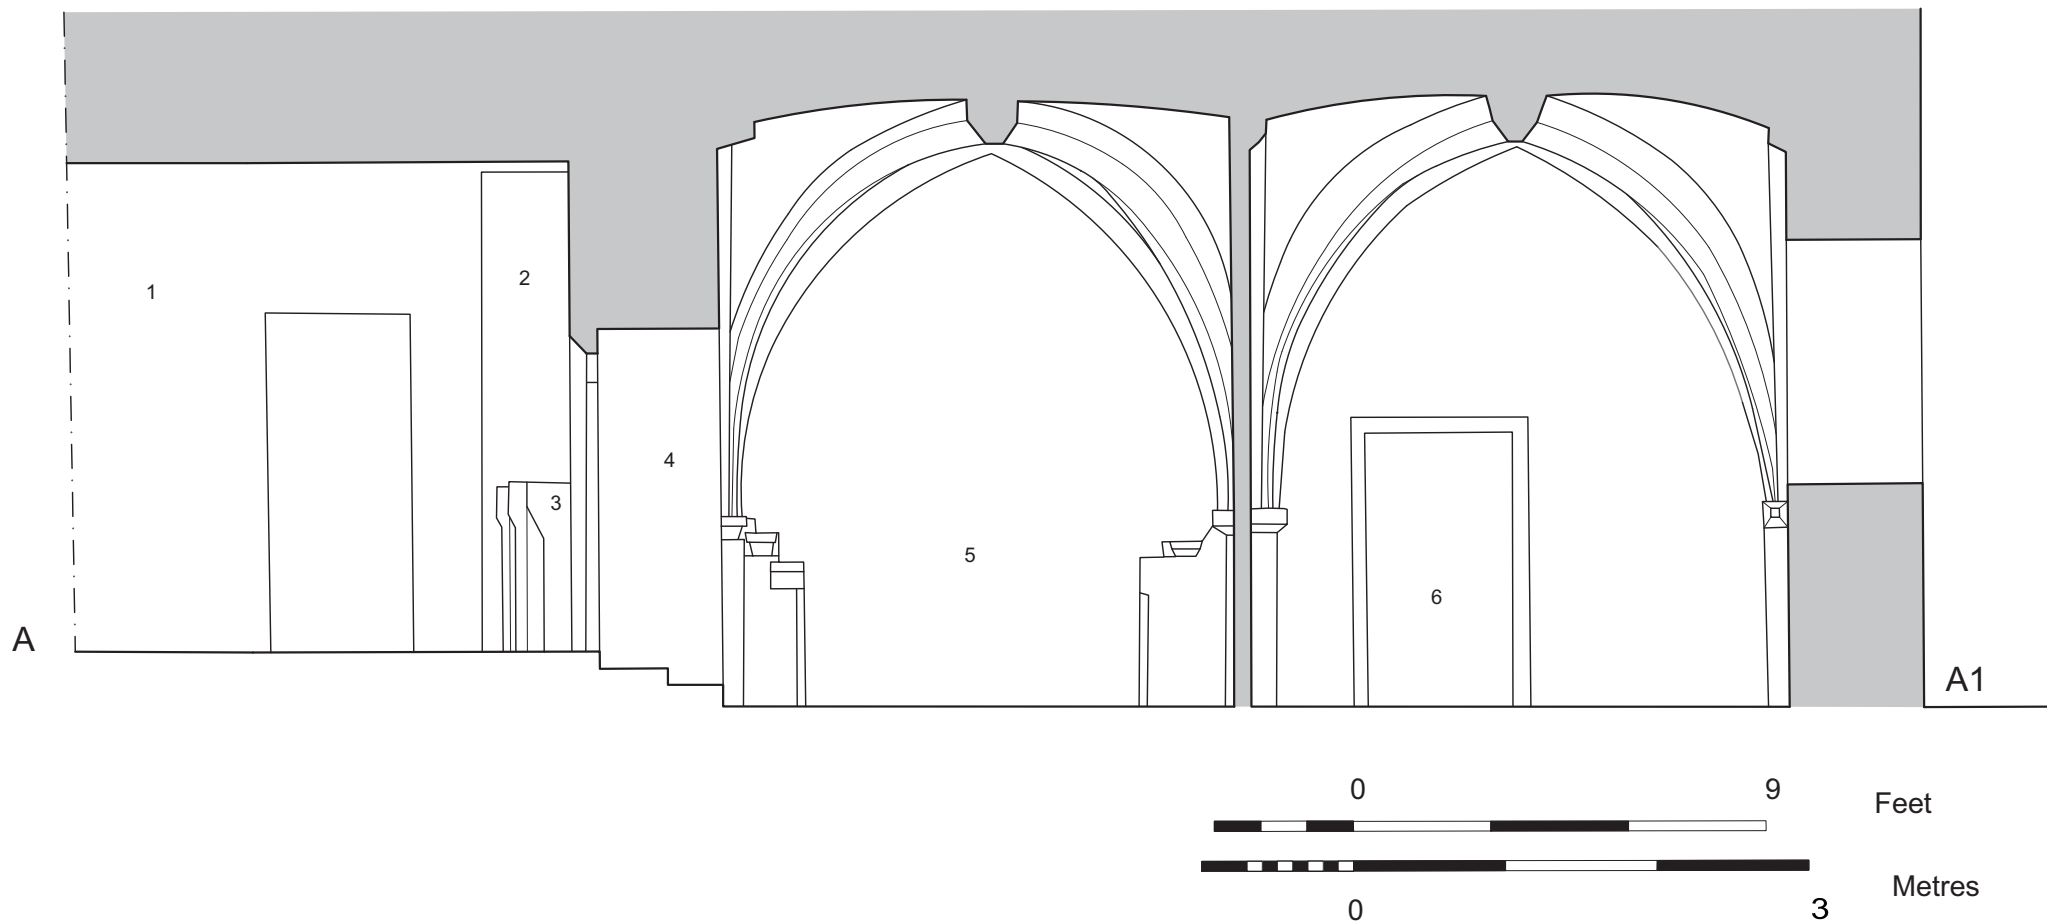
Figure 3: Sectional Elevation A-A1.
North facing. Print Scale 1:50

1. 19th century brickwork
2. Blocked window
3. Remains of column support providing evidence for removed medieval stone vaulting within Room G4.

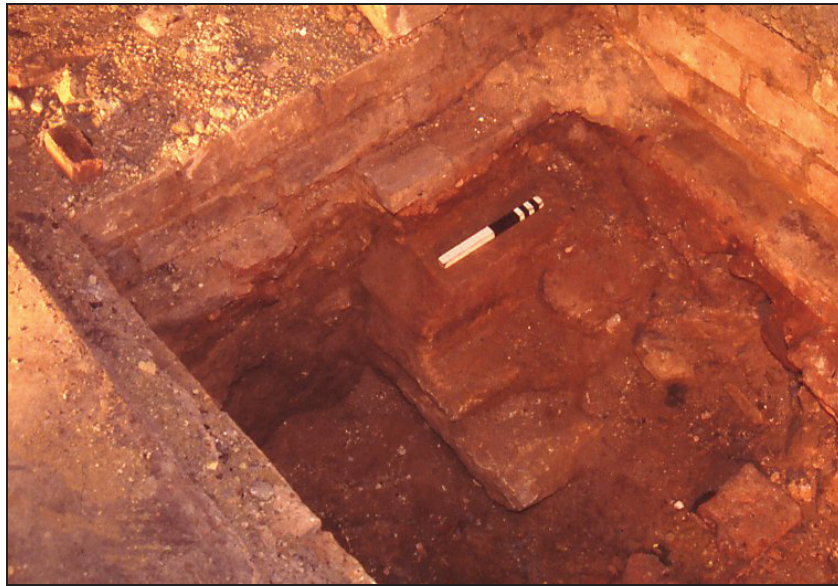
the removed 19th century staircase, the remains of a chamfered stone plinth course were revealed, representing the position of an early, external wall, aligned east/west (Figures 1 & 2; Plate 1). It seems highly likely therefore that this must mark the position of the southern gable end of the North Range, confirming, therefore, the three-bay layout of the principal medieval range, as previously suggested by Morriss (2004, 34).

A late medieval jug handle fragment was retrieved from the rubble surrounding the plinth course and has been identified as Bourne A ware, dating from *c.* 1450 AD.

Plate 1. Chamfered stone plinth course in Room G3, exposed within area of former 19th century staircase. Scale: 0.2m.

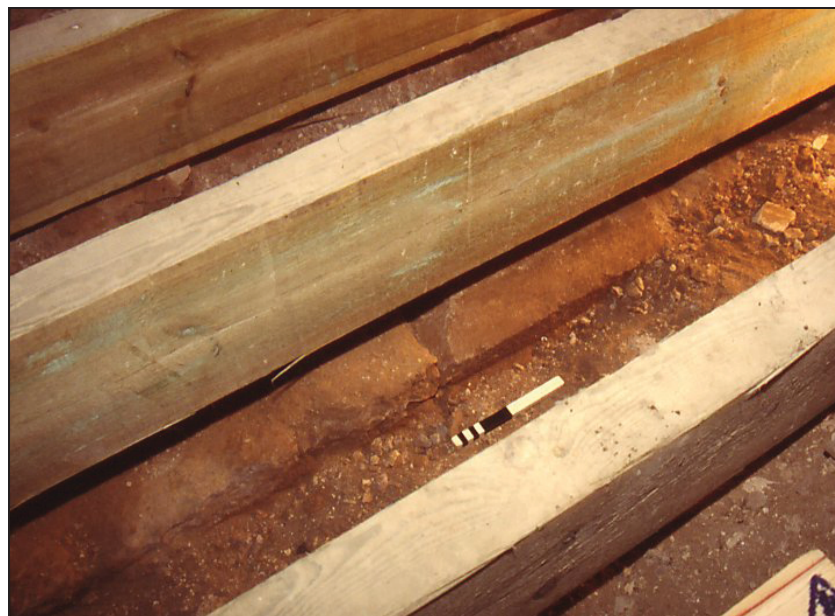
The eastern extent of the east/west plinth course is interrupted by a stretch of coursed, bonded stone rubble, but is seen again some 2.4m to the east (Plate 2). At this point, however, the plinth course turns at right-angles towards the north and appears to continue beneath the 19th century brick infill, which separates G14 from G11. The floor plan (Figures 1 and 2) shows that the turn in the plinth course is on the same alignment as the first of the stepped corbels on the eastern side of Room G11, and appears to indicate the position of an original opening through the medieval wall, with the coursed rubble representing an early phase of blocking. There is evidence to suggest therefore, that the corbels within G11 may be associated with a hooded stone canopy to a wide, principal entrance: this could only be confirmed, however, through further intrusive investigation within Rooms G11 and G14 (Plate 7).

Plate 2. Chamfered stone plinth course exposed beneath modern floor joists in Room G14. To the left of the 0.2m photo scale is rubble stone blocking of what may have been an original entrance.

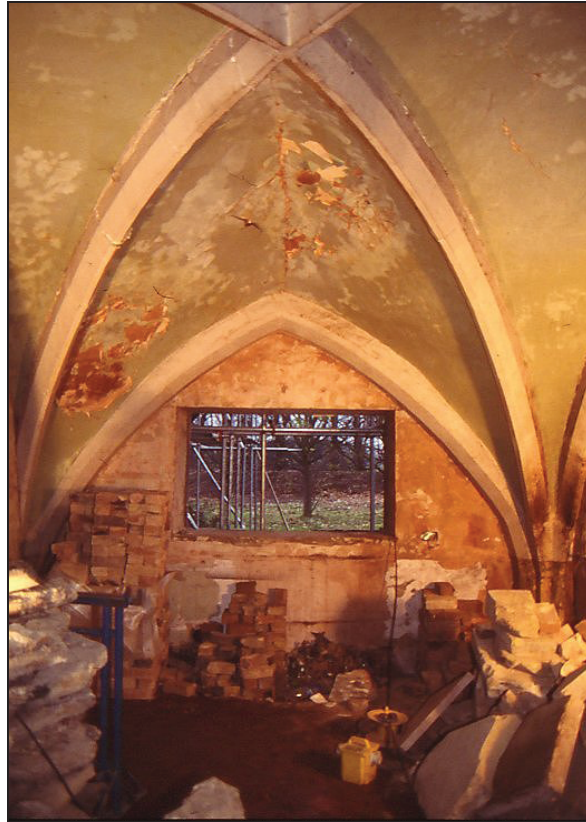
4.2.4 The vault over room G6 was evidently rebuilt in the 19th century. Between the stone ribs the vaulting consists of 3 inch brickwork. This was visible within G6 where areas of render were missing and from above where the infill material had been removed to expose the top of the vault (Plate 5). This was comparable with 19th century brickwork seen elsewhere within the complex and is presumably

attributable to the 1839 remodelling of the house. Earlier brickwork was used in the vault over G13: this is possibly 18th century in date although in the absence of more detailed investigation a medieval date cannot be entirely discounted (Plate 6). The vaults within G11 and G12 were not exposed (Plate 7). Areas of 18th century brickwork elsewhere in the house point to earlier alterations all but obliterated by the 1839 remodelling.

Plate 5. Vault over Room G6 with rendered 19th century brick between the stone ribs.

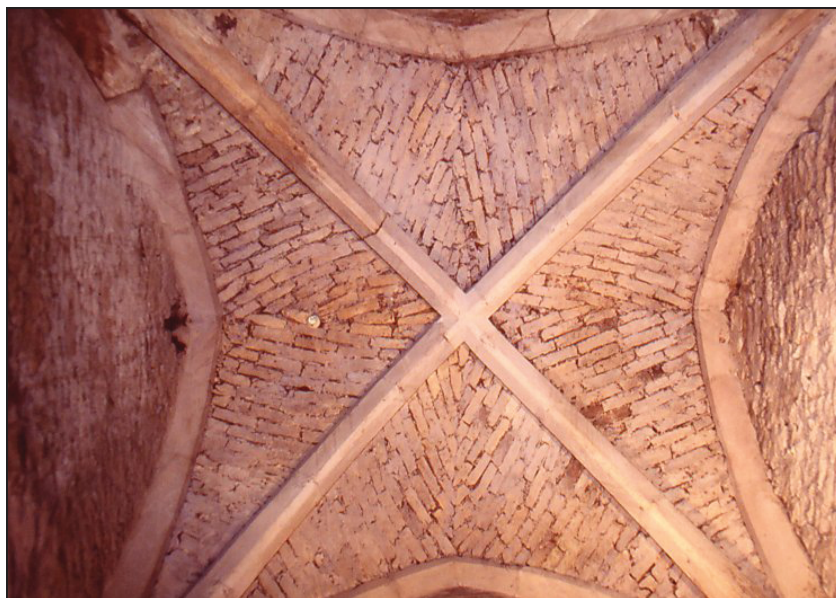
Plate 6. Vault over Room G13 with ?18th century brickwork.

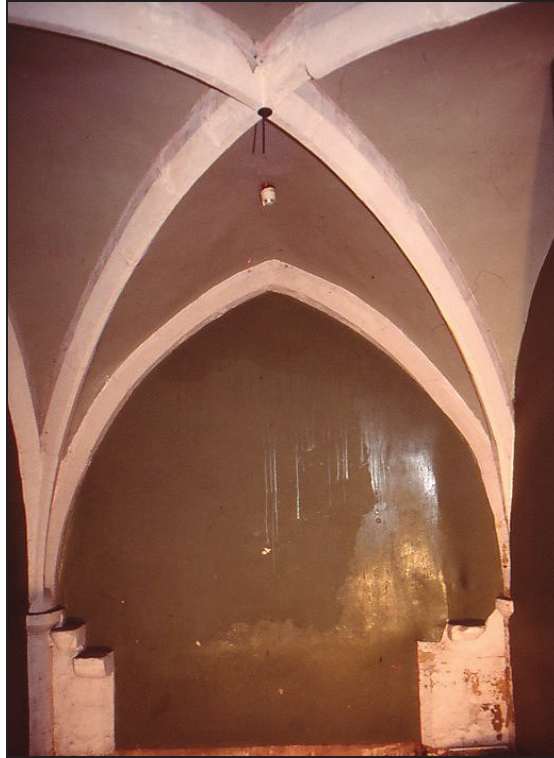
Plate 7. Room G11 vault and springing of removed canopy to entrance in south wall.

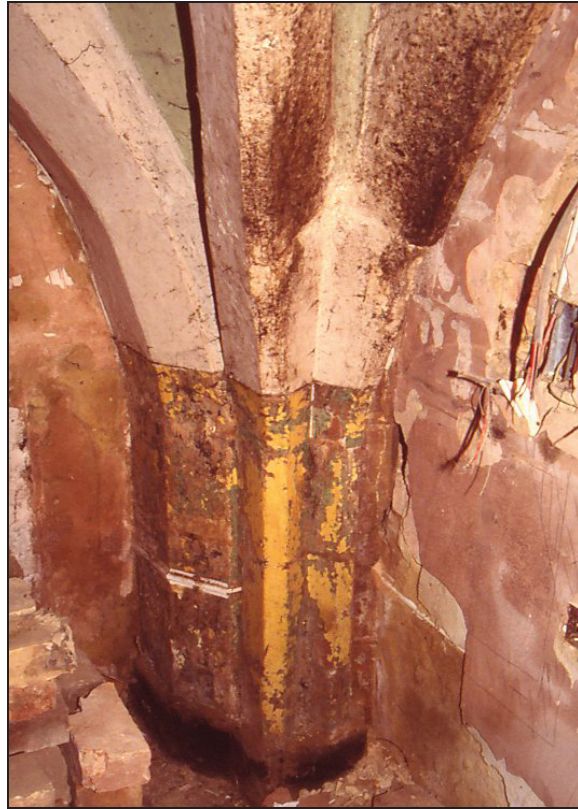
Plate 9. Springing of vault at north-west corner of Room G6 (Y on Figures 2 & 7).

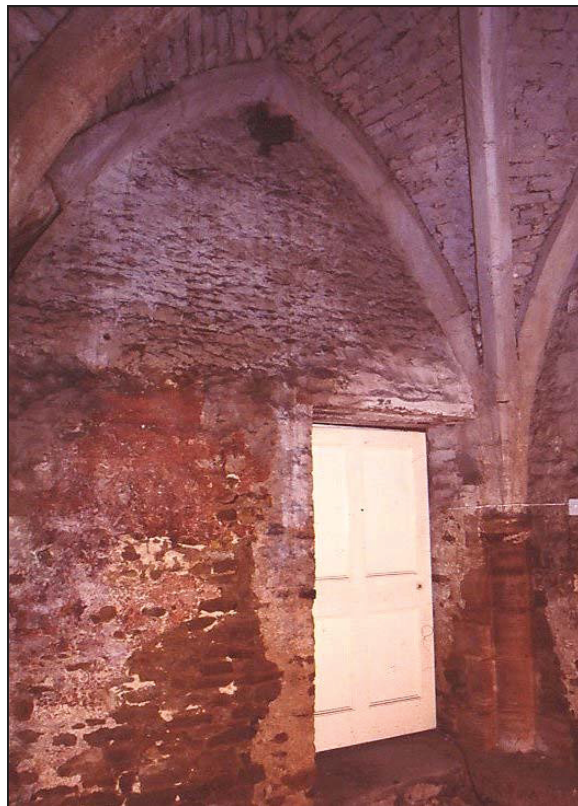
4.2.5 An area of early, red-painted or stained plaster on the north wall of room G13 could well be medieval in date (Plate 10). A single pottery sherd in the late medieval Bourne A ware (c.1450+) fabric was found at the surface of the soil deposit which formed ground level within this room.

Plate 10. Red-painted plaster on north wall of Room G13.
