**Archaeological Building Record
of a Ruined Farm Complex within
the Hamilton Northern Housing Area,
Humberstone, Leicester**

Neil Finn

For Mather Jamie

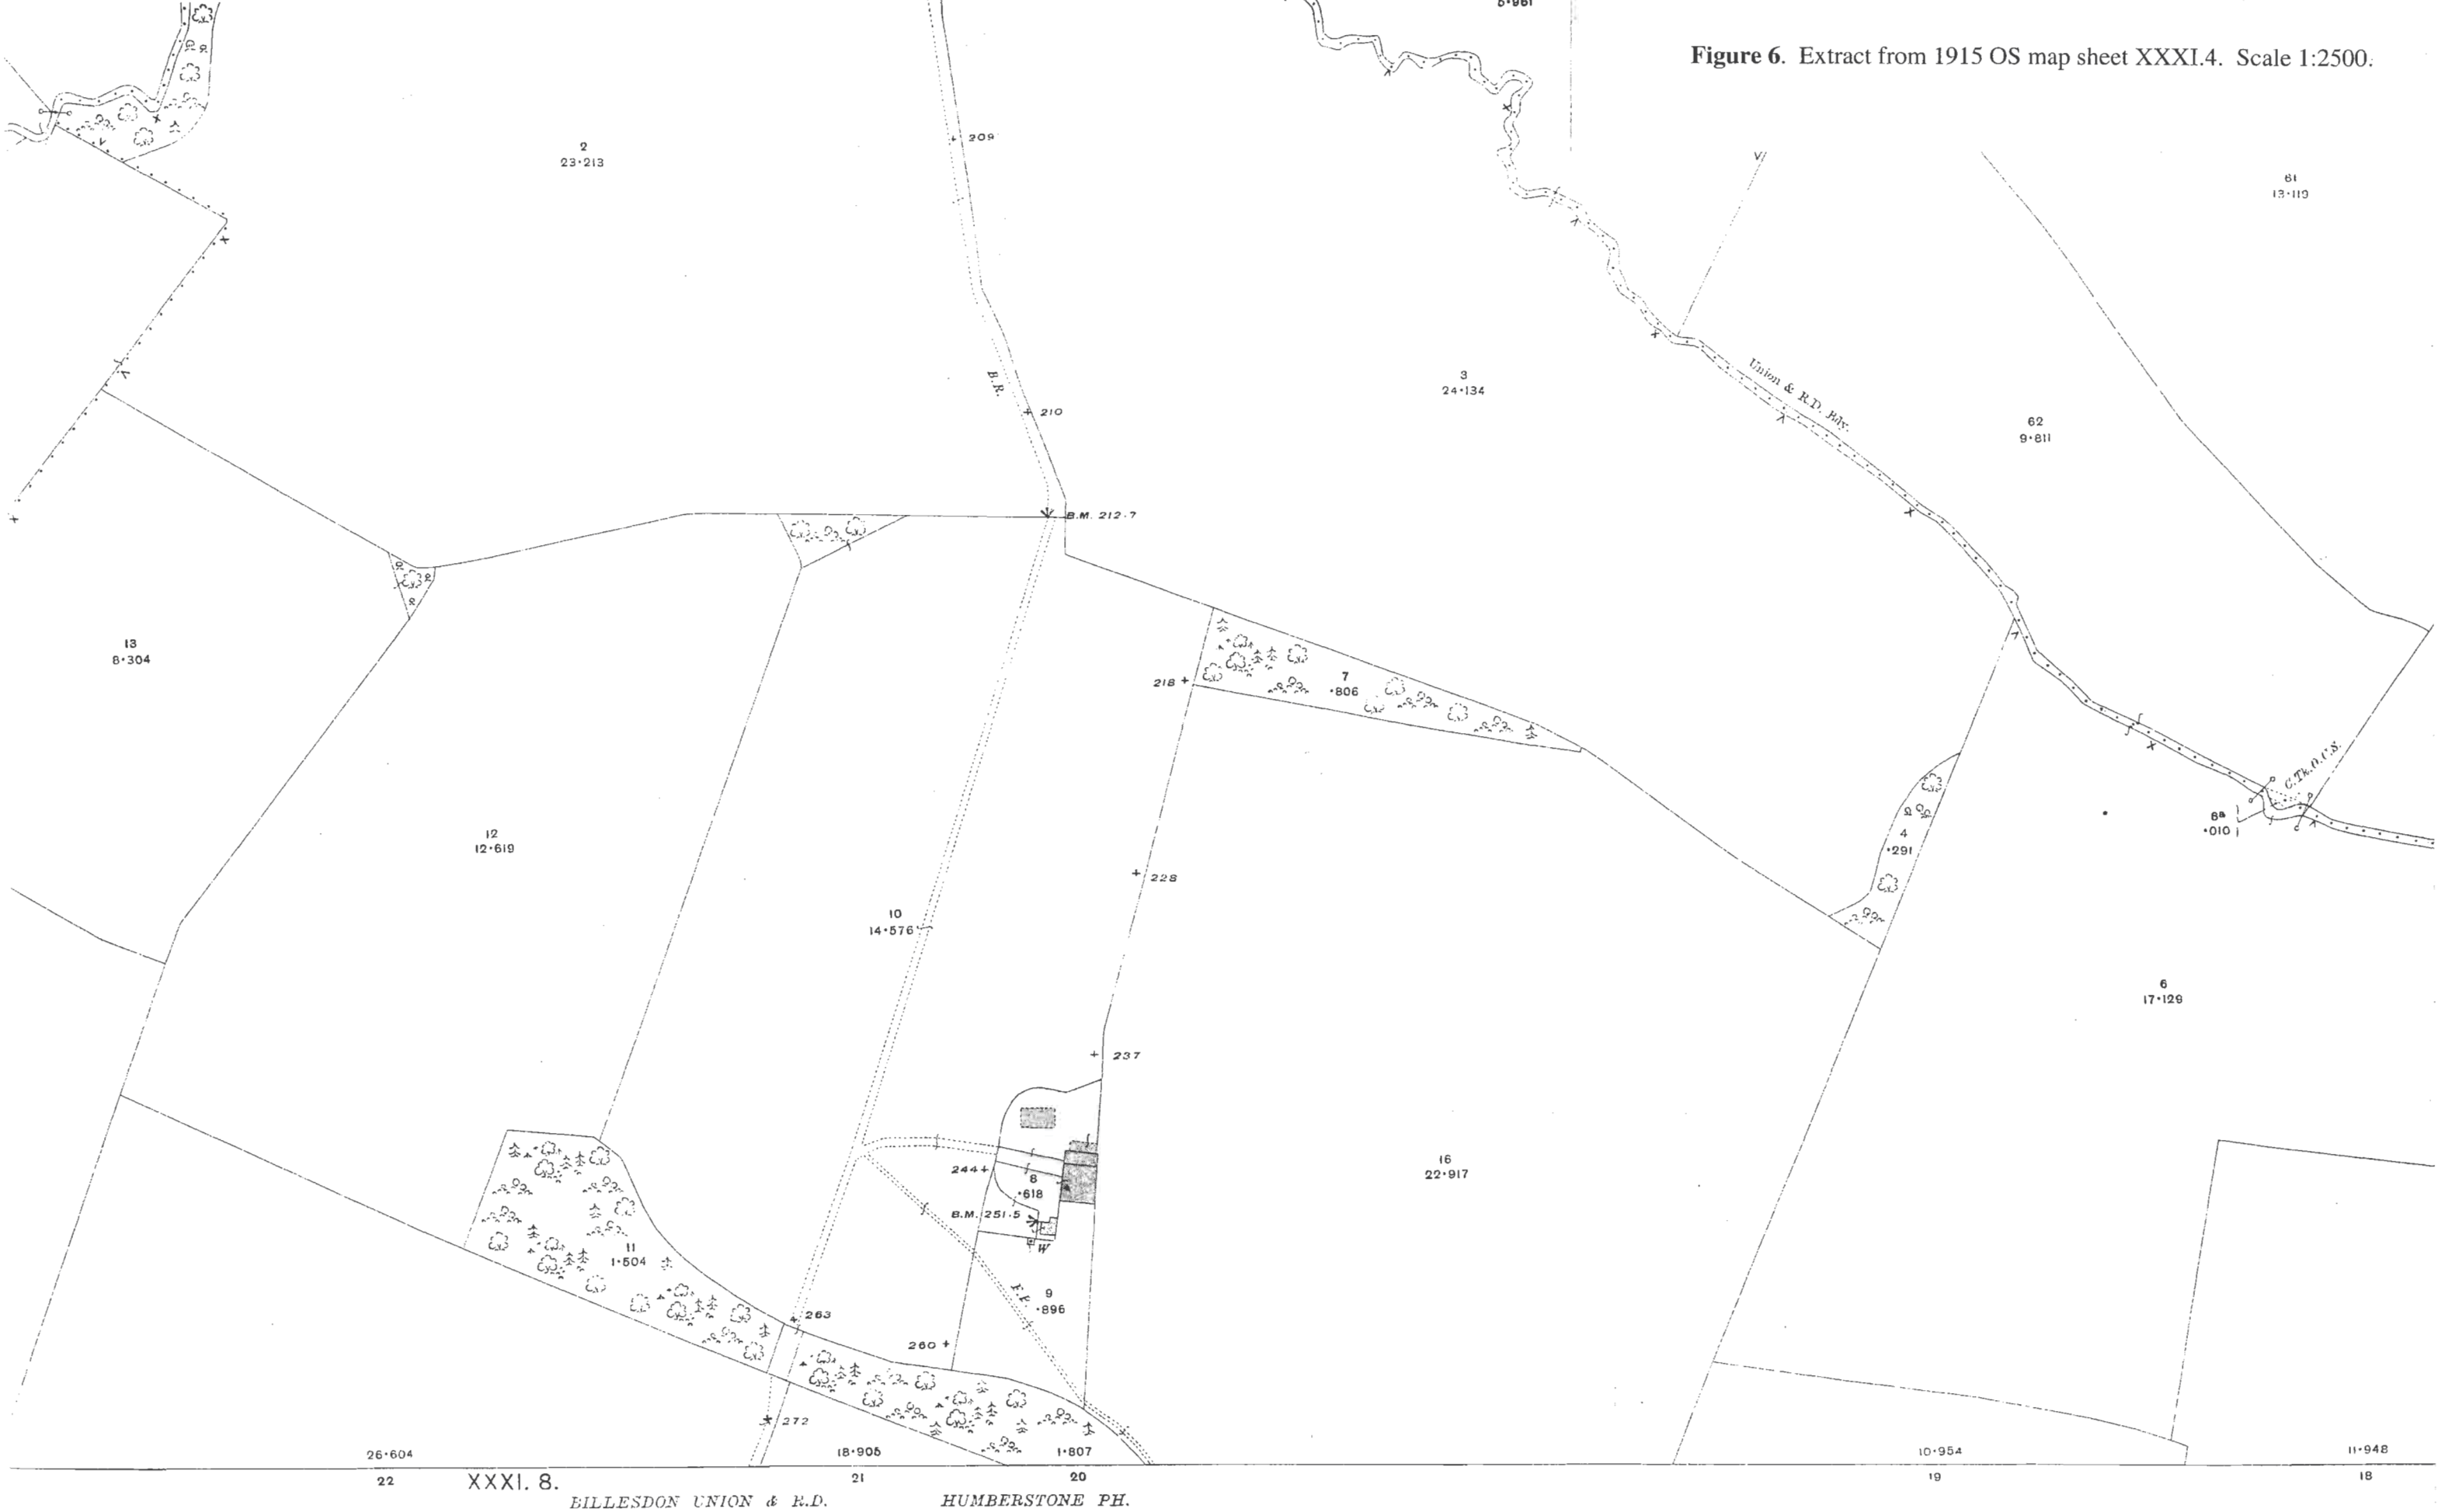
Figure 6. Extract from 1915 OS map sheet XXXI.4. Scale 1:2500.

By 1915 the house had been extended and another structure erected, against the north side of the livestock shelter. The dashed outline of this and the building to the north-west of the livestock shelter may indicate that these were roofed, but open sided structures (Figure 6).
