**A Photographic Survey of 'Bowstring Bridge',
the Former Great Central Railway Bridge,
Braunstone Gate, Leicester
(NGR SK 580 041)**

ULAS Report No 2009-181
©2009

For: Leicester City Council

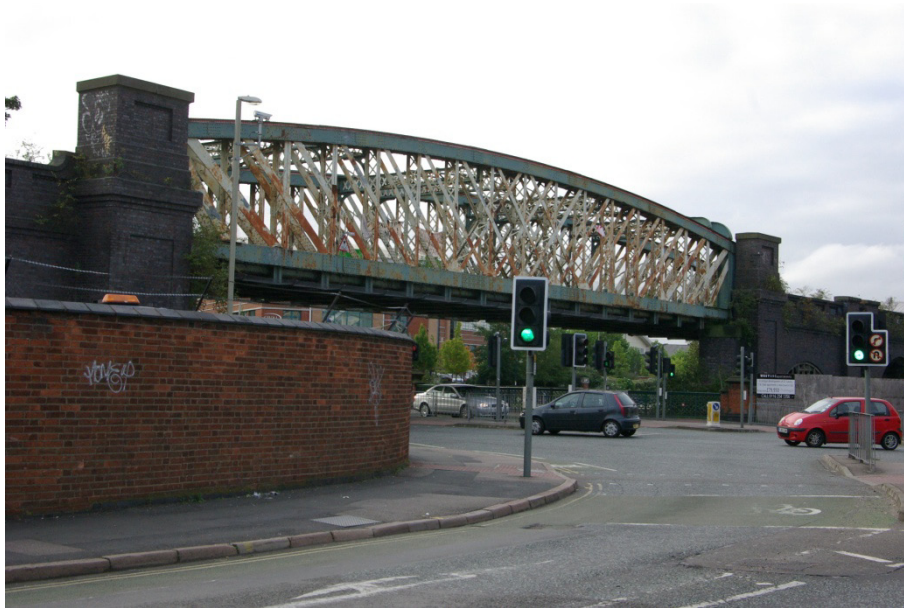
Figure 2 Bridge (Looking South East).

Bowstring Bridge is a steel truss bridge with steel deck plates on riveted cross and longitudinal girders and is painted green and cream with red detailing. The steel lattice girder frame is a riveted construction (*Figures 2 & 3*). It sits atop a blue brick viaduct bridging both the River Soar and New Park Street and Western Boulevard. To the north there is a short length of viaduct, to the south, there is a longer length and a second girder bridge. This southern stretch will be un-affected by the proposed works. The northern viaduct consists of six arches, some of which have been walled with a mix of red brick and more recent breeze blocks. The parapet has recessed panels and angled brick corbelling, the brickwork for the whole viaduct is an English Bond and is capped with moulded blue copings. There are shaped sandstone pads at the base of each arch spandrel which project outwards slightly.

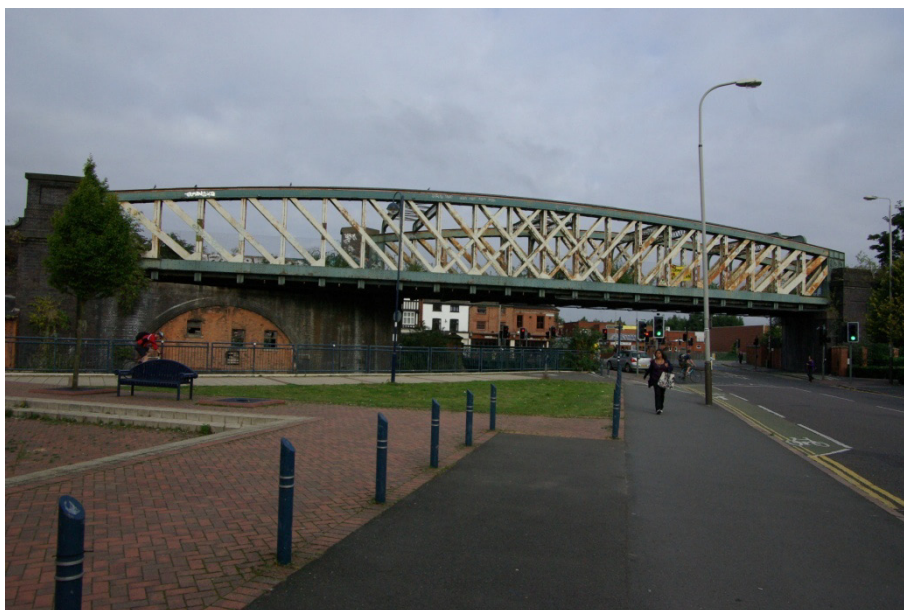
Figure 3 Bridge (Looking West).

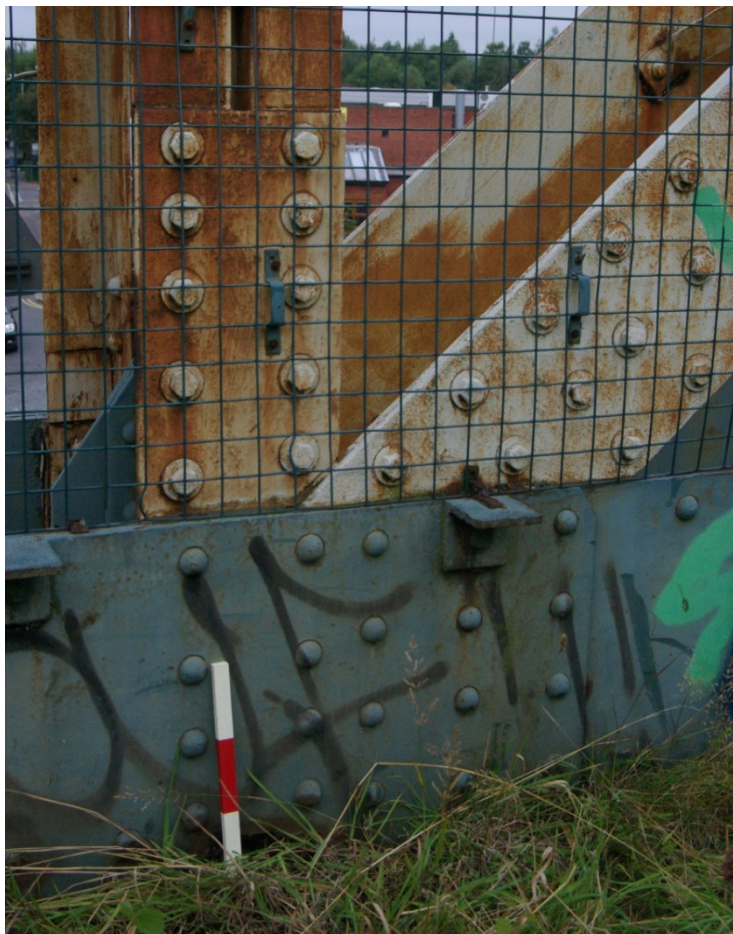
The most significant feature observed on the deck was the additional strengthening plates added to the internal faces of the diagonal braces and to a lesser extent the lattice girders themselves (*Figure 5*). These plates are clearly not original – they are held in place by 1¼ inch (32mm) bolts and not visible on any of the early Newton photographs of the bridge. The plates themselves lack the quality finish of the rest of the bridge, with rough edges as opposed the smooth rounded finish of the original steelwork; some of it is also heavily pitted, suggesting it is not such a high quality steel.

Figure 5 Bolted Strengthening Plates.

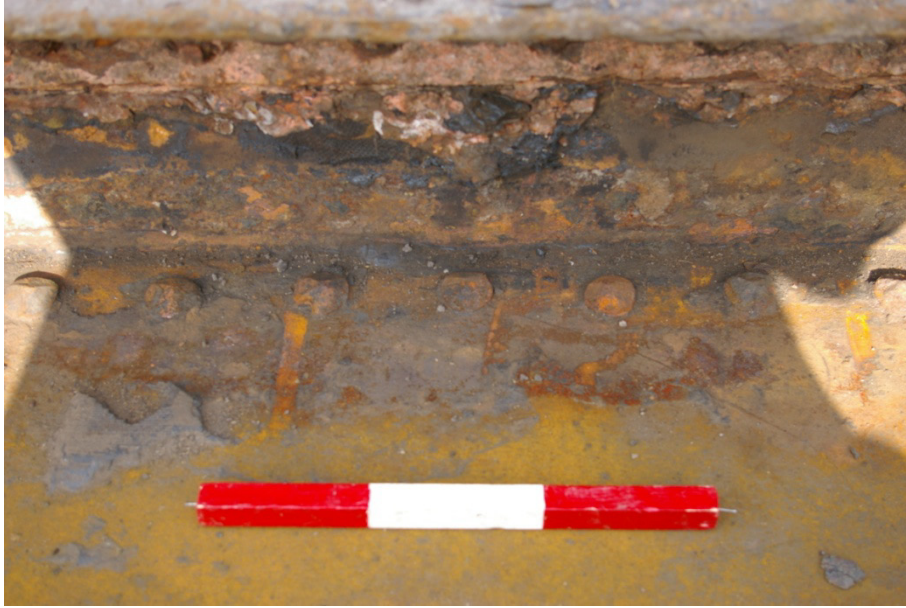
The removal of the ballast, prior to demolition exposed both the deck plates and the plate girders. Interestingly the rivets holding the deck plates to the plate girders are very poorly finished (*Figure 6*). All the other rivets, as expected are impeccably finished, those which were out of sight and difficult to finish were not. In places in excess of 150mm (6inches) of solid bitumen was coated onto the upper faces of the deck plates to prevent corrosion. The deck plates also have camber to prevent standing water.

Figure 6 Poorly Finished Rivets on Deck Plates.

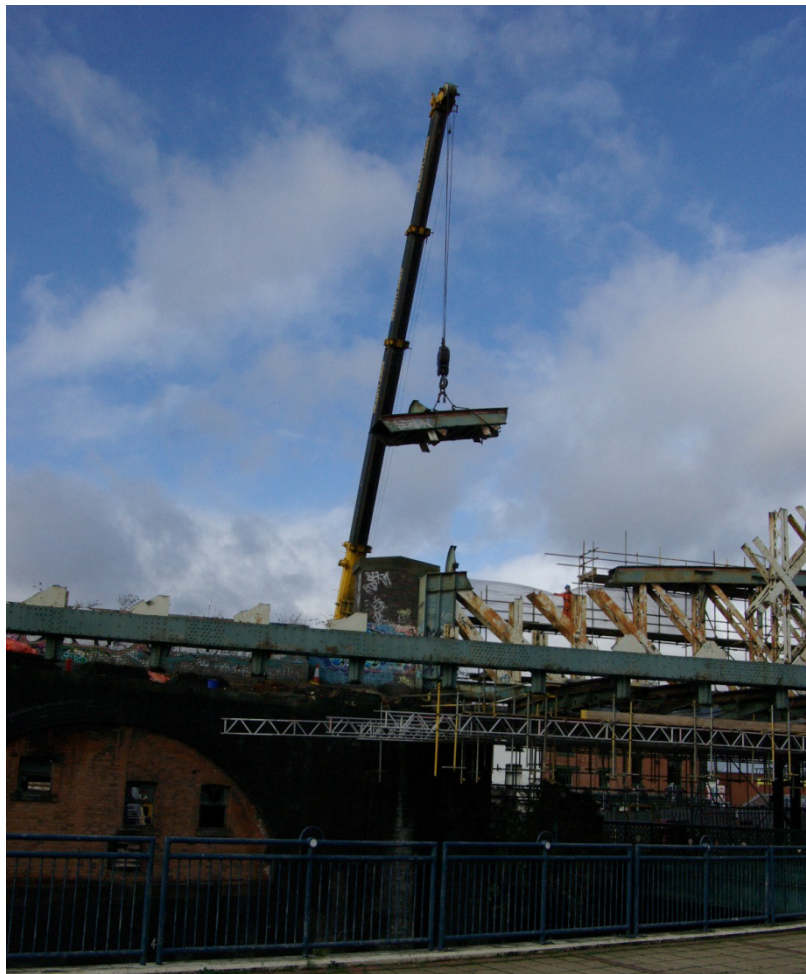
Figure 7 Dismantling in Progress.
