**An Archaeological Watching-Brief  
on the site of Groby Castle, at St Philip  
and St James Church, Groby,  
Leicestershire  
NGR: SK 523 076**

ULAS Report No. 2009-175  
©2009

**An Archaeological Watching-Brief on the site of Groby Castle,  
at St Philip and St James Church, Groby, Leicestershire**

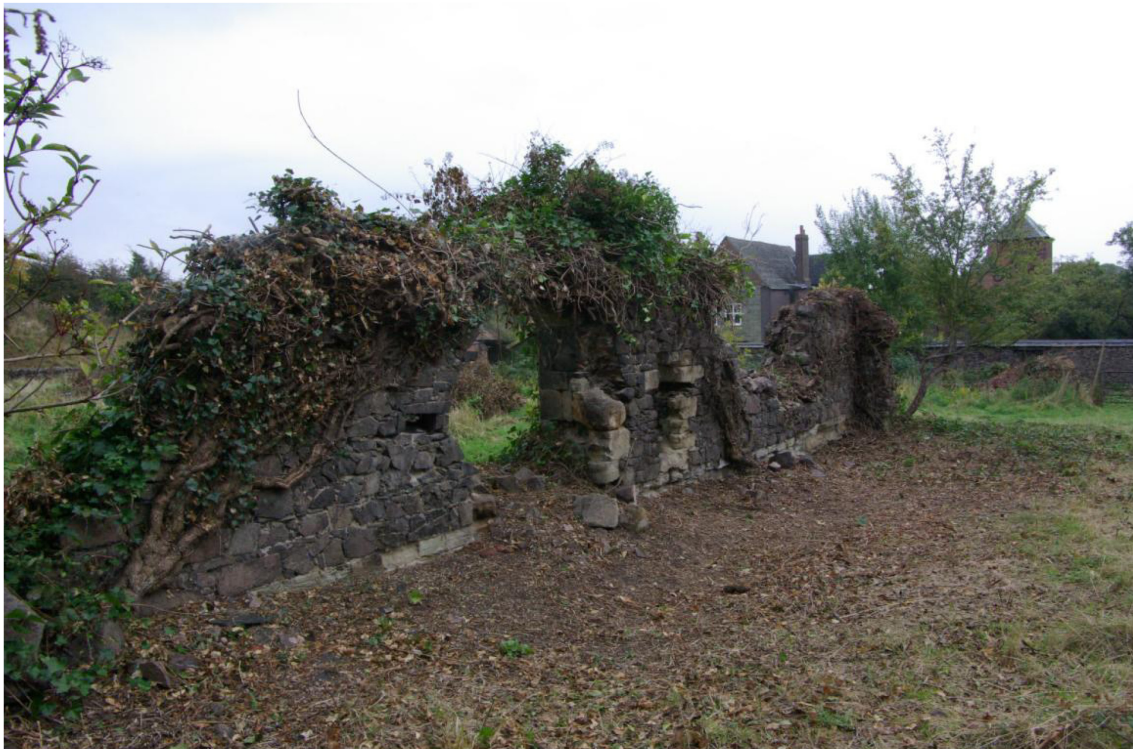
Figure 2: Extant remains of the medieval manorial complex  
Looking from the church towards Groby Old Hall. The area of work was to the left of the ruins

Other fragments of the medieval manorial complex remain as ruins in the paddock to the immediate south of the area of work, including a stone wall with an arched doorway and splayed window opening. According to the 1757 map this wall formerly extended up to the corner of the brick-built tower at the south end of the Old Hall. The medieval
