**An Archaeological Watching Brief  
And Photographic Record at  
5 Bridge Street, Barrow upon Soar,  
Leicestershire  
NGR: SK 5744 1728**

ULAS Report No. 2010-140  
©2010

**An Archaeological watching Brief and  
Photographic Record**

**5 Bridge Street, Barrow upon Soar**

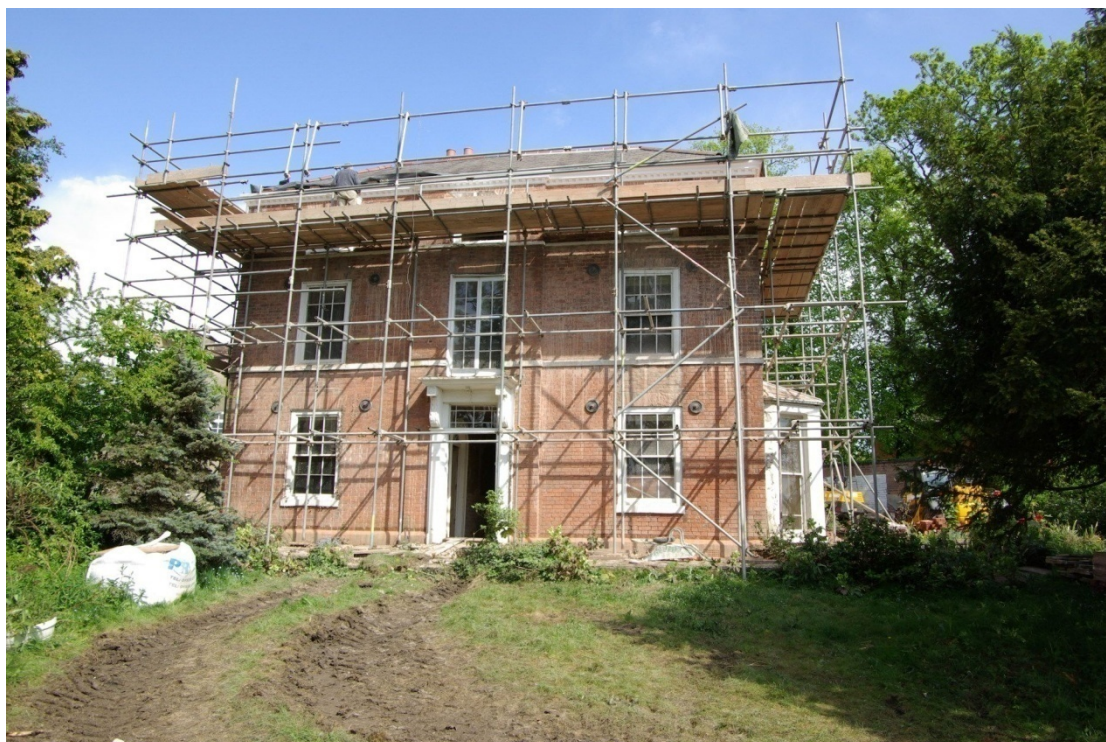
Figure 5 Cliffe House, western elevation

The main part of Cliffe House is presently undergoing extensive refurbishment making an internal inspection quite difficult, however the main external elevations were photographed and are shown in figures 5, 6 and 7. The external brickwork is currently being re-pointed but otherwise little is to be changed on the northern, western and southern faces. The brick built outbuildings located on the eastern side of the house were, until demolition, as shown on the current OS map although a wall and lean-to type structure extending to the eastern site boundary appear to have been removed prior to renovation. The fabric of the outbuildings suggests two phases of construction which supports the map evidence of a late 1940s or early 1950s room attached to the house followed by a late 1950s or early 1960s addition (figs. 8 and 9).

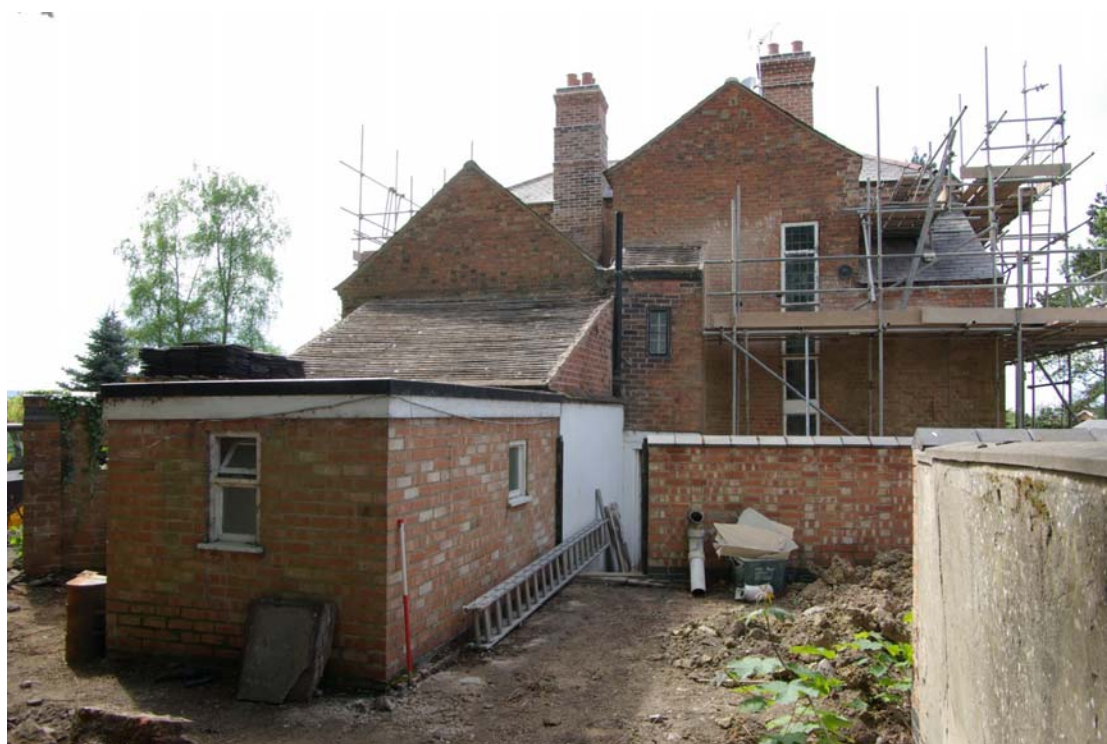
Figure 8 Outbuildings on eastern side of Cliffe House  
Looking south west, 1m scale

The later extension added to the north eastern corner of the 1950s outbuilding is a flat felt roofed structure constructed using stretcher bonded bricks (fig. 8). Inside, the space has been divided into a store room, a pantry and a short corridor with a door to the garden (fig. 14).

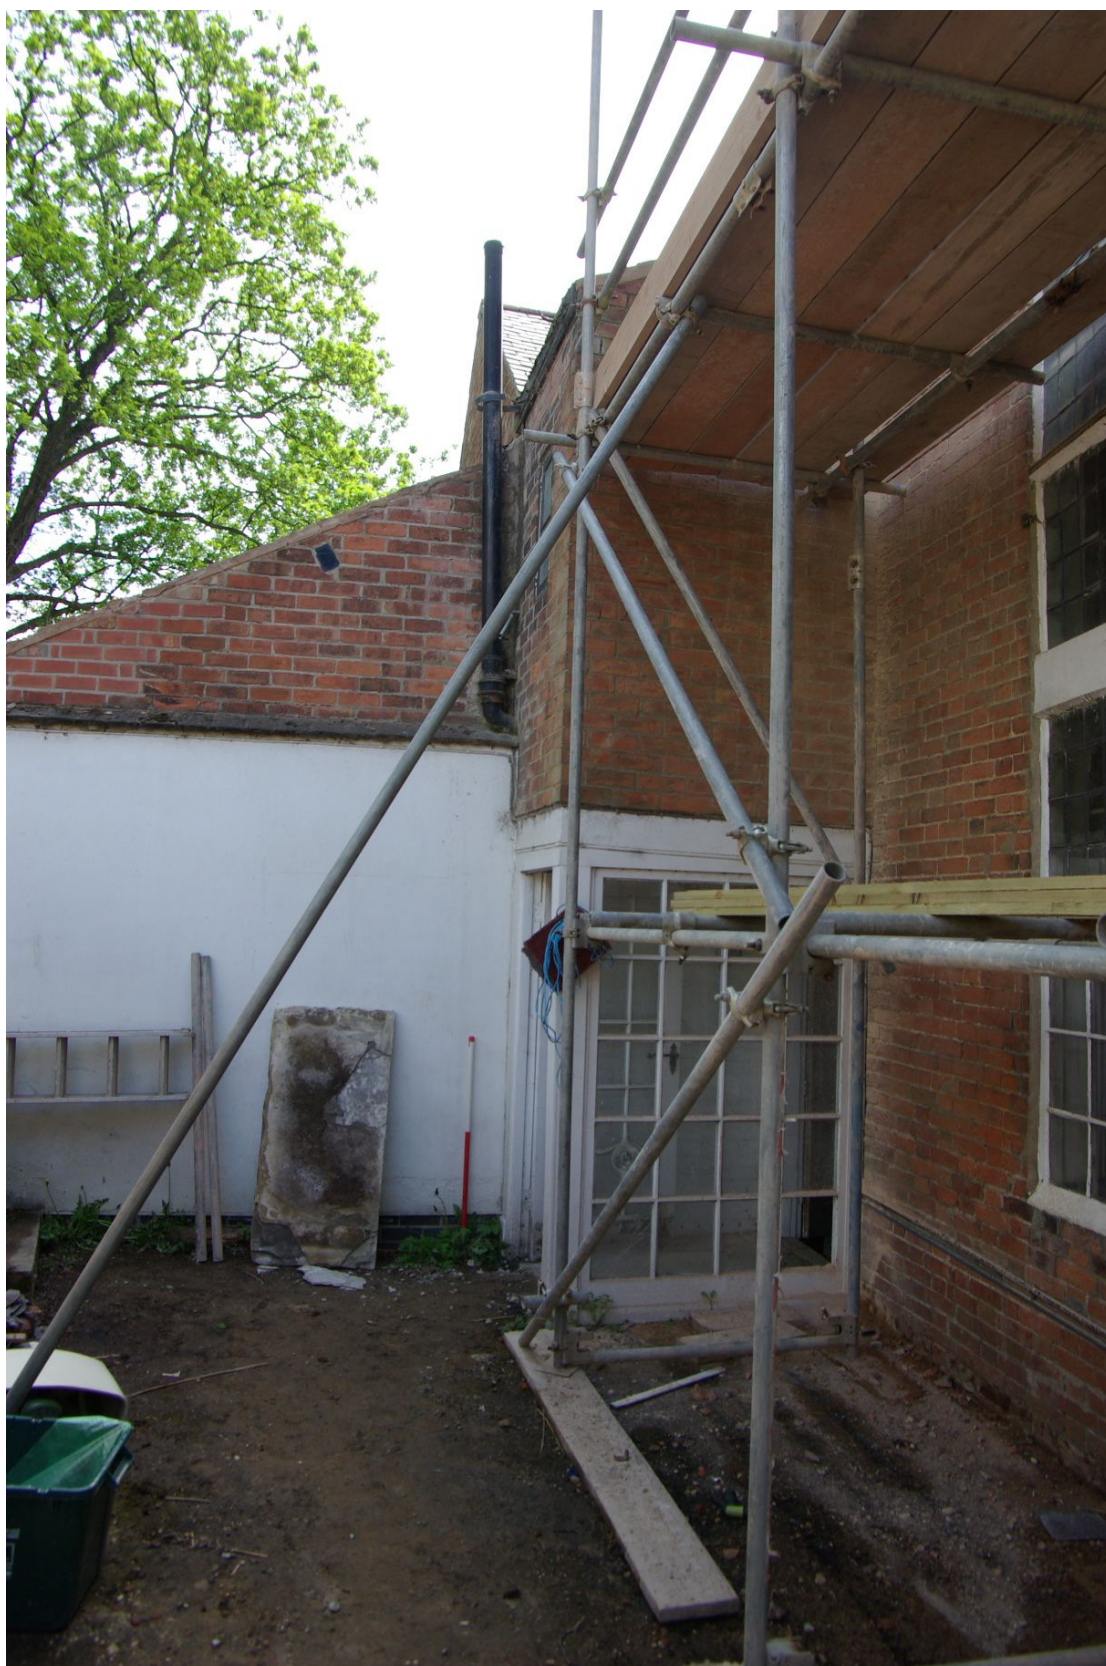
Figure 10 Toilet, to be demolished, over porch  
Looking south, 1m scale

A small toilet has also been added at first floor height above a rectangular timber porch in the north east corner of the main house (fig. 10). The toilet has a small pitched roof with a slate covering. The bricks used are the same type as in the 1950s extension. Inside the door from the toilet to the main house appears to have been knocked through when the toilet was added.

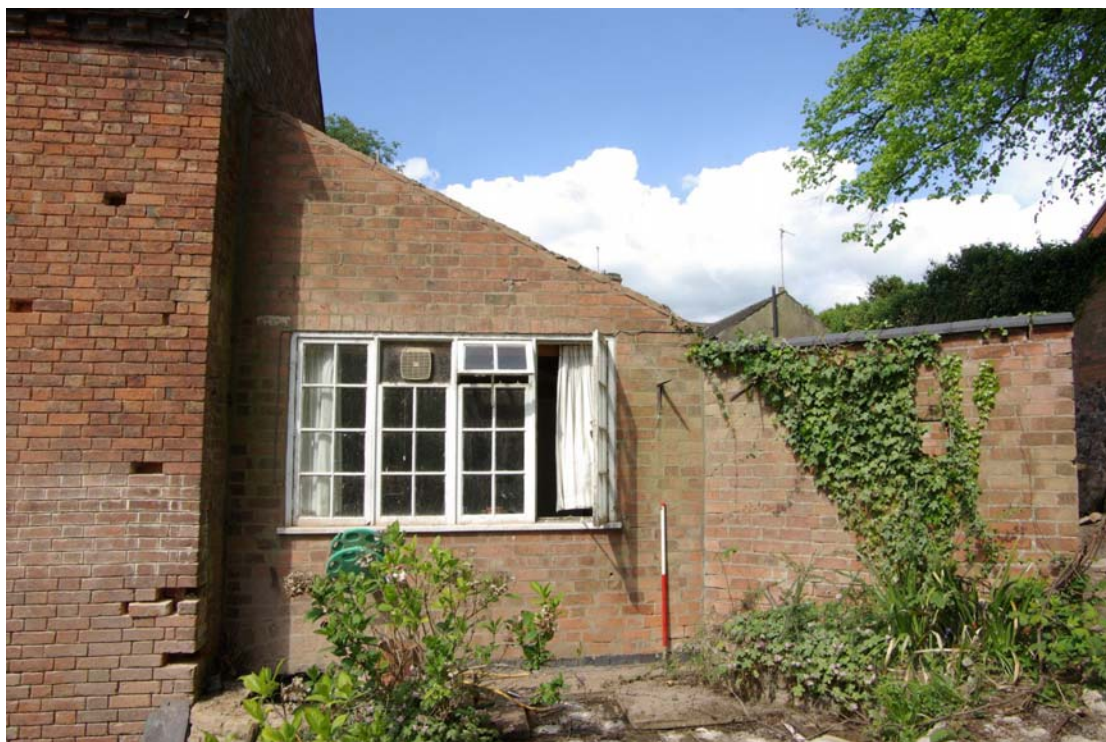
Figure 11 South elevation of extension  
Looking north. Note arch of freshwater tank in bottom left corner, 1m scale

The single storey 1950s addition has a lean-to slated roof attached to the main house with a single ground floor doorway piercing the wall into the house. On its southern elevation a low brick arch can be seen at ground level which spans a freshwater tank partially located beneath the outbuilding (figs. 11 and 12). The inside of the tank has a brick-vaulted arch and sides using similar-sized bricks to the outbuilding. Internally it has until recently been used as a kitchen and has little of architectural merit although a York sliding sash window on the eastern wall may have been re-used from elsewhere (figs. 13 and 14).

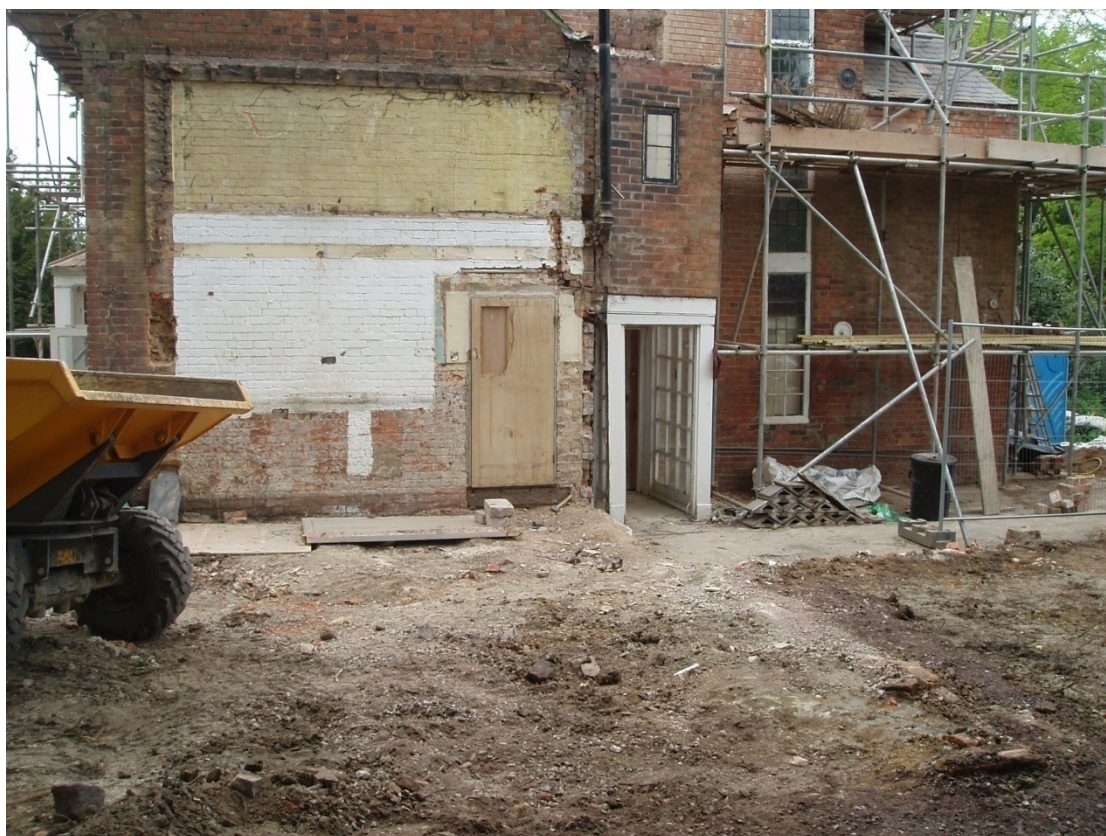
Figure 15 Eastern elevation of main house after demolition of outbuildings  
Looking west, the well is covered under boards to right of the dumper

After the demolition and removal of the outbuildings the ground, which rose towards the north and east, needed to be reduced in height in preparation for the proposed new extension (fig. 15). Removal of the buildings and debris revealed a circular brick lined well adjacent to the east wall of the main house and just to the north of the fresh water tank (fig. 16). The well was 1m in diameter and approximately 6m deep. Although there was no indication of the well prior to demolition it is now intended to preserve it and incorporate it into the new extension.

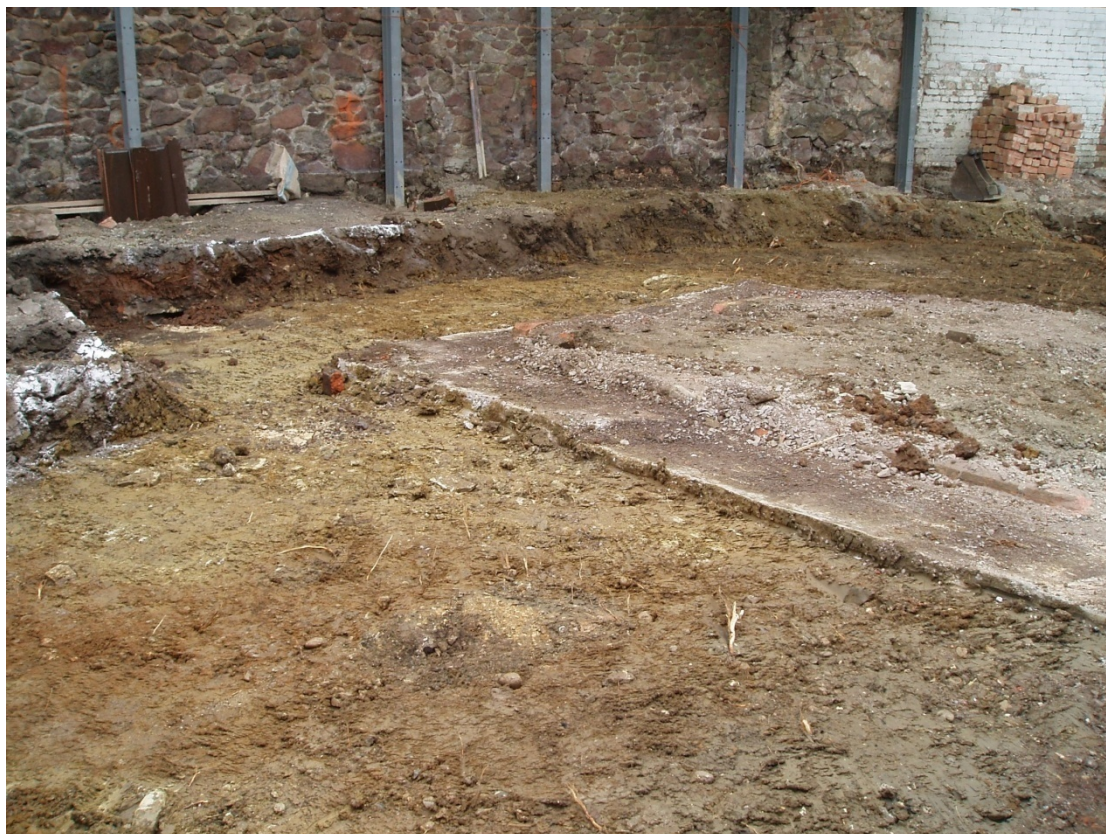
Figure 17 Stripped area and outbuilding foundations  
Looking south east

All of the mixed topsoil, building debris and modern disturbance was removed using a tracked mini digger fitted with a smooth ditching bucket to reveal natural substrata of mid- greenish grey silty clay and mid- yellow brown sandy clay (fig. 17). The natural clay was only around 0.1 to 0.15m below current ground level. The substantial concrete foundations for the demolished outbuildings have cut into the natural clay leaving only a narrow band of undisturbed clay around them. Within the footprint of the proposed extension only modern disturbance or undisturbed natural was observed. The modern disturbance included timber posts with timber and paint still in-situ, and tree root disturbance towards the south eastern edge of development.
