**An Archaeological Historic Building
Assessment of an outbuilding at
The Water Tower, Countesthorpe, Leicestershire
(NGR SP 570 958)**

**An Archaeological Historic Building Assessment of
An Outbuilding at The Water Tower, The Drive,
Cosby Road, Countesthorpe,
Leicestershire
(NGR SP 570 958)**

Pre Planning Enquiry

ULAS Report Number 2010-115

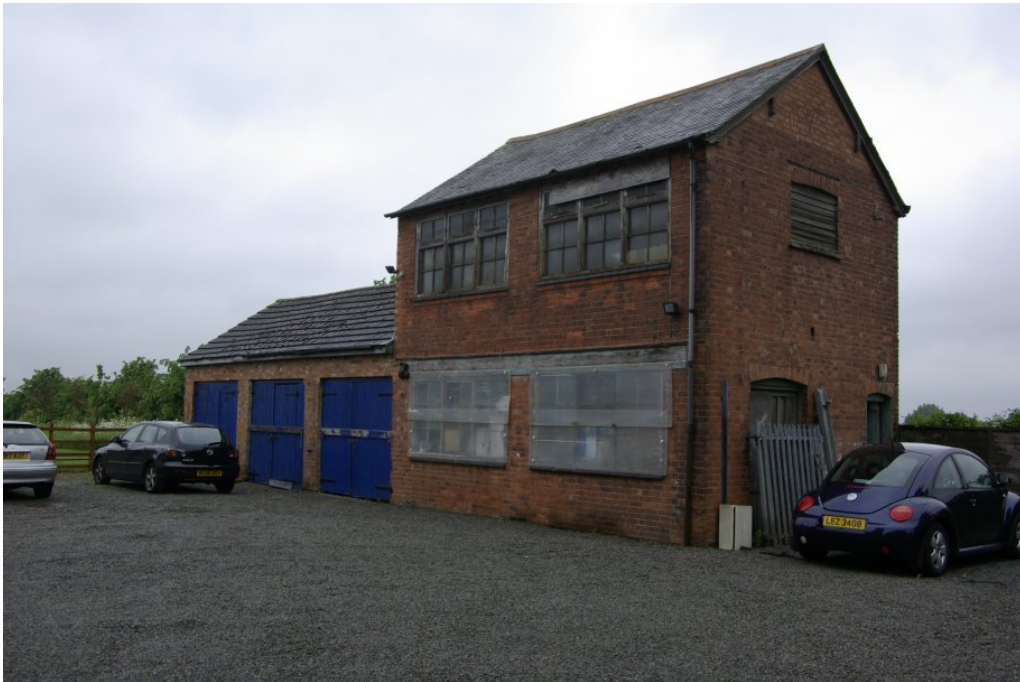
In isolation both buildings are of limited architectural or historical interest, however their association with the Leicester Cottage Homes and their location within the curtilage of a listed building means they are of some merit. Building A has undergone major alteration, while building B is largely unchanged.

Plate 2 Buildings A (left) and B (right) looking north-west.

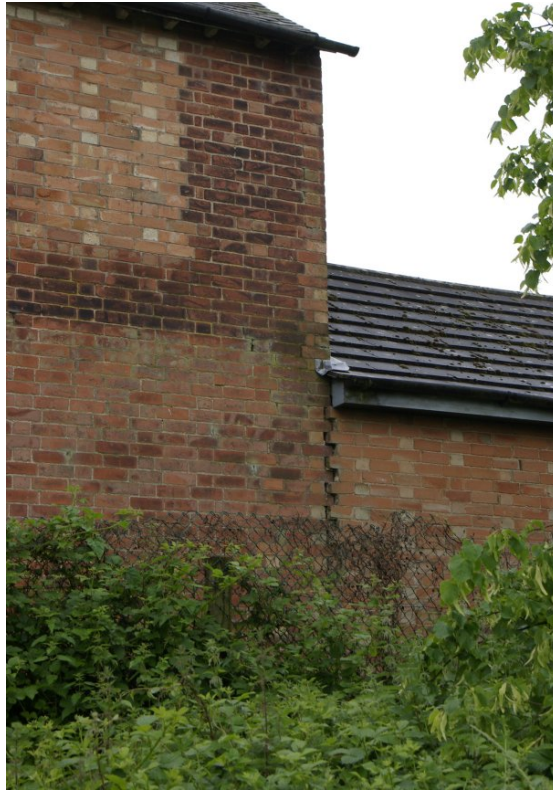
Further flourishes include the purlins projecting beyond the build line and moulded timber barge boards. The projecting purlins can also be seen on the western gable, suggesting the building was originally taller than building A. There is also a blocked entrance indicating the two buildings were joined at first floor level. On the northern wall there is evidence of a lost building of unknown form or appearance and a blocked window.

The original use of the buildings is difficult to ascertain. The appearance of building A suggests that it was originally a cart or carriage shed. It is located at the end of an avenue leading south to Cosby Road and may have housed any transport the Home had or operated. Building B is rather more difficult to assess. The southern elevation originally had two large openings and large windows on the first floor. It is possible; therefore, that each floor had a separate use; the first floor, with its fireplace and good light from the large windows may have been one of the workshops in which the children laboured, while the ground floor may have been an earlier cart shed. The northern elevation of B shows evidence of a lost building, possibly a lean-to added at a later date to provide additional weather proof storage.

Plate 5 Northern elevation showing blocked window, evidence of lean-to & new brickwork.

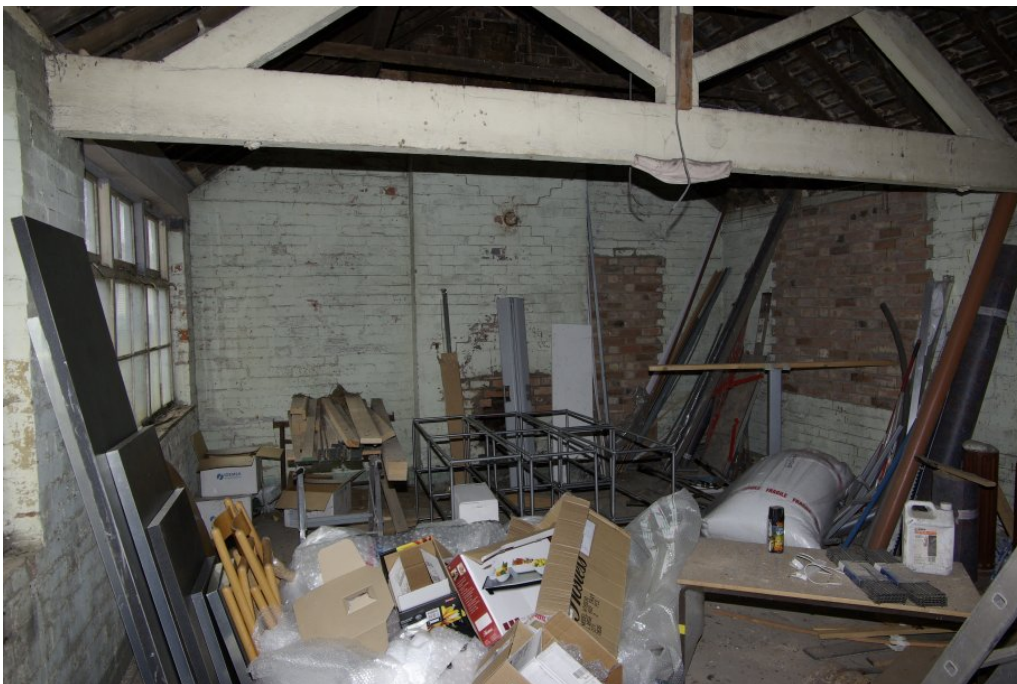
Internally there is little of architectural or historical significance, the interior, however, appears largely unaltered. The floor is laid with blue bricks and the internal reveals of the blocked doors are cant bricks. First floor access is via a rather steep staircase on the east gable. The first floor is a single room with a flat cambered arched fireplace and projecting chimney breast. There is a fitted cupboard over the stairs, which appears to be original, with some decorative timber moulding and tongued and grooved panelling enclosing the stairwell.

The room is currently open to the roof but the lack of paint on the higher roof timbers suggests that there was originally a ceiling within the room. The roof is held by a bolted king-post truss with raking struts. The large windows on the southern wall appear to be original and provide excellent light for the room.

Plate 6 General view of interior, Building B, first floor.
