**An Archaeological Strip, Map and  
Record Exercise at the Three Crowns  
Inn, High Street, Somerby,  
Leicestershire.  
NGR: SK 766 105**

ULAS Report No. 2010-066  
©2010

**For: Summerfish Developments Ltd**

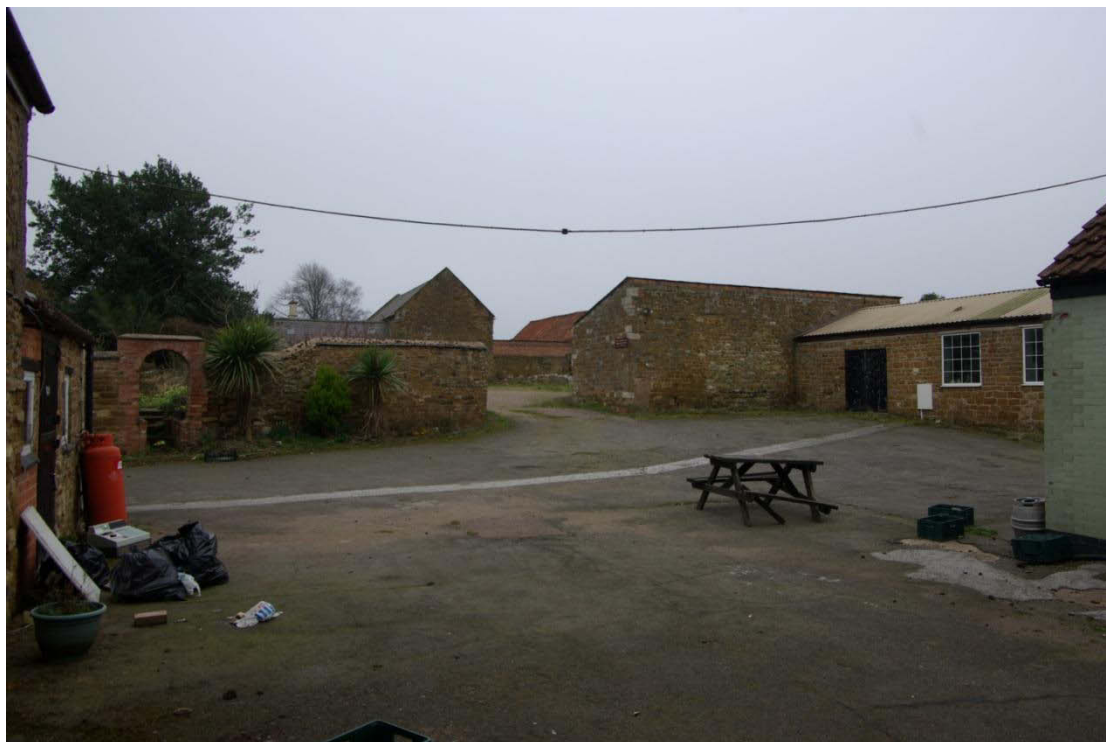
Figure 4 Courtyard and upper car park before development  
Lean-to stone barn and curving stone wall shown before demolition. Looking SW.

Initially, in order to provide adequate space for the semi-detached houses, the east to west lean-to barn at the southern end of the western barns was demolished. This proved to be constructed from a mix of ironstone and brick as noted in the building survey report. The foundations of the side walls of this building appeared to be very shallow and less than 0.2m deep. They were not constructed on an earlier foundation.

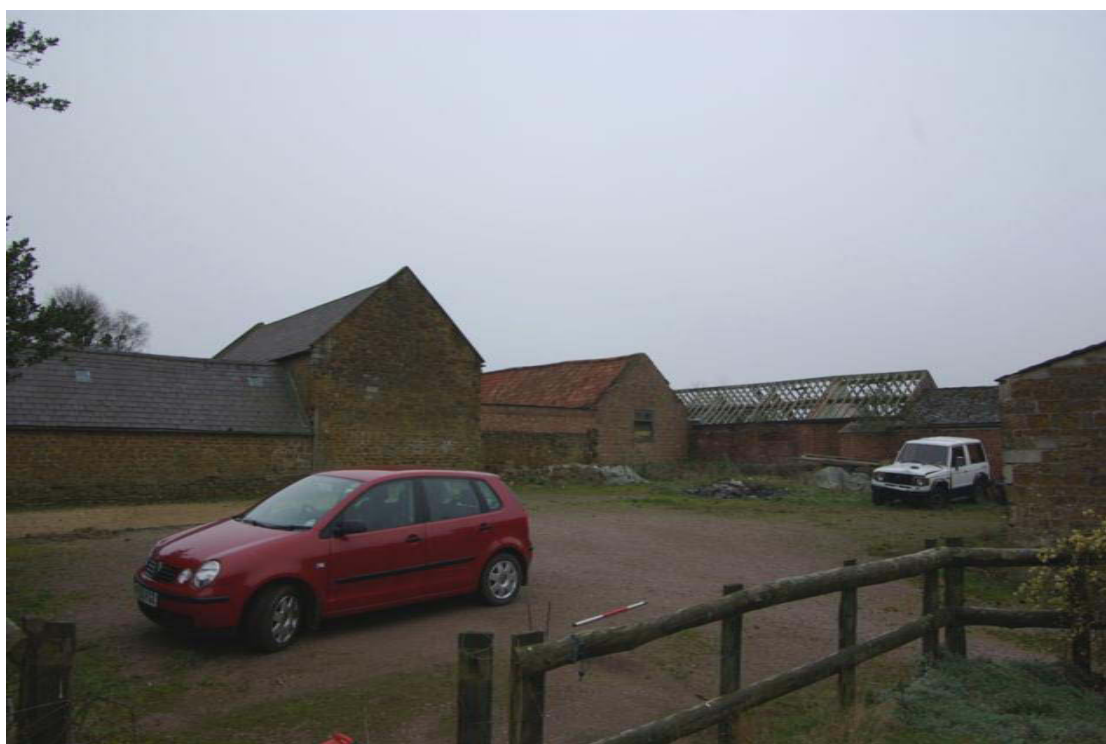
Figure 5 Upper car park before development  
Looking South west.

Prior to this programme of development this area was covered in mill-waste granite chippings with a gentle slope down from south to north. There was no indication of any of the demolished buildings noted in the background section above. Removal of the mill-waste revealed a mixed deposit of orange-brown sandy-clay across the whole area of the foundations. Sample excavation into this indicated that it varied in depth between 0.2m and 0.3m and was on top of a dark grey ashy layer on top of a mid-orange brown sandy clay natural substratum with frequent lumps of ironstone. The mixed layer contained a variety of early to mid- 20th century glass bottles and glazed jars. Removal of accumulated debris to the west of the foundations revealed a single layer of bricks probably relating to the demolished building attached to the western boundary wall.

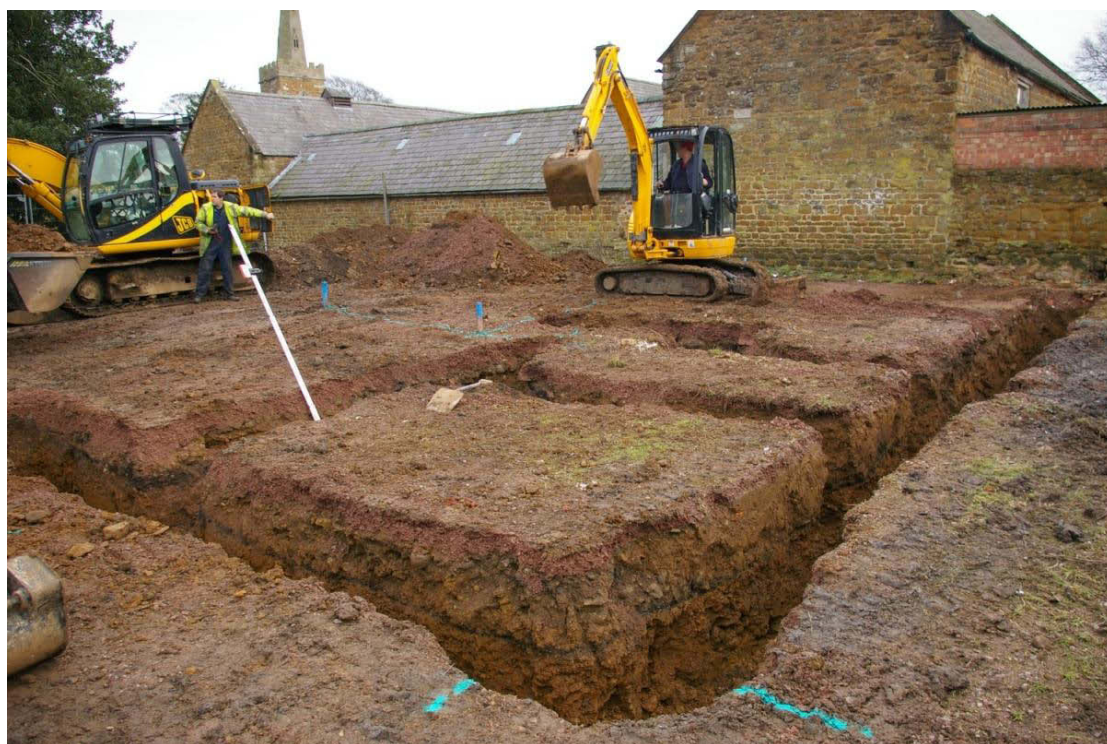
Figure 6 Semi-detached foundations  
Disturbed upper layers visible above black band of redeposited material.  
Looking south east.

Excavation of the remainder of the semi-detached plot foundations indicated that the whole area had been landscaped down to the natural substratum to create a level area with the loss of any overlying deposits which may have been present (fig. 6). The disturbed area appeared to respect the outline of the now demolished east to west lean-to barns which must therefore be of an earlier date. At the northern end of the foundation trenches no trace could be seen of the demolished building along the southern boundary which may suggest that it was an open-fronted structure with two side walls. There was no indication of any surviving floor or occupation layers in this area. No archaeological features or deposits were observed within the semi-detached house foundation area.

The lack of any archaeological deposits, or any trace of structures, within the site could be due to the landscaping and dumping episode seen in the area of the two semi-detached houses. This appears to have taken place at some stage during the early

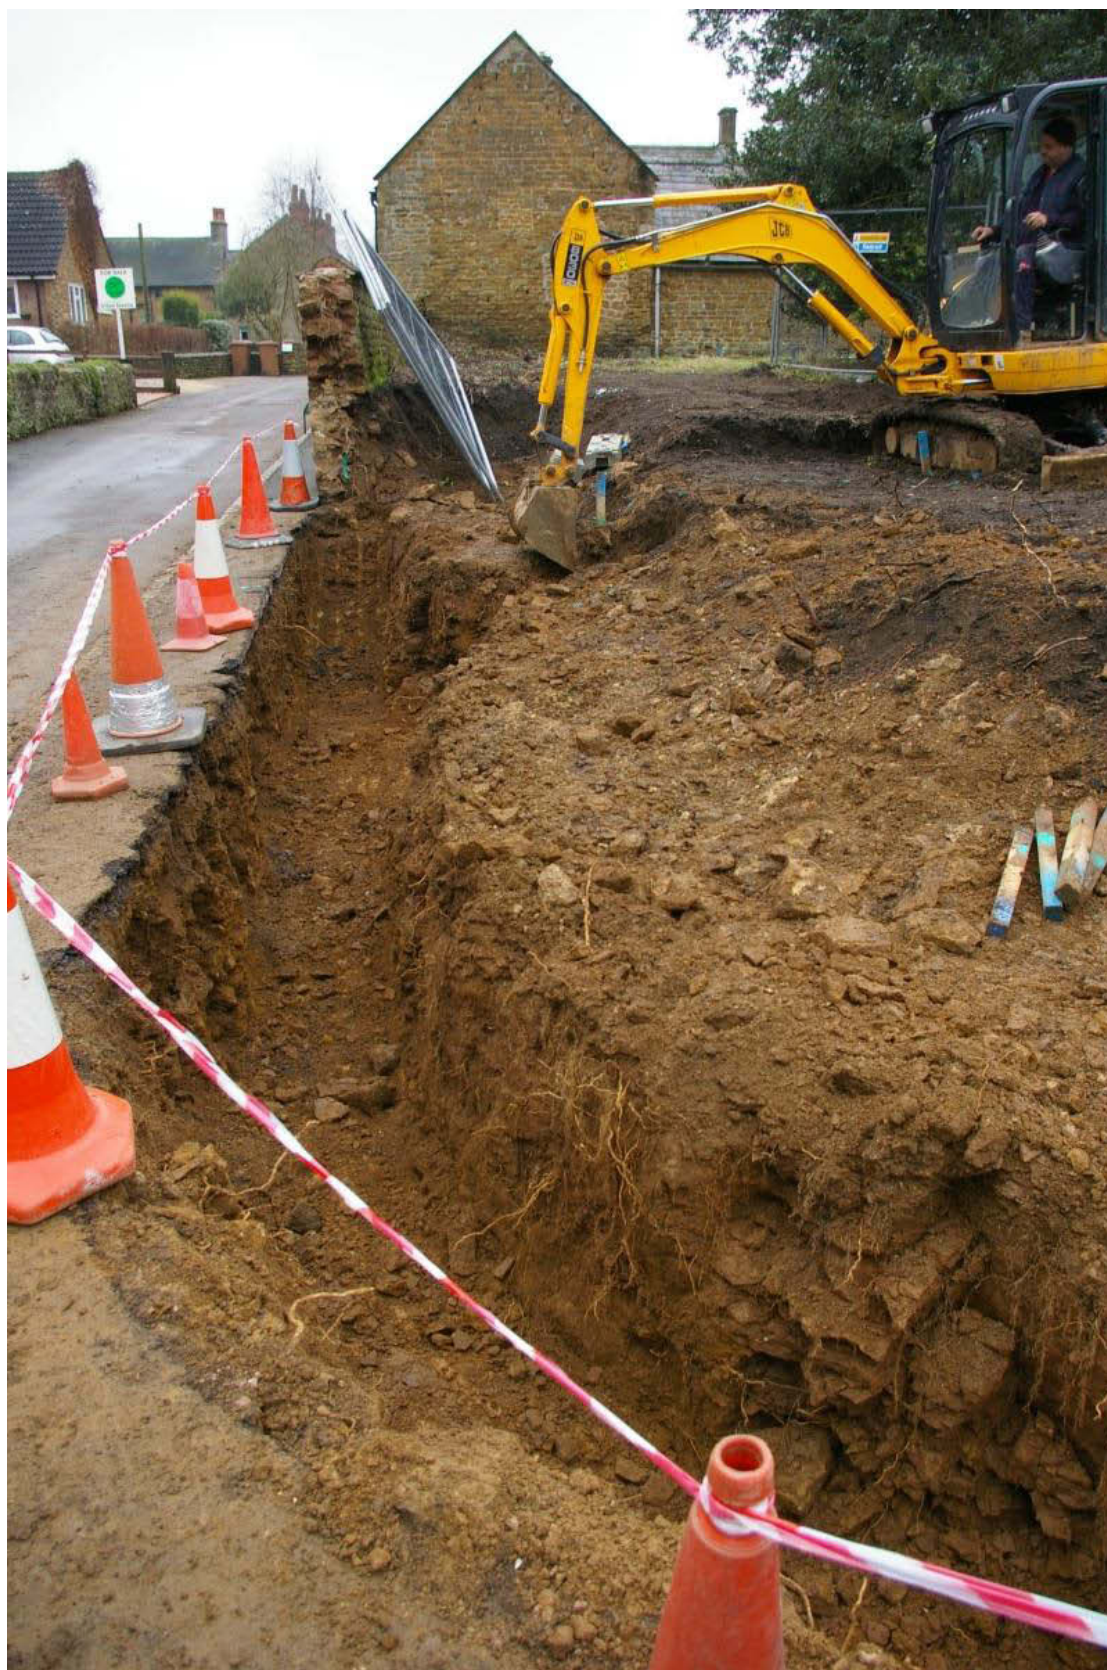
Figure 7 Excavating detached house foundations  
After demolition of wall and site strip around perimeter of site. Looking north.

Most of the area for the detached house, located along the eastern site boundary, had until recently been the public house beer garden and was laid out as a small garden and lawn with a large holly tree to the south which is subject to a tree preservation order. In order to dig the foundations the partial demolition of the stone boundary wall was necessary. Therefore, instead of an initial strip across the centre of the foundations, the topsoil level was reduced across the site and a 1m wide strip down to

the natural substratum was excavated around the perimeter of the stone wall prior to its demolition. The level of the mid orange brown sandy clay natural appeared to be at the same height as the adjacent road level. No archaeological features or deposits were observed within this stripped area.

During the subsequent demolition of the wall along Church Lane it could be seen that the wall foundations were cutting approximately 0.3-0.4m into the natural substratum and that the existing beer garden level was approximately 1m above the adjacent road level. Changes in the pointing of the wall where it entered the car park from Church Lane indicated that it had been rebuilt relatively recently. During demolition this was confirmed as it was found to be standing on a thick concrete foundation with fragments of modern brick embedded within it. The topsoil in the beer garden area appeared to have been extensively disturbed leaving only about 0.1m of dark orange brown clay sand subsoil. The excavation of the foundations for the detached house did not reveal any evidence of any archaeological deposits or features within the development area (figs. 7 and 8).
