**An Historic Building Analytical Survey (Level 2)**

**At the Three Crowns Inn, High Street,**

**Somerby, Leicestershire.**

**ULAS Report Number 2009-053**

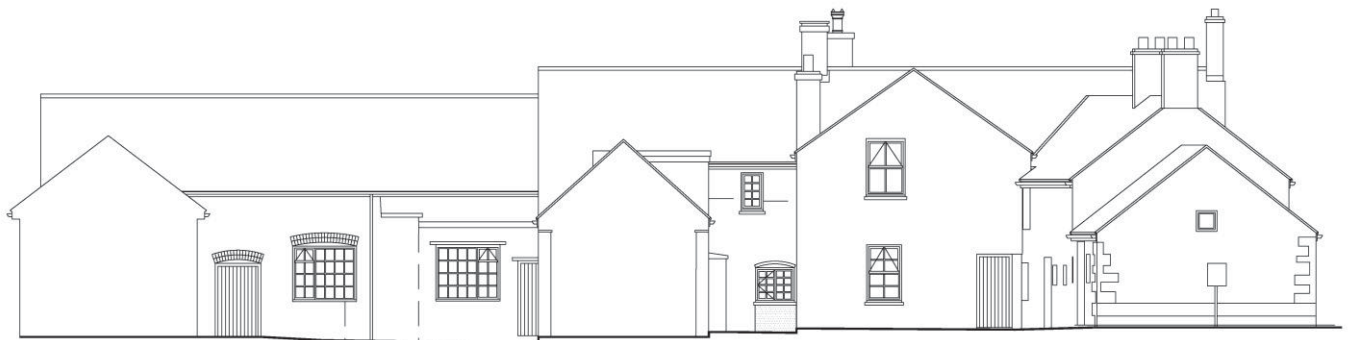
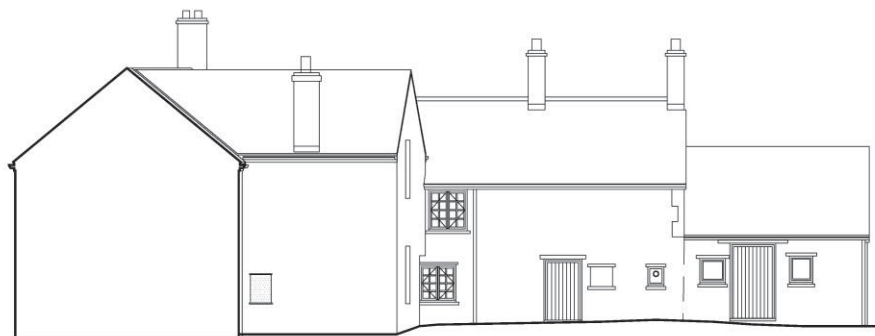
North facing elevation to High Street

The buildings belonging to the Three Crowns consist of an ironstone fronted two storey building facing onto High Street with a single storey stone barn joined to its western end (figs 2, 5, 6 and 7). Attached to its eastern end is another two storey stone fronted building forming the corner of High Street and Church Lane. Behind, and to the south of, these two buildings is a small courtyard which has been partially divided into two by a single storey rectangular building extending southwards from the rear of the High Street range. A two-storey extension has been added to the inner corner of the High Street and Church Lane buildings and further reduces the size of the courtyard. To the south-western corner of the High Street barn a range of brick and stone built barns extend southwards forming the western boundary to the courtyard. A stone and brick lean-to structure forms the east to west return corner of the courtyard with the remains of a high curving wall creating the eastern corner and boundary with Church Lane. To the south of the courtyard is an open area currently acting as a small car park and garden.

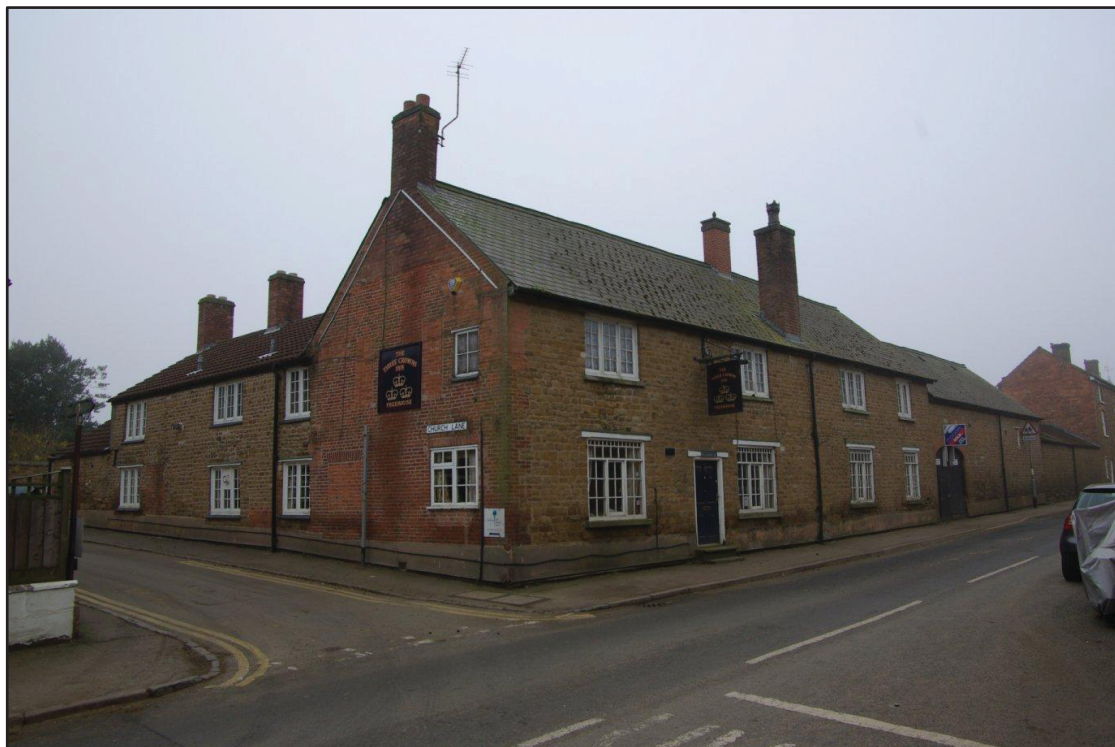
Figure 9 Three Crowns Inn  
Facing south-west

The main two-storey structure is built with coursed ironstone rubble and brick quoins on the western corner (figs 8 and 9). Constant splashing from the road and pavement has eroded the lower courses of ironstone quite badly so a band of cement render has been added to protect the lower courses. Thin red bricks with a fairly soft body form the lower part of the quoins up to the height of the bottom of the upper floor windows at which point they change to a harder, more orange coloured brick. The roof this building and the adjacent barn is of grey, presumably Welsh, slate with evenly sized and spaced courses and has a blue ceramic ridge. Three brick chimneys pierce the roof, two at ridge height and one, which is not shown in the photograph from the early 1900s, is at eaves height (fig. 8). The eight rectangular windows have wooden lintels with square multi-pane glass in each. The lower set of four windows have an interesting decorative detail consisting of a row of square clear glass panes running over the main opening frame with a second row of smaller alternately coloured red and yellow coloured glass panes at the head of the window (fig. 10). No blocked openings or straight line joints are visible on the face of the building until the joint with the connecting single-storey barn to the west. At this point large blocks of ironstone have been used to form an irregular joint over the eastern pillar of an arched double width doorway (fig. 11). This doorway appears to have been a full height door which has been lowered and a flat headed brick arch inserted along with a brick quoin on its eastern side. Two semi circular blind arches made from a single course of brick headers have been inserted into the barn wall to the west of the double doors although the function of these is not clear. Two square open vents can be seen just below eaves level and are consistent with ventilators used on agricultural buildings. A small rectangular wooden framed glazed window is also just below the eaves at the western

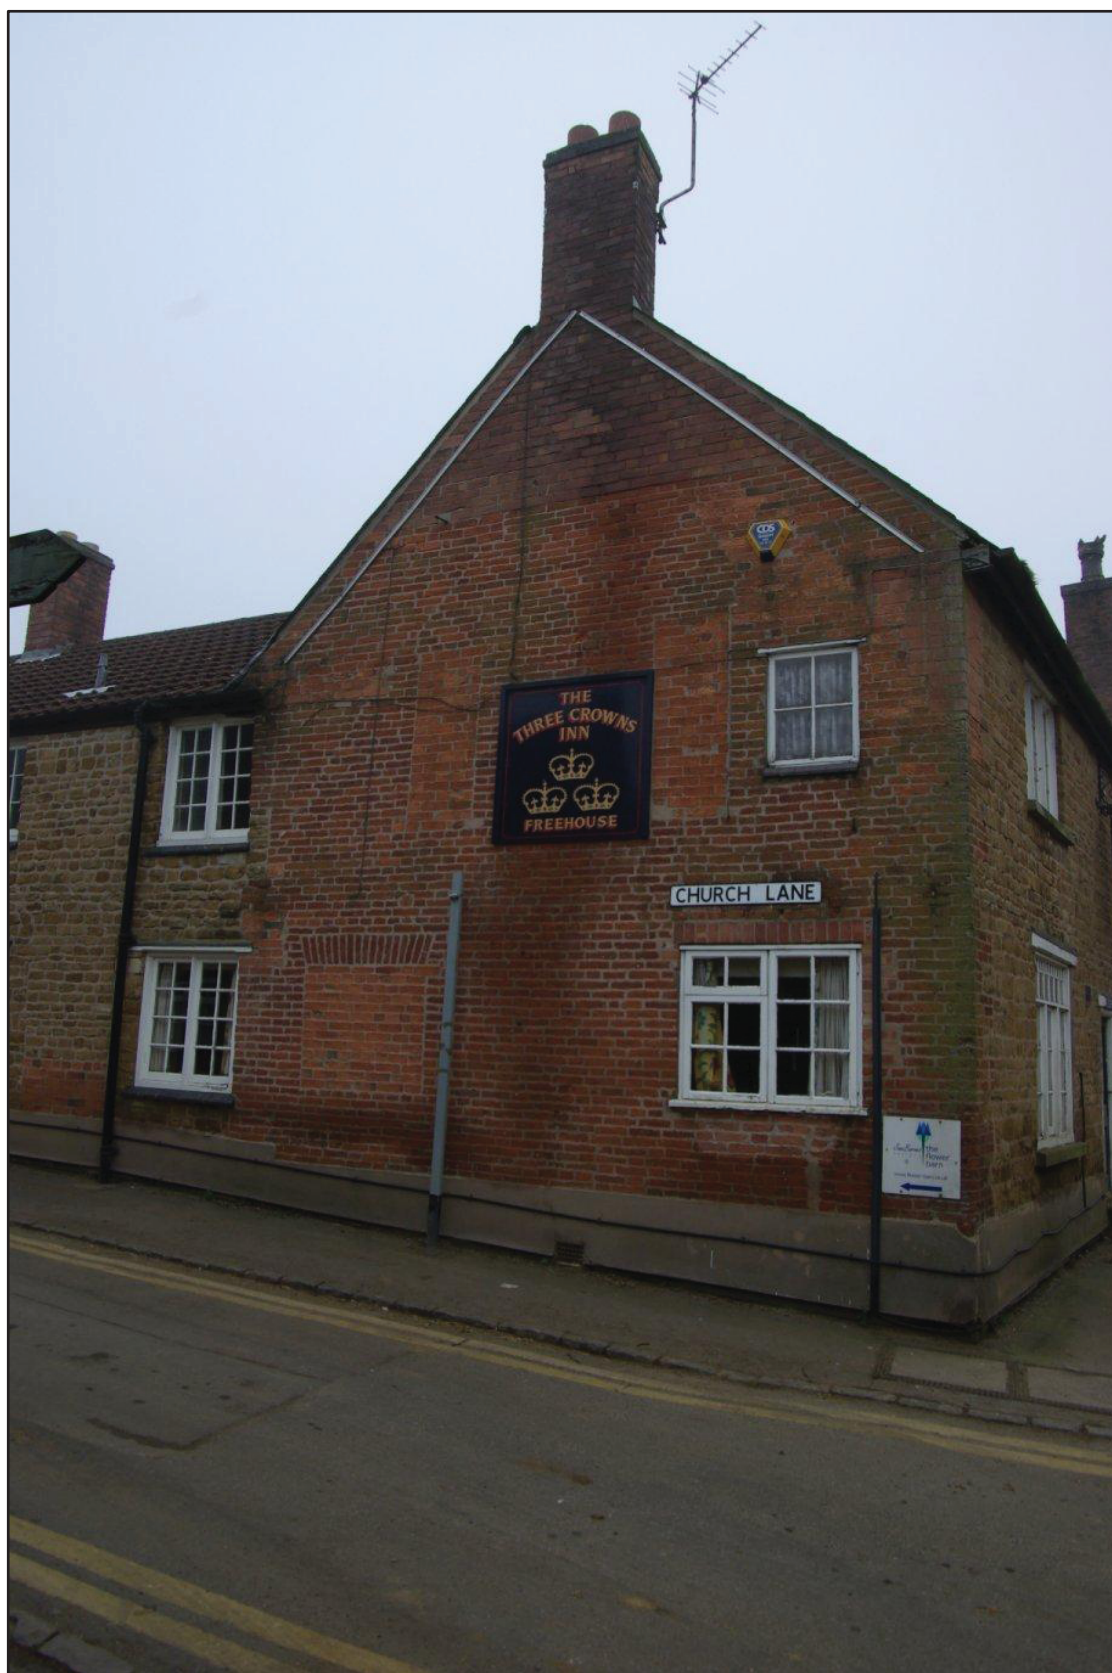
Figure 12 Church Lane gable end detail  
Facing south-west

Rounding the corner from High Street onto Church Lane shows that the High Street frontage changes to red brick on its eastern gable ended side (fig.12). The wall line follows the alignment of the road so that the angle between the High street and Church Lane walls is greater than 90 degrees. The bricks are handmade measuring 220mm long by 50mm high laid in a Flemish bond. A similar cement band has been applied to protect the lower courses of brickwork. A square wooden framed window is at ground floor level at the northern corner with a lintel made of brick headers. A brick blocked window which has a lintel made from upright stretchers is to the south of the existing window. The blocking bricks are slightly larger than the surrounding wall at 220mm by 60mm by 100mm wide. At first floor level there is a small four-paned window and evidence of two tall and narrow brick blocked openings which may have been windows. What appears to be a straight joint runs diagonally from the north and south sides towards the centre of the gable indicating a possible raising of roof height and a slight change of pitch. The upper courses of the gable end and the chimney have been rebuilt using what look like harder fired bricks.

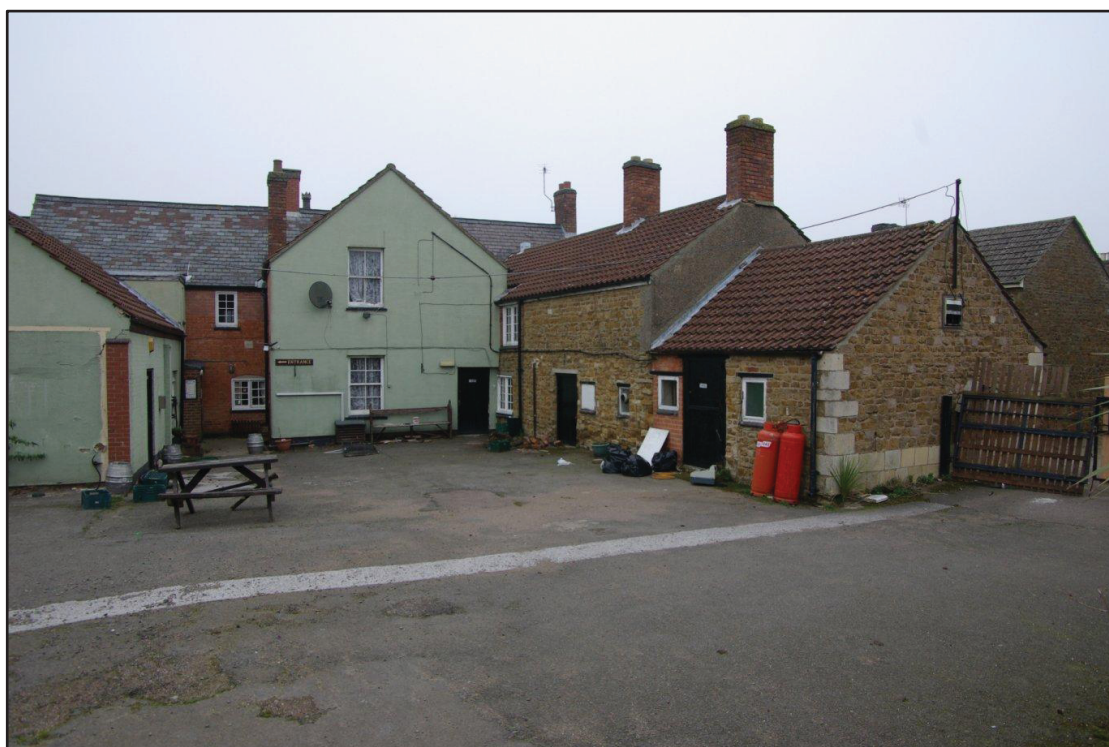
Figure 16 Courtyard area  
Facing north-east

This elevation forms the rear of the Church Lane range (fig. 16). As with the eastern side the roof is of thick cement pan tiles although a photograph taken in the early 1920s in the *Somerby Remembered* book shows this building in the background of a photograph with a slate roof. The small southern end block has a small window let into its ironstone face with a double doorway half blocked with modern bricks to create a single door. To the north a two-storey extension has been built against the rear of the High Street range which butts against the rear of the Church Lane range and slightly overhangs the Church Lane roof. Apart from the blocked doorway the west facing elevation appears to be in the same condition as originally built.

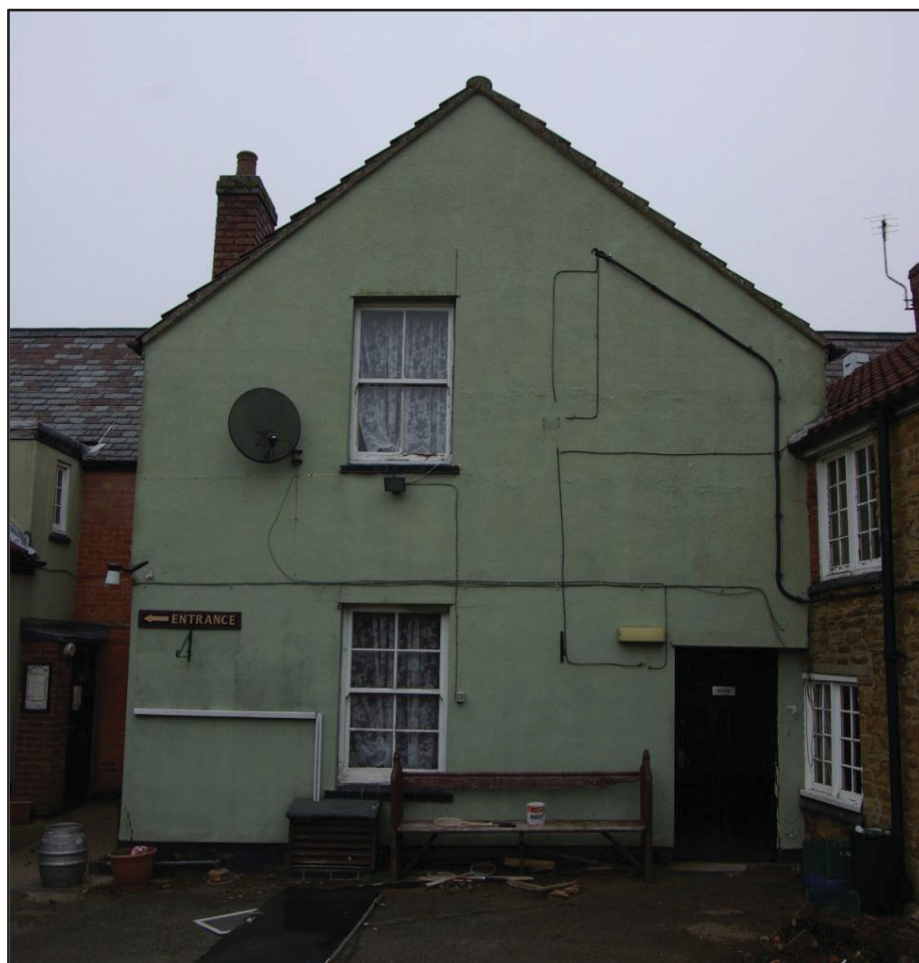
Figure 17 Rear of south extension  
Facing north

An extension from the rear of the High Street range projects out into the courtyard (fig. 17). The south facing elevation to this extension has been rendered leaving a sash window and single door on the ground floor and a sash window on the first. Both windows have blue brick sills but the ground floor window has four panes in each sash whilst the first floor has only two. The horns on each window are also different.

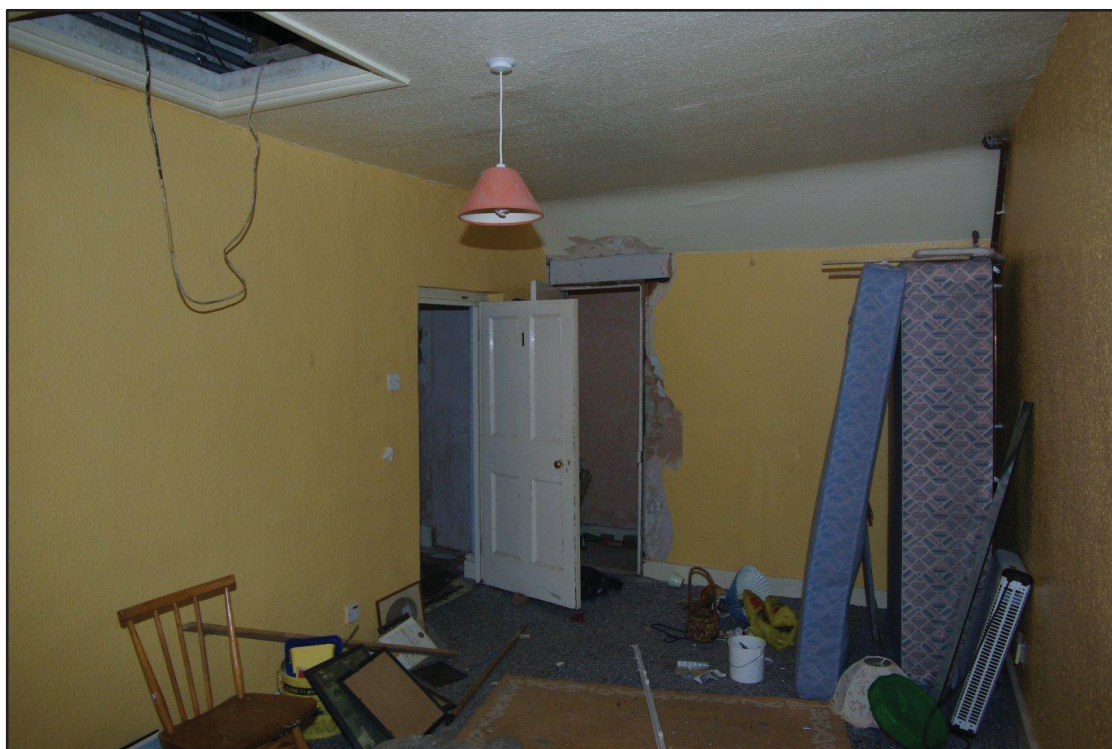
Figure 25 Bedroom One  
Facing south-east

Bedroom 1, at the western end of the High Street range, has a wooden four-panelled door with a masonry east wall supported by the large beam seen on the ground floor below (fig. 25). A loft hatch reveals the roof structure to consist of sarking boards attached to the upper side of the common rafters which are supported by a single purlin on their under side. A small toilet has been added by knocking out a window to create a door in the south wall. Only a wooden lintel belonging to the window survives. The toilet is built into the flat roofed addition to the toilet block discussed above.

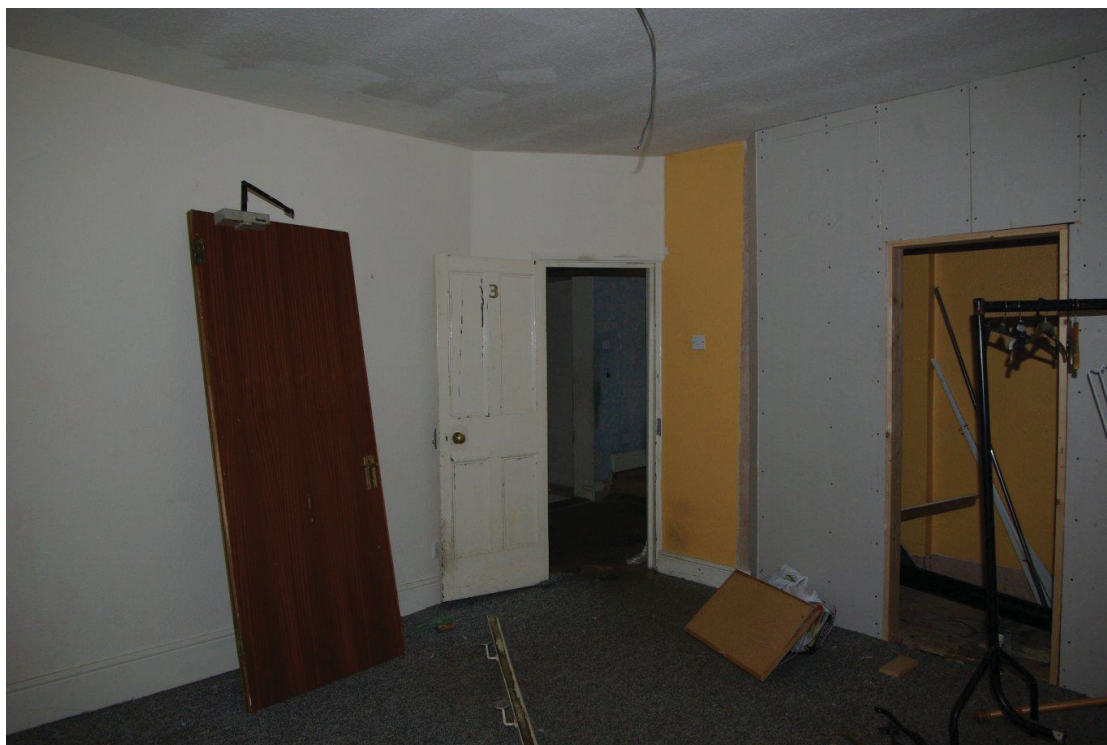
Figure 26 Bedroom Three  
Facing south-west

Bedroom 3 has its south western corner modified to cope with the increased size of the landing outside (fig. 26). A part built plasterboard modern shower room is being constructed in the east end of the room but little else is visible. The room, as with all rooms on the High Street range, appears to have a plaster floor and lath and plaster walls.

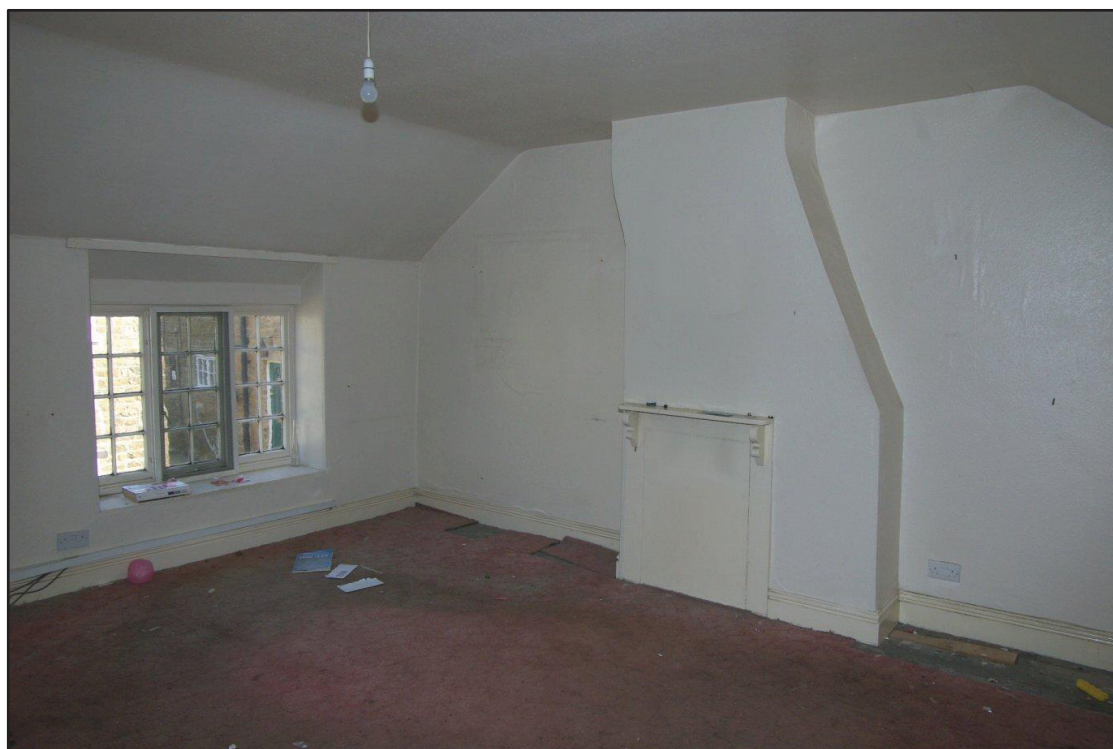
Figure 29 Bedroom Six  
Facing south-east

Bedroom 6, at the south end of the Church Lane range, has a blocked fireplace on the south wall (fig. 29). It has the same beaded skirting boards as elsewhere but is otherwise quite plain.

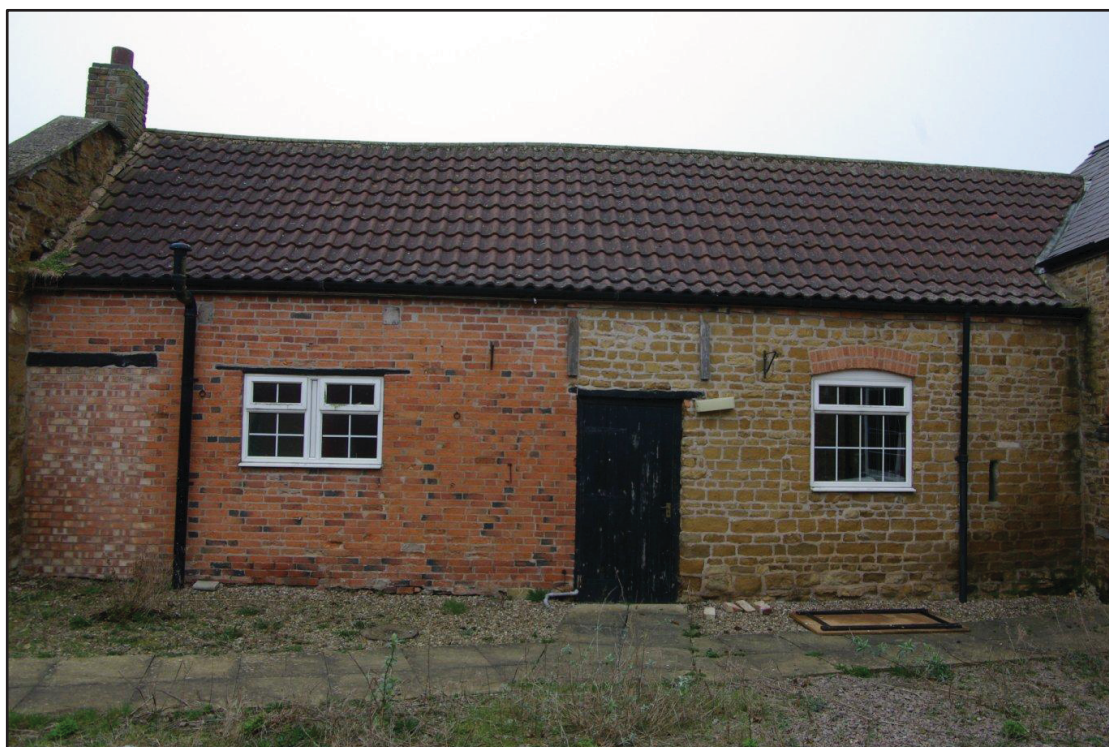
Figure 31 Western barns, north end  
Facing west

The west range of barns butt against the High Street barn and start with a single storey building half of stone and half of brick that has cement pan tiles on the roof (fig. 31). On the eastern face the eaves are slightly lower than the High Street barn despite the roofs being joined. The northern part of the first barn is of coursed ironstone rubble with a uPVC window filling an older opening with brick headers for the lintel. It also has a slit window which has been glazed and a single wooden door to the south. The southern part of this building is of red brick laid in a Flemish bond and with the bricks measuring 210mm by 60mm by 100mm wide. The window is modern with a flat wooden lintel and is next to a bricked up doorway also with a wooden lintel.

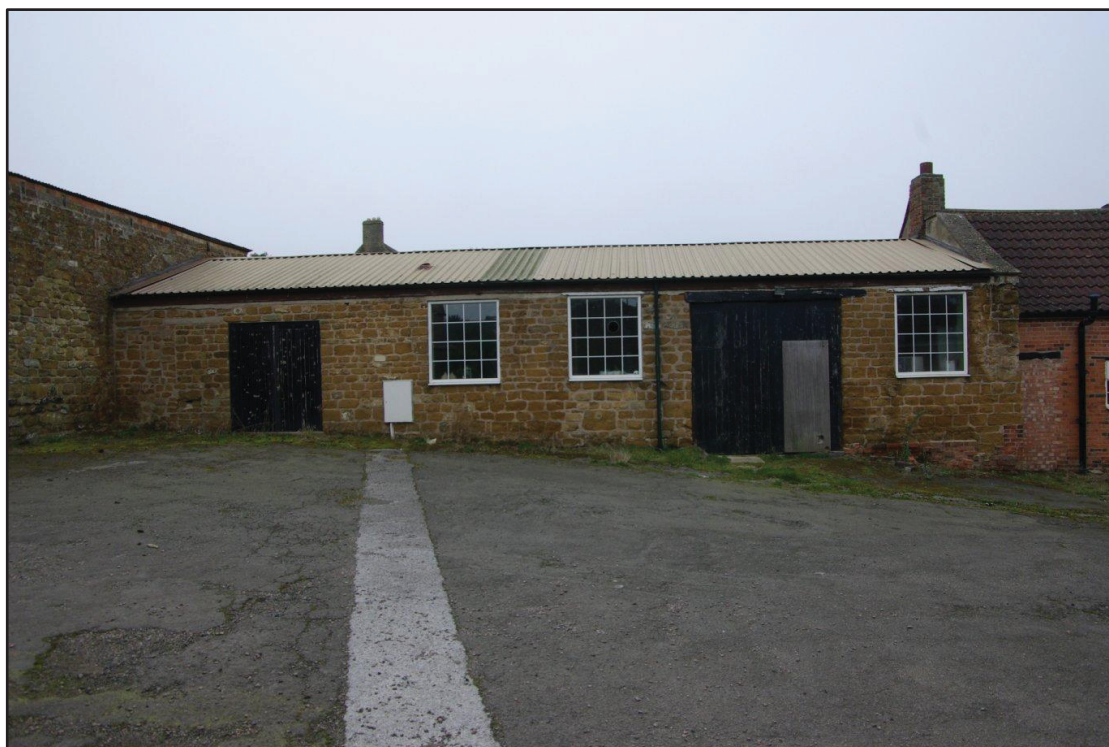
Figure 32 western barns, south end  
Facing west

To the south of the brick and stone building is a large single storey coursed ironstone rubble building with brick repairs to the north corner (fig.32). This originally had a steeper pitch to its roof as shown by a wide parapet at its north end which would have continued the same ridge height as the adjacent building. A flatter pitched corrugated steel roof is now present. Three large square modern windows have been inserted into the east elevation and have obscured any trace of earlier windows that may have been present. Full height double doors at the north end appear to be original as do the slightly lower doors near the south end. Evidence of a blocked single door can be seen in the southern corner.

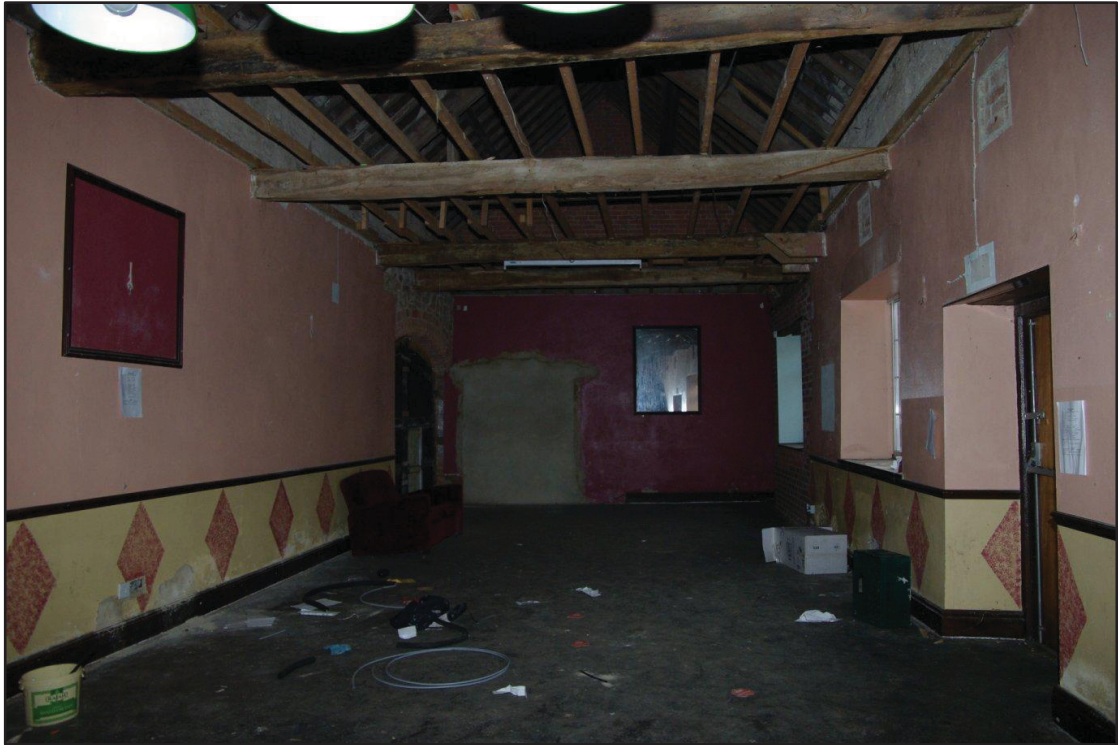
Figure 34 High Street barn  
Facing east

At the eastern end of the High Street barn a recently blocked doorway once gave access into the bar room when the barn acted as a function room (fig. 34). The 1903 auction notice mentions a carriage house or village room measuring 43 feet by 18 feet, the measurements of this room are 12.6m by 4.9m which converts to approximately 42 feet by 16 feet 4 inches. Large and substantial wooden double doors hung on shaped strap hinges lead out onto High Street. Although the rest of the room is plastered there is an area of exposed brickwork opposite to the double doors where the corresponding doors into the courtyard have now been blocked up. The blocked window visible from High Street can be seen in the western stone gable end. Holes in the brickwork on the eastern gable show where purlins and a ridge board from an earlier roof structure were once set. The present roof has trusses supporting two queen posts which in turn support the principal rafters that cross at ridge height in a lap joint. Cleated purlins sit on top of the principals and support the common rafters.

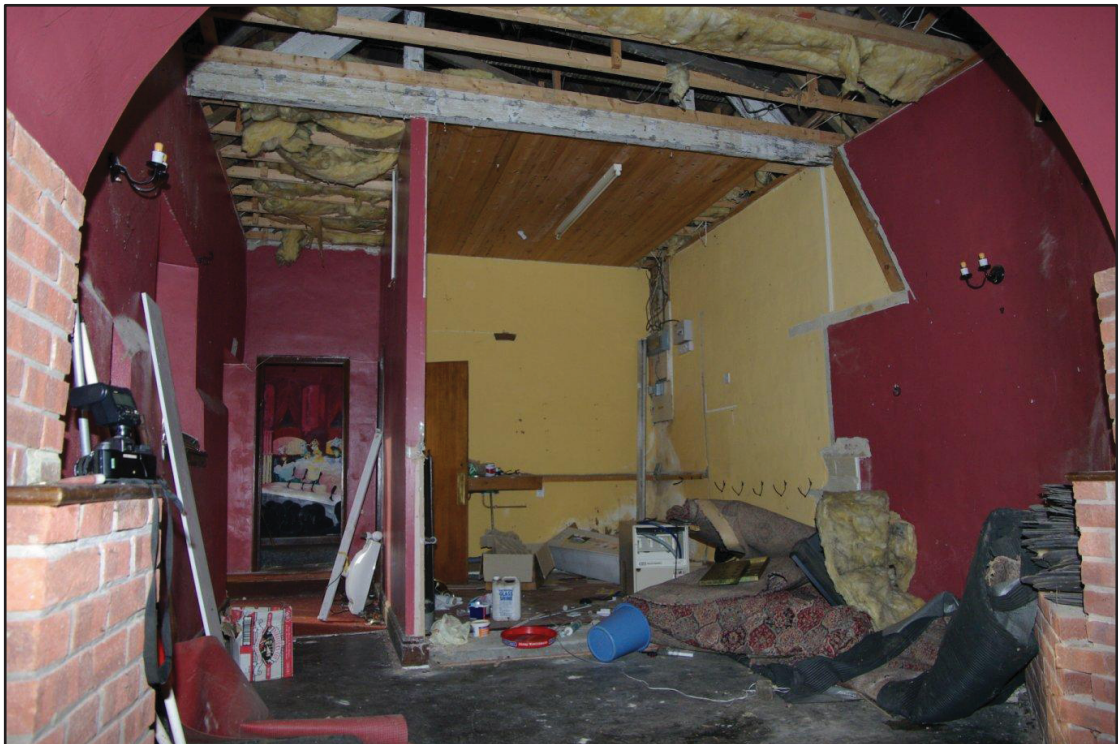
Figure 35 Western barns from High Street barn  
Facing south

A wide archway, of apparently modern design, is in the south-western corner of the High Street barn and leads into the western range of barns (fig. 35). The north-western corner follows the curious curving boundary of the site. The roof structure above is partially exposed and shows a fairly simple structure of common rafters. The stone portion of the room has been subdivided into smaller parts which are partially dismantled but still give little indication of their former use prior to this subdivision. A single step up leads into the brick part of the building which has had male and female toilet blocks built into it. Only two timber beams running east to west across the ceiling can be seen. Any other structural details are obscured by wall plaster or the toilet cubicles.
