**Archaeological Monitoring Work
during repairs to the Ha-ha and
groundworks for the Oxford and
Cambridge Building at Launde Abbey,
Launde, Leicestershire.
NGR: SK 797 043**

ULAS Report No. 2010-008
©2010

For: The Trustees of Launde Abbey

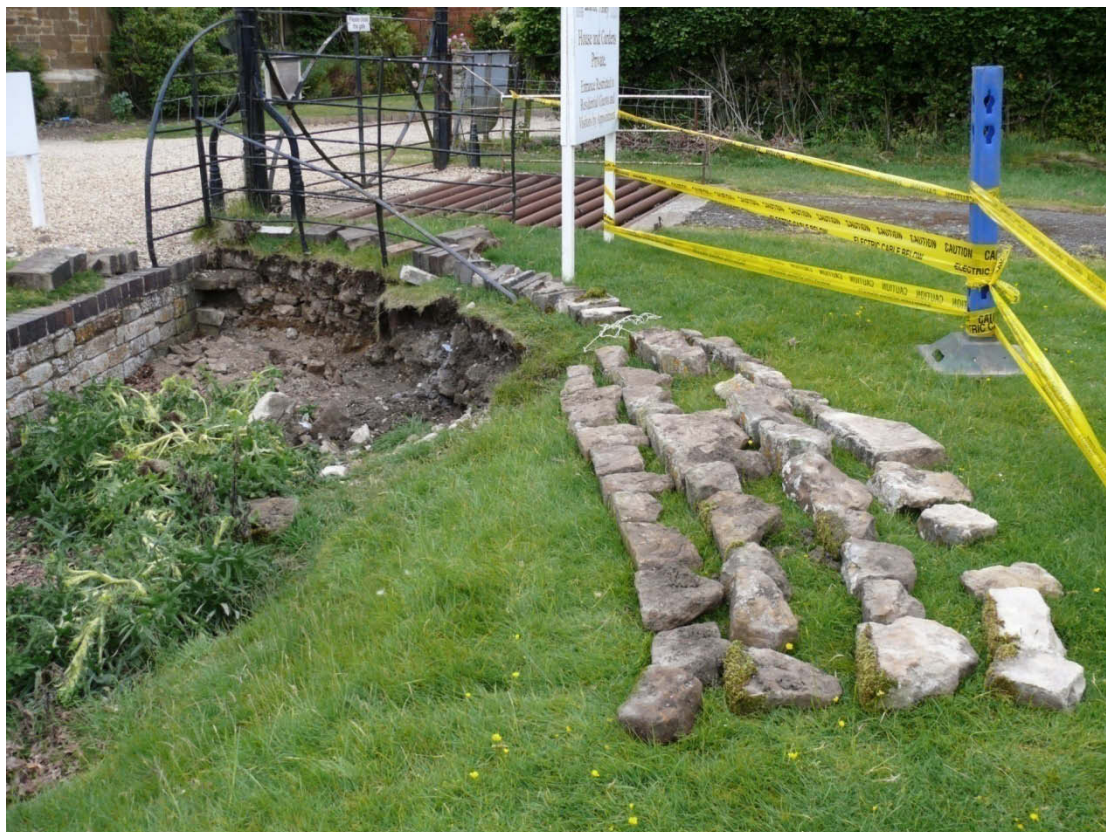
Part of the restoration work involved the small side wing at the southern end of the ha-ha wall which was dismantled and the stone cleaned before being reconstructed (fig. 3). The wing was found to consist of a single skin of roughly faced stones holding back a large amount of limestone rubble. It would appear that this part of the wall has been rebuilt at some stage as the southern end was bonded with a harder mortar than the crumbly degraded mortar at the northern end. A number of modern brick fragments were also noted in the wall fabric at the southern end. The high level of rubble retained behind the wall was not structural and may relate to the adjacent roadway and could be part of the road make-up. Three fragments of stone within the wall were found to have been faced with one having a moulded bead carved along one edge (fig. 4).

Figure 3 Side wing wall on south side of Ha-ha
Facing north east

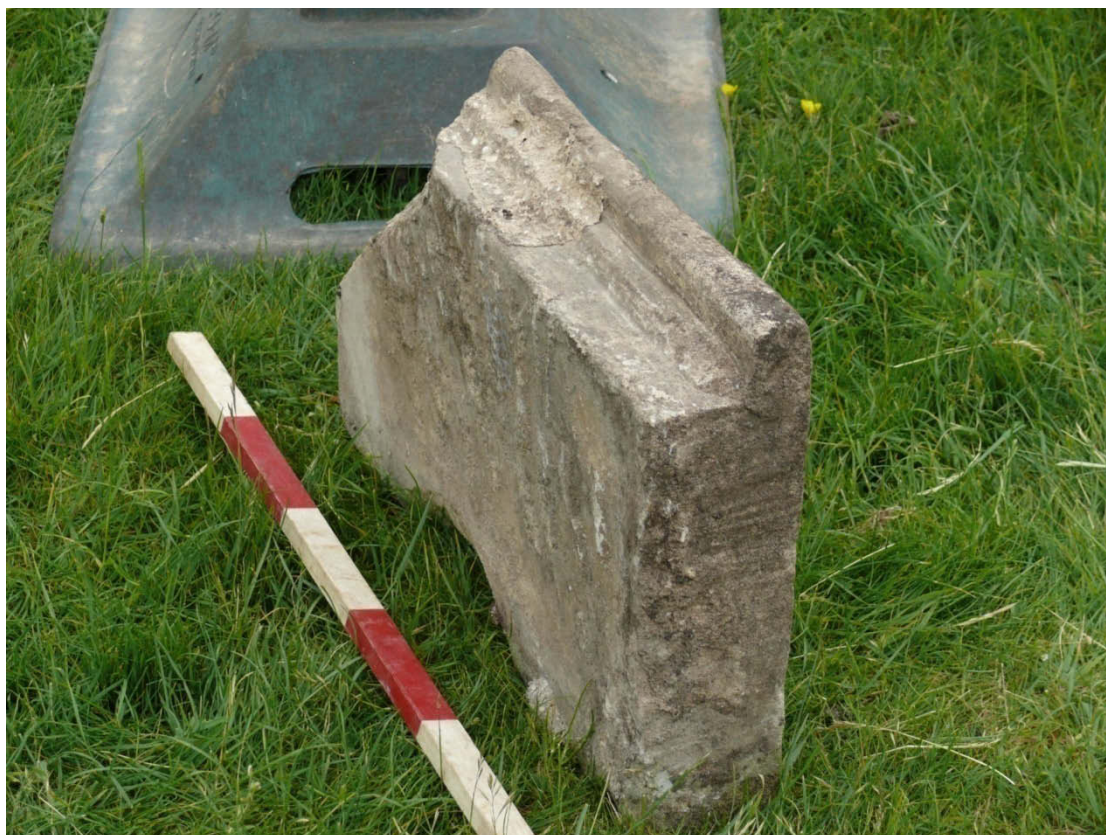
Figure 4 Moulded stone recovered from side wing wall
50cm scale

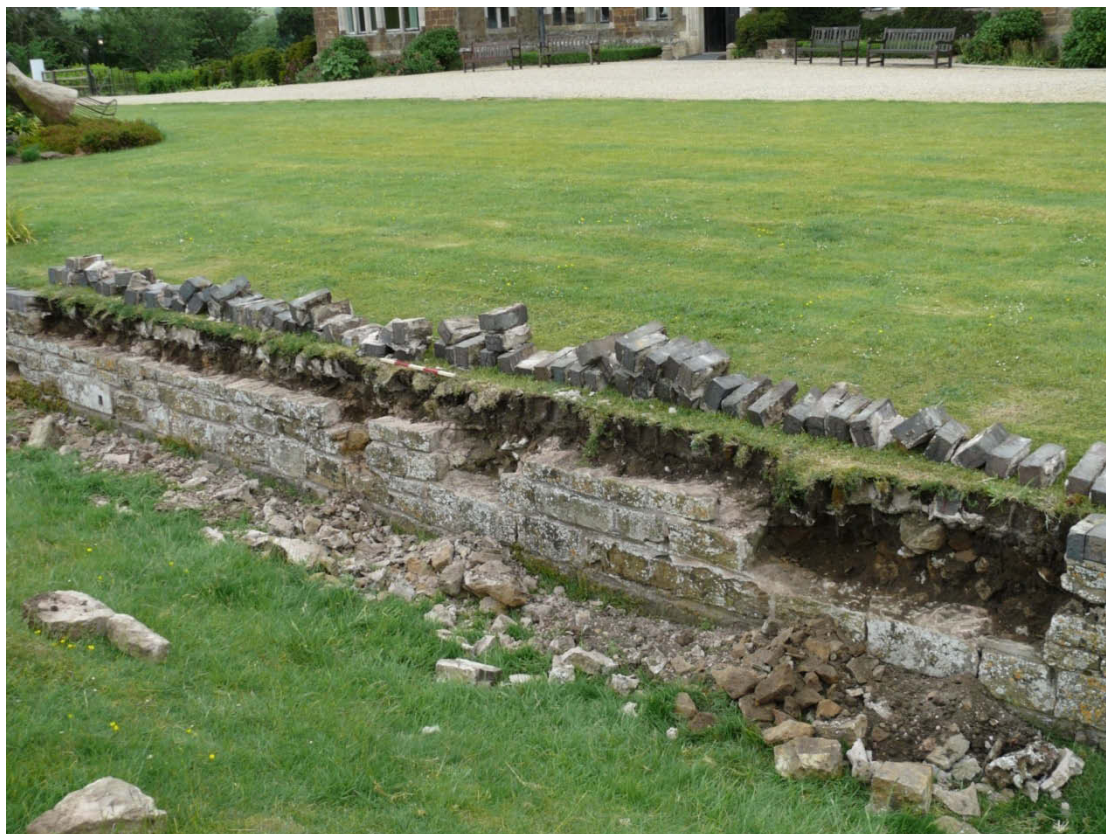
Along the south western portion of the Ha-ha only the brick copings and upper courses of stone needed to be repaired which meant that it was not possible to see any more evidence for the original priory walls seen in 2007 (fig. 5). Many of the removed stones showed that they had been chiselled to create a smooth outer face. One stone also had a small hole drilled into it although the reason for this was not clear. The backfill behind the wall appeared to consist of naturally shaped limestone rubble mixed within a dark brown topsoil type matrix.

Figure 5 South western portion of Ha-ha after removal of loose stones
Facing north east. 50cm scale

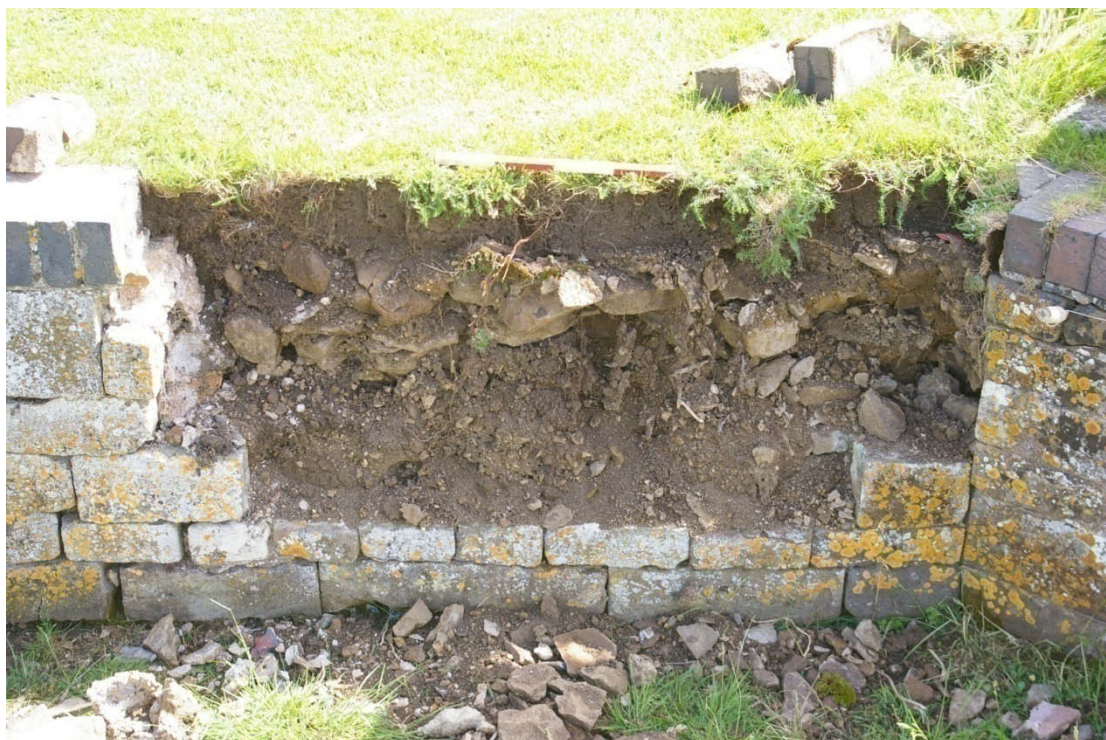
A 1.3m length of wall was rebuilt along the north western portion of the wall. Again only the brick coping course and the upper stone courses were removed to reveal the soil and rubble mix behind (fig. 6). Although this was near to the priory wall seen in 2007 no further evidence was observed during this work. No worked or moulded stones were recovered from this section.

Figure 6 Southern end of north western portion of Ha-ha
Facing east. 50cm scale

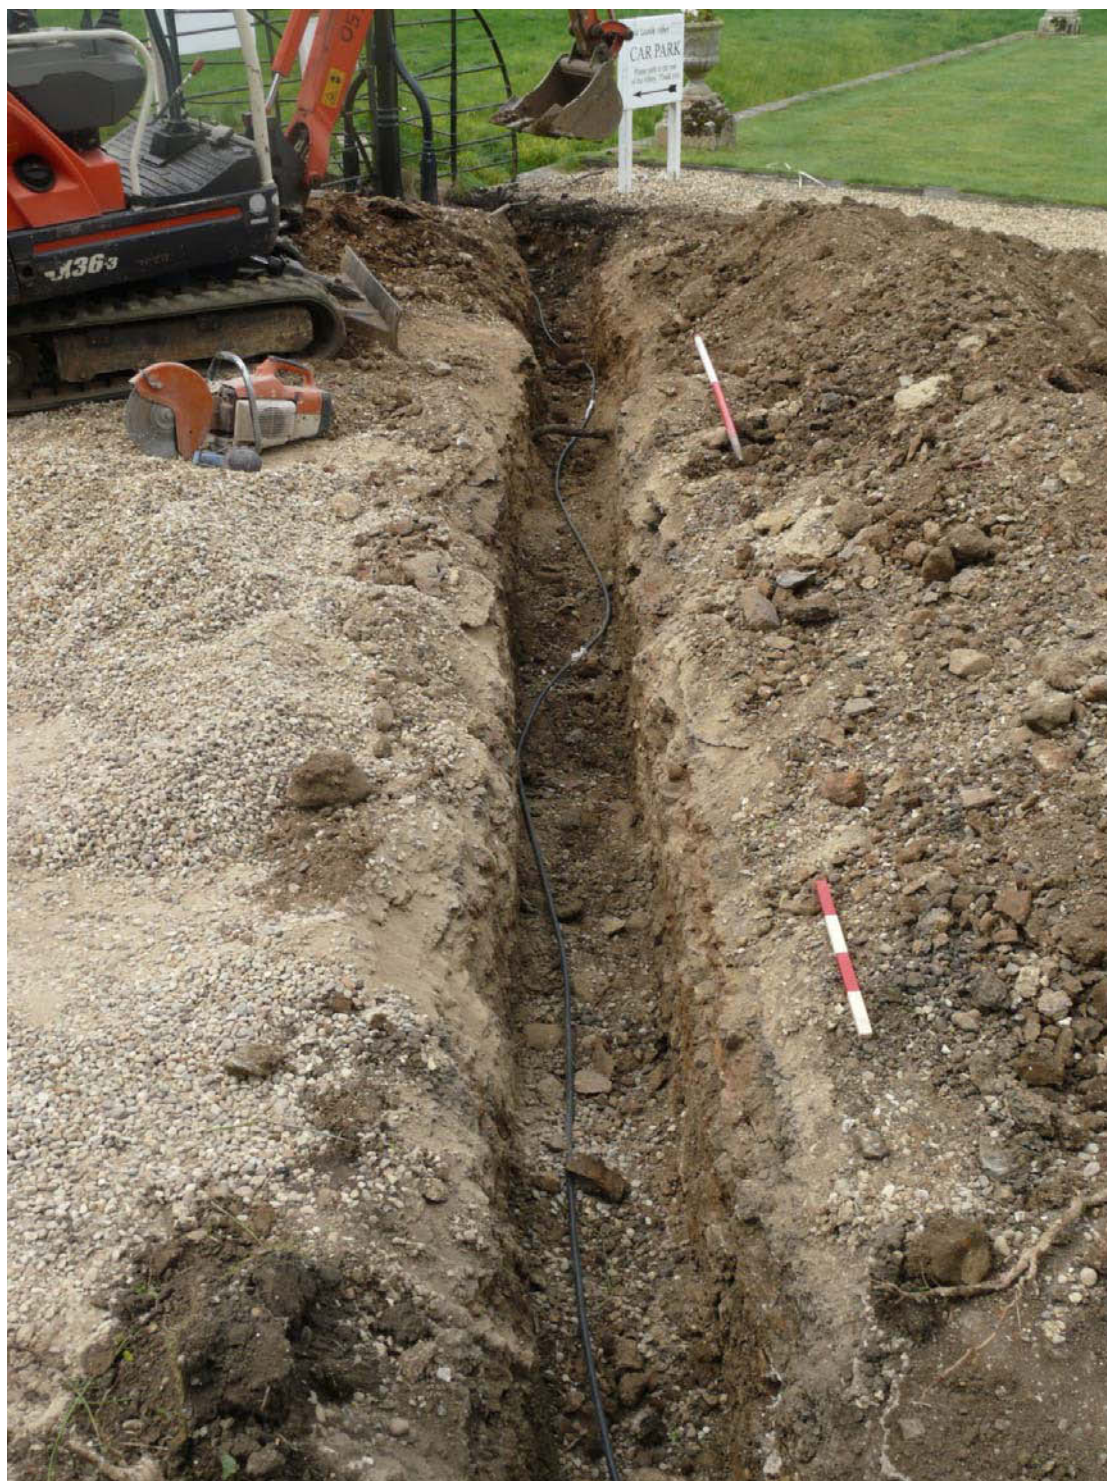
The restored Ha-ha will have a non-intrusive electric fence placed at the base of the ditch to replace the damaged barbed wire fence running along the top edge. To supply the new fence a cable trench had to be excavated from the south west corner of the house to the southern edge of the Ha-ha (fig. 7). The trench was approximately 0.6m deep and 0.5m wide. It was found that the gravel road surface covered a thin layer of Tarmac laid on a bed of rubble which in turn covered a layer of soil and stone rubble similar to that seen behind the Ha-ha walls. No archaeological features or deposits were observed within the sides or base of the trench.

Figure 7 Cable trench from house to Ha-ha
Facing north west. 1m and 50cm scales

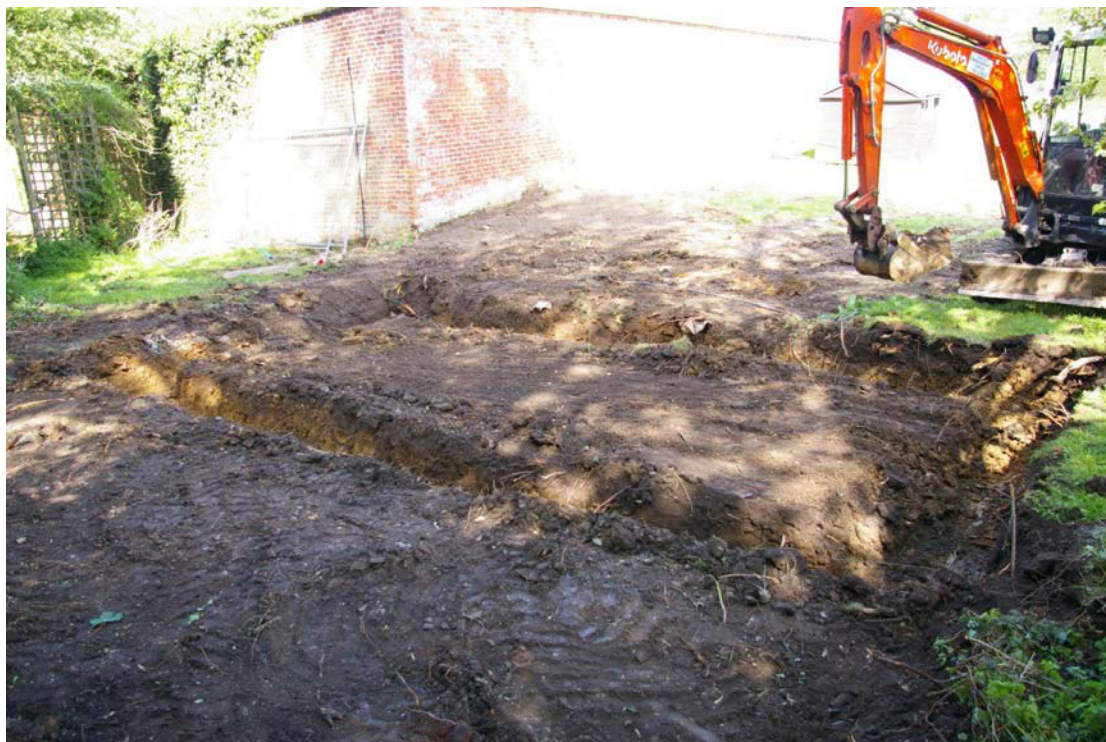
concrete raft slab was required. To achieve this, the topsoil was partially stripped across the whole area of the relocated building and a 0.5m deep trench was excavated around the perimeter of the building (fig.9). Approximately 0.35m of topsoil and subsoil were removed to reveal an orange brown sandy clay natural. No archaeological features or deposits were observed during this work.

Figure 9 Foundation trench for Oxford and Cambridge Building
Facing north east
