**A Strip, Plan, and Sample  
Excavation and watching brief  
at 4 Lady Gate, Diseworth,  
Leicestershire  
NGR: SK 453 243**

ULAS Report No . 2010-073  
©2010

**PA no. 09/00320/FUL**

**For: Keller Construction**

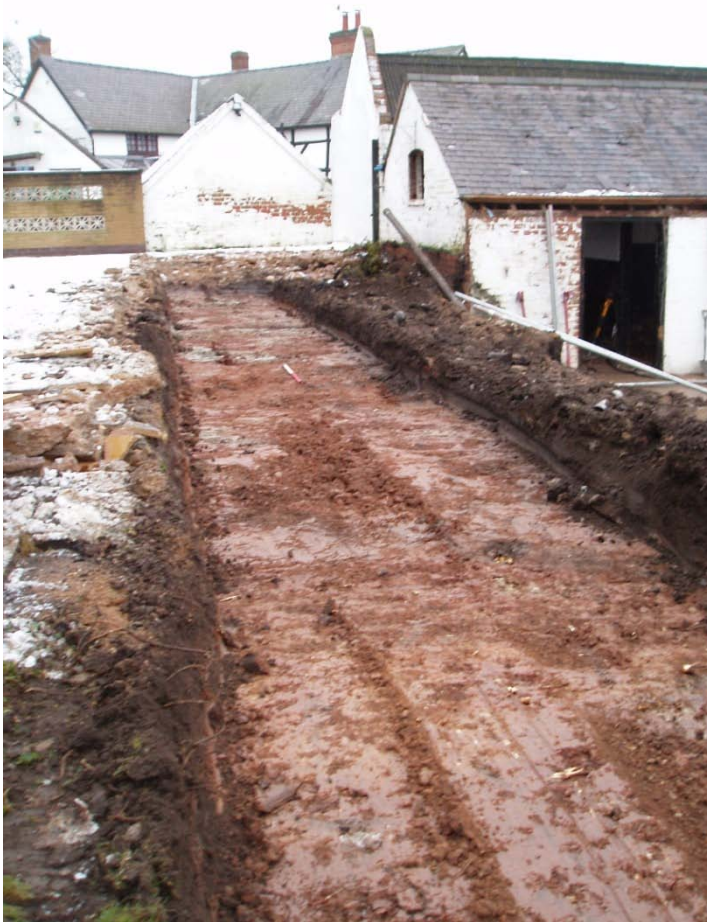
This area (Figure 3; also front cover, looking east) consisted of high ground covered with a concrete slab which was to be broken through and removed, the ground taken down to the level of the building immediately to the south. A retaining wall was removed on the south side of this area which revealed that the natural ground surface, a orangey clay, was overlain by a dark clayish loam. Over this was make-up comprising various dumps of CBM, concrete, ash, etc., acting as hardcore for the 0.25m thick concrete slab over. A 360o excavator was used to dig a 2m wide trench, firstly breaking and removing the slab and solid hardcore with a toothed bucket, followed by the removal of any loose hardcore and the garden-type soil in spits using a toothless bucket, until undisturbed natural strata were revealed. No archaeological deposits were encountered, and the only finds revealed were modern (i.e. 19th century or later) building material and china, which were not retained.

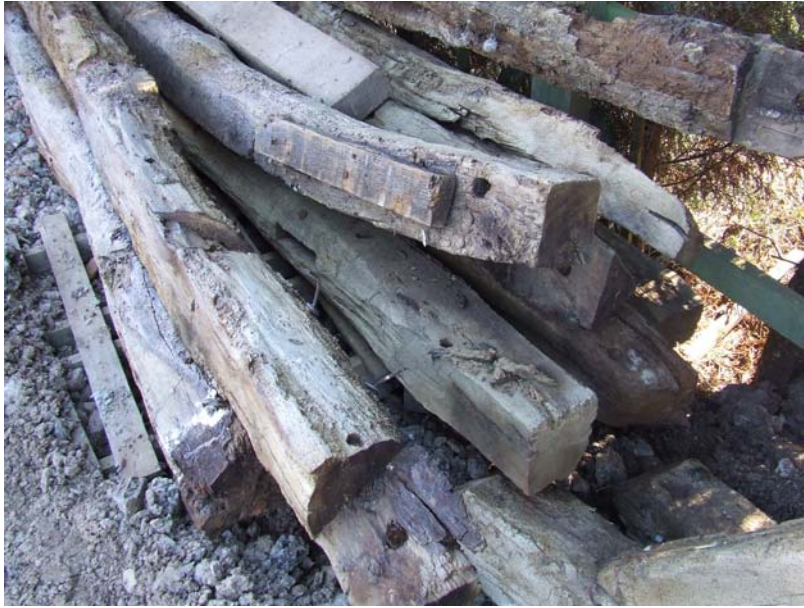
Figure 4 Detail of timbers

The major timbers of a dismantled roof (Figure 4, Figure 5) were stacked on the site, taken from one of the buildings undergoing alteration. The timbers included two roof trusses and a collection of long beams. The trusses, which appeared to be of oak with raked struts, were badly affected by woodworm. The principals were re-used, probably having originally served as wall-plates or some other component of a timber-framed structure. All joints visible were pegged. The purlins had been trenched into the principals. The roof was said to have come out of one of the buildings undergoing re-furbishment; the building in question (Figure 6) is certainly of more than one phase, but appears to be 18th century at the earliest. The trusses cannot be dated with any certainty on typological grounds, but the form would not normally be expected much after the end of the 17th century. However, it is possible that they were purpose-made for the building, or perhaps salvaged from elsewhere in the village for re-use. The opportunity was taken to make a brief photographic record of them where they lay.

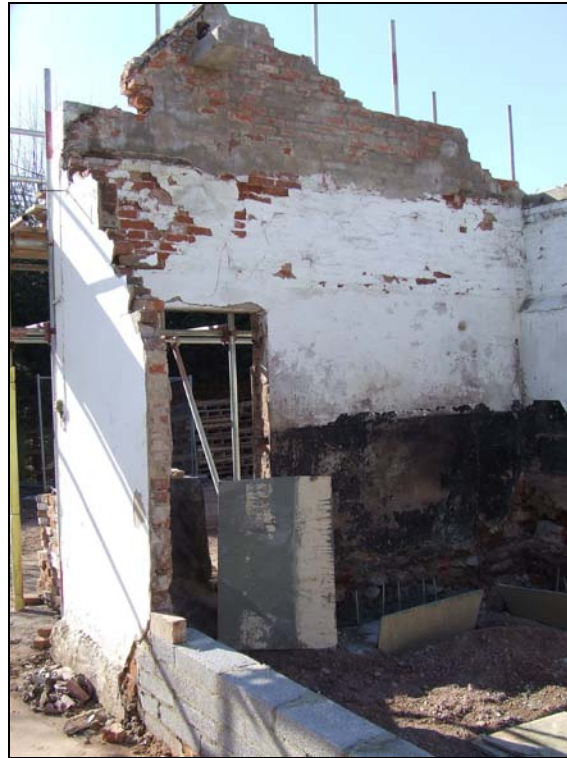
Figure 6 Building from which trusses were removed  
Note single skin thin brickwork, probably 18th century.
