**A Photographic Survey and Archaeological
Watching Brief at the Former Outwoods Timber Yard,
The Outwoods, Burbage, Leicestershire
(NGR SP 602 900).**

**University of Leicester
Archaeological Services**

ULAS Report Number 2007-155 ©2007

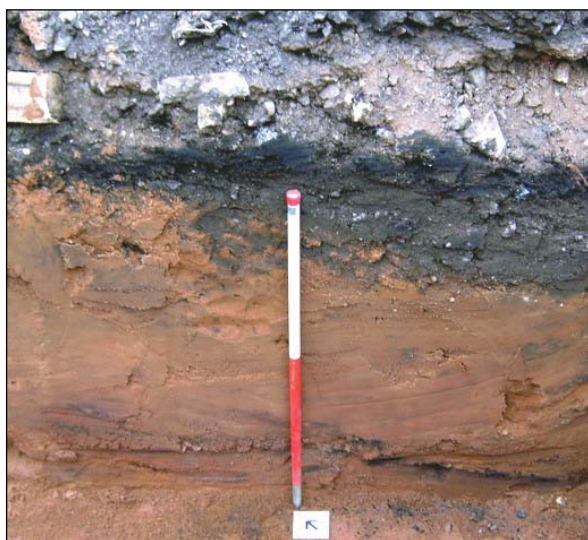
The trench excavated for the mains water trench was 0.4 metres wide, 0.75 metres deep and approximately 12.0 metres long, unfinished at the western end. Trenching revealed a layer of brick rubble on average 0.5 metres deep, below which was a thin (0.2 metres) layer of mid greyish brown sandy silt. Beneath this layer and to the base of the trench was undisturbed bedrock of bright gingerish orange medium grained sand with occasional pebbles. Trenching of the soakaway revealed a similar section, although a layer of greyish black ash and cinder lay between the rubble and the sandy silt and this silt layer was deeper, on average 0.3 metres.

Figure 5
The soakaway trench illustrating the layers described in the text. Metre ranging rod

The rubble layer may be attributed to the demolition and levelling of the buildings at the southern end, essentially the stables of Outwoods House. The ash and cinder layer was not particularly compact and did not appear to have been a surface, it may relate to an early phase of demolition. The sandy silt layer had the appearance of a garden soil possibly contemporary with the stable block. There were no features or deposits of archaeological significance in either of the trenches excavated and the general picture was one of undisturbed natural sand.

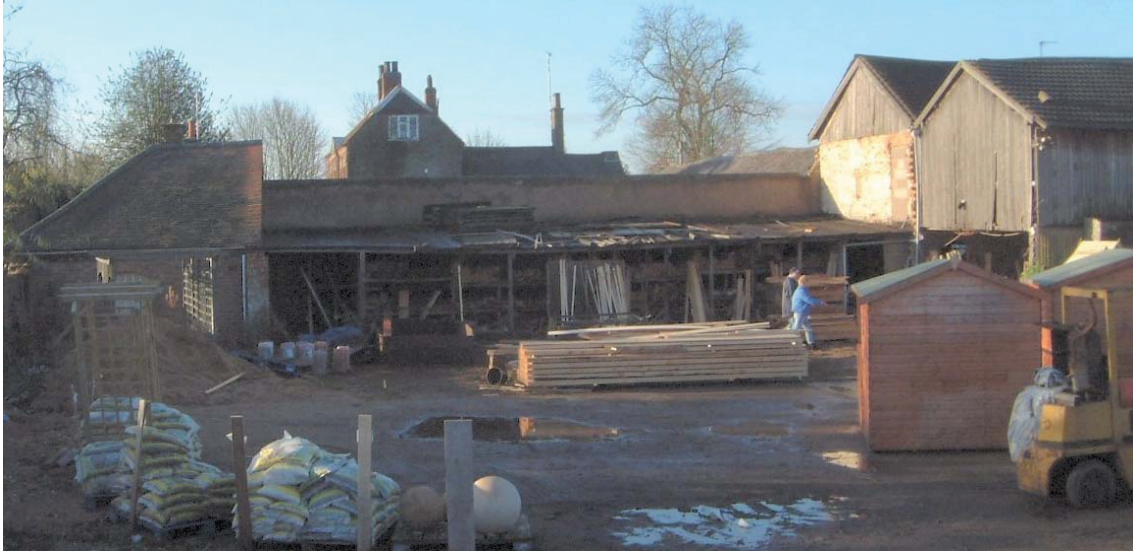
Figure 6 Pre-Demolition (Supplied by LCC).

According to photographic evidence, building 1 appeared to be a simple timber built lean-to built against the original and still standing rear wall. The structure itself is of

very little architectural interest, although it was a good example of twentieth century vernacular architecture.

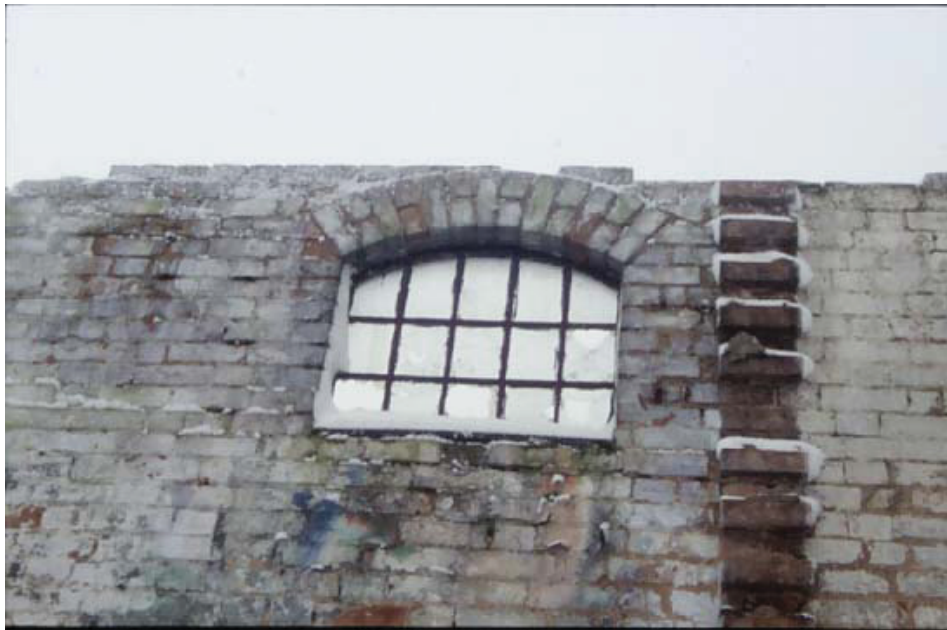
Figure 7 Exposed Iron Framed Window in Rear Wall

Unfortunately none of the supplied photographs clearly shows building 2, although what limited information exists suggest that building 2 was the sole remaining original element of the stable block. An examination of the remaining rear wall revealed vents suggesting that the building originally was a barn and there was also a straight joint within the brickwork of the adjoining cottage suggesting some degree of later partitioning took place. There is evidence of internal partitions also within the rear wall.

The brickwork consists of 9 ¼ inch by 3 inch red brick; the remaining windows are flat cambered arches in red brick, as are the doors. However, a closer examination indicated that the lowest fifteen courses were 9 inch by 2 inch hand-made bricks, indicating that this rear wall, at least had been rebuilt at some time.
