**An Archaeological Watching Brief at
40 Main Street, Medbourne
Leicestershire
NGR: SP 80040 93250**

ULAS Report No 2010-211.
©2010

For: Andrew Cory

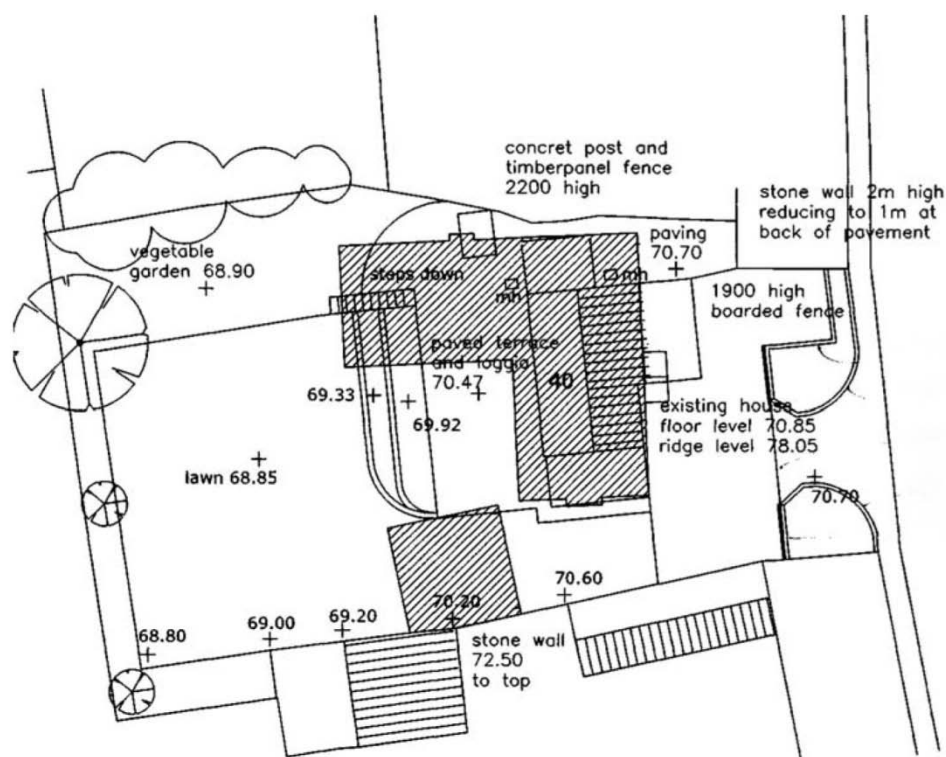
Figure 2: Site location plan showing proposed development (plan provided by client)

The fieldwork had been requested by the Senior Planning Archaeologist for Leicestershire County as archaeological advisors to the planning authority to identify and record any archaeological remains of significance prior to redevelopment of the land (Fig. 2). The fieldwork was carried out in accordance with Planning Policy Statement 5:

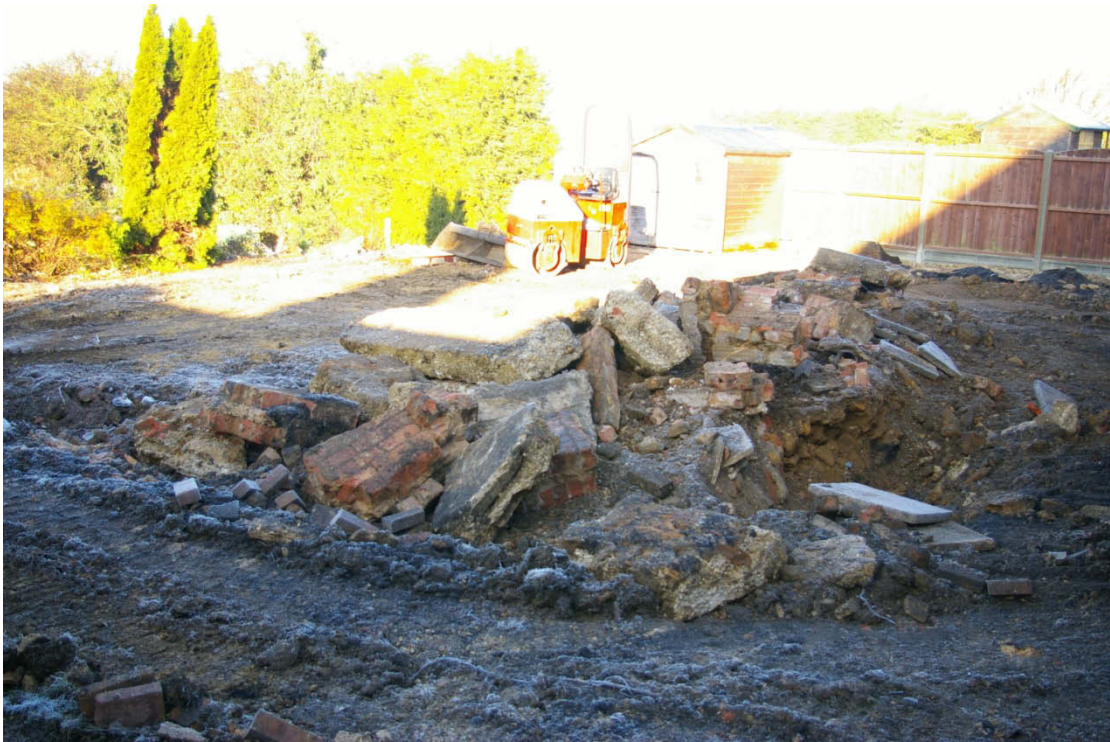
Figure 3: Demolished building, looking north

The ground was severely truncated from a recently demolished building (Fig. 3). Modern demolition and building hardcore (0.4-0.5m thick) overlay natural clay substratum (Fig. 4). No archaeological finds were present.

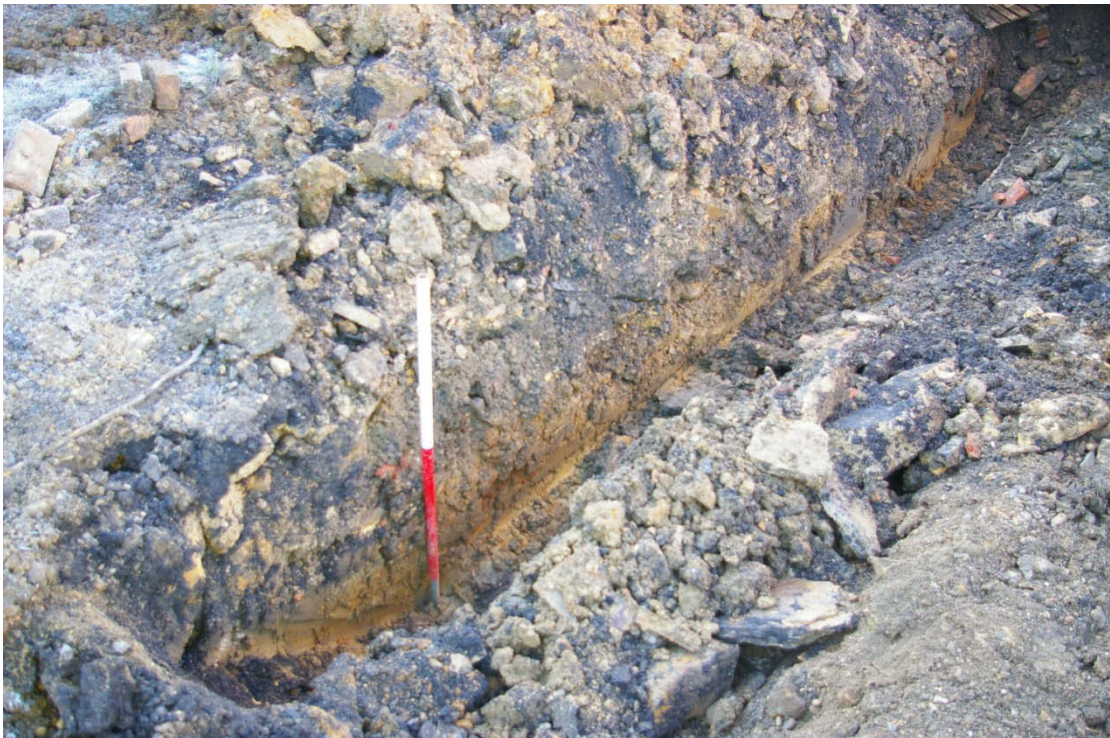
Figure 4: New development footing showing modern overburden / demolition overlying natural clay, scale 1m.

No archaeological features or finds were exposed during the groundworks at 40 Main Street, Medbourne, Leicestershire. The previous standing building had disturbed all topsoil and subsoil and some natural clay.
