**An Archaeological Watching Brief at
Nevill Holt Hall, Nevill Holt,
Leicestershire
(SP 816 937)**

**University of Leicester
Archaeological Services**

Report No. 2004/094

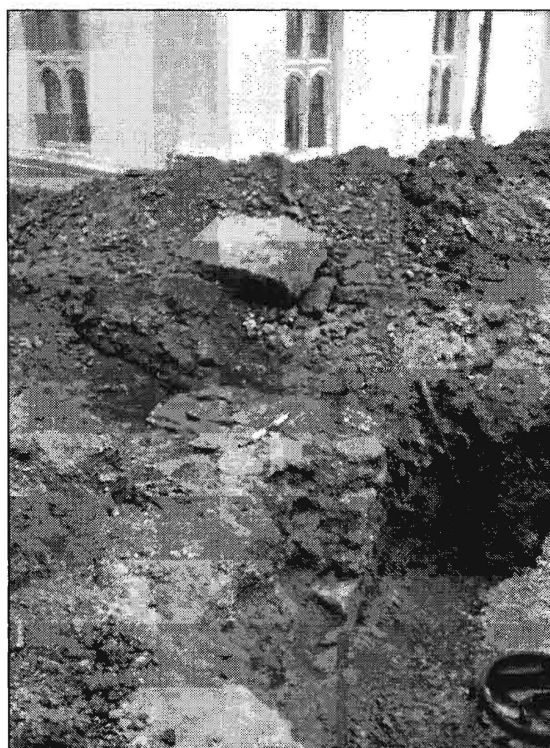
Plate 4: Wall (10) in Trench 10. Facing east.

At the western end of Trench 10 were the remains of what appeared to be three distinct walls. A 1.2m stretch of wall, measuring c.1.3m wide and aligned roughly northeast/southwest, was exposed during excavations at the junction between Trenches 10 and 11. Wall (10) consisted of ironstone blocks, apparently faced on the southern edge and bonded with brown silty clay, which yielded sherds of 13th/14th century pottery upon investigation (Fig. 7).

Drainage trenches located around the southern perimeter of the west wing located a number of walls that were thought to represent the remains of early garden walls. The most impressive of these was Wall (10), which was revealed during the excavation of the junction between Trenches 10 and 11 and, measuring 1.3m in width, would appear to represent the remains of a fairly substantial structure. The 1661 plan of Nevill Holt (Fig. 13), depicting an earlier layout for the west wing, indicates the presence of a gatehouse structure, noted as the 'Blew: gates', in the vicinity of the remains found. Although the plan does not provide any detail about the actual form of the structure

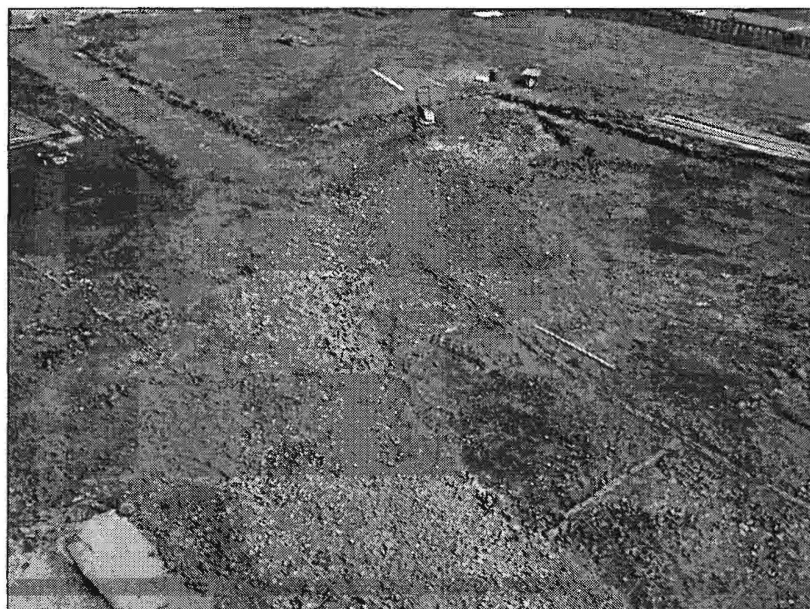
Plate 5: Aerial shot of cobbled surfaces. Facing south-east.

Further groundworks to the south of the Hall included the stripping of gravel from the existing driveway, reducing the ground level by 0.15m, to reveal the remains of a variety of cobble yard surfaces, consisting of areas of medium sized, rounded cobbles, apparently separated from areas paved with tightly packed, narrow limestone blocks, by a series of linear courses of limestone (Figs.8, 9, 10, 11). No dating evidence was located in association with the surfaces.

Extensive remains of cobbled surfaces were located during the stripping of gravel to the south of the building, in front of the main entrance to the hall (Figs. 8-11). Although no dating evidence was produced during the cleaning of the surfaces, the plan of 1661 shows a series of court and stable yards (Figs. 13 & 14), which would presumably have been cobbled, to have existed within this area at that time. Cobble divisions within the surfaces found may have been put in place for purely aesthetic purposes, or they may represent sub-divisions in the use of the courtyard areas. They do not appear to correspond, however, with the courtyard boundaries depicted on the early plan which are likely to represent more substantial wall structures and may represent instead the divisions between, for example, footpaths and vehicular trackways.
