**Newarke Houses Museum,  
The Newarke, Leicester:  
Assessment of Wall Fabric**

*For Leicester City Museums*

Report 2005/063 ©2005

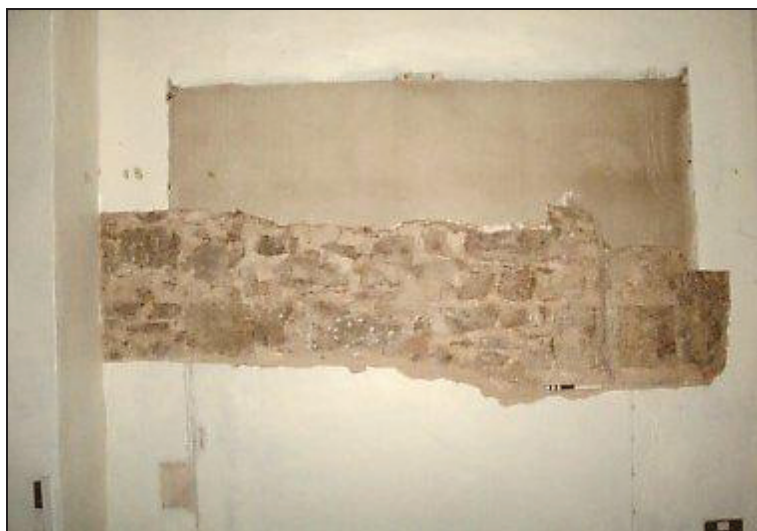
Illustration 4. Opening in plaster on NW wall face, note quoin to right of photo scale.

The wall fabric exposed was random rubble stonework bonded with lime mortar. Three courses of large, squared sandstone blocks were partially exposed at the SW end of the opening, these being dressed quoins at the external NW corner of the 16th century frontage range. These quoins were partially obscured by large reused Swithland roofing slates that had been set in mortar vertically onto the wall face, possibly to level up the surface before it was plastered.

Removal of plaster from both faces of the first floor wall exposed random rubble stonework. A series of large dressed sandstone blocks exposed on the NW face of the wall were evidently quoins at the external NW corner of the frontage range of Skeffington House. The stonework is likely to be late 16th century in date.

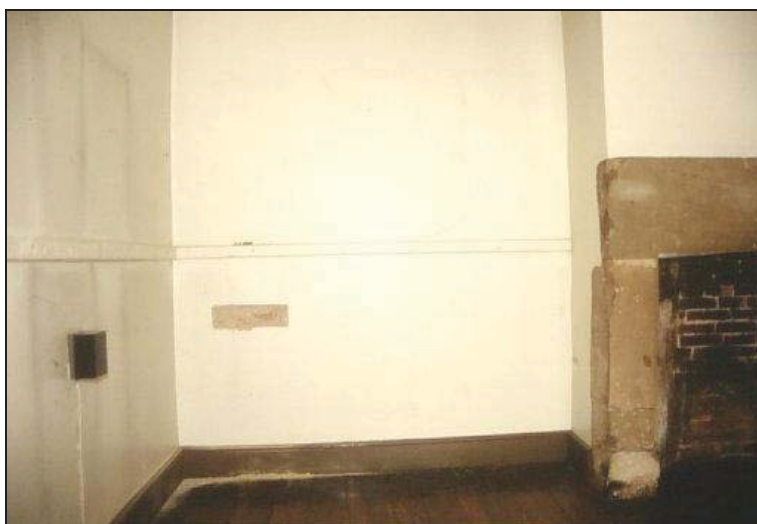
Illustration 5. Opening in SE wall face.

In the small opening on the SE face a coat of modern gypsum plaster overlay an earlier hair-tempered lime plaster with the remains of lime-wash or paint on its surface. This opening again exposed random rubble stonework and comparable rubble stonework was also visible above the first floor ceiling through a loft access hatch at this point. Above the stonework in the roof space 2 inch brickwork, of probable 17th century date, was noted.

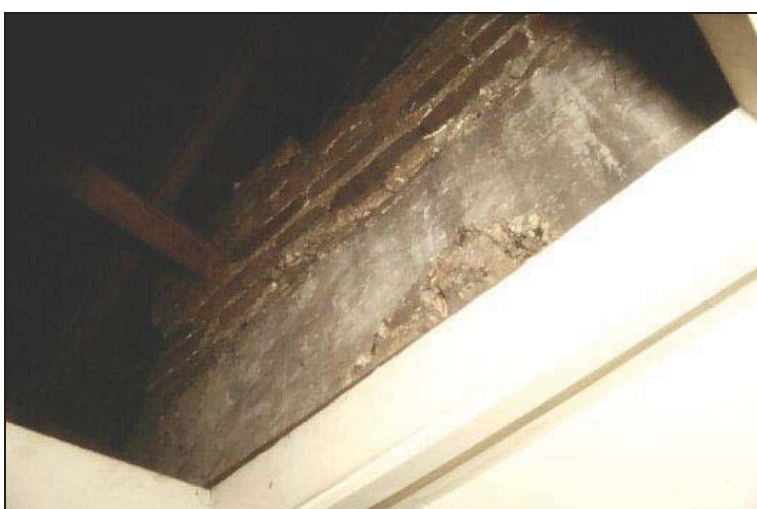
Illustration 6. Rendered stonework above ceiling level on SE wall face, with *c.* 17th century brickwork above
