**An Archaeological Watching Brief
At Butterley Works, Butterley Hill, Ripley,
Derbyshire, (SK 407 517)**

Planning Application No.AVA/2005/0375

ULAS Report Number 2007-034 © 2007

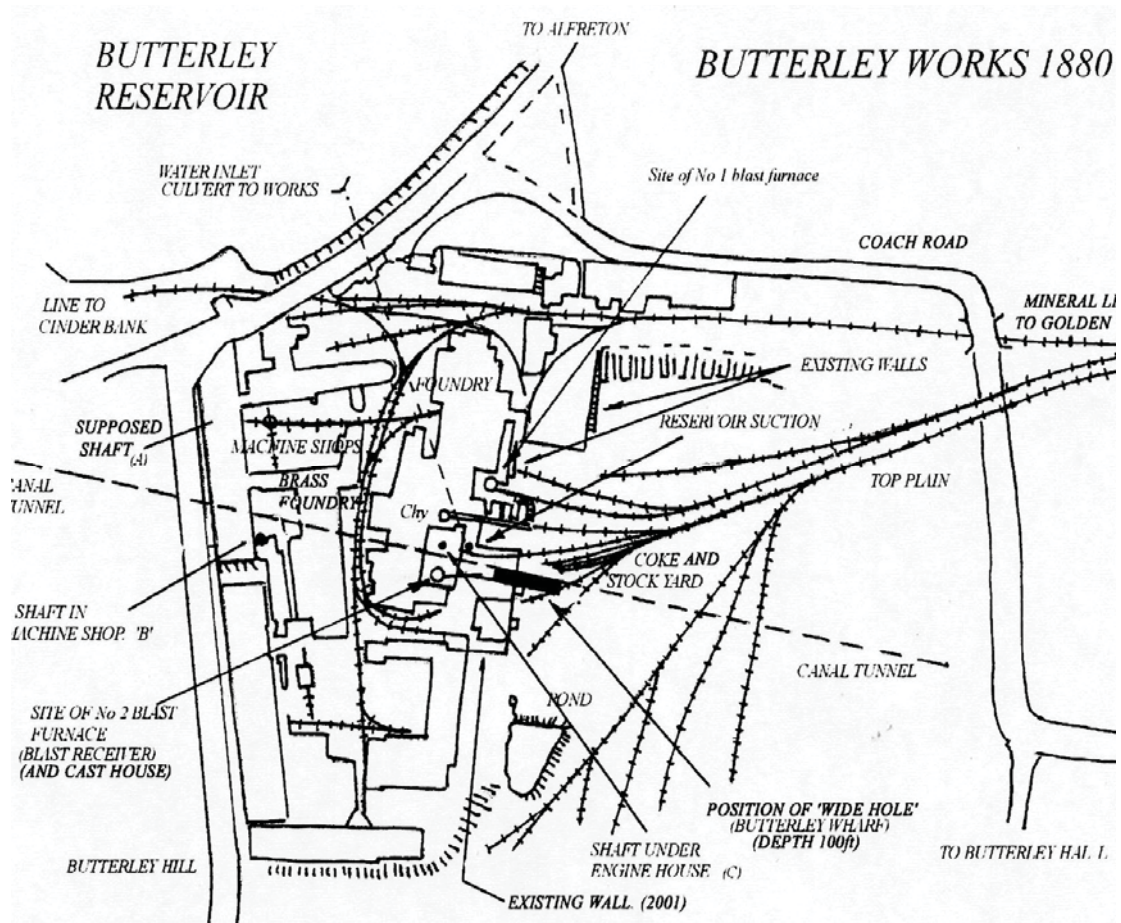
2. Site Plan of Butterley Works 1880
(Reproduced from 'Portal to Portal' by kind permission of D. Greenwood).

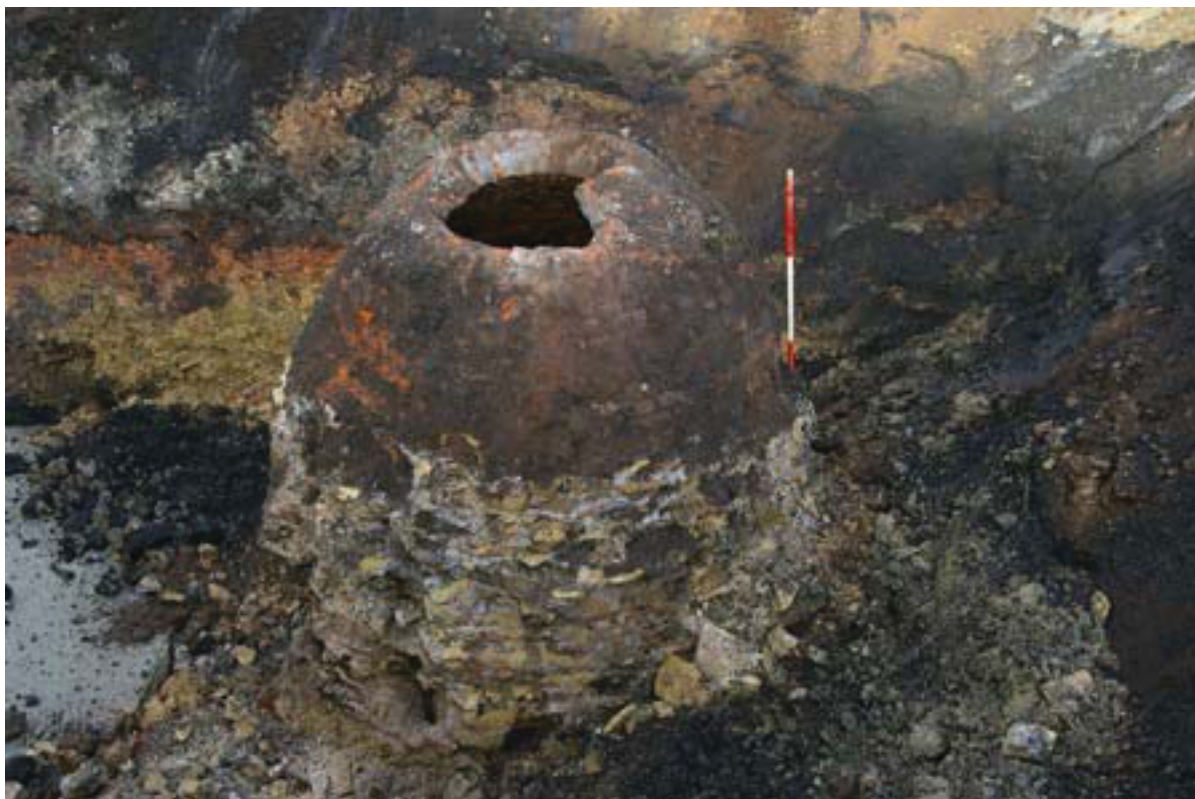
7.4 On close inspection of the second shaft (002), it was immediately apparent that the top had been capped in brick (003) (figure 4) forming a dome over the shaft, and measuring 1.5m from the summit to the bottom where it was bonded to the earlier structure. The diameter at this point was 2.13m (see below). The bricks used for the construction of the domed cap were red brick and measured approximately: 0.23m by 0.1m. The bonding material appeared to be dry lime mortar, slightly pink in colour

4. Shaft (002) Shaft Cap (003) Looking North

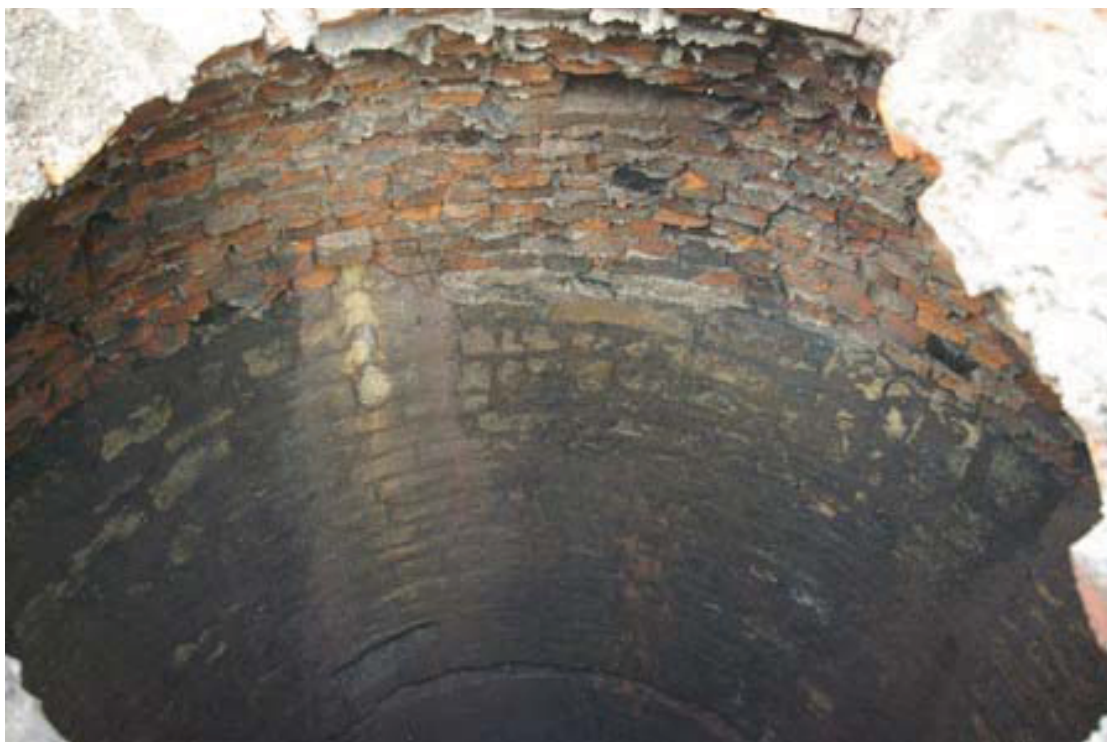
with very small black and white inclusions and the bond itself appeared to be a stretcher bond. Earlier machining had punctured a hole into the top of the domed cap which enabled the author to take some photographs looking into the shaft (Figure 5).

5. Looking inside the Shaft (002).

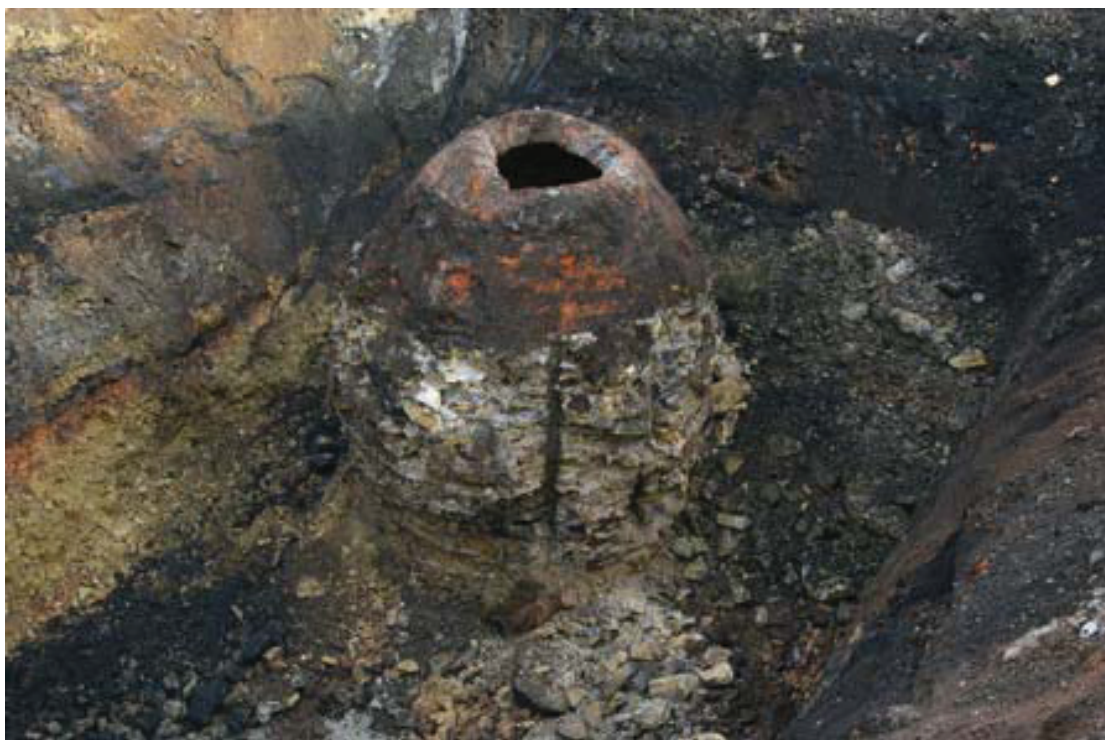
7.5 The shaft itself (002) measured 2.13m (7ft) in diameter and was exposed down to a depth of nearly 2m. The shaft was constructed out of yellow sandstone blocks measuring approximately 0.18m x 0.26m x 0.07m. These were also bonded with what appeared to be a dry lime mortar, which was mid-grey in colour with small white inclusions.

6. Shaft (002). Facing North-West

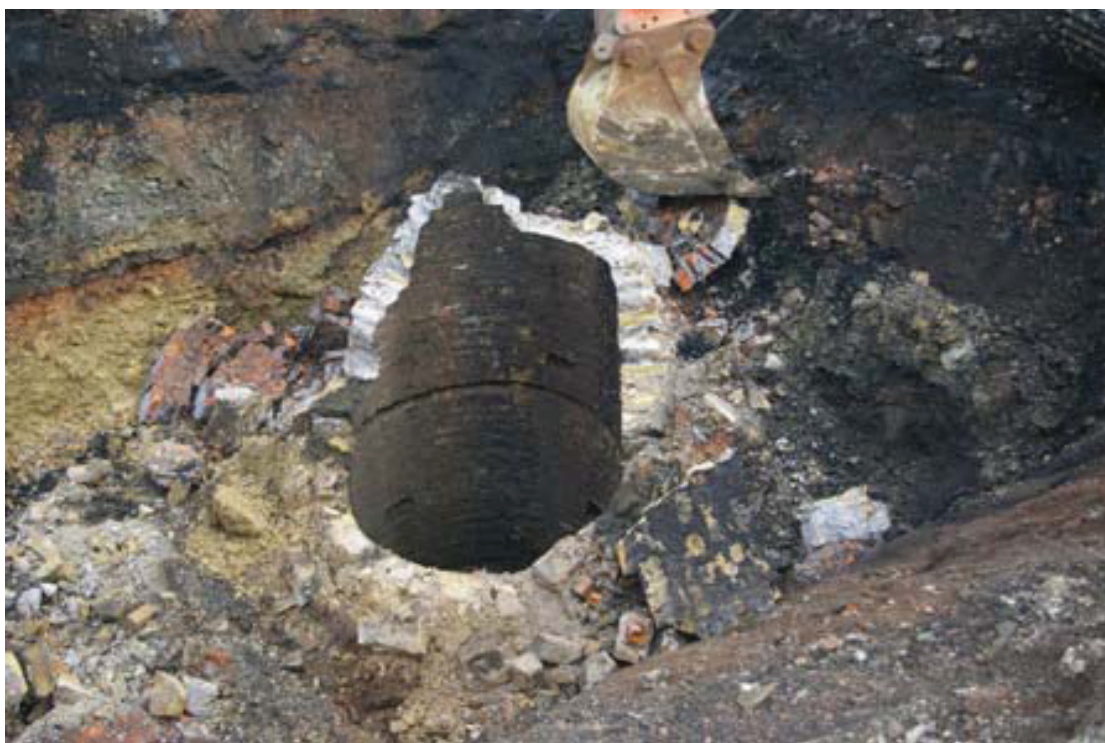
7.8 During the demolition of the second shaft for capping, it was apparent that the shaft had a 'groove' every *c.* 2m, dividing the shaft into 'drums' (Figure 7). Also clearly visible were the putlog holes (Figure 7) which were spaced out every few feet vertically for wooden planks to be inserted one above each other to create a scaffold for loading and unloading containers.

7. Demolition of Shaft (002) Showing 'Groove' and Putlog holes.

8.4 The width of the shafts is considered too wide for a simple ventilation shaft and the existence of putlog holes seems to confirm that the shafts were indeed for loading.

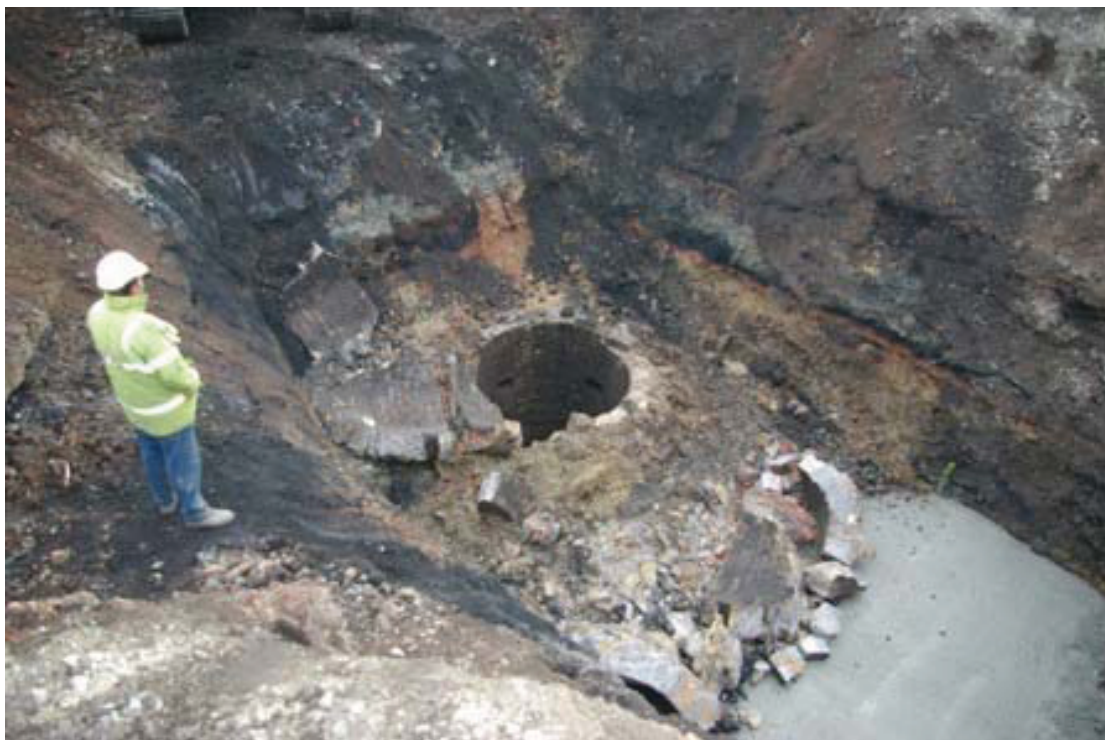
7.7 On the second visit to the site on the 31st January 2007, the ground workers had machined around the second shaft, without damaging it down to the depth of eight metres. Close inspection of the shaft on this visit was impossible due to the on site hazards. The author was able however to photograph the demolition and capping of the top eight metres of the shaft (Figures 7 & 8).

8. Shaft (002) ready for capping.

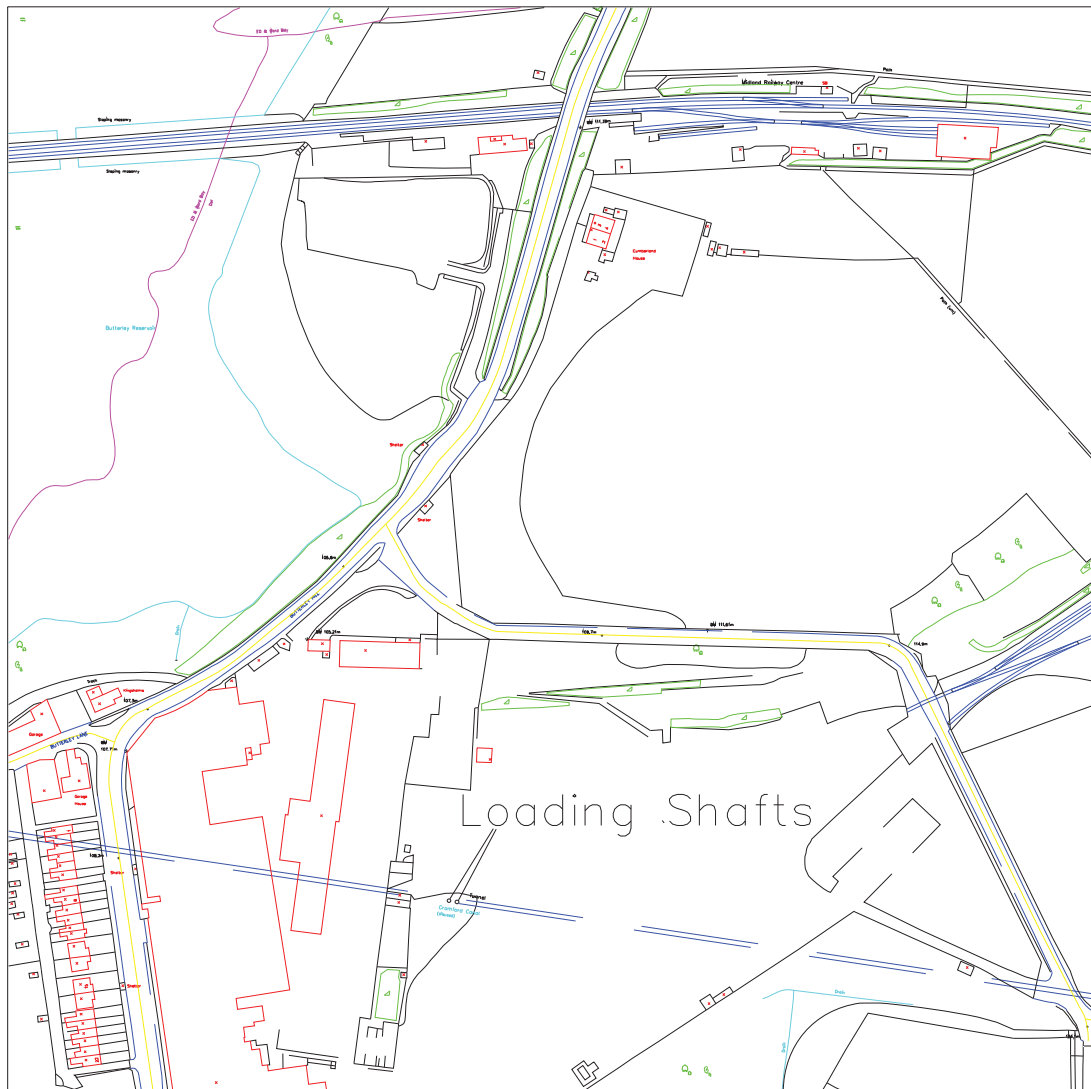
9.3 The results of the archaeological watching brief carried out on land at the former Butterley Works, Butterley, Ripley, Derbyshire (SK 407 517), on the 29th and the 31st January 2007 adds little to the existing body of knowledge of the Butterley Tunnel loading shafts. What can be ascertained however is that the two loading shafts do indeed seem to be the same shafts that were marked on the Midlands Railway plans (Fig.9), and the same as those observed by Robbin Mitton during his investigation of the Butterley Wharf in 1979, due to the identical dimensions and to the similar location. Moreover, the width of the shaft and evidence of putlogs does seem to confirm that the shafts were used for loading and not merely for ventilation, indicating that the shafts must equate with the loading shafts marked on the MR plans (Fig. 9).

9. OS Map Showing Butterley Tunnel and Approximate Location of the Loading Shafts.
