**An Archaeological Watching Brief
During geotechnical ground investigations
on land adjacent to the
M1 motorway (J. 23a-24)
Keyworth,
Leicestershire**

ULAS Report No. 2007-079 ©2007

An Archaeological Watching Brief during geotechnical ground investigations on land adjacent to the M1 motorway (J. 23a-24), Kegworth, Leicestershire (SK42).

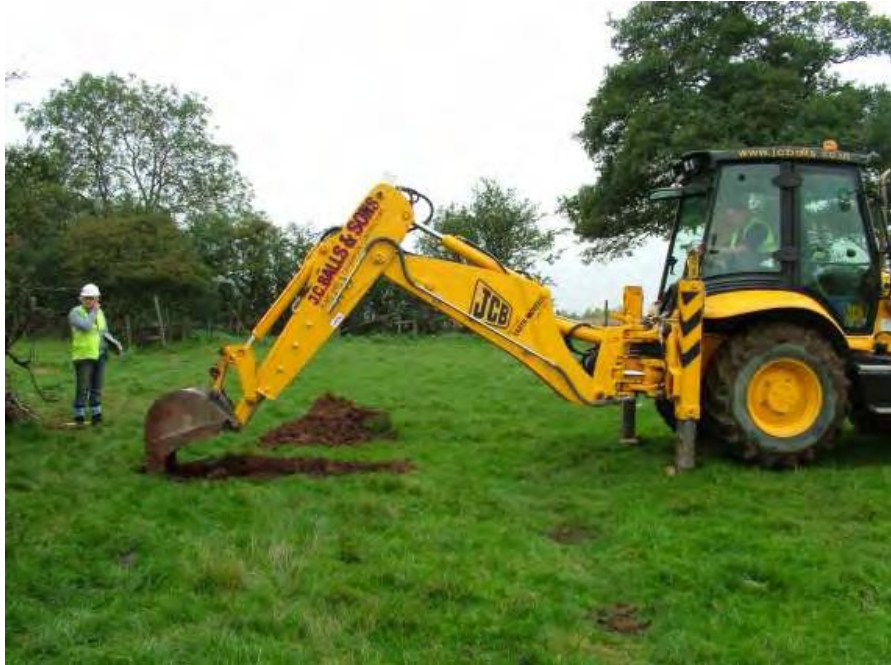
Sequence: Topsoil: 0.2m deep clayey loam with large and small roots and very few small stones. Overlying Mercia Mudstone

Remarks: Top of Mercia Mudstone looks very weathered or might be glacial till.

Plate 1: Work in progress on Trench 1070, looking south

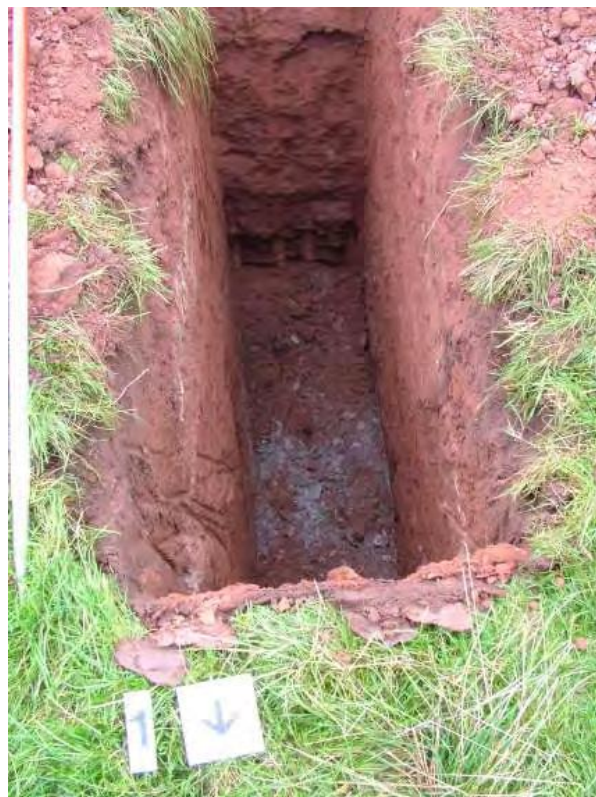
Sequence: Topsoil: 0.3m deep reddish brown clayey loam with very few stones. Overlying Mercia Mudstone.

Plate 2: Post-ex shot of Trench 1077, looking south

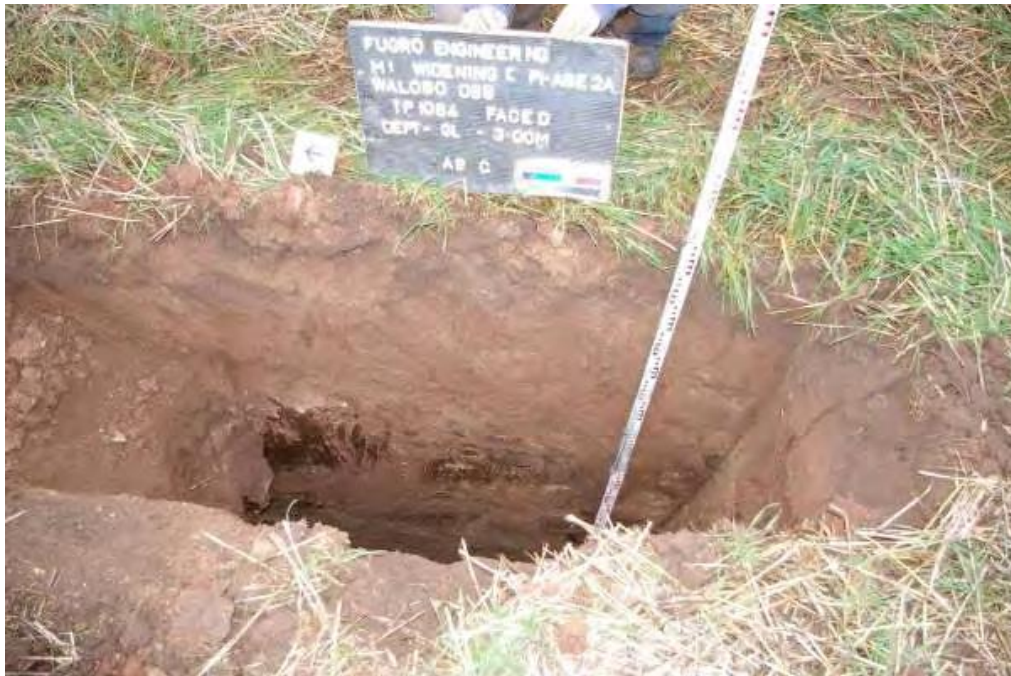
Sequence: 0.25m of topsoil overlying 1m of Glacial Till over friable sandstone.

Remarks: Field drain running north-south visible in west facing section.

Plate 3: West facing section of Trench 1084, looking east

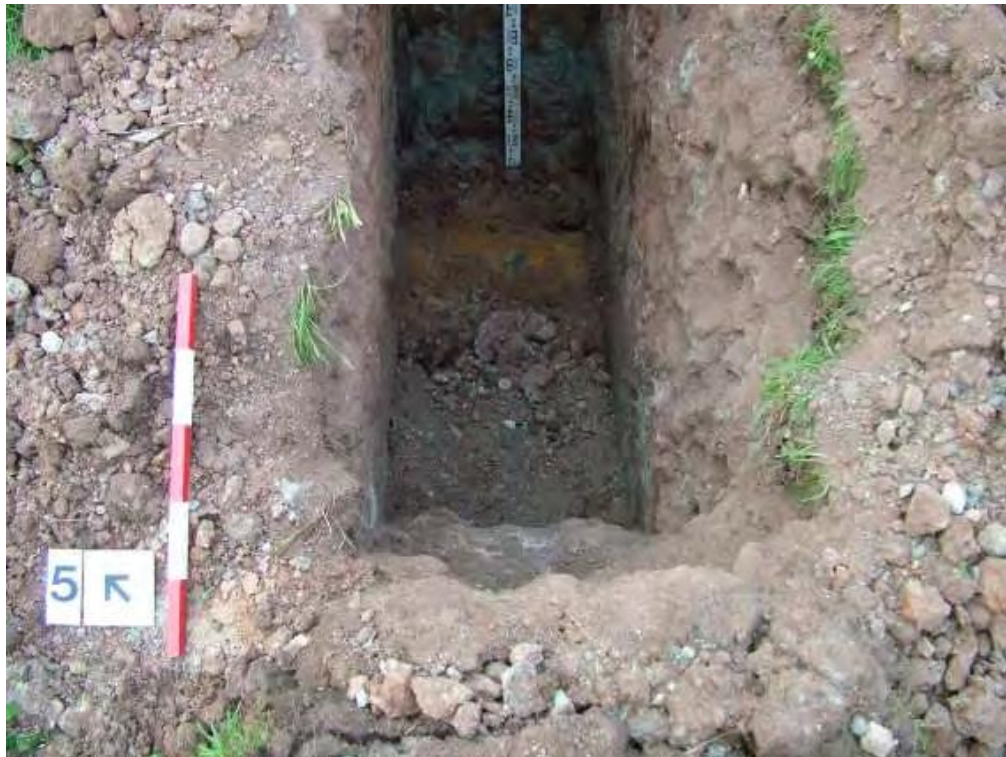
Sequence: Topsoil: 0.15-0.2m overlying Mercia Mudstone. Metal pipe at base again.

Remarks: moved from intended position due to gas main. Dug into bank and so deeper at rear face. Encountered metal gas pipe again and excavation halted at this point.

Plate 4: Post-ex shot of Trench 1082, against hedge, looking north east
