Historic Building Assessment

Site: 29-33 Borough Street, Castle Donington, Leicestershire.

Report No. 2007-100

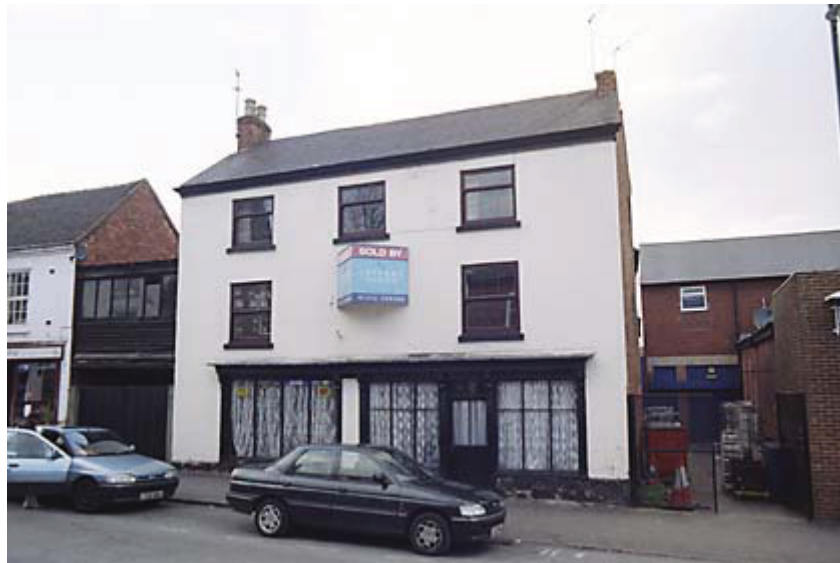
Figure 1: 29-33 Borough Street in 2003, when it was awarded Grade II Listed Building status. (©Mr Ray Freeman (01 June 2003))

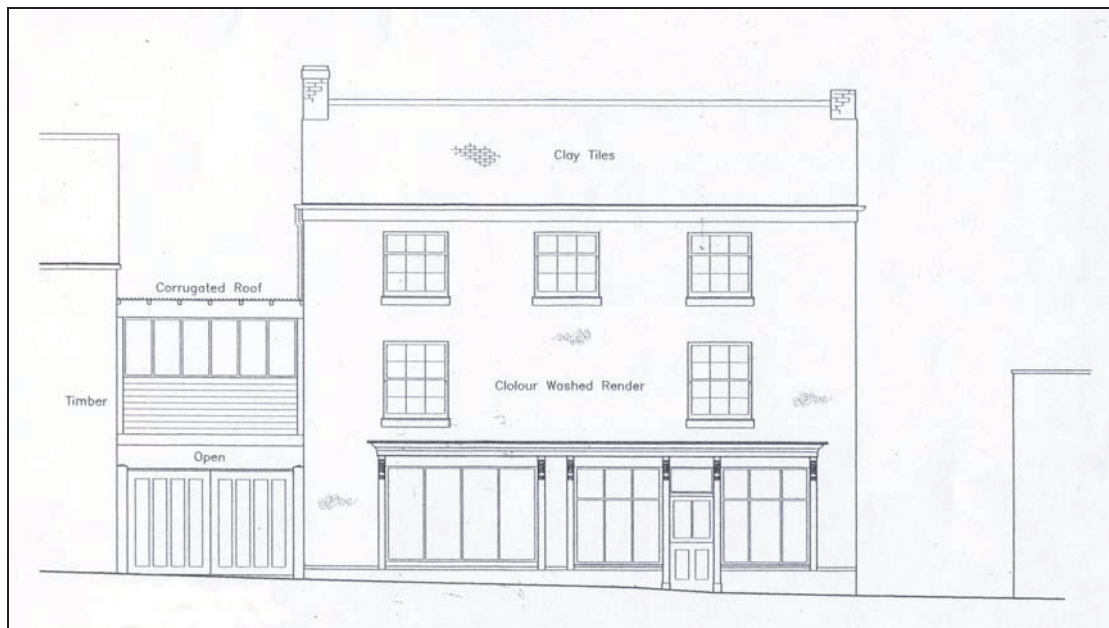
Figure 3: Existing Borough Street Elevation (Peter Hill Architects 2007).

The principal façade on Borough Street will remain largely unaltered excepting the replacement of modern hardwood windows with traditional sash windows (Figure 3), new cast iron guttering and reclaimed chimney pots. The timber and glass shop front will be renovated, but retained in its' existing form. The timber clad extension (to the left of Figure 3 and Figure 4) is to be replaced with a two storey brick extension in Flemish bond with lime

The main entrance onto Borough Street includes a later 19th century shop front (Figure 3 and Figure 4). The shop entrance consists of a central door with large six-panelled windows to either side, resting on a painted brick stall-riser. The door is of four panels with the upper two of glass. The window is framed by pilasters and moulded consoles supporting a narrow canopy. The fascia is also narrow (and therefore would not have borne the shops name) but does contain a row of awning hooks.

Front elevation: *beneficial impact*. The modern mahogany windows will be replaced with sash windows. This will be more sympathetic to the original style of the house. The shop front is to be preserved, but renovated. Modern chimney pots are to be replaced with reclaimed pots.

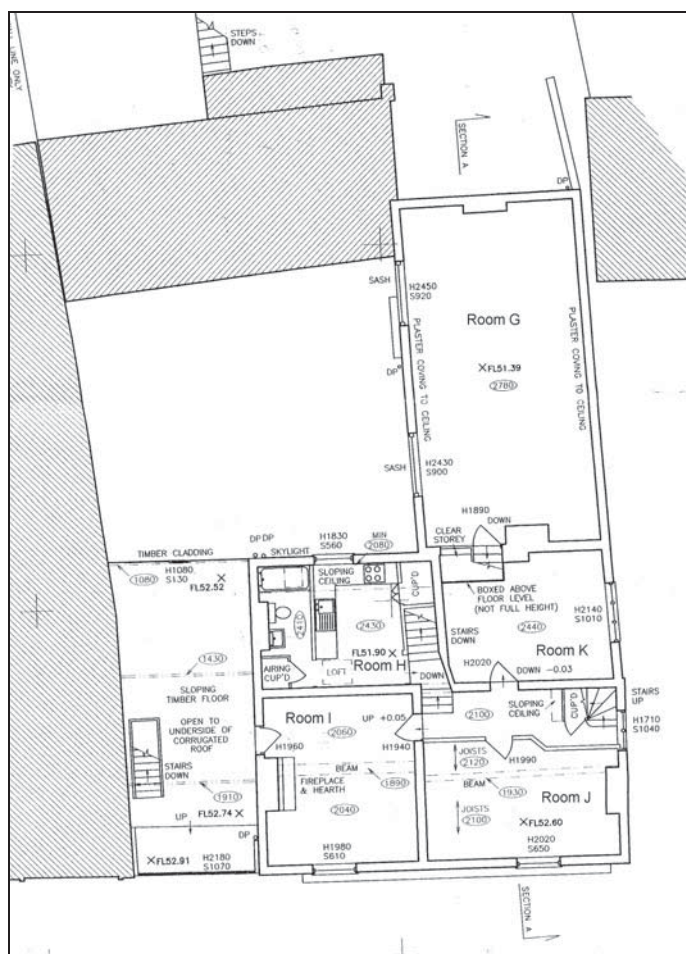
Figure 6: First Floor plan (with letters G-K identifying rooms).

Room H – the modern central partition is to be removed and the whole room will become a bathroom. The current doorway is to be blocked in with a new entrance to Room I inserted (this area will become a landing at the top of the new staircase rising out of Room E).

Room I – the new staircase (rising out of Room E) will be inserted into the rear of this room. A new partition wall will be added to Room I to separate the bedroom space from the stairwell. The doorway into the extension will remain in the same location, but the door in the opposing wall will be blocked in.

Room J – no structural alteration proposed.

Room K – the room will be converted into a kitchen/dining room.

Rear building – the first floor will comprise a landing area with two bedrooms and a bathroom. The rear window overlooking the garage is to be blocked-in to accommodate a renewed pitched roof to the garage.

Room H: *moderate impact*. The modern internal wall and bathroom fittings will be removed and replaced with a new bathroom. This will include some plumbing work (to accommodate the relocated bath and shower). The door will be blocked-in and replaced with a door leading to Room I.

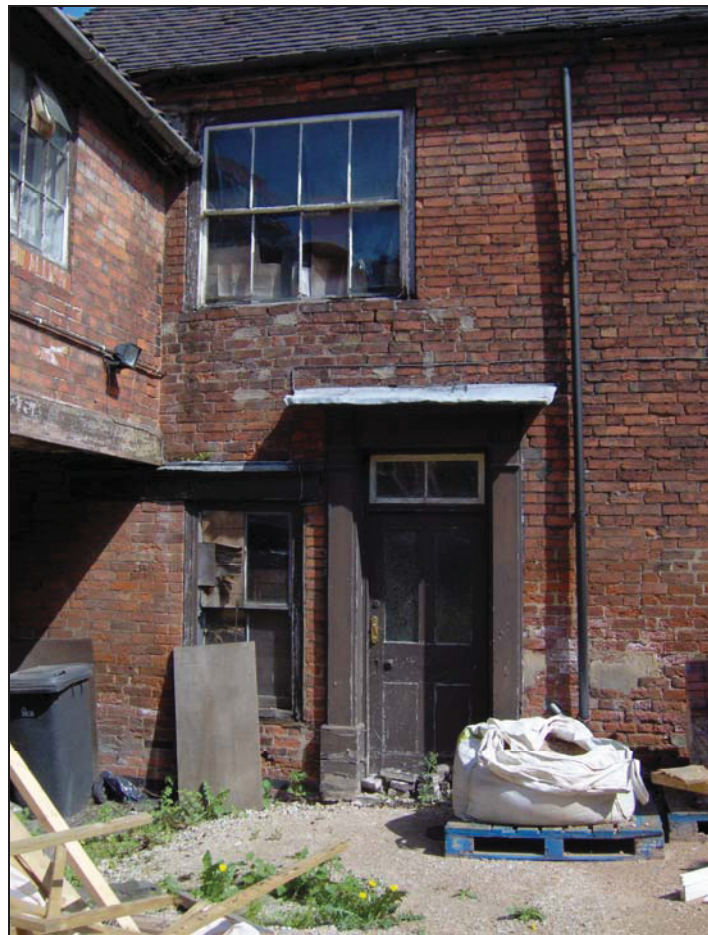
Figure 8: Sash window (Room A) and main courtyard entrance (Room B).

The window facing the inner courtyard is immediately adjacent to the outside door in Room B (Figure 8). D. Smith (Independent Vernacular Architecture Specialist, *pers. comm.*) noted that this arrangement was often designed to be used to pay workers; an early form of a counter system.

A third door leads into the courtyard. This is of an early 19th century type; four plain (un-moulded) panels, wide rails and stiles and with a two-panelled over-door light above (Figure 8). On the exterior face the door frame includes elegant moulded pilasters supporting a leaded door canopy.

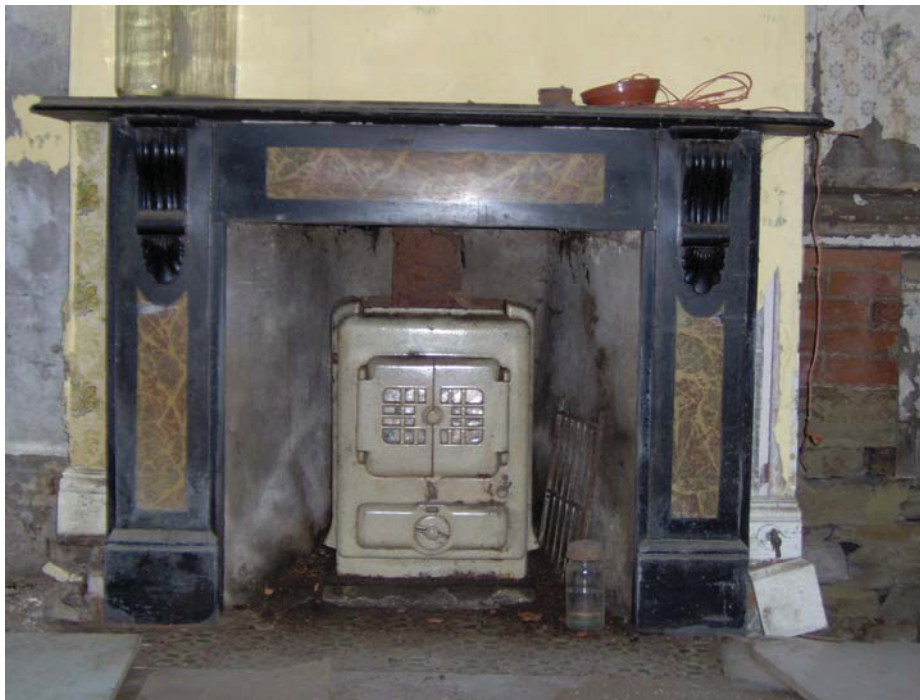
Room C: A parlour. Timber floorboards, deep skirting (constructed as two overlapping planks – a poor mans deep skirting!), slate fire surround painted with marble effects and a pretty buttercup patterned tiled hearth (Figure 9). The fire place has been replaced with a c. 1930's enclosed cream stove.

To the right of the fireplace (Figure 9), removal of a portion of the wall plaster shows that this wall rests on a foundation wall of sandstone. This is evident in several locations around the front portion of the building and in the cellar and will be discussed more fully in Section 5.4 'Basic Chronology'.

Figure 9: Room C, painted slate fire surround . Note the sandstone footings revealed to the right of the fireplace.

Stone footings are also visible between Rooms C and D (Figure 9), which suggest the building may have been either originally L-shaped or that there may have been an extension to the rear (Figure 13, Phase 1A). Although the bricks are of a similar size and quality in Phases 1 and 1A, differing bonding suggests the Borough Street elevation could have been constructed before 1A.

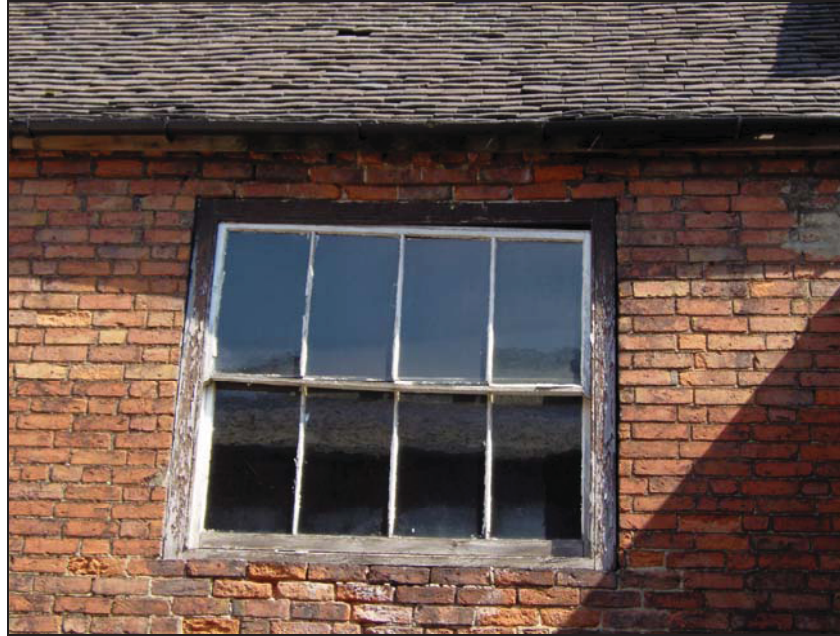
The sash window facing the courtyard is large (running from the ceiling to the skirting). The interior window frame is deeply moulded, giving an impression of elegance, although the exterior frame is plain with no sill or lintel (see Figure 11 for a similar example).

Figure 11: Large sash window facing the courtyard, Room G.

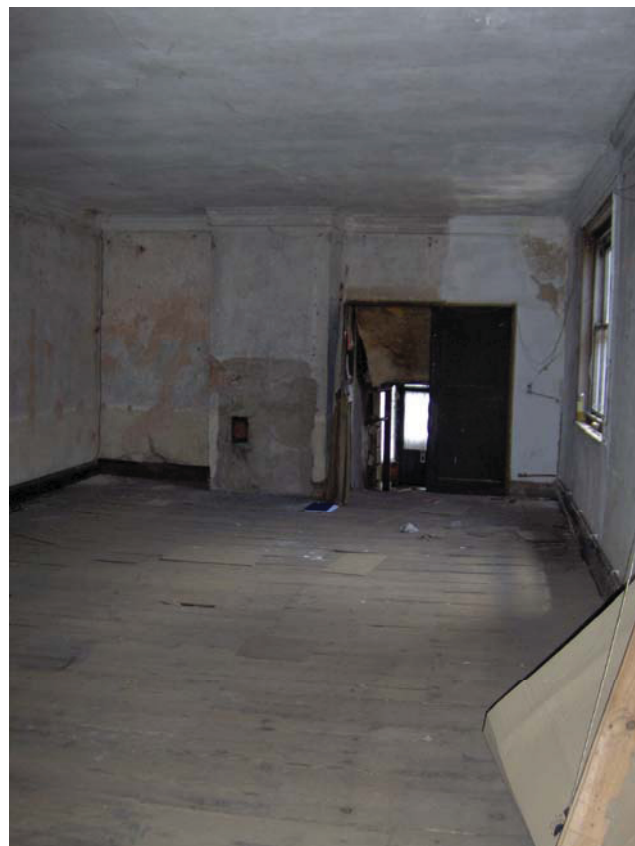
Room G: From the rear of Room D six steps lead up to a long gallery room (lying over Rooms A, B & C). The room has floorboards (of inconsistent sizes), moulded skirting, a chair rail (or dado) and two large sash windows (Figure 11). There are fireplaces at both ends of the room and an elegant plaster cornice (Figure 12).

The original function of this room is uncertain. The large supporting joist in Room B below and the unusually large sash windows suggest an industrial purpose (such as framework knitters who had heavy machines and required good light) but the elegant cornice, two fires

and chair rail suggest a grander function such as a meeting room. Local historian Bruce Townsend described the room as a ballroom, although this would seem less likely in view of the roughness of the floorboards.

Figure 12: Room G, the long gallery with plaster cornice and chair rail (left of picture).

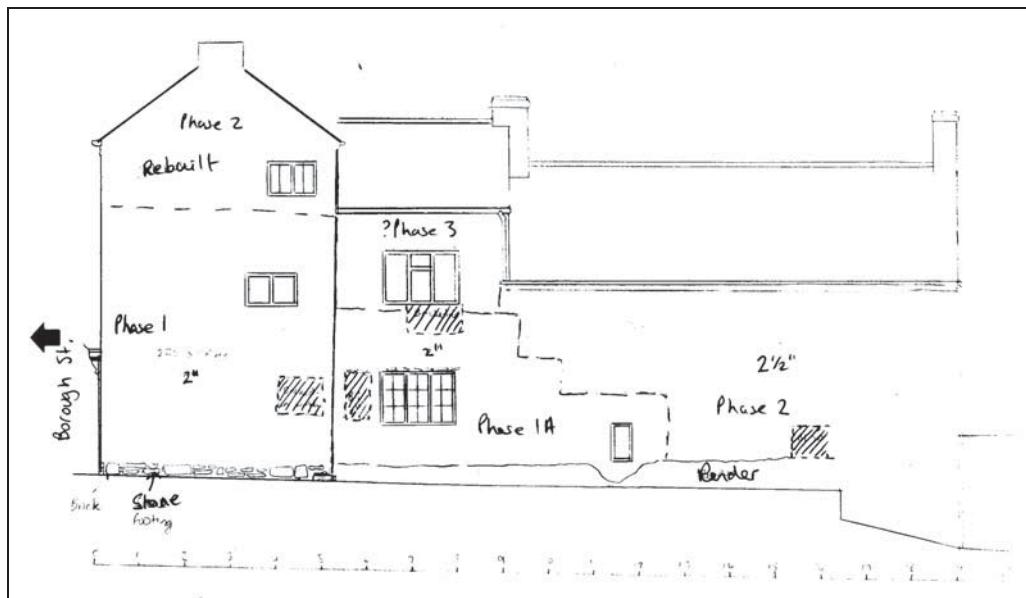
Figure 13: North elevation (adjacent to Co-op Supermarket) showing proposed building phases. The hatched areas denote bricked-in windows.

There is a clear indication in the brickwork that the third storey of the Borough Street building is a later addition or repair to Phase 1 (Figure 13). Although it was not possible to measure the third storey brickwork, it looked to be of a similar size, colour and bond to both the two-storey extension to the rear (Rooms A, B, C & G) and in part a further extension (now Room F). The interior fittings of these rooms support the suggestion that they were constructed at the same time (*for example* 6" blue quarry tiles are used in both parts (Rooms A, B and F), and both contain mid-late 19th century fire-places).

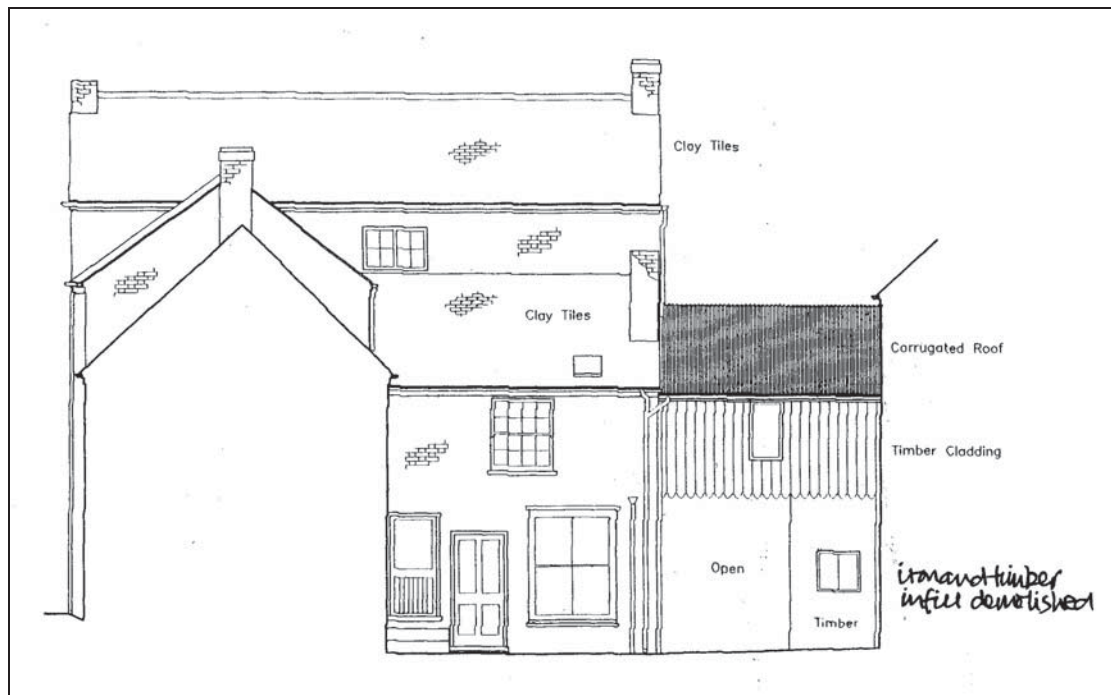
The arch between Room D and Room F (Figure 10) suggests that this arrangement of rooms, with an open walkway between the two, pre-dates the main staircase (there is evidence for an earlier staircase in Room E). It is also likely that this open way between the two spaces pre-dates the insertion of a second back door (Figure 14, the door to the left).

Figure 14: Courtyard elevation of the rear of the house. Note the two adjacent back doors.

Courtyard elevation: *beneficial / minimal impact*. The sash windows are to be repaired. No details were provided to assess the impact of new sewerage pipe works but these could potentially have an impact on the appearance of the courtyard elevations.
