**An Archaeological Watching Brief at
Kirby Muxloe Castle, Kirby Muxloe
Leicestershire (SK 523 046).**

For English Heritage

**University of Leicester
Archaeological Services**

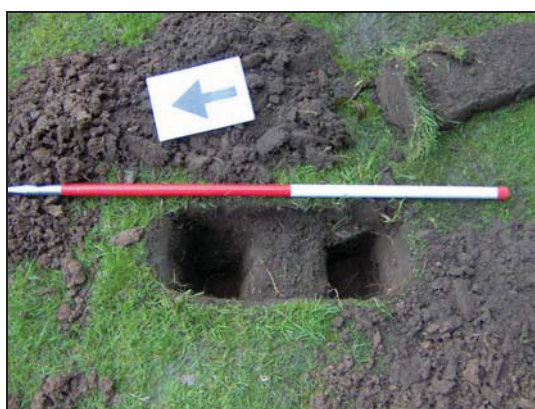
3.2.1 The holes were hand excavated by Rivermeade Signs using a post-spade 0.2m wide in level spits under continuous archaeological supervision.

Plate 1 – The new postholes.

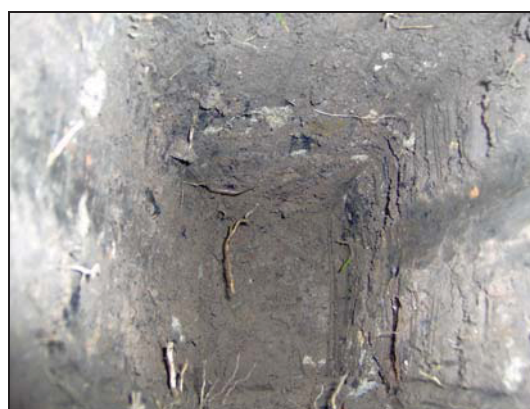
Below this, an archaeological layer was revealed. It consisted of a light mid-yellowish red firm sandy clay with frequent charcoal, slate fragments *c.*50mm, sandstone fragments *c.*50mm, occasional small and large rounded stone, rare crushed red brick, sandstone and iron panning (3).

The sandstone observed in contexts (2) and (3) was of an identical colour to that of the sandstone dressing in the window frames and gateway to Kirby Muxloe Castle.

Plate 2 – Section in southern new posthole.

The nature of layer (3) is reminiscent of medieval clay flooring or a make-up material. The presence of the same coloured sandstone and red brick flecks to that found in the Castle, along with slate fragments is suggestive of structural remains. It is possible that the layer is associated with the construction of Kirby Muxloe Castle, or any form of robbing that may have occurred of the superstructure since then. The clay may be re-deposited natural substratum from the construction of the moat with building construction material mixed in. Alternatively, the presence of a clay floor could be evidence of a building that once existed here prior to, or contemporary with, the construction of the Castle.
