**An Archaeological Standing Building Survey
at 15-17 Gaol Street, Oakham,
Rutland
(SK 859 087)**

ULAS Report No 2009-021 ©2009

**An Archaeological Standing Building Survey at 15-17 Gaol Street, Oakham,
Rutland (NGR SK 859 087)**

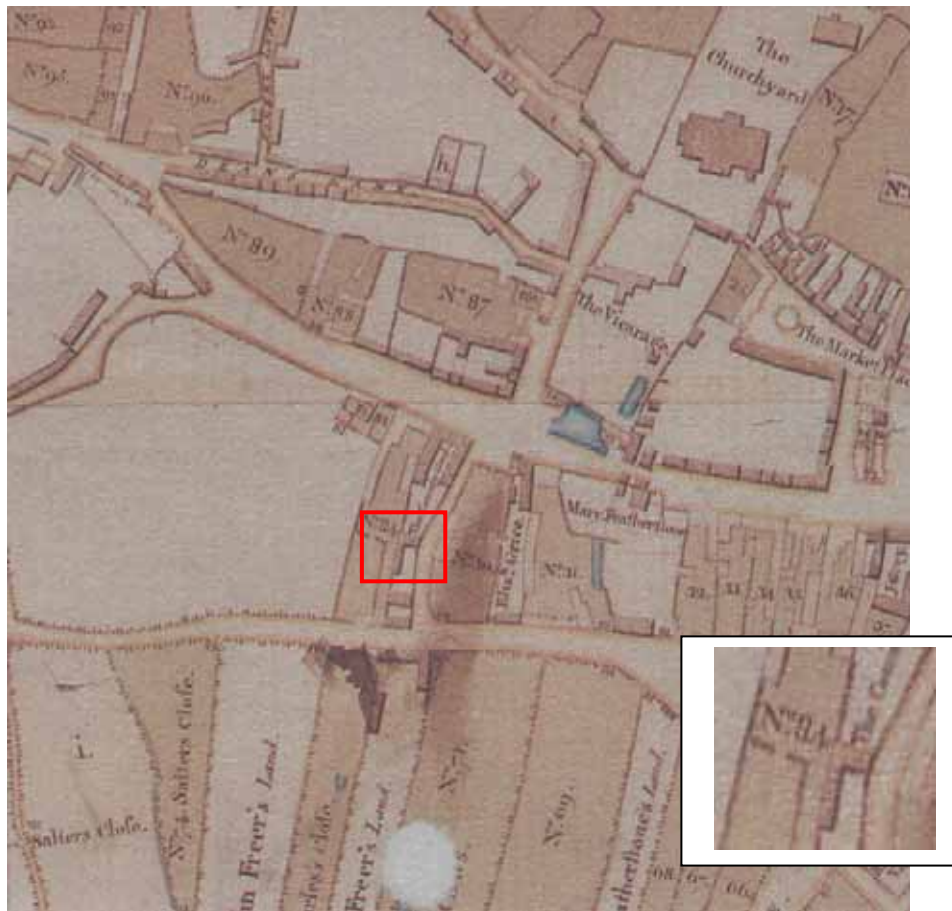
Figure 3 Cullingworth Map of 1787 (Including Detail).

The next and probably most significant map is the Cullingworth Map of 1787 (*Figure 3*). The proposed development site is clearly identifiable and includes a building in the same location and approximately the same size and alignment as Building A. The easternmost gable, fronting Gaol Street also has the same angle to the street. Given the clear evidence of rebuilding and re-modelling recorded, it is unlikely that any of the building remains, with the possible exception of the southernmost wall. There is no evidence of Building B, there is a wing projecting to the south; of which no evidence remains on the standing wall, however, there was no clear view of the south facing elevation due to the proximity of a neighbouring building. The westernmost

wall, did, however continue to the south and may represent another remnant of this building.

The westernmost wall (the rear wall of building B) may also be recorded on the Cullingworth Map, possibly as part of the County Gaol. The external stonework is virtually un-dateable, but the internal brick skin is clearly 18th century in date, indicating the stone-built wall was already standing in the 18th century. There is a strong possibility, therefore, that this western boundary wall is a remnant of the County Gaol. Both cartographic sources and a visual inspection indicate that the wall continues for the full length of Gaol Street and is clearly visible as the gable wall of number 61 South Street (*Figure 19*). The straight joint indicates that it pre-dates number 61.

Both the southernmost and westernmost walls pre-date the buildings, fortunately both of these walls will be retained within the development. The Cullingworth Map suggests that both walls were likely to have formed parts of the curtain wall of the County Gaol.

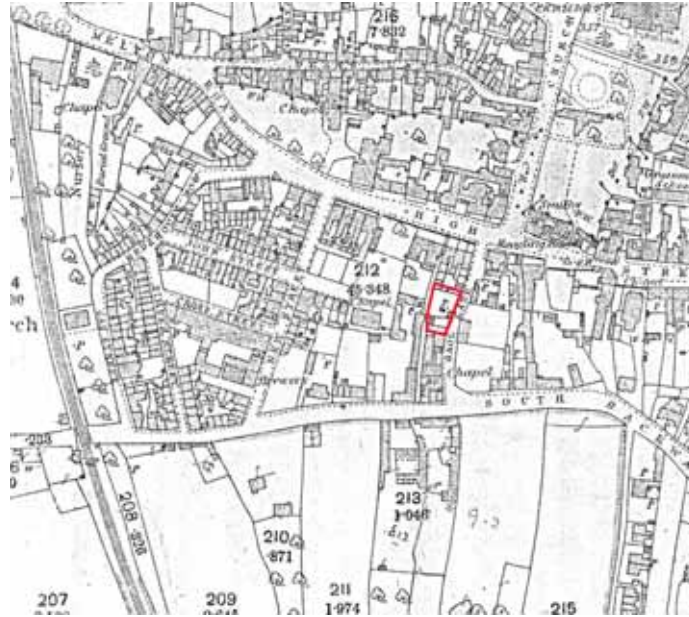
Figure 4 1886 Ordnance survey map of Oakham Sheet Rutland No IX.2 with development area outlined.

By the time the First Edition Ordnance Survey was published in 1886 (*Figure 4*), the building recorded on the Cullingworth Map has altered considerably; the map probably records the building as it stands today. There is evidence of a building occupying the footprint of building B; it is too small, however, to be the standing building.

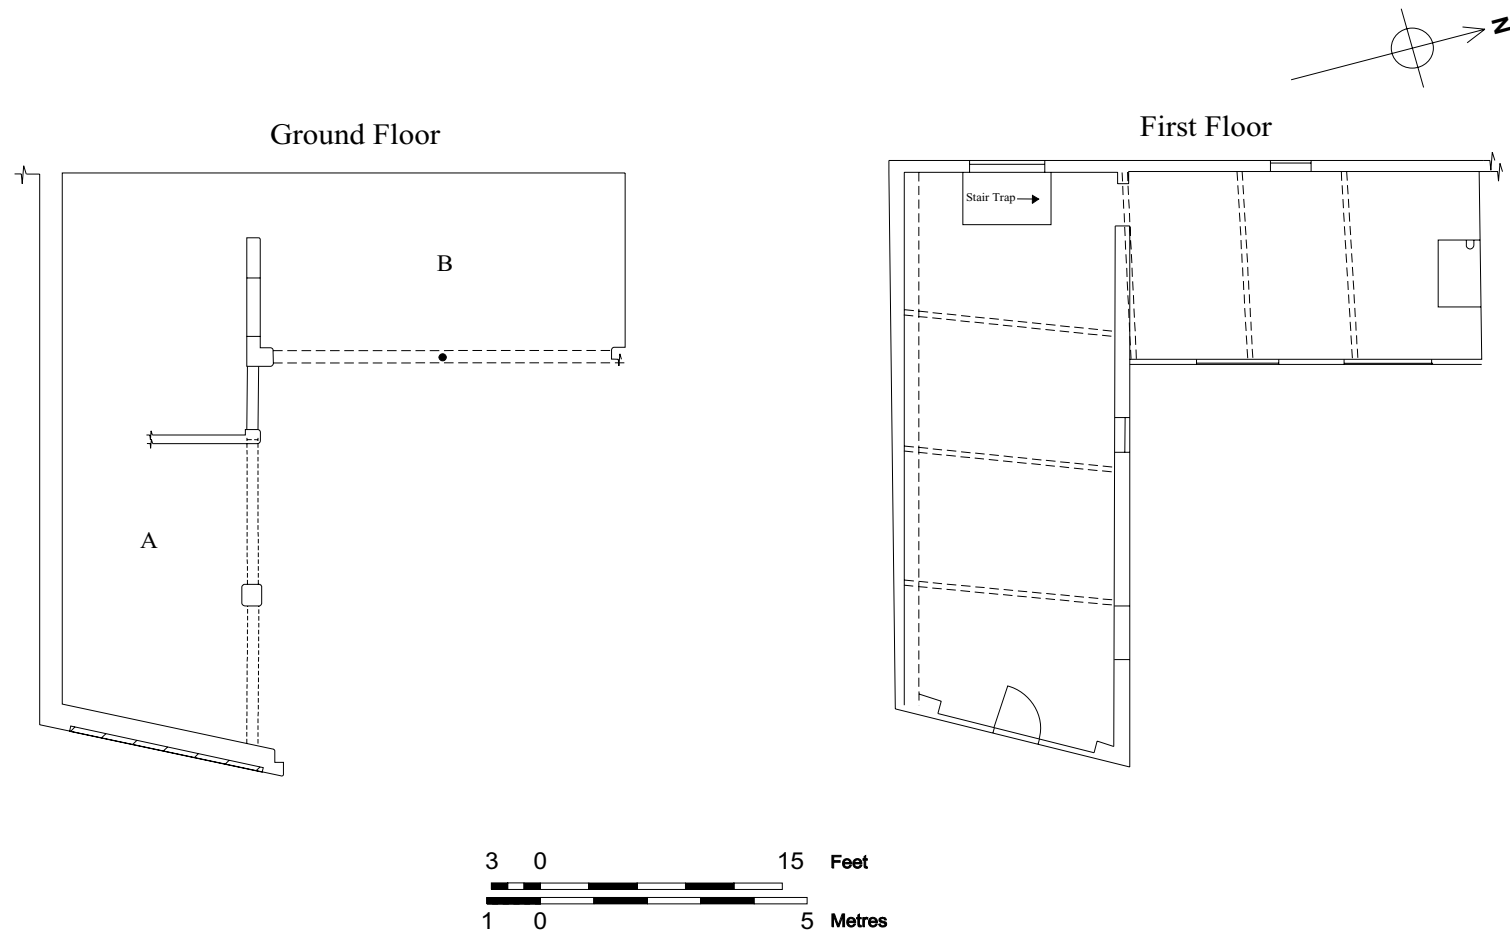
Figure 6: Floor Plans.

3.1 Building A (Figure 6)

Despite its appearance, A appears to be the earliest of the buildings and has undergone a number of episodes of re-building and re-modelling. The southern wall is of good quality coursed ironstone (*Figure 14*), which has been limewashed internally. It is likely to be the earliest element of this building and may be the remains of an earlier building. The gable fronting Gaol Street has a more complex history (*Figure 12*); externally the gable is Victorian red brick (9 inch by 3 inch, by 4 inch) with a close-boarded loading door at first-floor level and what appears to be a blocked coach entrance at street level, recently re-pointed. Internally, however, there is no evidence of this blocked cart entrance and the brickwork is 2½ inch thick hand made, dating from the 18th century. The gable has apparently been re-skinned during the late 19th century, no doubt to replace the soft 18th-century bricks which had probably begun to disintegrate after a century exposed to the elements. The external brickwork matches that of the north-facing wall at first floor level. It is likely,

3.2 Building B (Figure 6)

This building forms the western boundary of the proposed development area and is open fronted at ground floor level and timber clad at first floor level; once again there is a central first-floor loading door. Both gables are brick built, again 9 inch by 3 inch, by 4 inch Victorian red bricks and once again bullnosed brick piers, suggesting the Victorian rebuilding seen in Building A also affected this building. The first floor is carried on a timber lintel supported by a central cast iron column. The rear, western wall is 2 ½ inch hand made bricks, dating from the eighteenth century (*Figure 13*) on the internal face of an earlier mixed ironstone and marlstone rubble wall. An examination of the external elevation indicated at least three separate phases of building (*Figure 11*), all utilising the earlier stone wall.

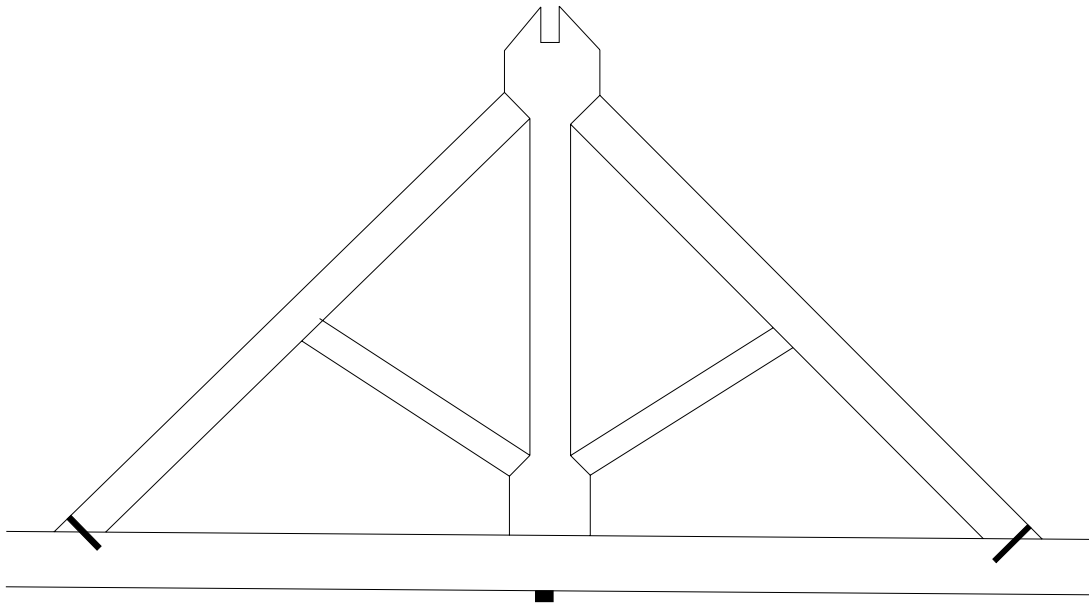
Figure 7 Sketch of Roof Truss, Building B (Not to Scale).

The roof is more complex than that recorded within A (*Figures 7 & 11*); it has two large king post trusses supporting twin purlins on cleats, the post is bolted through the

tie-beam. Unusually the trusses are not square to the walls, it is possible, therefore, that these trusses were not built specifically for this building but recovered from another. Trusses cannot be shortened without affecting the structural integrity, when it is necessary to use a truss which is too long it can be mounted at an angle in order to reach the correct span. This is what has more than likely occurred in this example. Once again the roof is Welsh slate.

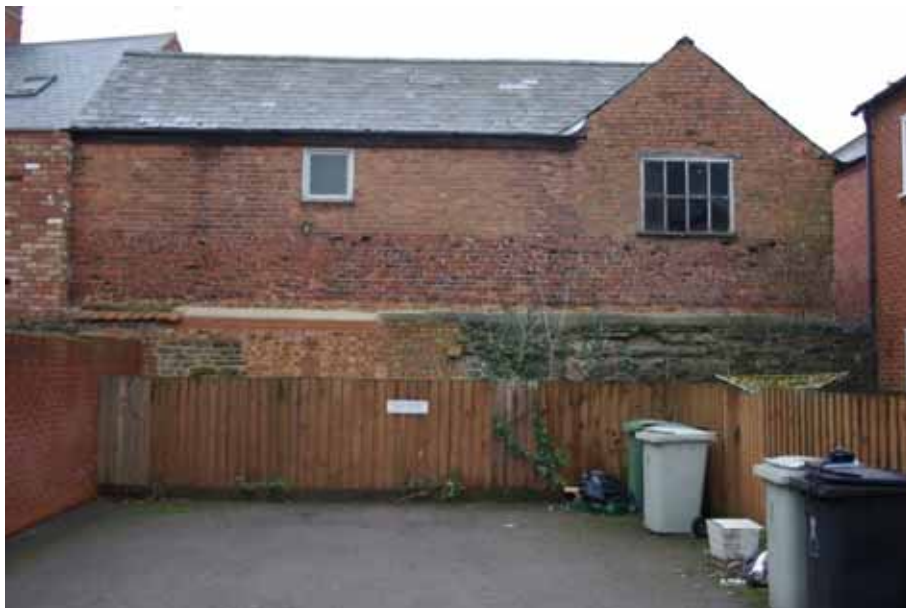
Figure 11 Rear Elevation, Building A to the right, Building B to the left.

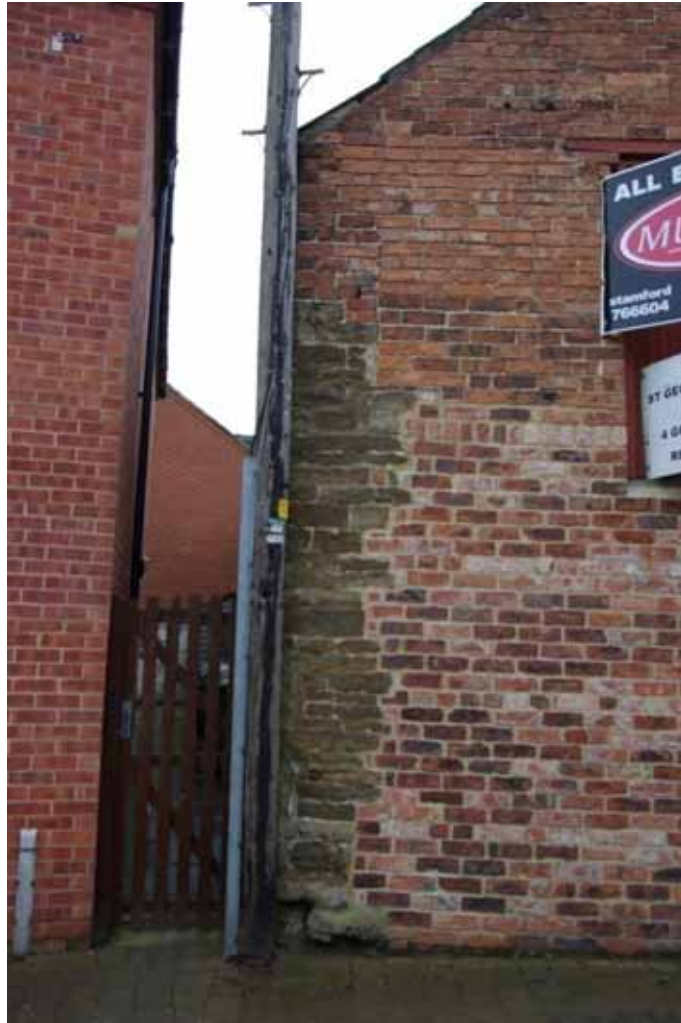
Figure 12 Eastern Gable of Building A Showing Different Building Phases.

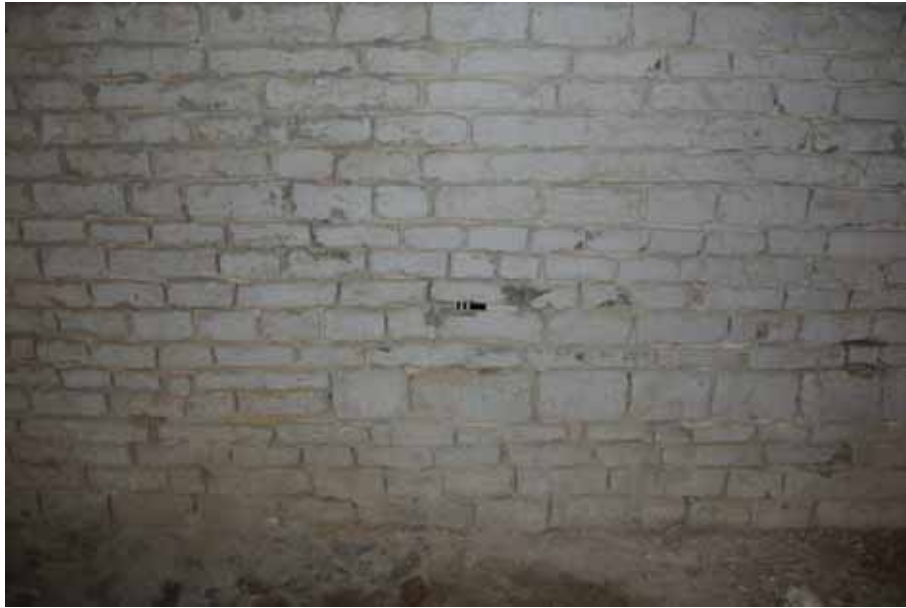
Figure 14 Southern Wall of Building A, Internal.

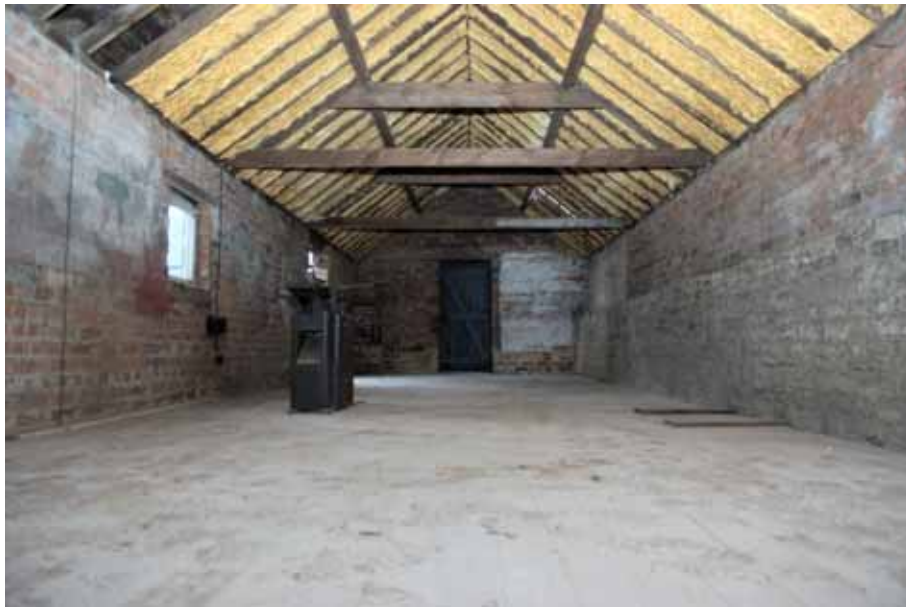
The roof is interesting in its simplicity. It is essentially a common rafter construction supported by three 'semi-trusses' formed by rafters of heavier scantling with a collar and tie-beam supporting a long purlin (*Figure 15*). Unusually, the middle tie beam does not sit below the rest of the truss; it is offset to the adjacent rafter. The roof is Welsh Slate.

Figure 15 Building A, First Floor.

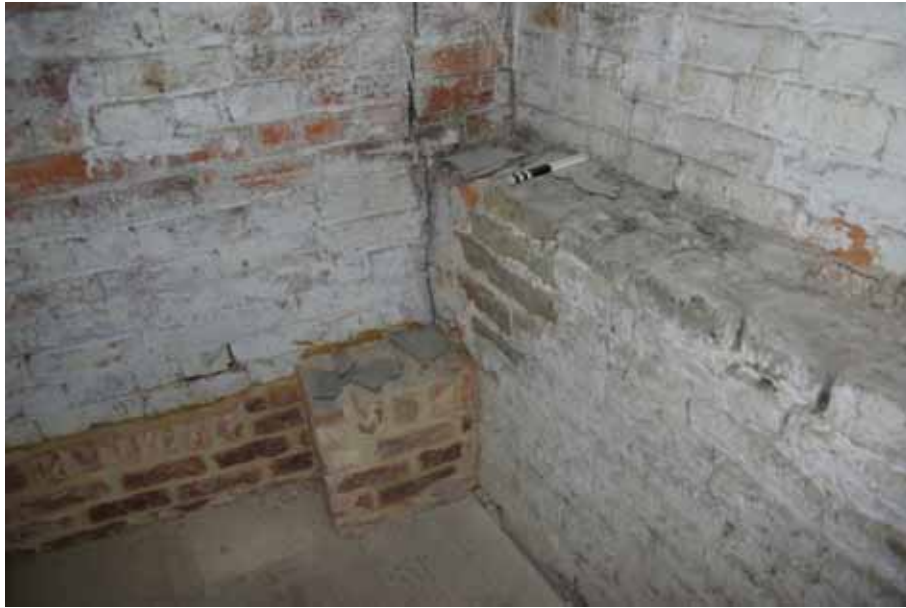
First floor access to both wings is via a stair ladder adjacent to the western wall of A, possibly an original feature. As with the ground floor, there is little of architectural or historical interest remaining. The southern ironstone wall is clearly visible; a brick wall has been built upon the ironstone (*Figure 16*) raising the eaves height to their current level. Further evidence of the re-building of the eastern gable can also be seen with brick plinths (*Figure 16*) abutting the north and south walls and the wall itself only being a single skin.

Figure 16 Building A, Southern Wall (with scale) and Eastern Gable.

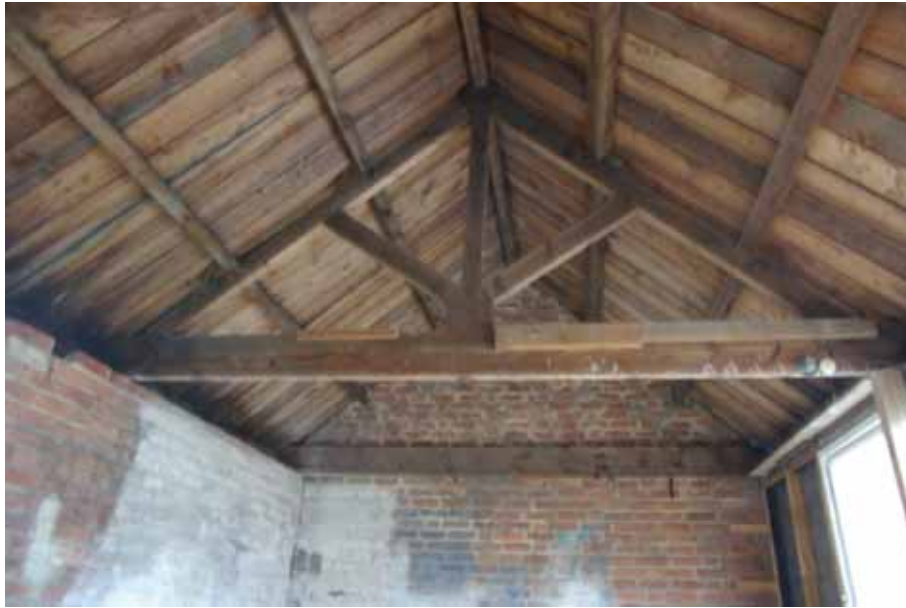
Figure 18 Building B Roof Truss.

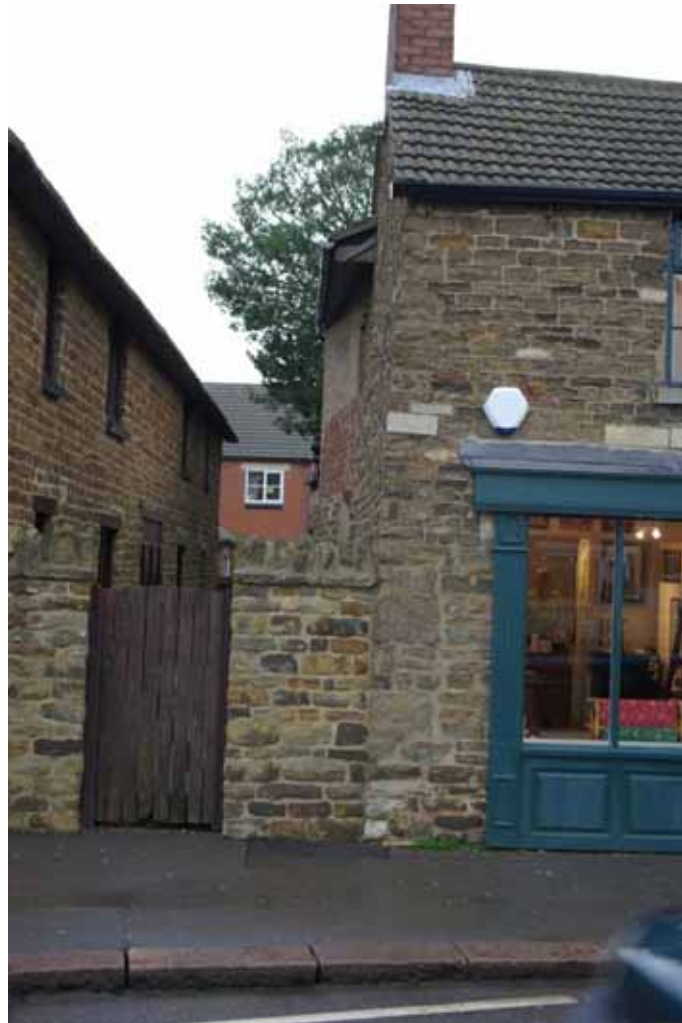
Figure 19 61 South Street, Showing Earlier Gable Wall.
