**An Archaeological Watching Brief
on the site of Hugglescote Baptist
Church, Dennis Street, Hugglescote,
Leicestershire**

ULAS Report No 2009-178
©2009

**For: Lychgate Homes Ltd.
Planning application no. 09/00253/7**

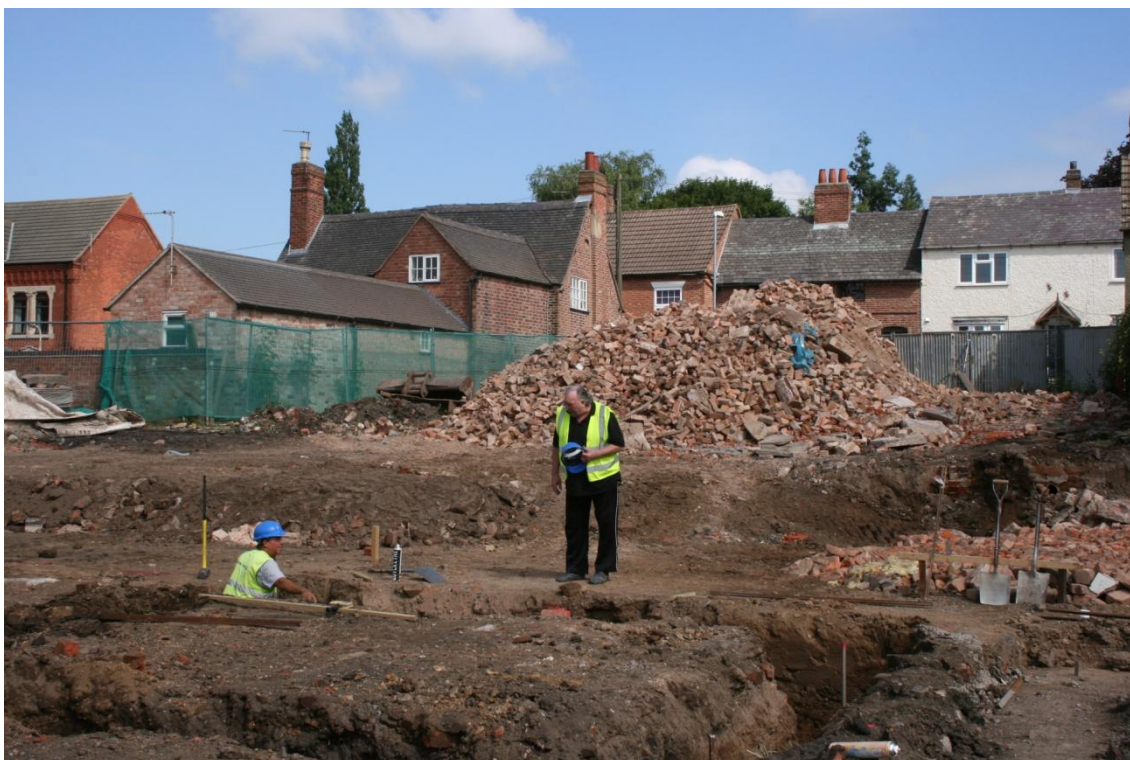
Figure 3: View looking north across the development area towards Dennis Street

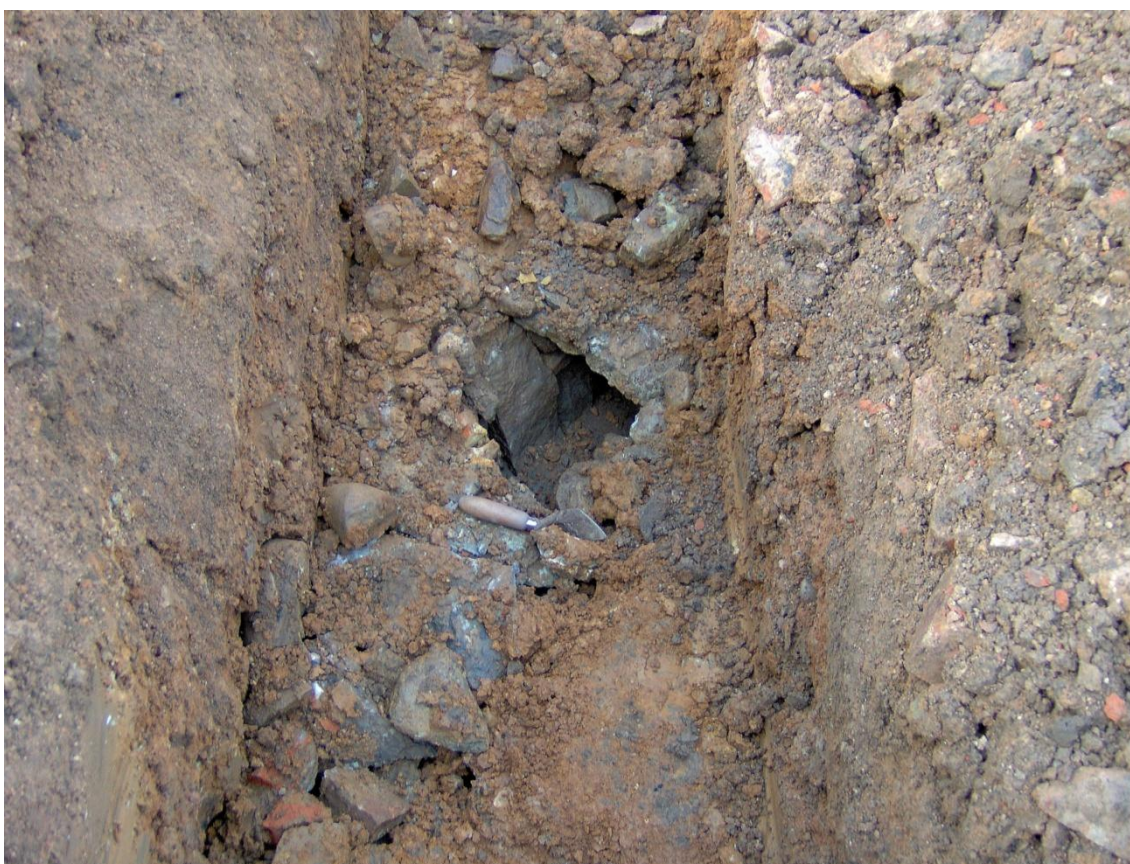
Just one feature of note was identified within this frontage area. This was a narrow stone-lined culvert (Figure 4 and Figure 5) running from north-west to south-east across the south-west corner of Plot 1. It was constructed at the base of a 0.4m wide tapered linear cut, c.1.2m to c.1.3m deep, using pitched irregular sized granite stones capped with further large flat granite and slate slabs to create an inverted triangular channel c.0.1m to c.0.2m wide. Deposited on the culvert's roof was further well packed rubble (including granite, brick and slate) before the trench was backfilled with redeposited clay indistinguishable from the surrounding natural.

Figure 4: View showing the exposed stone culvert beneath Plot 1. Looking west

This culvert appeared to be draining water away from 16 Dennis Street beneath the chapel, which it pre-dated, following the natural drop of the ground down to the south into the valley of the River Sence. As clearly as could be distinguished from the little of its alignment revealed it appeared to be heading beneath the 19th century brick outhouse in the garden to the rear of 22 Dennis Street. This, however, could be coincidental.

The one exception was the presence of the stone-lined culvert running across the frontage area. Its exact purpose other than to carry away water, a role it appears to still be adequately fulfilling judging by the presence of fresh water-born sediment in its channel, remains unclear, as does its date, although it clearly predates the construction of the church in 1874. The small quantity of brick within its construction was of similar fabric and size to the bricks used to infill the timber-framing of the 17th century building (no. 16) to the west and, as it also appears to extend away from this building, it is possible it could be contemporary with it.

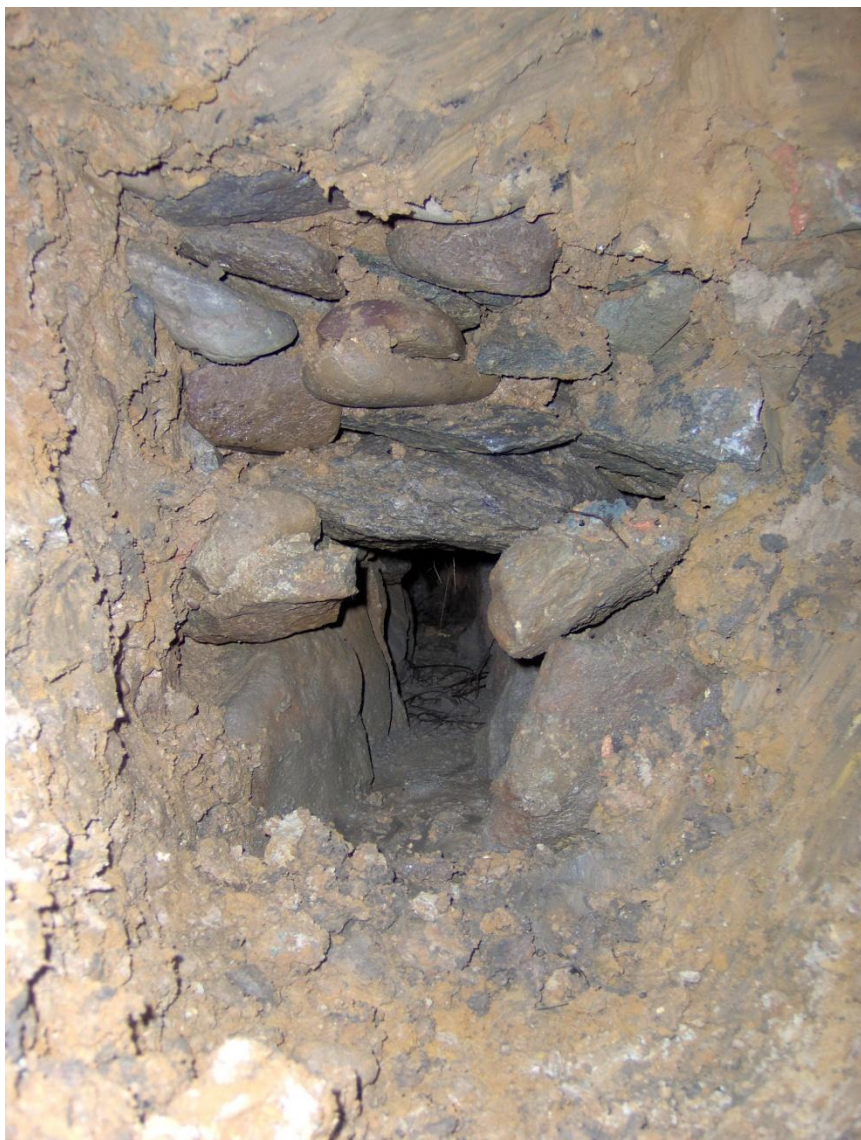
Figure 5: View showing an exposed section across the stone culvert

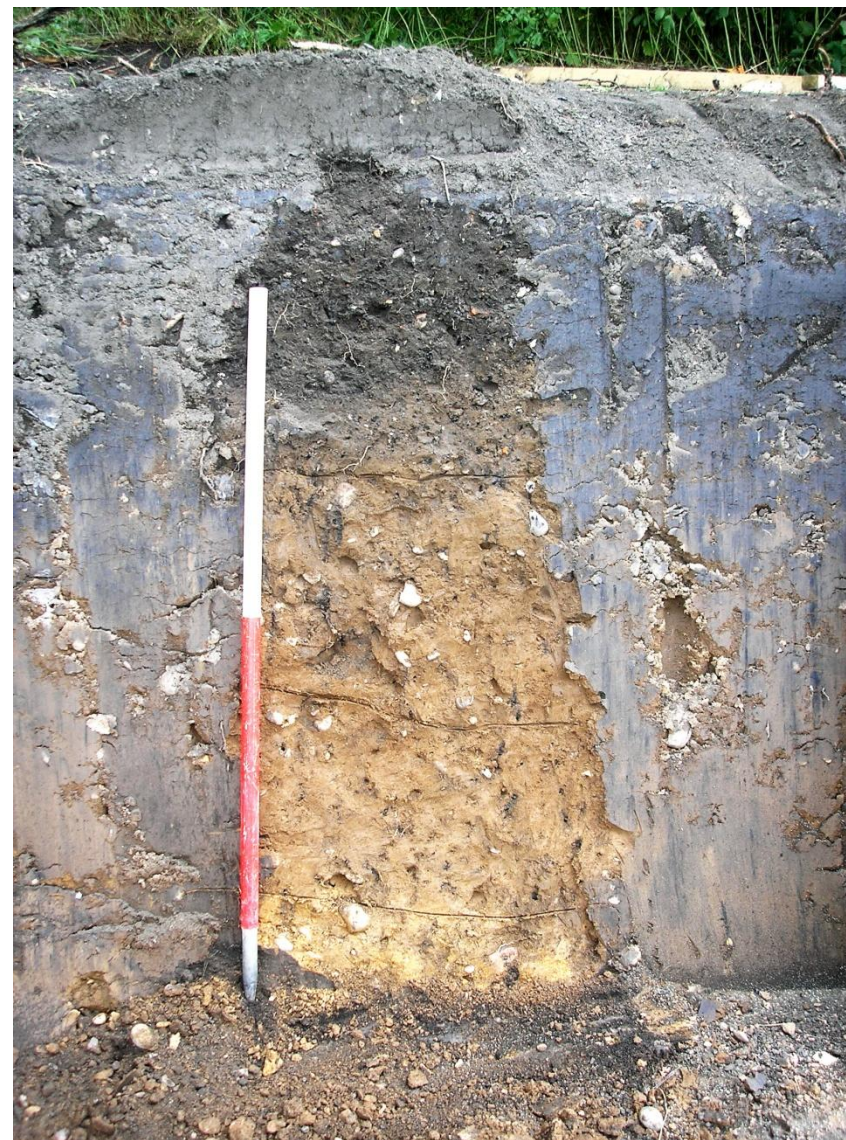
Across the rear of the site similar natural sandy-clays were observed c.1.4m below the top of the footings. This was c.2m to c.2.5m below their observed level along the street frontage and clearly shows the natural drop in slope from north to south across the site. Here though, this natural material was sealed beneath naturally occurring subsoil of pale yellowish-brown clayey-silt (Figure 6). This was observed to be c.0.62m thick across the western end of site (Plots 3 and 4) but was only c.0.31m thick to the east beneath Plots 8 and 9.

It was sealed beneath a further *c.*0.4m to *c.*0.46m of dark brown silt which likely represented the area's ground-level prior to terracing associated with the construction of the chapel (Figure 6). Evidence of this terracing was apparent along the southern edge of site where a brick retaining wall marked a *c.*0.8m drop between the ground level within the development area and the pasture beyond. Across the southern half of the development area ground level appears to have been deliberately raised with up to *c.*0.57m of very dark brownish-grey topsoil mixed with large quantities of 19th century building rubble spread across the site to level the slope off.

Figure 6: View showing a typical section of stratigraphy in the southern half of the development area
