**An Archaeological Watching Brief
at Manor Court,
Lutterworth Road,
Bitteswell Leicestershire
(SK 538 857)**

ULAS Report No 2010-170
©2010

Planning Application: 10/00739/PCD

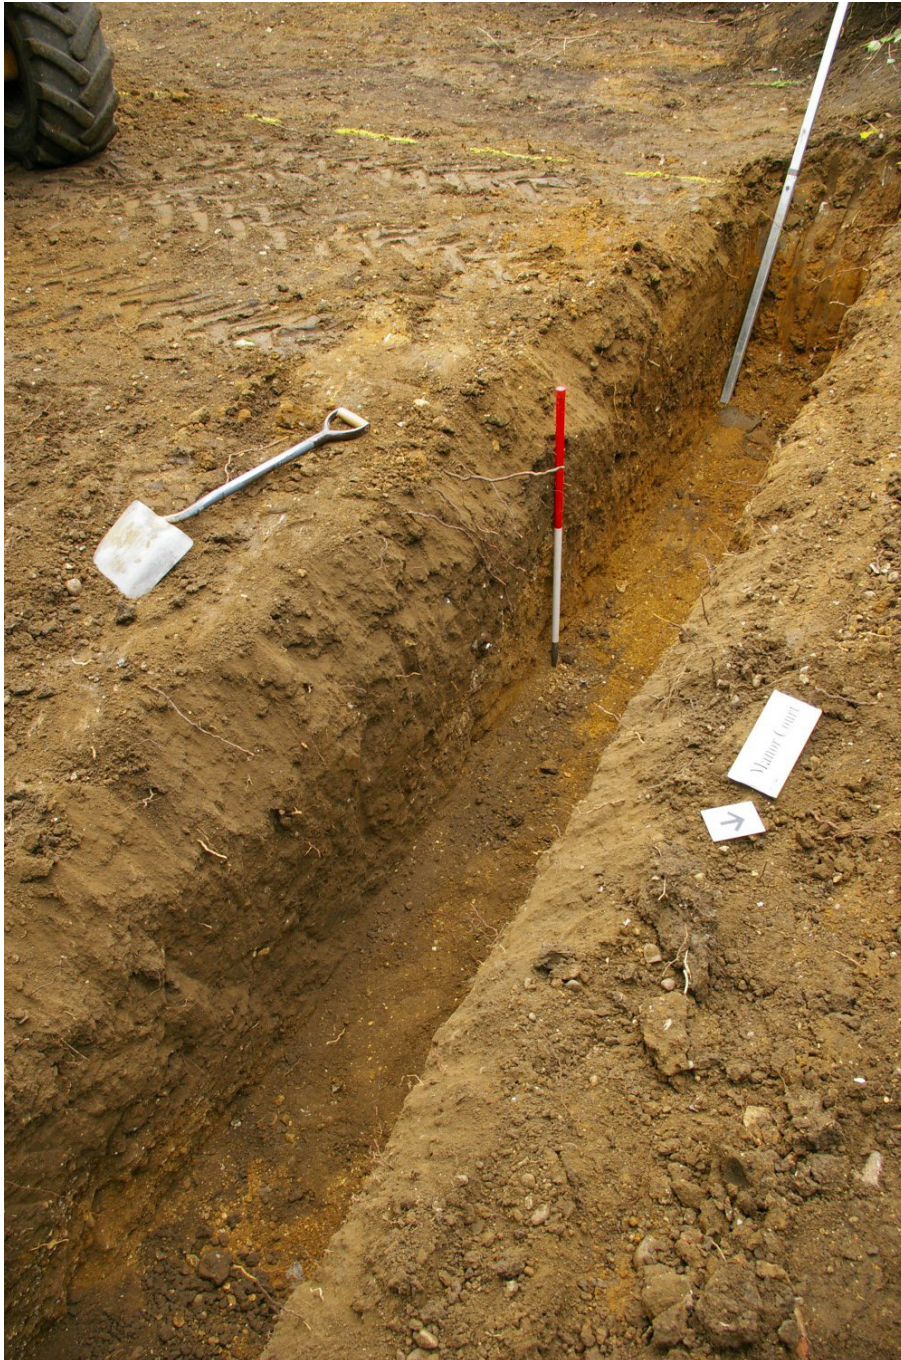
Figure 2 Backfilled Borrow Pit Visible in Northernmost Footing Trench.

Towards the northern end of the proposed development area the underlying substratum became increasingly disturbed, with no clear undisturbed geology. Approximately 400mm of garden soil was excavated revealing a mixed deposit of silty sand with abundant inclusions of 19th- and 20th-century glass and ceramics. Due to the unclear nature of this layer it was decided to monitor the excavation of the footings as well. The excavation of the northernmost footing trench revealed a series of borrow pits (*Figure 2*) excavated to exploit the underlying gravels. Nothing of archaeological significance was exposed within the remainder of the footing trenches.
