**An Archaeological Watching Brief
at Elm Farm,
Main Street,
Higham on the Hill, Leicestershire
(SP 38191 95568)**

ULAS Report No 2010-194
©2010

Planning Application: 10/00338/FUL & 10/00339/LBC

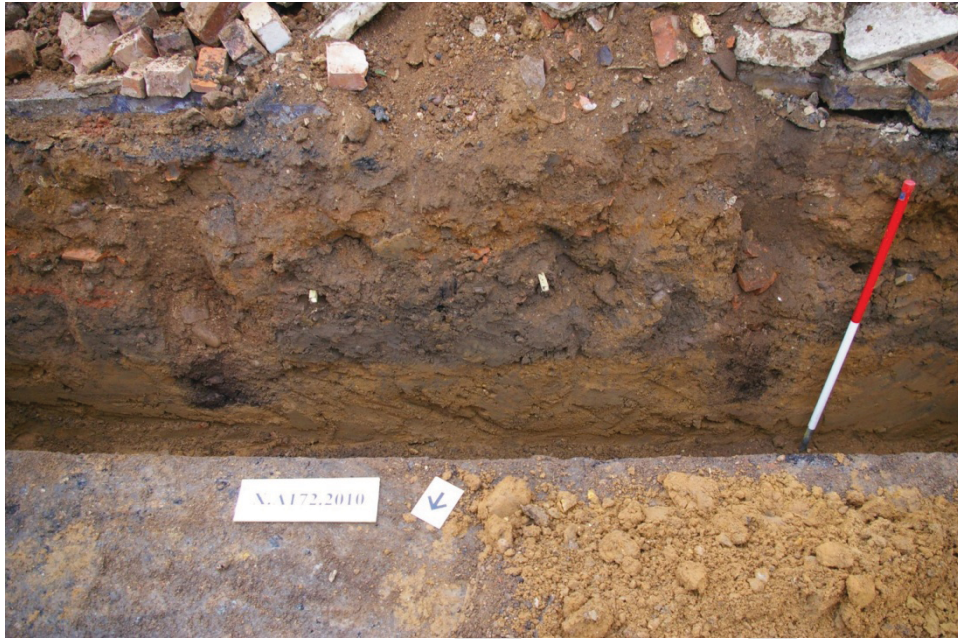
Figure 3 North Facing Frontage Section (western end).

The frontage trench contained a quantity of Charnwood rubble stone and brick rubble, clearly relating to the earlier building. The north facing section (*Figures 3, 4 & 8*) did contain a number of potentially archaeological layers which had been sealed by the floor of the recently demolished building. There were two separate floor levels; the westernmost floor (009) was made up of a cobbled surface and appeared to abutt the gable wall of Elm Farm whilst the second floor (008) was to the east and was red clay. A single sherd of 18th- to 19th-century glazed earthenware pottery was recovered from (005), but was on the surface of (008) suggesting a likely occupation and abandonment date (Finn, N. pers comm. Not retained). There were also two large post pipes, [001] and [002] which were clearly later as they cut all the visible layers, both have decayed timber at their bases.

The proposed works would have no further impact upon these layers and they were recorded and left *in-situ*.

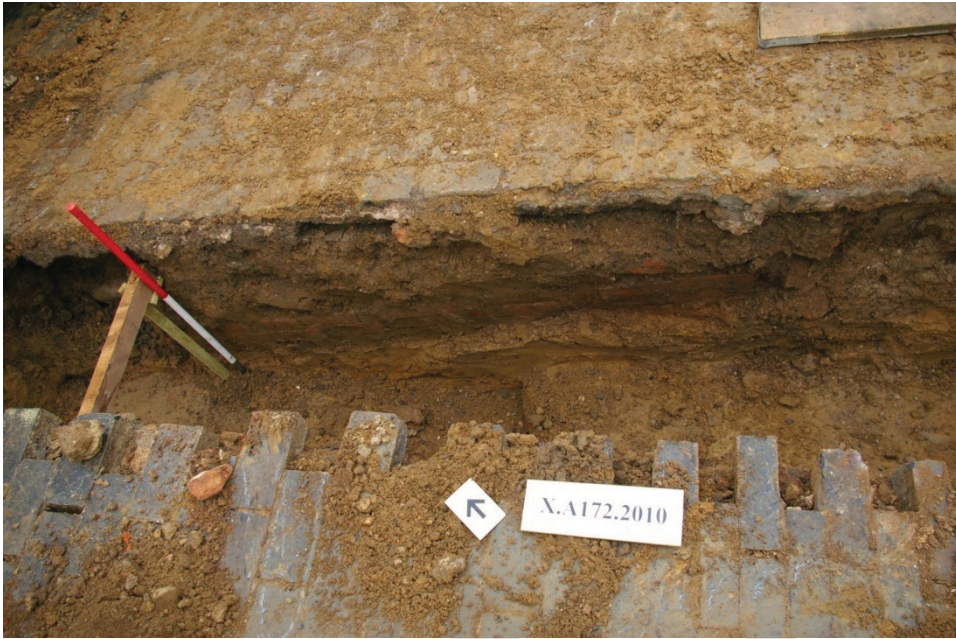
Figure 5 Brickwork Exposed in Easternmost Trench.

the undisturbed substratum almost immediately and contained nothing of archaeological significance. The easternmost trench contained a dry-built red brick wall within the west-facing section, aligned north-south. The brick dimensions were 9inch by 3inch by 4inch, suggesting a later 19th-century construction date. A void towards the northern end of the trench revealed a ceramic pipe, on the same alignment as the wall, suggesting the two are related.

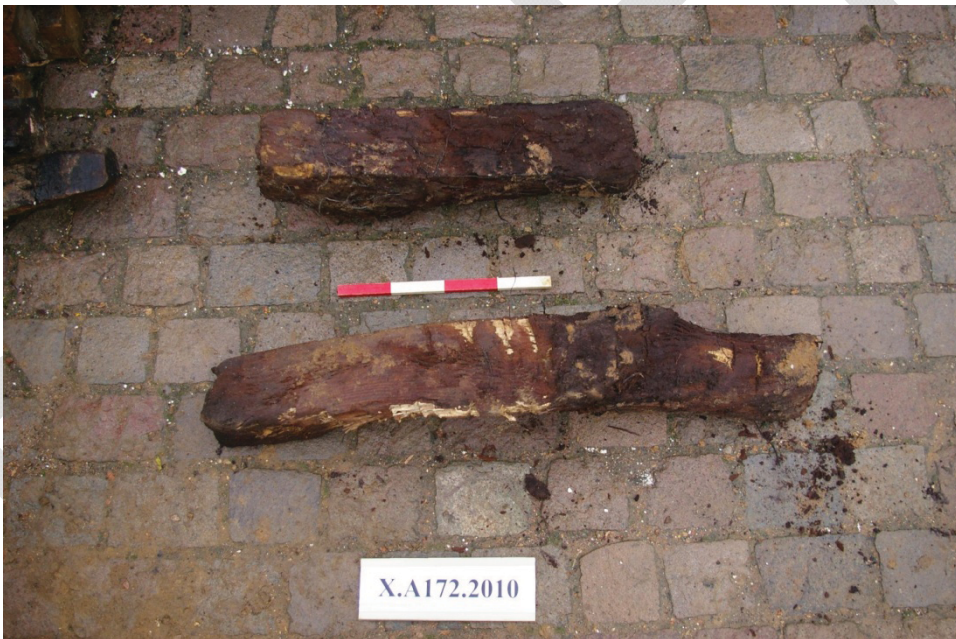
Figure 6 Timber Recovered from [010] & [011].

A further visit was carried out once the blue-brick floor had been lifted in order to monitor further ground reduction work. Once the blue bricks had been lifted two upright timber beams were exposed [010] and [011] (*Figure 6*); which, along with the outline of those observed within the northern trench ([001] & [002]), created a square pattern; once removed the beams reached a similar depth as [001] and [002]. The exact purpose of this structure is unclear; it is possible that the beams represent the remains of earlier stalls within the recently demolished building. If so, it is unclear as to why the beams were set so deeply below the ground level.
