**A Photographic Survey of a Barn at  
Ivy House Farm,  
Main Street, Glooston,  
Leicestershire.  
(NGR P 750 958).**

**ULAS Report Number 2008-146**

*University of Leicester Archaeological Services was commissioned by Mr. G. Jervis to undertake a photographic survey of a barn at Ivy House Farm, Glooston, Leicestershire. Planning permission had been granted for the conversion of the barn to residential use.*

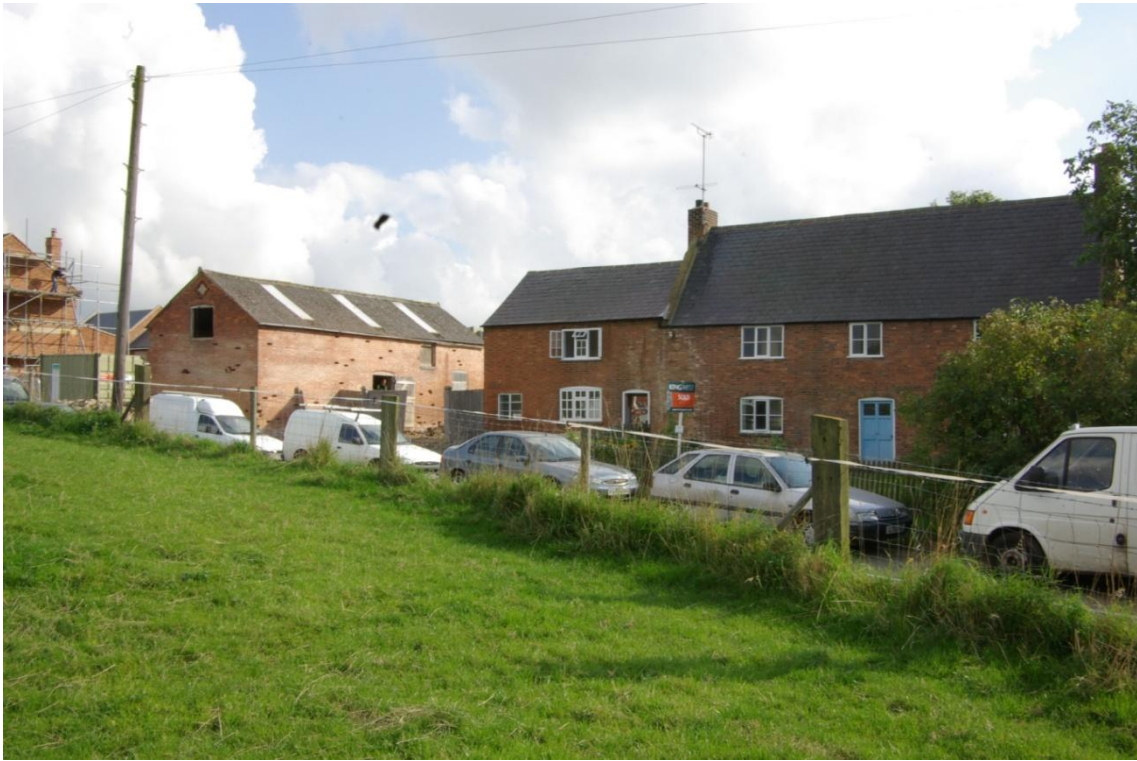
**Figure 3** Ivy House Farm with the recorded barn to the left.

The building consists of a linear range of buildings, aligned east-west, facing Ivy Farm to the south (*Figure 3*). The westernmost end of the range is a large two-storied barn while to the east were two single-storied buildings. Both of the eastern buildings had been largely demolished before the site visit, leaving only part of the front wall of the middle building standing. An examination of a pre-demolition photograph suggests that the easternmost building was a later extension in what appears to be Fletton bricks, which would suggest a mid to late twentieth century date for its construction.

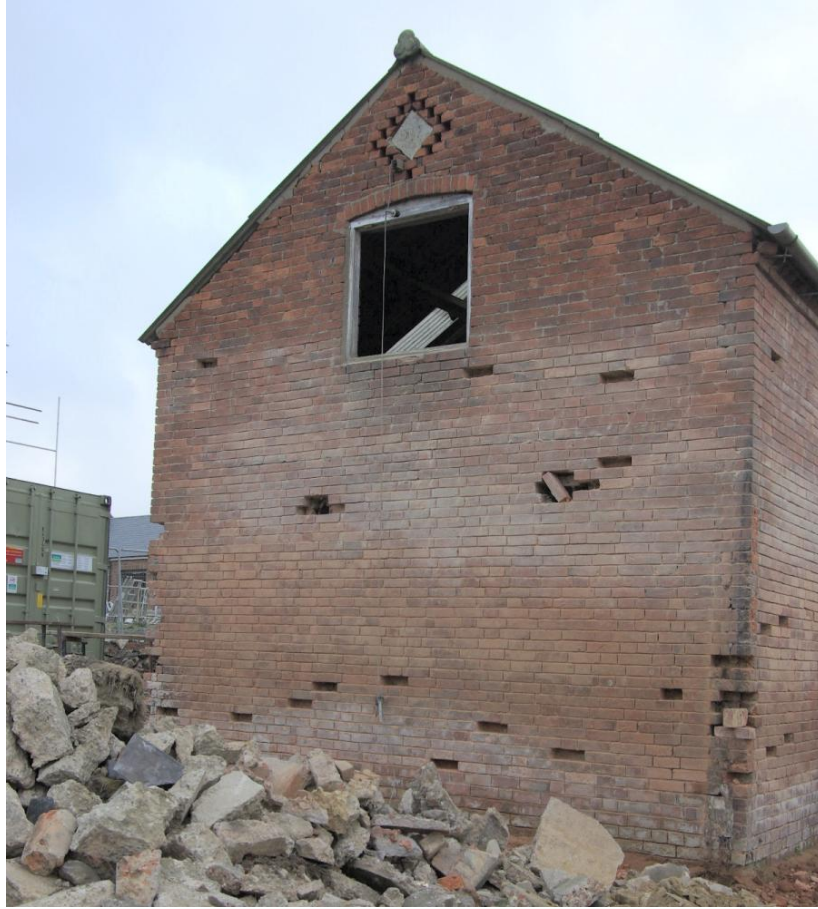
**Figure 5** Left Hand Gable (From the Southwest)

The left-hand gable (*Figure 5*) contains a diamond-shaped date stone inscribed 1797 with a carved ellipse above and below (*Figure 8*). Surrounding the date stone is a diamond-shaped array of vents or pigeon holes. The right-hand gable (*Figure 6*) is plain, showing only the whitewashed outline of the recently-demolished building and is in a rather precarious condition.

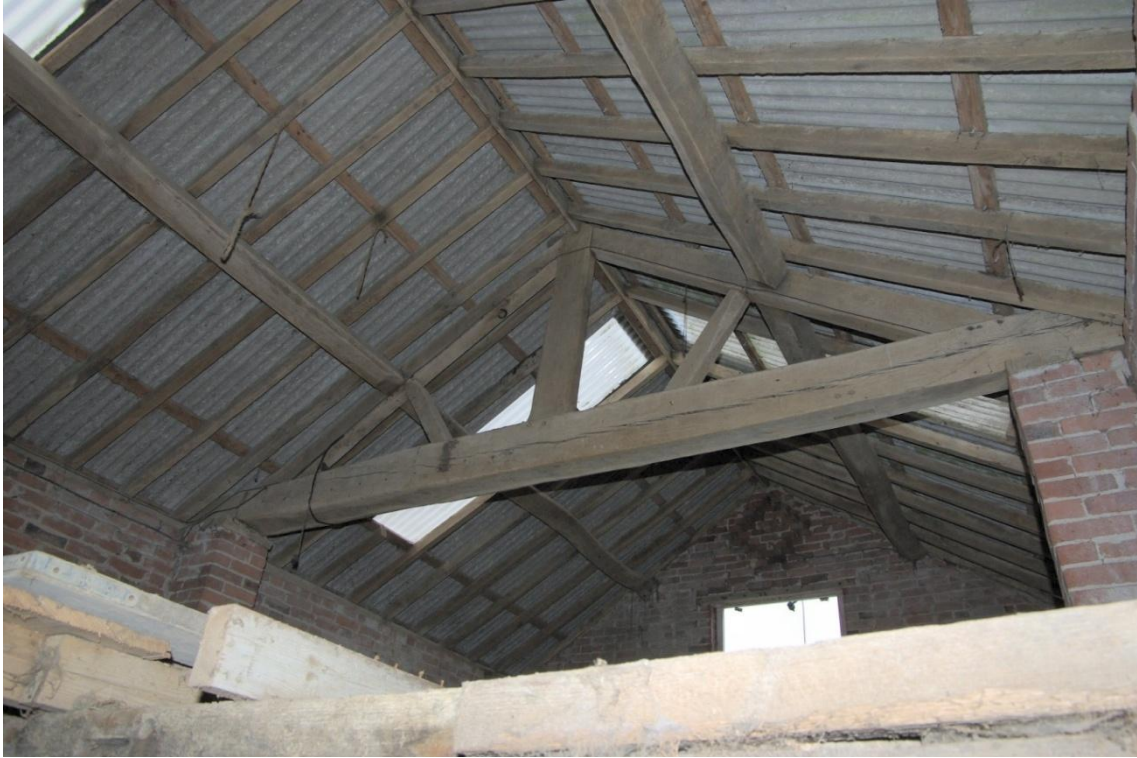
**Figure 9** Roof Truss.

The roof is by far the best surviving feature of the building; it is a pegged king post design with raking struts in oak (*Figure 9*). There is limited evidence that at least the tie beams are reused, however, the uniformity of these marks on both trusses may suggest the whole roof structure was salvaged from elsewhere and reused in this barn.

Both roof trusses showed possible evidence of re-use, suggesting that this barn may have replaced an earlier barn, from which these trusses were salvaged and re-used. The reclaimed railway sleepers are also a good example of the vernacular tradition of the twentieth century, no doubt the railway sleepers were cheaper than other timber and possibly available locally with the closure of a large number of railway lines in the 1960s, the nearest being the Great Northern & London & Northwest Joint Railway (G. N & L & N. W. Joint Railway); closed to passenger trains in 1953 and finally closed to all traffic in 1964. Given their width they may have been sourced from the nearby Hallaton Junction.

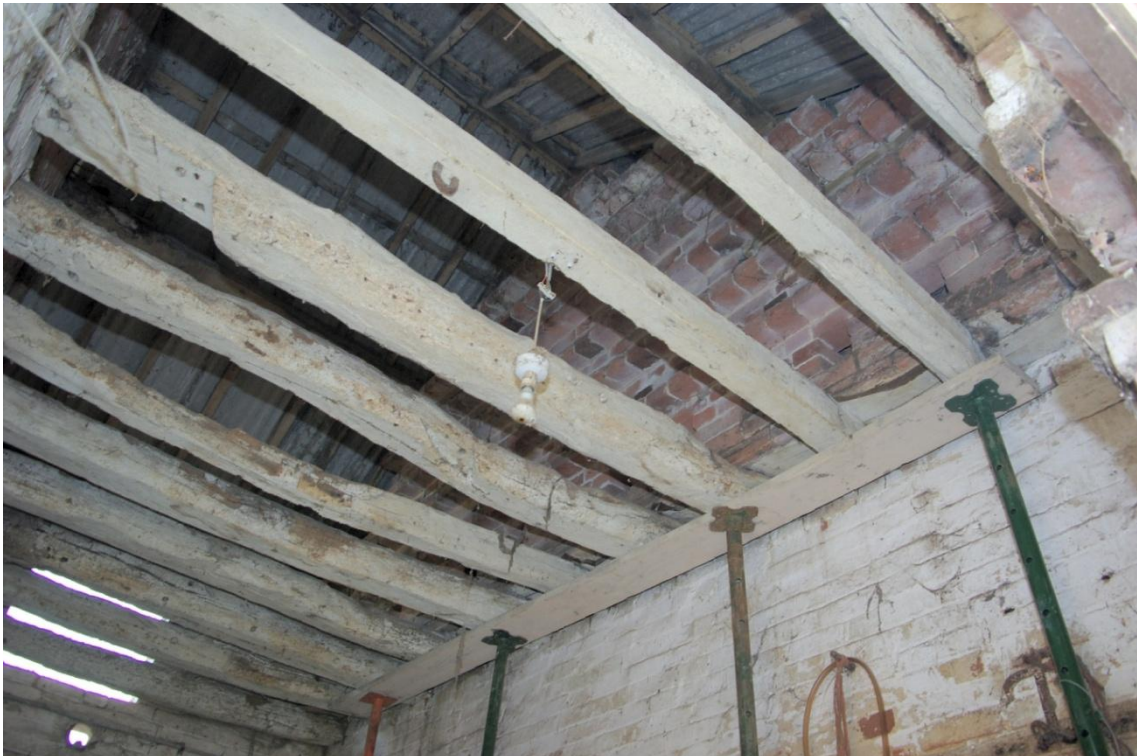
**Figure 12** Limited View of Roosting Ledges on Right Hand Gable.

Internally, the barn is divided into two unequal rooms; the smaller of the two, A, is to the right while B is to the left. The wall is a later insertion. Within room A there are extensive roosting ledges on the gable wall (*Figure 12*), apparently supported by the inserted timber floor. This room was deemed unsafe for closer examination. There is little of architectural or historical interest within room B. A floor supported on a framework of reused railway sleepers has been inserted (*Figure 10*); the sleepers used as joists measure 4.75m long (15' 8") and must, therefore have originally come a mainline, perhaps underlying a set of points. Most of the sleepers still have railway information stencilled on (*Figure 11*) and one has the same information painted freehand. The information indicates the sleeper formed part of a set of points laid in 1958 (Fred Hartley *pers com*). An early, if not original, red-brick floor survives in the left-hand side of the barn while there is a modern concrete floor to the right.
