**An Archaeological Standing Building Survey of
the 1926 Extension to the Former Atkins Works,
Lower Bond Street, Hinckley,
Leicestershire
(NGR SP 4270 9415)**

For: Hinckley & Bosworth Borough Council

**ULAS Report Number 2008-163
©2010**

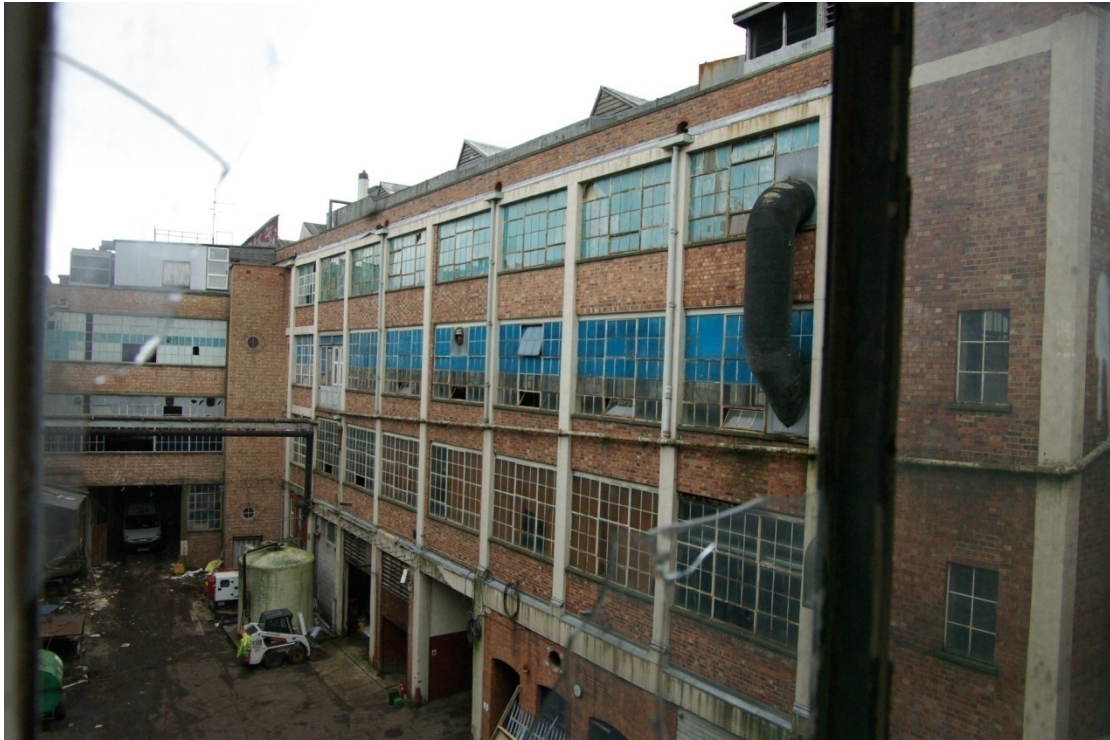
Factory 2 occupies the centre of the proposed development area and is a four storied building of red brick and reinforced concrete frame of five bays with a stairwell to the right (south) and a north light roof. The central bay is open at ground level providing vehicular access through the site. The later extension follows almost exactly the design of the earlier building but is identifiable by the more obvious concrete frame used on the front elevation. The windows are large steel framed Crittal style with 39 panes, the top centre panel is on a central pivot opening and the bottom centre panel hinges at the bottom. Some of the opening lights have been replaced by fixed vents. At second floor level of the northern most bay there is a horizontal shuttered timber door, it is possible that this replaced a window, or may be an original feature. The concrete beam at first floor level has lead flashing on its upper surface, it is more than

Figure 5 Front Elevation (Looking North-Northeast).

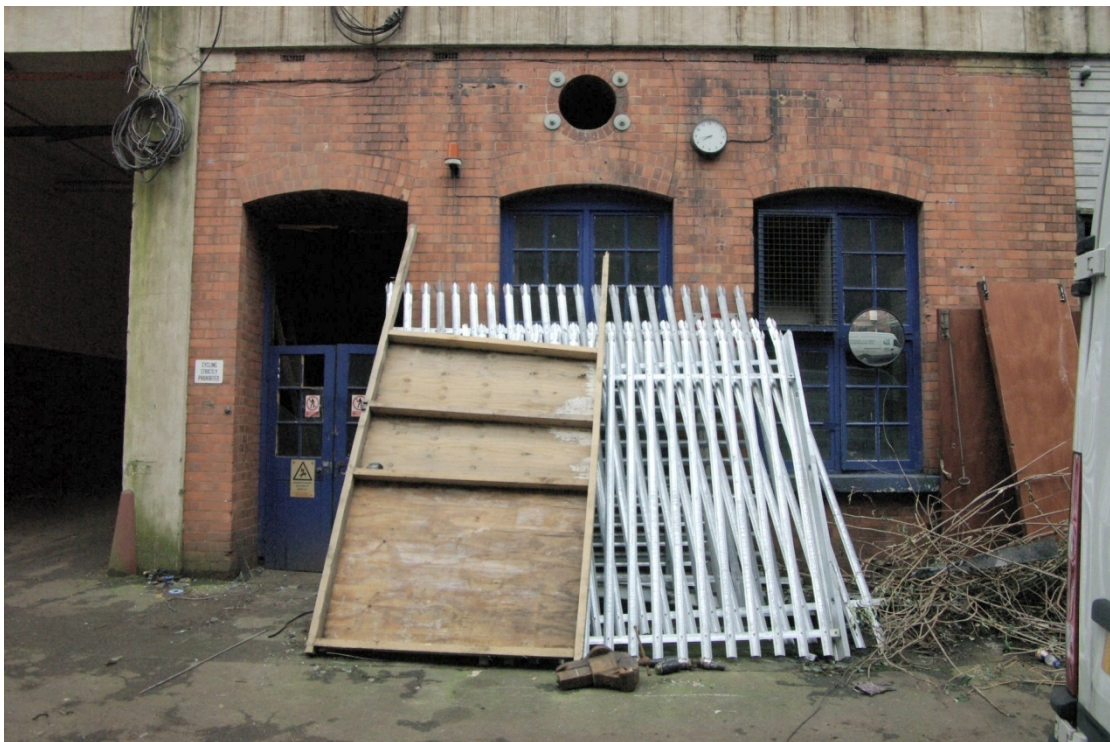
The most significant aspect of the front elevation is the apparent use of parts of an earlier building towards the southern end of the factory. This is most apparent at ground floor level on the three southern bays; this part of the building is clearly earlier 9inch by 3inch red bricks in an English Bond. There are two original windows and an original door surviving, all with flat cambered arches above and concrete sills, the timber windows appear to be original as well. Above the central window there is an original circular opening, probably a vent. The walls are extremely wide; 670mm (2' 3") at floor level, suggesting the original building stood several stories high.

Figure 6 Detailed View of Retained Brickwork within southern end of Front Elevation.

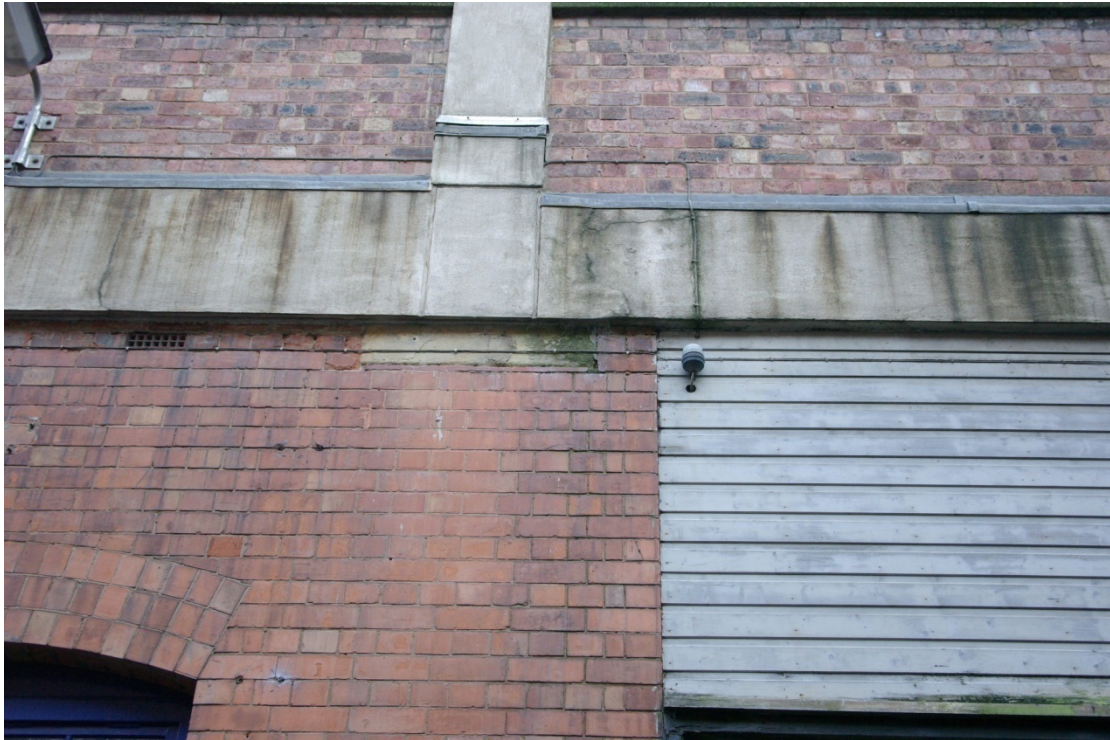
Figure 7 Change in Concrete Frame Near Retained Bays.

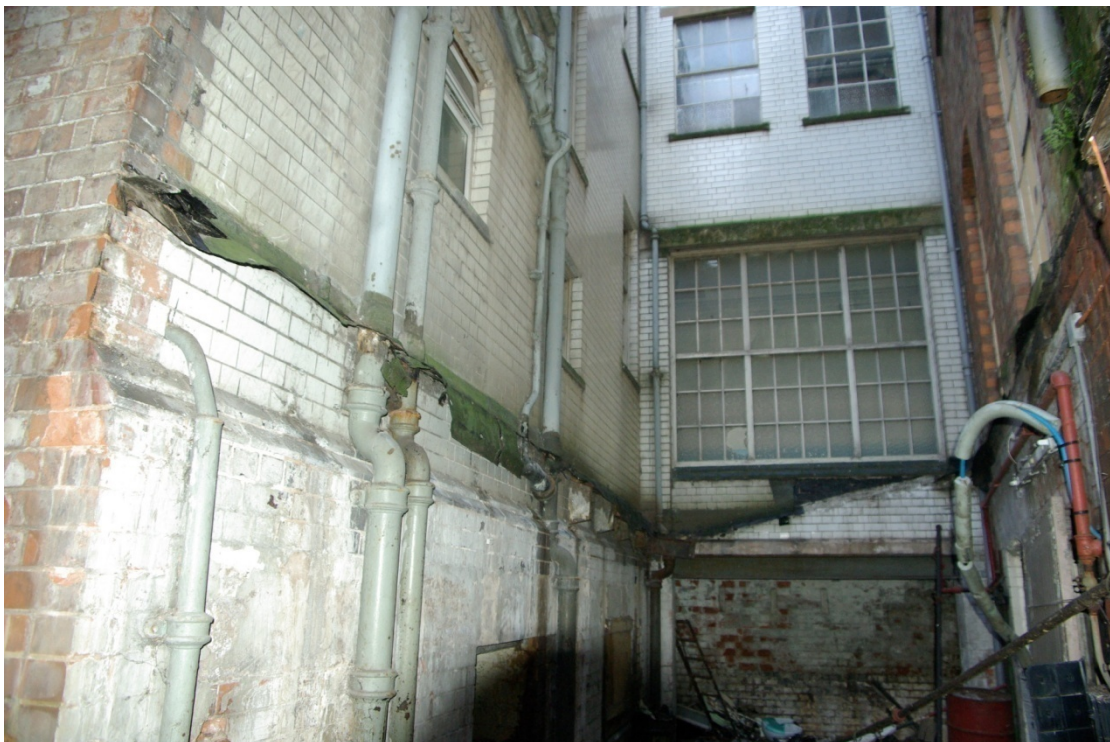
An external examination of the stairwell on the southern gable of factory 2 suggests that it too is from an earlier building, both the bricks and the bond match that of the other early structure. It is possible, therefore, that these two parts of the factory are the remnants of the earlier building which stood on this part of the site and could be seen on the earlier edition Ordnance Survey (*Figure 3*).

Figure 8 Southern Gable of Retained Stair Tower.

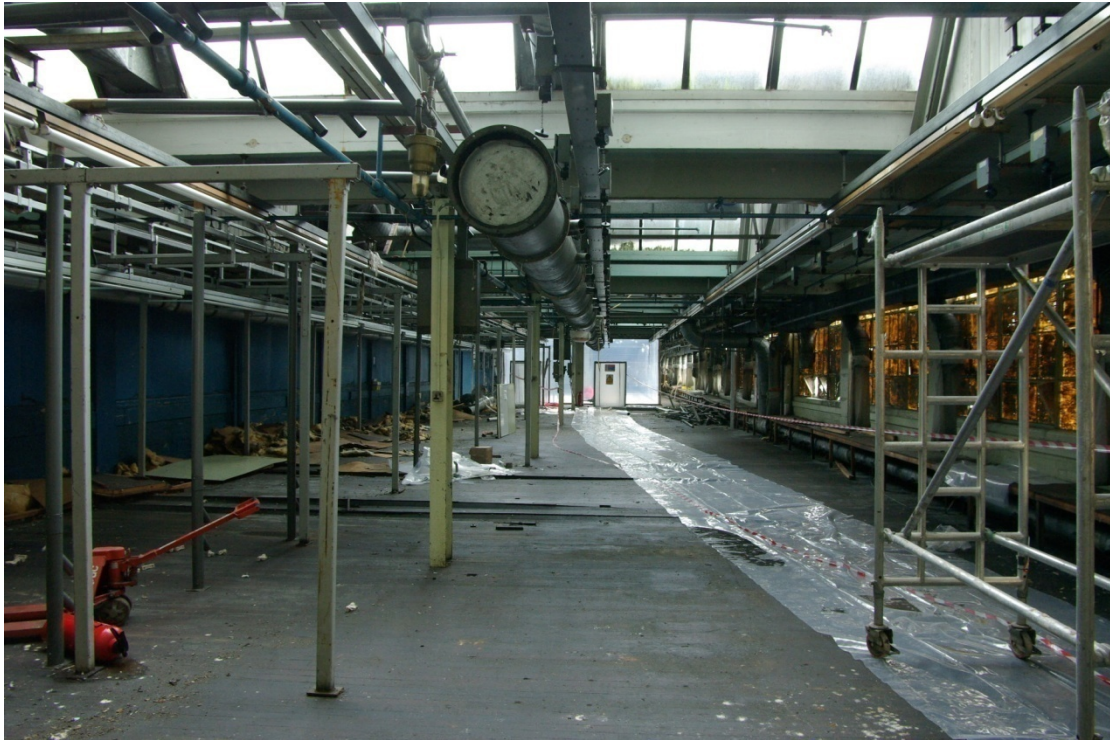
The third floor appears to have been the least modernised of all the floors and bears all the signs of a hard life. The original maple floor is still in place but buckled in places by water saturation and completely in grained with grease. This grease also covers every surface within the room. Suggesting this where raw materials were processed prior to joining the production line on the lower floors. Where the floor has started to lift the lower concrete floor can be seen below, between this and the maple flooring there appeared to be another timber layer, it is unclear whether this is an earlier floor or a surface onto which the maple boards were laid. As with the first floor there were the outlines of removed machinery visible on the floor near the front wall.

Figure 9 Third Floor, General View.

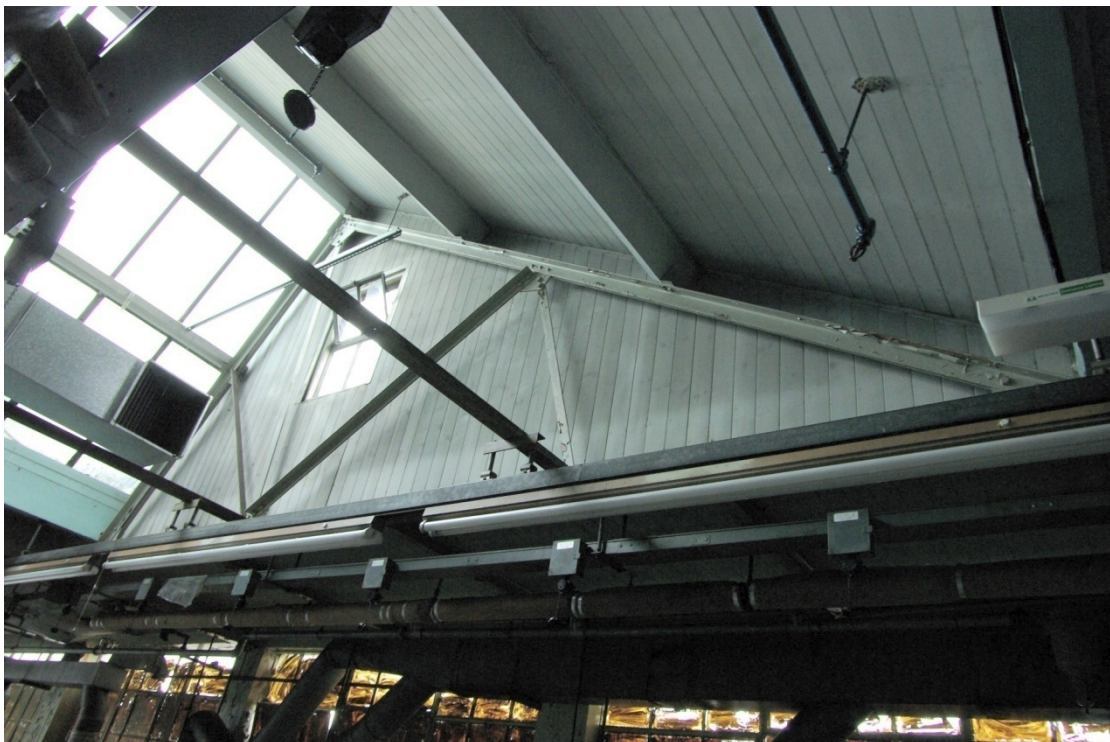
As with most factory buildings of this era the roof is a north light structure with trusses constructed in a combination of flat bar and angle bar for the web members, built up sections of double angle bar for the chord sections and built up hollow channels (or C sections) for the beam. These built up sections are extremely strong and durable and normally reserved for bridge construction. As expected the steel work comes from a number of sources, the flat bar is stamped LILLESHELL while the angle is stamped CARGO FLEET ENGLAND. Lilleshall was the last iron and steel producer in Shropshire, who by about 1925 were only rolling steel, and firing only one furnace to produce it.

This is an unusual roof construction, the use of these built up sections and heavy sections are normally reserved for roofs with a long span or bridges, not for a relatively small, common north light roof like the one recorded. Using the double angle for the chord sections and hollow channel for the beam allows the gusset plates onto which the webs are bolted to be held on both sides with a bolt through, causing less stress on the plate resulting in a very strong joint. The shorter of the flat bar web members is attached to the beam without the use of a gusset plate, being nearly vertical this bar is likely to be under compression and the designer decided there was no need for a gusset plate. The other, more diagonal members would experience tension, therefore angle bar is used and a gusset plate and as mentioned above supported from both sides by the built up sections of the chord above and beam below resulting in a very strong roof.

Figure 10 Detail of Roof Construction.

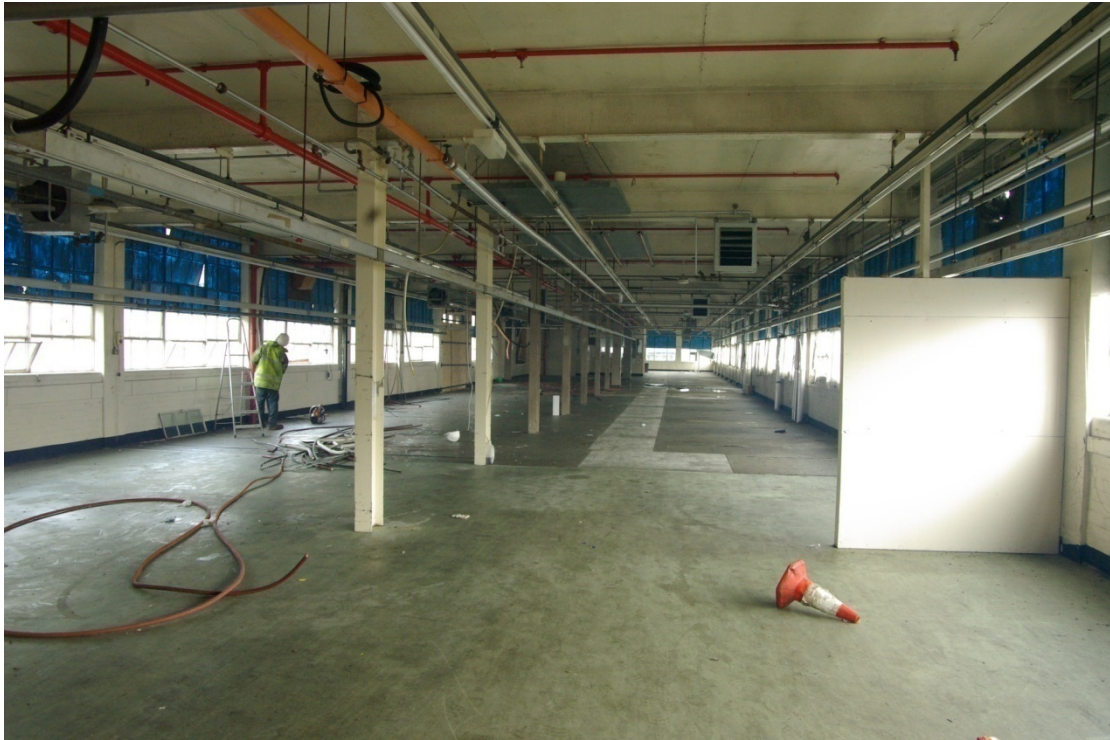
The second floor is almost identical in lay out to the first floor, with only a few minor differences; most notably no inserted partitions. The floor has had a vinyl cover laid, probably over the original maple. Despite being empty there is more visual evidence of the working factory on this floor than on the first floor; the windows in the rear wall are uncovered, filling the space with light, suggesting this remained a manufacturing space up until the factory's closure. There are changes in the flooring, no doubt denoting pedestrian routes between machinery, there is a guard rail maintaining a clear route to the lift indicating that it too remained in use until the factory's closure. There is also an array of electrical fuse boxes and trip switches mounted on the wall of the lift shaft, surrounded by a safety rail, again evidence of the factory at work. Further evidence of the factory at work can be seen with a small screen near the door to the stairwell and in the fact that the first two centre columns from the right are painted a different colour and may represent a division of labour or processes.

Figure 11 Second Floor, General View.

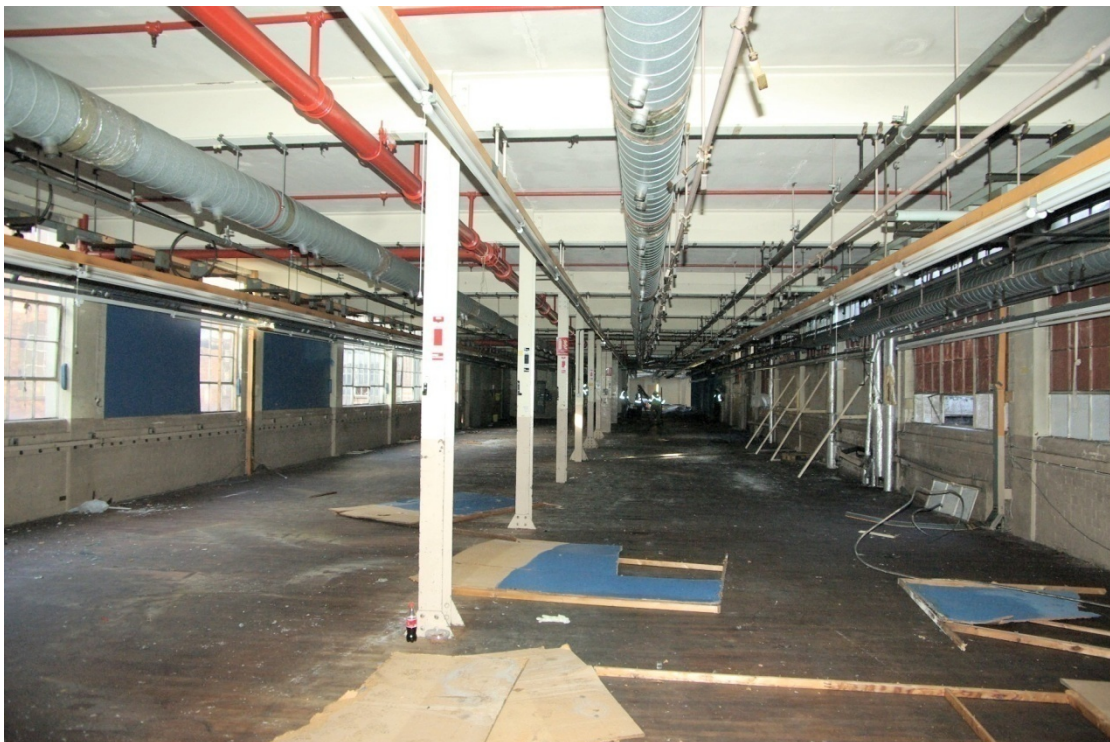
Evidence of the factory in use could be seen throughout the room, including the outline of stripped out machines on the floor towards the front of the room. Unusually there is a bank of 240volt sockets along the front wall immediately below the widows; it would be assume that a factory of this size would use three phase electricity. These sockets may, therefore, suggest owners ceased to up grade and maintain the factory to the highest standards, possibly reflecting the harsh economic conditions the hosiery industry experienced in United Kingdom during the later part of the twentieth century.

Figure 12 First Floor, General View.

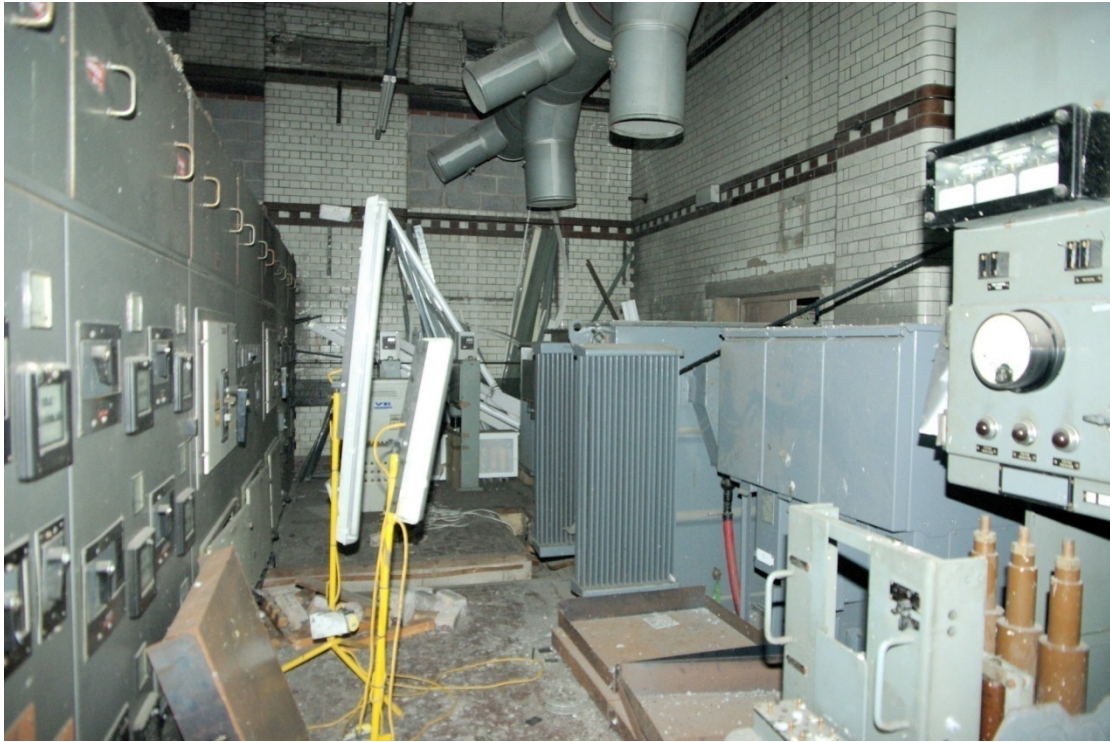
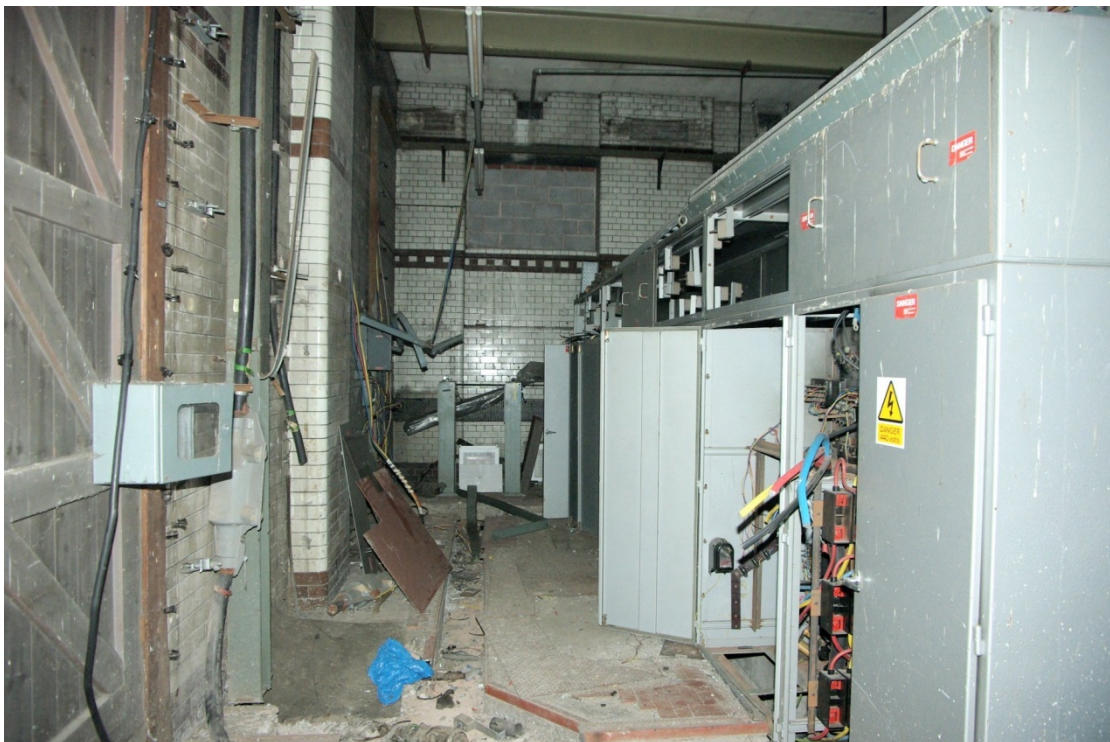
The interior of the southern most bays provide the clearest evidence of the retention of elements of the earlier building. The interior of the central bay (C) is clad in white glazed bricks with a two course decorative motif in brown glaze in an English Bond. A style and design which is clearly nineteenth century in date. These glazed bricks were commonly used in the engine house of nineteenth century factories, it is possible, therefore, that this was the earlier buildings engine house and that is why it

Figure 13 Ground Floor, Room C.

Figure 14 Ground Floor, Room C.

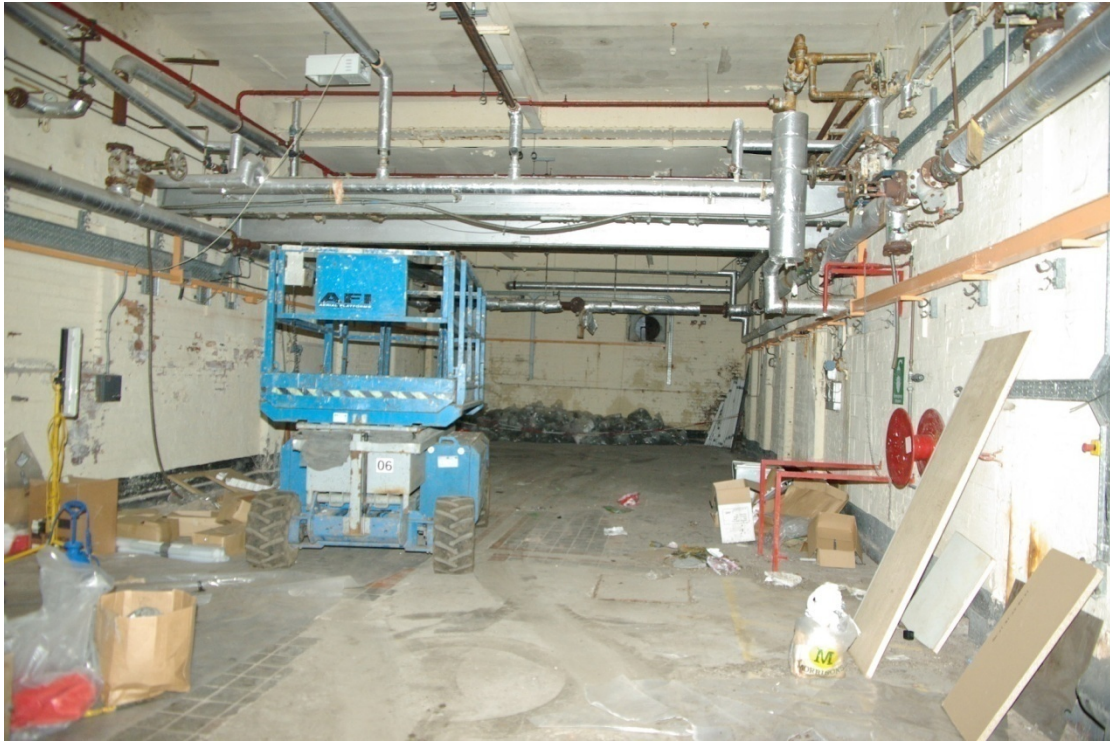
Figure 15 Ground Floor, Room A.
