**An Archaeological Excavation and Photographic  
Survey undertaken at  
Church Farm, Seaton,  
Rutland.**

**(SP 9005 9823)**

**Planning Application: PA/06/0324/9**

**Archaeological Excavation and Photographic Survey Undertaken at Church Farm,  
Main Street, Seaton, Rutland (SP 9005 9823).**

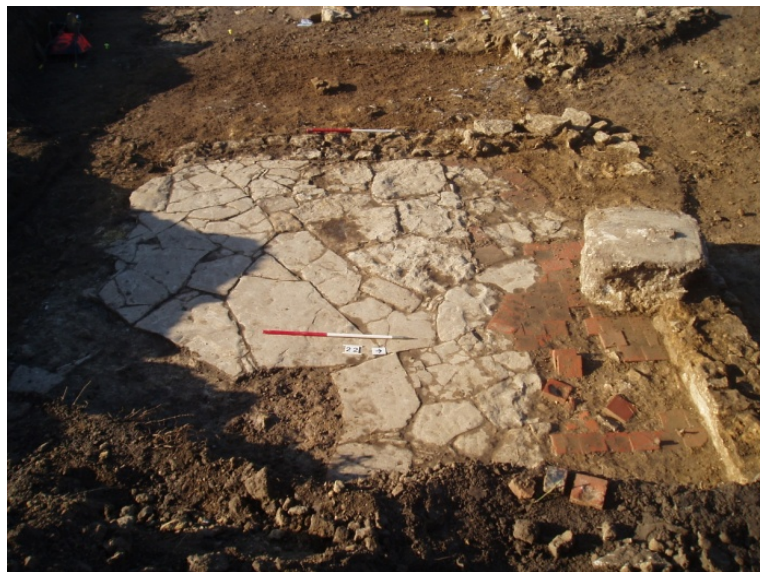
**Figure 3** Flagstone floor with quarry tile repair (right).

The building itself was a stone construction surviving to a height of three to four courses in places. Some of the flagstone floors survived *in-situ*, most notably in the eastern room and towards the centre of the building. All of the *in-situ* flagstones appear to be shattered but still serviceable, which would suggest that the existing gaps are where whole flag stones were salvaged prior to demolition. There was also evidence of the repair of these floors with both brick and quarry tiles (Figure 3). Outside the building there were two areas of pitched stone surface, both of which are located to the rear of the building; in all likelihood this surface was originally the full length of the building but has been lost in places; the stone used was the same ironstone used within the building itself.

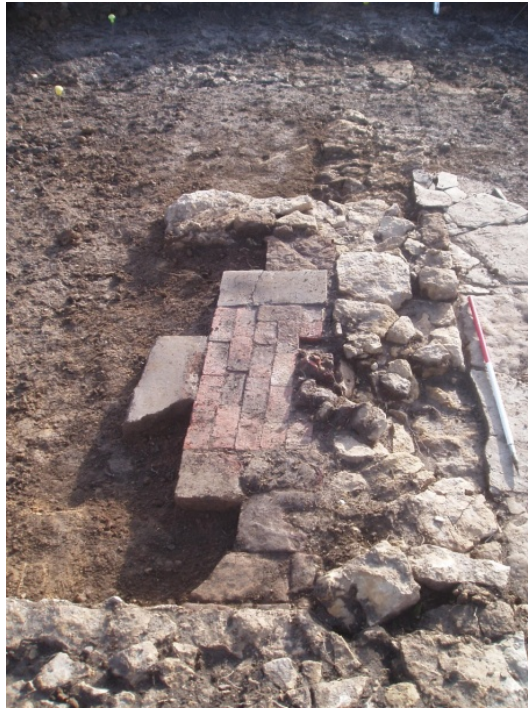
The fireplaces themselves are a composite of stone and brick, the latter was possibly used to replace a burnt out stone hearth. Both are unusual in the fact that they are not central to either room, in the central room the fireplace is of set to the rear, approximately 0.56m from the rear wall, while the fireplace in the second room is only approximately 0.80mm from the front wall. The western fireplace incorporates some of the plum coloured limestone, possibly as a decorative flourish.

**Figure 4** Western Fireplace.

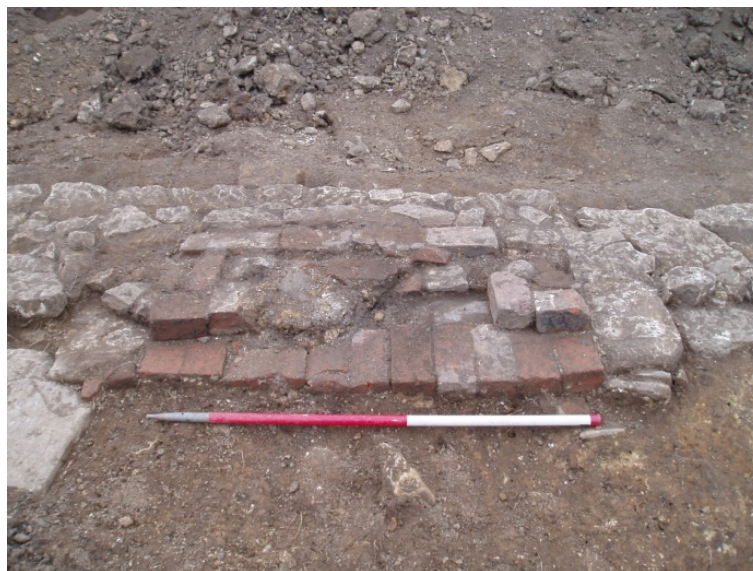
**Figure 5** Eastern Fireplace

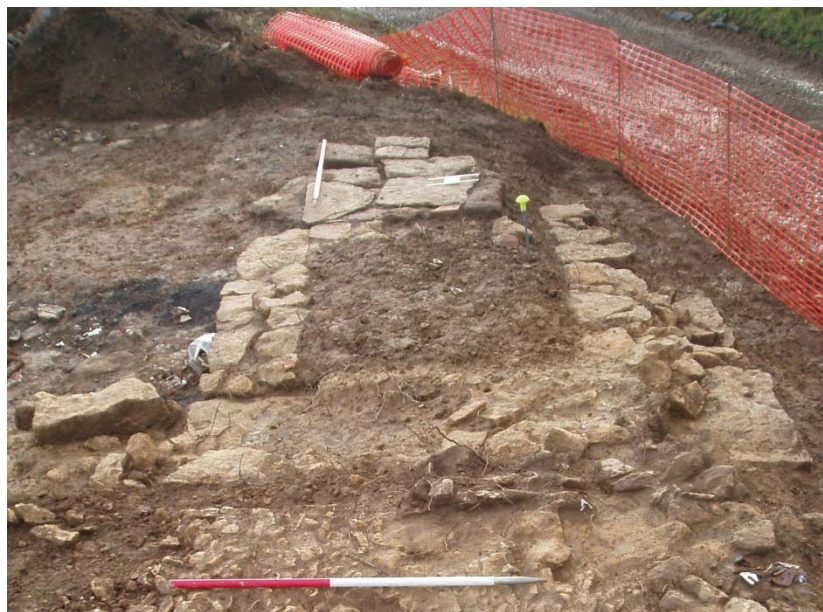
The most unusual feature within this room is the large square feature in the south-west corner (Figure 6). This appears to be tied into the main walls of the building and is likely to be contemporary. The interior of this feature appears to be re-deposited ironstone, similar to the substrata in some parts of the building. The exact purpose of this feature is unclear, although it is possible that it represents some sort of dairy feature. Within a traditional farm plan, separate dairies are rare and were more often attached to the farmhouse (Brunskill. 1982). This part of the building may therefore be the dairy with the remains of its original fixtures. While it is possible that it represents some sort of large oven, it is thought more likely that most of the cooking would have taken place on the fire within the domestic part of the building to the east.

**Figure 6** Stone Feature in the western bay.

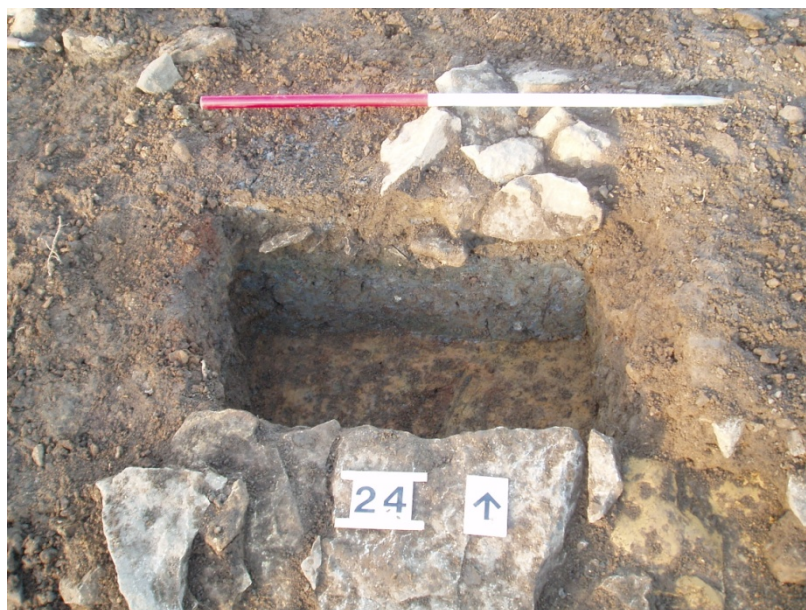
A second cut feature [27] was also identified within this room, this time abutting the front (south) wall (*Figure 7*), and the eastern edge appeared to respect what would have been the edge of the flagstone floor. There was a loose rubble surface sealing the pit, excavation of which revealed a primary (26) and a secondary fill (25) below a final fill (24), from which several sherds of Midland Yellow ware and Earthenware (see section 7) were recovered, dating from c.1500 through to c.1725/1750. The location of this pit suggests that it is contemporary with this part of the building and provides a possible date for the structure.

**Figure 7** Pit [27] showing relationship with the southernmost wall of building (foreground).

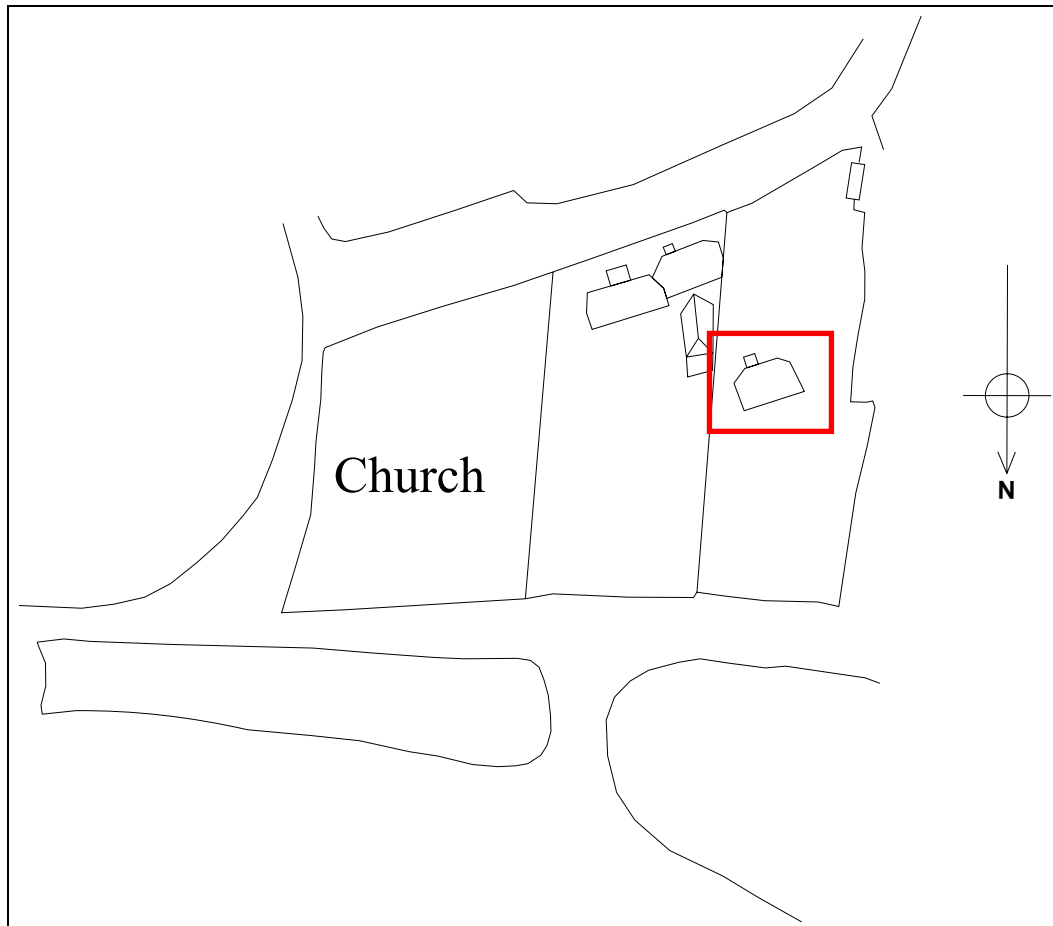
**Figure 8** 1635 Estate Map.  
(Drawing derived from the original map, too poor to reproduce)

The earliest available map dates from 1635 (Figure 8), and appears to show a building within the proposed development area. As the plan also appears to show a chimney the building is likely to be a domestic building. The location of this building matches the location of the excavated building. Unlike the building uncovered during the excavations, the building on the map appears to have a central chimney or possibly a chimney on the right of the building only, in which case, it is possible it may not be the excavated building. However in view of the very schematic nature of this plan the chimney position should be treated with caution.

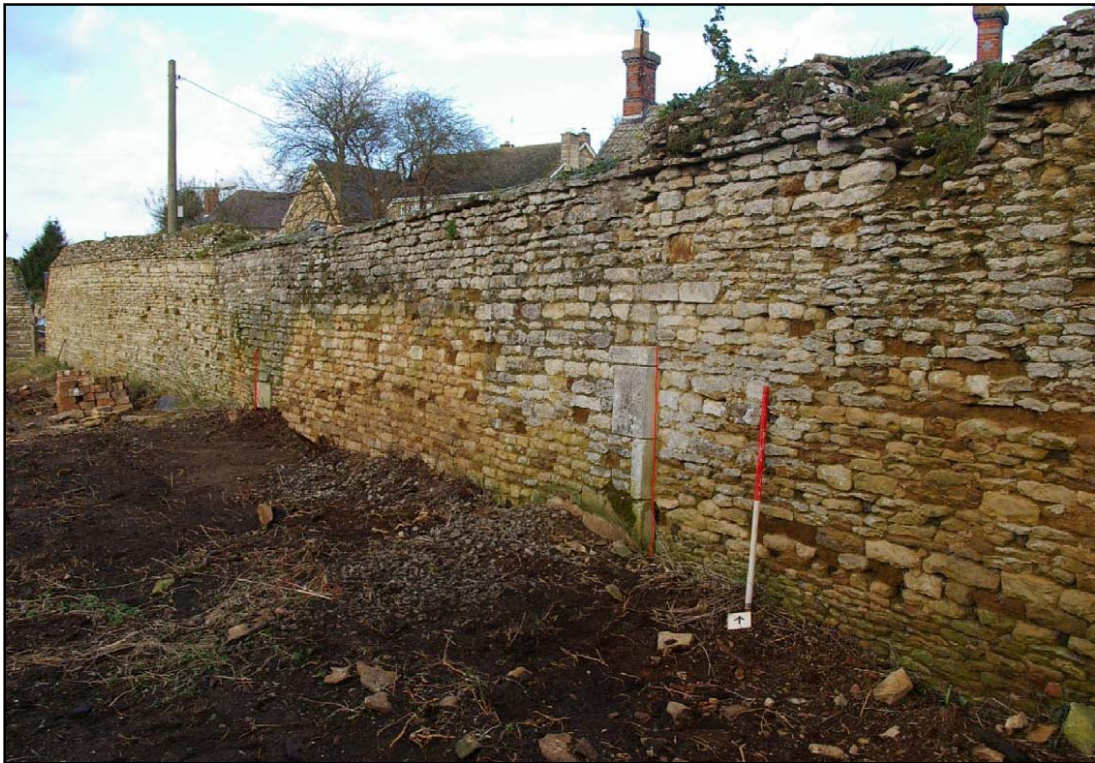
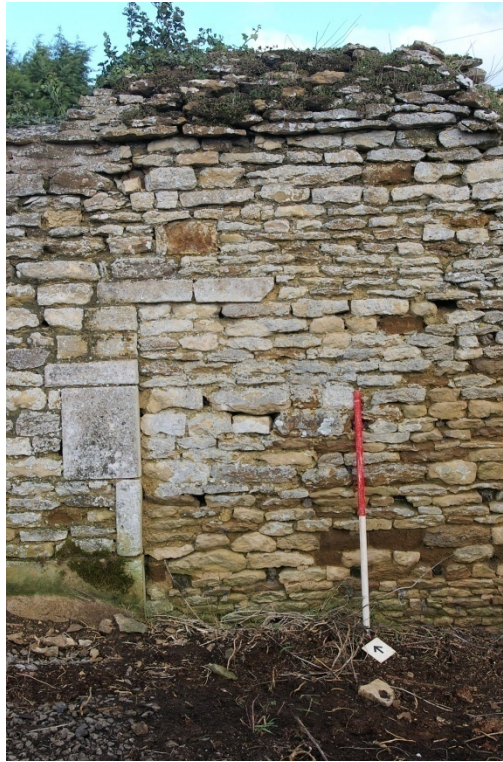
The northernmost wall only contained limited evidence of a single building (*Building 1*, Figure 13). Two short sections of quoin work, reaching approximately one metre above the current ground level (Figures 14 & 15); approximately 8 metres apart indicate the likely location of a building recorded on the tithe map of 1847 (Figure 10). The stonework consisted of coursed shaped lias limestone while the quoins are in contrasting oolitic limestone; the iron oxide in the lias causes it to weather to a golden brown colour while the oolite weathers to a creamy grey colour. There is no evidence of the building on the north-facing elevation of the wall, suggesting that this elevation has been re-faced.

**Figure 14** Building 1 Visible in the northernmost wall.

**Figure 15** Building 1 Detail of easternmost quoin work.

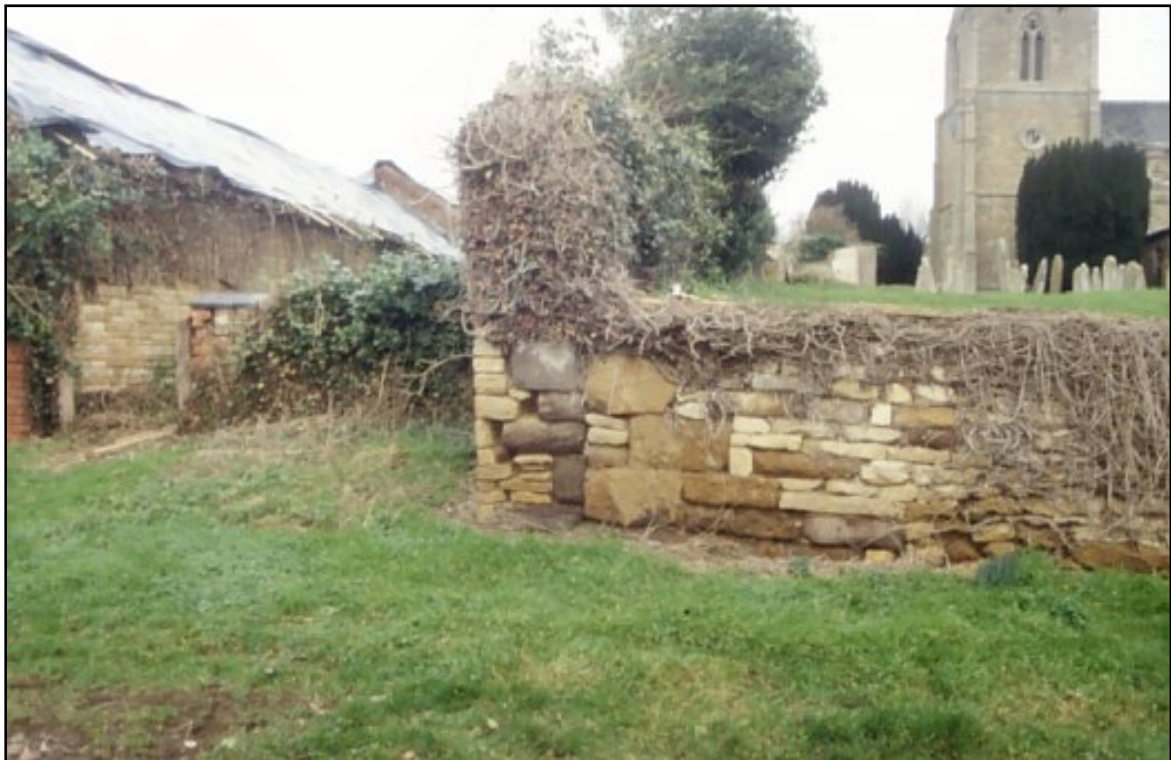
The second building (*Building 2*), again has only limited remains, this time in the south-easternmost corner of the proposed development area (Figure 13). Once again it is only the quoin work which survives (Figures 16 & 17) and indicates that this part of the boundary wall was indeed a building. The quoins are built of an unusual plum coloured limestone, producing what would have originally been a rather striking effect.

**Figure 16** Building 2 General view from the north.

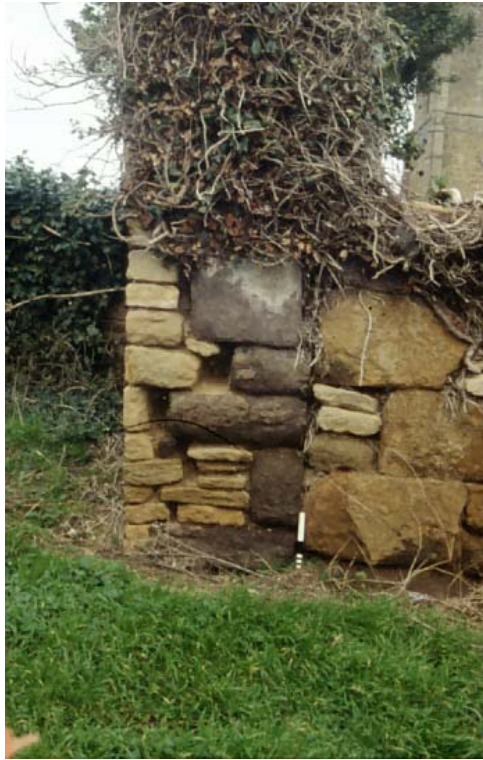
**Figure 17** Building 2 Detail of quoin work.

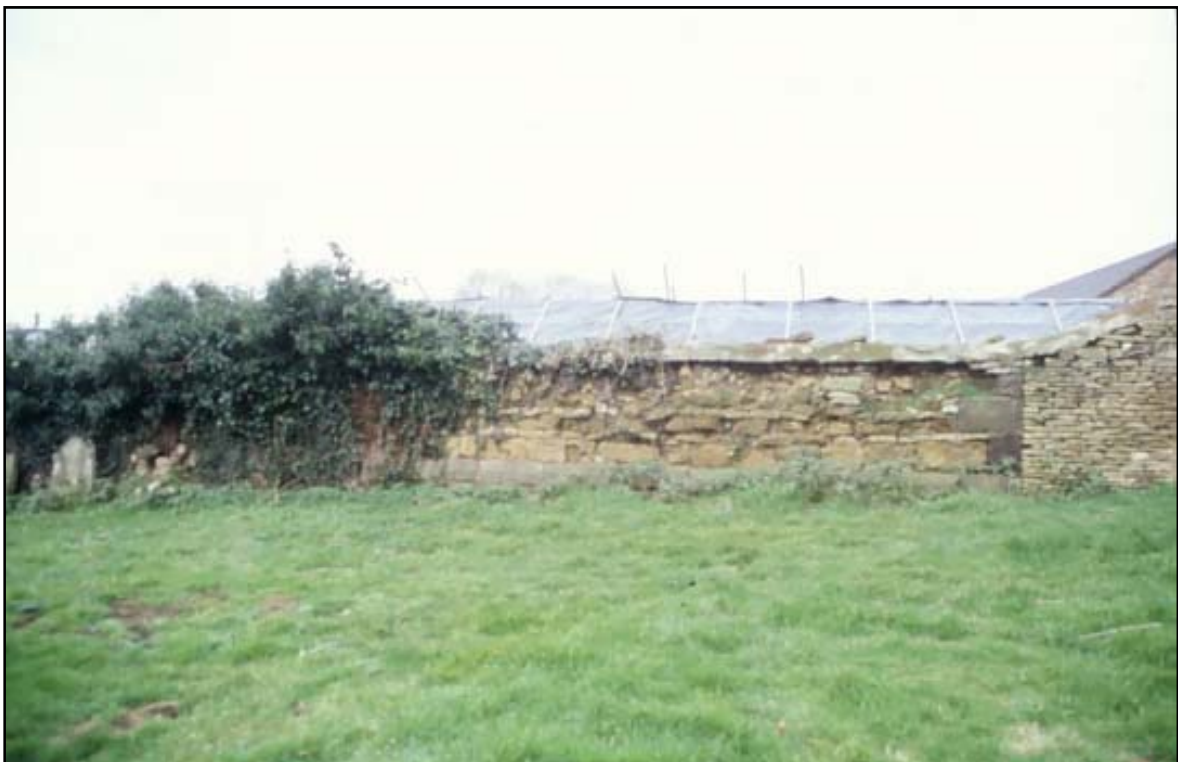
The final building (*Building 3*) within the proposed development area appears to have been the most significant; the remains of the building are located in the easternmost boundary wall with All Hallows Church, towards the centre of the plot (Figure 13). The most substantial remains are located on the church side of the standing wall (Figure 18) where the remains appear to represent the gable end of what must once have been a rather striking building. The quoin work (Figure 19) was again in the plum coloured limestone, which was also used in an angled stone plinth (Figure 20), approximately 150mm above the current ground level. Polychrome banding of limestone and ironstone has been used for the rest of the building stone. David Smith (1992) suggests that the practice of using the two types of stone decoratively began in the early 17th century, providing a tentative date for this building.

**Figure 18** Building 3 General view (looking west)

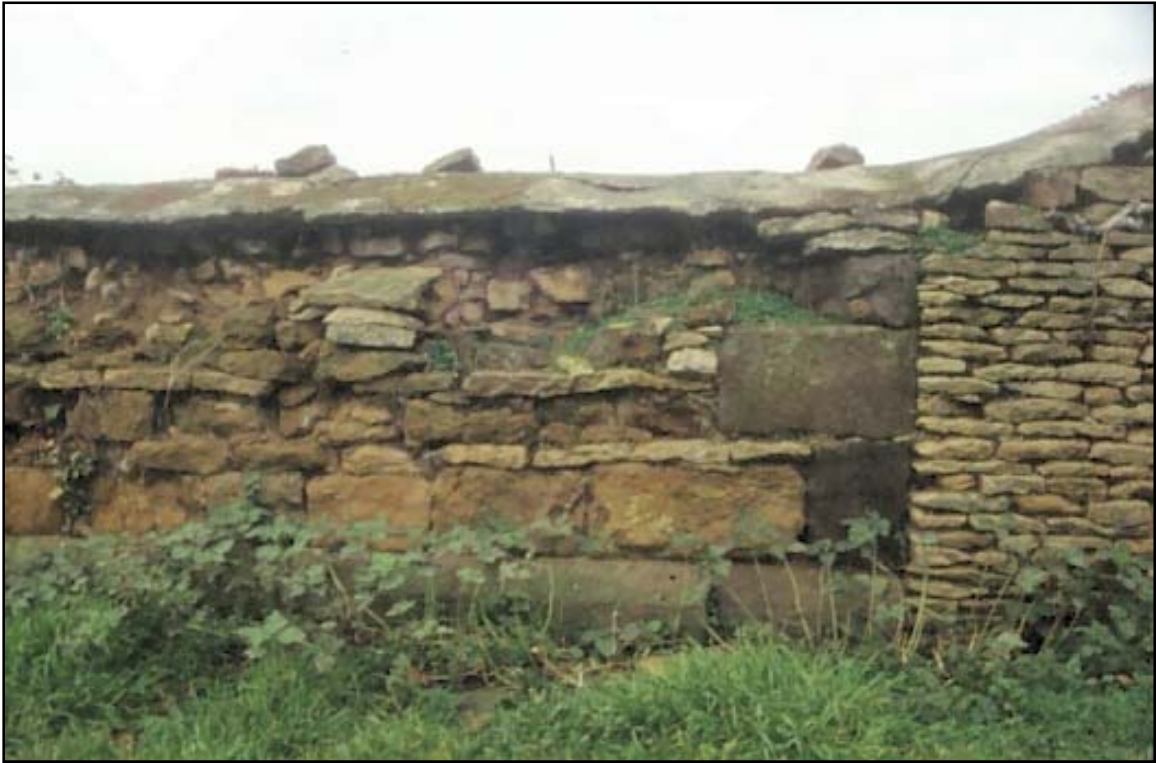
**Figure 19** Building 3 Detail of quoin work and banding.

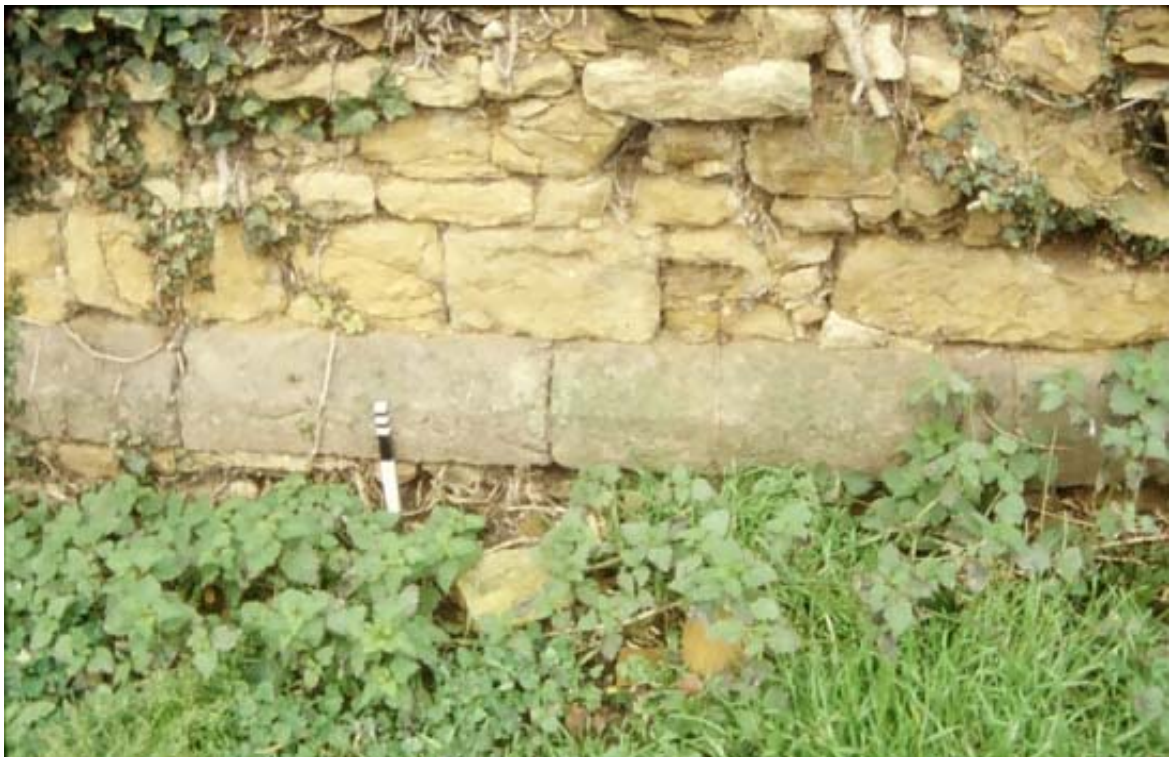
**Figure 20** Building 3 Detail of plinth.
