**A Photographic Record of The Bath  
Hotel, Shearsby, Leicestershire  
(SP 622 902)**

**Planning Application No. 01/1469/3**

**For Corporate Architecture Ltd**

University Of Leicester  
Archaeological Services

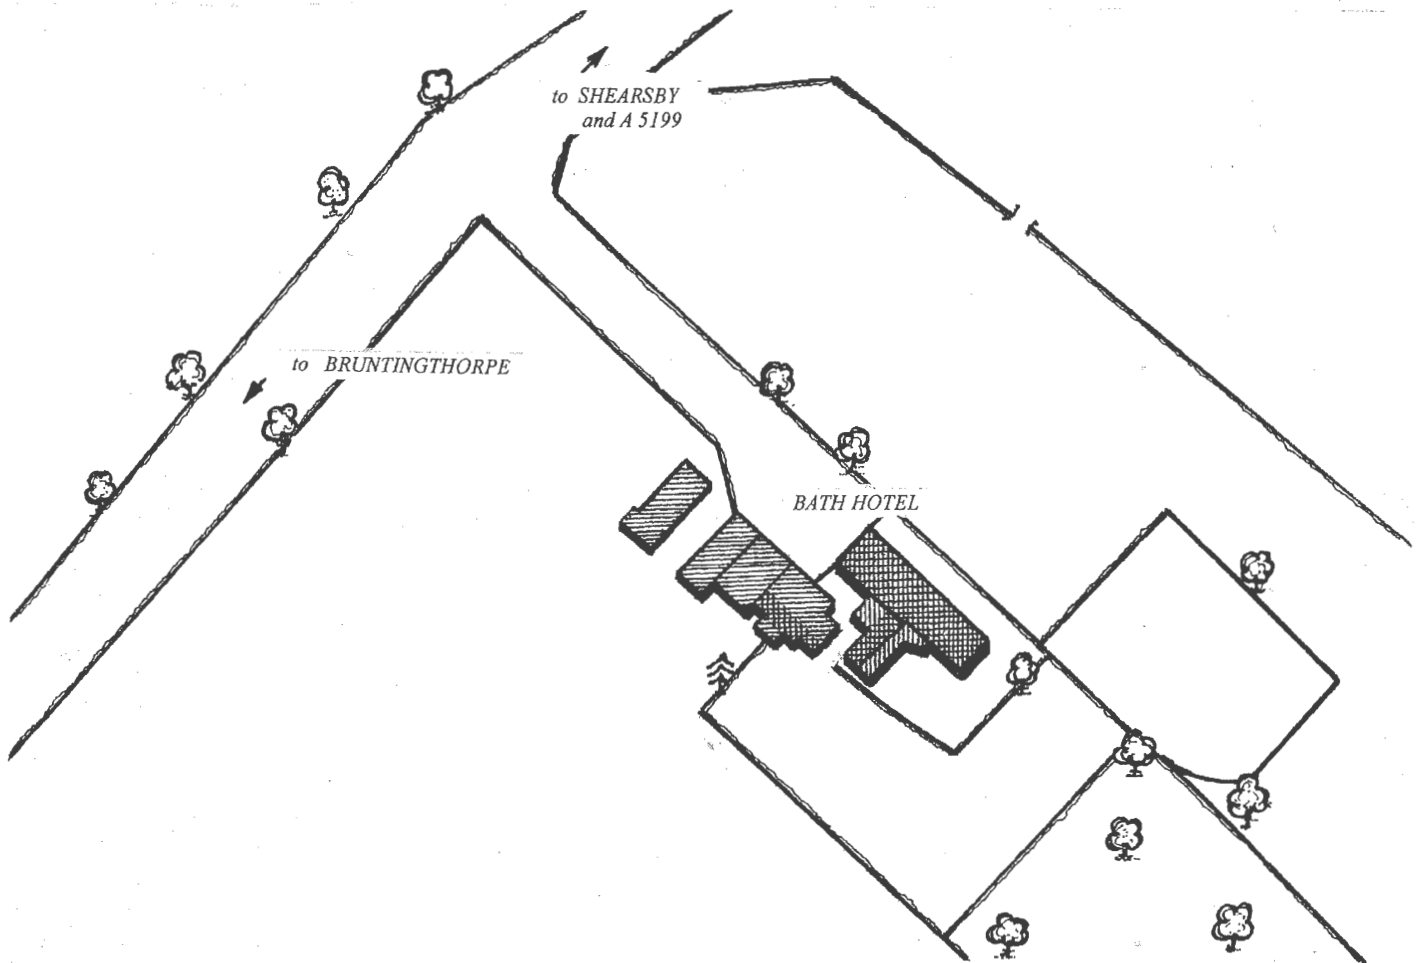
**Fig. 2 Site: Bath Hotel, Shearsby – based on 1<sup>st</sup> edn 25" Ordnance Survey map (1886), showing Bath Hotel and associated outbuildings. Cross-hatched areas indicate features surviving to present day.**

Early editions of the 25inch, Ordnance Survey Maps, show a two buildings lying at right angles against the west elevation of the 18<sup>th</sup> and 19<sup>th</sup> century buildings forming the Bath Hotel, (see Fig.2)<sup>8</sup> The palimpsest of a building can be identified in the brickwork of the west elevation of the 19<sup>th</sup> century build and the single storey, pitched roof building now engulfed by later additions and extensions appears to be a remnant of this group of buildings. However no confirmatory evidence could be found as the remnants of walls of this surviving building had all been re-plastered.

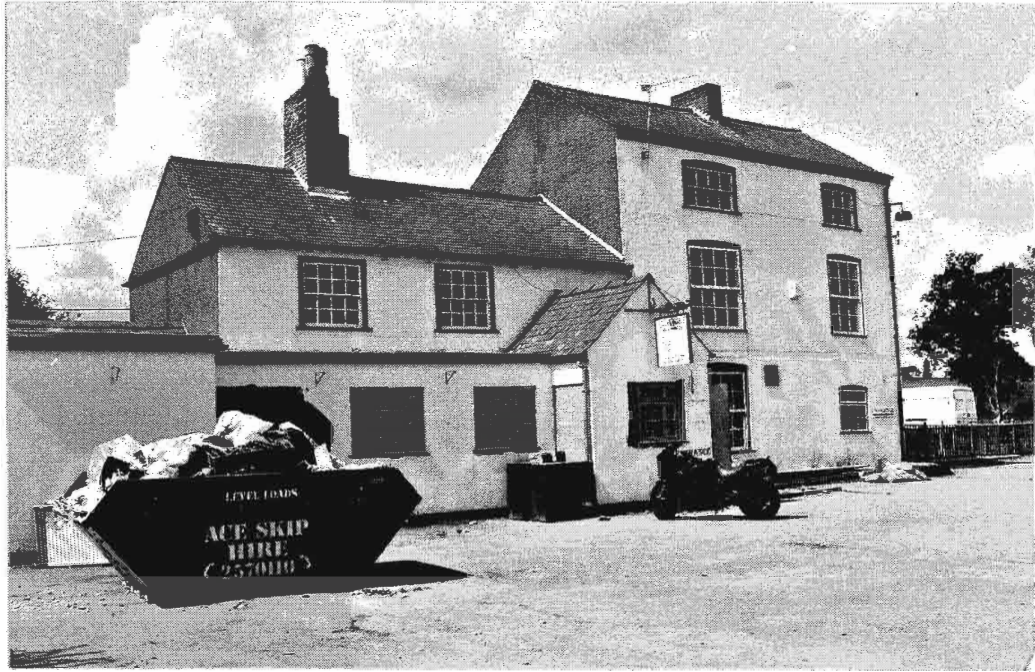
*Plate 1 (above) Bath Hotel - view from the south-east. Principal elevation showing late 18<sup>th</sup> and early 19<sup>th</sup> century phases of building. The 18<sup>th</sup> century section (left) is of two bays with the entrance passage, the later 19<sup>th</sup> century three-storey, two bay section, was probably an addition to accommodate visitors to the spa. The entry porch and front passageway are late 20<sup>th</sup> century additions.*

The earliest surviving part of the **Bath Hotel** complex consists of a two storey, two-bay, brick built fragment of a late 18<sup>th</sup> century, post-Enclosure farmhouse, i.e. post-1774. The brickwork of the front wall of this building is raised in Flemish Bond, (see Plate 8) and there is a dentil course at the eaves. The south gable of the building has been rendered and the brickwork of the rear, west elevation, was not sufficiently distinct to identify clearly. The roof of this 18<sup>th</sup> century building is of Welsh slate, (see Plates 5 and 8), indicating it has been re-roofed at some stage during its history, as Welsh slate does not appear on Leicestershire buildings until the second quarter of the 19<sup>th</sup> century. Two, eight-over-eight paned, sash windows of the original house are retained at first floor on the east elevation. On the rear elevation the windows appear to be late 19<sup>th</sup> or early 20<sup>th</sup> century replacements for the original series. This 18<sup>th</sup> century building also contains part of a ground floor passageway near its northern end. A later entry porch set on the east elevation of the building, (see Plates 1, 2, 3), now conceals the original entrance door. Characteristic of much rural building of its time this farmhouse was only one room deep and would appear to have originally been a linear arrangement of three bays with a passageway forming the characteristic, Midland farmhouse plan type of two bays : passageway : one bay, an arrangement which first appeared in the medieval farmsteads and was carried over into the post-medieval, brick building tradition of the late 17<sup>th</sup> and 18<sup>th</sup> centuries. The surviving two bays of this building are set either side a centrally located chimney that shows evidence of having been modified on several occasions and has lost all diagnostic details at ground floor level, (see Plate 5). Most of the entrance passage which relates to this earliest phase of building, c 1774, has been obliterated by later alterations at ground floor.

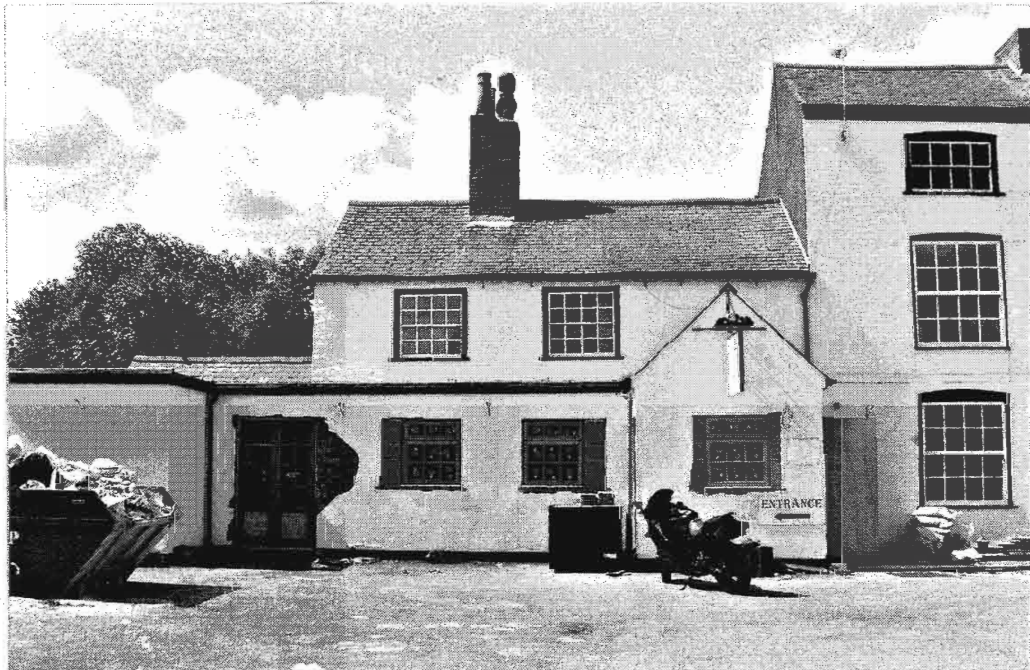
*Plate 2 (below) Bath Hotel - view showing 18<sup>th</sup> century section of building, modern entrance porch and passageway.*

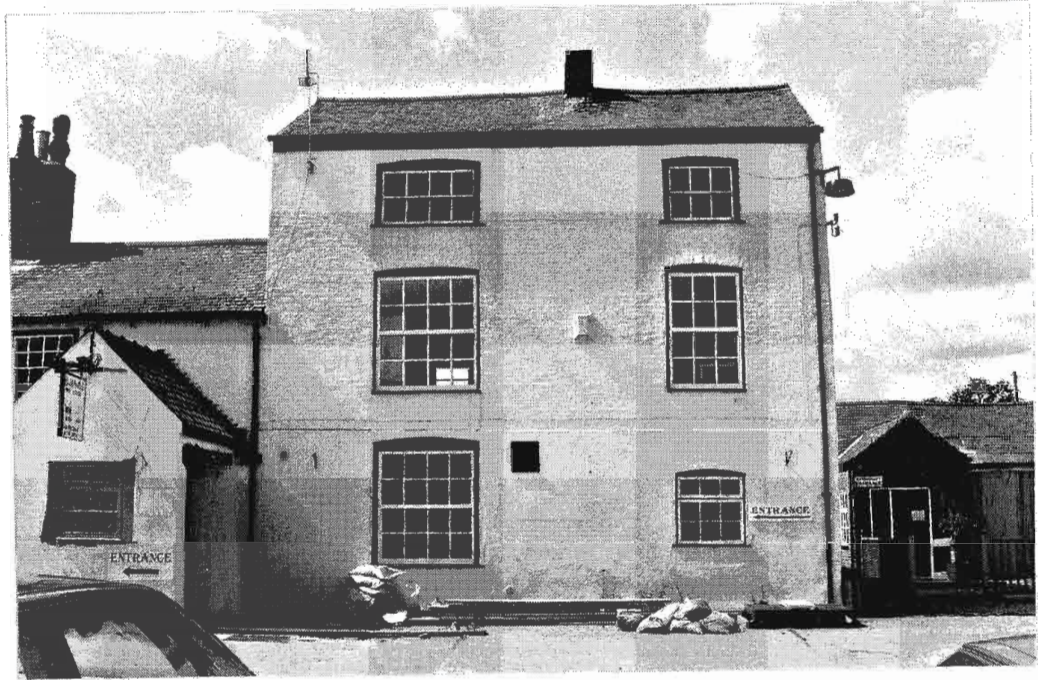
*Plate 3 (above) - view of Bath Hotel from east showing early 19<sup>th</sup> century, principal elevation with five of original six windows.*

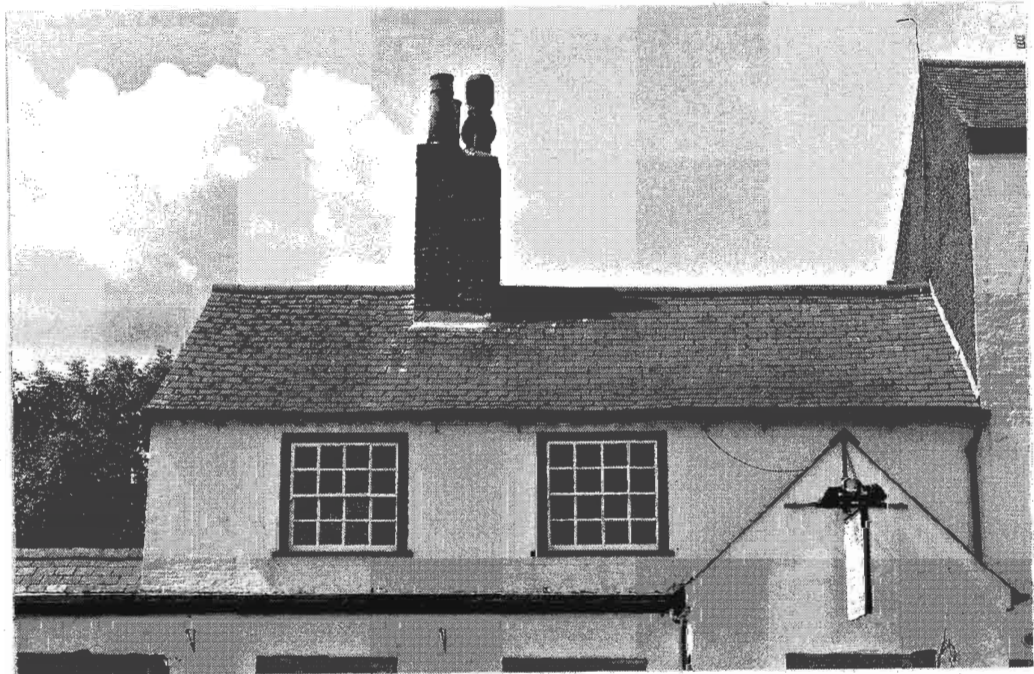
*Plate 4 (below) detail of first floor elevation of 18<sup>th</sup> century build, also showing a much altered chimney stack in this part of the building.*

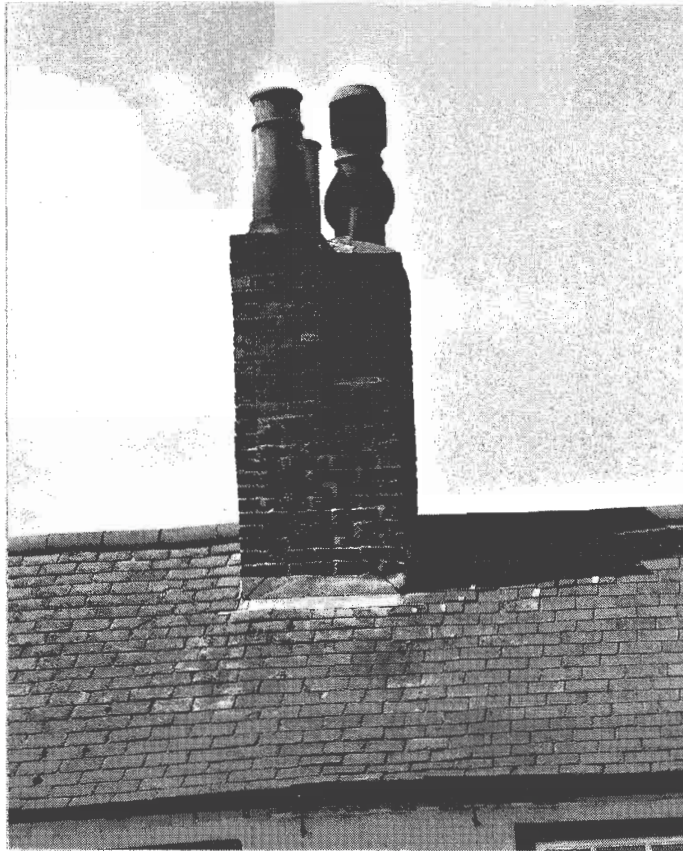
*Plate 5 (above) detail of altered chimney stack in 18<sup>th</sup> century part of building, also shows Welsh slate roof, also shows dentil course of brickwork at eaves.*

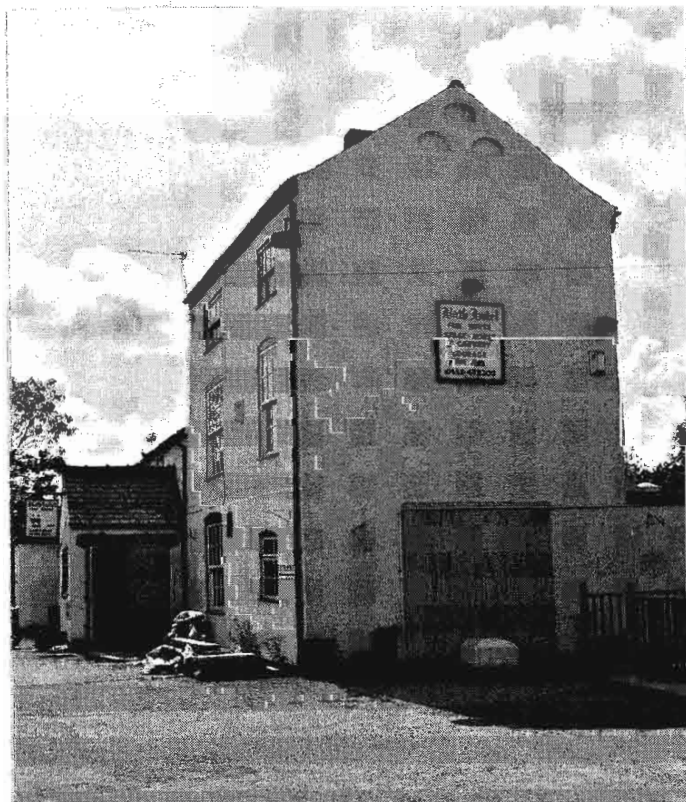
*Plates 11, 12 Detail view of the 19<sup>th</sup> century north gable of Bath Hotel showing the three recesses which may originally have been bee-boles.*

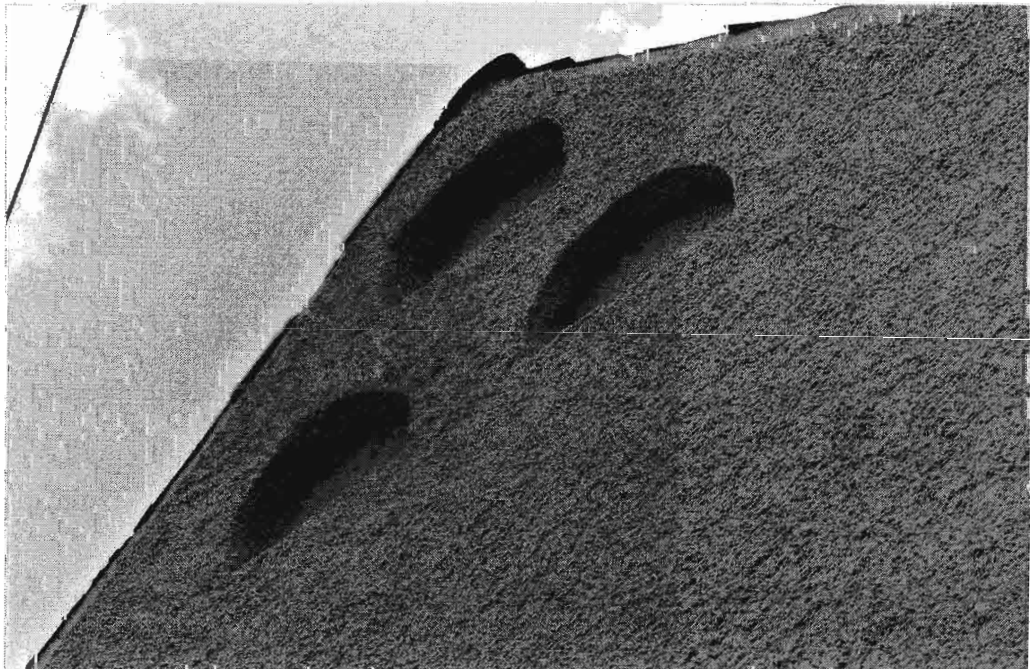
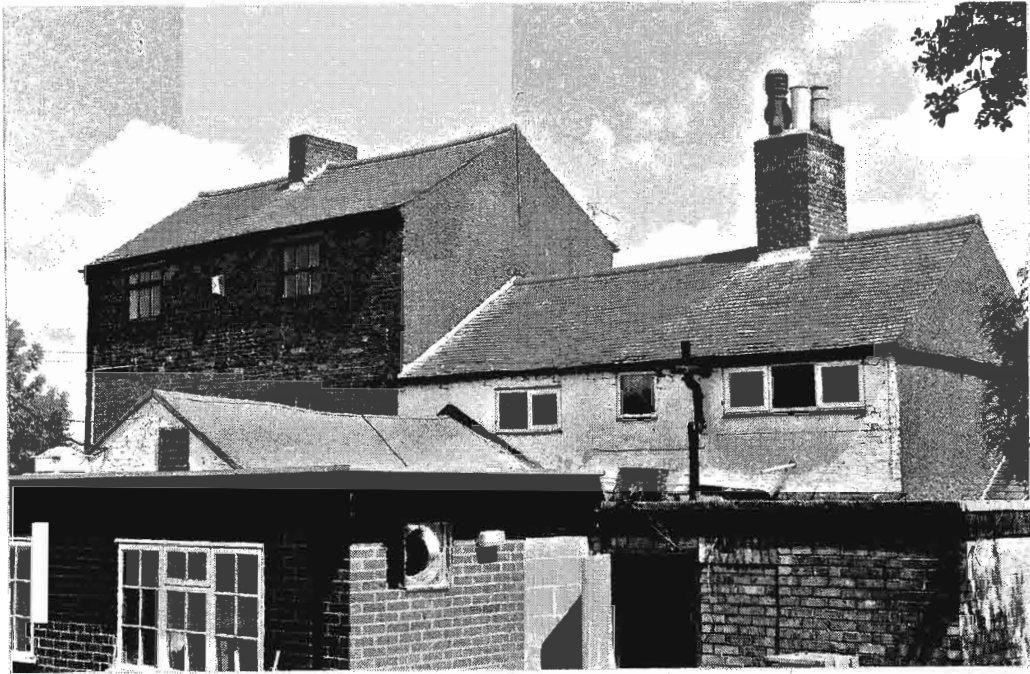
*Plates 13, 14 Views of the west elevation of the Bath Hotel showing the extensive infill. The two pitched roofs belong to earlier buildings that were part of the original farmstead.*

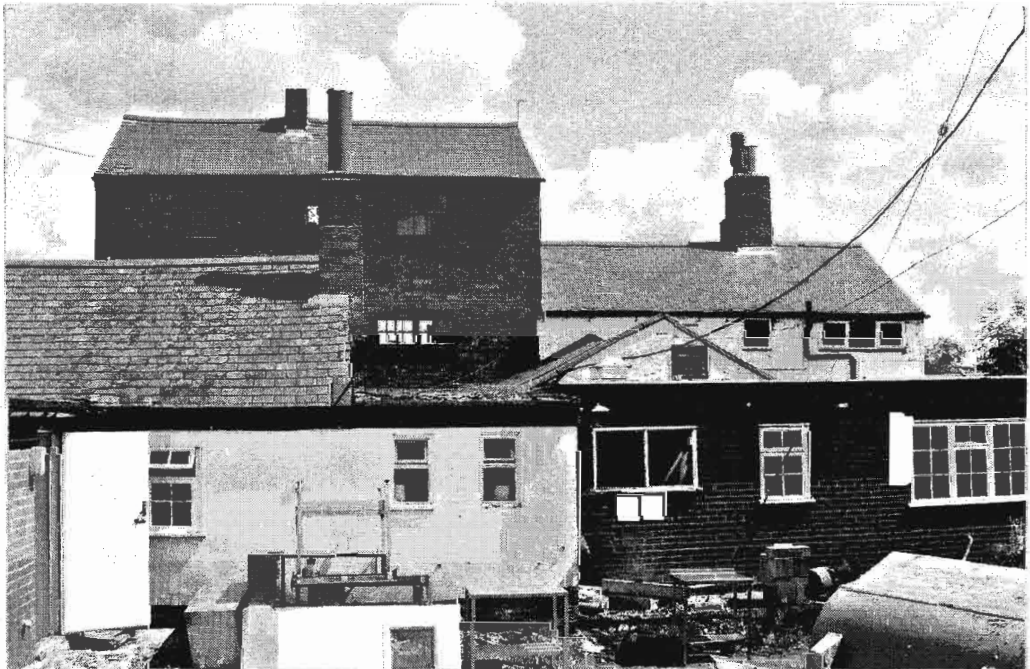
**Plate 15** Detail of 19<sup>th</sup> century building's west elevation, showing three-over-three paned, sash window at second floor and segmental arched window at first floor. Also shows Flemish garden Wall Bond of this elevation. The gable palimpsest, part of which can be seen in this photograph appears to be part of a now demolished building shown on early Ordnance Survey maps.

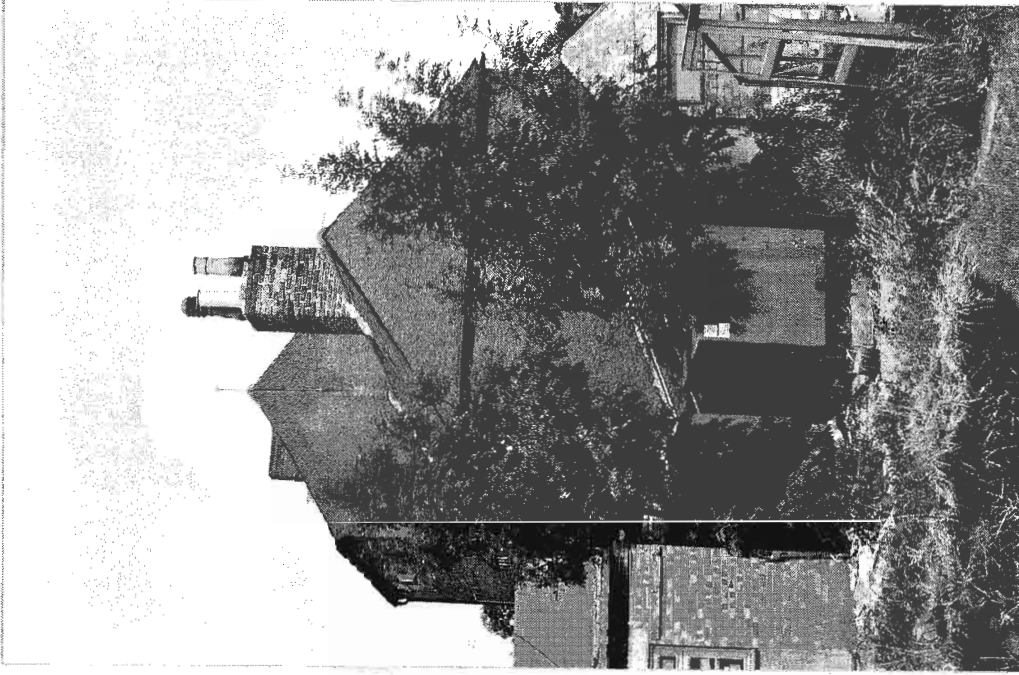
**Plate 16** The Bath Hotel, view from south-west showing rendered gables of the 18<sup>th</sup> and 19<sup>th</sup> century buildings.

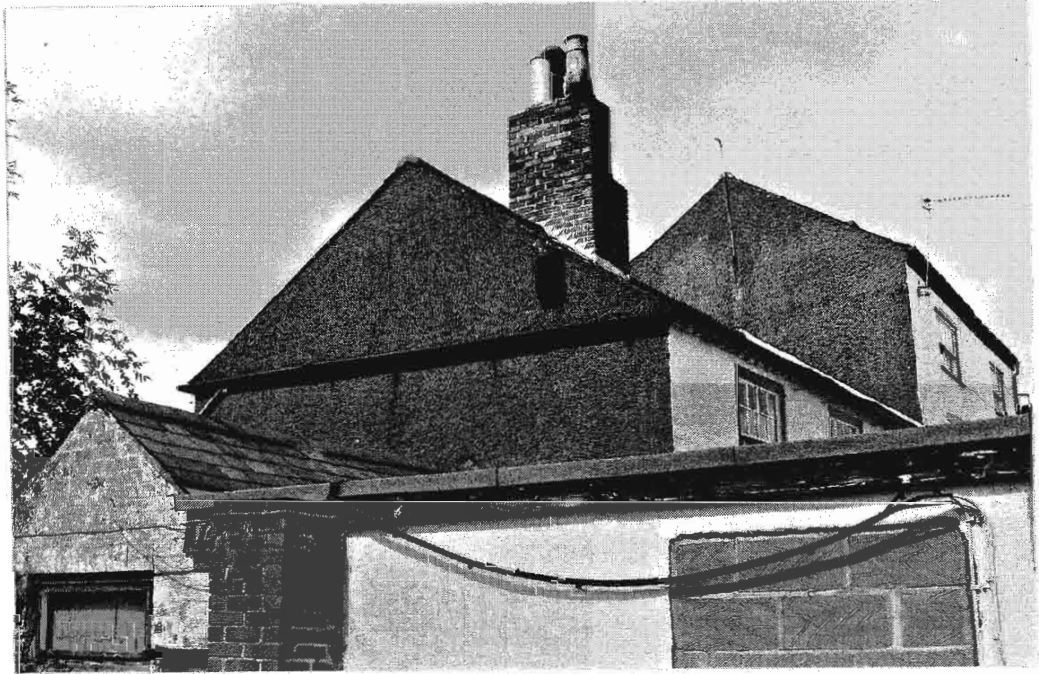
*Plate 17 (above) view from south-east showing rendered gables of the 18<sup>th</sup> and 19<sup>th</sup> century builds with the 20<sup>th</sup> century additions in foreground.*

At the south end of the 18<sup>th</sup> century section of the building a single storey brick extension with pitched, slate roof has been added sometime during the first half of the 20<sup>th</sup> century. This appears to have served as a store for the licensed premises.

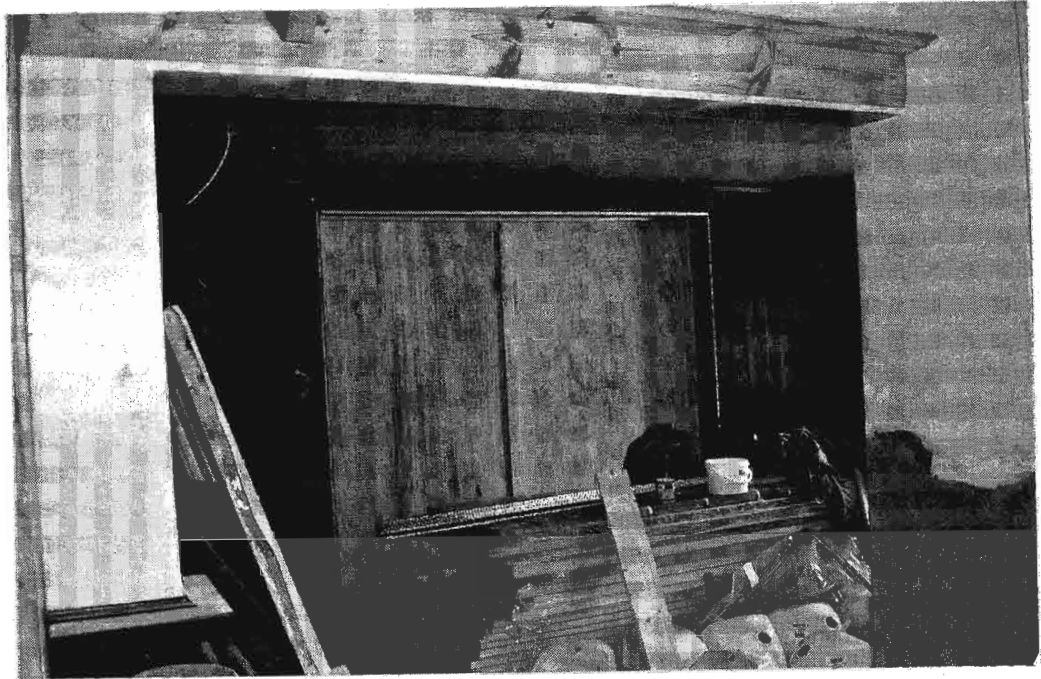
*Plates 21, 22 General views of Ground Floor of 19<sup>th</sup> century building, looking into original yard space subsequently filled by later buildings and now in process of refurbishment for restaurant use. All wooden shelves and beams shown in this series of Plates, i.e. 19 – 26, and 28 - 32 have been cleaned by sandblasting or a similar radical cleaning process.*

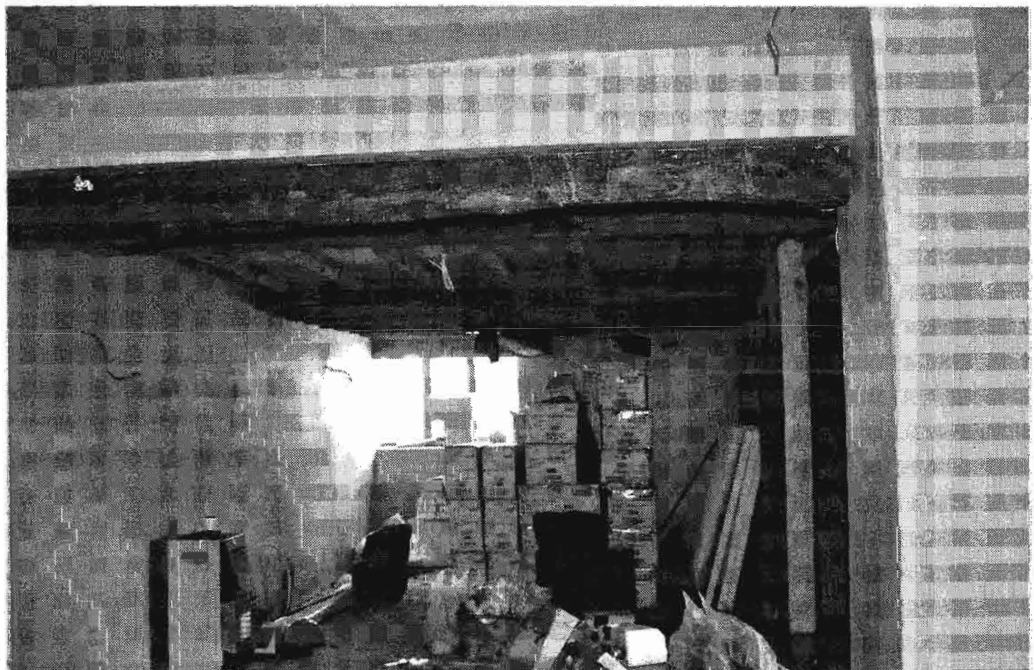
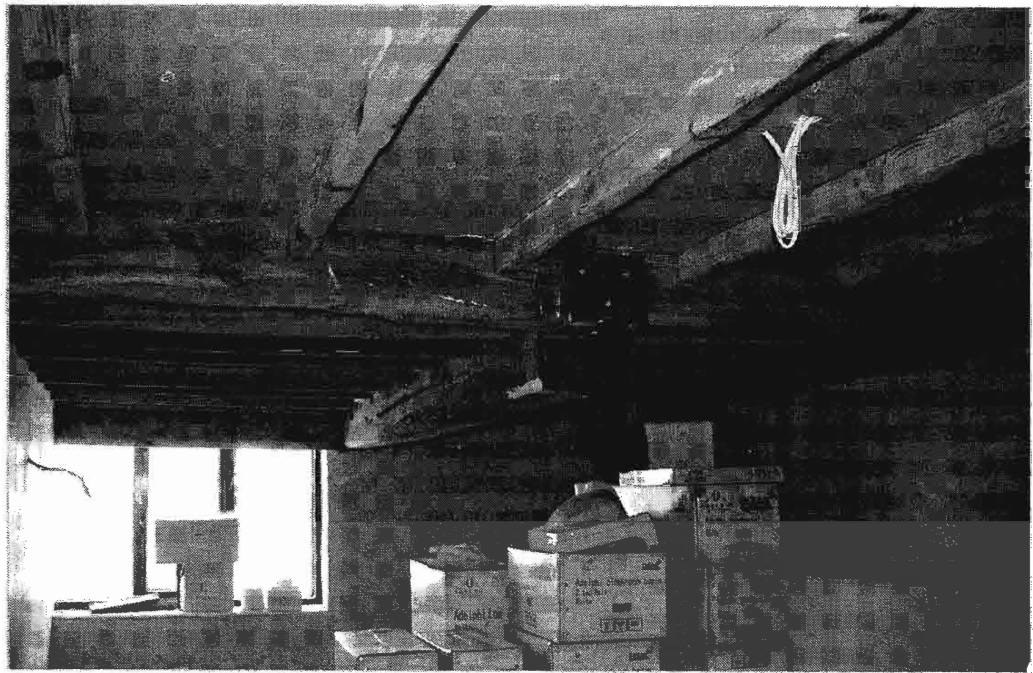
*Plates 23, 24 View of Ground Floor ceiling of 19<sup>th</sup> century building, with re-used material, (above). (Below) first floor structure of 19<sup>th</sup> century build with re-used beam and joists visible.*

A second pitched roof building, having a chimney at its south gable, lies at the western edge of the present group of infill buildings within the yard area. This buildings appears to have been part of the earlier range of farmyard buildings, (see Plates 13, 14, 18). At the time of this survey both the buildings with pitched roofs formed part of the range of single storey service, storage and dining facilities of the licensed premises, (see Fig.2), that had expanded considerably during the second half of the 20<sup>th</sup> century. Internally some of these infill units have been fitted out with suitable 'retrieved' materials in the form of timber roof trusses, (see Plates 23, 24, 25, 28, 30 – 32, c10, c11 – 16).

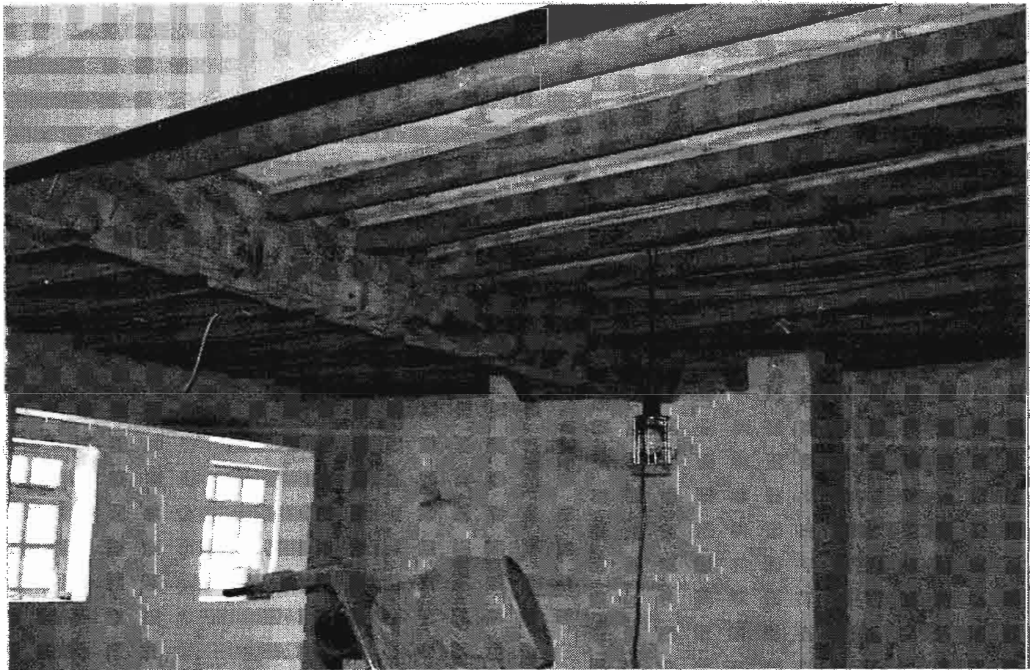
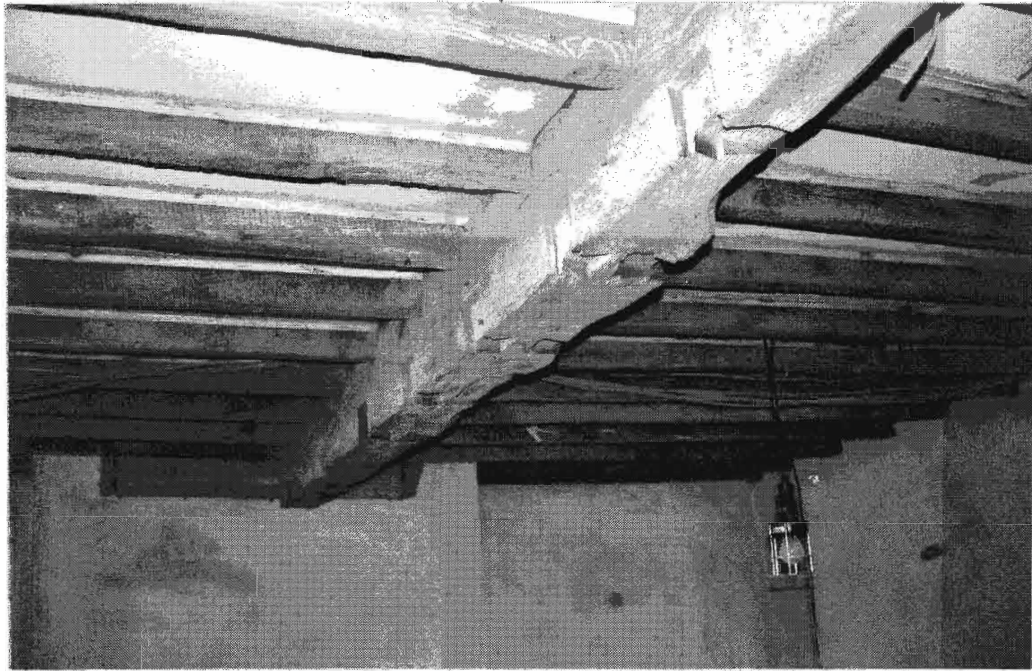
*Plates 25* Detail of ceiling structure at first floor showing re-used beam and joists.

*Plate 26* 19<sup>th</sup> century quarry tile and brick flooring in 18<sup>th</sup> century part of building.

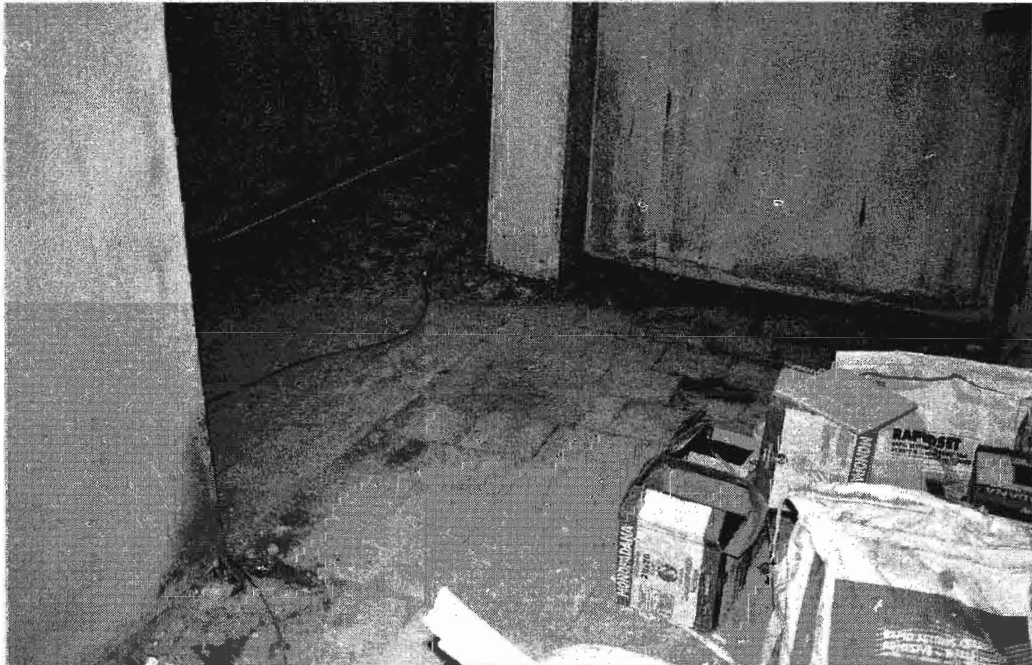
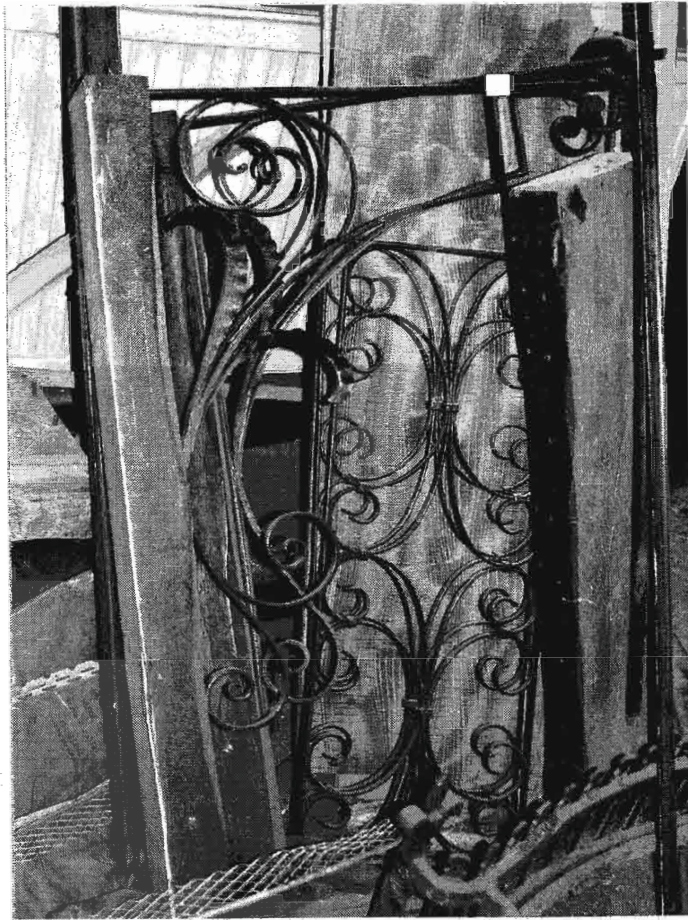
*Plates 27 Wrought ironwork decoration removed from unknown location and stored on the Ground Floor.*

*Plate 28 Re-used floor structure used as ceiling of single-storey building on west side of original farmhouse. All the panelling is 20<sup>th</sup> century.*

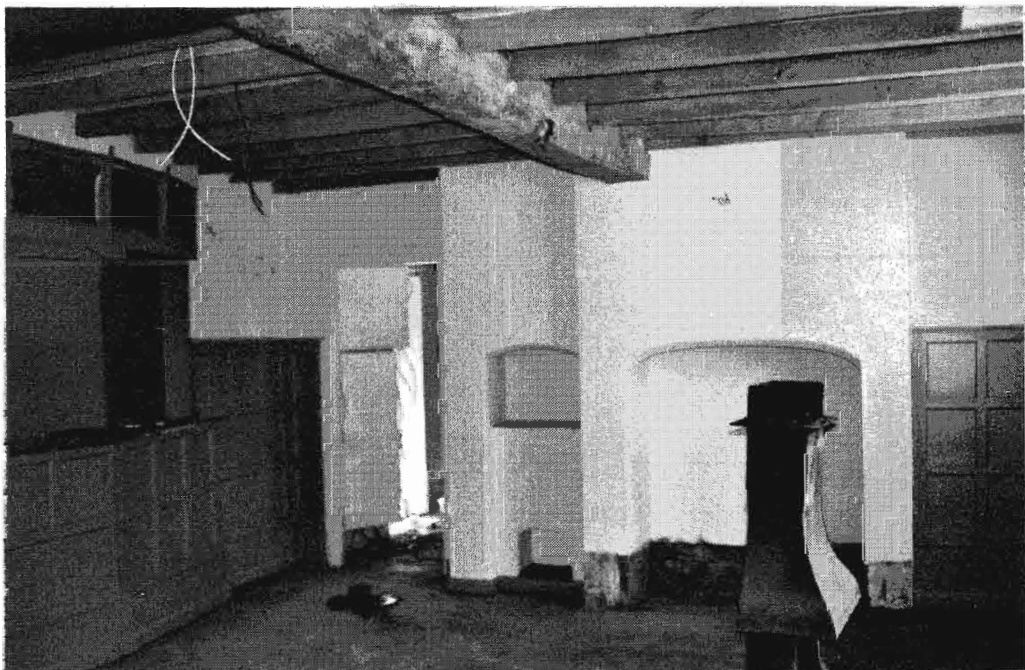
*Plate 29 Modern Bar with 20<sup>th</sup> century panel decoration  
in converted outbuilding area on west side of house.*

*Plate 30 Re-used oak structure in roof of single-storey extension*

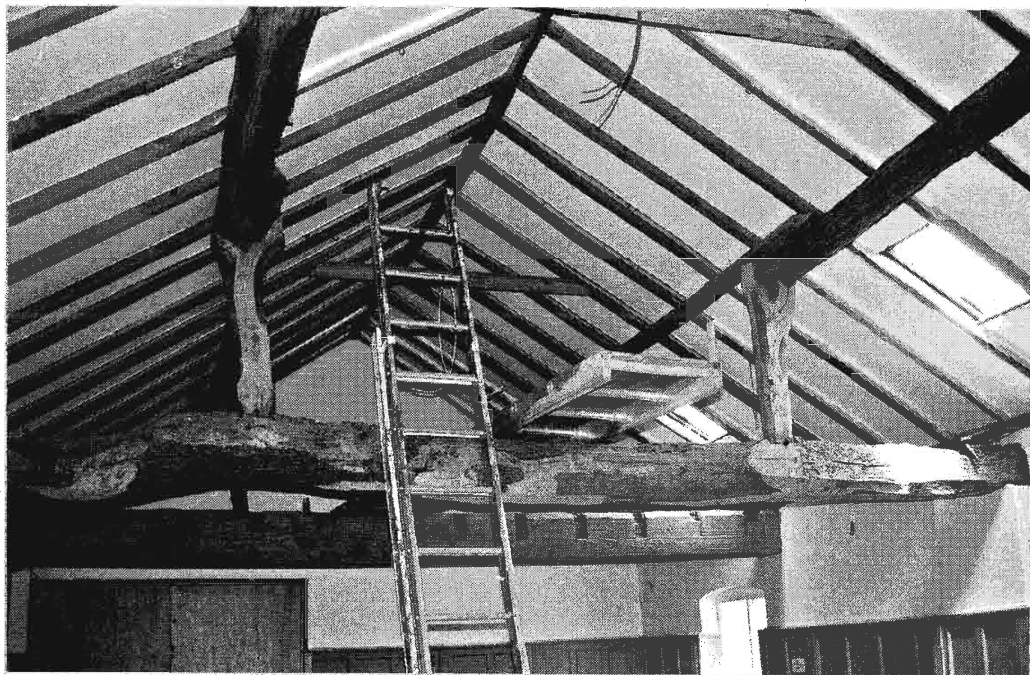
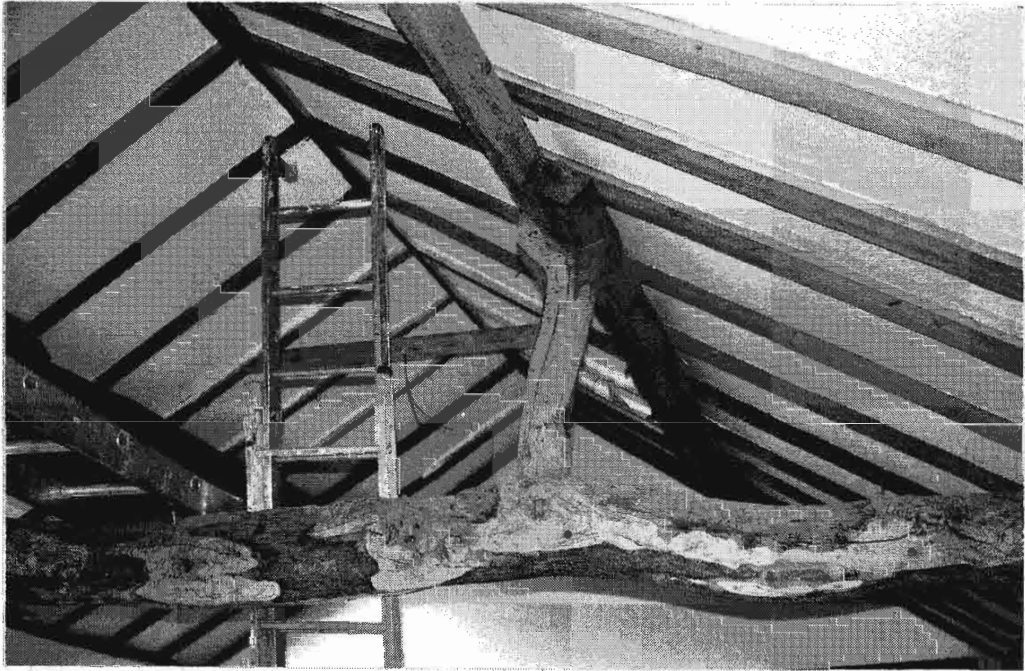
*Plates 31, 32 Re-used oak structure introduced into roof of single storey extension on west side of building.*

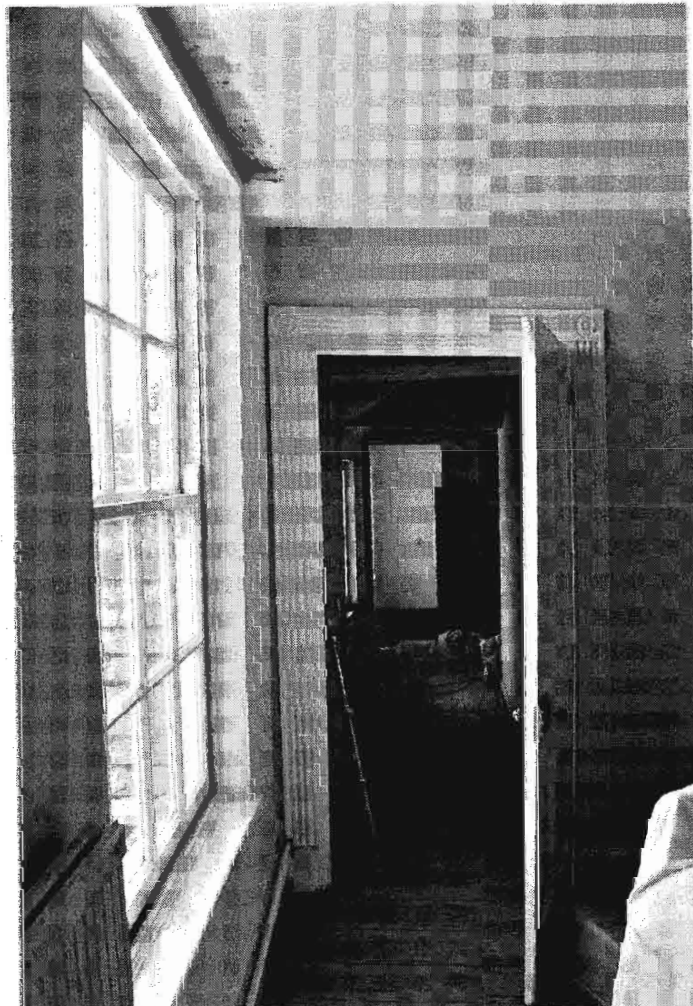
*Plate 39* Detail of first floor ceiling of 18<sup>th</sup> century build showing exposed purlin.

*Plate 40* Exposed section of principal rafter structure in the 18<sup>th</sup> century first floor area of the house.

Some of the roof timbers remained exposed in the first floor areas of this section of the building. In the bathroom area a shallow pitched principal rafter with a trimmed purlin and tie-beam was visible, (see Plates 39, c22), in the adjacent room the partition wall contained a waney edged principal rafter and a cut section of a purlin, (see Plates 40, c23).

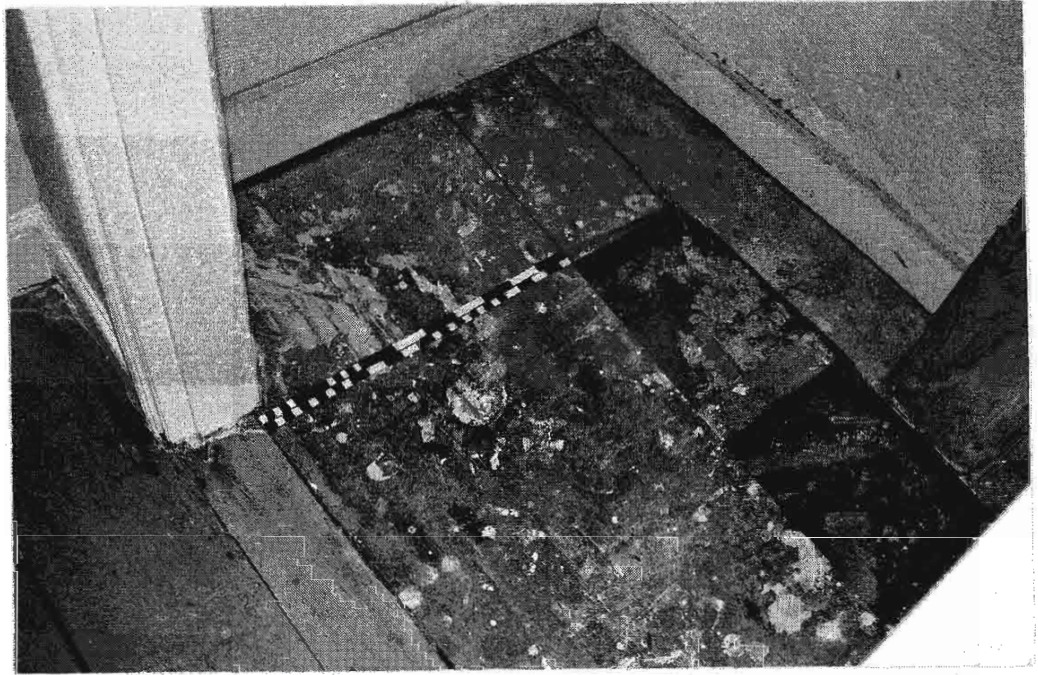
*Plate 41* Wide hardwood floorboarding exposed in cupboard under stairs of 19<sup>th</sup> century first floor.

*Plate 42* second floor window to west of 19<sup>th</sup> century build, see also *Plates 14 and 15*.

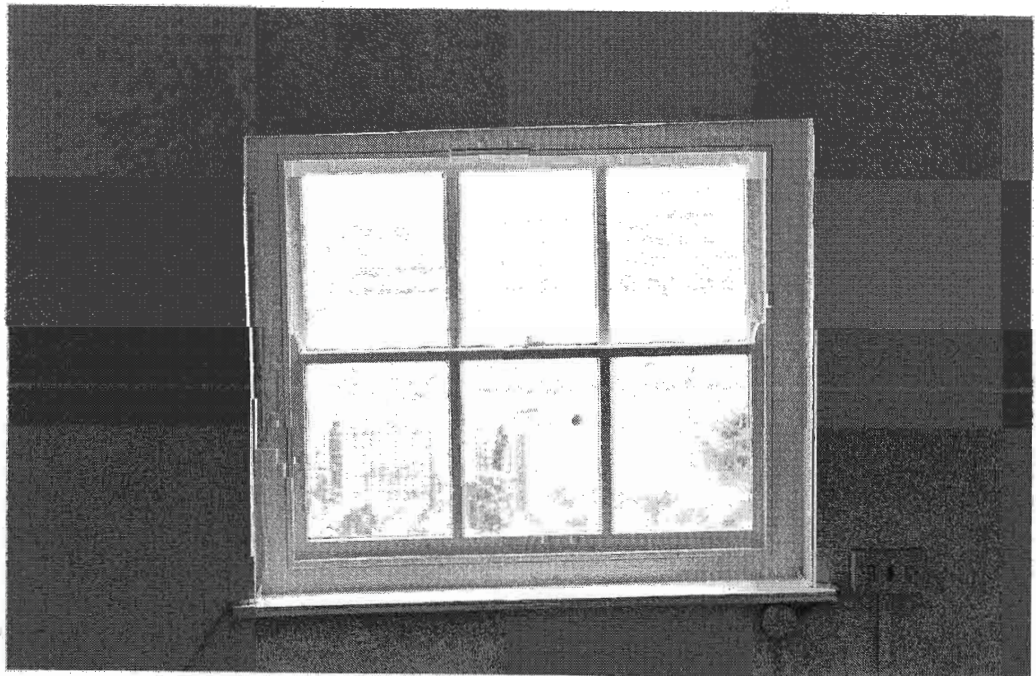
*Plate 43* Second floor east window of 19<sup>th</sup> century build, see also *Plates 1 and 7*

*Plate 44* Staircase leading from first to second floor of 19<sup>th</sup> century build and rising against the south gable.

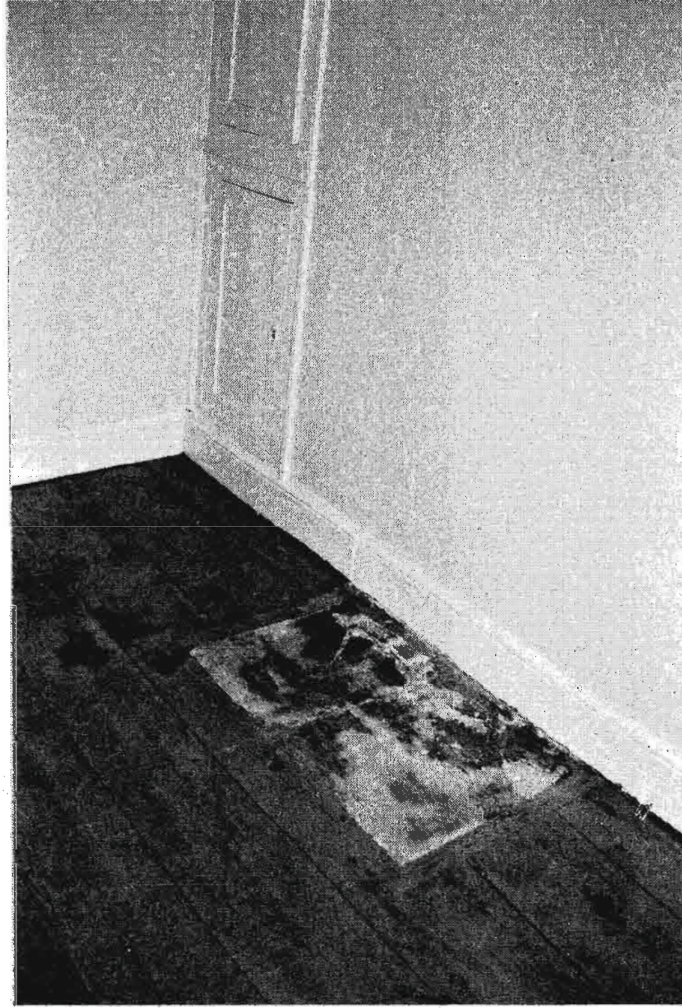
*Plate 47* *Hearth of removed fireplace in second floor, north wall of 19<sup>th</sup> century build.*

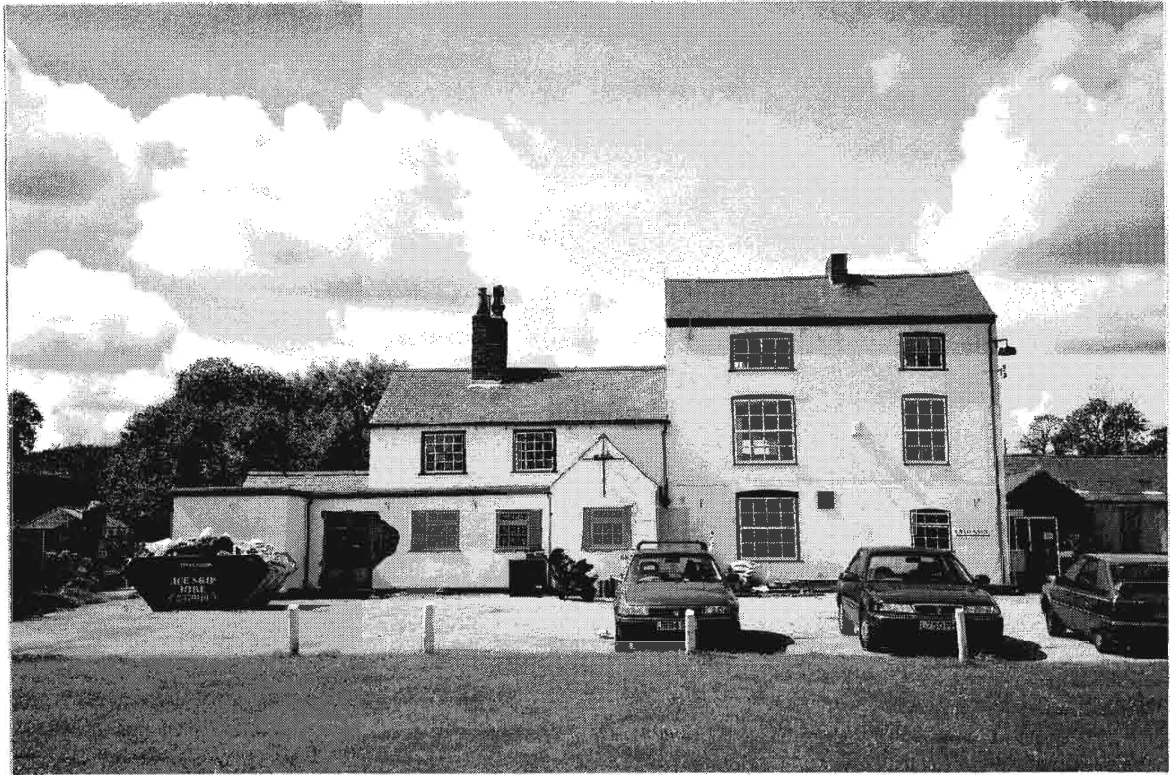
*Colour Plate c1 Front elevation the Bath Hotel showing two storey 18<sup>th</sup> century section and three storey early 19<sup>th</sup> century section with 20<sup>th</sup> century porch and other additions around the 18<sup>th</sup> century build.*

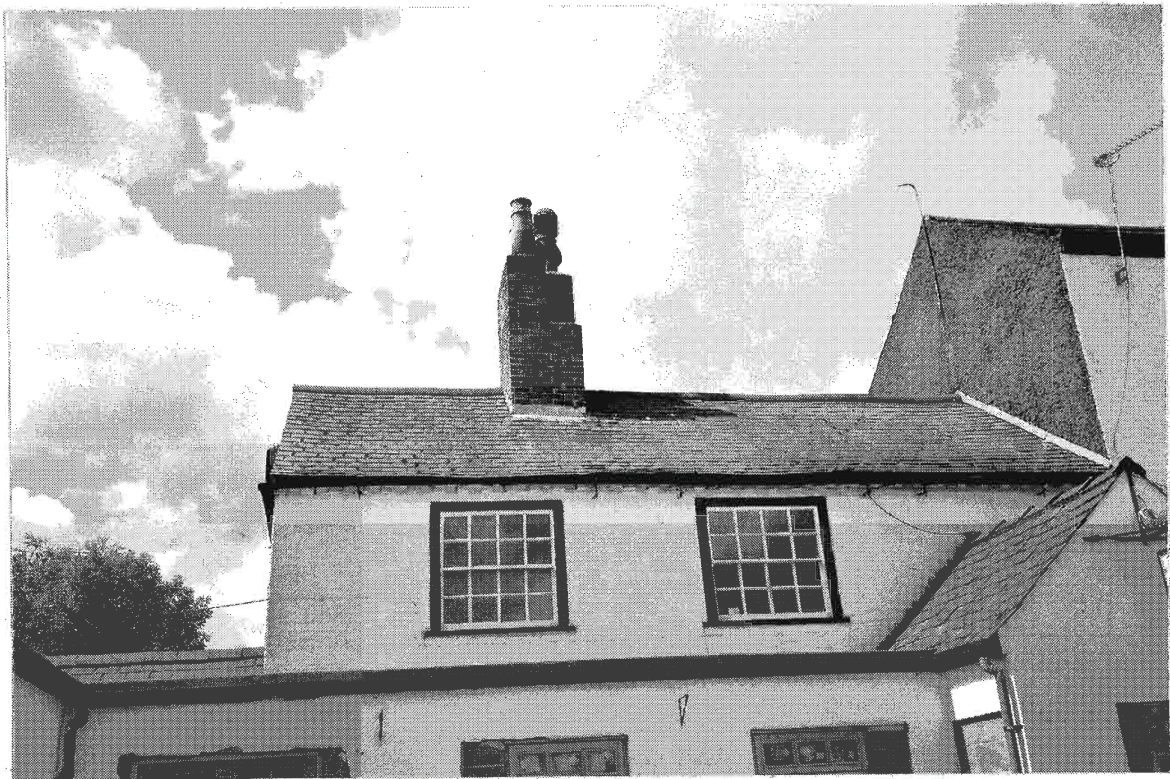
*Colour Plate c3 The Bath Hotel showing early 19 century build from east*
