**A Photographic Record of The Bath  
Hotel, Shearsby, Leicestershire  
(SP 622 902)**

**Planning Application No. 01/1469/3**

**For Corporate Architecture Ltd**

University Of Leicester  
Archaeological Services

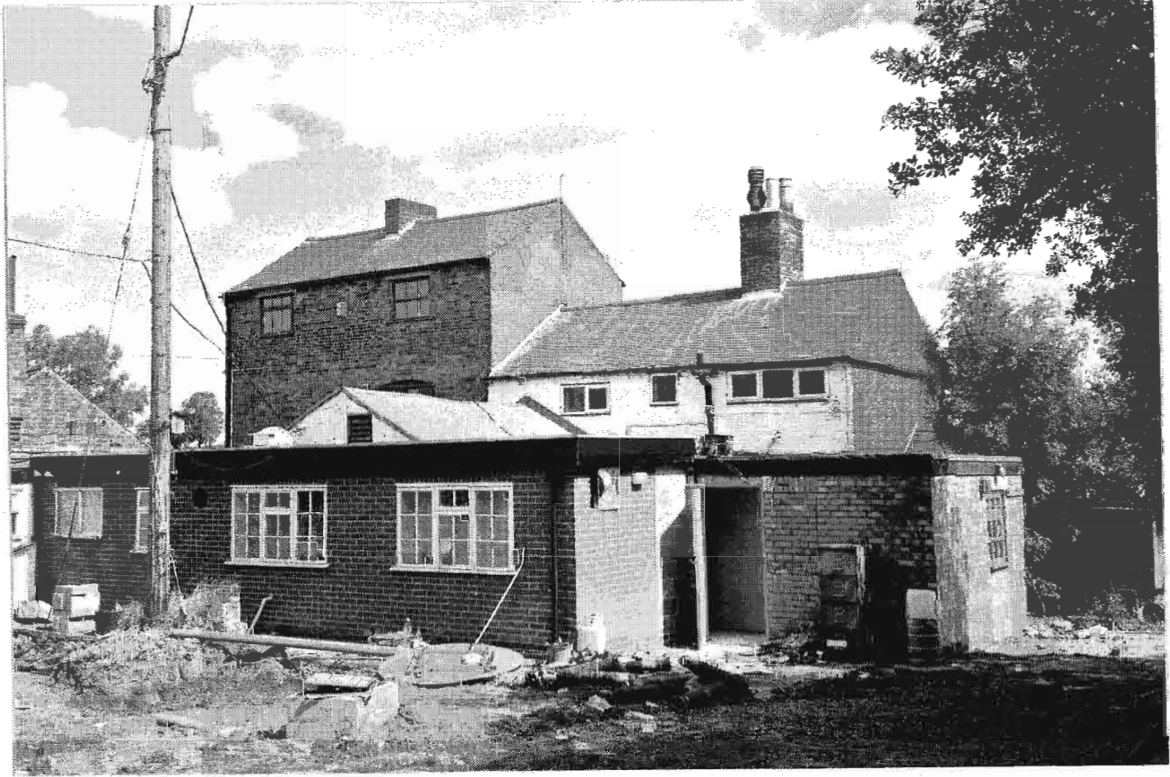
*Colour Plates c5, c6 Single storey 20<sup>th</sup> century extensions lying to the west of the 18<sup>th</sup> and 19<sup>th</sup> century sections of the Bath Hotel. The pitched roofs visible in these two photographs are believed to be part of the earlier, farm outbuilding complex.*

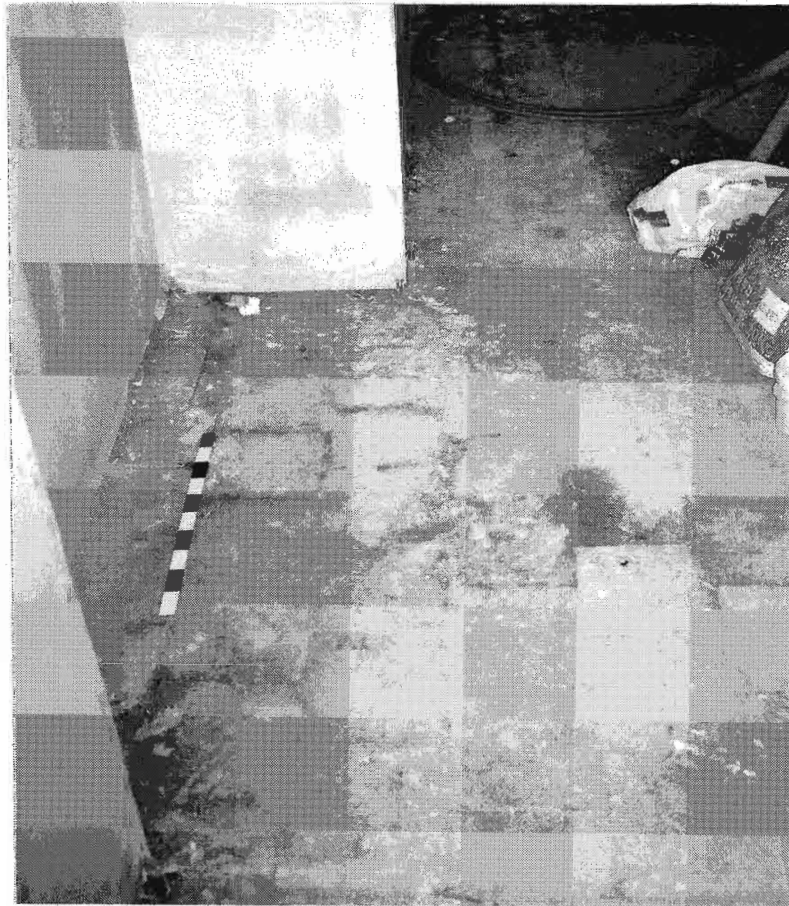
*Colour Plate c9* Ground floor 19<sup>th</sup> century quarry tiling in the 18<sup>th</sup> century part of house.

*Colour Plate c10* Converted outbuilding with ceiling of re-used structural timbers

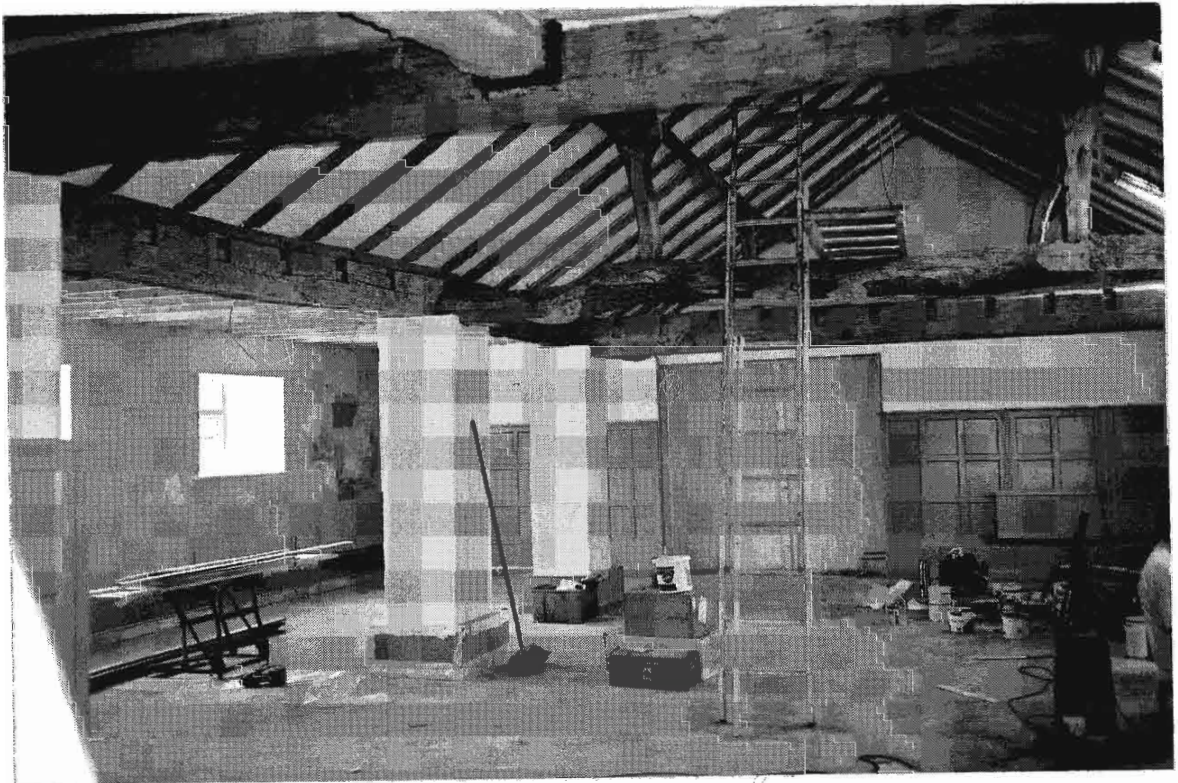
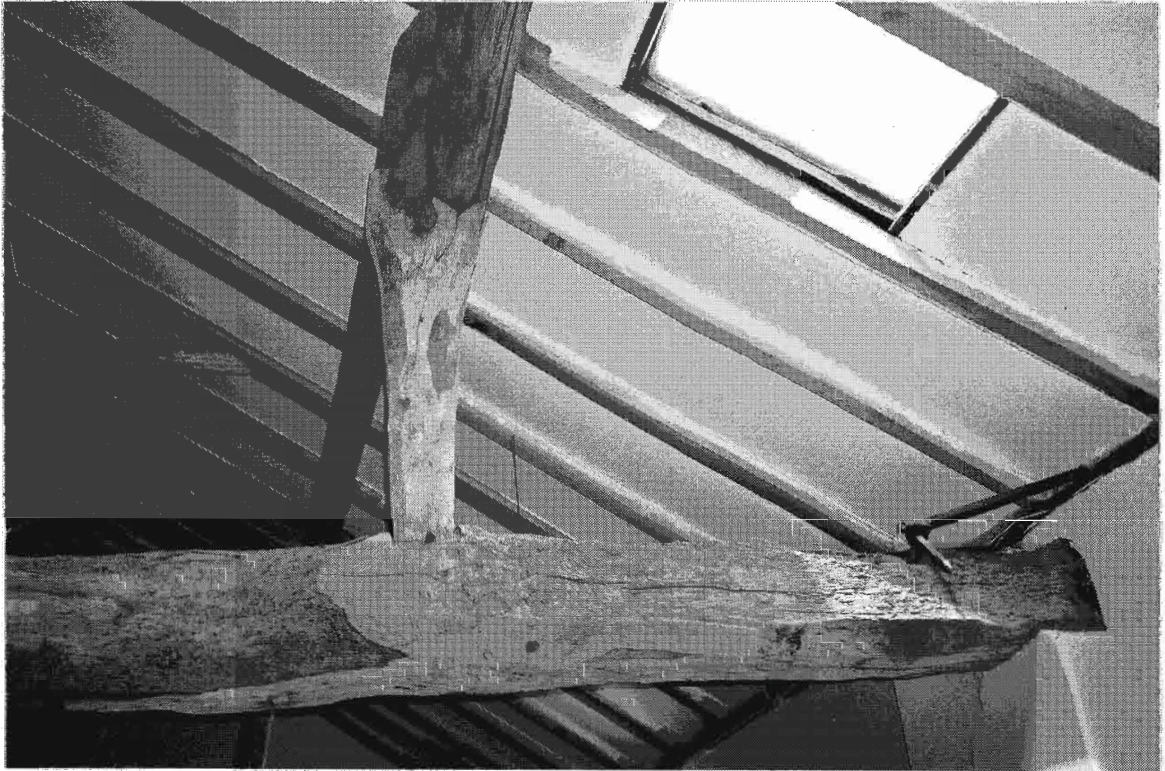
*Colour Plates c13, c14 Detail showing re-used timbers in extension roof*

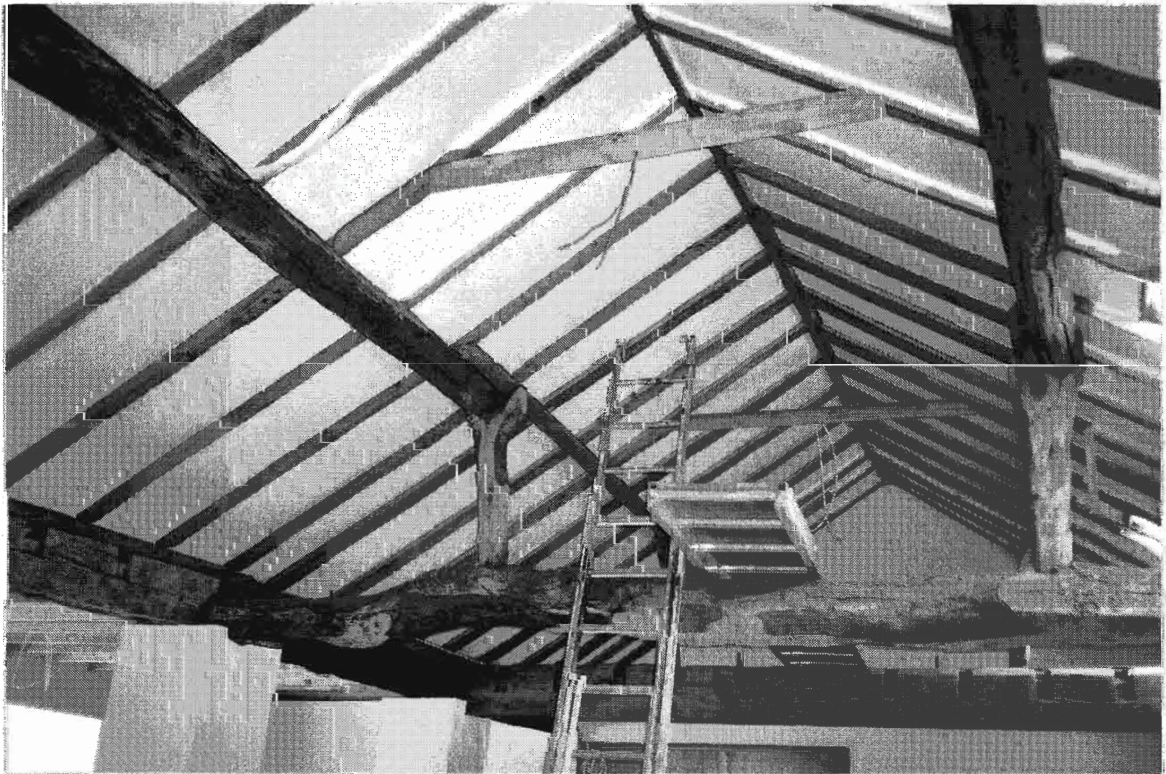
*Colour Plate c16 Steel joint to re-used timbers in extension roof*

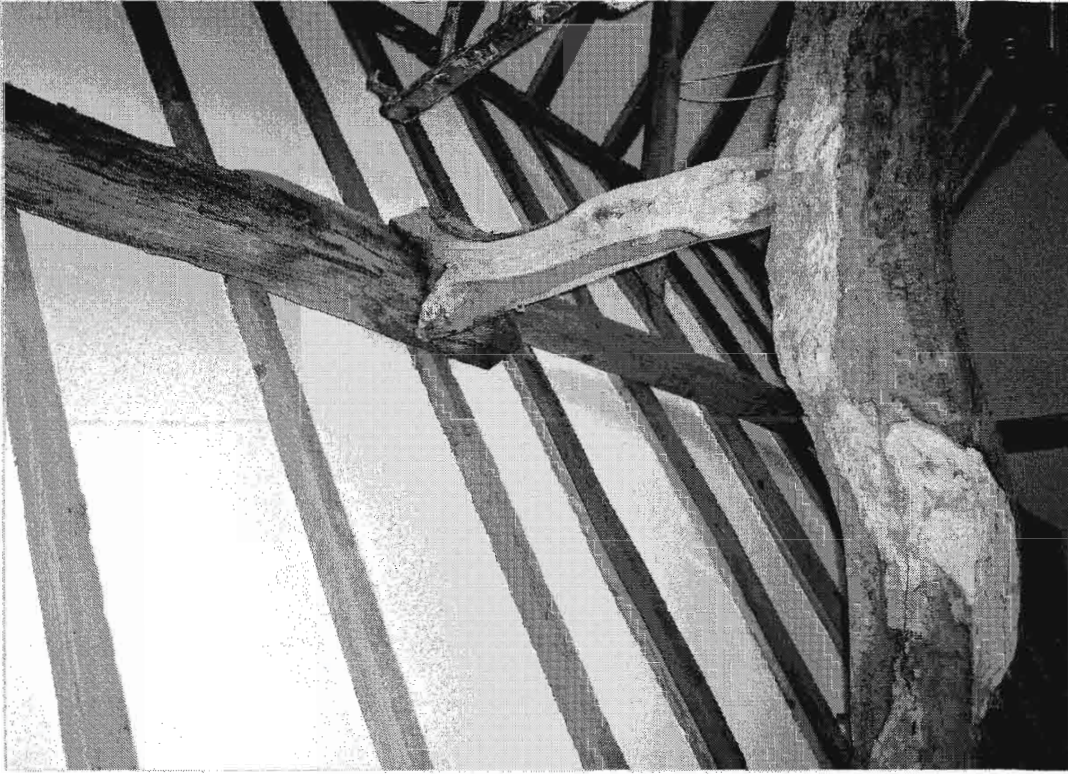
*Colour Plate c15 Re-used timber detail in extension roof.*

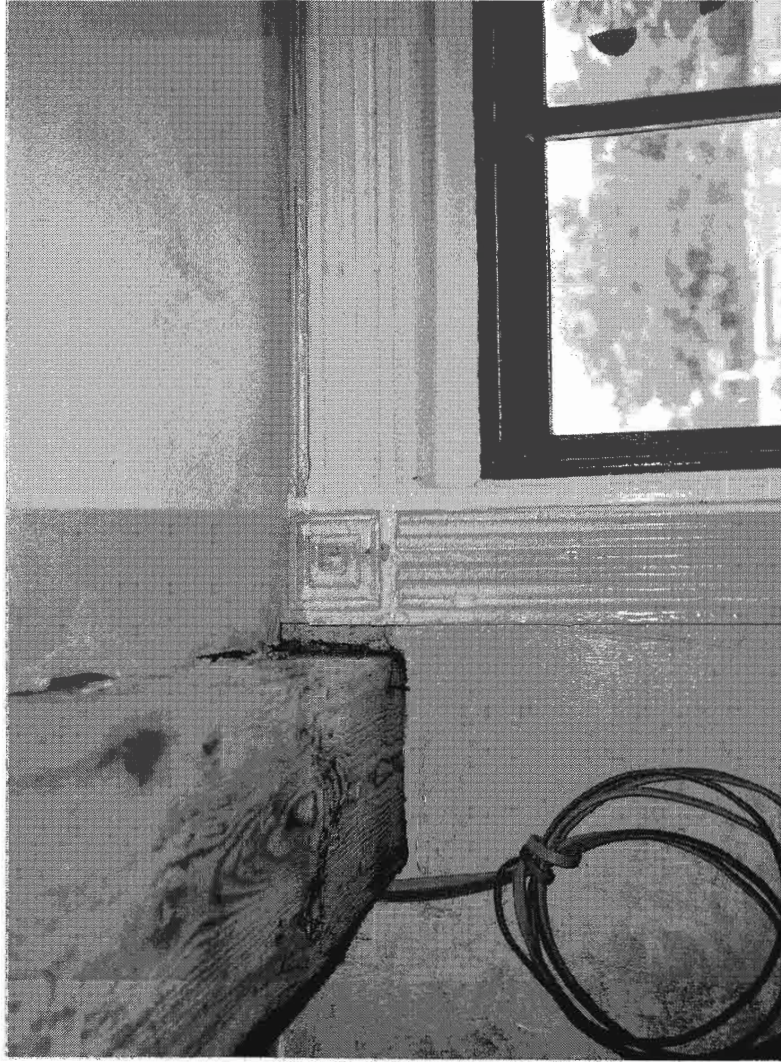
*Colour Plate c17 Ground floor window frame showing reeded surround and paterae stops in 19<sup>th</sup> century section of house.*

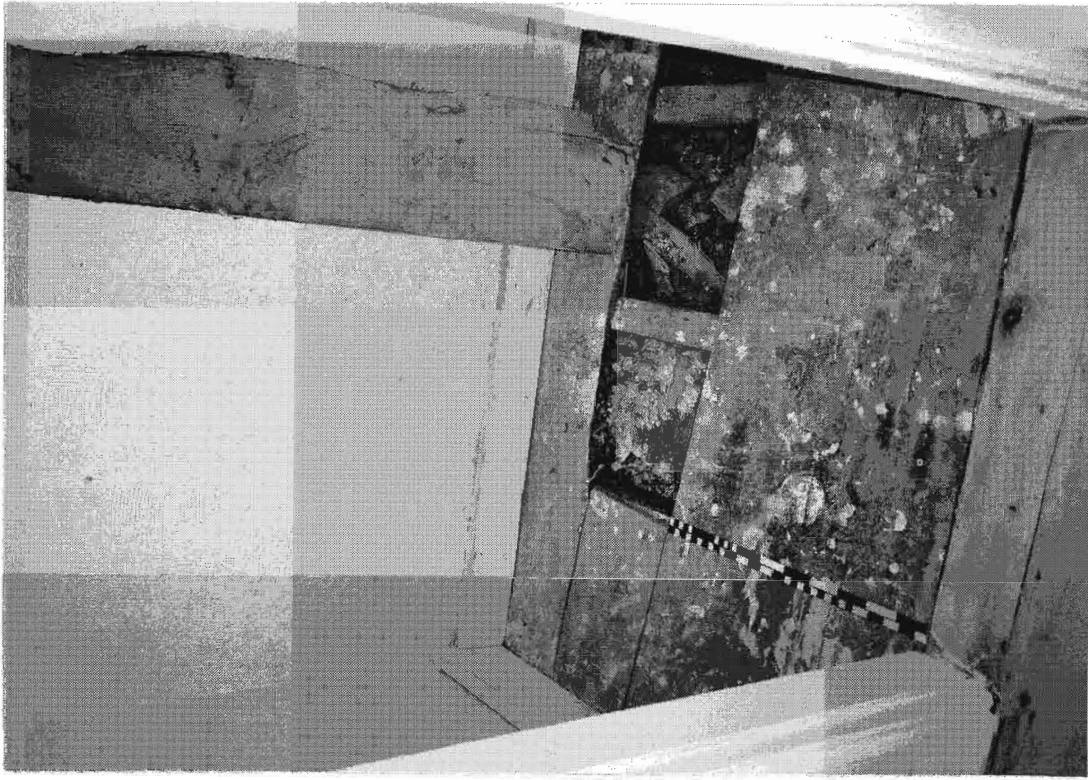
**Colour Plate c22** Detail of exposed truss section showing tie-beam, principal rafter and purlin in present bathroom of 18<sup>th</sup> century build.

Some of the roof timbers remained exposed in the first floor areas of this section of the building. In the bathroom area a shallow pitched principal rafter with a trimmed purlin and tie-beam was visible, (see Plates 39, c22), in the adjacent room the partition wall contained a waney edged principal rafter and a cut section of a purlin, (see Plates 40, c23).

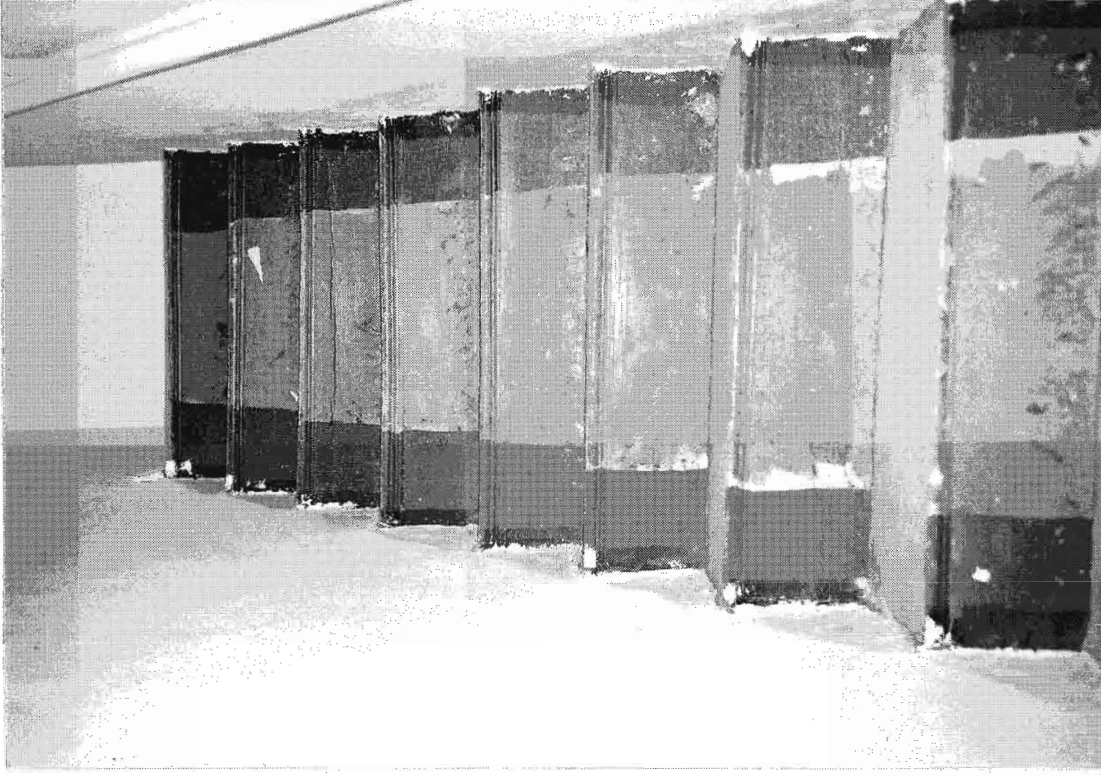
**Colour Plate c24** Stairs set against the south gable wall leading from first to second floor of the 19<sup>th</sup> century build.

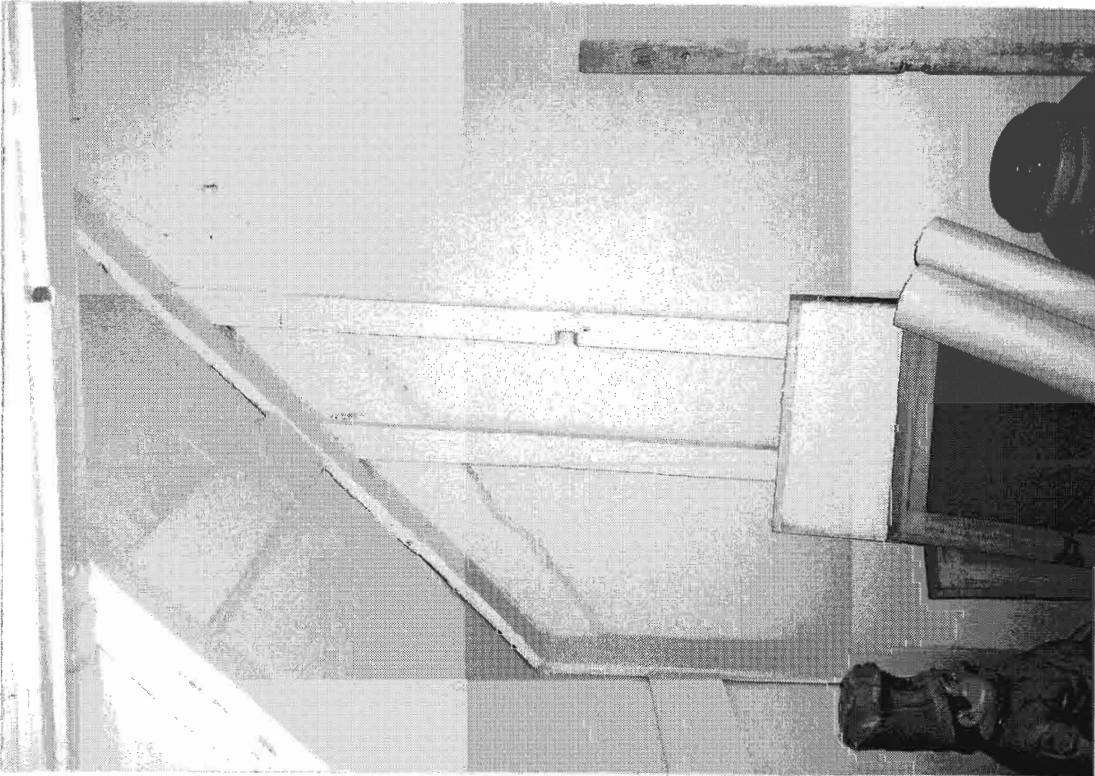
**Colour Plate c23** Exposed sections of principal rafter and purlin in the 18<sup>th</sup> century first floor roof.

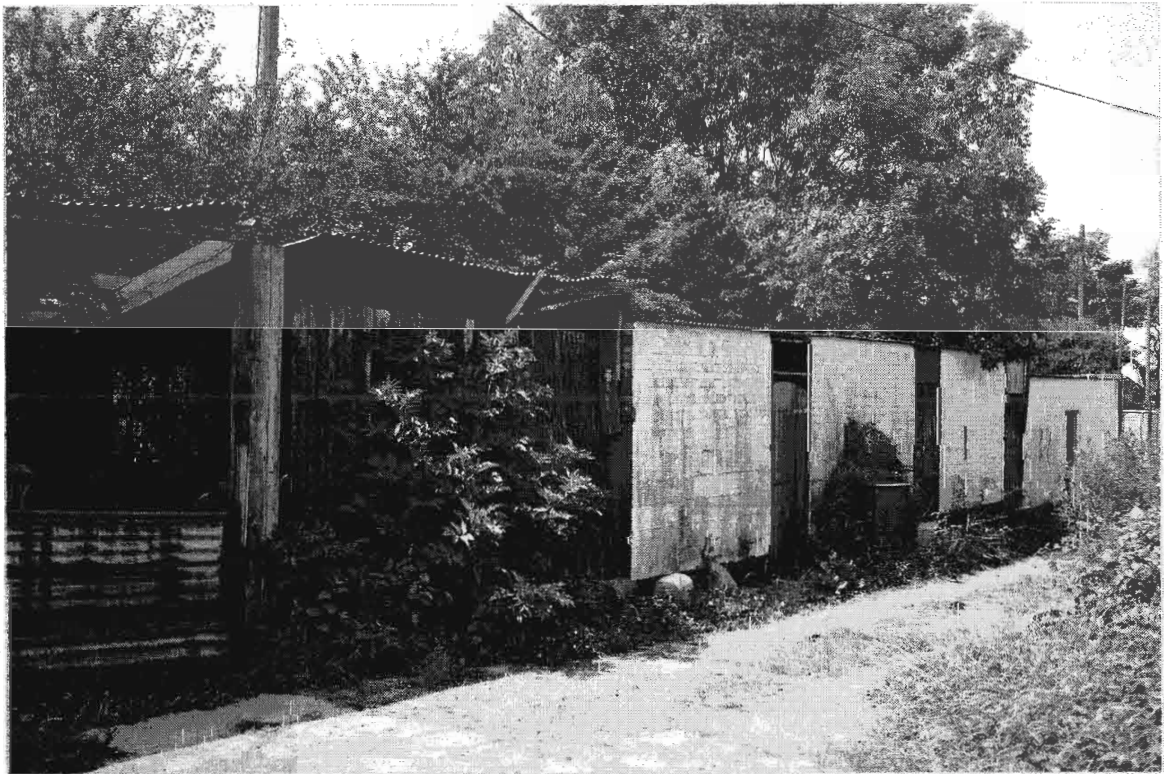
*Colour Plate c29 Southern end of outbuildings to the west of the Bath Hotel, currently used for storage of gardening machinery and furniture, but previously used as lambing sheds.*

*Colour Plate c30 Outbuilding lying to the south of the Bath Hotel.*

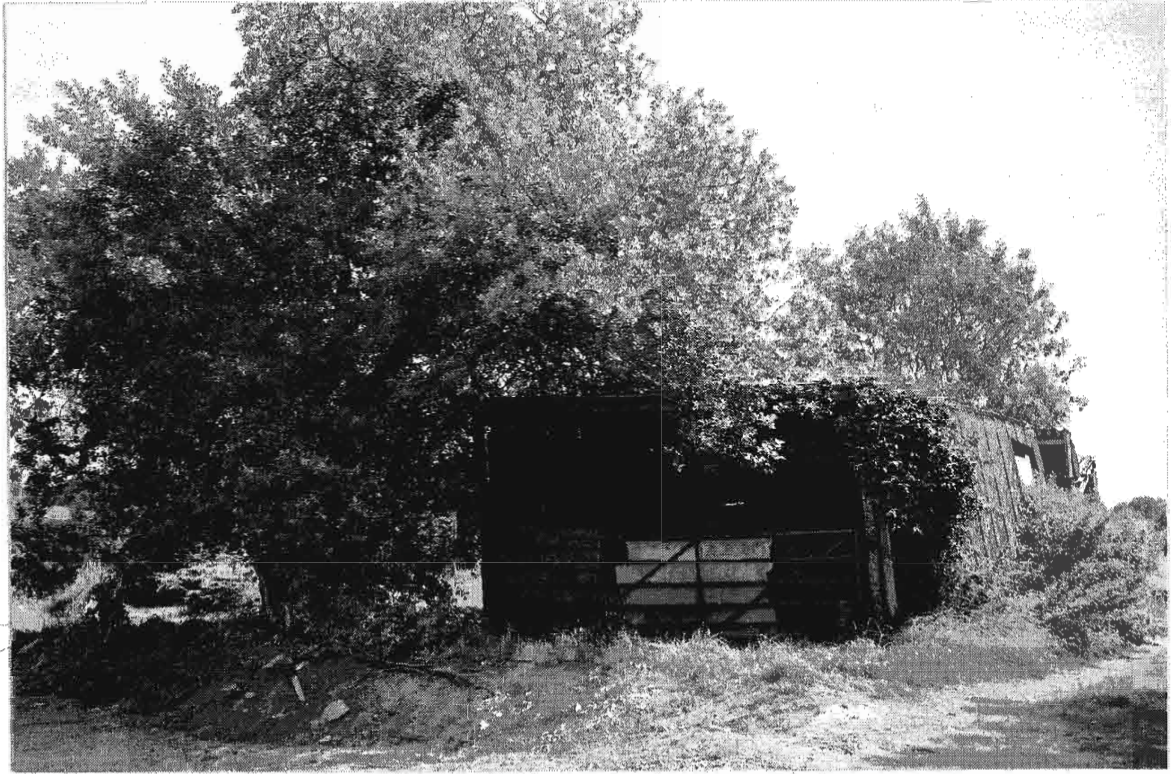
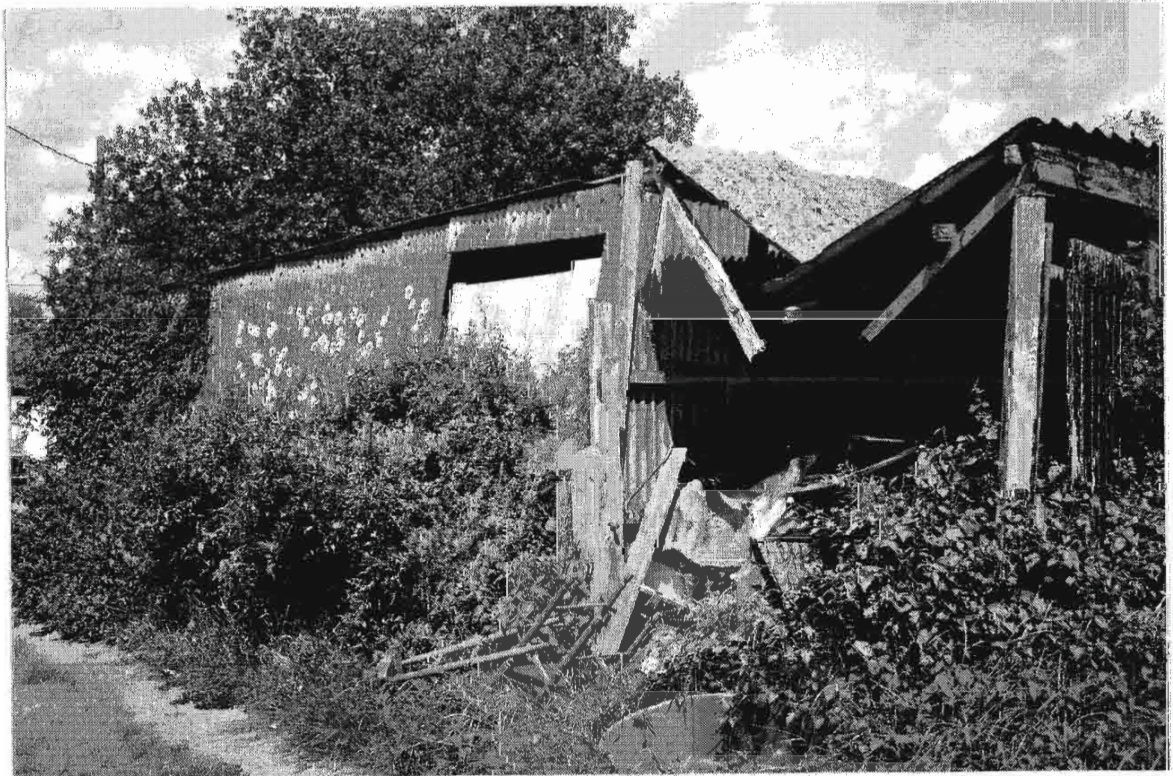
*Colour Plate c31* Outbuildings lying south of the **Bath Hotel**, viewed from the north. Latterly used as a loose box.

*Colour Plate c32* Additional outbuilding unit attached to loose box shown in *Plate c31*, now used as store for broken Bar furniture.
