**M1 Junctions 21-30, Leicestershire/
Nottinghamshire/Derbyshire:
Archaeological Walkover Survey**

University Of Leicester
Archaeological Services

Report No 2004-190 ©2004

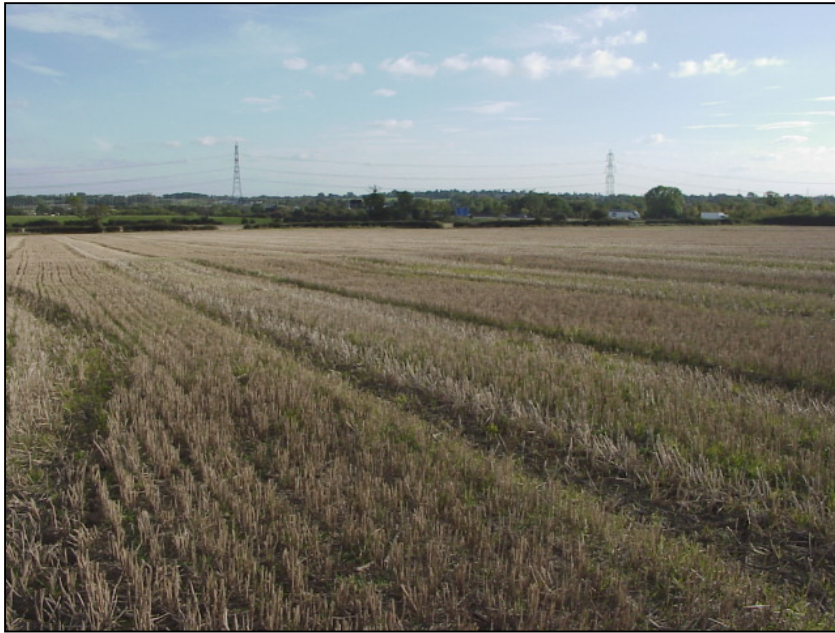
A raised earthwork runs roughly east - west across the western field on a similar alignment to the Roman road but to the north of its supposed route (Plate 1). Previous work (Liddle 1993) suggested that the road actually lies south, however the line is only projected. The earthwork disappears before reaching the eastern field; however this field had considerably higher stubble that may have obscured the earthwork. It seems likely that this earthwork represents an old field boundary although the possibility that it is related to the Roman road cannot be discounted.

The same field also contains other possible earthworks consisting of three raised areas that could be house platforms or pillow mounds. However the stubble within the field makes it difficult to be certain that they are archaeological features.

Plate 1:
Linear earthwork
noted in Area 13

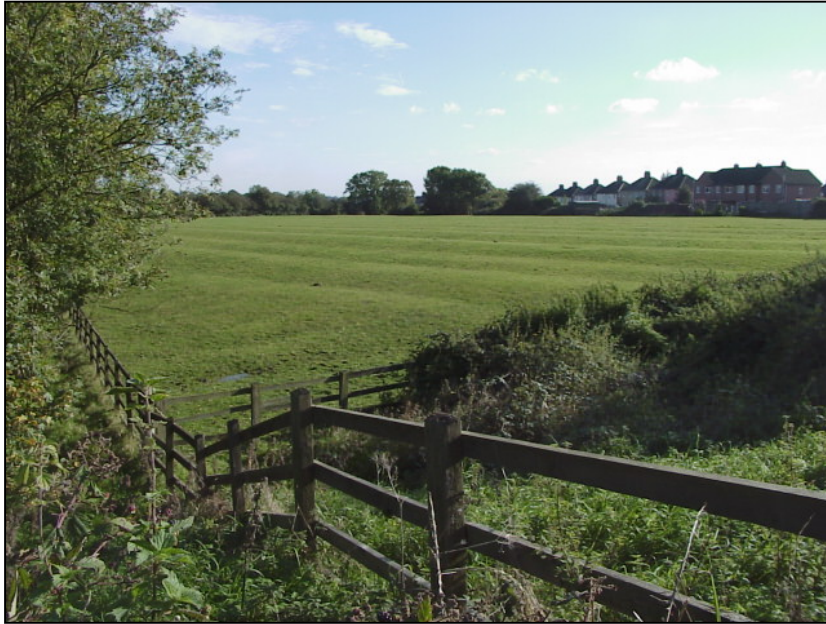
An area of ridge and furrow was noted next to the motorway. The earthworks are very well preserved and are aligned north-west to south-east, abutted by further earthworks aligned south-west to north-east in the north-west corner of the field (Plate 2).

Plate 2
Ridge and
furrow within
area 16.

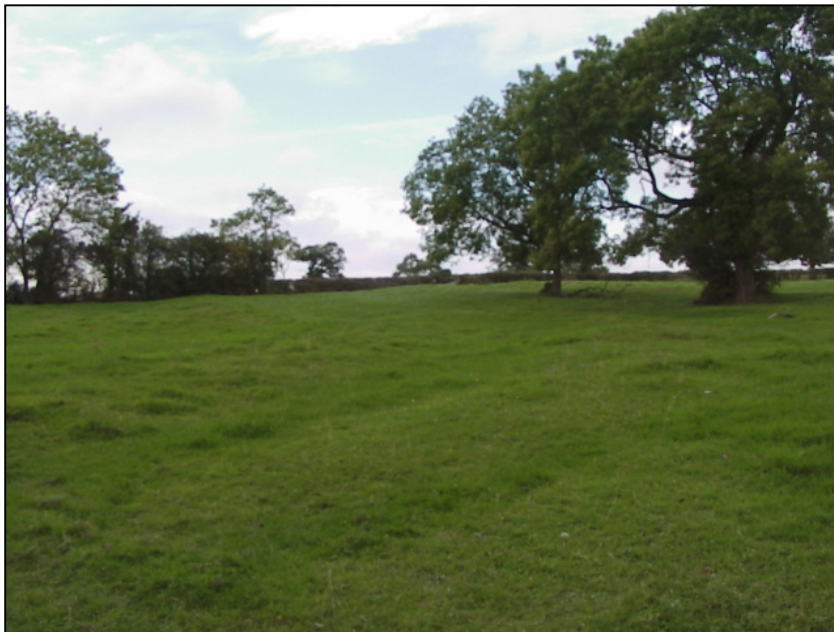
Four rows of well preserved ridge and furrow are visible here. There is an old field boundary to the north of the ridge and furrow with further earthworks behind it. Adjacent to these earthworks is the possible remains of a hollow way that has been totally truncated on the eastern side by a modern concrete path possibly laid during construction of the M1.

Plate 3:
Ridge and furrow in
Area 21

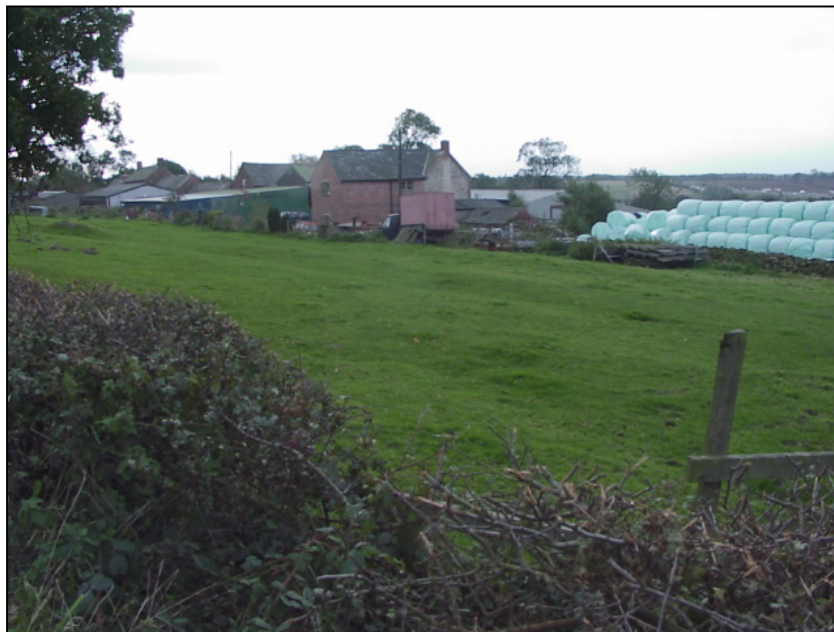
The two southern fields contain relatively well preserved ridge and furrow aligned south-west to north-east. The north-eastern field also has ridge and furrow running in the same direction (Plate 4). The north-western field contains earthworks, probably old field boundaries.

Plate 4:
Ridge and furrow
in area 26

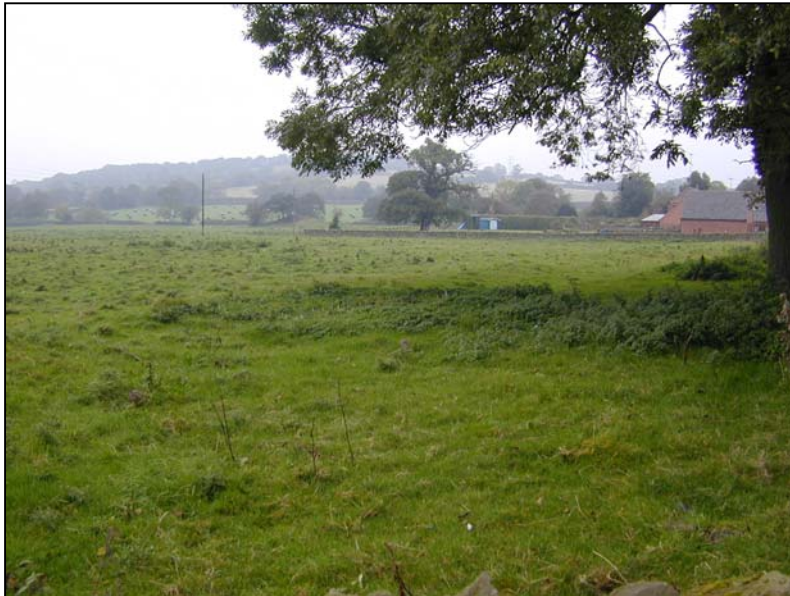
Within the western field lies a mound that looks like a possible minehead. The field also contains linear earthworks aligned east to west, possibly enclosure boundaries, although the dense undergrowth made identification difficult (Plate 5). Within the eastern field close to the road are a number of irregular earthworks with stone rubble present, probably indicating a demolished building. A natural stone ridge in middle of field appears to have been used for quarrying in past (Plate 6).

Plate 5:
Earthworks in
area 33.

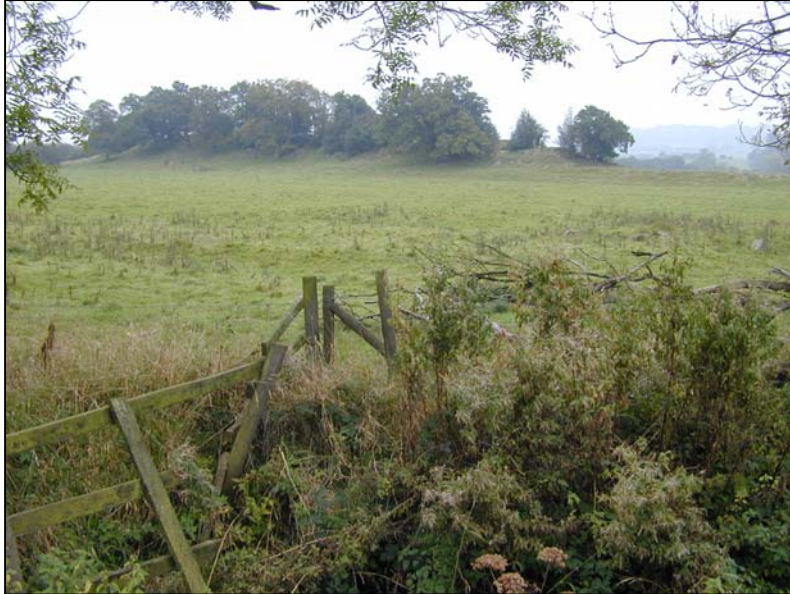
Plate 6:
Irregular earthworks
and a natural ridge
used for quarrying in
Area 33

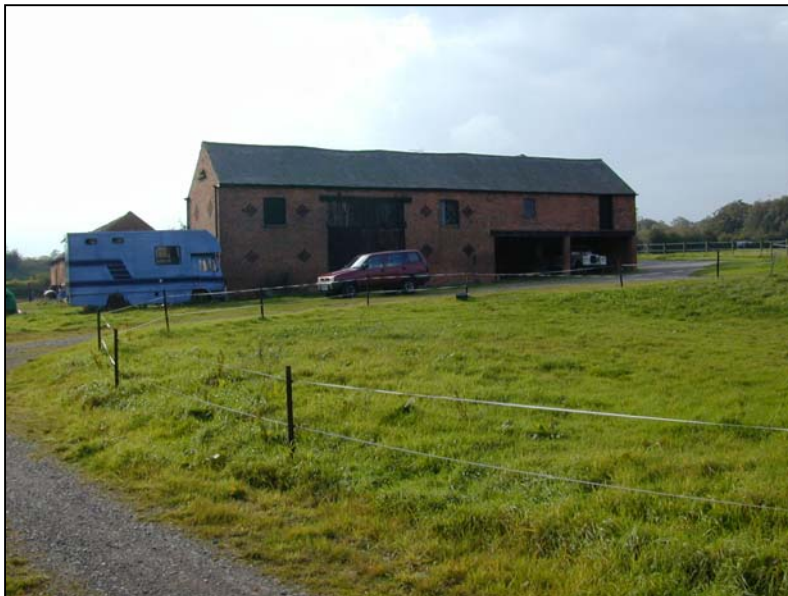
A large 19th century brick built threshing barn was visible in this area. It appears to be in very good condition, with double doors and two storeys with one side designed for the parking of carts within it (Plate 7). Other buildings in vicinity probably date to the same time but none were not investigated further due to the presence of fierce dogs.

Plate 7:
Brick built threshing
barn in area 48.

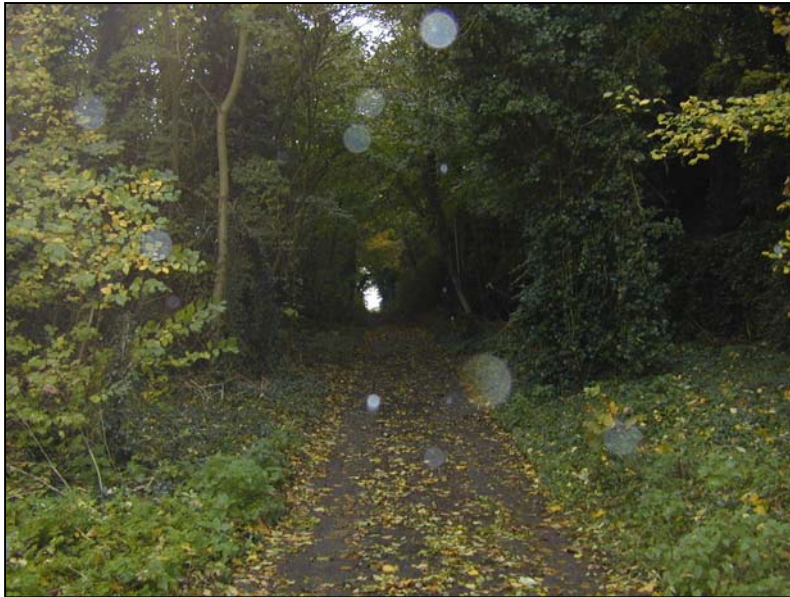
A narrow driveway (Brickyard Lane) appears to utilise the remnants of a hollow way, with steep sides and trees planted on top either side (Plate 8). A track continues from it running south.

Plate 8:
Possible
hollow way in
area 56

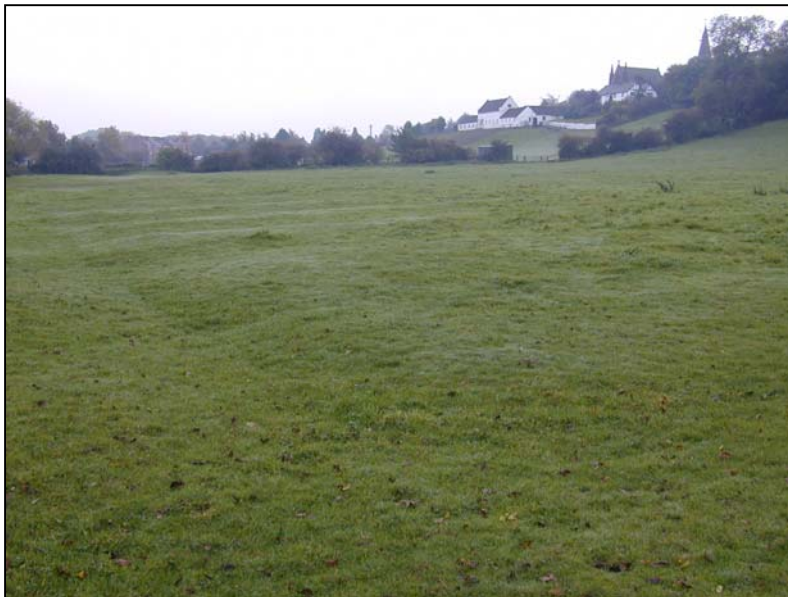
Five fields of well-preserved ridge and furrow, were noted here (Plate 9). They were aligned east-west, and partly lie within the conservation area.

Plate 9:
Ridge and furrow in
area 77

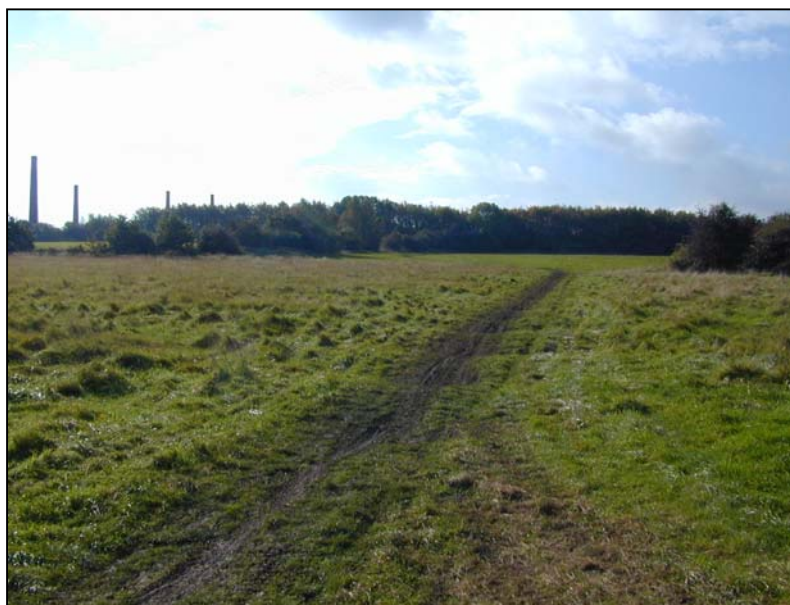
This area contains east/west oriented ridge and furrow, quite well preserved (Plate 10).

Plate 10:
Ridge and furrow in
area 100 with post-
medieval chimneys in
the background.

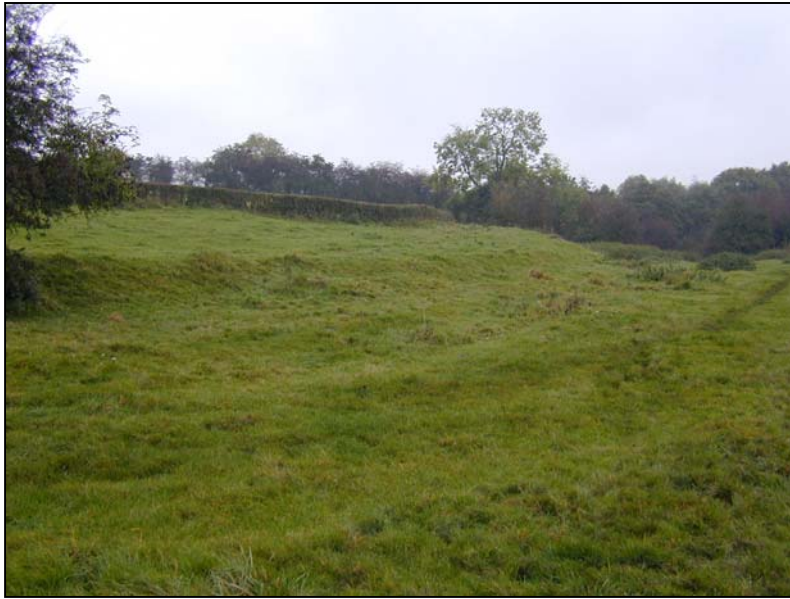
A number of irregular earthworks were noted in this field, possibly connected to the dismantled railway to the south (Plate 11). It was difficult to assess the precise nature and extent of earthworks due to the undergrowth. There is a curvilinear bank running north to south that again could be connected with the railway, (possibly a cutting?).

Plate 11:
Irregular earthworks
possibly associated
with the railway in
area125.

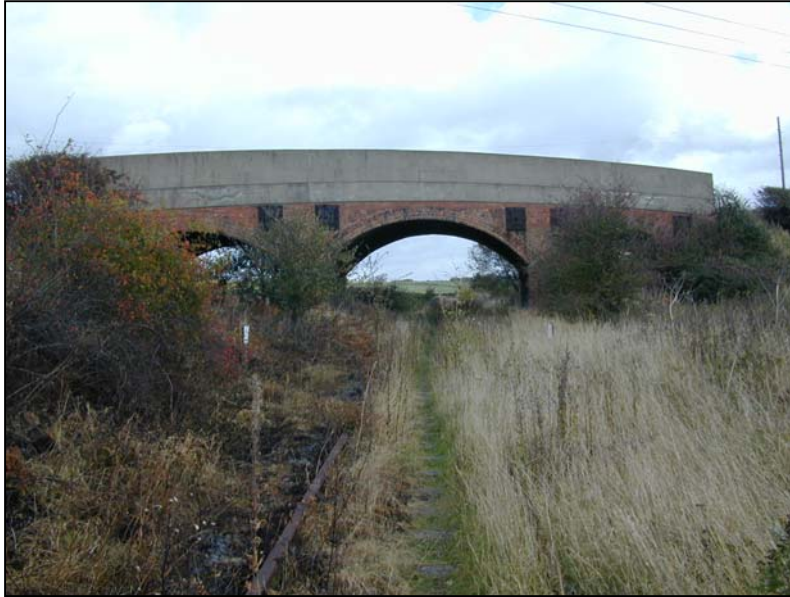
There is a c. 19th / 20th century disused railway here (probably associated with the open cast mine) with the track still in place. A brick bridge spanning with three arches spans the railway cutting (Plate 12).

Plate 12:
Disused railway
and bridge in
area139

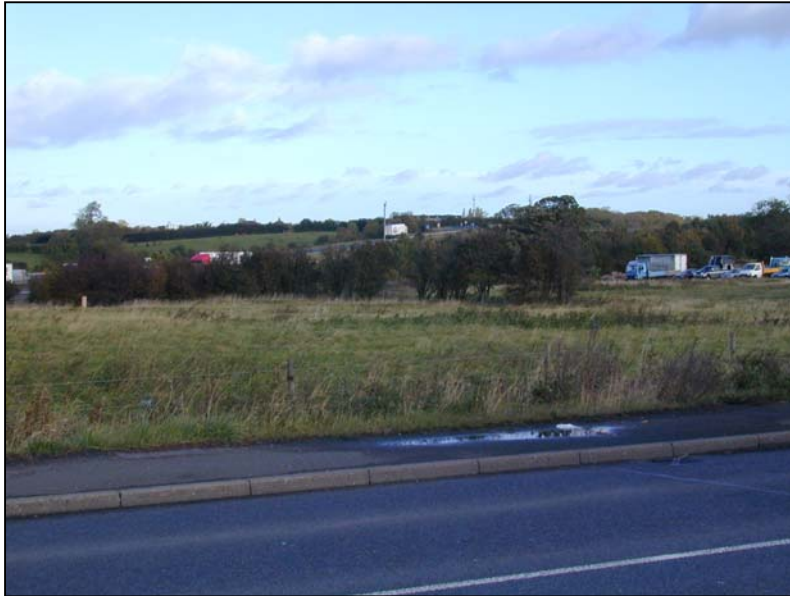
There are a number of irregular earthworks here. Their function is unknown but they may relate to open cast working and tipping in this area rather than be archaeological in origin (Plate 13).

Plate 13:
Uneven earthworks in
area 144.
