**59 & 59½ Highcross Street, Leicester:
Historic Building Statement**

**Supplementary Historic Building Statement
On the Rear Range of
59 Highcross Street, Leicester**

University of Leicester Archaeological Services

Report 2005/012 ©2005

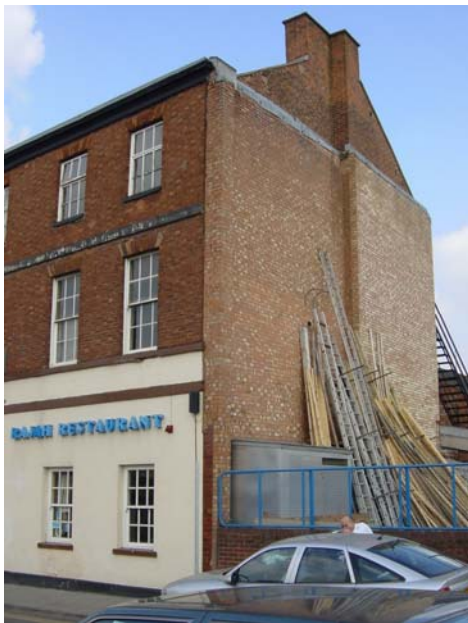
The south gable wall of the frontage block has a modern 'skin' wall reinforcing the brickwork where the adjacent building has been demolished.

Figure 1: Grade II listed No.59 Highcross Street. Note the 'skin' wall against the southern gable end.

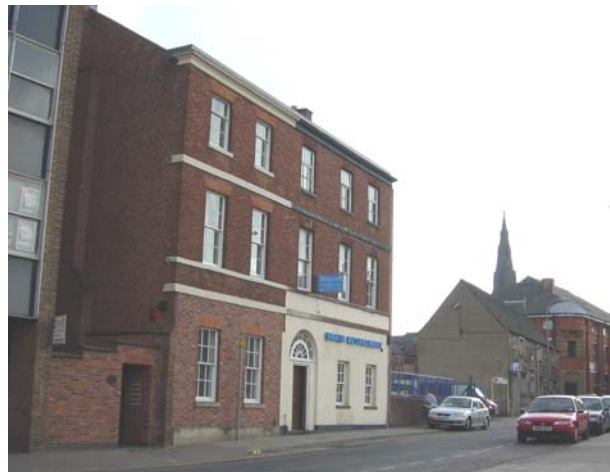
The building is a three-storey former town house of substantial proportions, now divided into two properties. The Highcross Street elevation is five sash window bays wide, of red brick with gauged arches, with rendered bands at first and second floor level and a first floor cill level. It has a slightly projecting crowning cornice and frieze band, somewhat small-scaled, and a low parapet above now clad in lead. The central front door, originally flanked by sidelights, has a semi-circular traceried fanlight. The south (right hand) half of the ground floor facade is rendered with two inserted sash windows that are much smaller than those of the rest of the facade. North of the main entrance the ground storey facade (59½) has been reinstated in domestic form within the last decade using reclaimed brickwork and good replica sash windows, replacing a 19th century shop front which is seen in early photographs (Figures 3 & 4). The roof is covered in non-local slate, probably Welsh slate.

Figure 2: General view of No.59 Highcross Street.

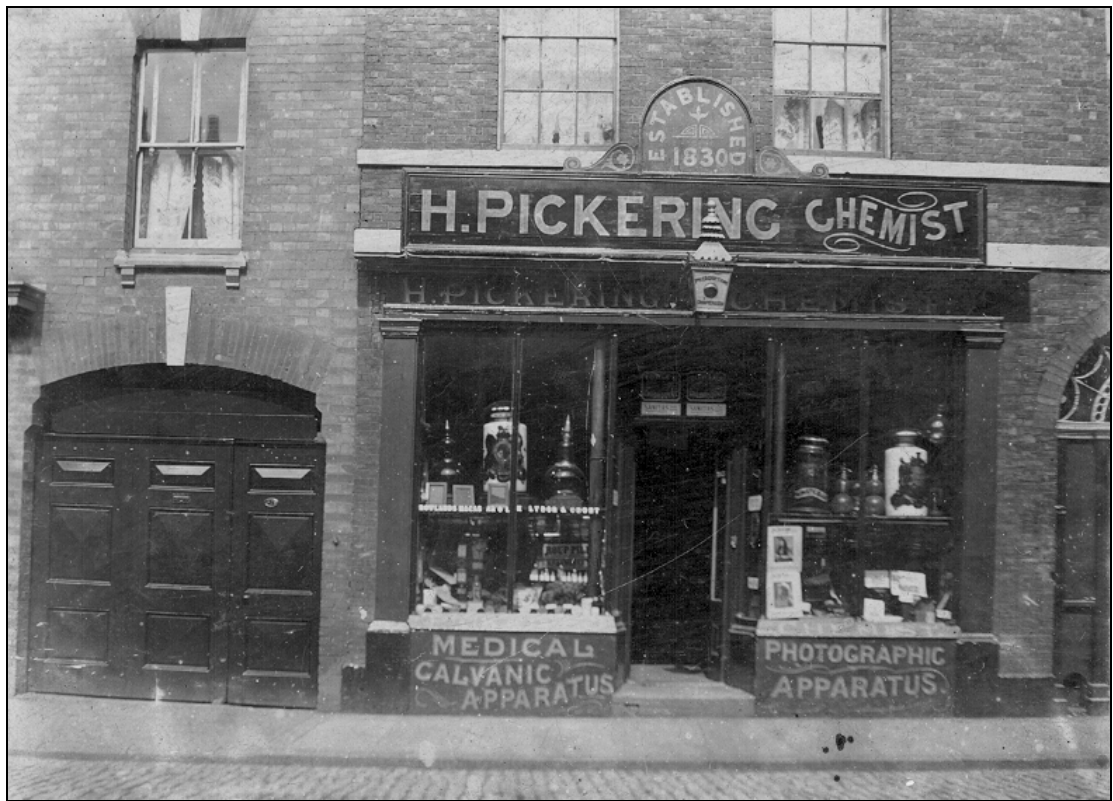
In the photographs of *c.*1877 (Figures 3 & 4) the areas on either side of the main door, presumably originally glazed sidelights, are timber panelled. A boot scraper is located to the left of the door. The same timber panelling is evident in the 1958 photograph (Figure 5). In

Photograph of northern section of building ie. 59½ Highcross Street.

Annotated on reverse:
59 Highcross Street Leicester
c. 1877

Shows 19th century shopfront of H. Pickering Chemist, established 1830. Stall boards bear legends: *Medical galvanic apparatus* and *Photographic apparatus*

Figure 3. 59½ Highcross Street c. 1877.

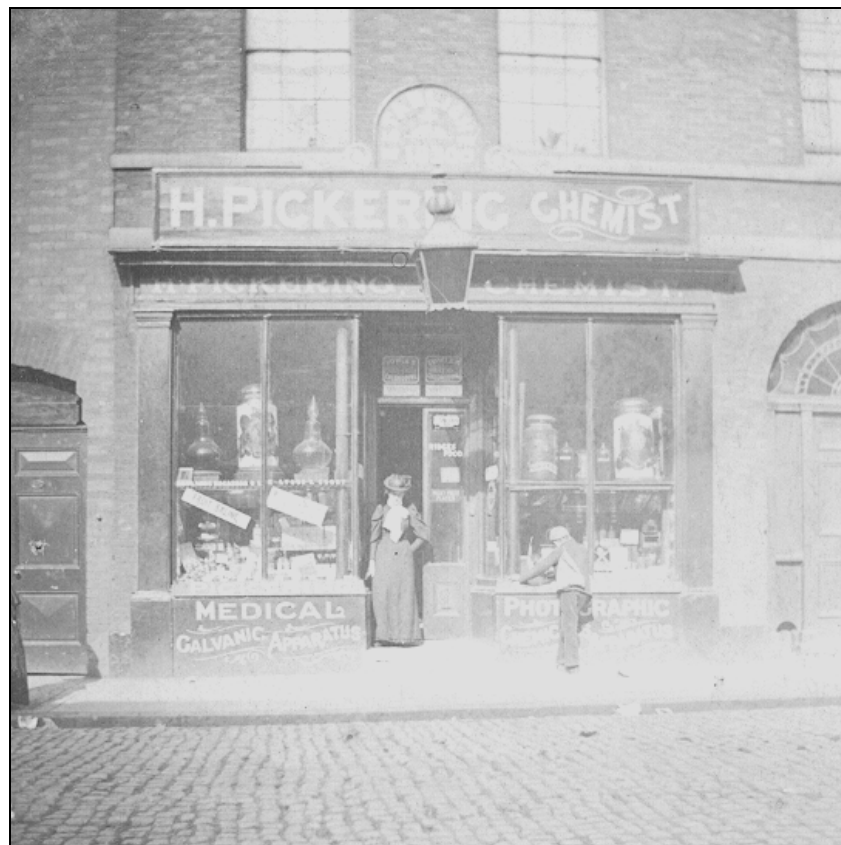
Similar photograph to above, though not identical; woman standing in shop doorway and child looking in window. Shows a little more of main doorway and fanlight.

Henry Pickering
Chemist
61 Highcross Street, Leicester
Wright's Directory 1884
Donor Mr. P.A. Sloane
Foxton Lodge, Foxton

Figure 4. 59½ Highcross Street, late 19th century.

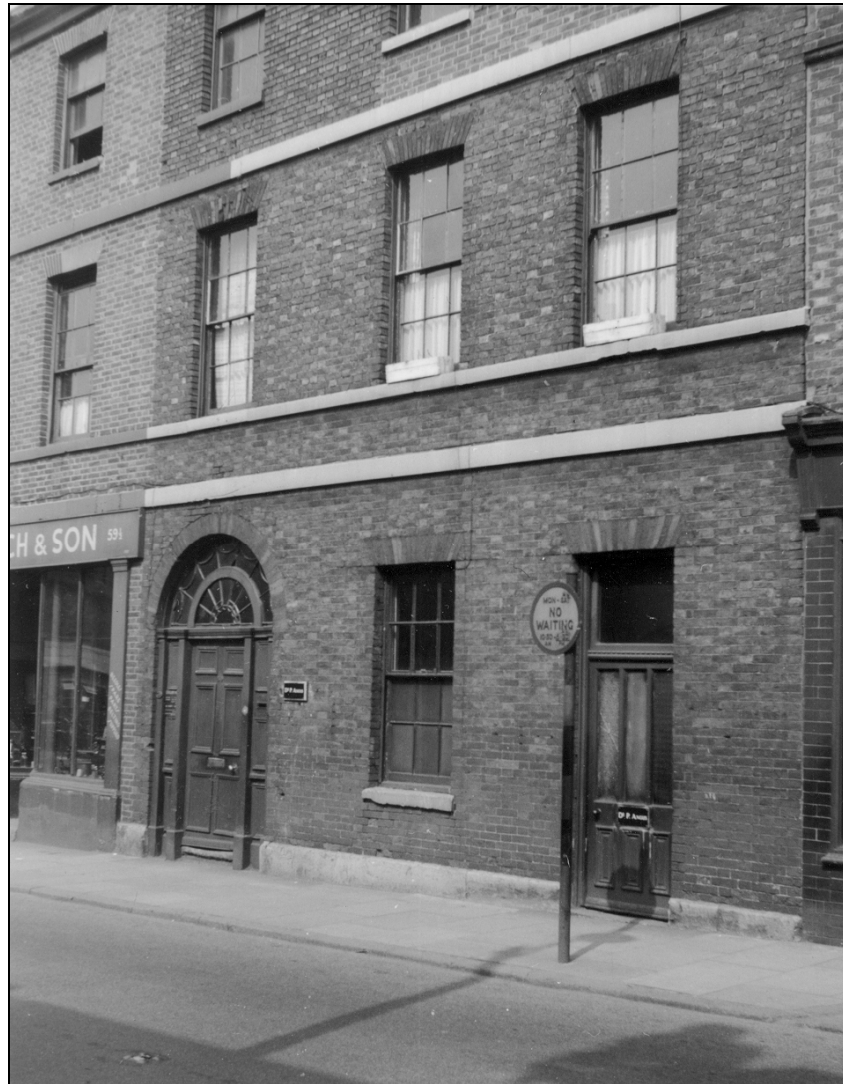
the same photograph it is seen that the southernmost ground floor window had been converted into a doorway (in the 19th century by the look of the door) giving access to a doctor's surgery. Trade directories may again provide some indication of how long this business had operated from these premises.

Annotated on reverse:
18th century house Highcross Street [20]
Leicester Highcross Street
1958
No. 59 & 59½
Church & Sons (plastic envelope says Clarke & Sons, but last 2 letters over shop front of 59½ are clearly ...ch – check trade directories)
Doctors (Dr Adams)
Etc

This shows the main doorway and right hand (south) part of 59 Highcross Street, plus part of shopfront to left (ie 59½).

To the right of the main door is a window similar to those on the first floor and to the right of this a panelled and glazed door. This is presumably a later insertion – door and plain overlight look 19th century. The shopfront to the left is that in the 19th century photos (see above), but modified.

Figure 5. 59 Highcross Street, 1958.

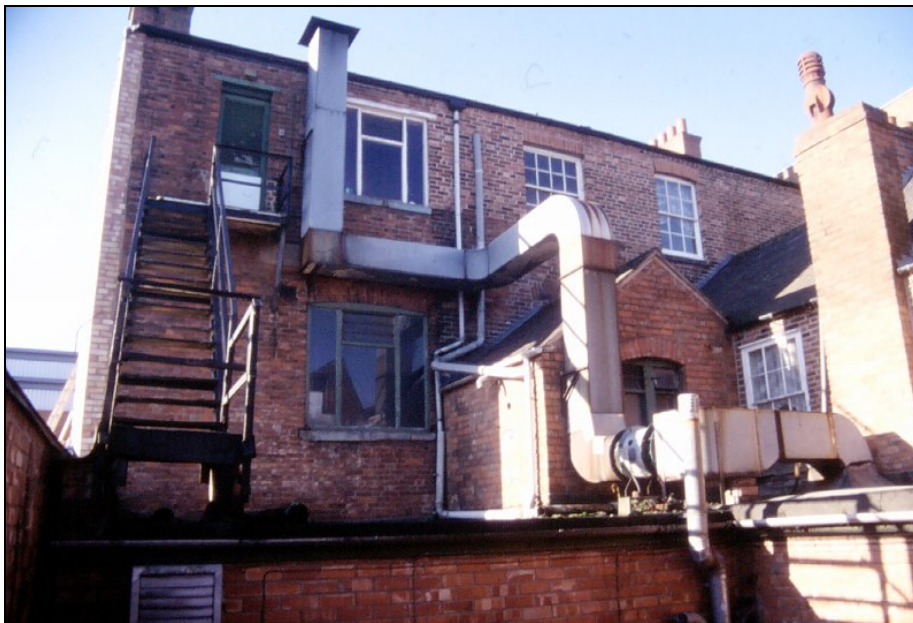
Three distinct structural elements are apparent from the external inspection (excluding a free-standing timber shed against the southern boundary wall of the property which is very recent in date and will not receive further consideration) (Figure 6). The earliest element is a small two-storey brick-built block with Welsh slate roof, on the north side of the plot (Figures 1 & 4, and outlined in green on Figure 6). This has a single first floor window with brick segmental arch head in the east gable wall. The ground floor forms part of the kitchen to the Rajah restaurant and is open into an adjacent single-storey range to the east (see below). Female and male toilets occupy the first floor. Access to the first floor is via an inserted doorway on the half landing of the 18th century frontage range; an original window opening was modified to form the doorway. This block was probably constructed in the latter half of the 19th century, certainly before 1895 as it appears on a Goad fire insurance plan of that year (LLRRO DE4702/14/2; Figure 4).

Figure 1. Rear of 59 Highcross Street showing the first floor section of the 19th century two-storey range (behind extractor ducting).

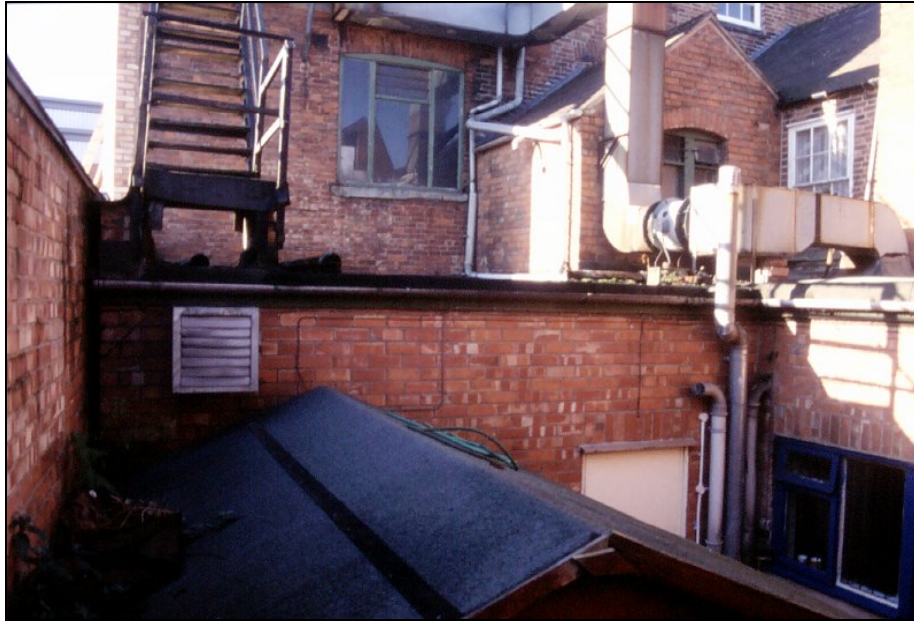
Occupying the southern part of the plot is a large single-storey flat-roofed range (outlined in orange on Figure 6). The brickwork of the east (rear) elevation is again attributable to the second half of the 20th century, and in all probability the last two or three decades (Figure 2). This range does not appear on a fire insurance plan of 1961 (LLRRO DE4702/15/2; Figure 5). The thickness of the south wall of this block suggests that it was constructed inside the line of the southern boundary wall to the property.

Figure 2. Rear of 59 Highcross Street showing the late 20th century single storey flat roofed range (centre of frame).

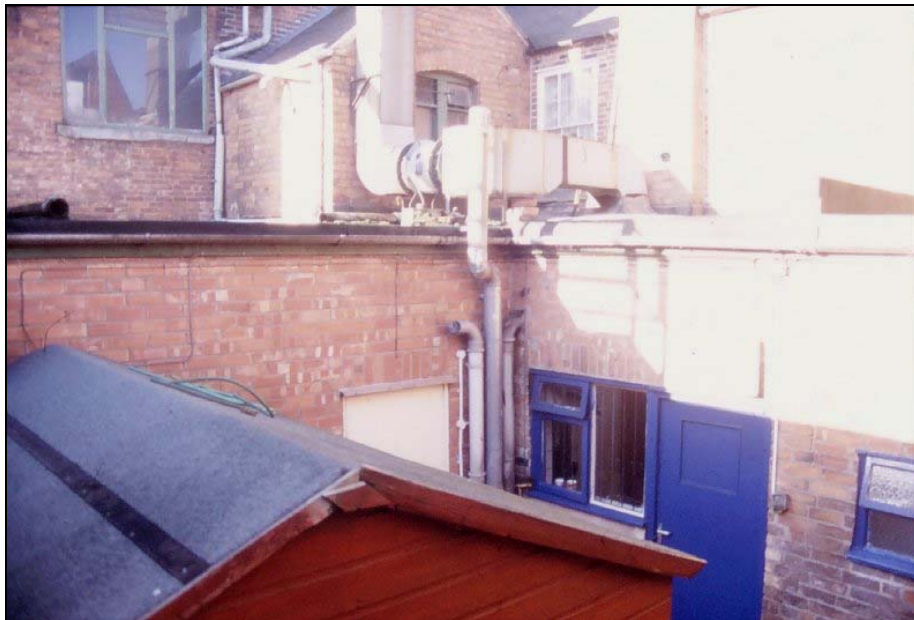
To the east of the two-storey range described above is a single-storey brick-built block with flat roof, mainly occupied by the restaurant kitchen. Beyond the kitchen area, towards the rear of the plot, is a toilet with separate access from the yard (Figure 3, outlined in blue on Figure 6). There are several distinct phases of brickwork in the south wall of this block. The earliest brickwork is in the lower section of the toilet. The toilet block was extant by 1895 and appears on the Goad fire insurance plan of that year (LLRRO DE4702/14/2), located to the rear of a single-storey range of similar plan form to the extant block (Figure 4). However, the brickwork of the south wall between the toilet area and the two-storey range is comparatively recent, certainly attributable to the second half of the 20th century and very probably the last quarter of that century (Figure 3).

Figure 3. Rear of 59 Highcross Street showing (on right) single storey flat roofed range on north side of plot. In the lower right corner of the frame is the 19th century toilet block.

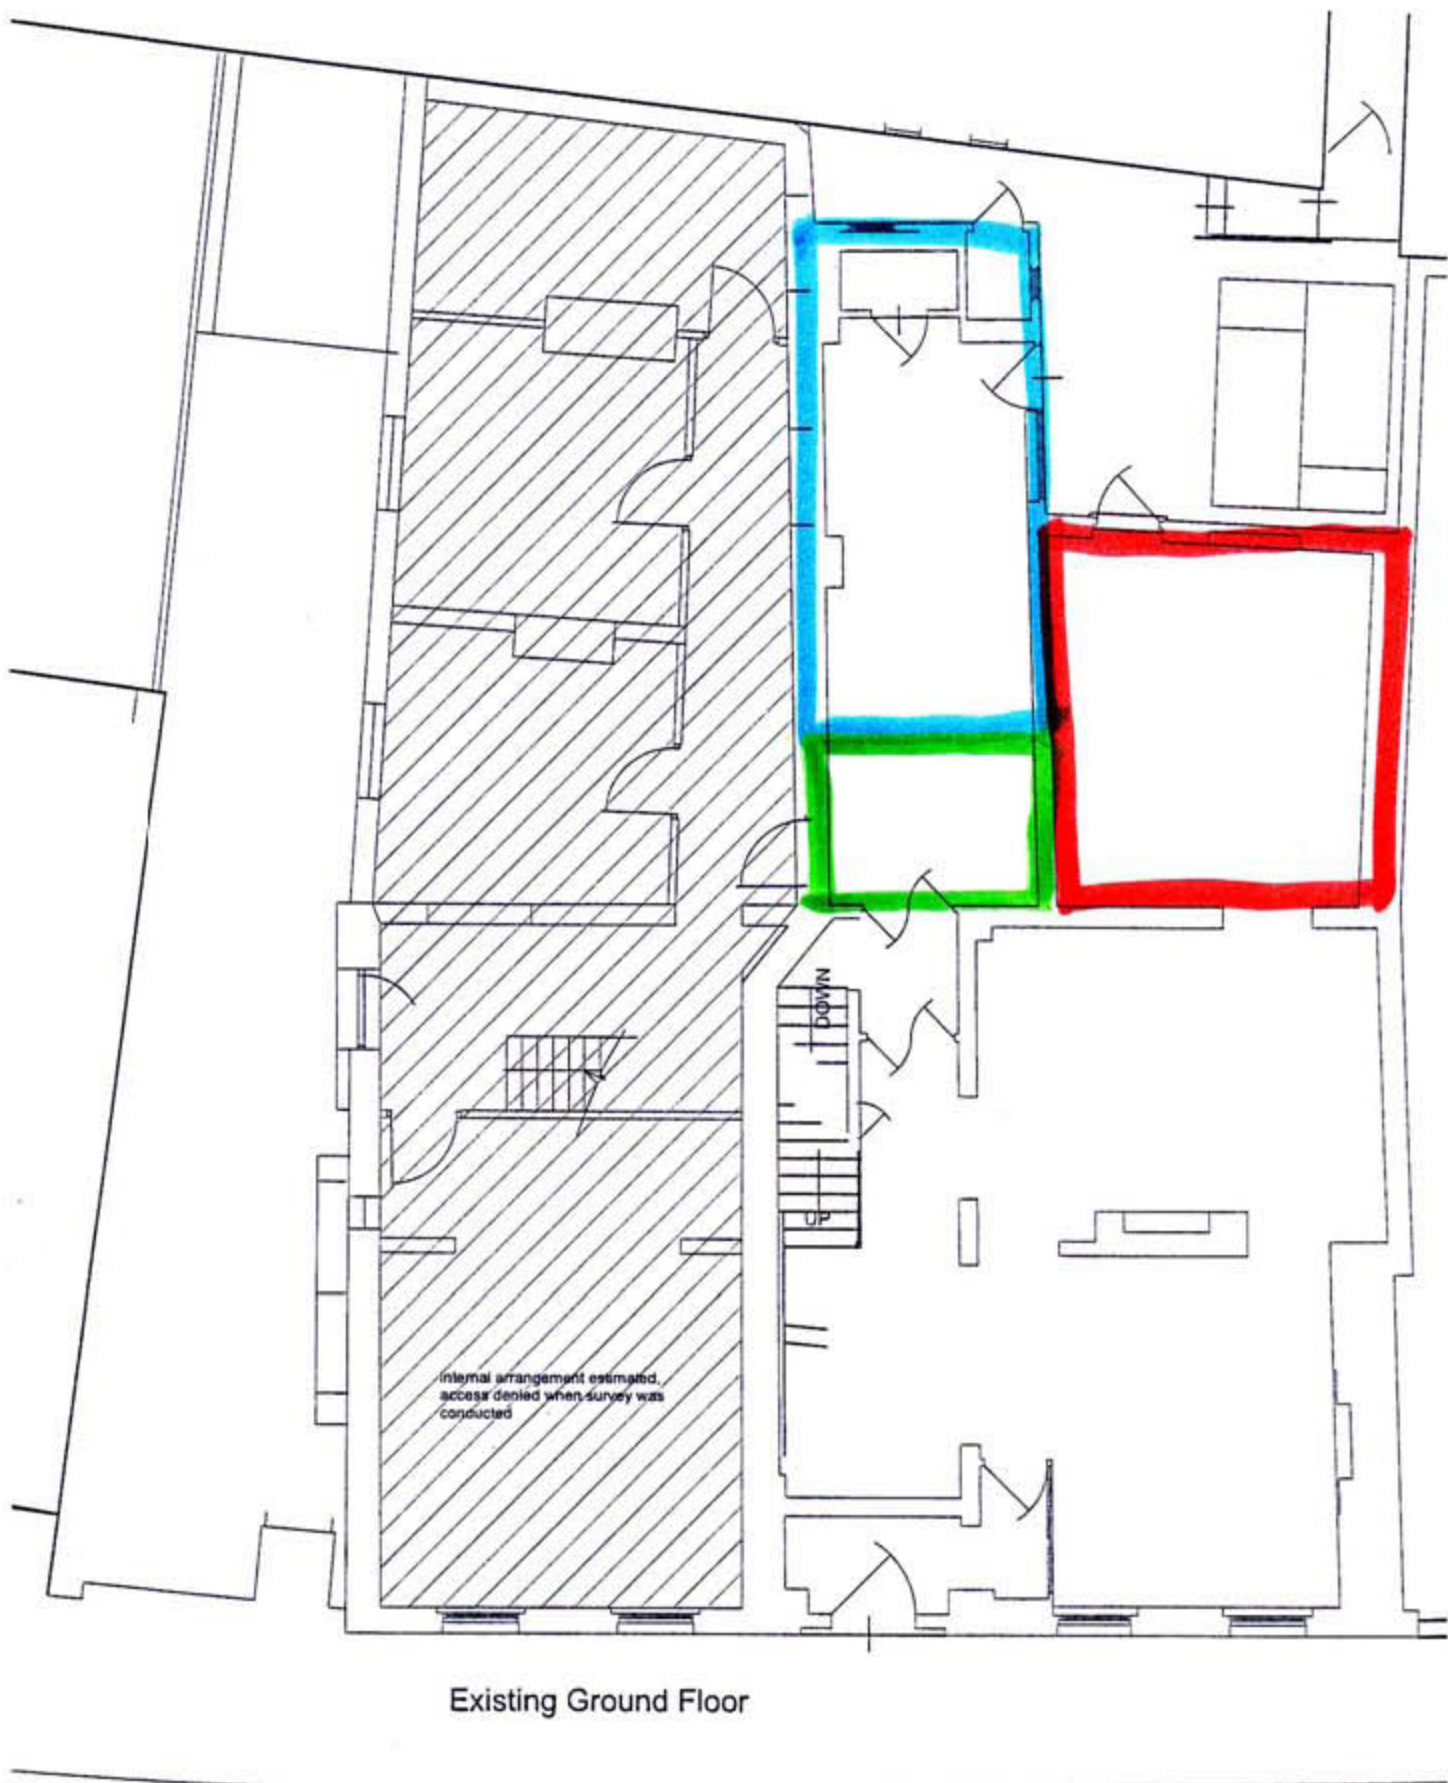
- Two-storey block: 2nd half of 19th century
- Single-storey block: 2nd half of 19th century, partly rebuilt late 20th century
- Single storey block: late 20th century (post-1960)

Figure 6. Ground Floor Plan of 59 and 59½ Highcross Street illustrating the three distinct structural elements to the rear range of number 59. North to left of page (approx.).
