**An Historic Building and
Archaeological Impact Assessment
of Ravenstone Farm,
Higham on the Hill,
Leicestershire
NGR SP 383 954**

Report 2005/078 ©2005

An Historic Building and Archaeological Impact Assessment of the Grade II listed building known as Ravenstone Farm, Higham-on-the-Hill Leicestershire

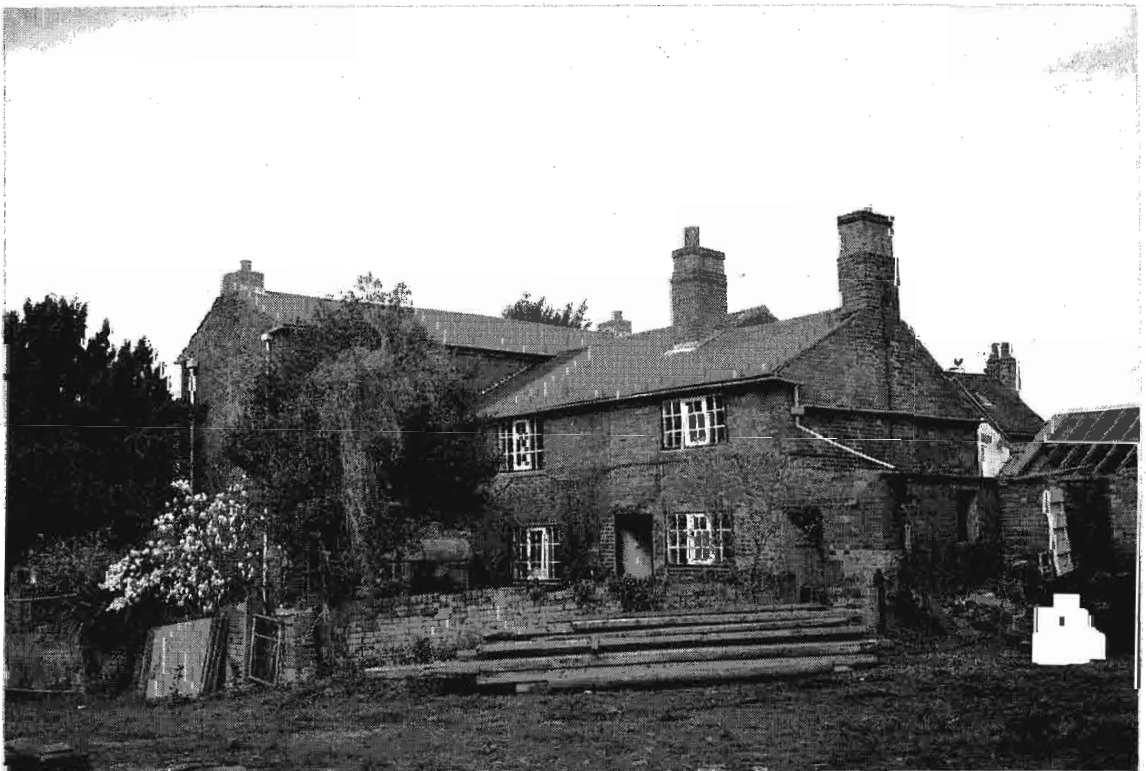
Plate 2 Ravenstone Farm, view of rear of house from the Yard area

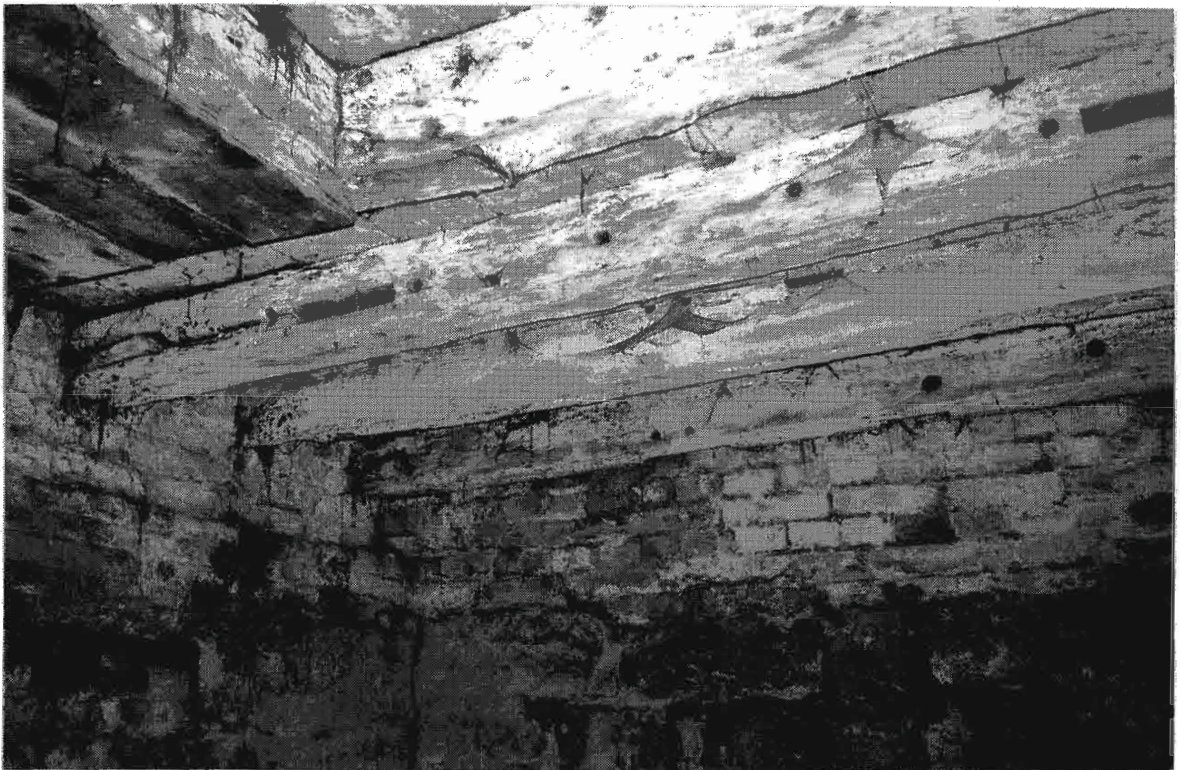
Plate 4 Detail showing joists to floor of room G 1 in cellar with vee-grooves, mortises and stale holes, being re-used sections from a timber-framed building.

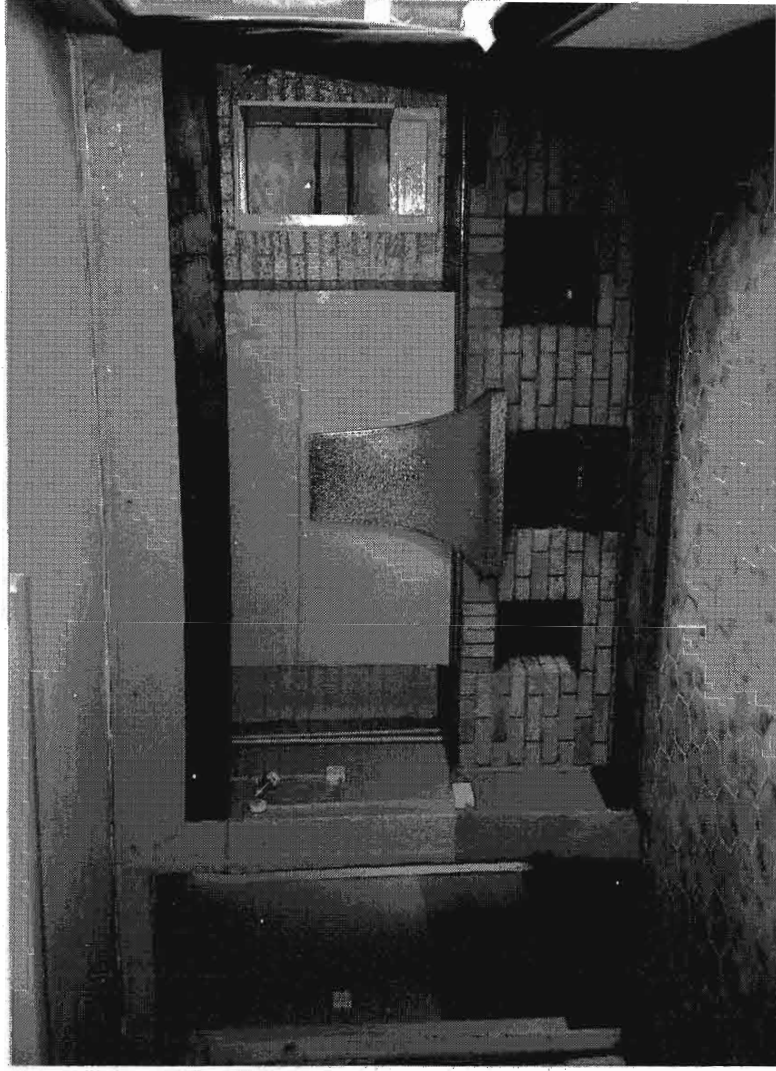
Plate 6 Fireplace in G 4, showing the straight fireplace bressummer and modern brick fireplace inserted into hooded area. On the right the sole surviving detail of the earlier fireplace arrangement survives in the form of a dry cupboard with drawer underneath

This work requires a doorway to be cut through the brickwork of the rear gable wall of the chimney-breast. There is limited headroom, 1.84m, maximum, (6ft) imposed by the fireplace bressumer which passes across the front of the chimney breast in supporting the chimney hood.

Any proposed works to remove or reduce the bressumer would be considered to pose an unacceptable threat to the historic fabric of the building.

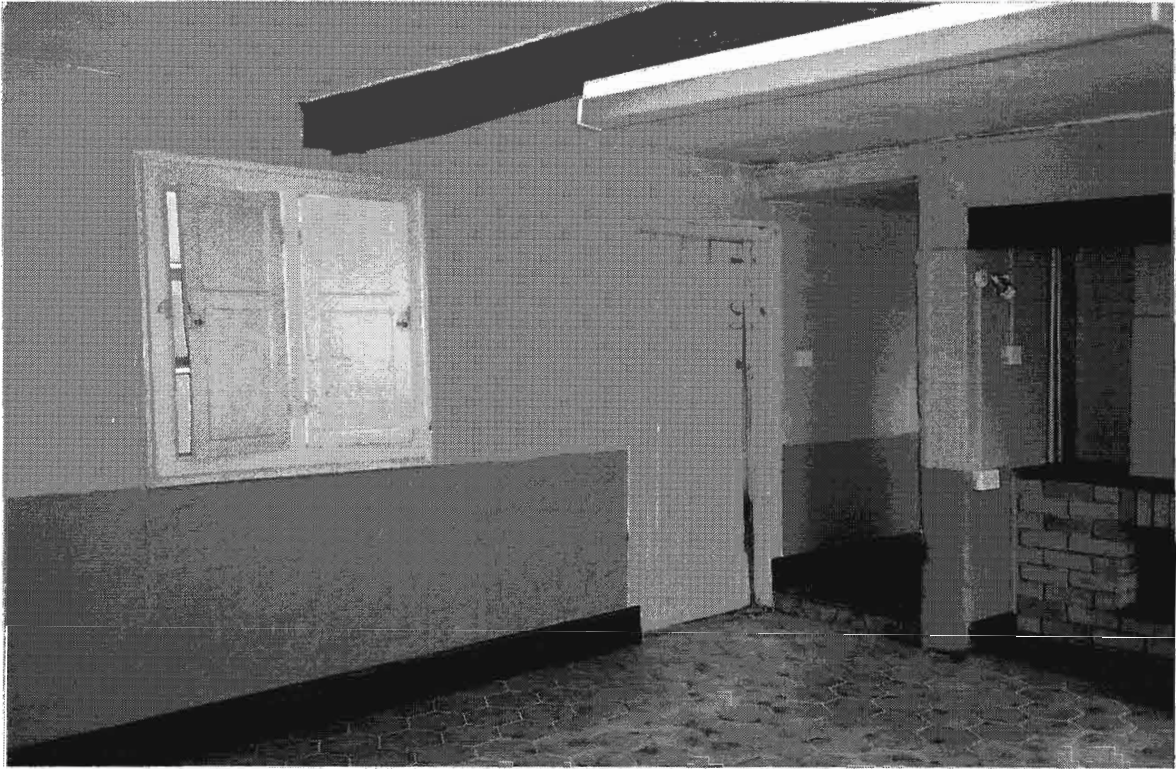
Plate 7 Interior detail of room G 4, looking towards fireplace and rear of building. Showing the plank and ledged door leading into G 6, Pantry, panelled doors of the wall cupboard, access to G 7 and part of chimney hood bressummer.

The doorway has a pegged frame with a ledged and planked door with hand-wrought iron-work. In terms of diagnostic details the doors best face is that to the rear, i.e. *G 4*. In order to retain the greatest amount of information concerning the door it is recommended that the wall to seal this doorway should be on the hallway side.

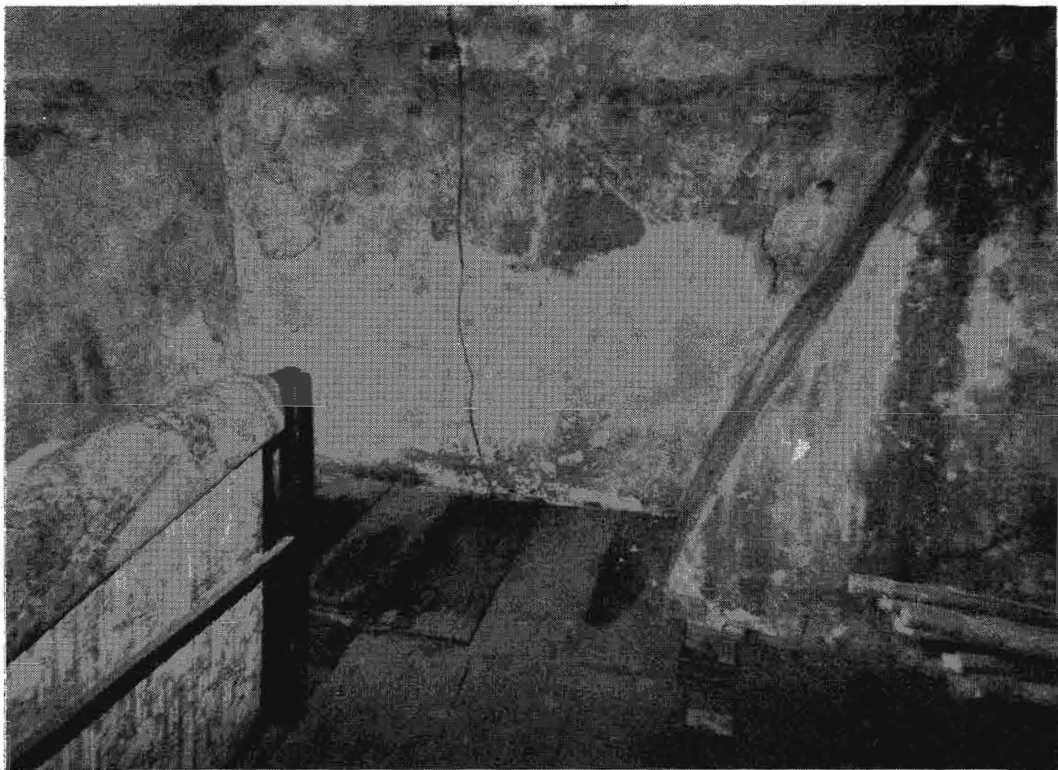
F 9, forms the single chamber at the end of this range. It is lit by a single, three light window overlooking the farm-yard. This room can be accessed by the service stairs rising from the Scullery or by passing through *F 7*. As far as can be identified, this chamber is floored with wide, hardwood boards. The hooded, chimney breast from the Scullery fireplace passes up the gable wall of this chamber, (*see Plate 10*).

Plate 10 Detail of chimney hood at F 9 with stairs rising from G 7 to left and a section of the wide, hardwood, planked floor in foreground.

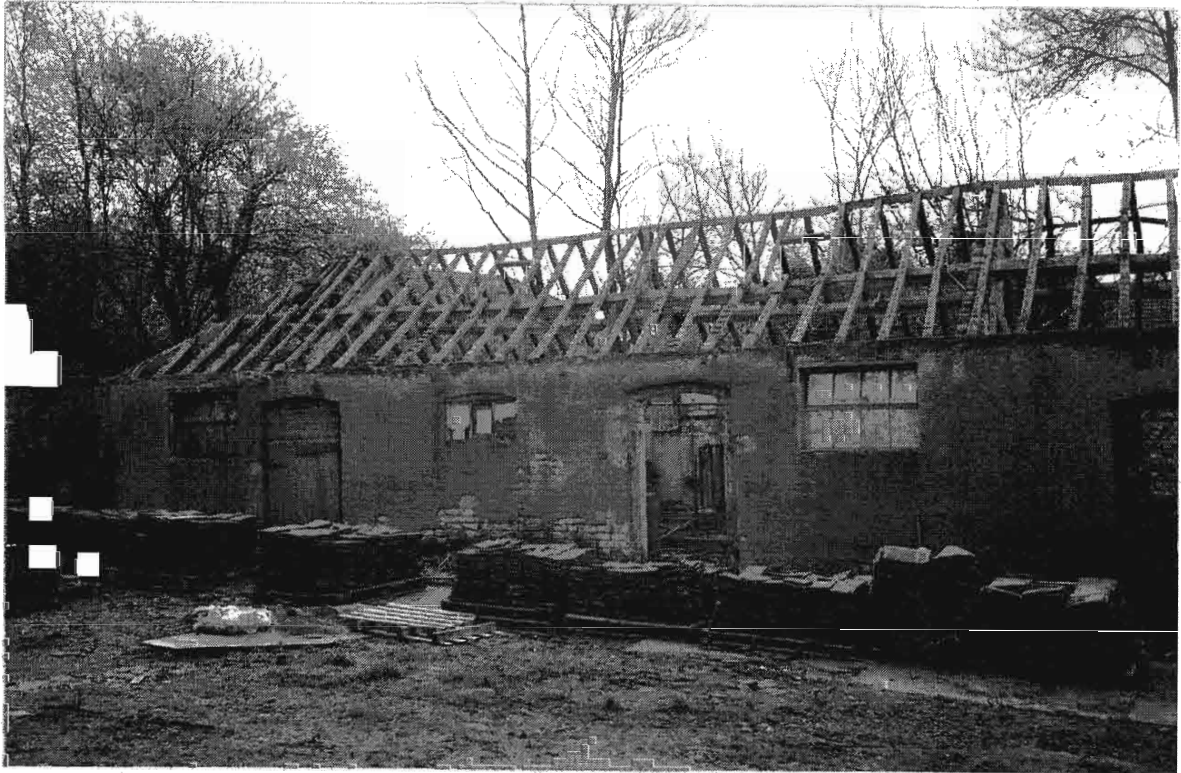
This later, three-bay range of brick building, has a hipped roof at its east end and was gabled at the west end. The building, which is not recorded on the 1806 Enclosure Award map, (see Fig.2), appeared to have been part of a Dairy unit and, despite having been extensively 'slighted' still retained some of the original tethering stalls. The roof was supported by an internal partition brick wall and two, deal, through-purlin, bolted king-post trusses with raked struts rising from adjacent to the foot of the king-post. The three ledged and braced, access doors from the farm yard all had segmental heads to them. Additional internal light was provided by two, eight paned, fixed light windows and a segmental headed, three pane window. This range of building had a mortar rendering.

Plate 13 General view of part of Barn A, showing hipped gable at its west end and conventional type of windows and doors present.

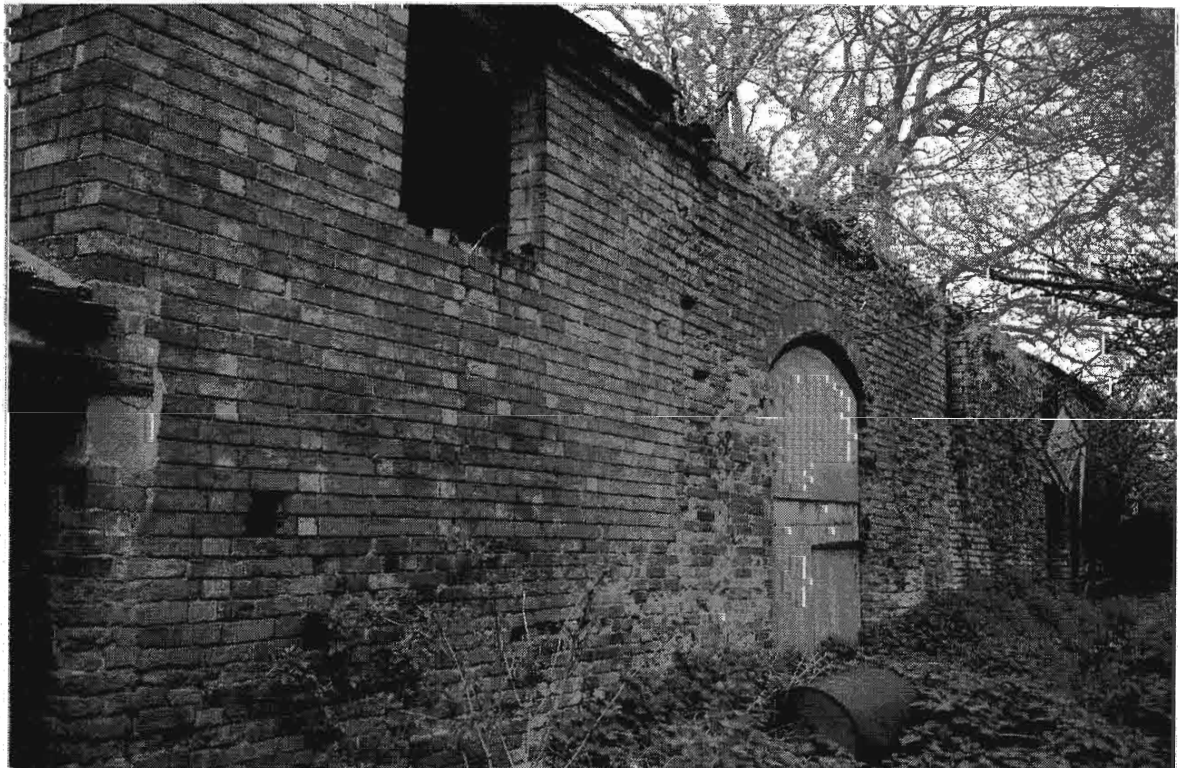
This is the principal building of the yard complex and is a two storey, three bay, brick barn with clay tile roof, having three courses of stressed brickwork at the eaves. The end bays of the Barn are partially boarded over. Externally much of the brickwork of Barn B, particularly that on the east elevation was in a poor condition, (see *Plates 14,15*). Externally and more particularly internally, Barn B's walls bear testimony to changing practices in farming over the two hundred years of its existence, many of which required adjustments be made to the fabric of the buildings. The central bay of Barn B is separated from the other two bays by a pair of flank walls, (see *Plate 16*), and has single, opposed, ledged and braced, wagon entrance doors with arched heads. A square headed doorway with overlight gave access into the north, end bay of the Barn and a segmental headed doorway with ledged door gave access to the south, end bay.

Plate 14 Rear, i.e., west elevation of Barn B with single, wagon entrance door and showing the severely weathered condition of much of the brickwork

The proposed works appear to effectively remove Barn B's few surviving, diagnostic details, particularly the roof structure. While it is acknowledged that the brickwork of several areas of the barn as existing is severely decayed the extent to which the proposed works replace historic material with modern is extremely radical.

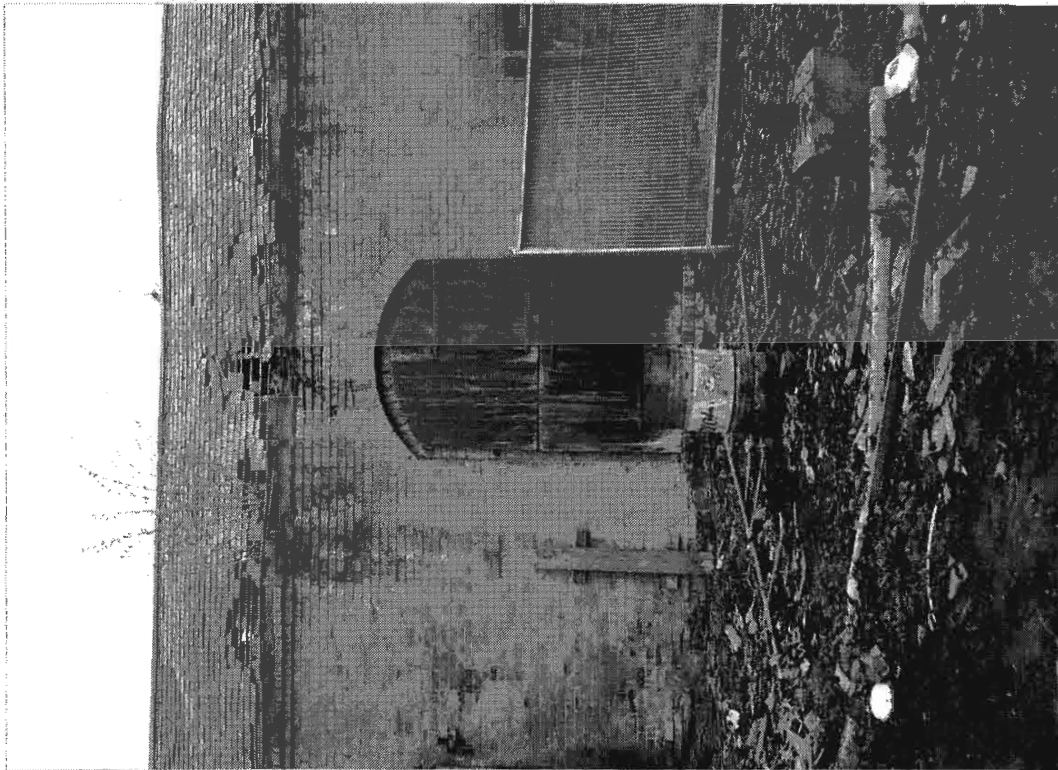
Plate 15 Front elevation detail of Barn B, showing the single, wagon entrance door with arched head. Detail of the eaves brickwork is visible where the roof tiles have slipped.

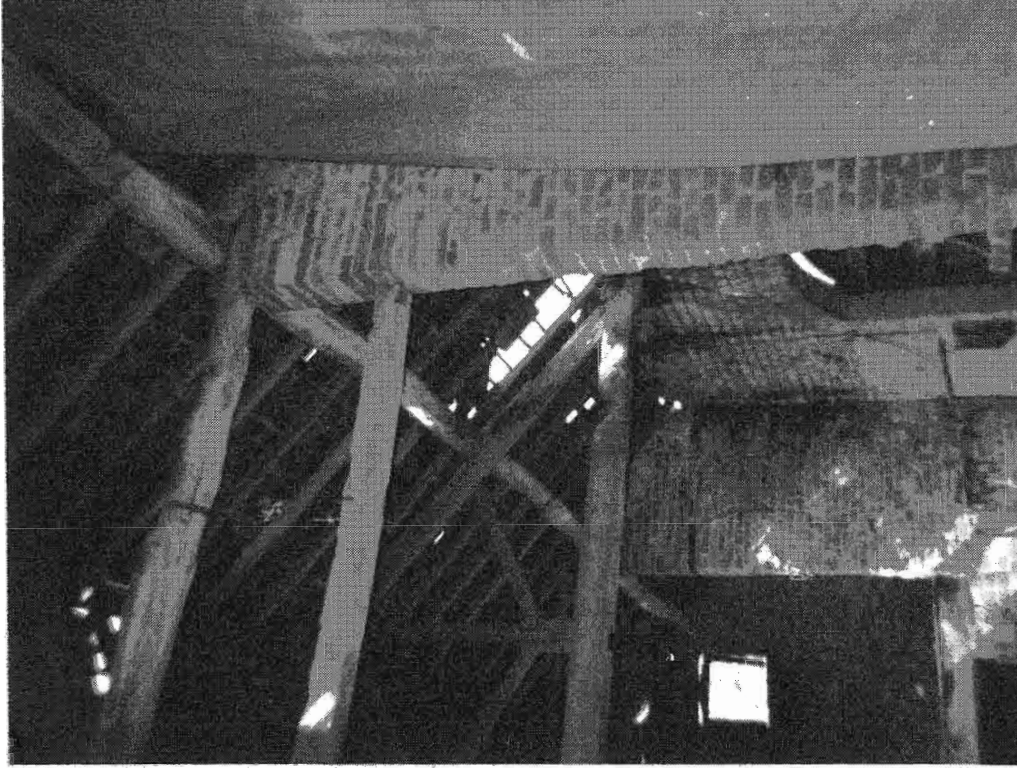
The roof Barn B is supported by a single, through purlin, deal, bolted, king-post truss with raked struts stepped from the swollen base of the king-post, (see *Plate 16*). The purlins, most of which appear to be hardwood, are also carried on a pair of tie-beams spanning the interval between the brick stub walls that defined the wagon entrance area of the barn. The south, gable wall of Barn B retained some earlier brickwork which included a series of four, segmental arched recesses that may originally have been open, (see *Plate 17*). The function of these four features remains unexplained. A suggestion that they may have been bee-boles seems unlikely as they are set close to the ground and would have been adjacent to one of the farm's major thoroughfares.

Plate 16 Interior detail of Barn B showing the brick flank walls at the wagon entrance bay and single, king-post roof truss.

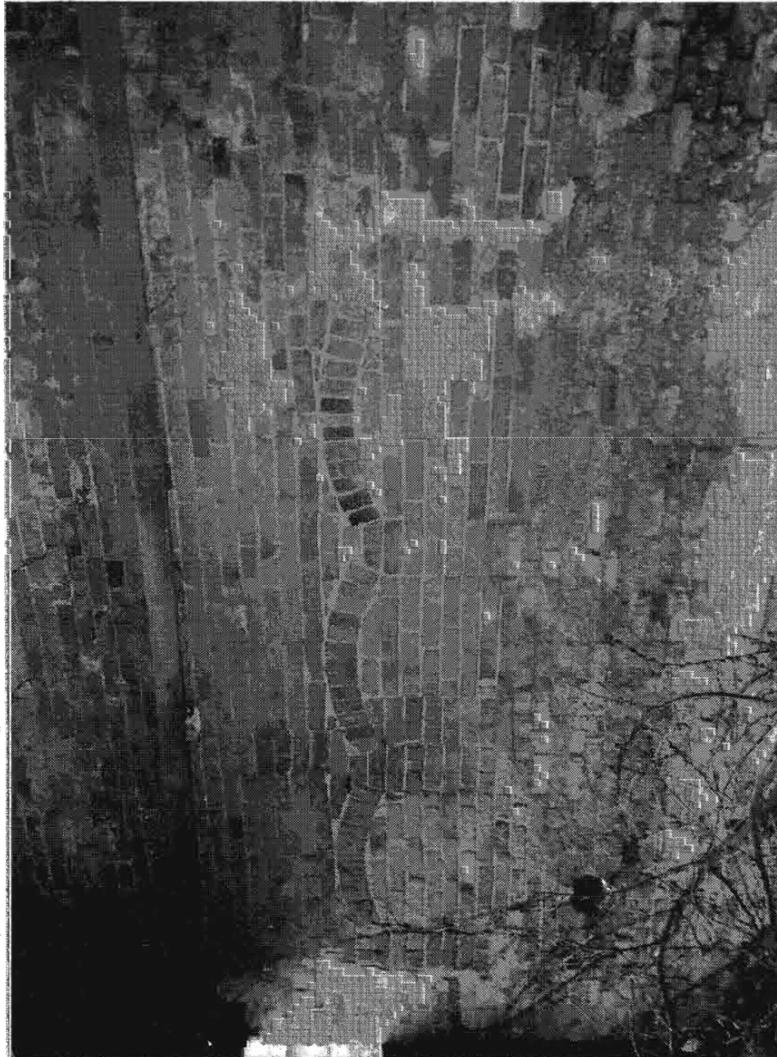
Plate 17 Detail of the series of late, C18 brick arches with C19 blocking set into the south, gable wall of Barn B.

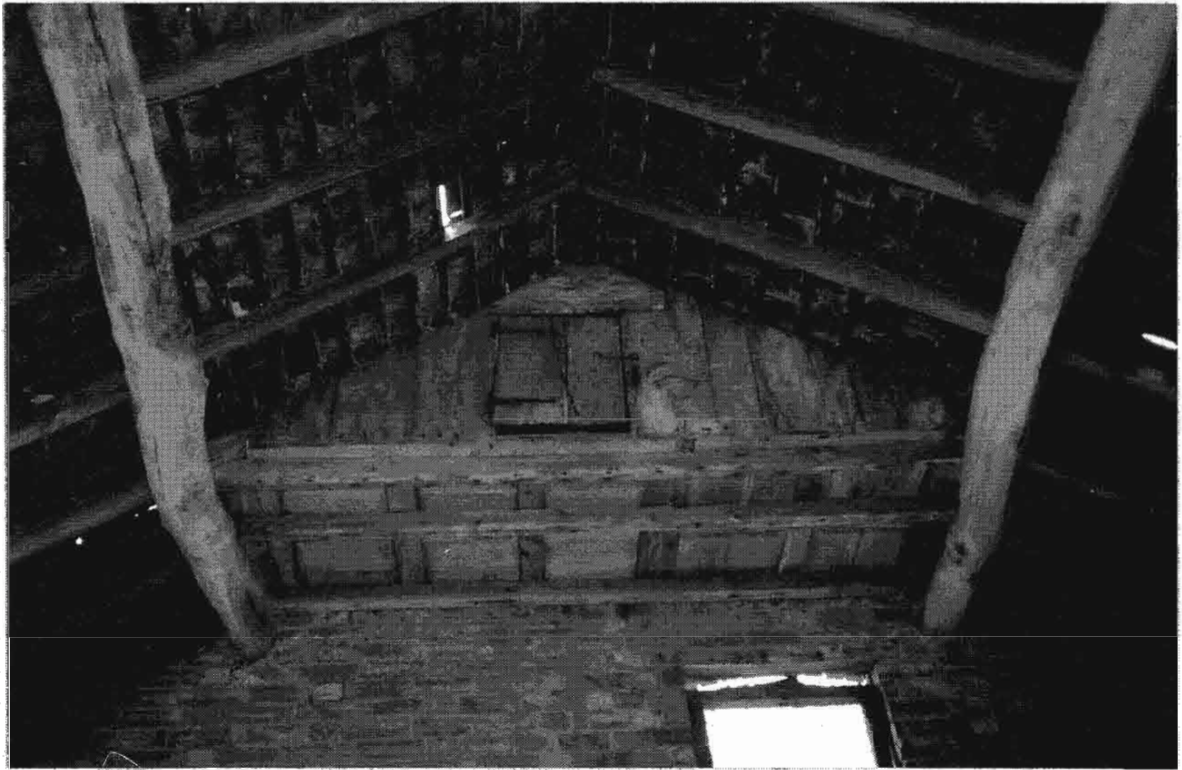
In the peak of the south gable of Barn B a series of eight, snapped, header bricks are set at the base of individual access holes of a pigeon loft. Internally at the peak of the gable there is a rare survival in the form of a wooden, boarded pigeon loft set on the topside of the purlins. This appears to be part of the original structure of the barn. An access door into this area is hung on strap hinges. At present there is no access to this feature which appears to be in comparatively original condition, (*see Plate 19*).

Plate 19 View of the late, C18 pigeon loft, supported by the topside of the purlins and set in the apex of the south gable of Barn B.

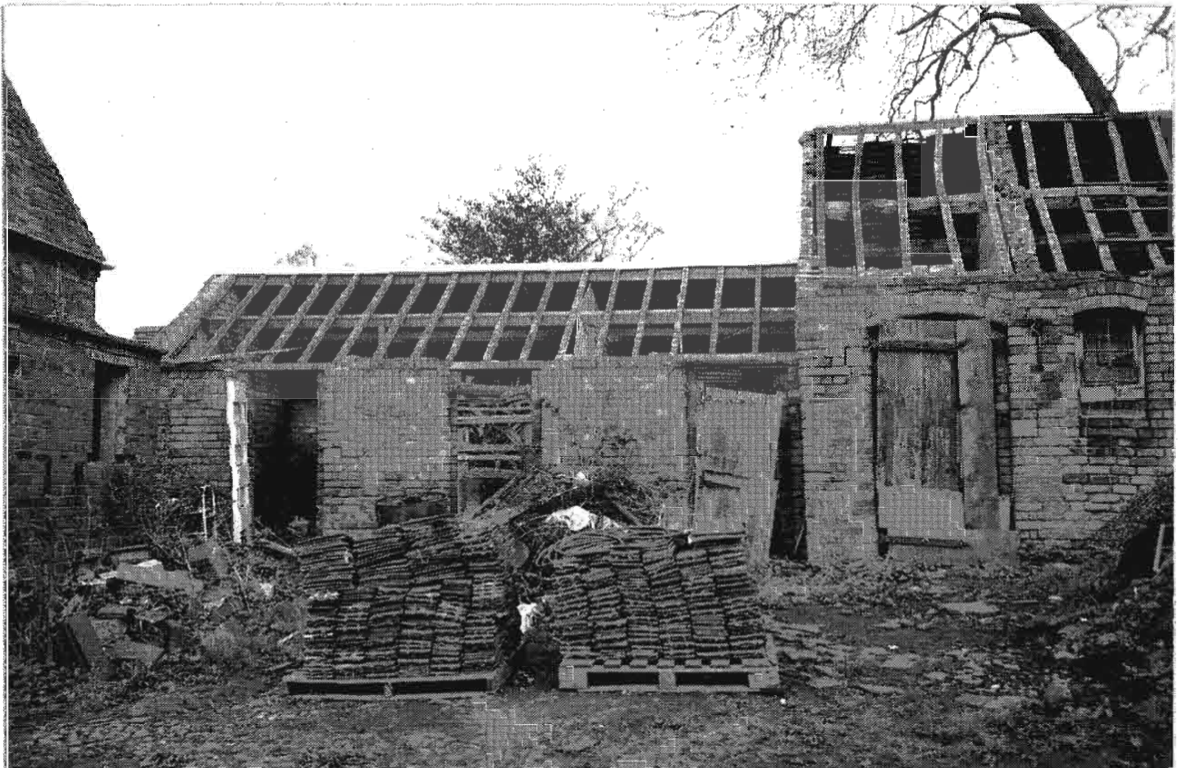
The range of brick building identified as Barn C consists of two distinct units of stock accommodation set in line. The larger group of buildings contains four bays of building and a smaller, shorter run of two unequal bays of building lies to the west, (*see Plate 20*). The range seems to originally have been built as stabling and loose boxes for both the farm and house horses and the rear wall of the larger range of buildings had a series of brick mangers to it. A short bay at the east end of the larger unit of this range was probably a house horse stable. As observed in the notes of Barn B, (*see above*), there may have been a horse-grooms bothy at first floor of the west end of this range. The boarded doors of both units were ledged and hung on industrially produced strap hinges whose hooks were set into sandstone blocks built into the Barn walls. The doors and windows of the larger part of the range had segmental heads to them. The windows were six light, cast frames and had two rows of chamfered, blue bricks serving as soffits. The smaller unit, which had no windows to it, had three, plain framed door-heads with ledged, half-doors.

Plate 20 General view of Barn C, showing the two different dimensions of stables and loose boxes to right and stalling for cattle to left.

The proposed works respect the greater part of the existing fabric and layout of this range though the proposed designs of the doors and windows fail to draw references from the local vernacular tradition. Refurbishing for residential use will require the removal of all the brick mangers set alongside the rear, i.e. north wall of this range.
