**Archaeological Fieldwork for the Earl Shilton Bypass,
Leicestershire:
Site A, off Elmesthorpe Lane, Elmesthorpe
(SP 460 966)**

ULAS Report No 2009-085

**Wayne Jarvis, with contributions from
Nicholas Cooper, Leon Hunt,
and Deborah Sawday**

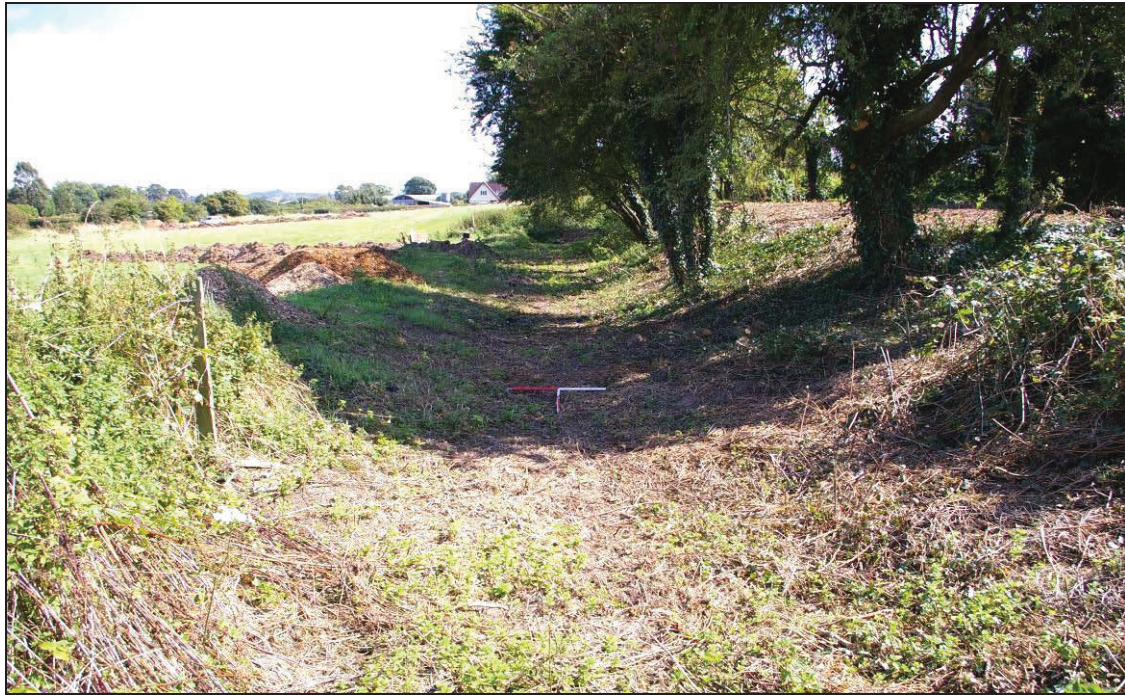
Plate 4, Main ponds (right) looking east along east-west ditch line („quarry scoop’), prior to clearance

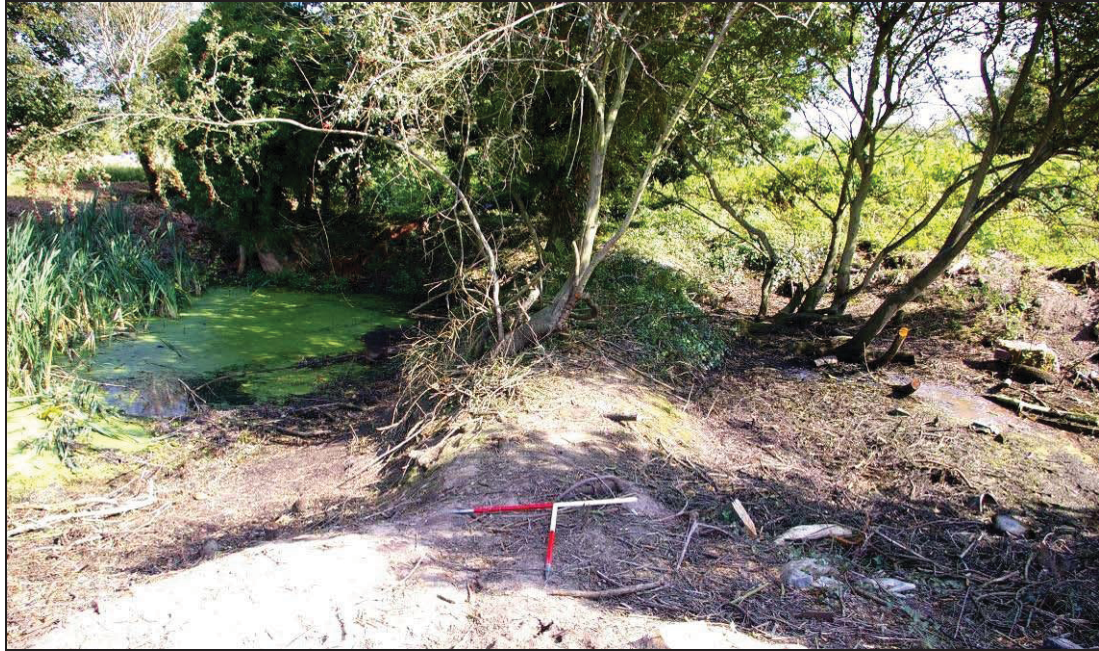
Plate 5, Interior of ponds looking east along partition between pond 1 (left) and Pond 3 (right), prior to clearance.

numbering on Fig. 5) always remained wet. The ponds were clearly watered from one or more natural springs that rise in the slope north of Church Farm, with water running freely through sandy layers in the natural substratum. At the start of works the ponds were covered with dense vegetation, including tree cover. All the ponds had some infill of modern rubbish, with the south-west pond (Pond 3) being the most full.

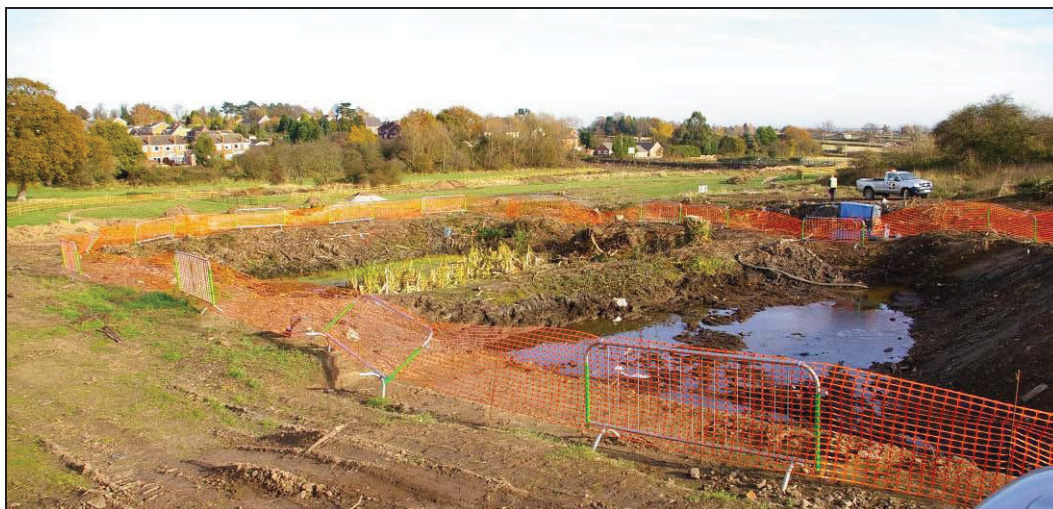
Plate 7 The ponds after clearance and removal of modern landfill, looking north-east. Foreground Pond 3 (flooded), left Pond 1.
