**An Archaeological Standing Building
Survey Of The Former Lace Factory,
Oxford Street/Regent Street, Long Eaton,
Derbyshire (SK 48960 33771).**

ULAS Report Number 2006-XXX

Summary

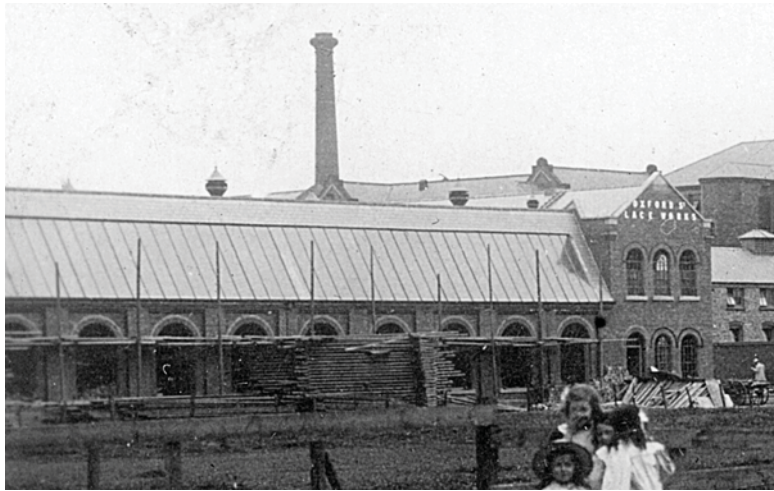
Figure 3. Oxford Street Works c.1907 (Photograph Supplied By K. Reedman).

The first of the recorded buildings (*Building 01*) fronted onto Oxford Street on the northern edge of the proposed development. The building is a single storey red brick building with a north light roof of Welsh slate. The Oxford Street frontage is rather ornate in appearance, with large arched windows, decorative blue brick detailing and red brick corbelling and English bond brickwork.

The windows themselves are steel framed semi-circular arched windows with a central four light opening resting atop carved sandstone sills, almost full length. Of which, thirteen still remain intact. There is a single course of decorative blue headers included within the arch above the window. At ground level there is a blue brick plinth six courses deep with a splay header top course. At eaves level there is two courses of red brick corbelling. Towards the centre of the existing frontage a double

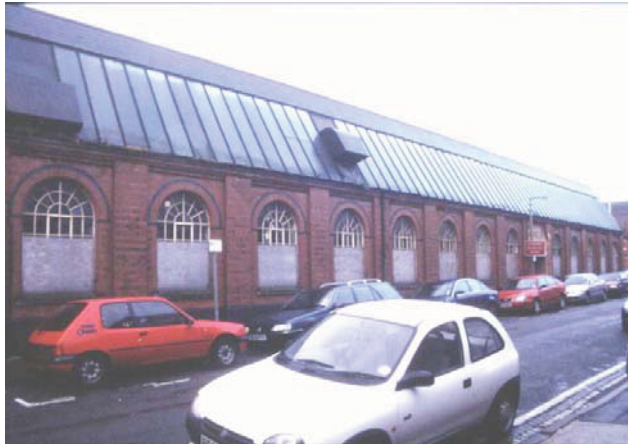
Figure 4. Oxford Street Frontage (Building 2).

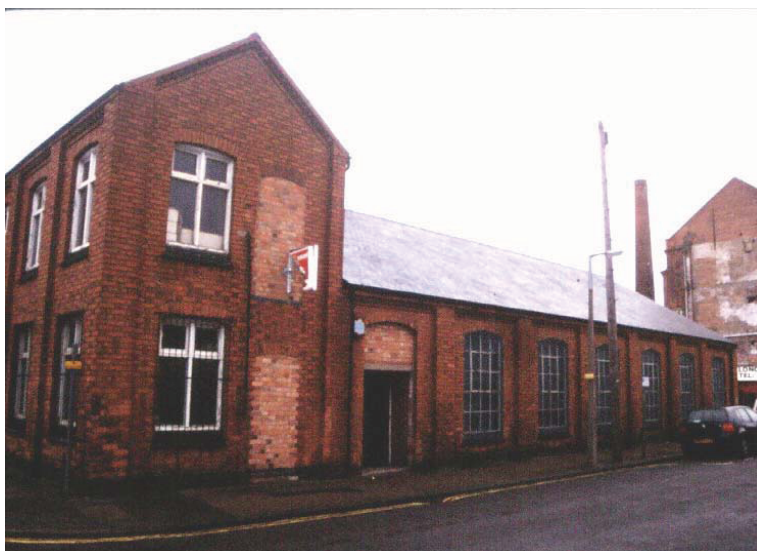
Building 2 is set back from Oxford Street, fronting Fletcher Street and was originally New Mills; what is now the front of the building originally abutted the rear of Oxford Street Works. As with the Oxford Street Works, New Mills is a single storey red brick building with a north light roof of Welsh slate; it is much less ornate than Oxford Street Works, but still aesthetically pleasing. The brickwork is Flemish bond with decorative corbelling and cambered arched windows with splayed blue brick sills, three courses deep and a blue brick plinth with a splayed top course. There are six intact steel framed windows with a central four light opening, a seventh window, to the left has been partially blocked and a door inserted.

Figure 5. Regent Street Frontage (Building 2)

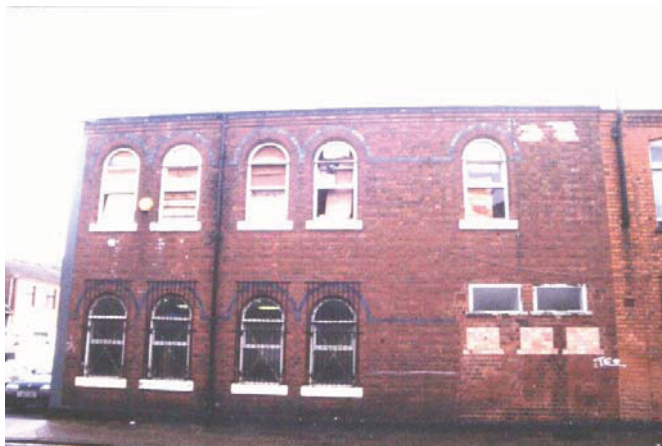
Building *3a* consists of a two storied red brick building with a mono-pitched roof of Welsh Slate. Stylistically the exterior of the building is identical to building 1, the only difference being the windows are timber sash, one of which has been blocked at ground floor level. Only approximately half of the building remains, the gable and rear wall have recently been clad in corrugated steel sheets.

Figure 6. Fletcher Street Frontage (Building 3a).

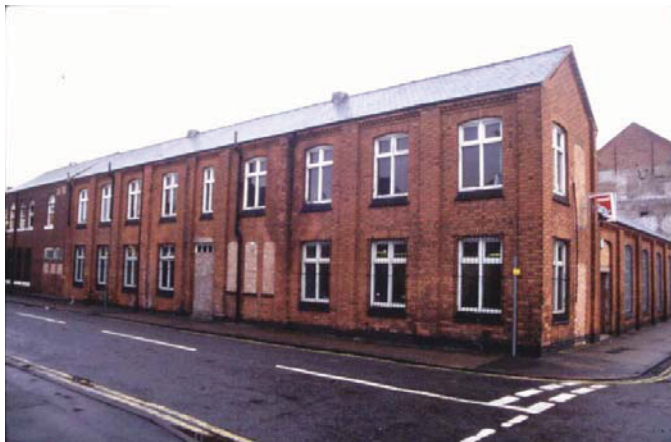
Building 3b was originally part of New Mills and unlike building 3a and appears to have remained largely unaltered. Stylistically it is identical to building 2, and again much less ornate than building 3a. What appears to have been the original pedestrian entrance on the Regent Street gable has been recently bricked up, as has a first floor entrance directly above.

Figure 7. Fletcher Street Frontage (Building 3b).

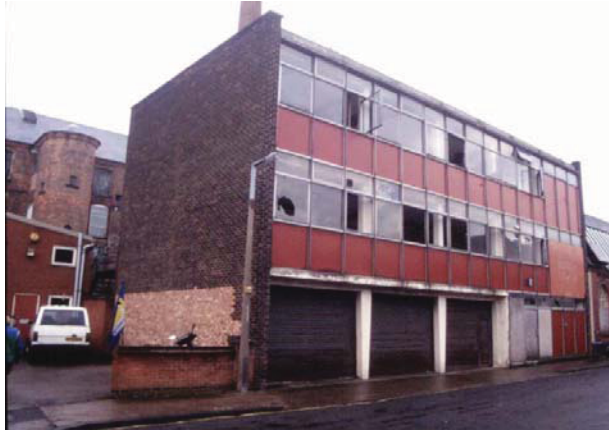
The final building within the proposed development area is building 4; a three storied building fronting Oxford Street, to the left of building 1. The building itself dates from the 1970's and is of concrete and steel frame construction with a half glazed frontage and flat roof. The ground floor is a loading bay over which are two floors of offices.

Figure 8. Oxford Street Frontage (Building 4).

The building was in a very derelict condition with serious pigeon infestation no close internal inspection was carried out. An external examination indicated that the ground floor acted as a loading bay; vehicle access was via three steel roller shutter doors to the left and there was a pedestrian entrance on the right, first floor access was via a stairway on the right hand side of the building. What was visible of the upper stories were in a very poor state of repair with very little in the way of identifiable architectural features; other than the ceilings, which were of suspended polystyrene tiles.
