**An Historic Building Assessment and Record  
of the Standing fabric forming the Grade II\*  
Listed Building known as Bradgate Stables  
(Bradgate House) Groby,  
Leicestershire (SK 092 517)**

University of Leicester Archaeological Services

Report No. 2006/055 ©2006

**AN HISTORIC BUILDING ASSESSMENT  
AND RECORD OF THE STANDING FABRIC FORMING THE  
GRADE II\* LISTED BUILDING (NOW RUINOUS)**

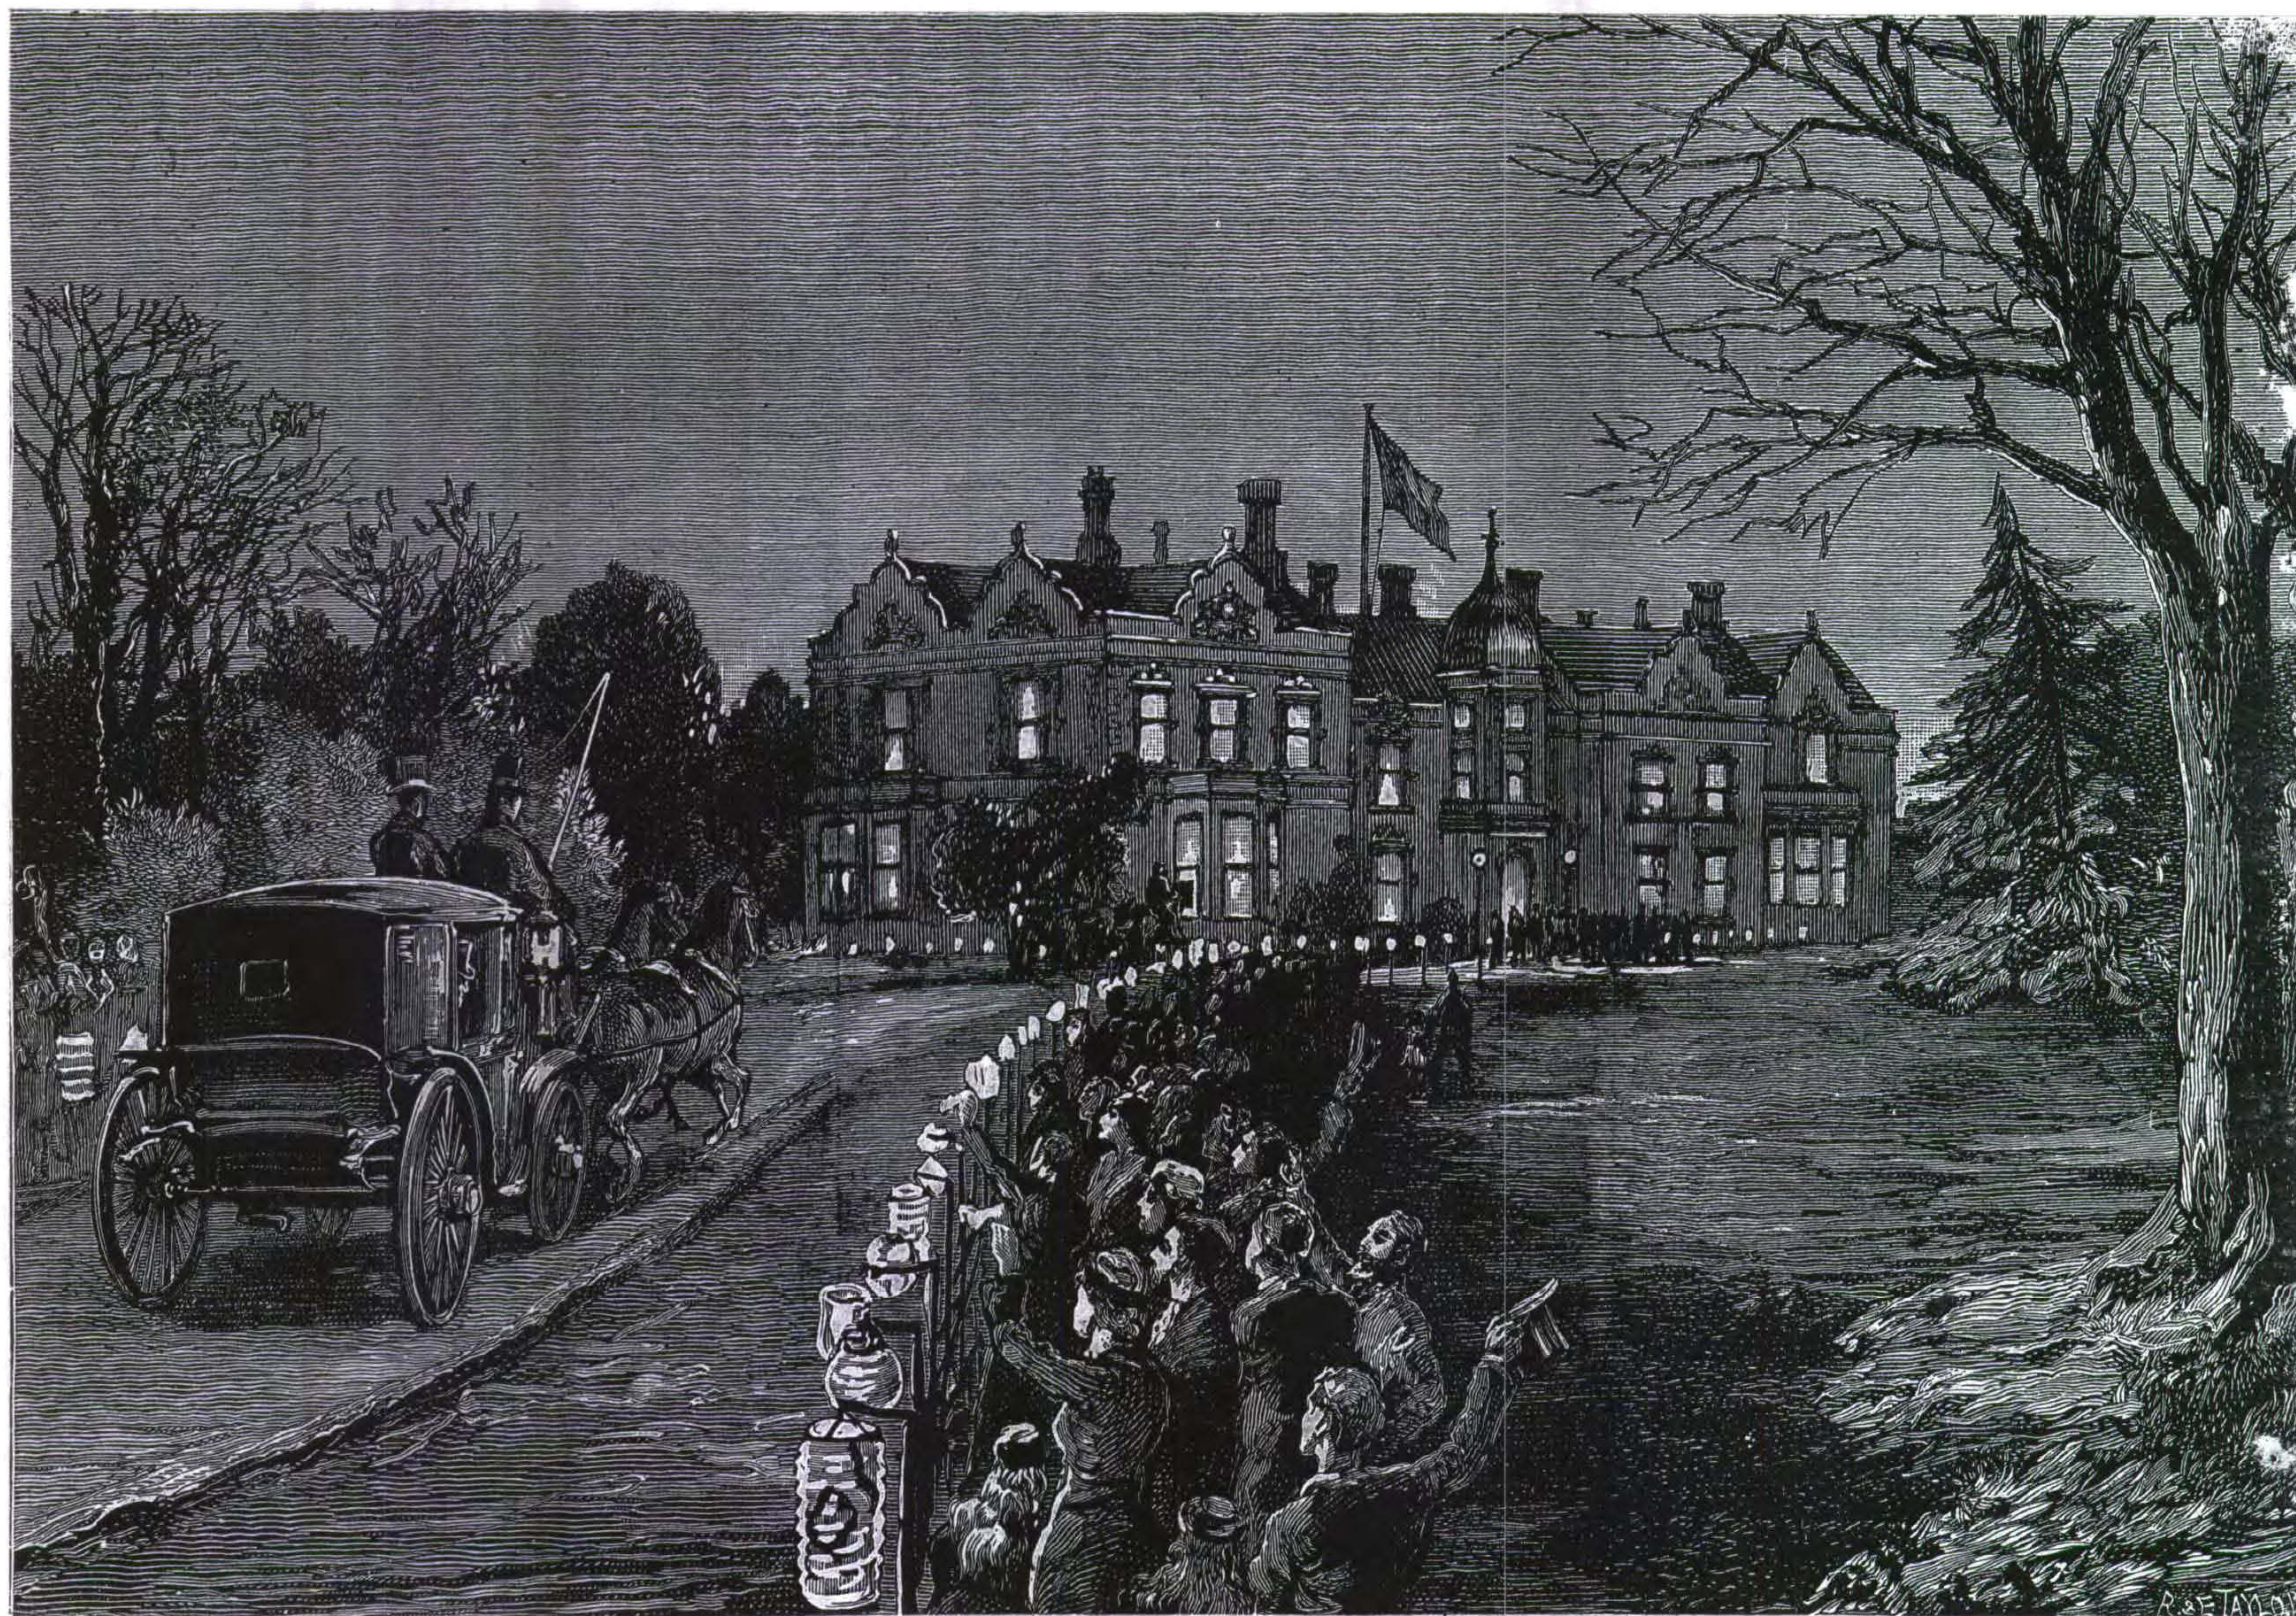
*Insert Illustration 1* Family group with two children sitting on the stag silhouette and a centrally positioned gas lamp to the left of the group. The leather apron on the man would suggest this is the family of George Fitchett who was the Estate's Farrier - c.1861 – c.1887. The five doors of the Carriage House in the North Range, with two first floor pitching doors, can be seen behind the group.

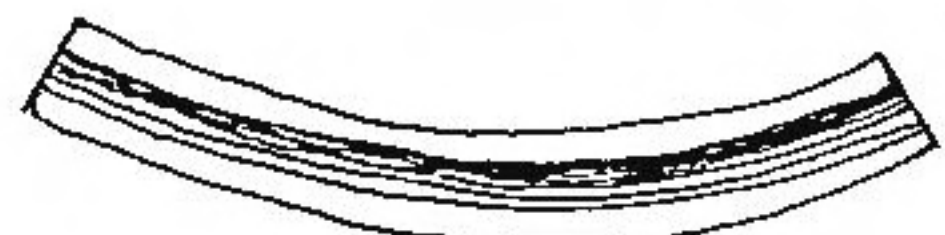
S 4 Pediment coping stone sections

*Recorded displaced*

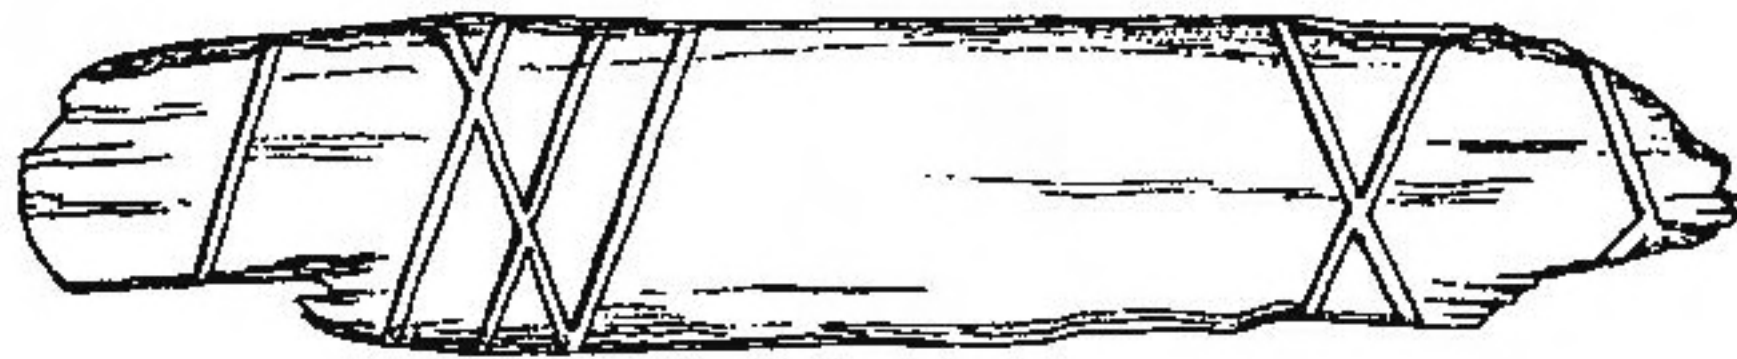
*Fig. i* Section of floor board with a parts of a series of rase mark minims.  
*Fig.ii* Rase mark minims and possible numeral 4 incised on a salvaged floor joist.

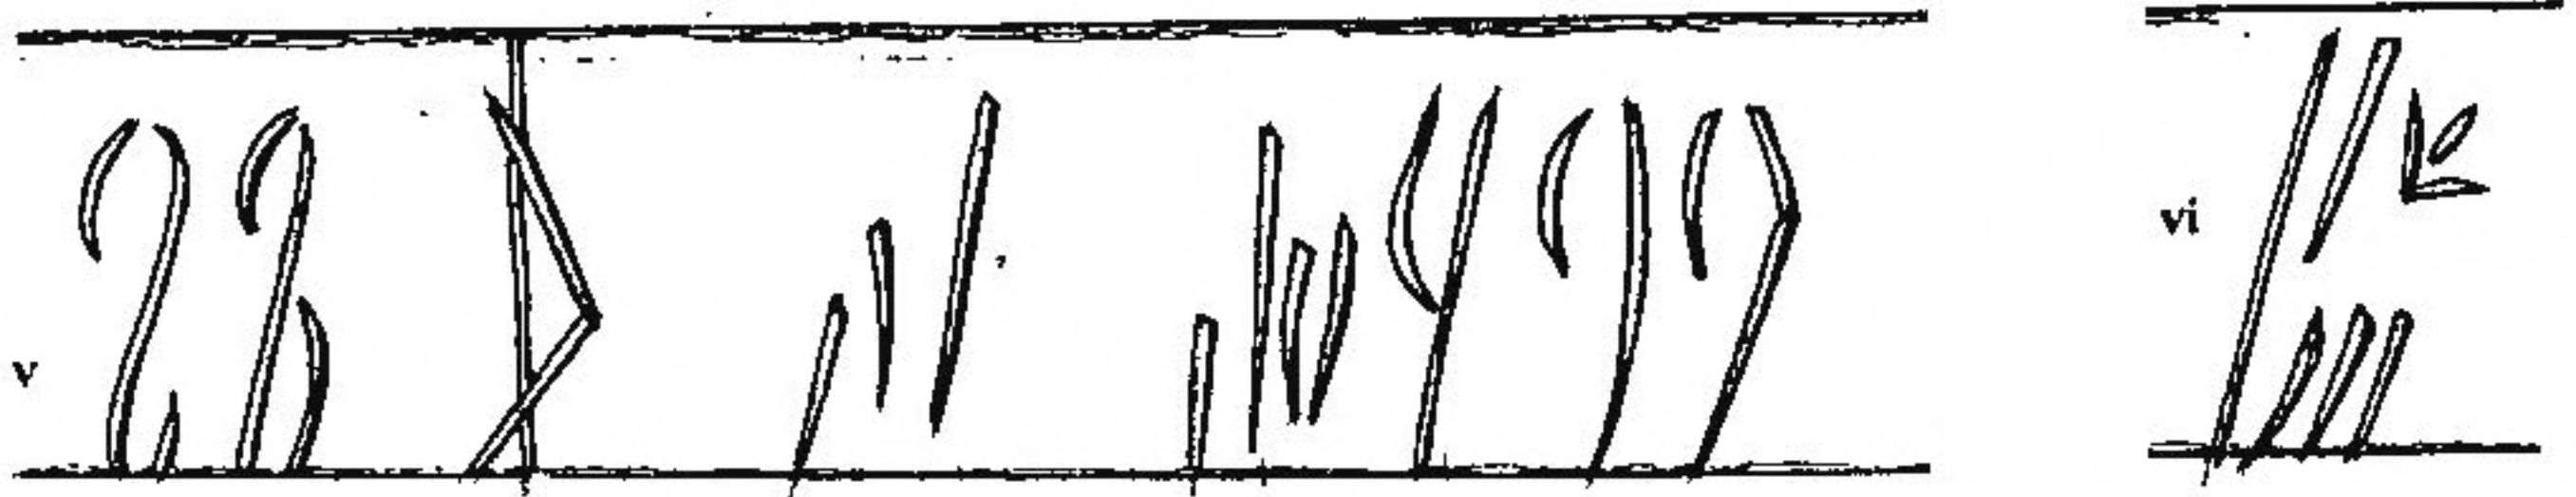
vi

**Fig. v** Tie-beam section with numerals 8 8 (Left) and 4 9 9 (Right).  
**Fig. vi** Additional series of marks at the right end of the same tie-beam.  
**Fig. vii** Demolition cut section of tie-beam carrying the numerals 0 9 or 6 0.  
**Fig. viii** Section of rotted tie-beam with two groups of minims with arms that may denote batch marks for a consignment of twenty two items, also the numerals 1 9.  
**Fig. ix** Back-to-back crescent forms situated at the end of the only roof truss that survived, in situ, in the north-west corner of the West range.

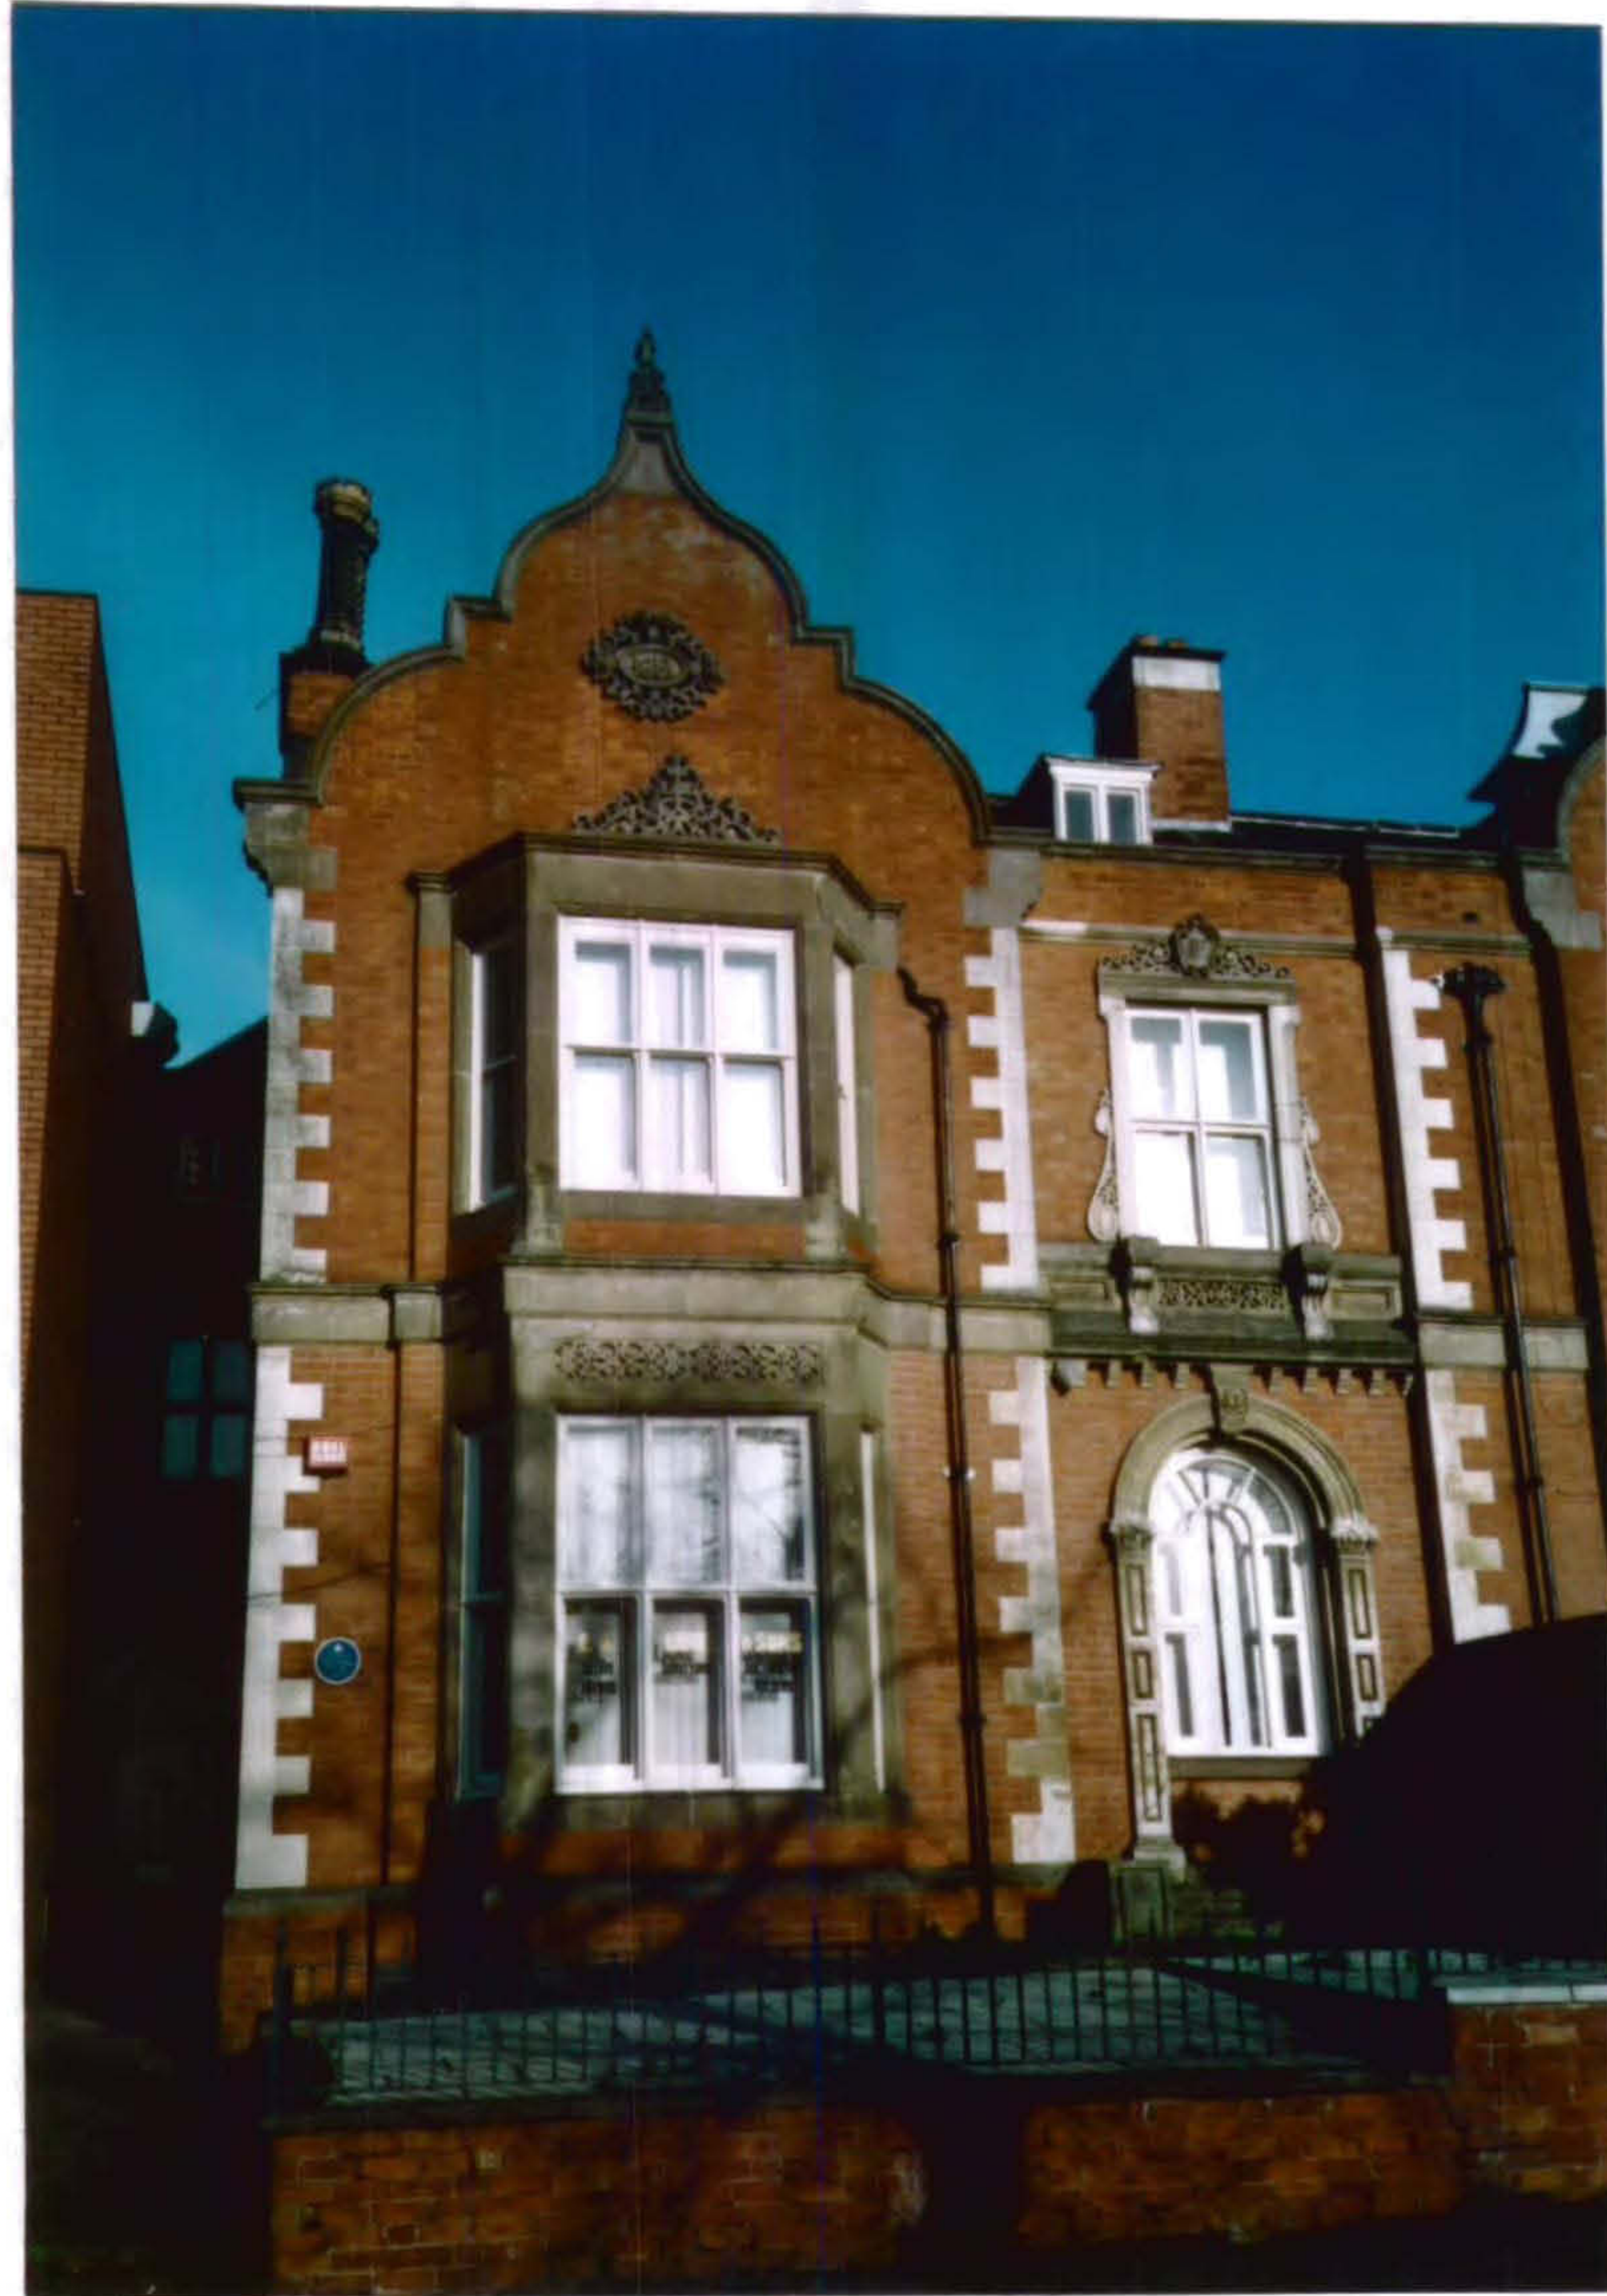
*Plate 1 Leicester : 100 Regent Road showing decorative details of a similar type to those used on Bradgate House and Stables. Building dated 1851.*

The newly built Bradgate House, which at the height of its social prowess employed a staff of 13 male and 16 female, indoor servants,<sup>18</sup> was the centre for numerous great house parties where shooting in Bradgate Park was the main attraction. In January 1882 the Prince of Wales, (later King Edward VII), attended a shoot at Bradgate. The occasion was reported on and commemorated by an engraving in the *Illustrated London News* of January 21<sup>st</sup> 1882. The Prince arrived at the Midland Railway Station in Leicester and was driven in an open carriage through the decorated streets of the town. The engraving shows the carriage, now with its hood up, arriving at Bradgate House in the winter twilight with the house staff and tenants lined up alongside the lantern lit carriage drive to the house where lights blaze in every window. Silhouetted against the evening sky are a series of Dutch gables and a cupola roof over the main entrance, (see *Insert Illustn. 2 after p.10*). The same details can be seen with greater clarity in a late 19<sup>th</sup> or early 20<sup>th</sup> century photograph, (see *Insert Illustn.3, after p.10*), which also shows the extensive use of decorative, strapwork ornament associated with both doors, windows and the gable ornament as well as the ornamental brickwork of the chimney stacks. Similar ornamental details, though on a much reduced scale, can be seen on No.100 Regent Road, Leicester, which carries a datestone of 1851, (see *Plate 1*).

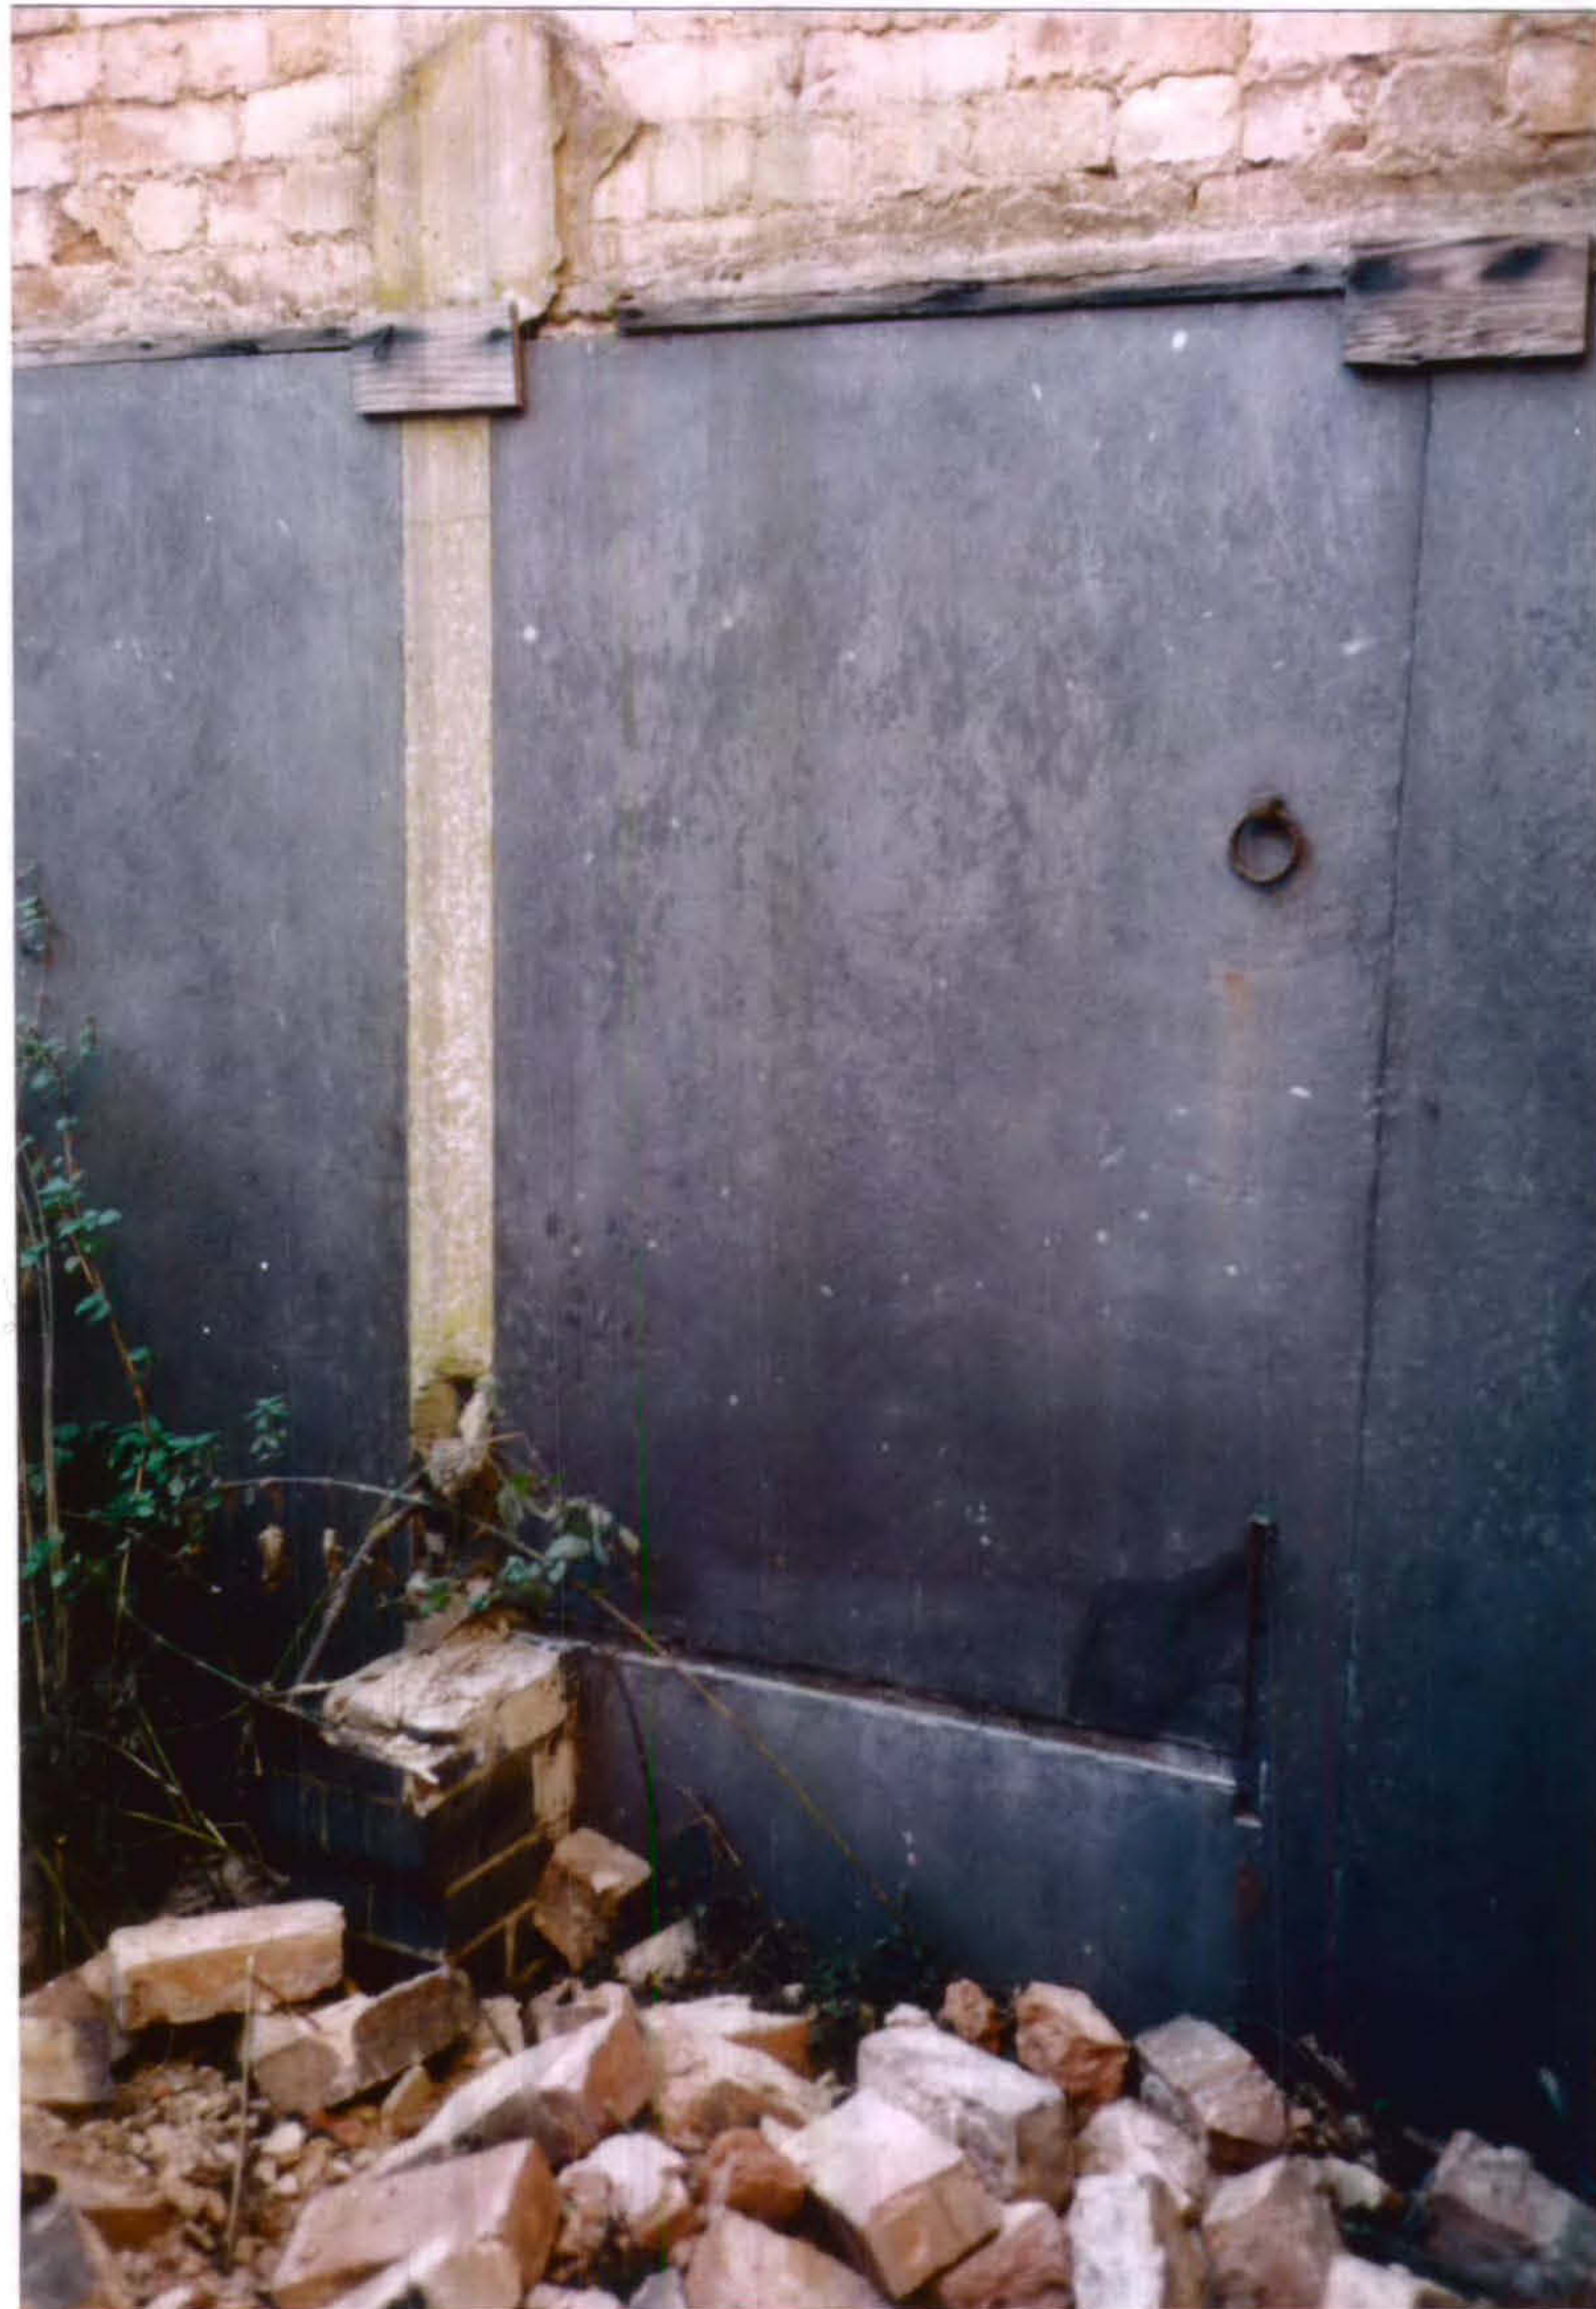
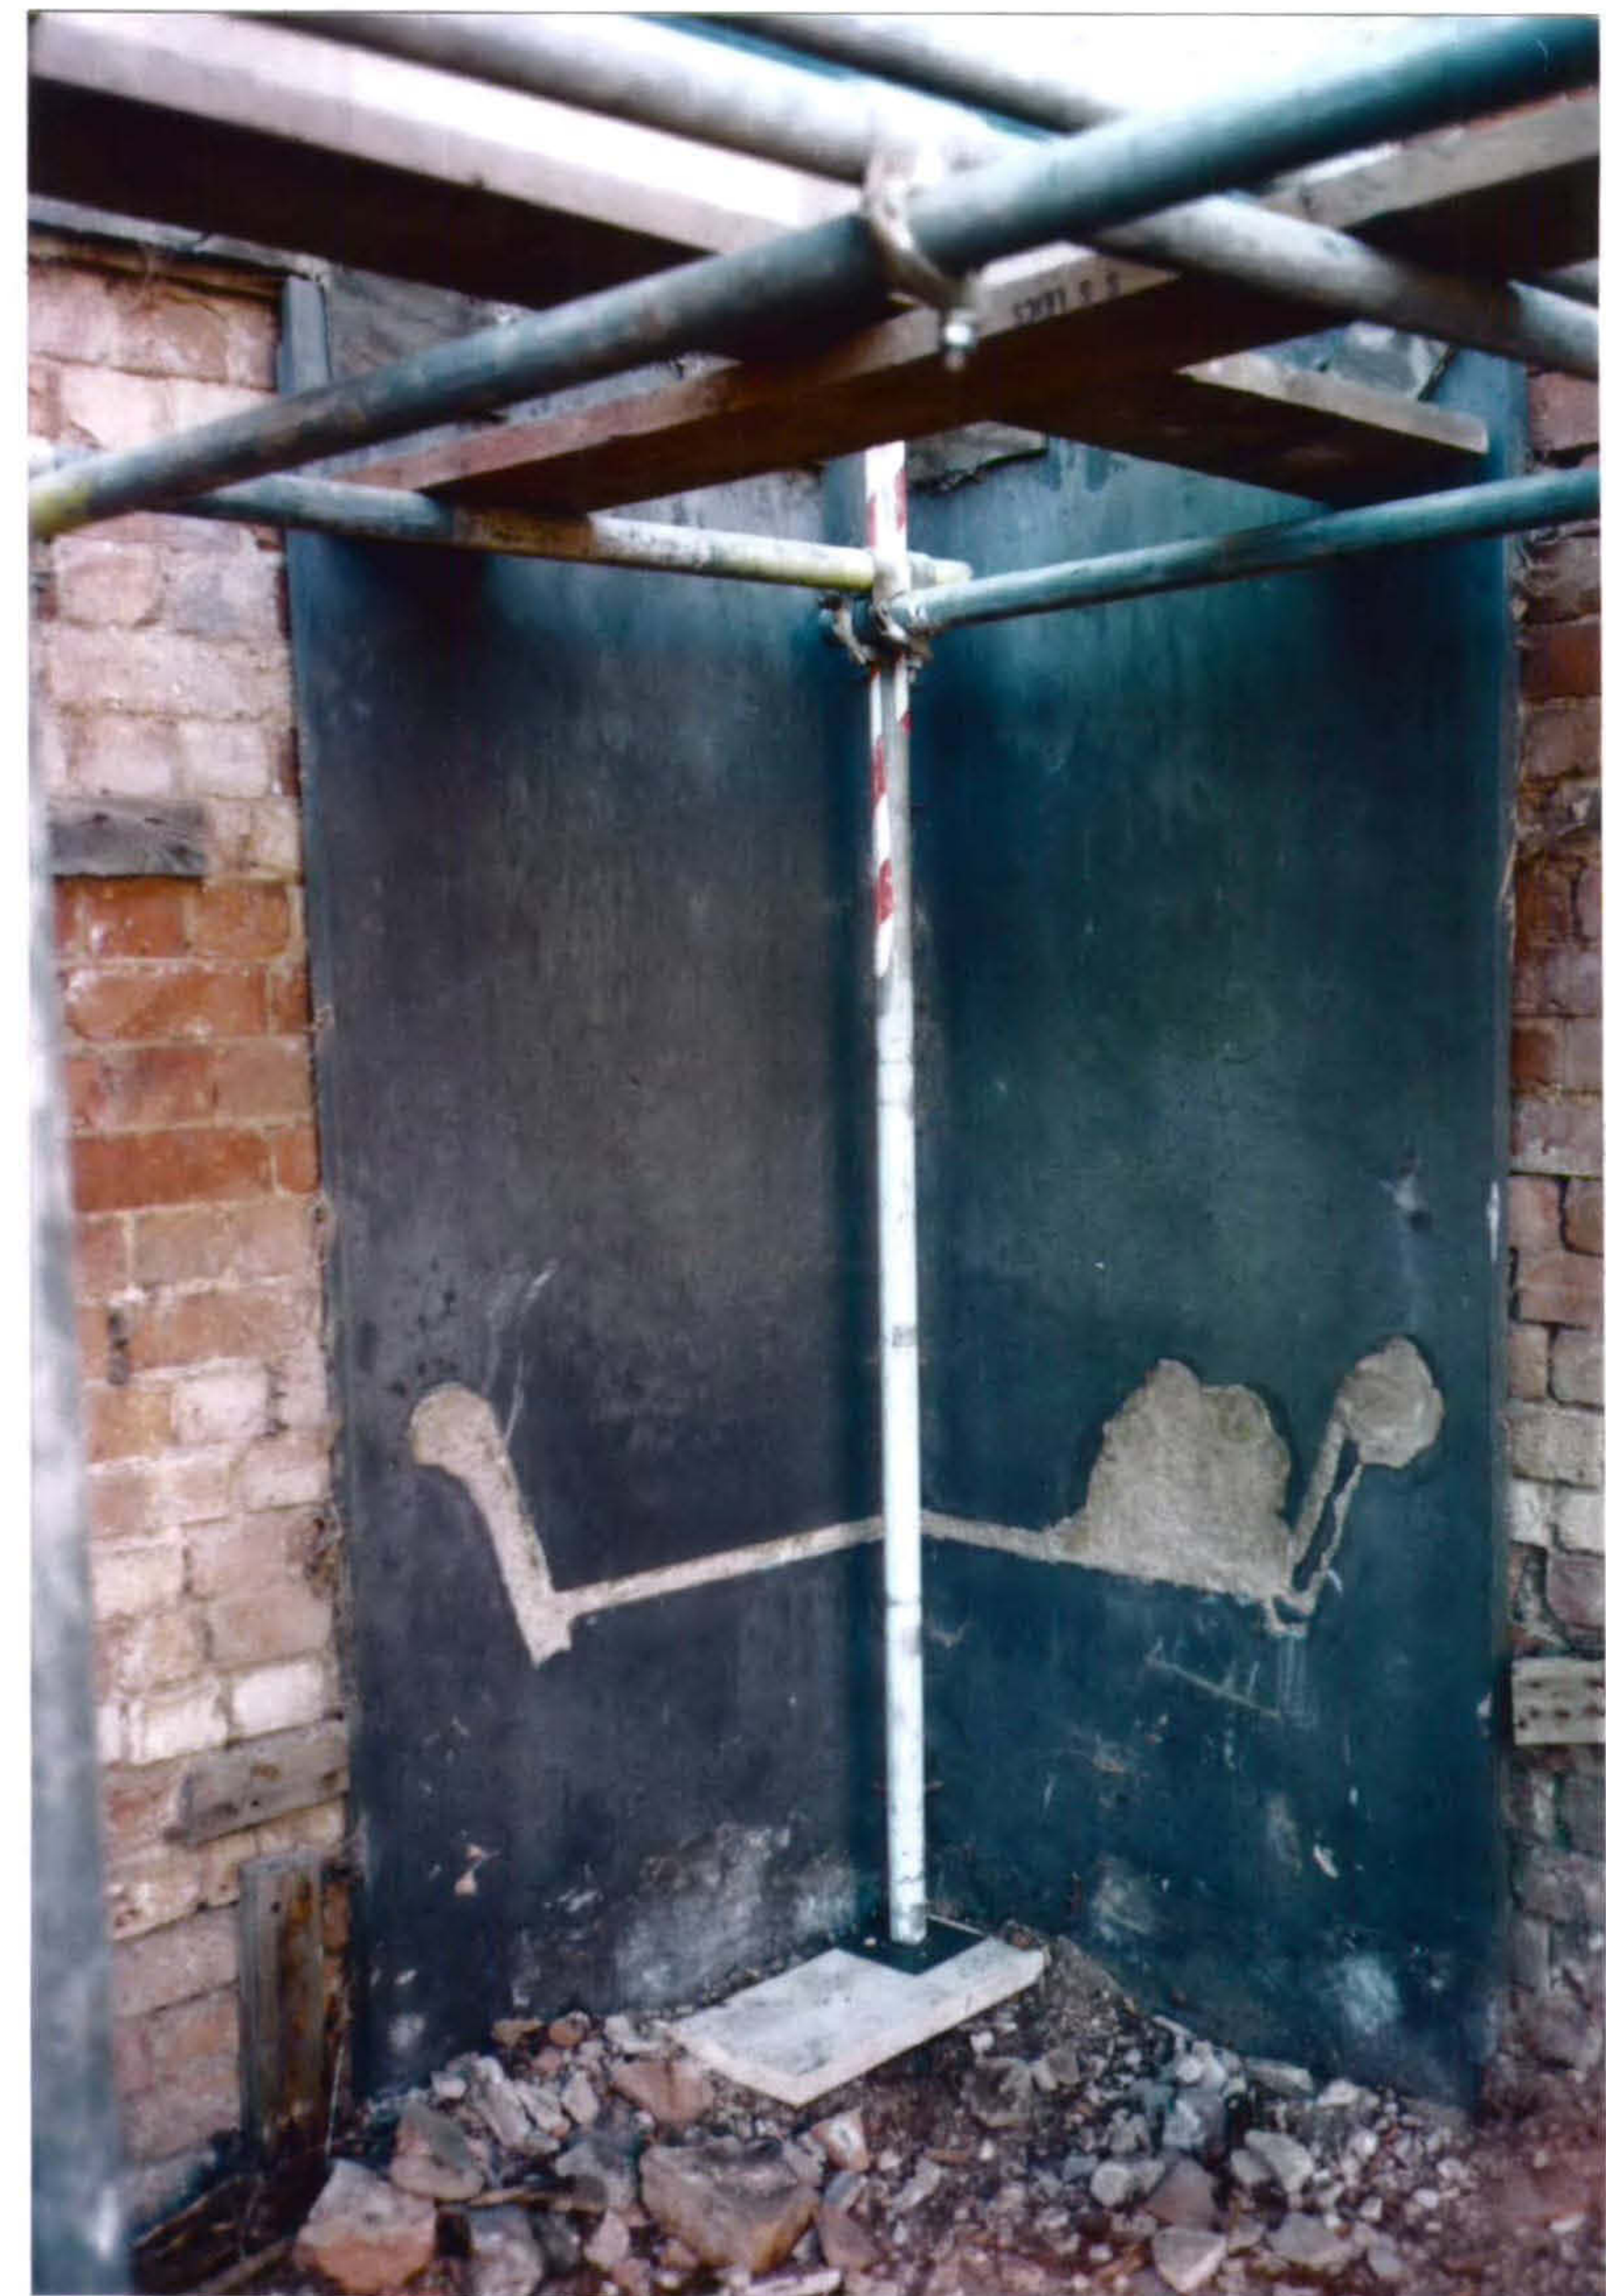
*Plates 9 and 10 showing sections of Groby Slate used to line brickwork of the Stables. Both slates have chased out sections for slate manger sections. The slab on the left has a ring for a hay-net installed. Parts of the wooden, wall-mounted battens onto which the slates are mounted can be seen.*

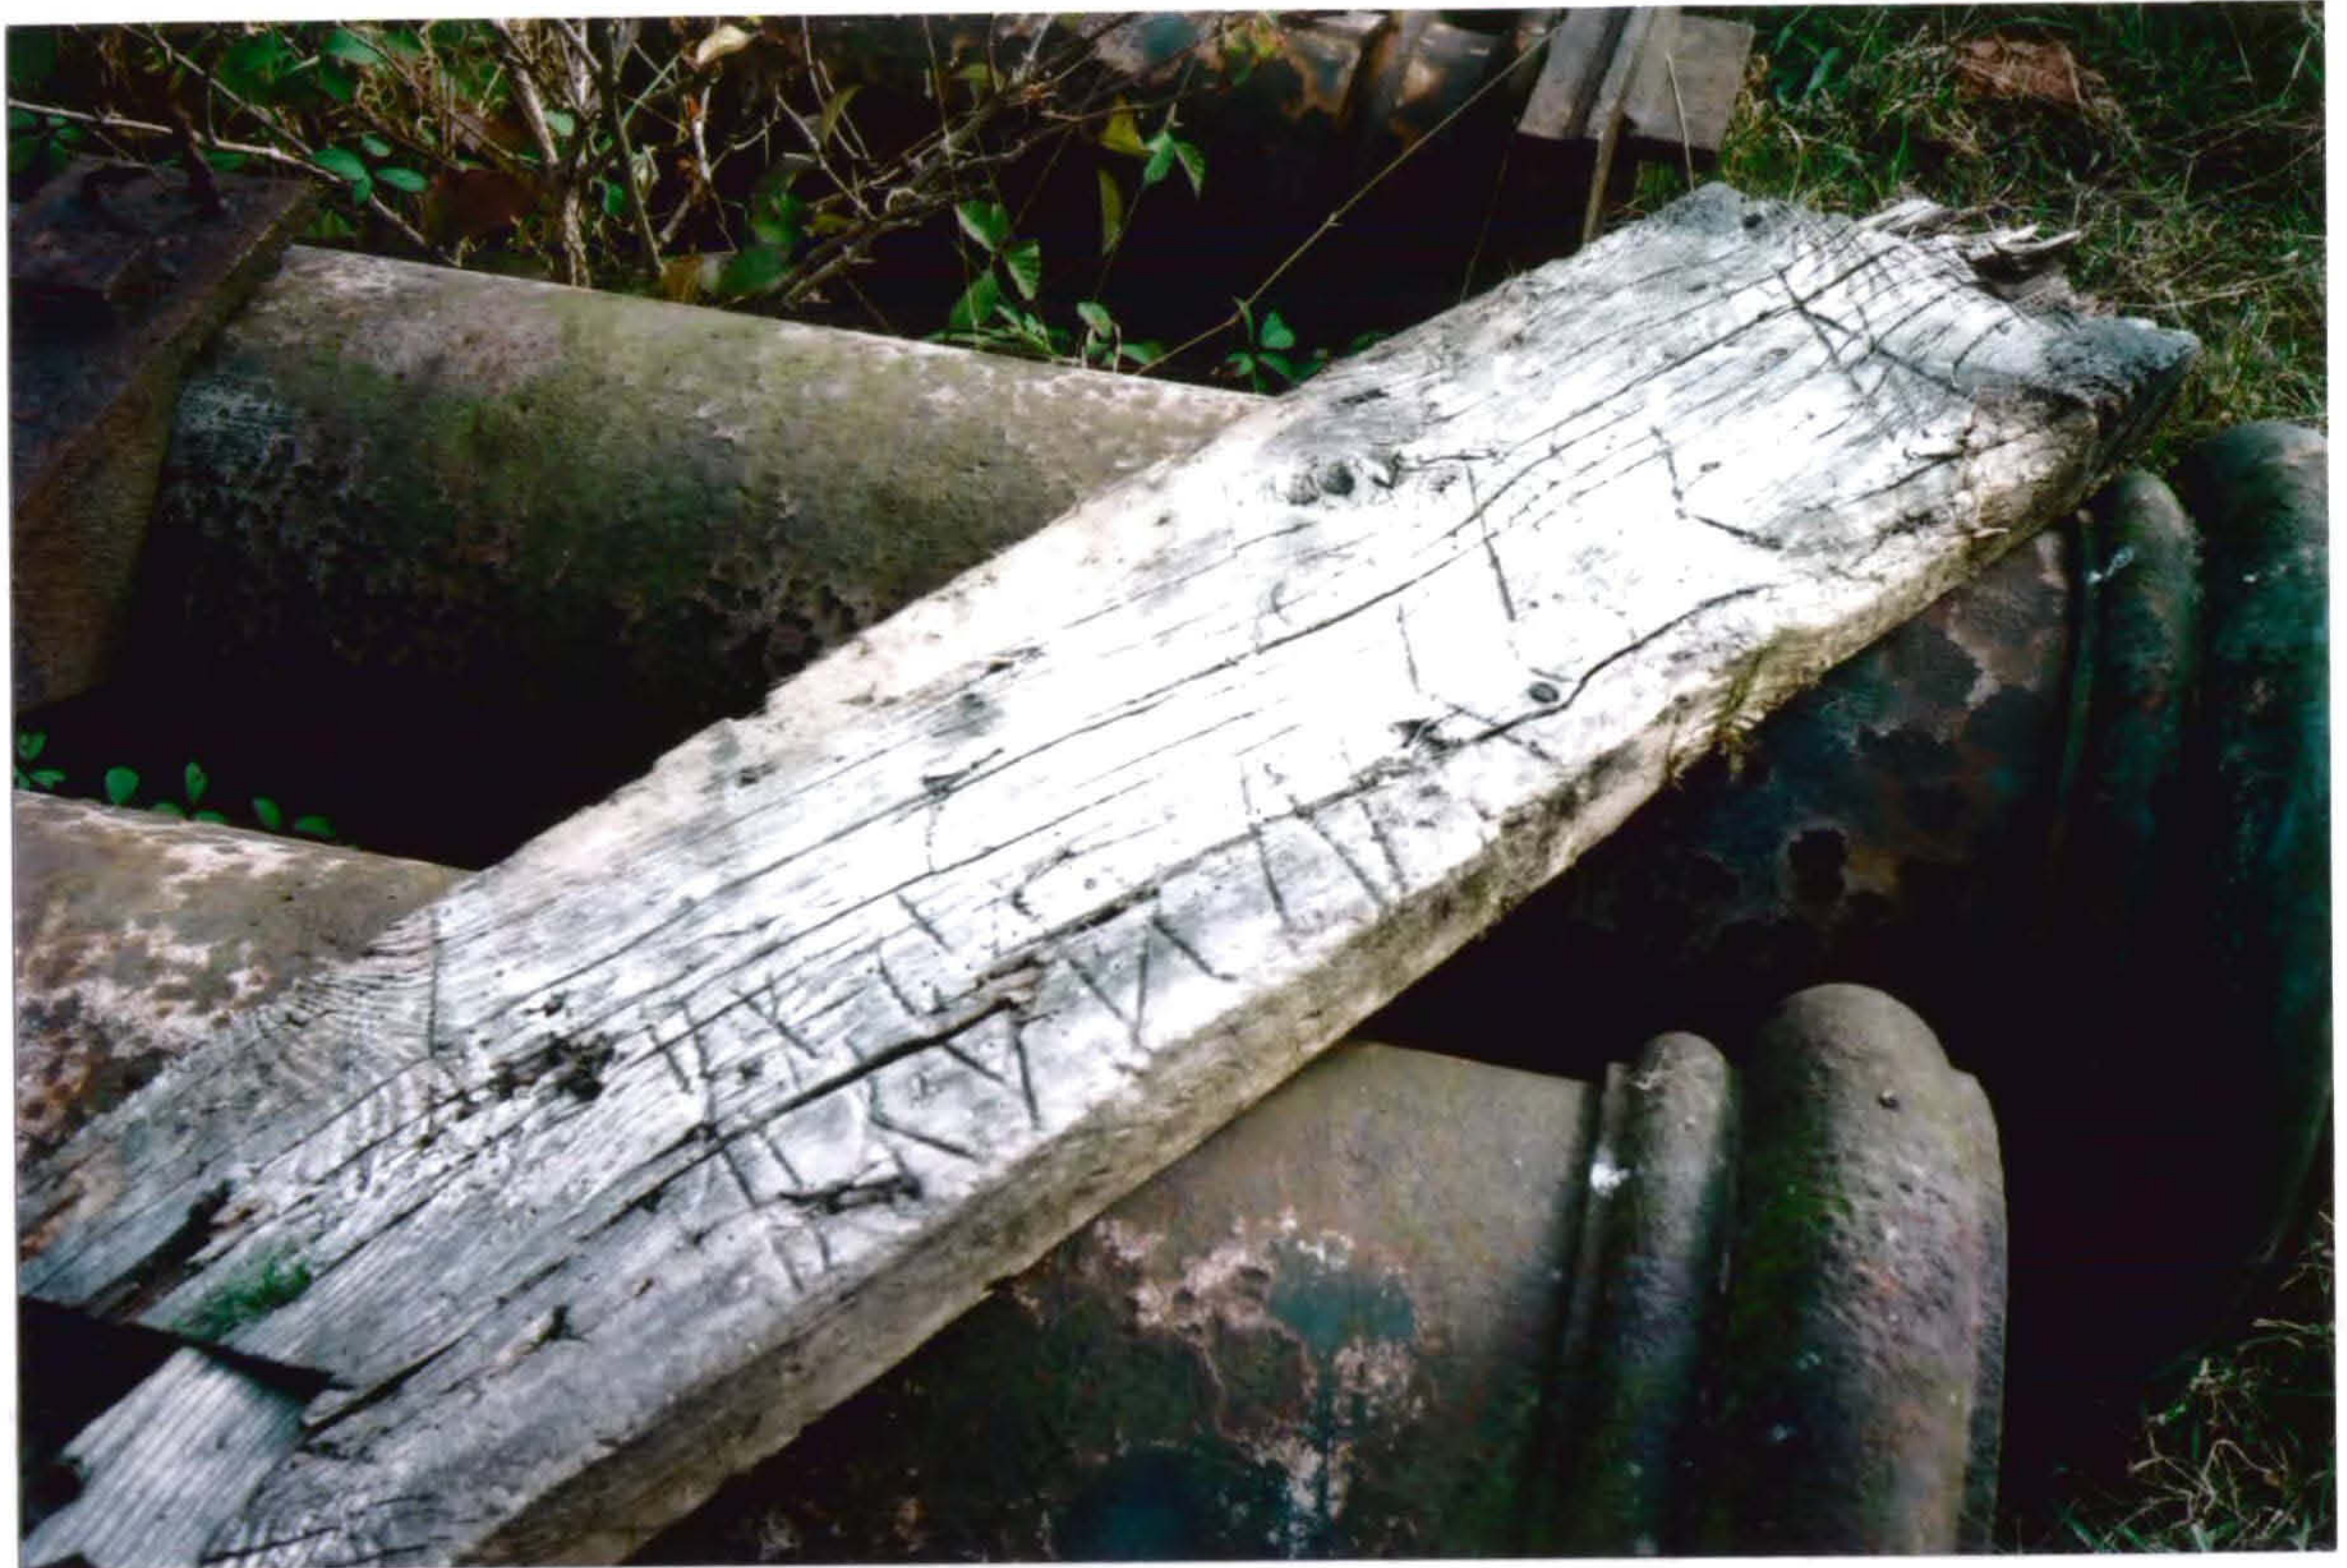
*Plate 11 Timber section with rase markings, see Fig.iii, p.26.  
The beam is sitting on top of two cast-iron columns similar to the  
two surviving examples standing in the Carriage House area.  
Location: salvaged materials area.*

Fig. iii Unprovenanced section of timber with rase marked numerals 262 and two minims with diagonal slash mark to the right of them. The marks to the left of the numerals have not been deciphered. The timber was a sawn fragment, possibly a spine beam, found in a pile of debris.  
 Fig. iv Section of tie-beam from a demolished principal rafter truss, with letters AXN and numerals which may be read as either 5's or 3's. The three vertical minims with diagonal slash may relate to batch marking for shipping.
